REPORT NUMBER: TWG-MGA-2015-004

**SIDE AIRBAG OUT-OF-POSITION INJURY
TECHNICAL WORKING GROUP**

**mitsubishi motors (thailand) co., ltd.
2015 Mitsubishi Mirage ES 5-Dr Hatchback
NHTSA No.: M20155600TWG2**

FINAL REPORT

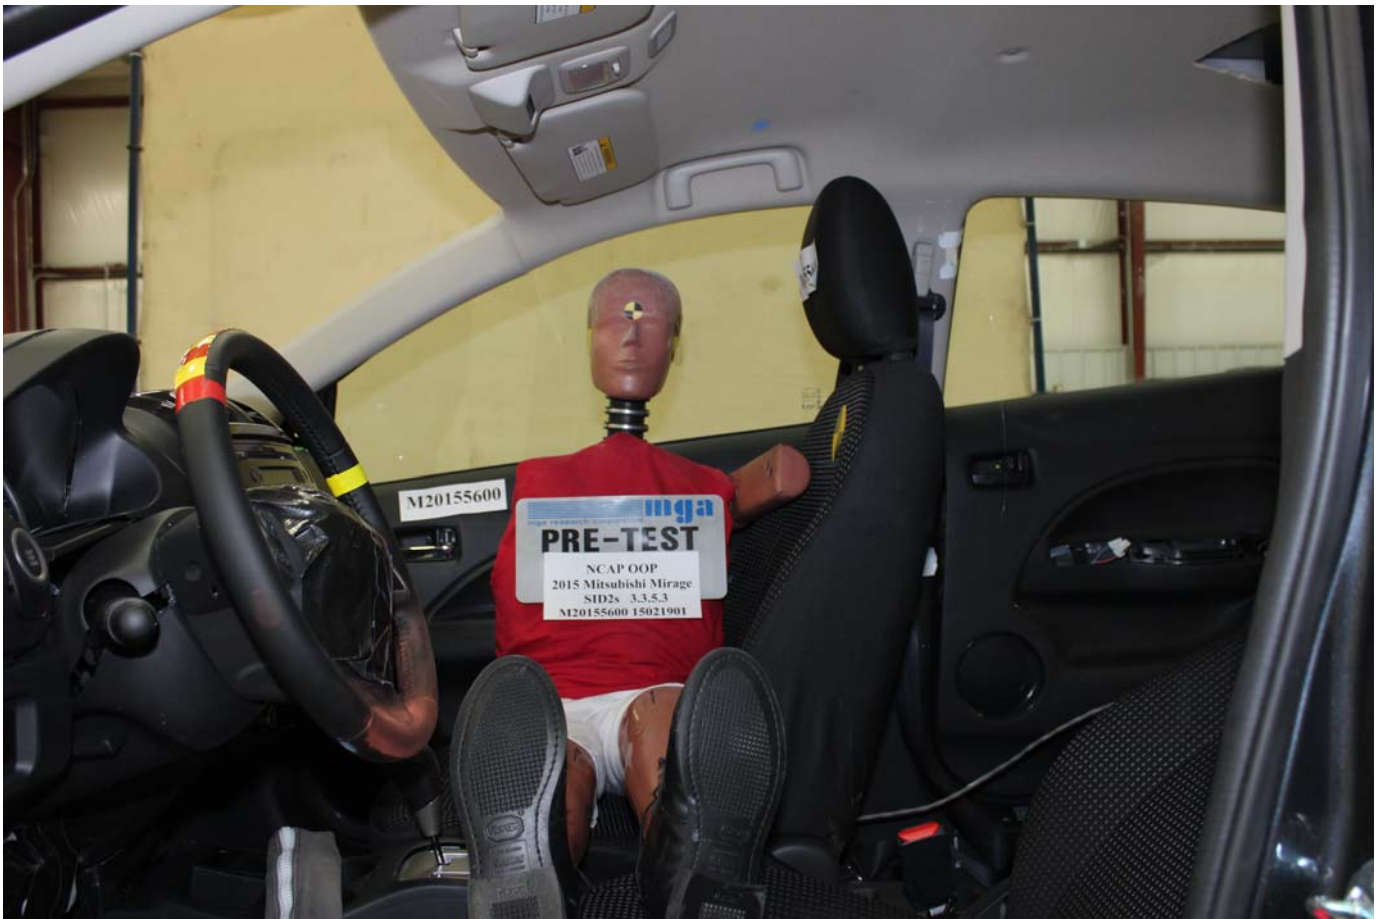
Photo No. 5 - Pre-Test SID-IIs Dummy Left Side View

The SID-II's dummy was placed in the right front passenger seat facing toward the center of the vehicle with its arm against the seatback. The arm was rotated horizontally in the forward direction with respect to the dummy. The seat track was adjusted forward to minimize the vertical distance between the dummy's head and curtain airbag. The dummy's pelvis was slid outboard until the dummy's back contacted the door trim panel or armrest and the CG of the head was centered in the deployment trajectory of the airbag. The vertical plane through the centerline of the dummy's rib-stiffener and shoulder bolt was parallel to the centerline of the vehicle. Masking tape was wrapped around the dummy's neck bracket to hold the dummy in place.

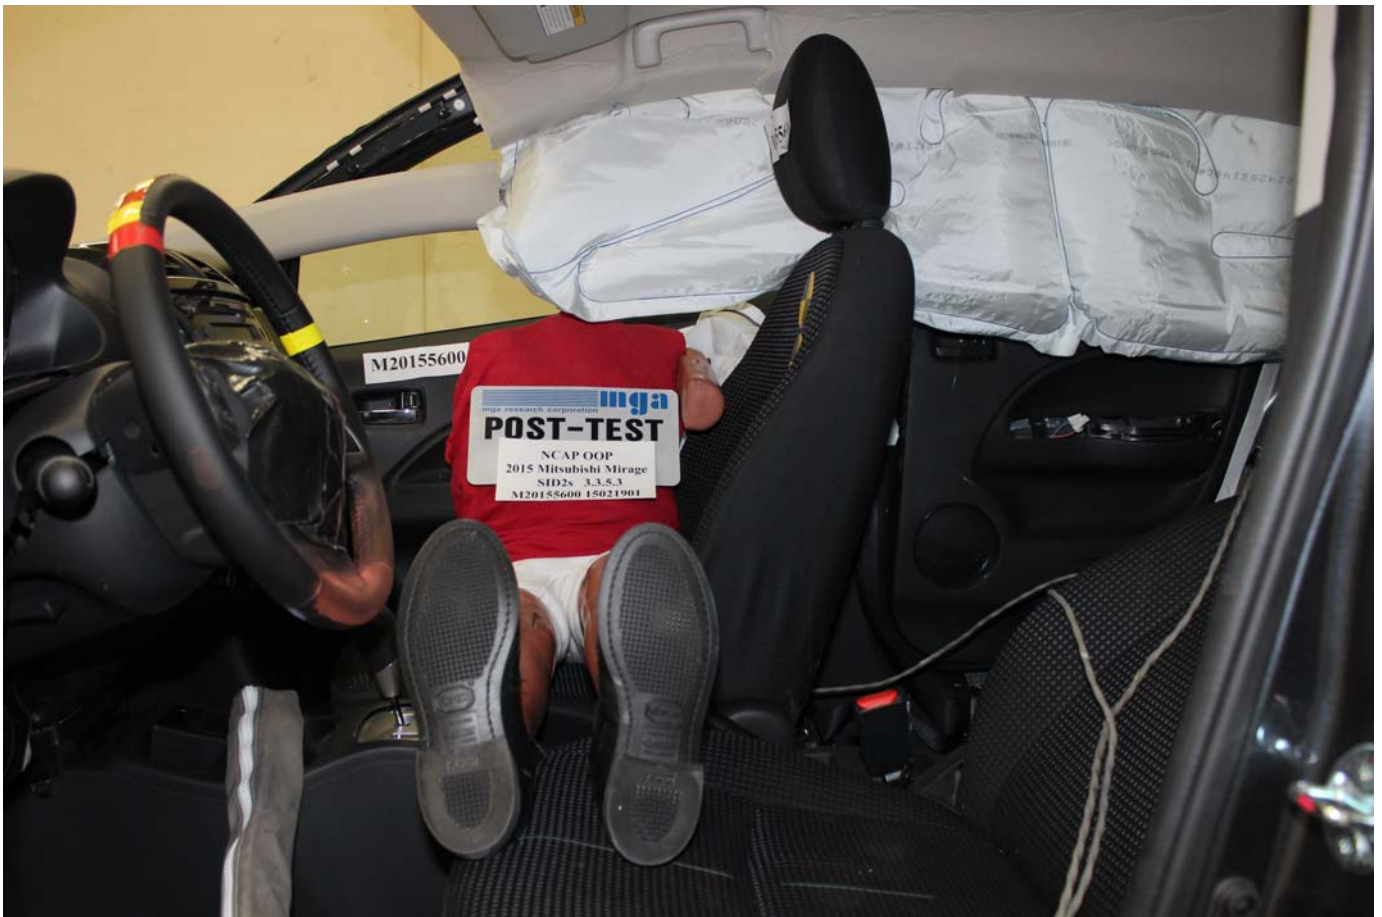
Photo No. 6 - Post-Test SID-IIs Dummy Left Side View

- Curtain airbag to top and front of head
- Torso bag to left torso and left pelvis

Visible Dummy Contact Points	
Head Contact	Curtain airbag top and front of head
Left Shoulder Contact	None
Left Torso Contact	Torso bag
Left Pelvis Contact	Torso bag

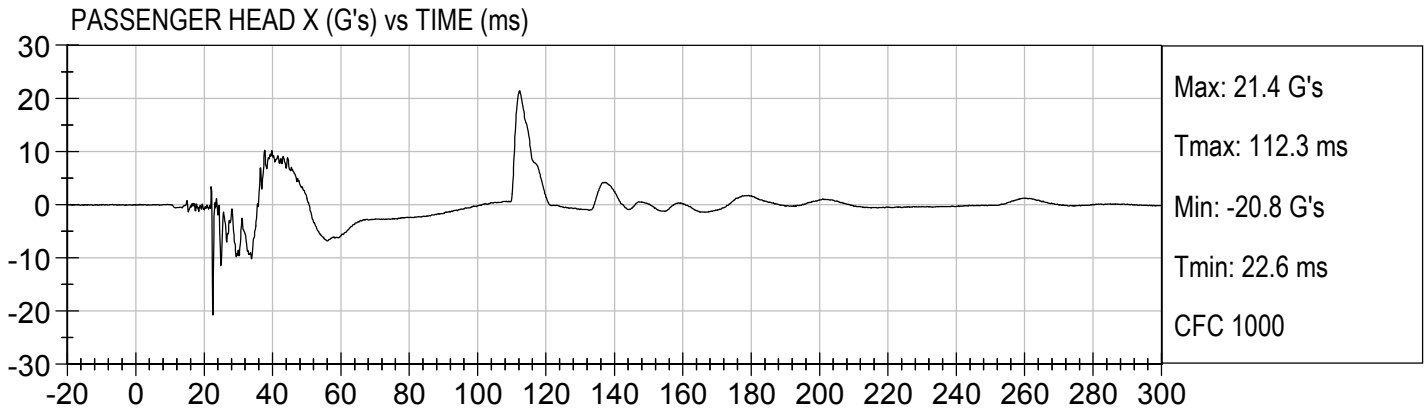
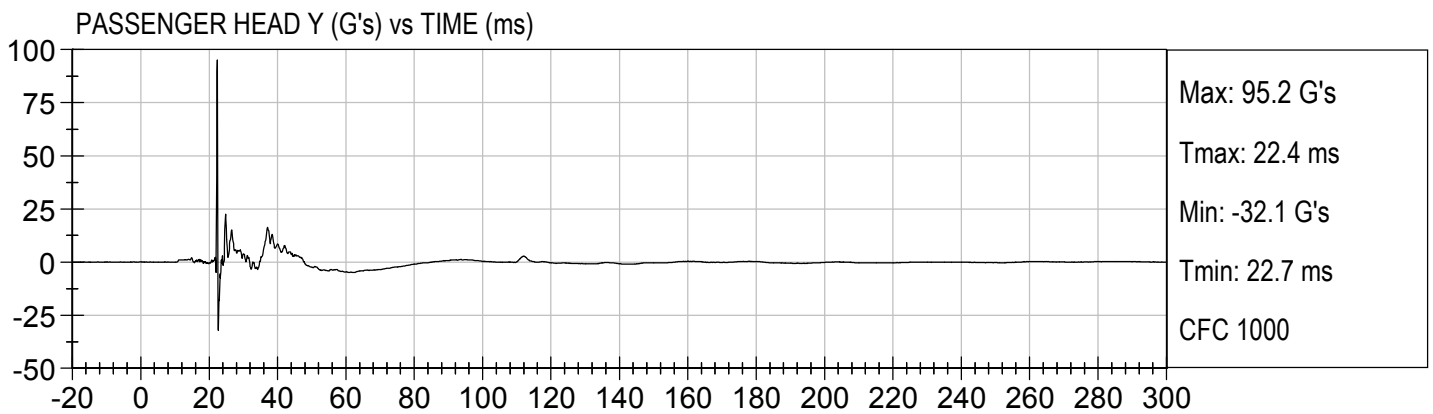
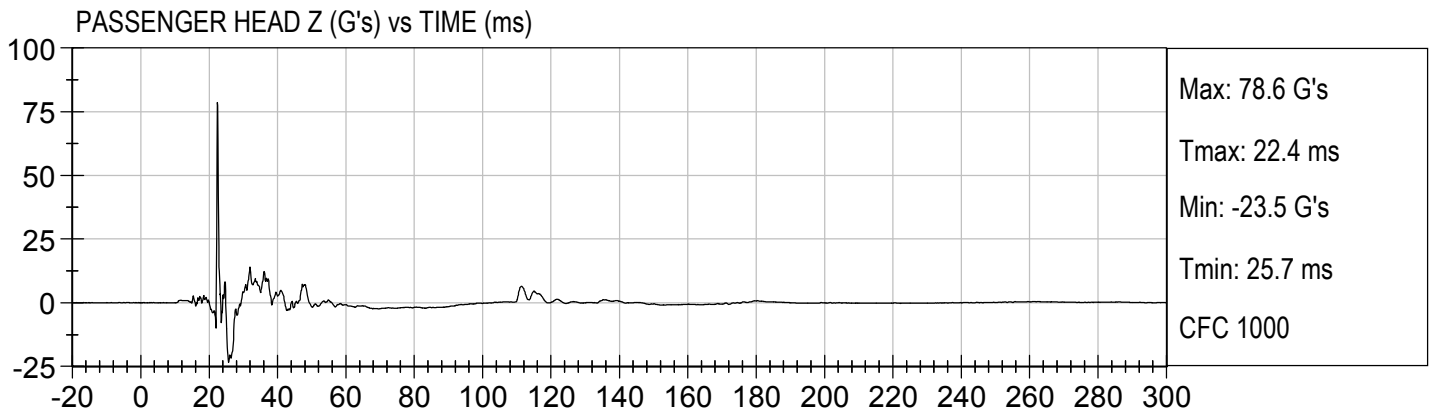
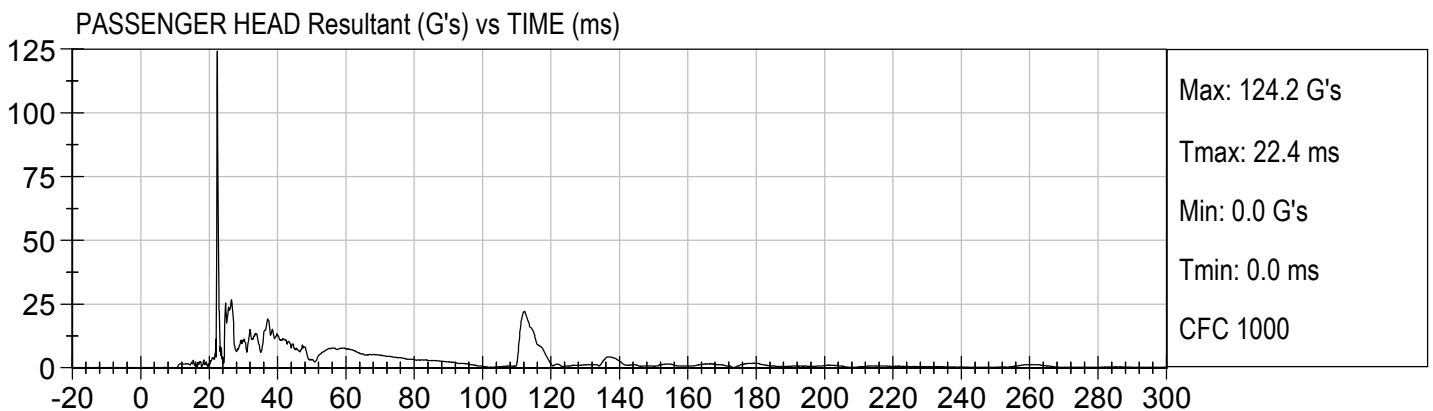
<u>Page No.</u>
Figure No. 1.	Passenger Head X Acceleration vs. Time	23
Figure No. 2.	Passenger Head Y Acceleration vs. Time	23
Figure No. 3.	Passenger Head Z Acceleration vs. Time	23
Figure No. 4.	Passenger Head Resultant Acceleration vs. Time	23
Figure No. 5.	Passenger Upper Neck X Force vs. Time	24
Figure No. 6.	Passenger Upper Neck Y Force vs. Time	24
Figure No. 7.	Passenger Upper Neck Z Force vs. Time	24
Figure No. 8.	Passenger Upper Neck Resultant Force vs. Time	24
Figure No. 9.	Passenger Upper Neck X Moment vs. Time	25
Figure No. 10.	Passenger Upper Neck Y Moment vs. Time	25
Figure No. 11.	Passenger Upper Neck Z Moment vs. Time	25
Figure No. 12.	Passenger Upper Neck Resultant Moment vs. Time	25
Figure No. 13.	Passenger Curtain Airbag – Fire Voltage vs. Time	26
Figure No. 14.	Passenger Curtain Airbag – Fire Current vs. Time	26
Figure No. 15.	Passenger Seat Airbag – Fire Voltage vs. Time	26
Figure No. 16.	Passenger Seat Airbag – Fire Current vs. Time	26

MAXIMUM VALUE			
		Position No. 2			
DESCRIPTION	UNIT	MAXIMUM	TIME (ms)	MINIMUM	TIME (ms)
Head X	g	21.4	112.3	-20.8	22.6
Head Y	g	95.2	22.4	-32.1	22.7
Head Z	g	78.6	22.4	-23.5	25.7
Head Resultant	g	124.2	22.4		
Upper Neck Fx	N	448.9	41.2	-52.5	140.7
Upper Neck Fy	N	194.8	42.0	-247.9	22.7
Upper Neck Fz	N	47.3	47.1	-1708.1	24.9
Upper Neck F Resultant	N	1713.4	24.9		
Upper Neck Mx	Nm	14.4	34.6	-12.7	42.9
Upper Neck My	Nm	40.9	43.3	-2.2	20.4
Upper Neck Mz	Nm	9.6	71.1	-1.0	0.3
Upper Neck M Resultant	Nm	42.9	43.0
