REPORT NUMBER: TWG-MGA-2015-005

**SIDE AIRBAG OUT-OF-POSITION INJURY
TECHNICAL WORKING GROUP**

**FORD MOTOR COMPANY
2015 Ford Transit 150 LR Wagon XLT
NHTSA No.: M20150203TWG2**

FINAL REPORT

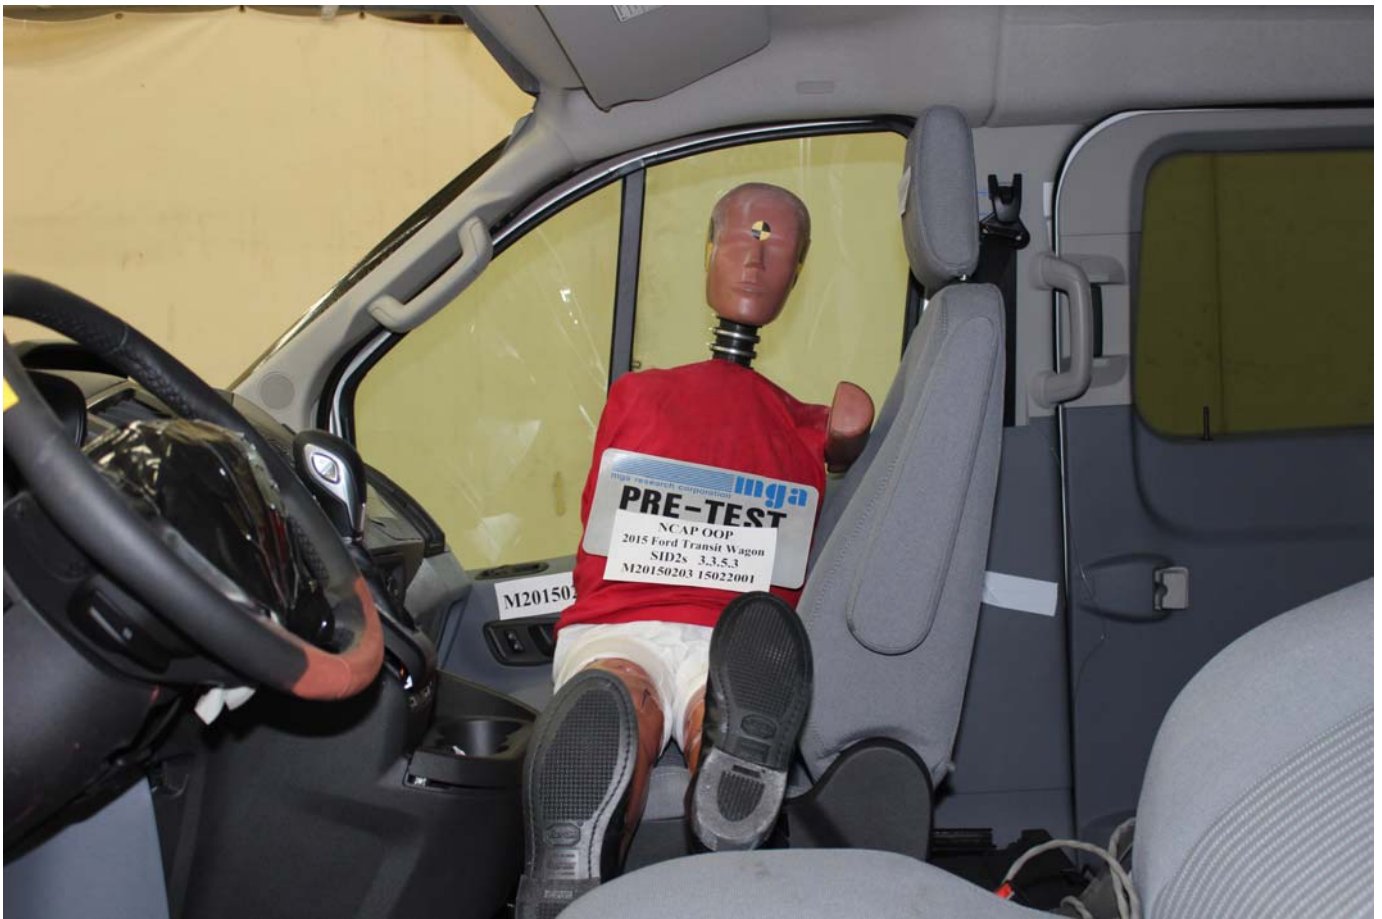
Photo No. 5 - Pre-Test SID-IIs Dummy Left Side View

The SID-II's dummy was placed in the right front passenger seat facing toward the center of the vehicle with its arm against the seatback. The arm was rotated horizontally in the forward direction with respect to the dummy. The seat track was adjusted forward to minimize the vertical distance between the dummy's head and curtain airbag. The dummy's pelvis was slid outboard until the dummy's back contacted the door trim panel or armrest and the CG of the head was centered in the deployment trajectory of the airbag. The vertical plane through the centerline of the dummy's rib-stiffener and shoulder bolt was parallel to the centerline of the vehicle. Masking tape was wrapped around the dummy's neck bracket to hold the dummy in place.

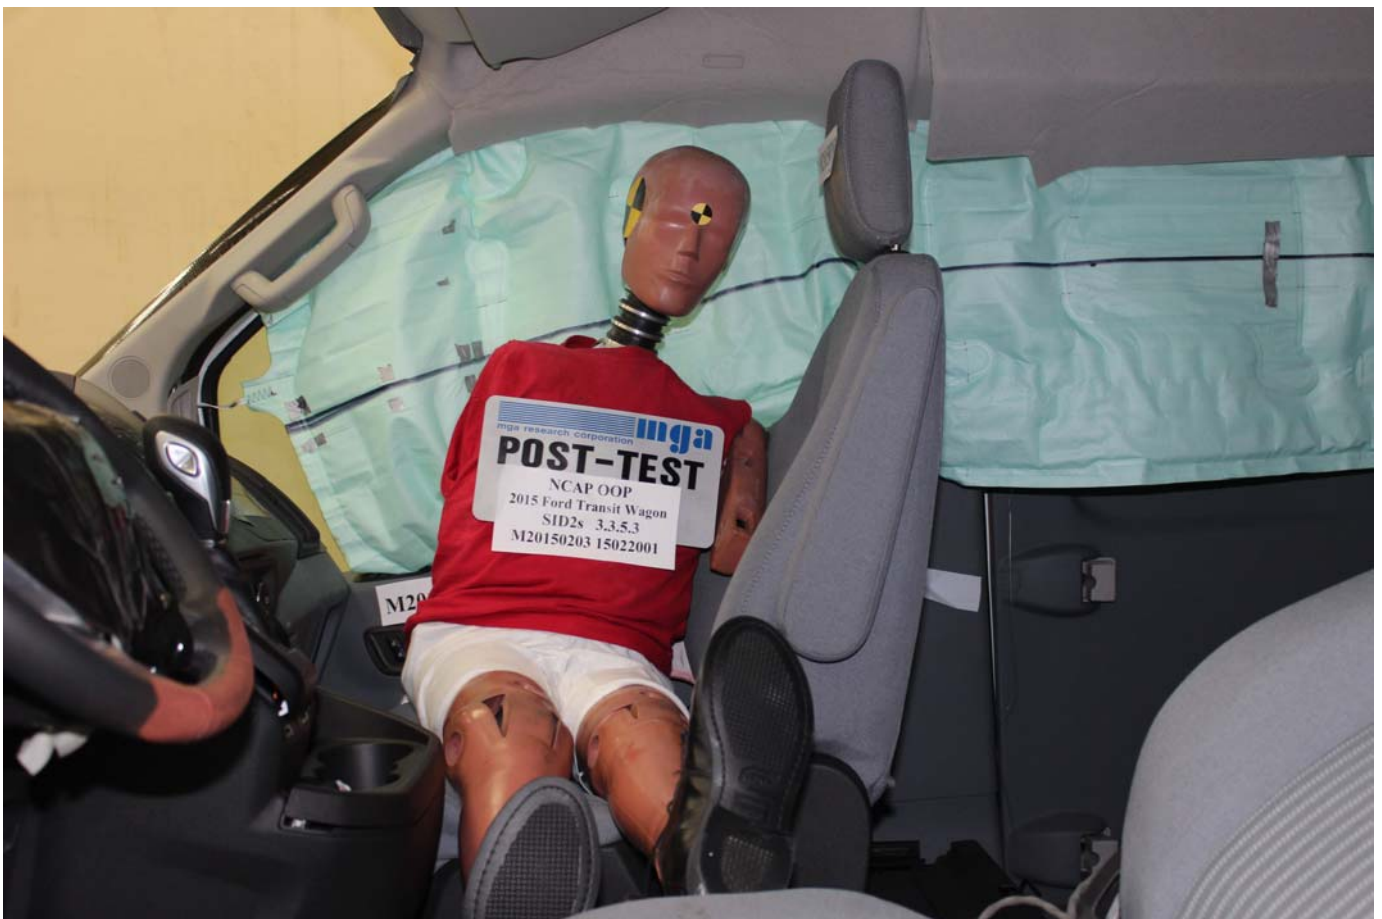
Photo No. 6 - Post-Test SID-IIs Dummy Left Side View

- Curtain airbag to top and back of head
- Torso bag to left shoulder, left torso and left pelvis

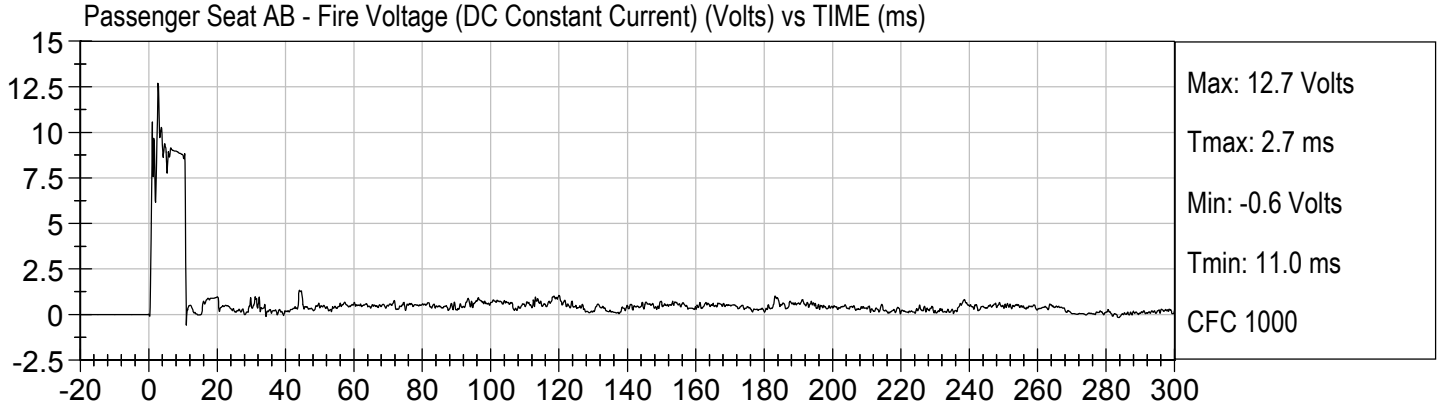
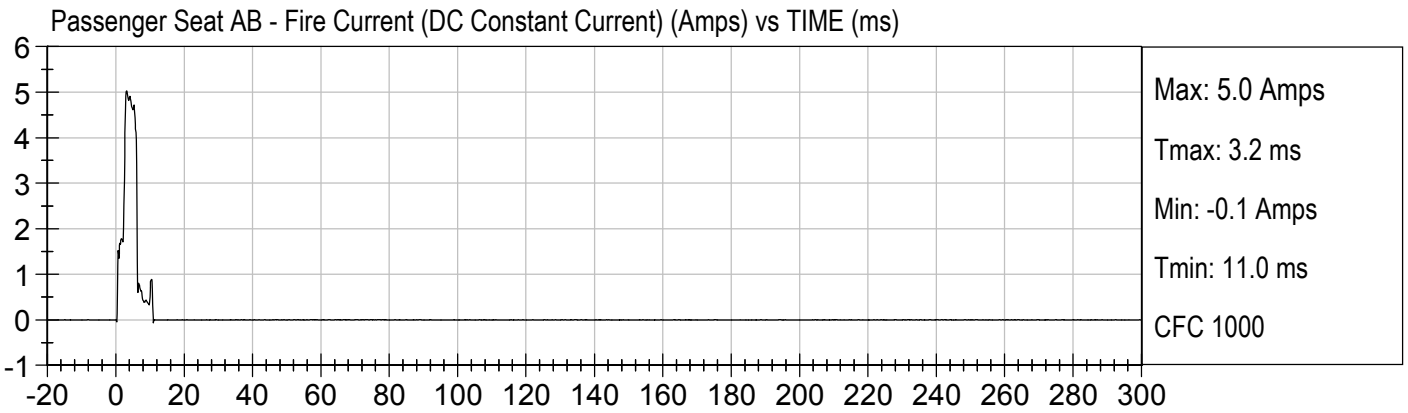
Figure No. 17.	Passenger Seat Airbag – Fire Voltage vs. Time	27
Figure No. 18.	Passenger Seat Airbag – Fire Current vs. Time	27
