REPORT NUMBER: TWG-MGA-2015-006

**SIDE AIRBAG OUT-OF-POSITION INJURY
TECHNICAL WORKING GROUP**

**FORD MOTOR COMPANY
2015 Ford Expedition XLT EL 4X4 SUV
NHTSA No.: M20150210TWG2**

FINAL REPORT

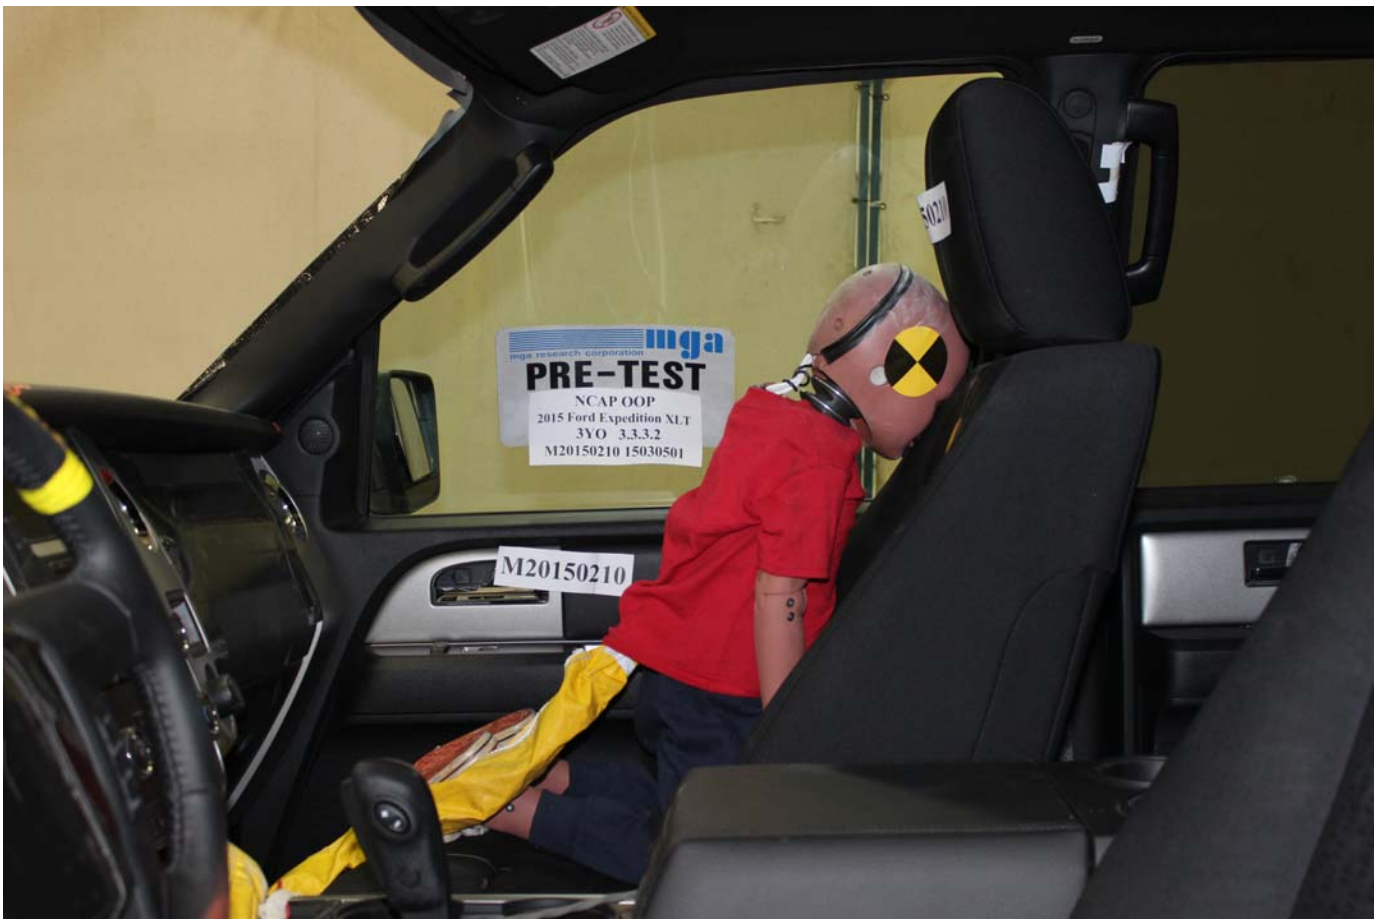
Photo No. 5 - Pre-Test 3-Year-Old Child Dummy Left Side View

The Hybrid III 3-Year-Old child dummy was placed in the right front passenger seat along the outboard edge of the seat cushion, kneeling and facing rearward. The vertical centerline of the dummy's sternum was aligned as close as possible with the leading edge of the seatback bolster. The sternum contacted with seat. The dummy's head was placed in between the seat bolster and pillar/side trim to maximize contact between the sternum and seatback. The head remained in its neutral orientation. The outboard leg was positioned at the outboard edge of the seat cushion and parallel to the seat centerline and remained on the cushion. The outboard knee and lower leg was slid toward the seatback/seat cushion junction until the top edge of the upper rib was aligned horizontally with the top edge of the airbag module. The inboard leg was aligned parallel to the centerline of the seat cushion. The inboard knee and lower leg was slid toward the seat bight until a line drawn through both shoulder bolts was perpendicular to the vehicle centerline. The inboard arm was rotated towards the seatback until the thumb contacts the seatback. The outboard arm and hand was rotated to hang down as close to vertical as possible.

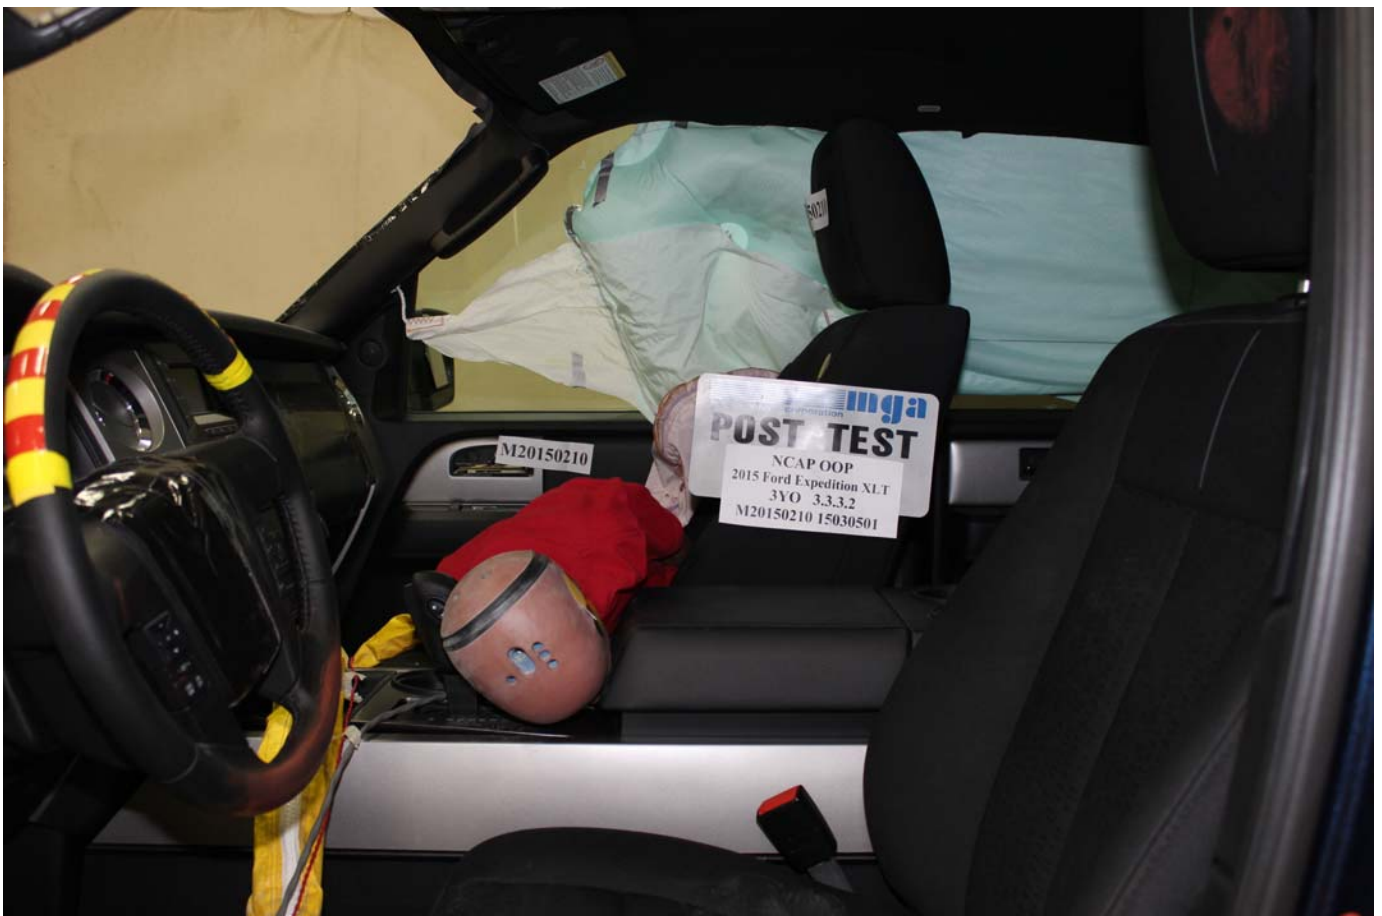
Photo No. 6 - Post-Test 3-Year-Old Child Dummy Left Side View

- Curtain bag to left side of head and left shoulder
- Torso bag to left side of head, left shoulder, left torso, and left pelvis
