**REPORT NUMBER: TWG-MGA-2015-007**

**SIDE AIRBAG OUT-OF-POSITION INJURY  
TECHNICAL WORKING GROUP**

**MAZDA MOTOR CORPORATION  
2015 Mazda CX-9 Sport SUV  
NHTSA No.: M20155401TWG2**

**FINAL REPORT**

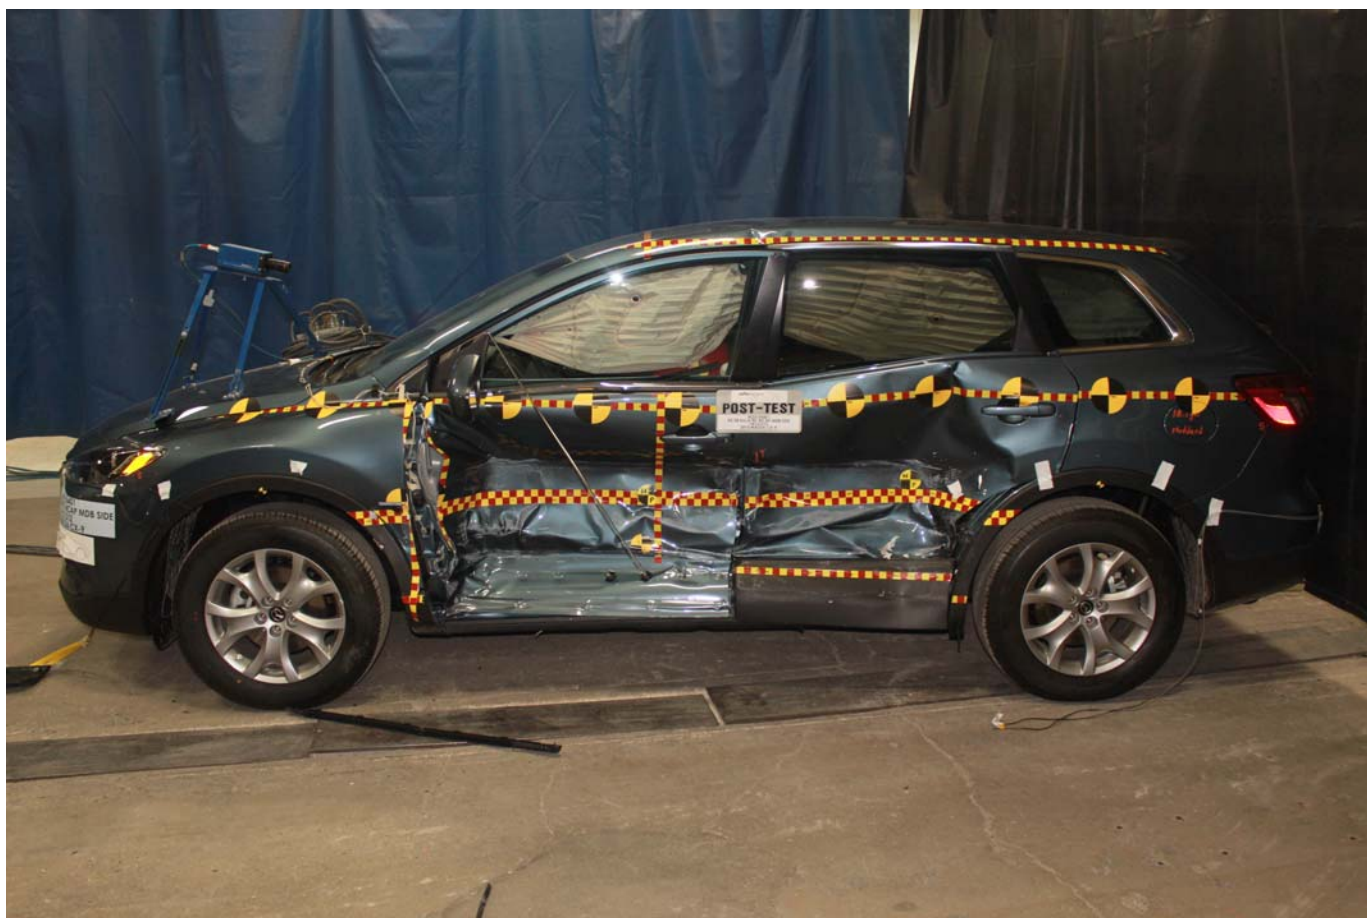
Photo No. 4 - Post-Test Vehicle Left Side View

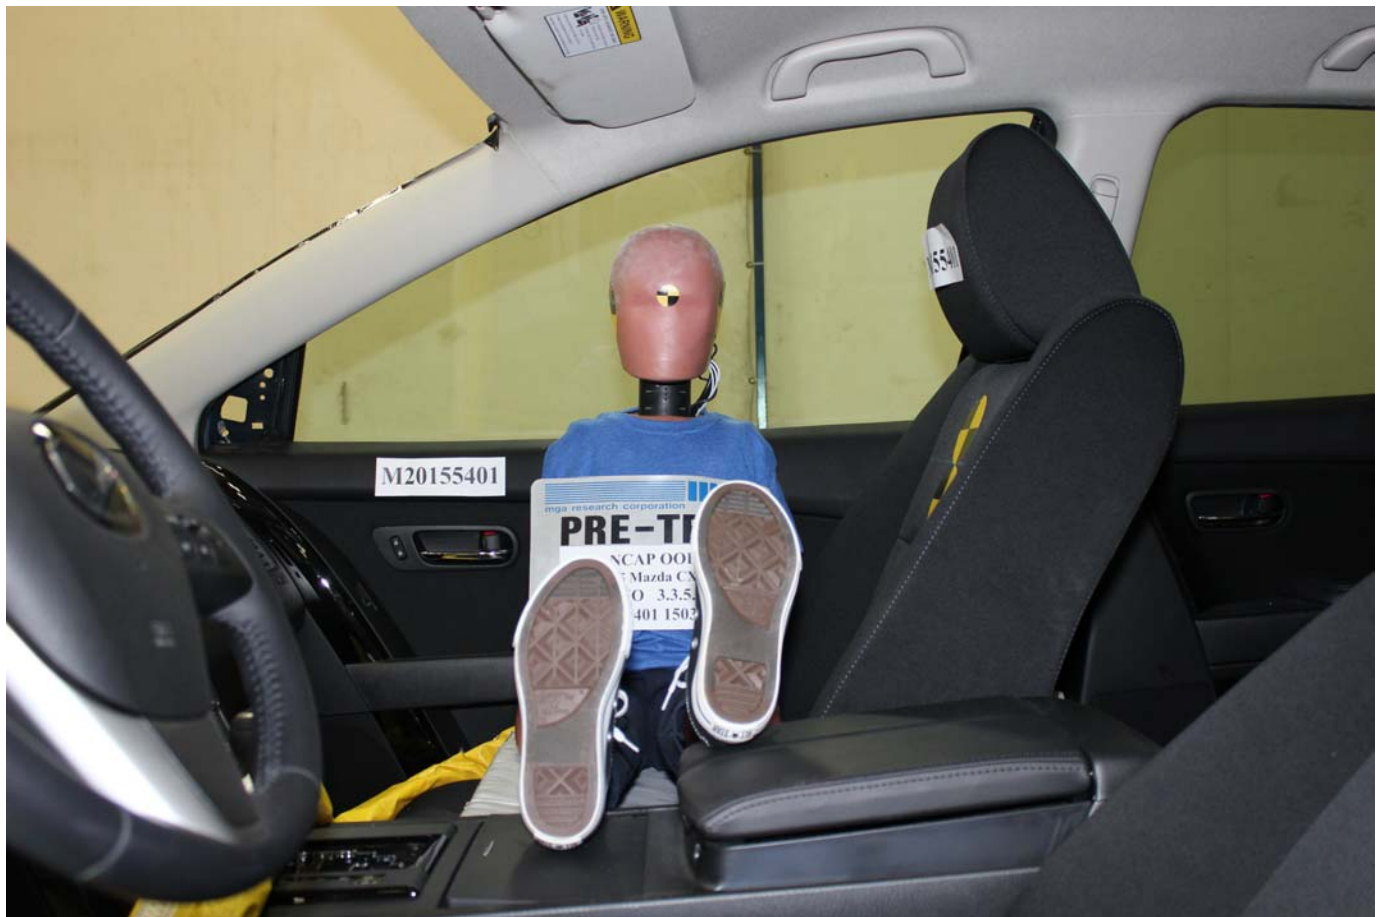
Photo No. 5 - Pre-Test 6-Year-Old Child Dummy Left Side View

The Hybrid III 6-Year-Old child dummy was placed in the right front passenger seat along the outboard edge of the foam block, facing inboard with its legs extended and arms hanging at its sides. The seat track was positioned forward to maximize the cushion to head interaction. The dummy's pelvis was slid outboard until the dummy's back contacted the door trim panel or armrest and the center of gravity of the head was centered in the deployment trajectory of the airbag. The head remained in its neutral orientation. A vertical plane through the centerline of the dummy's shoulder bolts was parallel to the vehicle centerline. The dummy's arms were bent at the elbow until the fingertips contacted the foam block.

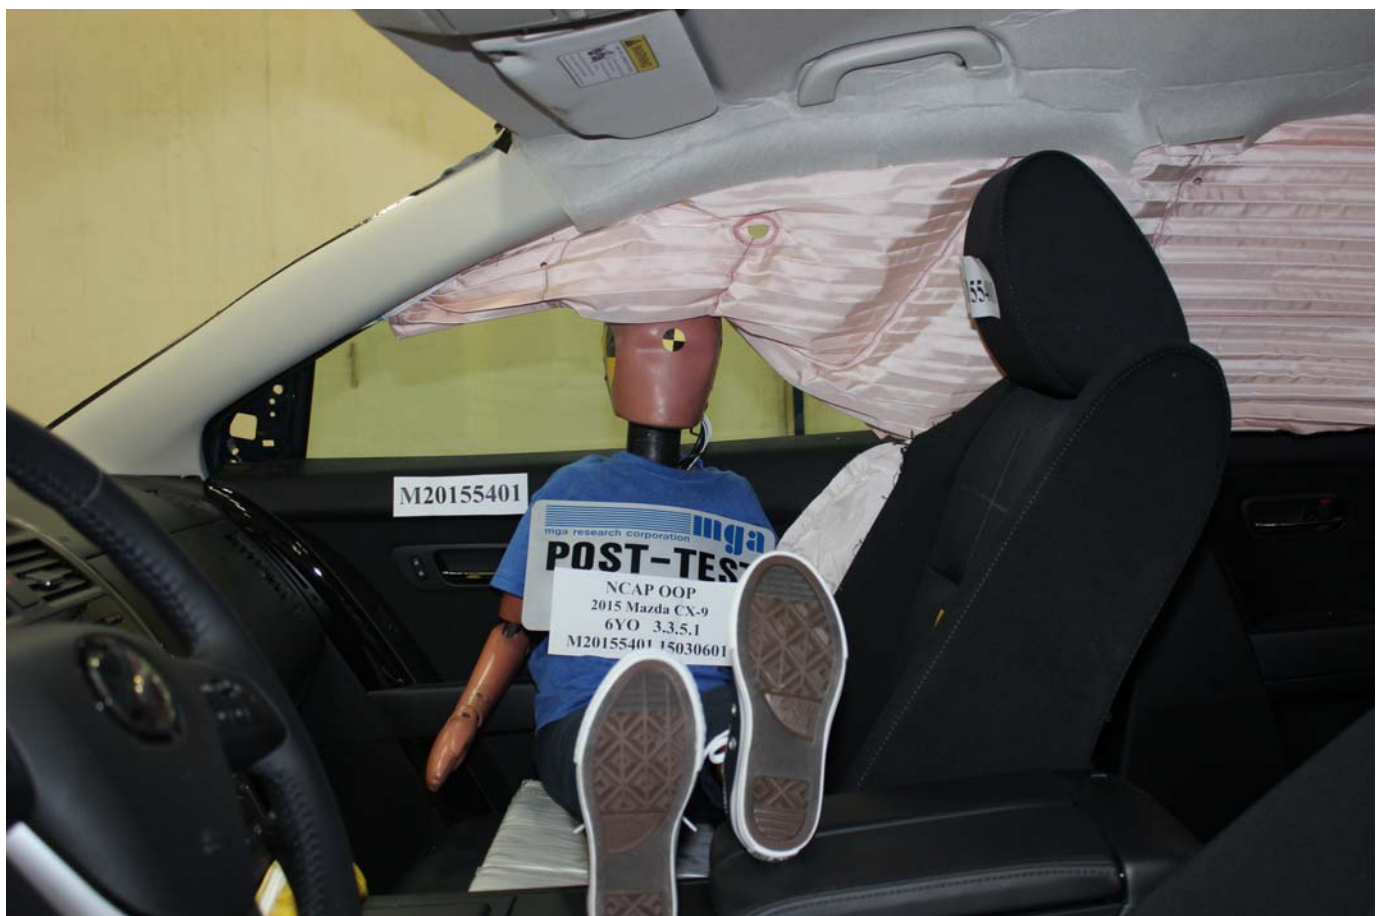
Photo No. 6 - Post-Test 6-Year-Old Child Dummy Left Side View

- Curtain airbag to top and front of head
- Torso bag to left side of shoulder, torso, and pelvis

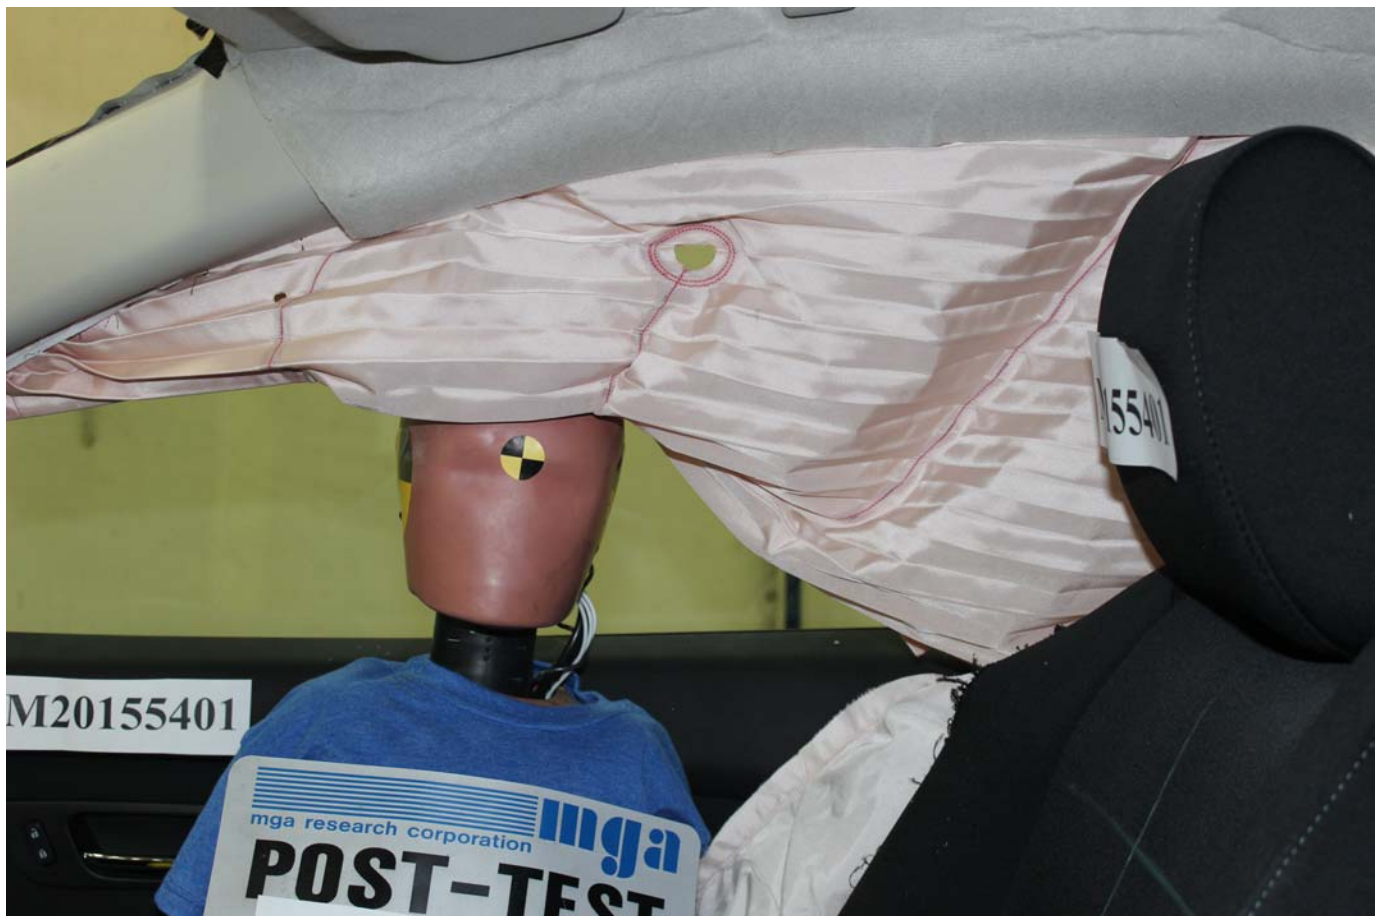
Photo No. 8 - Post-Test 6-Year-Old Child Dummy Left Side Closeup View

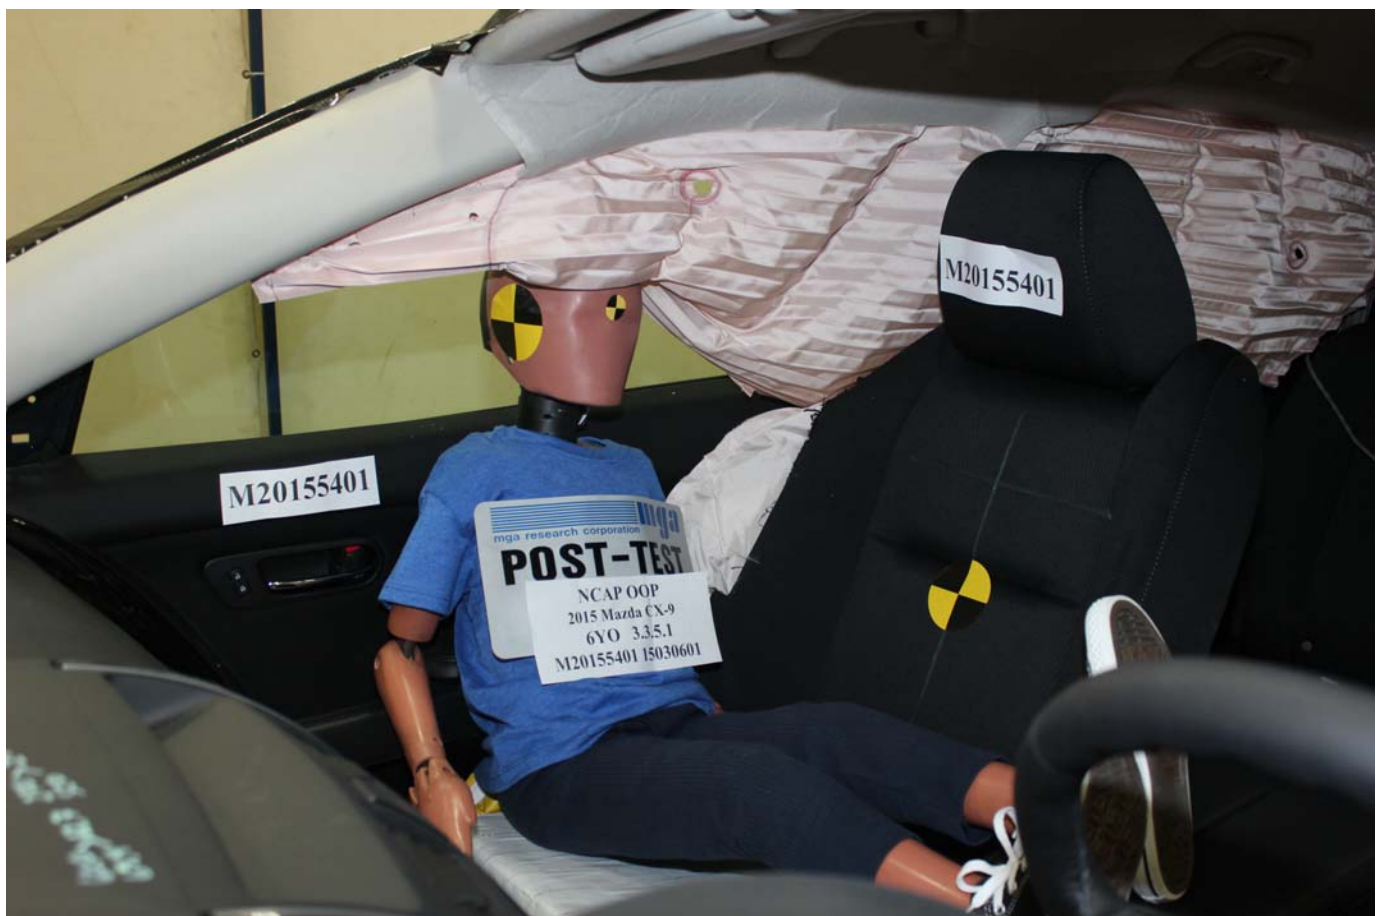
Photo No. 10 - Post-Test 6-Year-Old Child Dummy Left  $\frac{3}{4}$  Front View

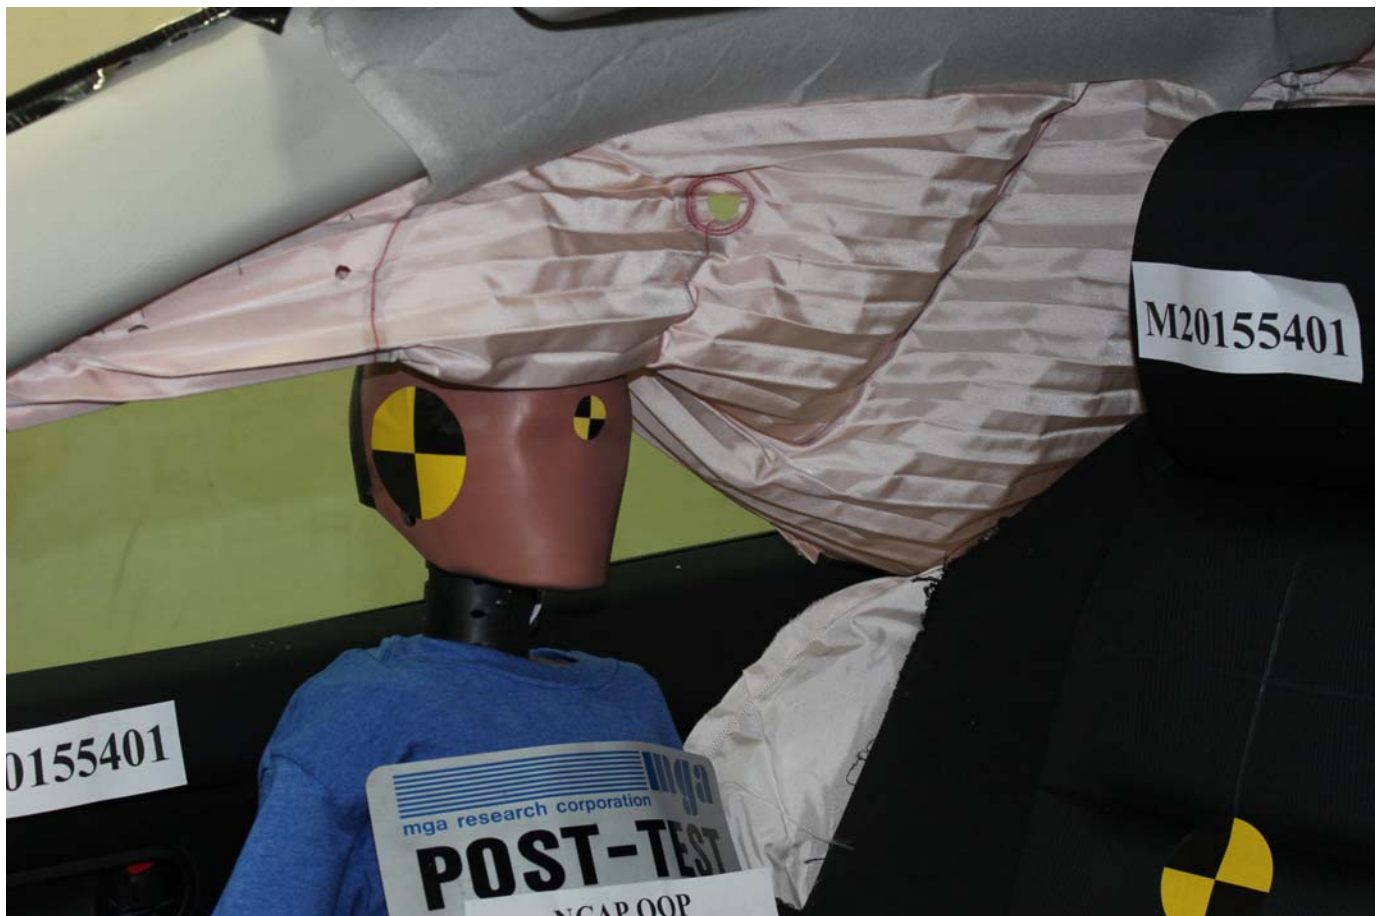
Photo No. 12 - Post-Test 6-Year-Old Child Dummy Left ¾ Front Closeup View

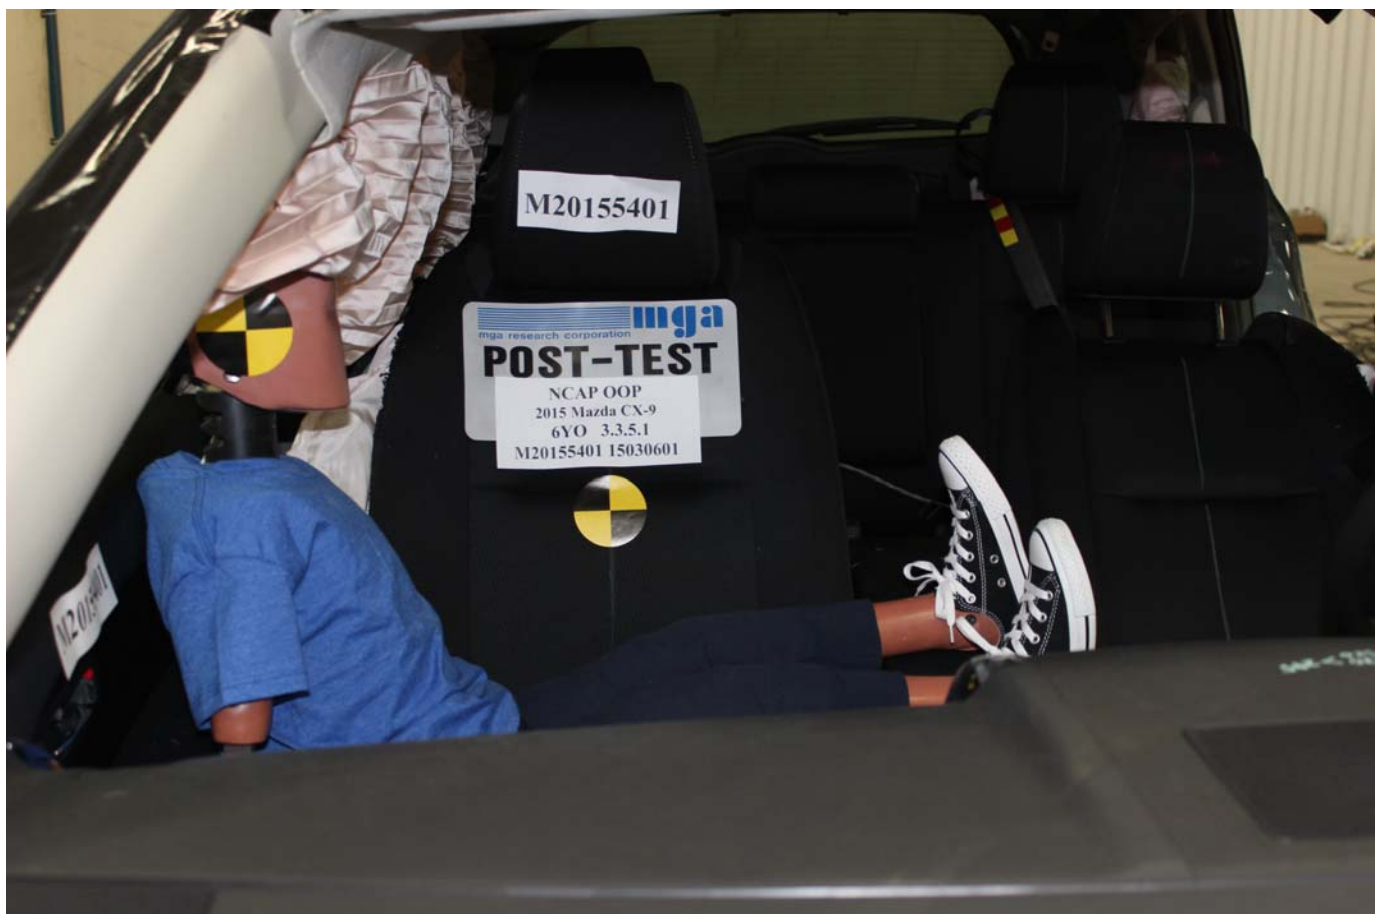
Photo No. 14 - Post-Test 6-Year-Old Child Dummy Front View

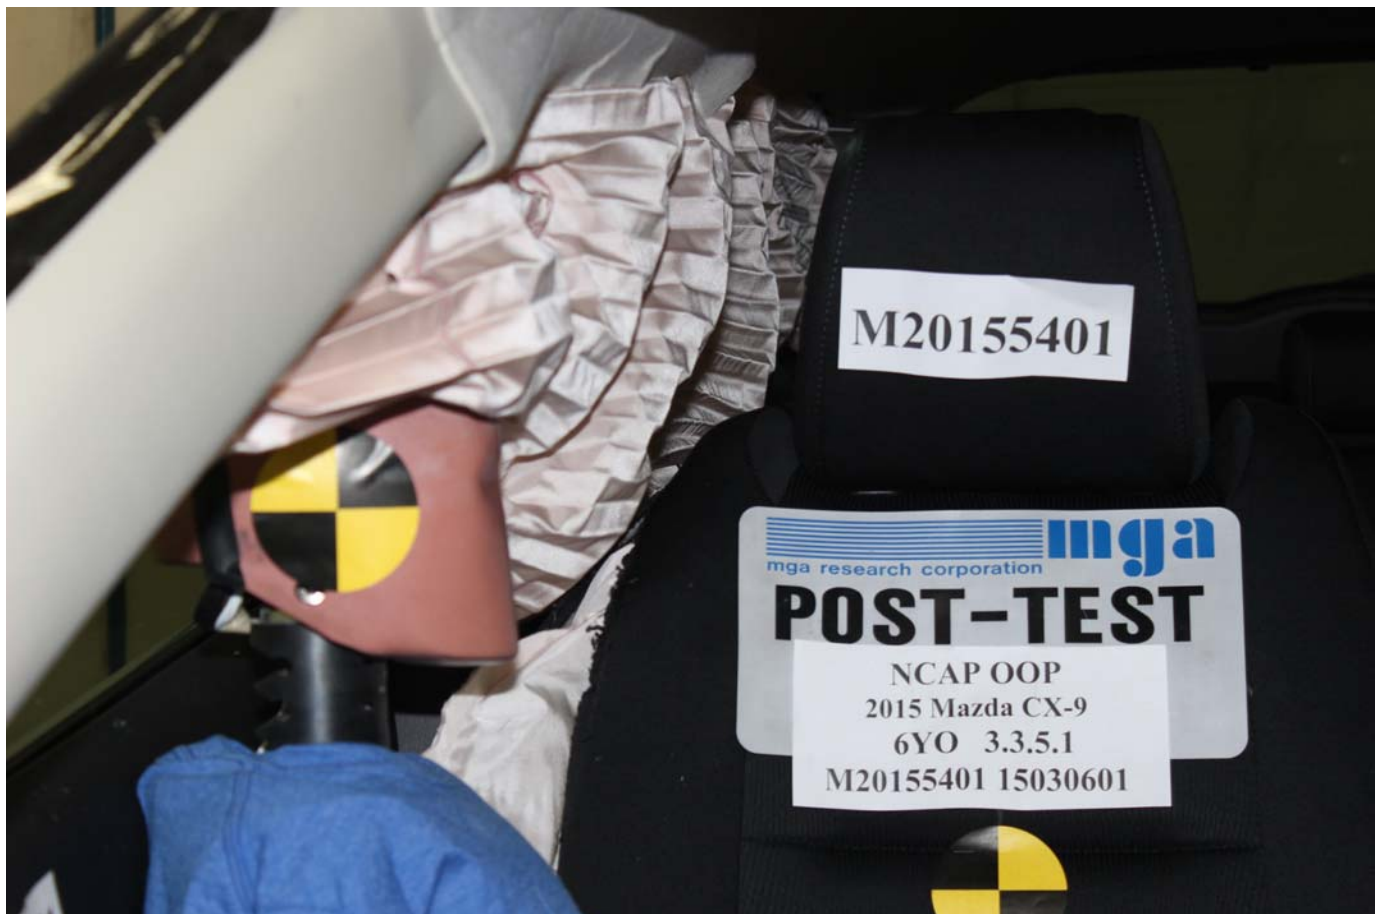
Photo No. 16 - Post-Test 6-Year-Old Child Dummy Front Closeup View

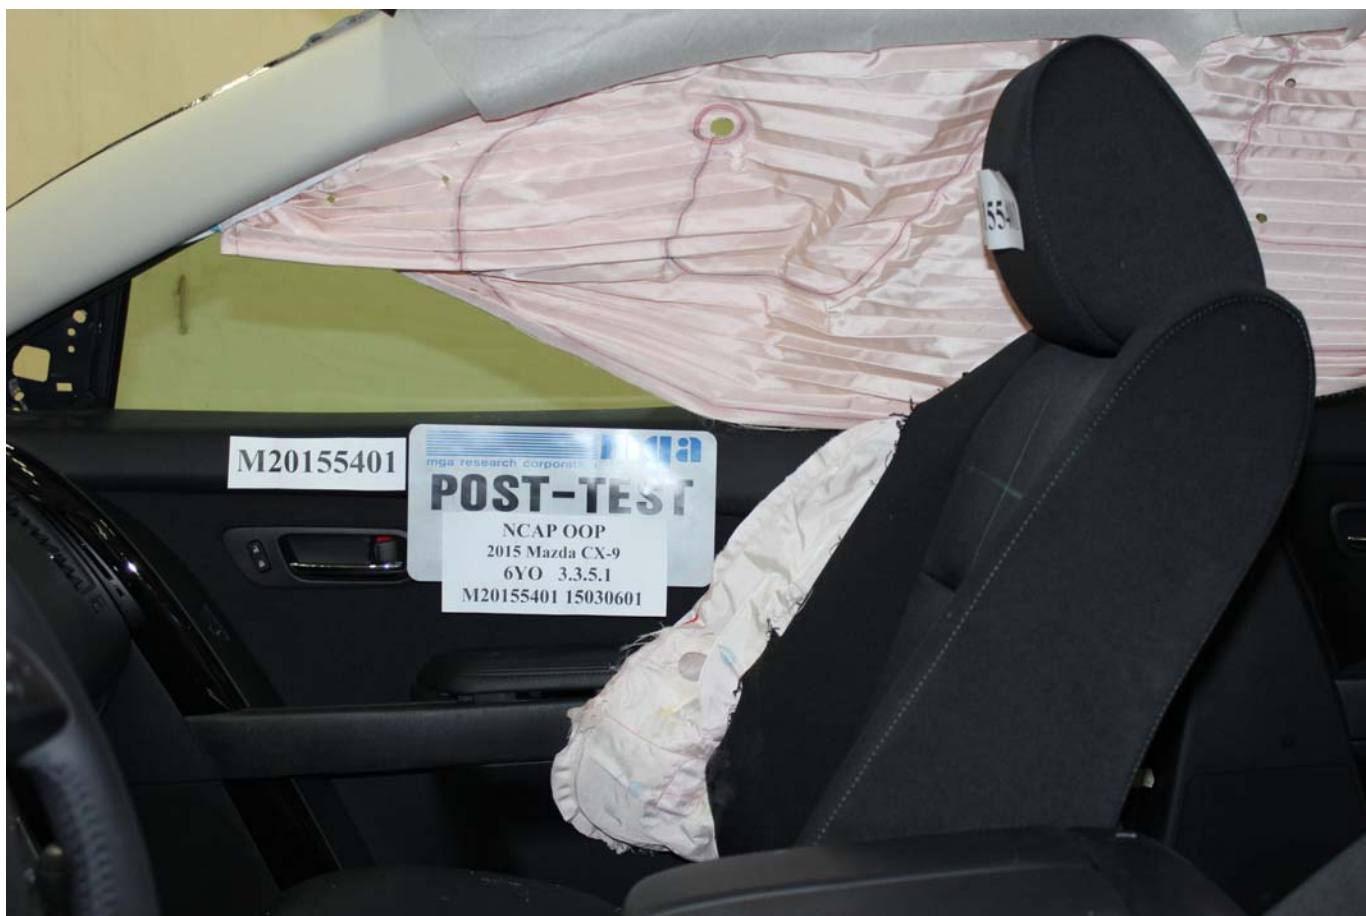
Photo No. 22 - Post-Test Curtain Airbag Left Side View

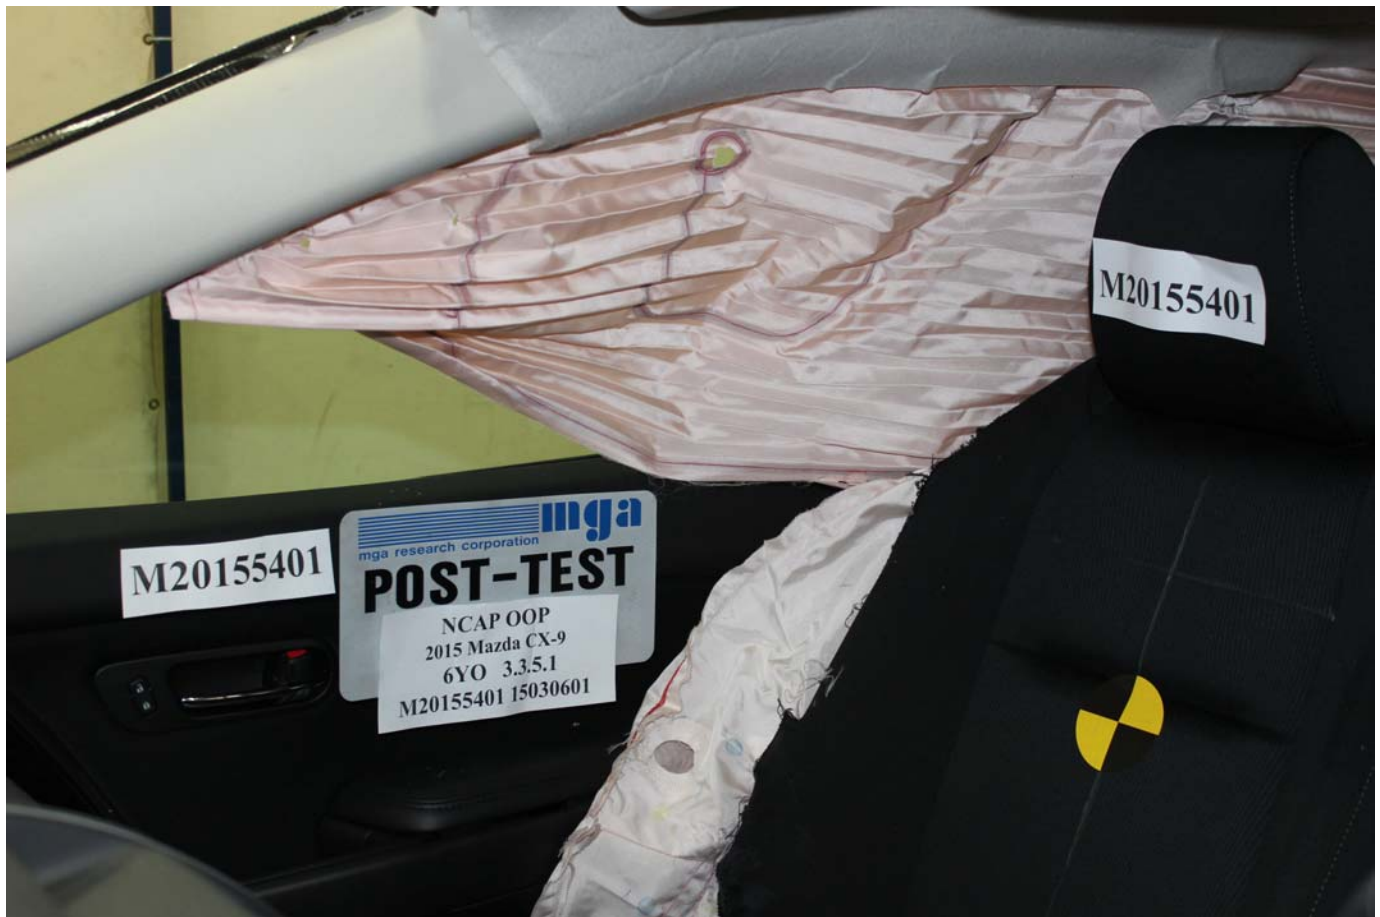
Photo No. 23 - Post-Test Curtain Airbag Left 3/4 Front View

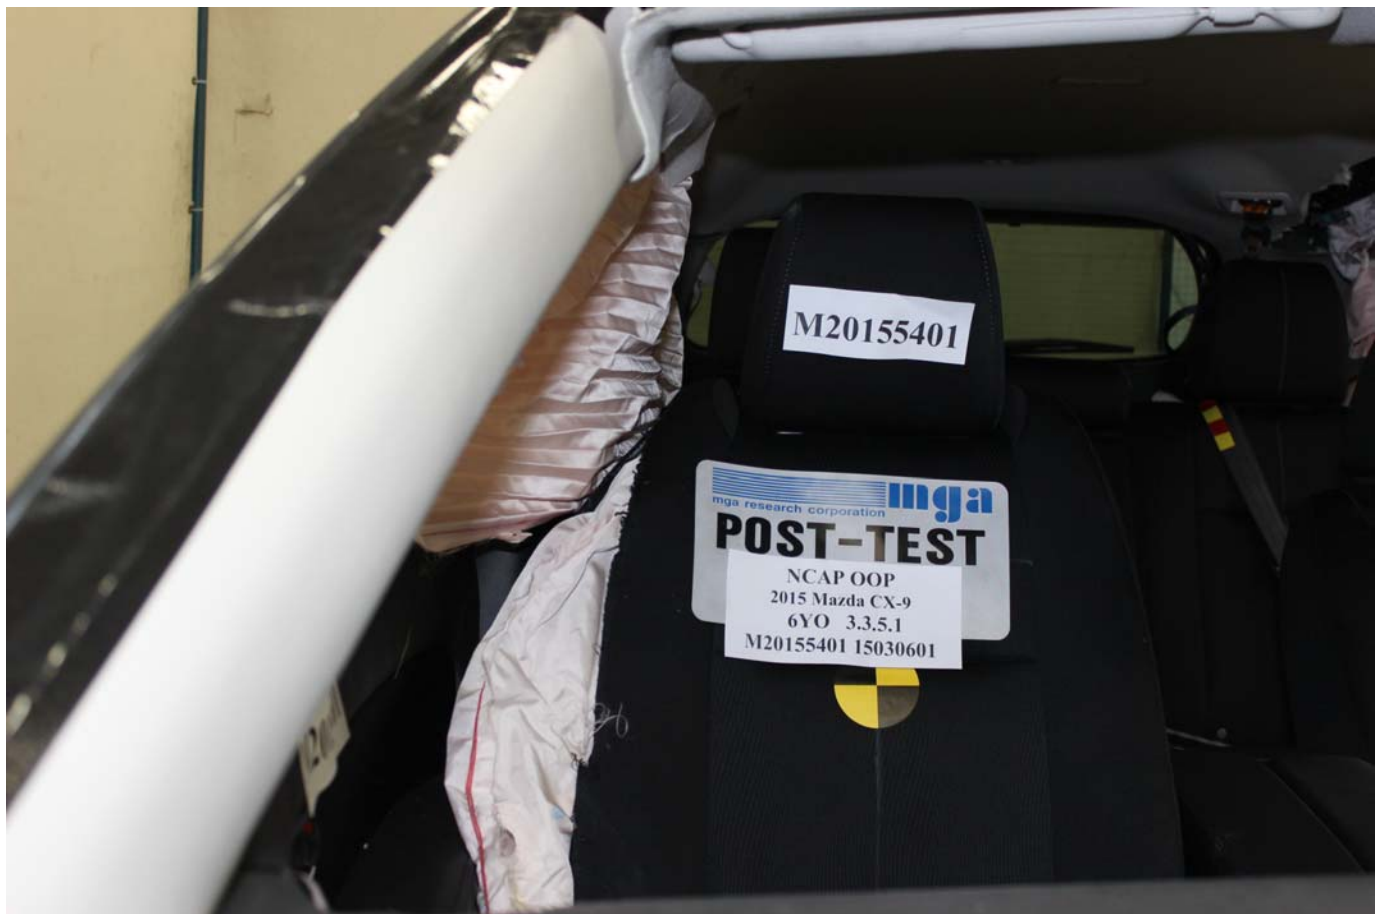
Photo No. 24 - Post-Test Curtain Airbag Front View

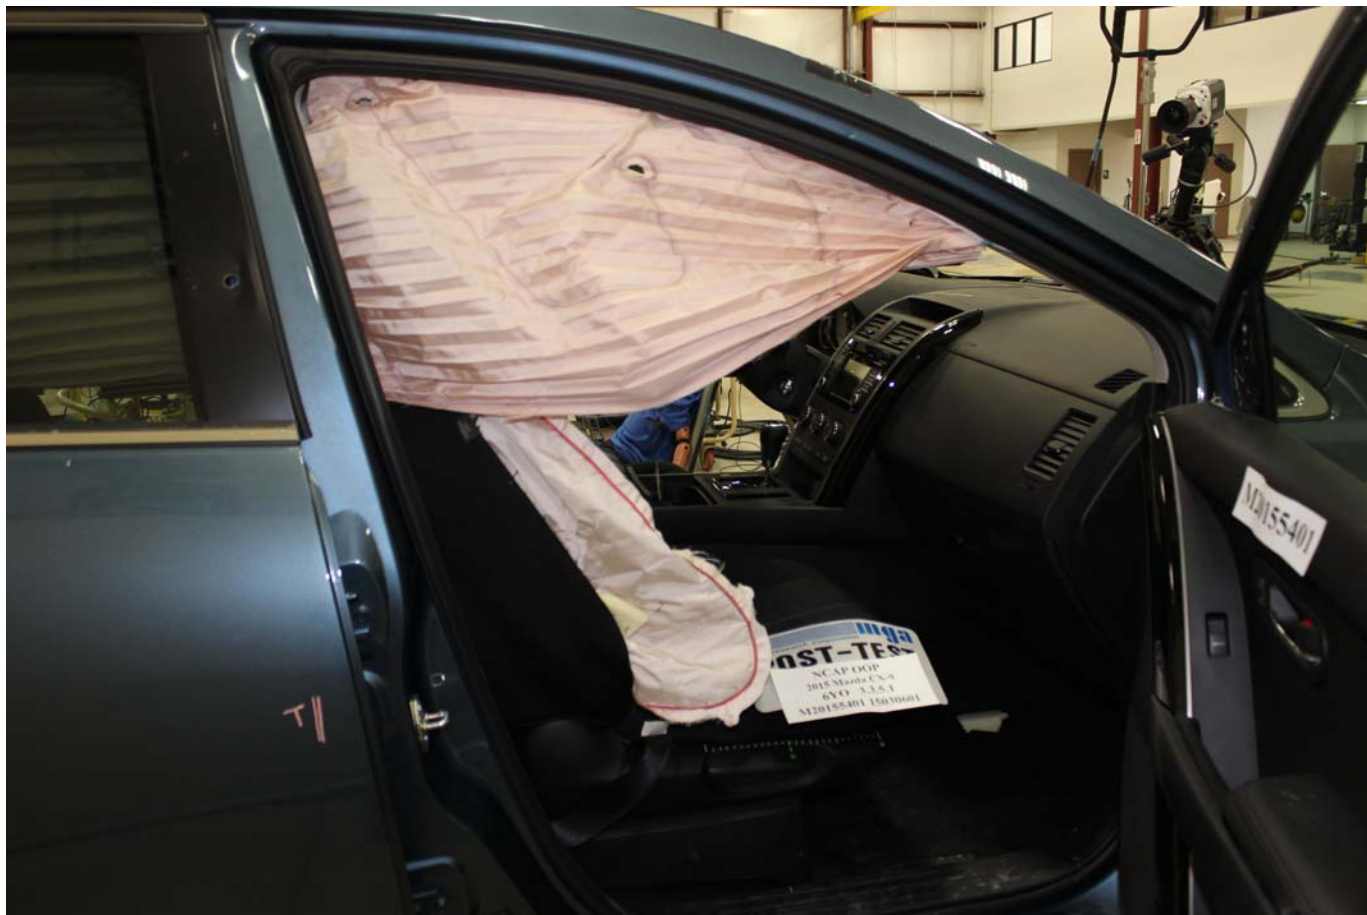
Photo No. 25 - Post-Test Curtain Airbag Right Side View (Door Open)

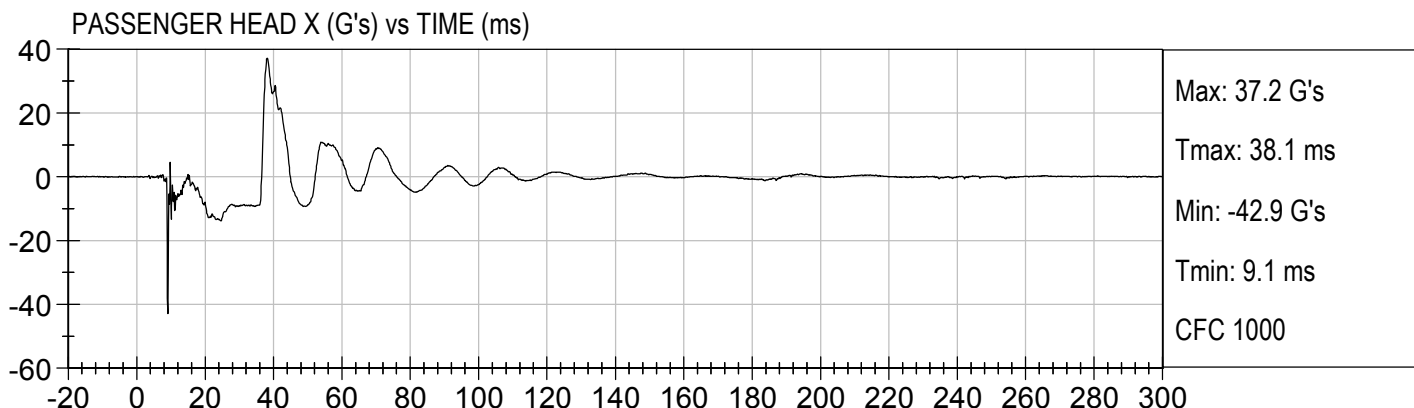
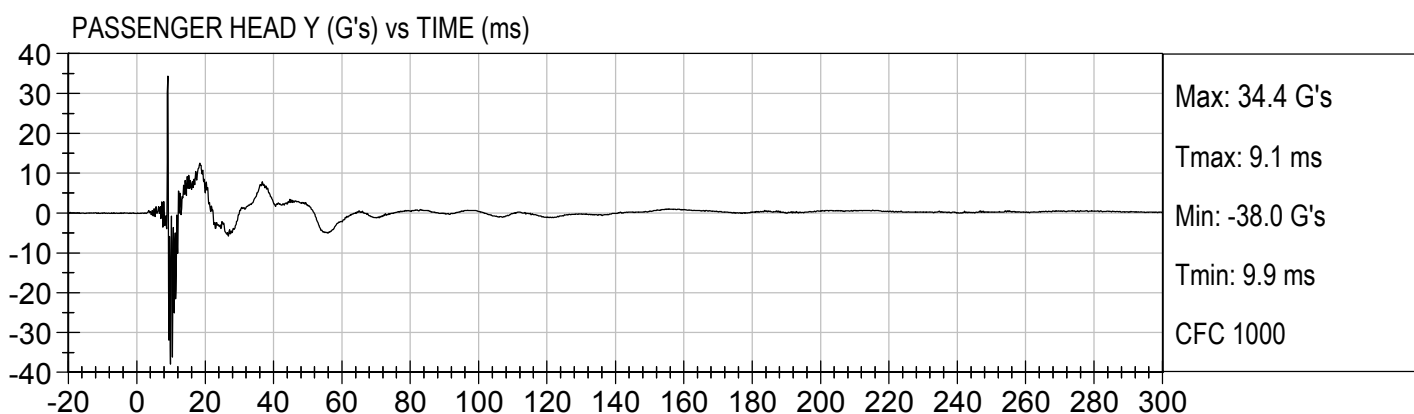
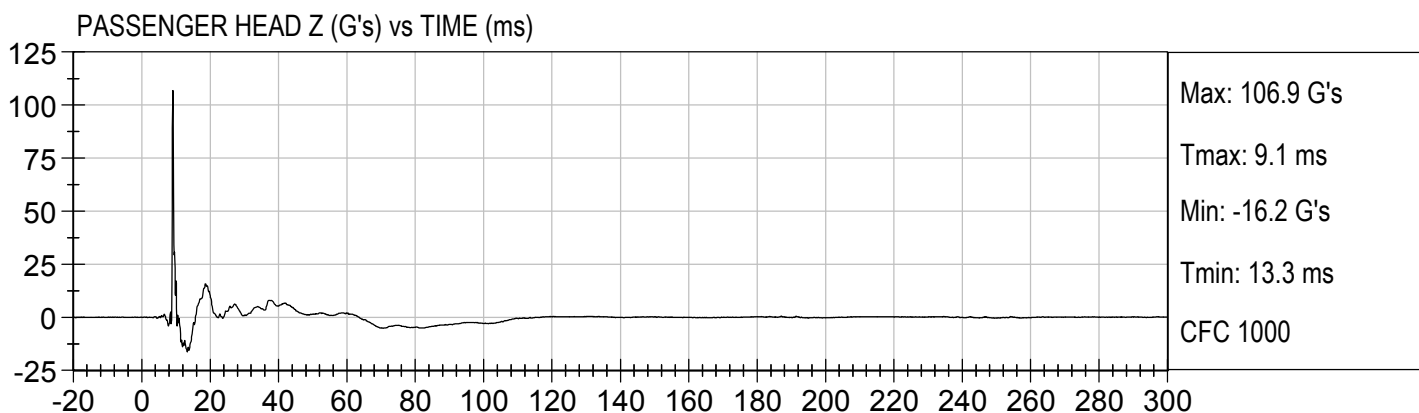
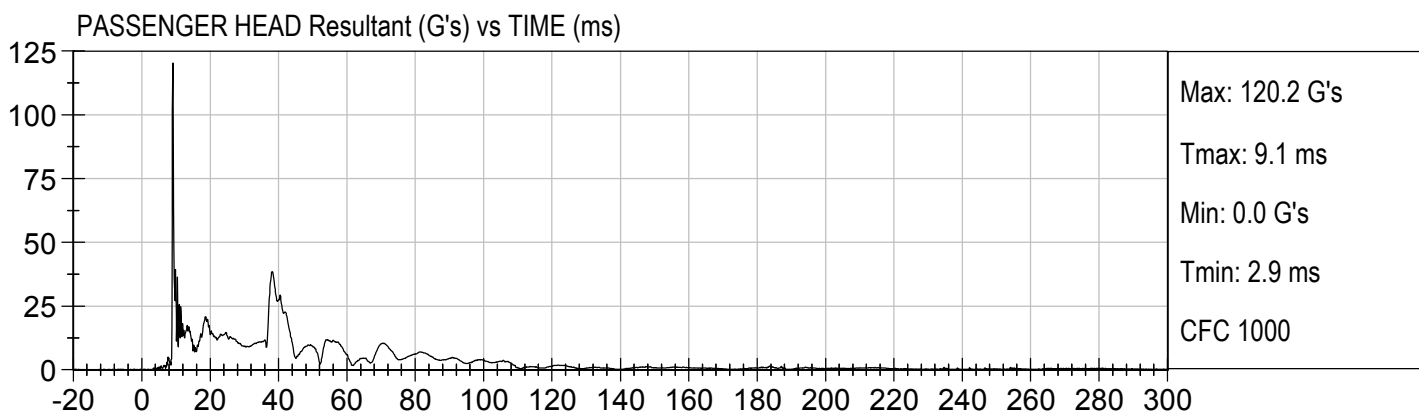
| | <u>Page No.</u> |
|---|---|
| Figure No. 1. Passenger Head X Acceleration vs. Time | 23 |
| Figure No. 2. Passenger Head Y Acceleration vs. Time | 23 |
| Figure No. 3. Passenger Head Z Acceleration vs. Time | 23 |
| Figure No. 4. Passenger Head Resultant Acceleration vs. Time | 23 |

| DESCRIPTION | UNIT | MAXIMUM VALUE | | | |
|---|---|---|---|---|---|
| Head X | g | 37.2 | 38.1 | -42.9 | 9.1 |
| Head Y | g | 34.4 | 9.1 | -38.0 | 9.9 |
| Head Z | g | 106.9 | 9.1 | -16.2 | 13.3 |
| Head Resultant | g | 120.2 | 9.1 | | |

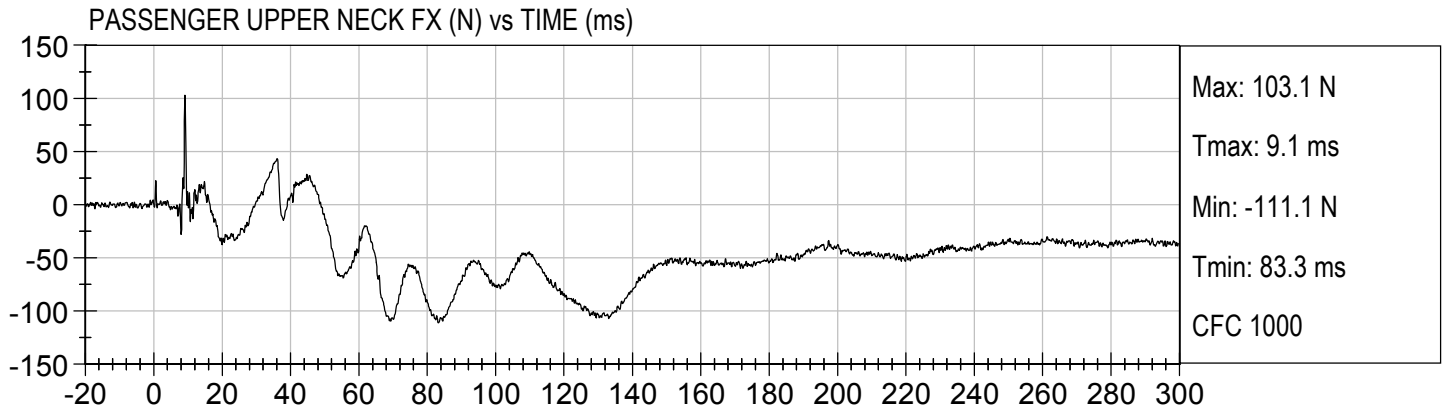
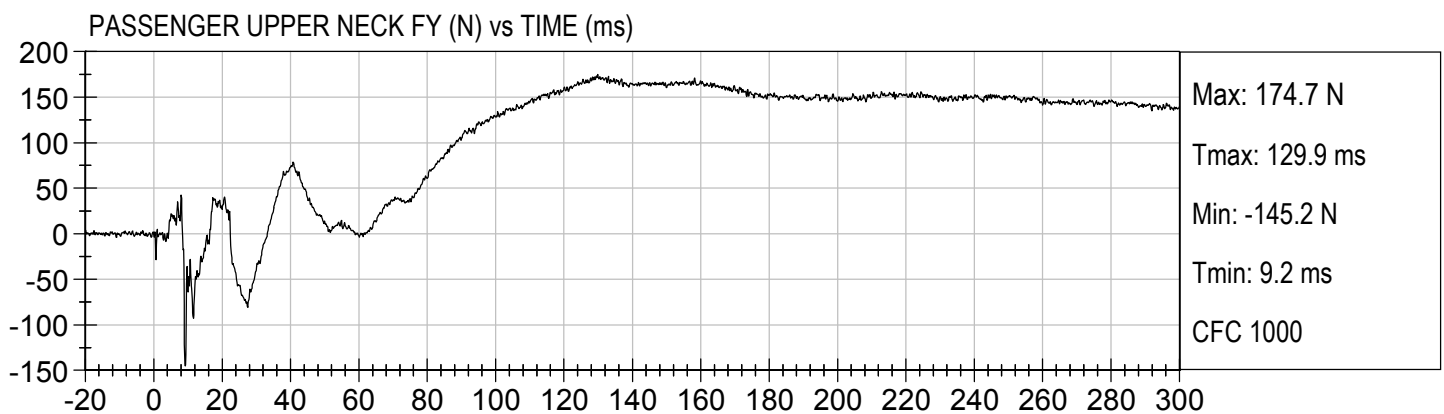
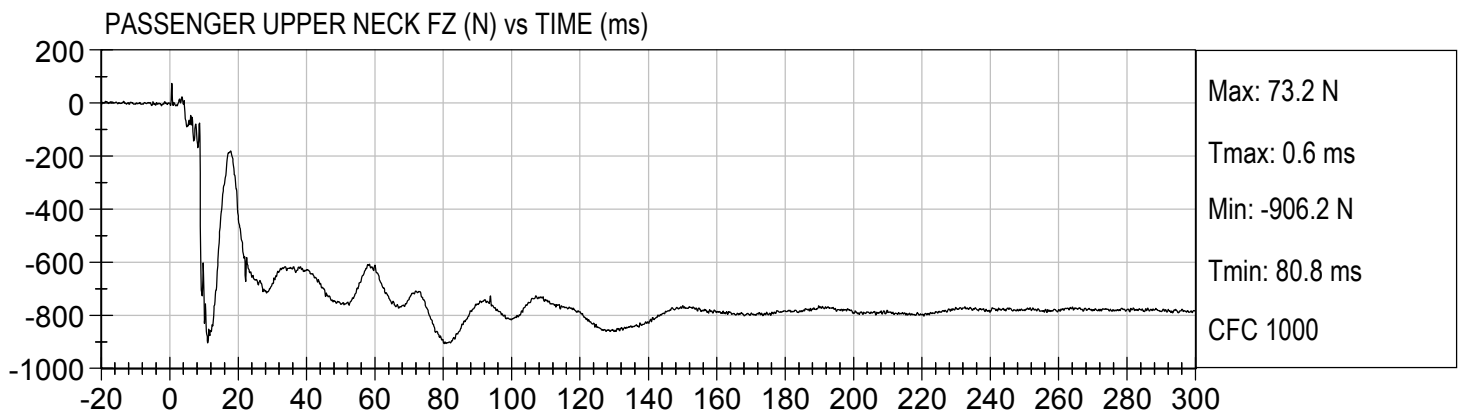
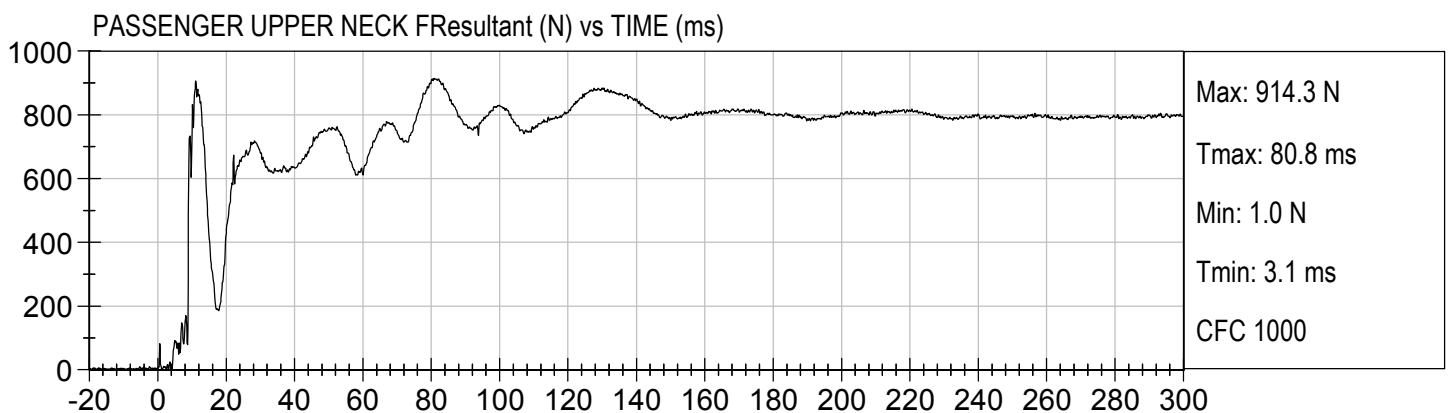
| | <u>Page No.</u> |
|---|---|
| Figure No. 5. Passenger Upper Neck X Force vs. Time | 24 |
| Figure No. 6. Passenger Upper Neck Y Force vs. Time | 24 |
| Figure No. 7. Passenger Upper Neck Z Force vs. Time | 24 |
| Figure No. 8. Passenger Upper Neck Resultant Force vs. Time | 24 |

| DESCRIPTION | UNIT | MAXIMUM VALUE | | | |
|---|---|---|---|---|---|
| Upper Neck Fx | N | 103.1 | 9.1 | -111.1 | 83.3 |
| Upper Neck Fy | N | 174.7 | 129.9 | -145.2 | 9.2 |
| Upper Neck Fz | N | 73.2 | 0.6 | -906.2 | 80.8 |
| Upper Neck F Resultant | N | 914.3 | 80.8 | | |

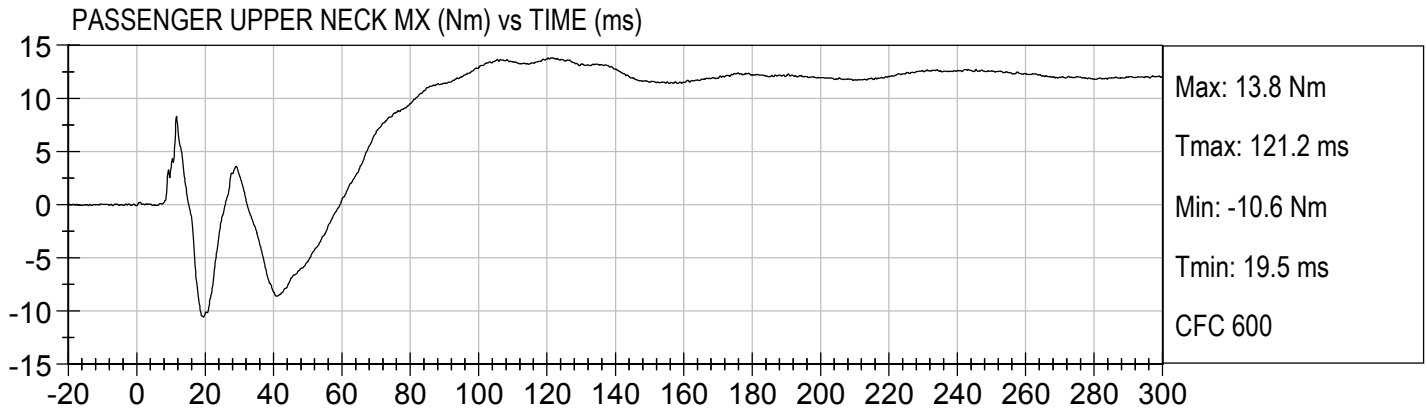
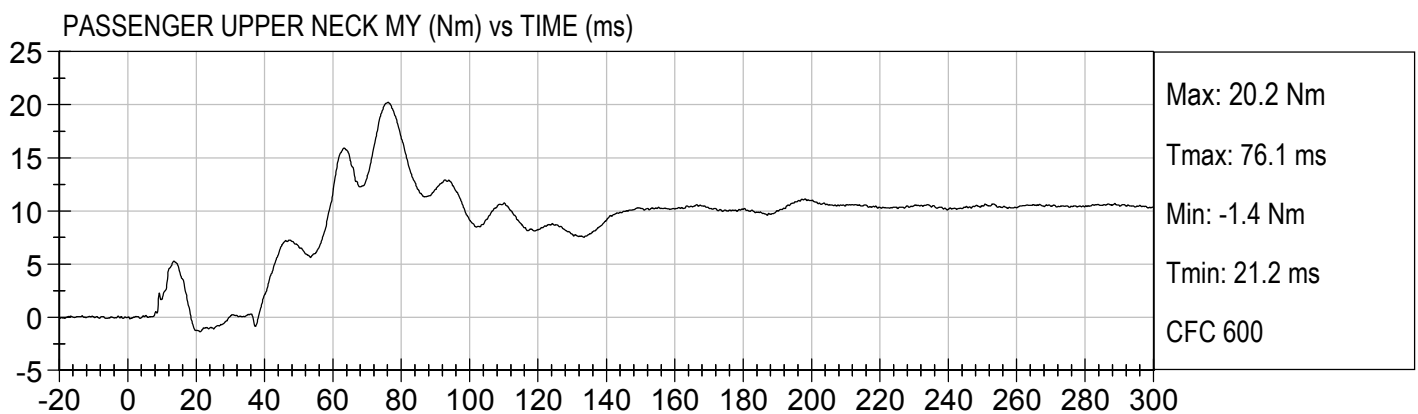
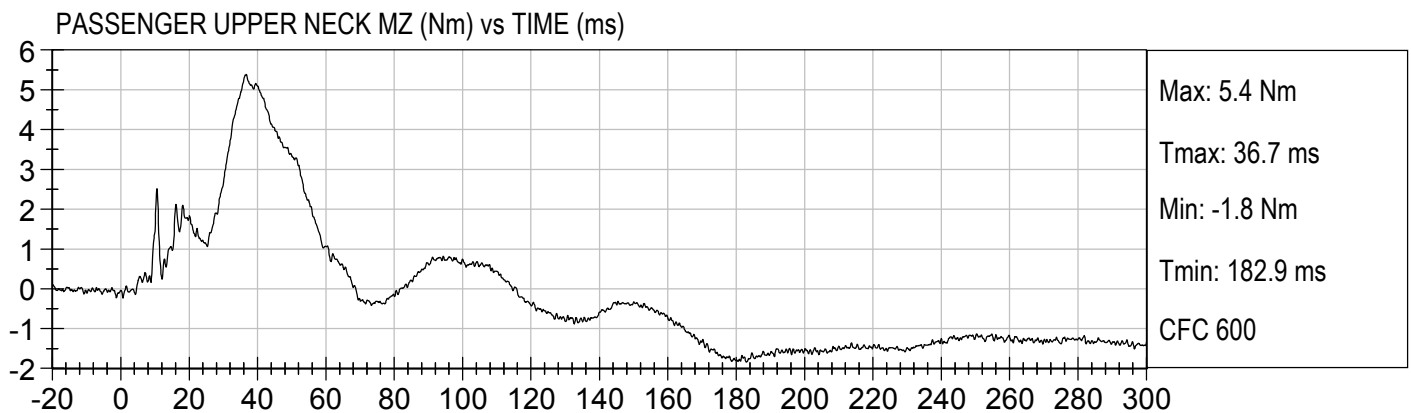
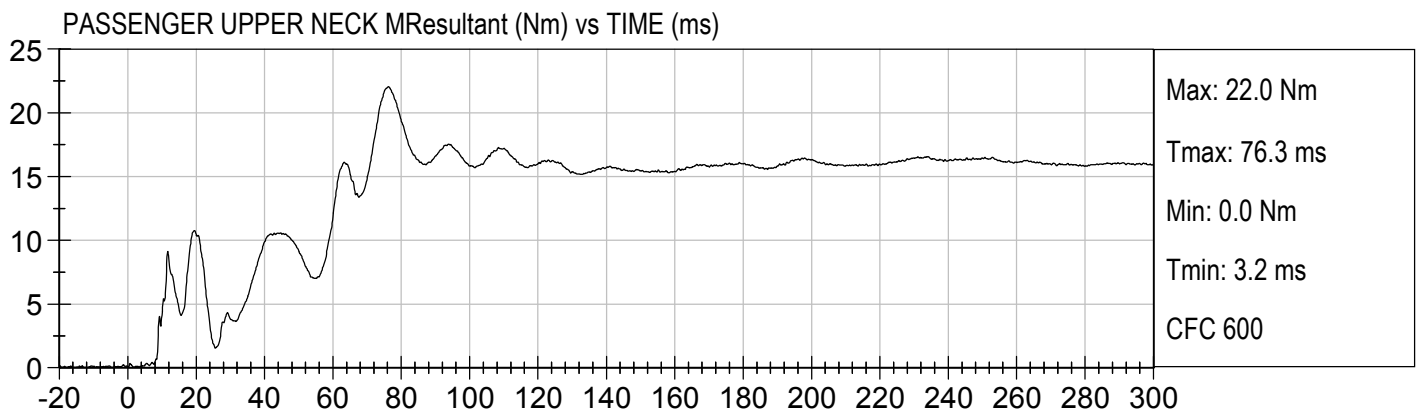
| | <u>Page No.</u> |
|---|---|
| Figure No. 9. Passenger Upper Neck X Moment vs. Time | 25 |
| Figure No. 10. Passenger Upper Neck Y Moment vs. Time | 25 |
| Figure No. 11. Passenger Upper Neck Z Moment vs. Time | 25 |
| Figure No. 12. Passenger Upper Neck Resultant Moment vs. Time | 25 |
