**REPORT NUMBER: TWG-MGA-2015-007**

**SIDE AIRBAG OUT-OF-POSITION INJURY  
TECHNICAL WORKING GROUP**

**MAZDA MOTOR CORPORATION  
2015 Mazda CX-9 Sport SUV  
NHTSA No.: M20155401TWG2**

**FINAL REPORT**

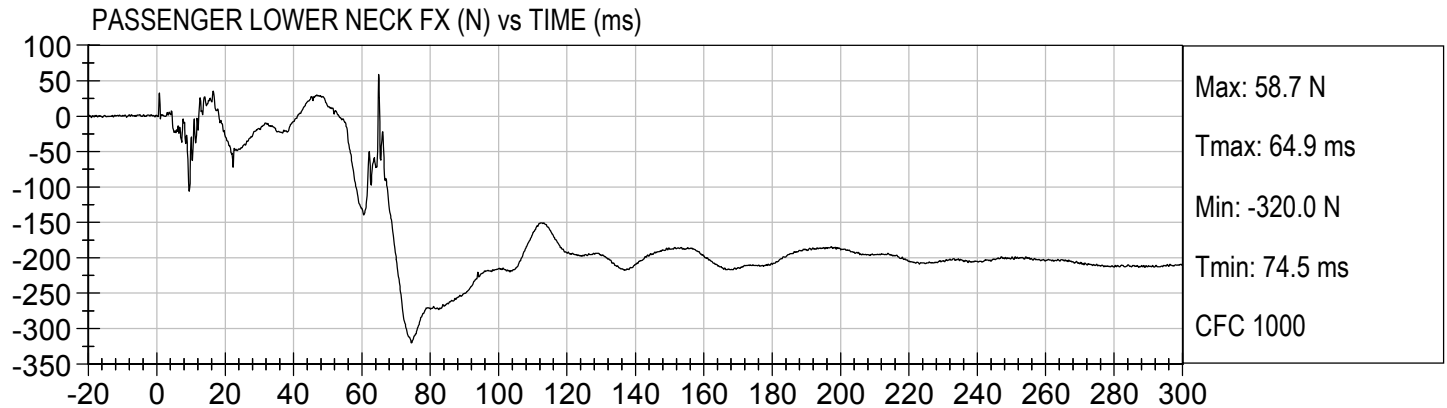
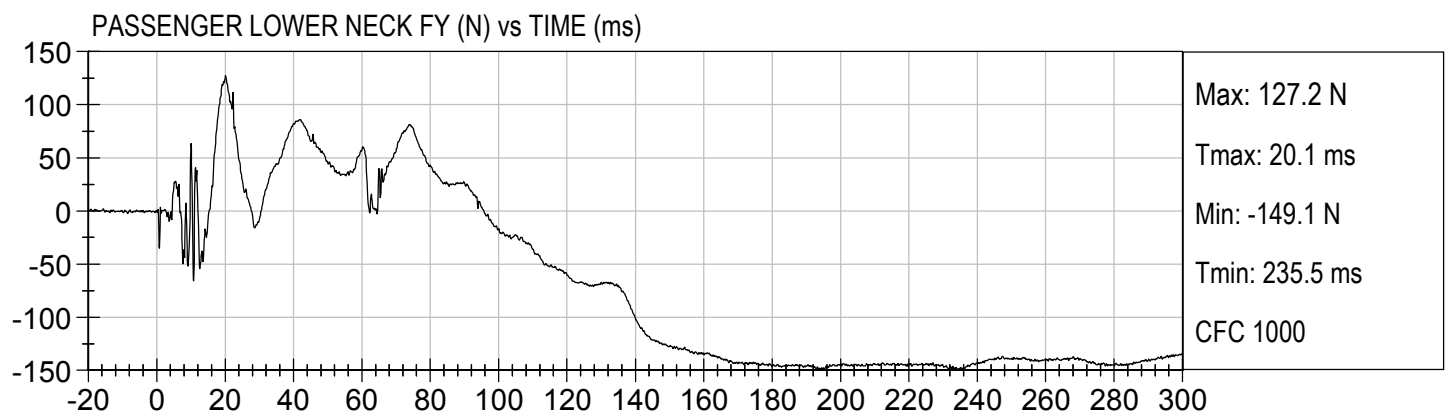
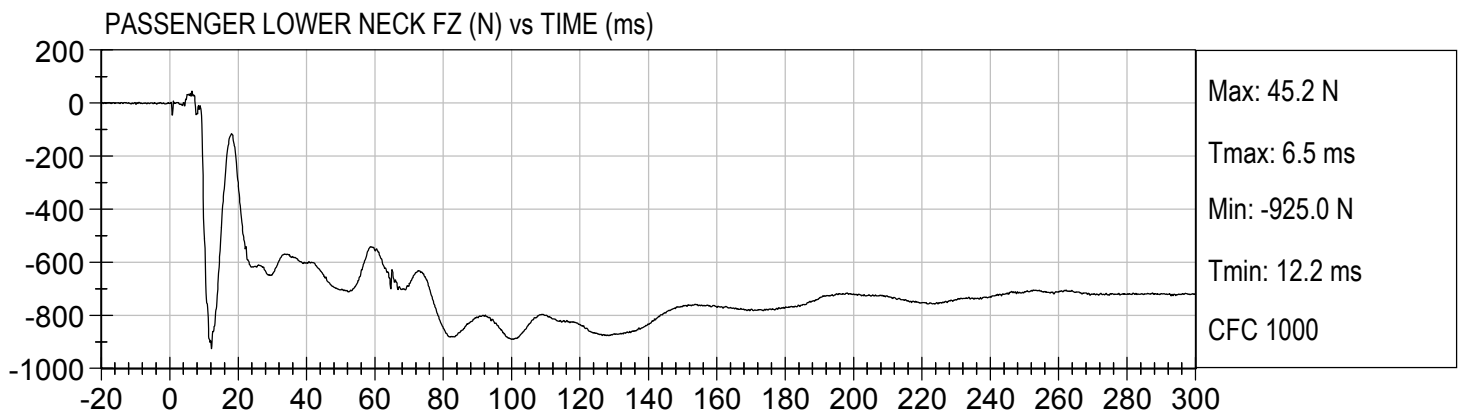
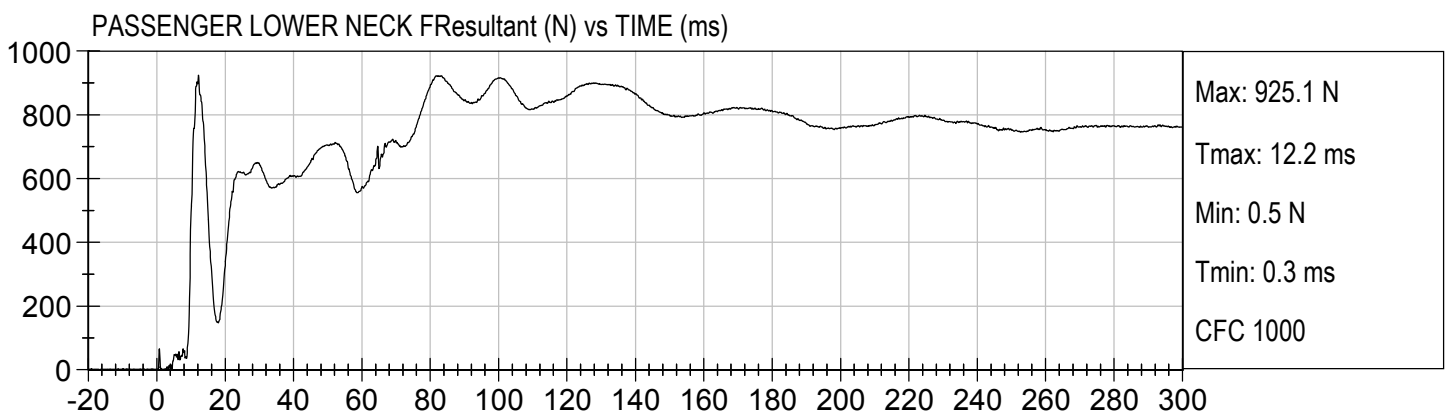
| | <u>Page No.</u> |
|---|---|
| Figure No. 13. Passenger Lower Neck X Force vs. Time | 26 |
| Figure No. 14. Passenger Lower Neck Y Force vs. Time | 26 |
| Figure No. 15. Passenger Lower Neck Z Force vs. Time | 26 |
| Figure No. 16. Passenger Lower Neck Resultant Force vs. Time | 26 |

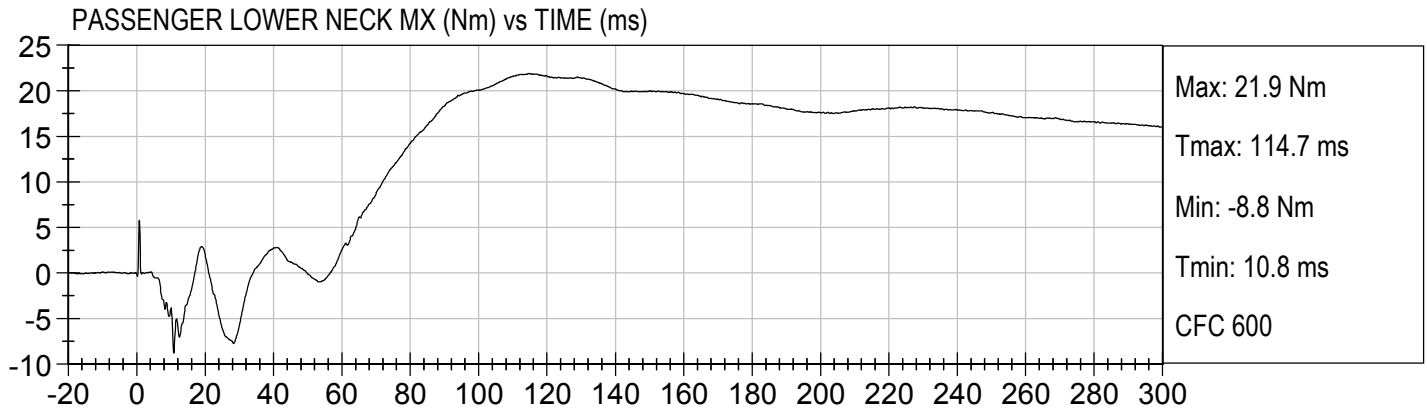
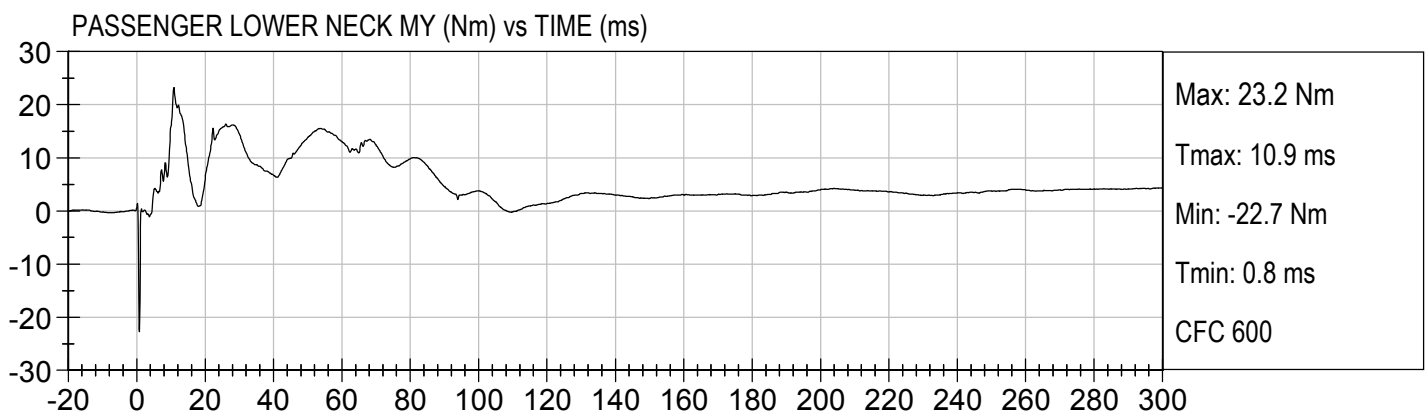
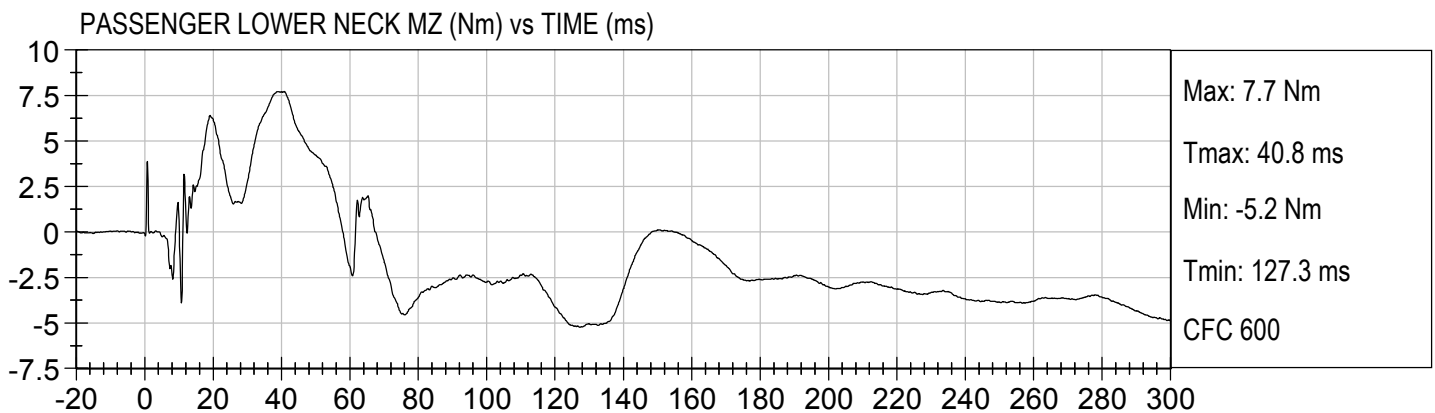
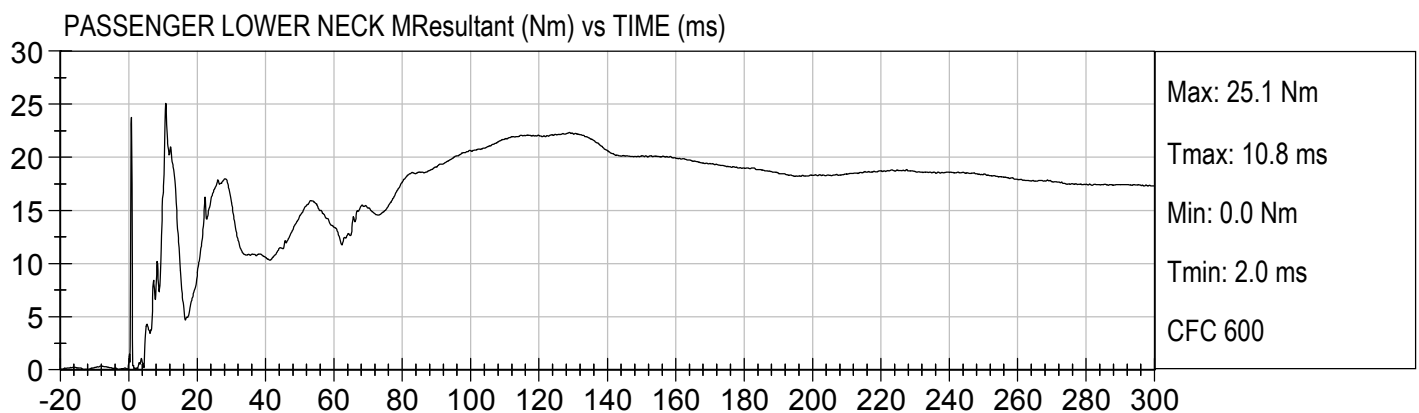
| | <u>Page No.</u> |
|---|---|
| Figure No. 17. Passenger Lower Neck X Moment vs. Time | 27 |
| Figure No. 18. Passenger Lower Neck Y Moment vs. Time | 27 |
| Figure No. 19. Passenger Lower Neck Z Moment vs. Time | 27 |
| Figure No. 20. Passenger Lower Neck Resultant Moment vs. Time | 27 |

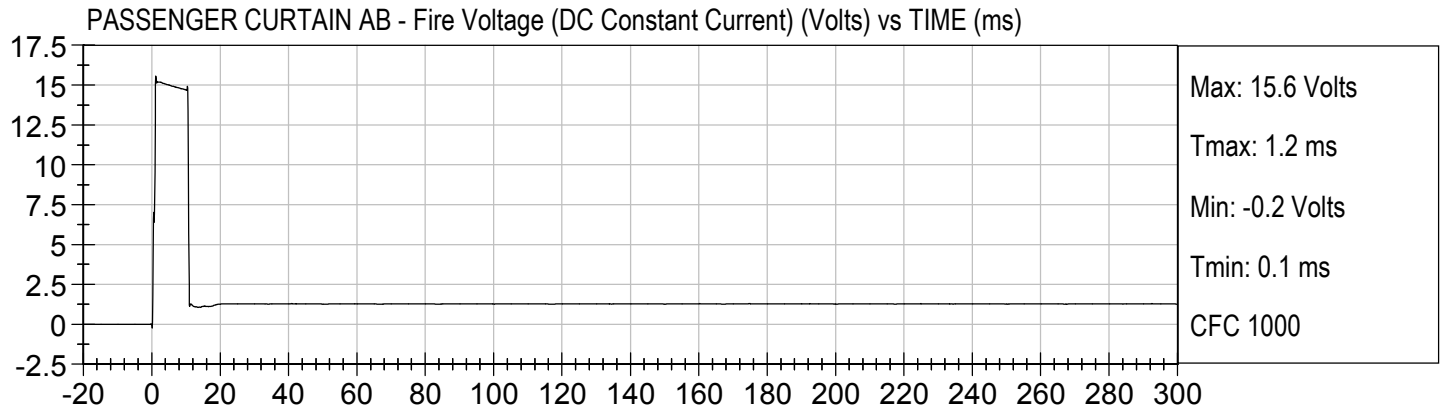
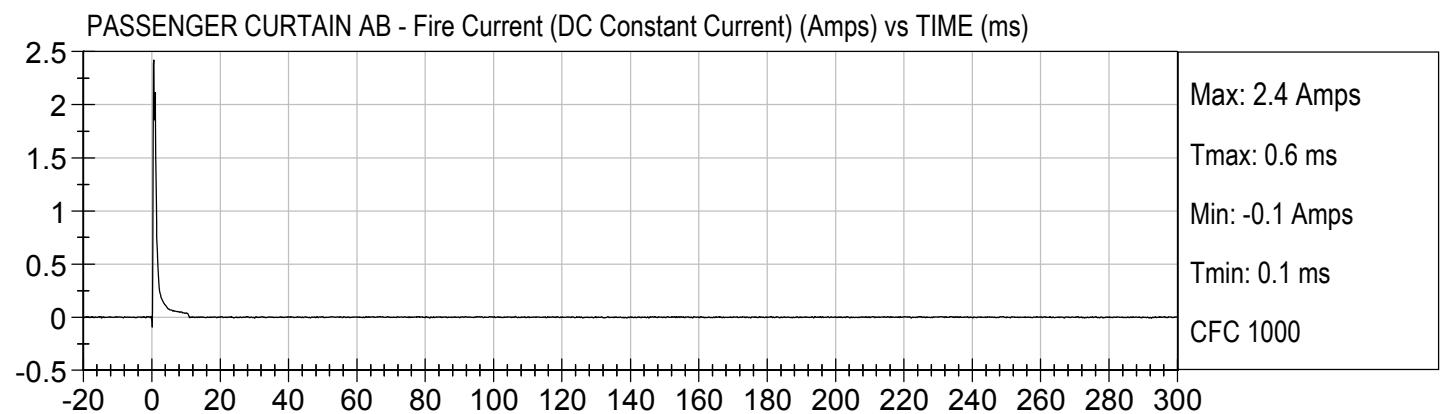
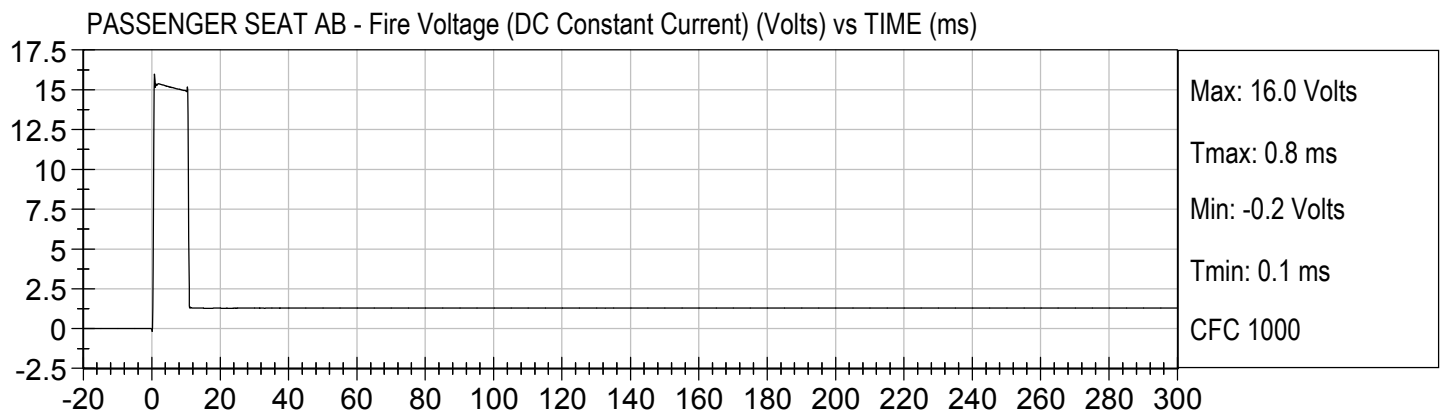
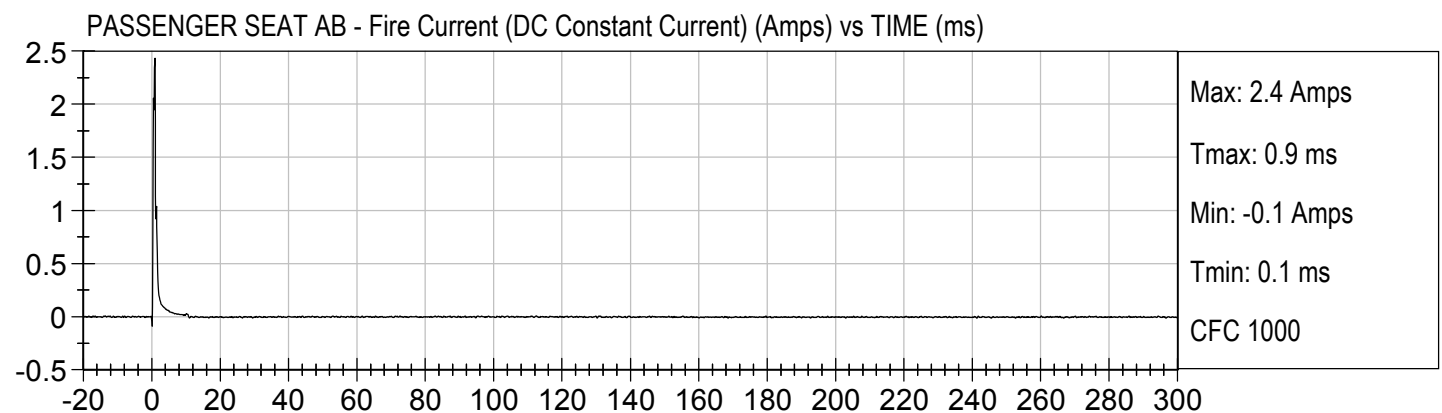
| | <u>Page No.</u> |
|---|---|
| Figure No. 21. Passenger Curtain Airbag – Fire Voltage vs. Time | 28 |
| Figure No. 22. Passenger Curtain Airbag – Fire Current vs. Time | 28 |
| Figure No. 23. Passenger Seat Airbag – Fire Voltage vs. Time | 28 |
| Figure No. 24. Passenger Seat Airbag – Fire Current vs. Time | 28 |
