**REPORT NUMBER: R&D-CAL-12-003**

**MOVING BARRIER TO VEHICLE CRASH TEST IN SUPPORT OF NHTSA'S  
FRONTAL OBLIQUE OFFSET PROGRAM  
RESEARCH MOVING DEFORMABLE BARRIER INTO LEFT FRONT OF A**

**2013 NISSAN VERSA**

**90.1KPH, 15 DEGREE ANGLE, 35% OVERLAP**

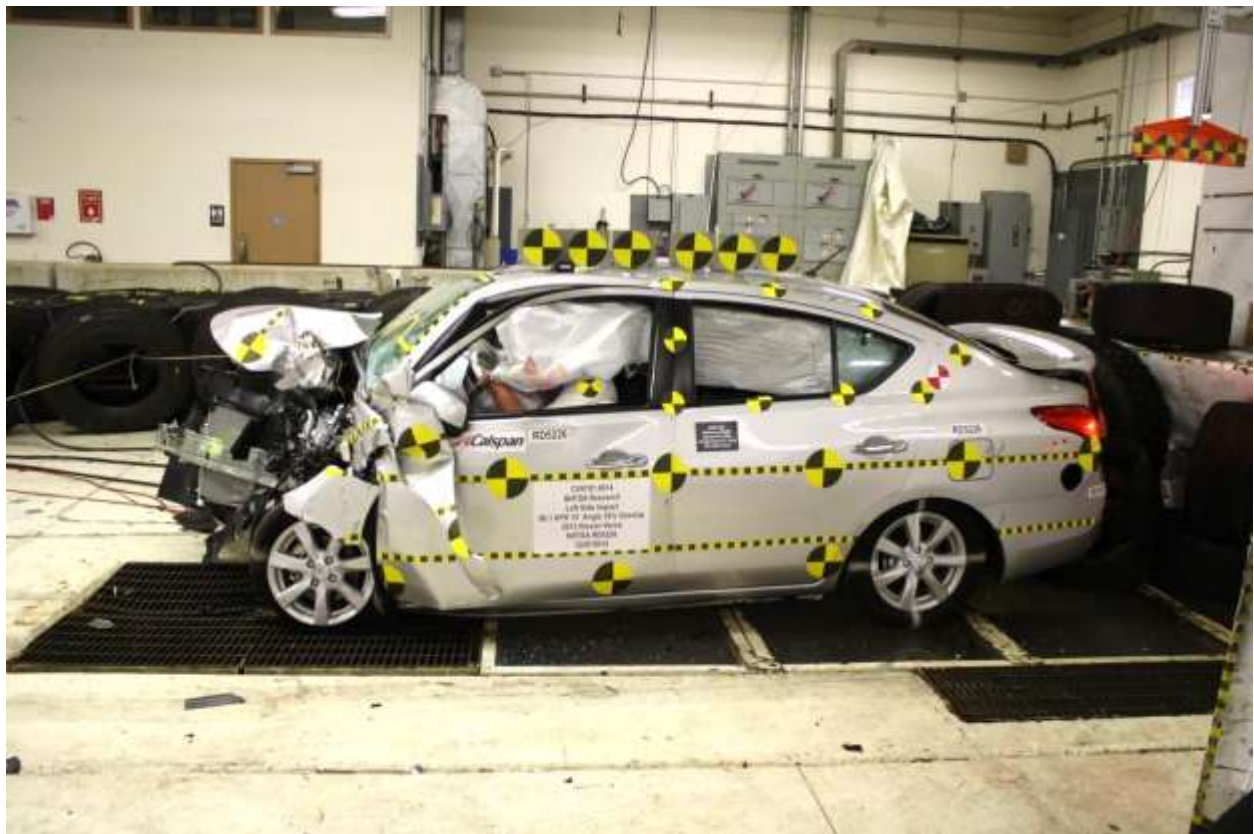
**No. 010 Post-Test Left Side View of Test Vehicle**

All four vehicle doors remained closed and latched during the test. The left front door was deformed as a result of the impact causing it to be non-operational. The remaining doors all remained operational after the test.

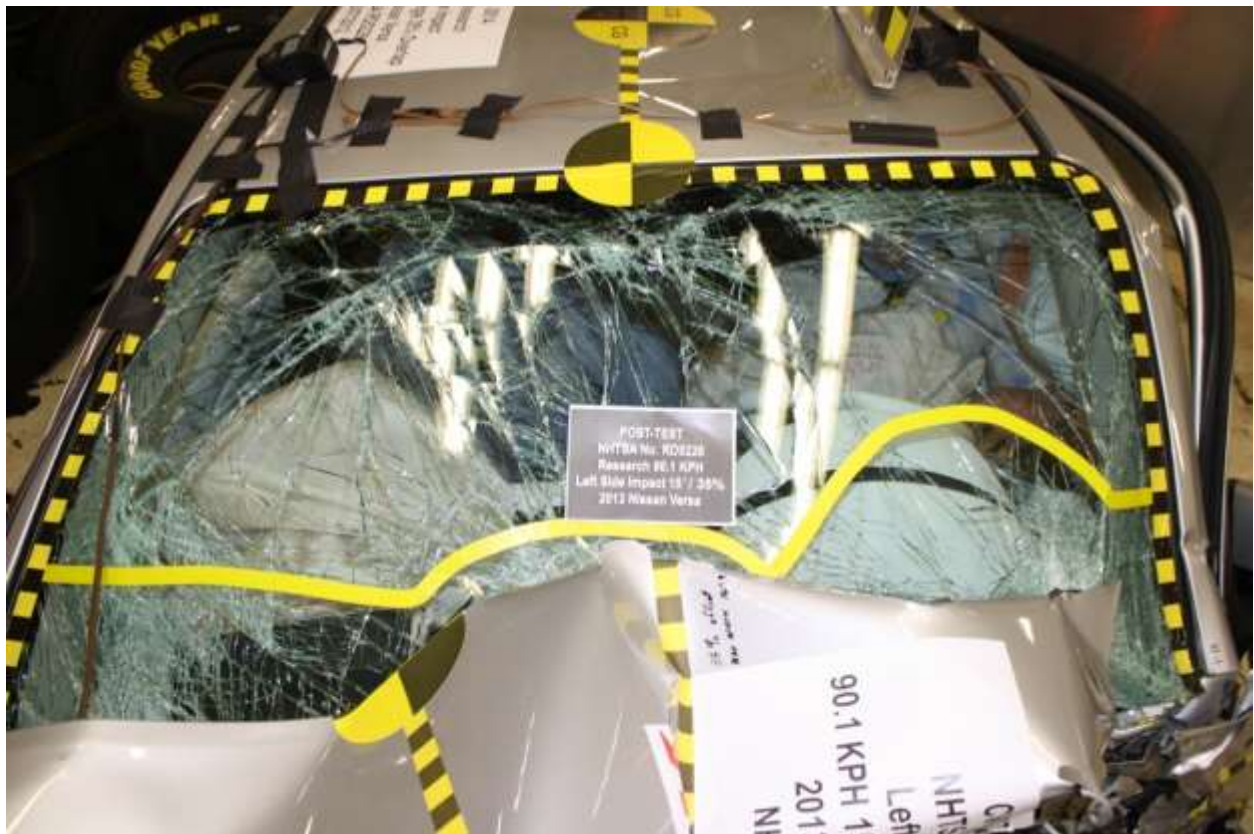
**No. 033 Post-Test Windshield View**

There was 90.5% total windshield retention, with 81% and 100% retention on the left and right sides, respectively. There appeared to be no intrusion into the protected zone of the windshield during any portion of the impact event. The maximum static crush of the vehicle was 691 mm at C1 to the left of the vehicle's centerline. The maximum crush of the structural bumper beam was 688 mm at B1, to the left of the vehicle's centerline. Additional information pertaining to static crush measurements can be found on Data Sheet No.12 of this report.

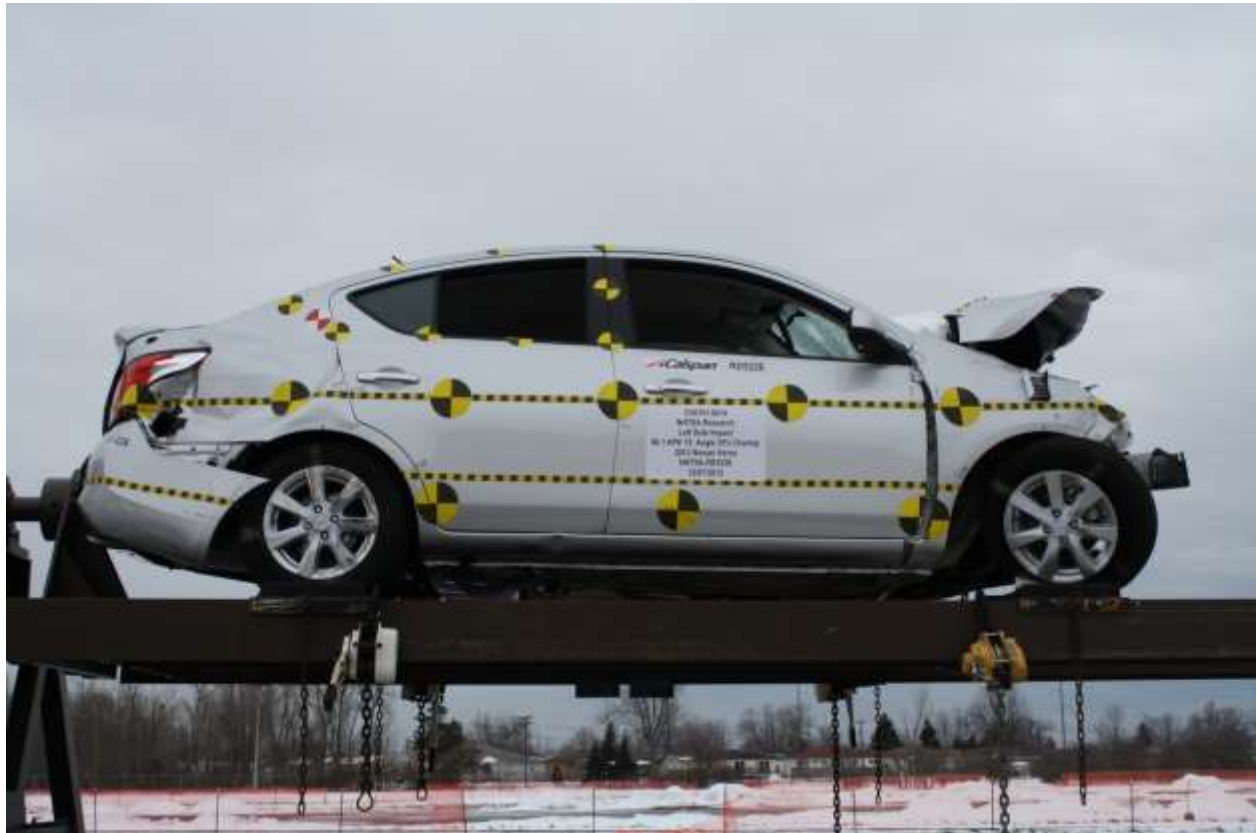
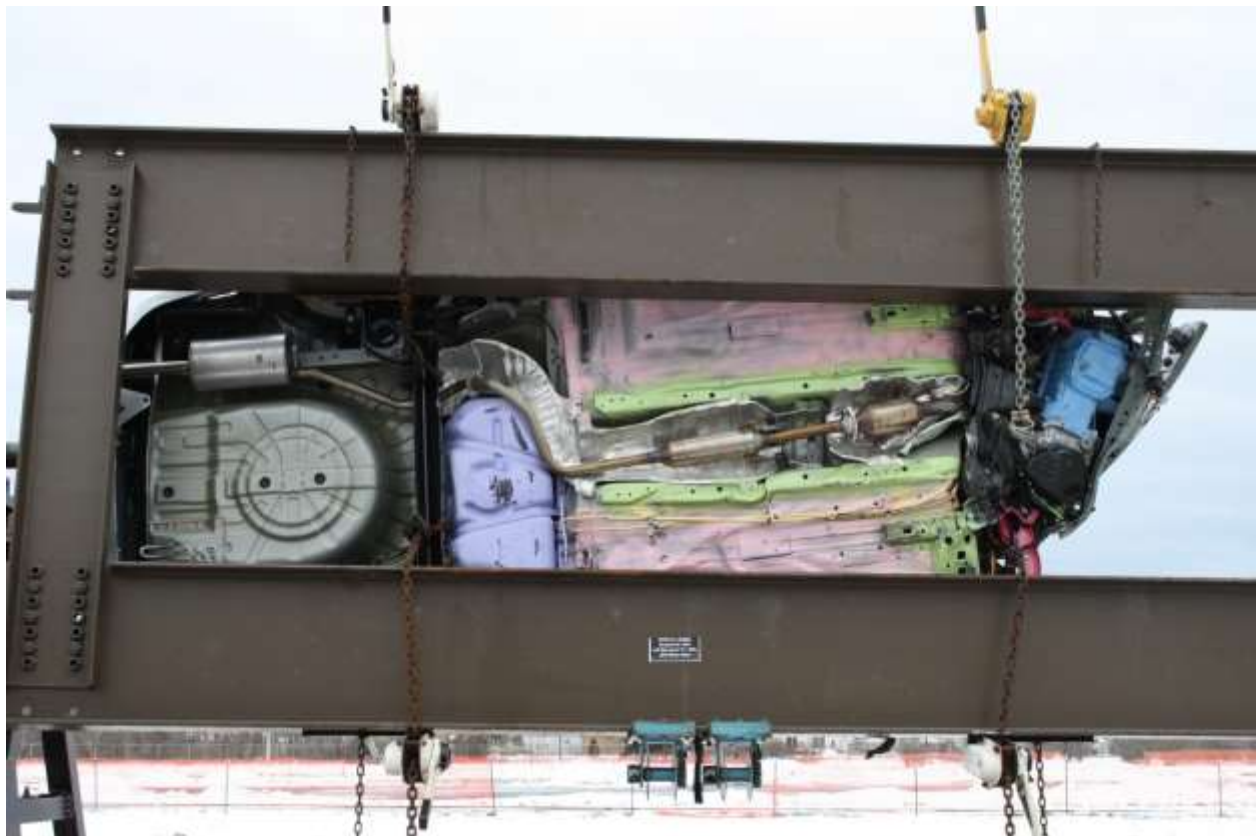
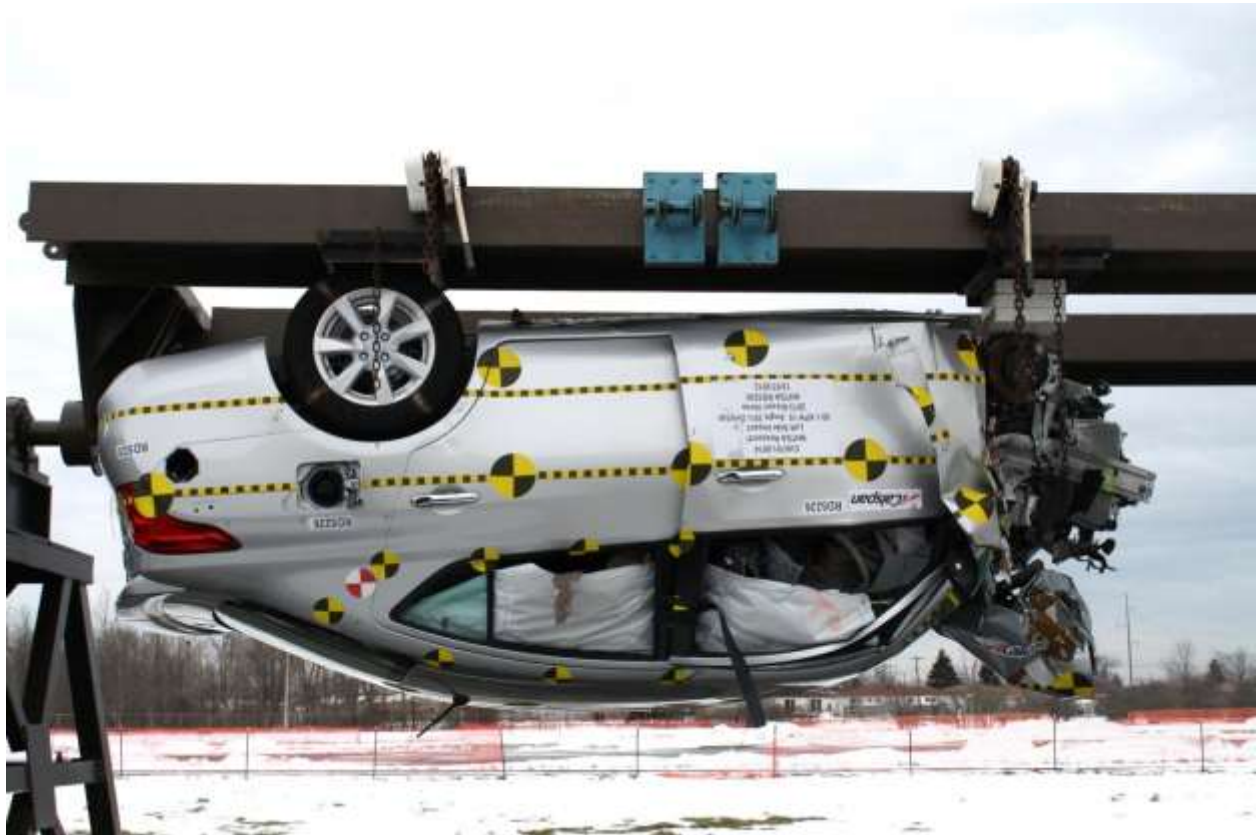
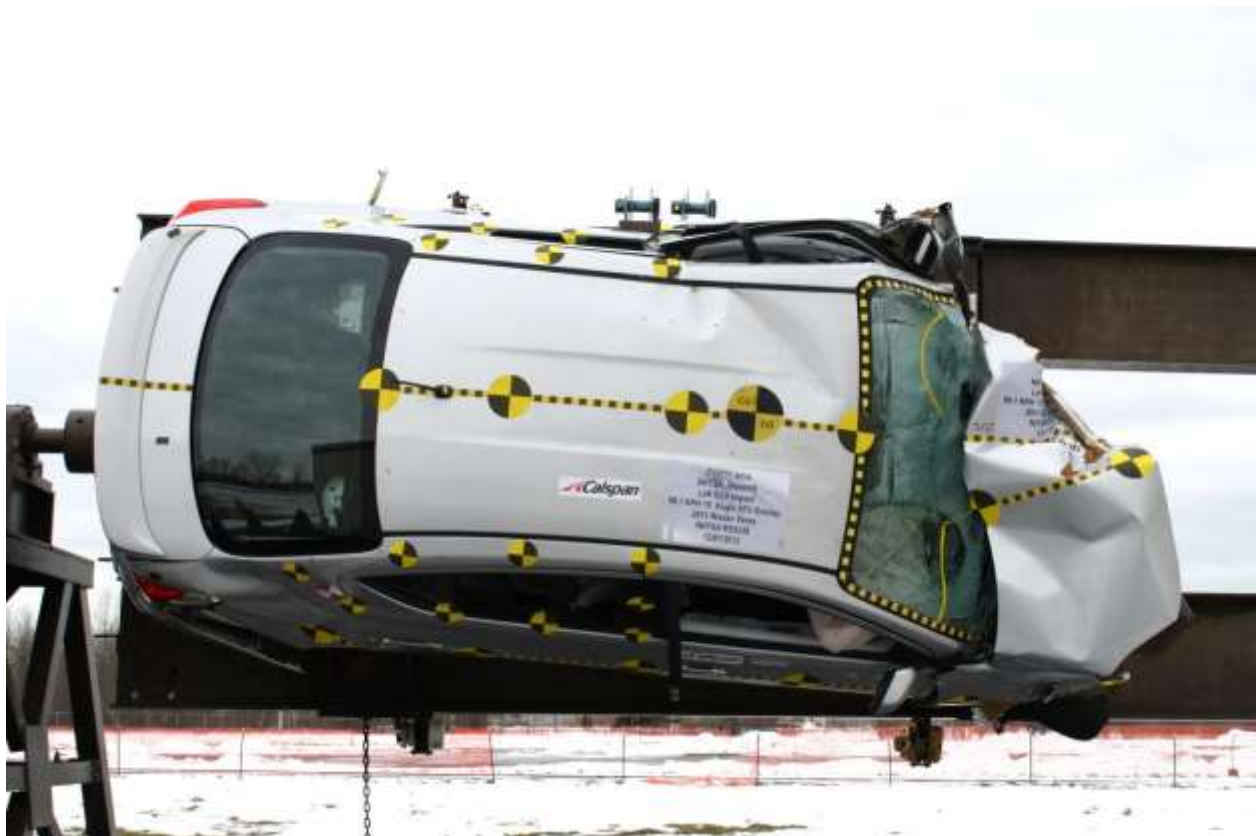
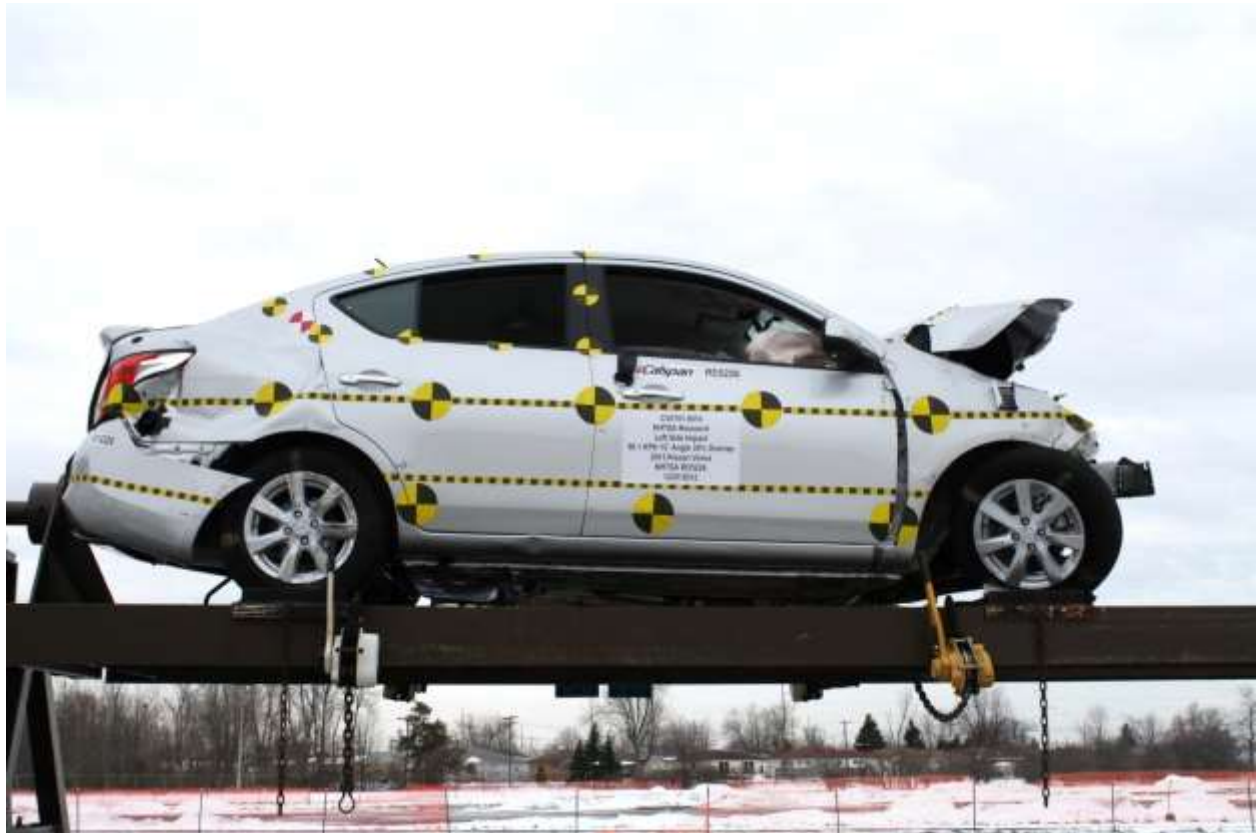
**No. 180 Vehicle at 0 Degrees on Static Rollover Device**

**No. 181 Vehicle at 90 Degrees on Static Rollover Device**

**No. 182 Vehicle at 180 Degrees on Static Rollover Device**

**No. 183 Vehicle at 270 Degrees on Static Rollover Device**

**No. 184 Vehicle at 360 Degrees on Static Rollover Device**

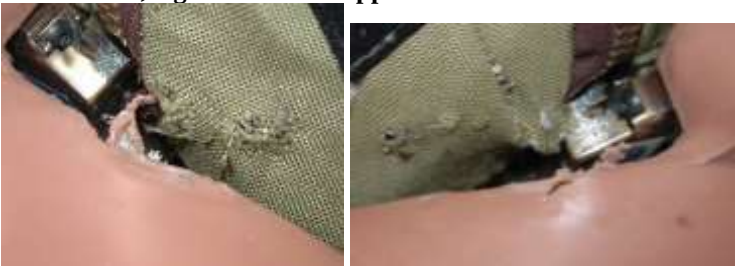
| ABDOMEN | |
|---|---|
| Y / N | No evidence of tearing, cuts, or broken stitches in upper abdomen bag and zipper<br><b>-holes in left, right sides near zipper</b><br> |

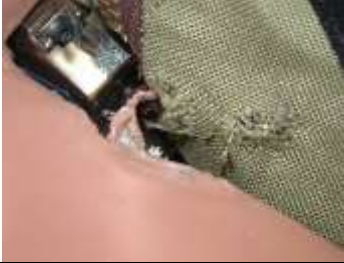
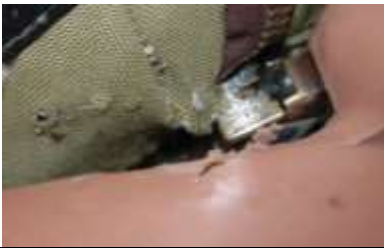
| Y / N | No evidence of tearing, cuts, or broken stitches in upper abdomen bag and zipper<br><b>-holes in left, right sides near zipper</b> |

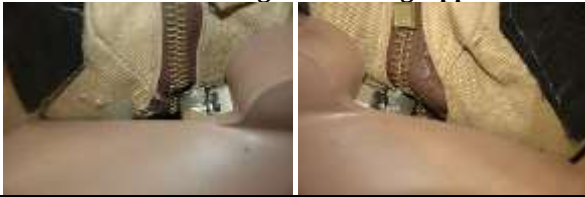
| Y / N | No evidence of tearing, cuts, or broken stitches in lower abdomen bag and zipper<br><b>-torn stitches on left/right side at leg zipper</b> |

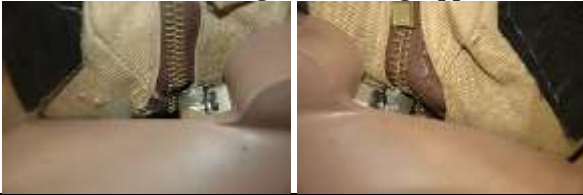
| Y / N | No evidence of tearing, cuts, or broken stitches in lower abdomen bag and zipper<br><b>-torn stitches on left/right side at leg zipper</b> |
