**REPORT NUMBER: R&D-CAL-12-004**

**MOVING BARRIER TO VEHICLE CRASH TEST IN SUPPORT OF NHTSA'S  
FRONTAL OBLIQUE OFFSET PROGRAM  
RESEARCH MOVING DEFORMABLE BARRIER INTO LEFT FRONT OF A**

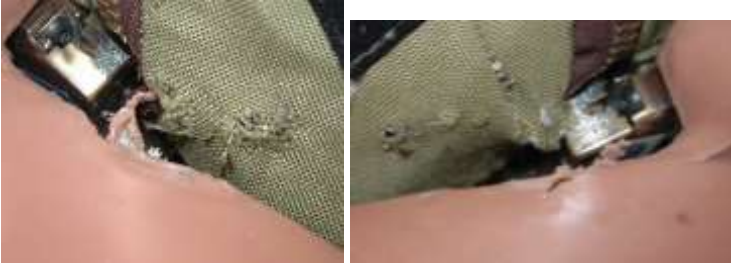
| Y / N | No evidence of tearing, cuts, or broken stitches in upper abdomen bag and zipper<br><b>-holes in left, right sides near zipper</b> |

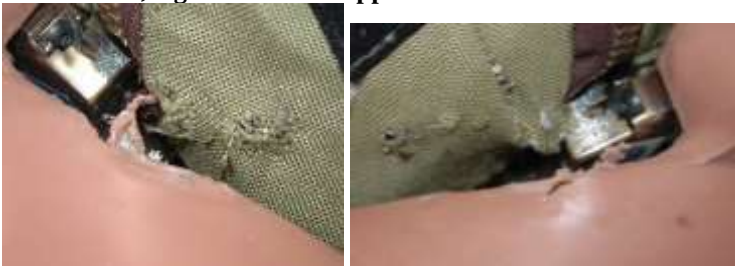
| ABDOMEN | |
|---|---|
| Y / N | No evidence of tearing, cuts, or broken stitches in upper abdomen bag and zipper<br><b>-holes in left, right sides near zipper</b><br> |

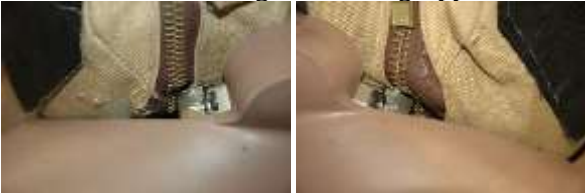
| | |
