**REPORT NUMBER: R&D-CAL-12-006**

**MOVING BARRIER TO VEHICLE CRASH TEST IN SUPPORT OF NHTSA'S  
FRONTAL OBLIQUE OFFSET PROGRAM  
RESEARCH MOVING DEFORMABLE BARRIER INTO LEFT FRONT OF A**

**2013 FORD TAURUS**

**90.1KPH, 15 DEGREE ANGLE, 35% OVERLAP**

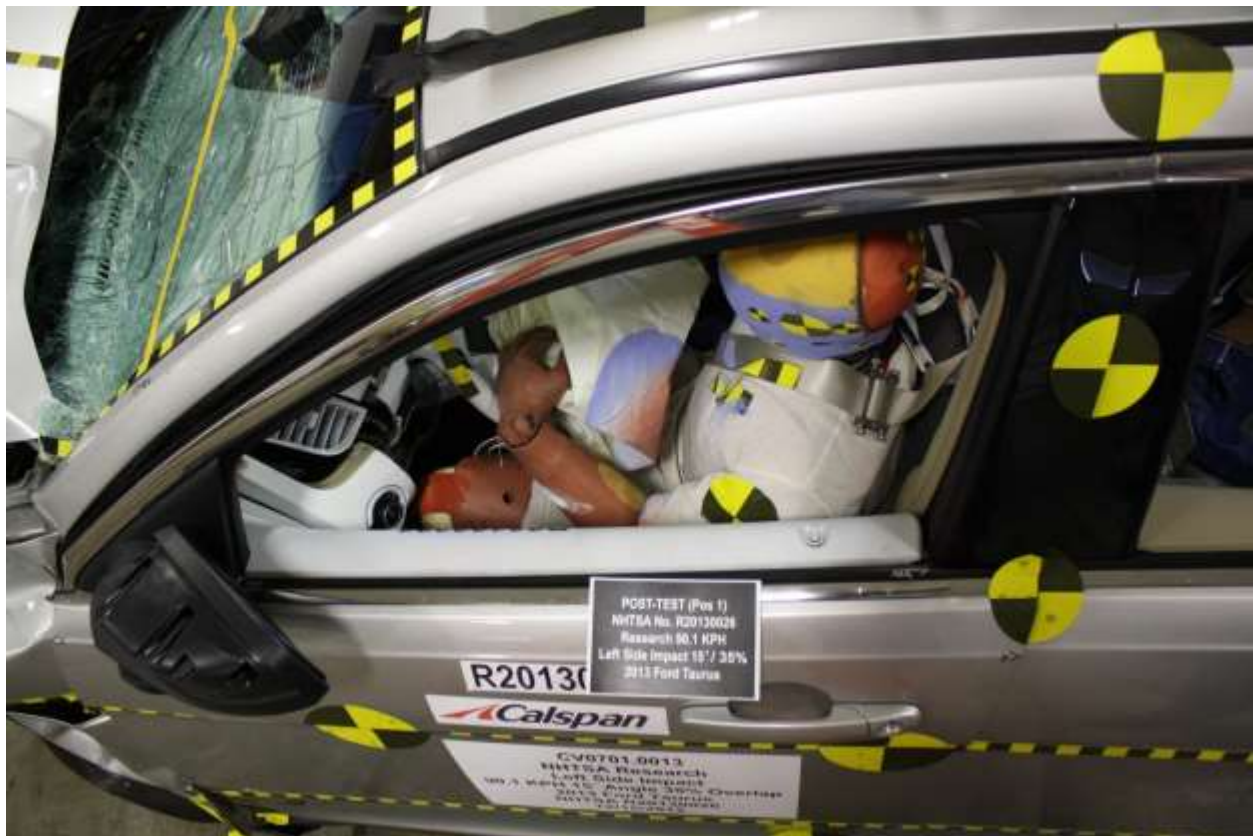
No. 061 Post-Test View of Driver Door Clearance

- Driver's side A-Pillar buckled rearward. Resulting in separation between the top of the door and roof sill. (See Photo No.061 in Appendix A)
- Windshield cracked throughout with some minor separation along the bottom right and left side
- Hood did not remain latched during the impact event and bent upwards exposing the engine compartment

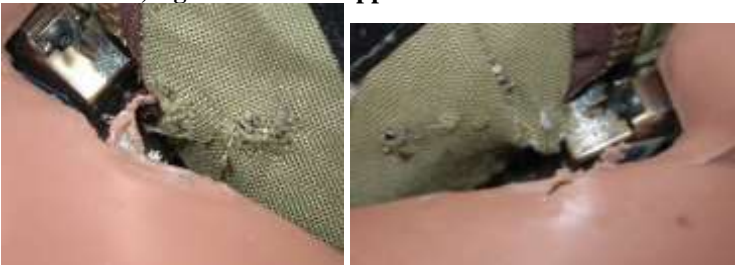
ABDOMEN	
Y / N	No evidence of tearing, cuts, or broken stitches in upper abdomen bag and zipper <b>-holes in left, right sides near zipper</b>

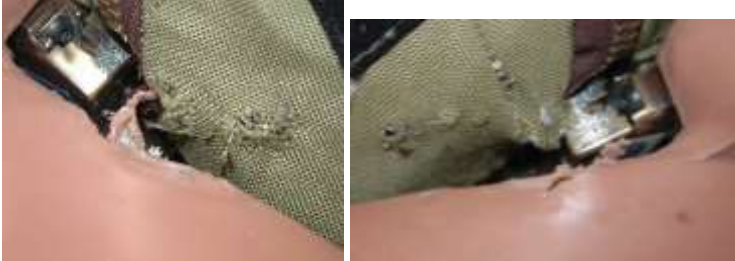
<b>ABDOMEN</b>	
Y / N	<p>No evidence of tearing, cuts, or broken stitches in upper abdomen bag and zipper  <b>-holes in left, right sides near zipper</b></p>

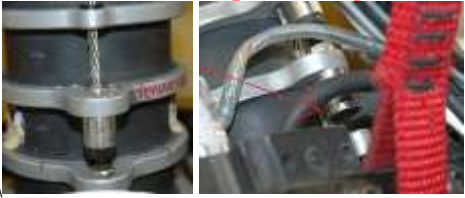
NECK	
Y / N	Neck cables slide freely through holes in neck plates
Y / N	Neck cables show no sign of fraying, broken strands, or kinking
Y / N	<p>No evidence of debonding between neck pucks and plates            If N – indicate which interface (where plate/puck 1 attach to upper neck load cell):  <b>-cracks in neck rubber, 2-3, 3-4</b>  <b>-Lower rear neck stop is missing</b></p>

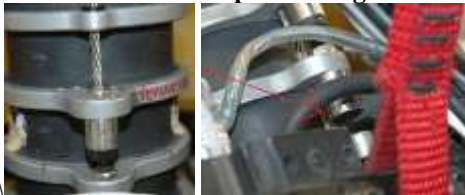
NECK	
Y / N	Neck cables slide freely through holes in neck plates
Y / N	Neck cables show no sign of fraying, broken strands, or kinking
Y / N	No evidence of debonding between neck pucks and plates If N – indicate which interface (where plate/puck 1 attach to upper neck load cell): <b>-cracks in neck rubber, 2-3, 3-4</b> <b>-Lower rear neck stop is missing</b>
