**REPORT NUMBER: NCAP-MGA-2016-001**

**NEW CAR ASSESSMENT PROGRAM (NCAP)  
Frontal Barrier Impact Test**

**MAZDA MOTOR CORPORATION  
2016 Mazda CX-5 Sport AWD 5-Dr SUV  
NHTSA No.: O20165401**

**FINAL REPORT**

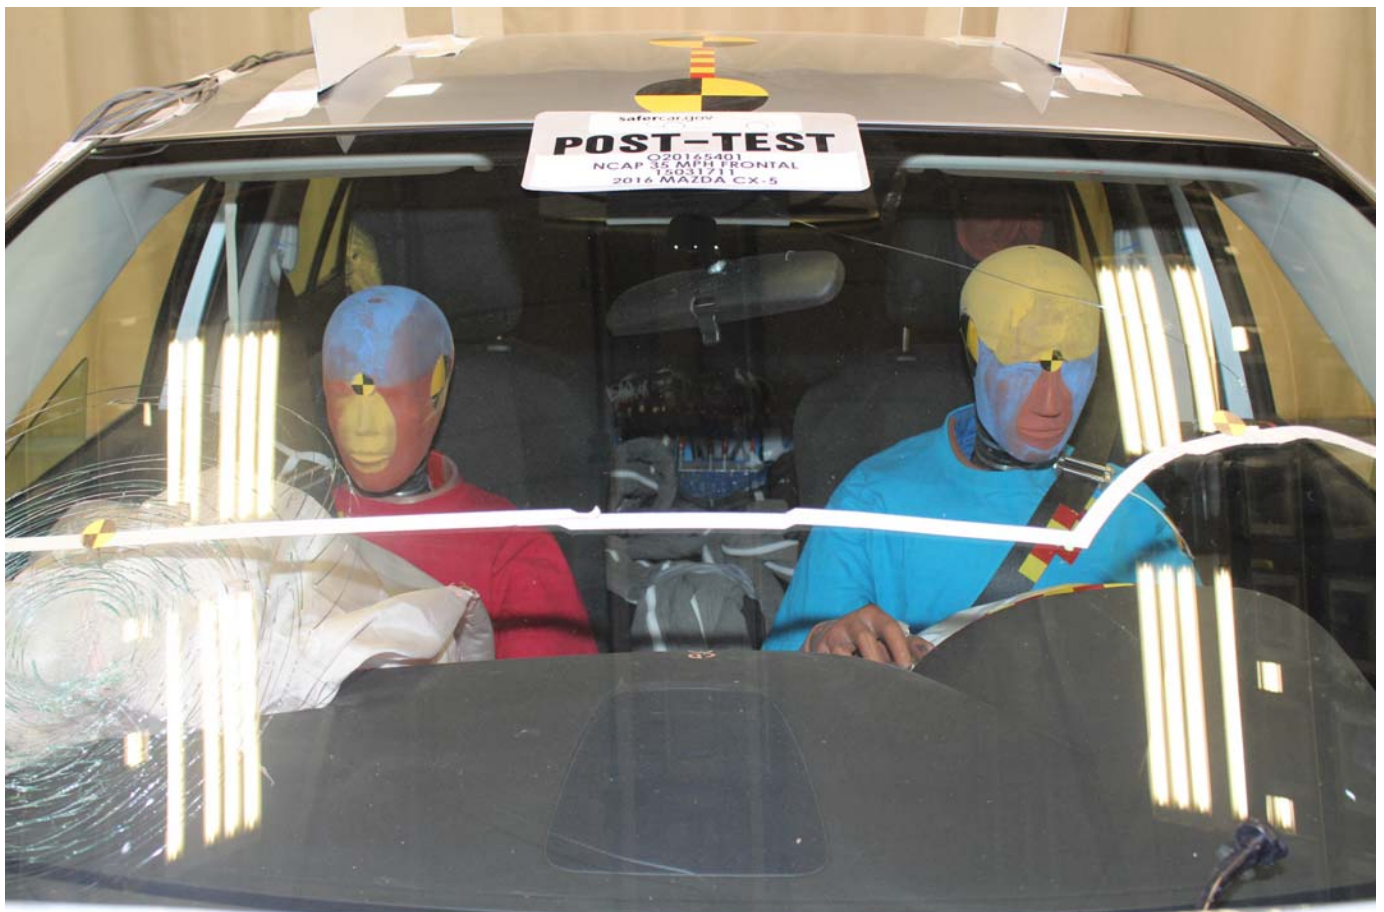
No. 018 Post-Test Windshield View

| Critical Areas of Performance | Observations and Conclusions |
|---|---|
| Windshield Damage | Cracked |

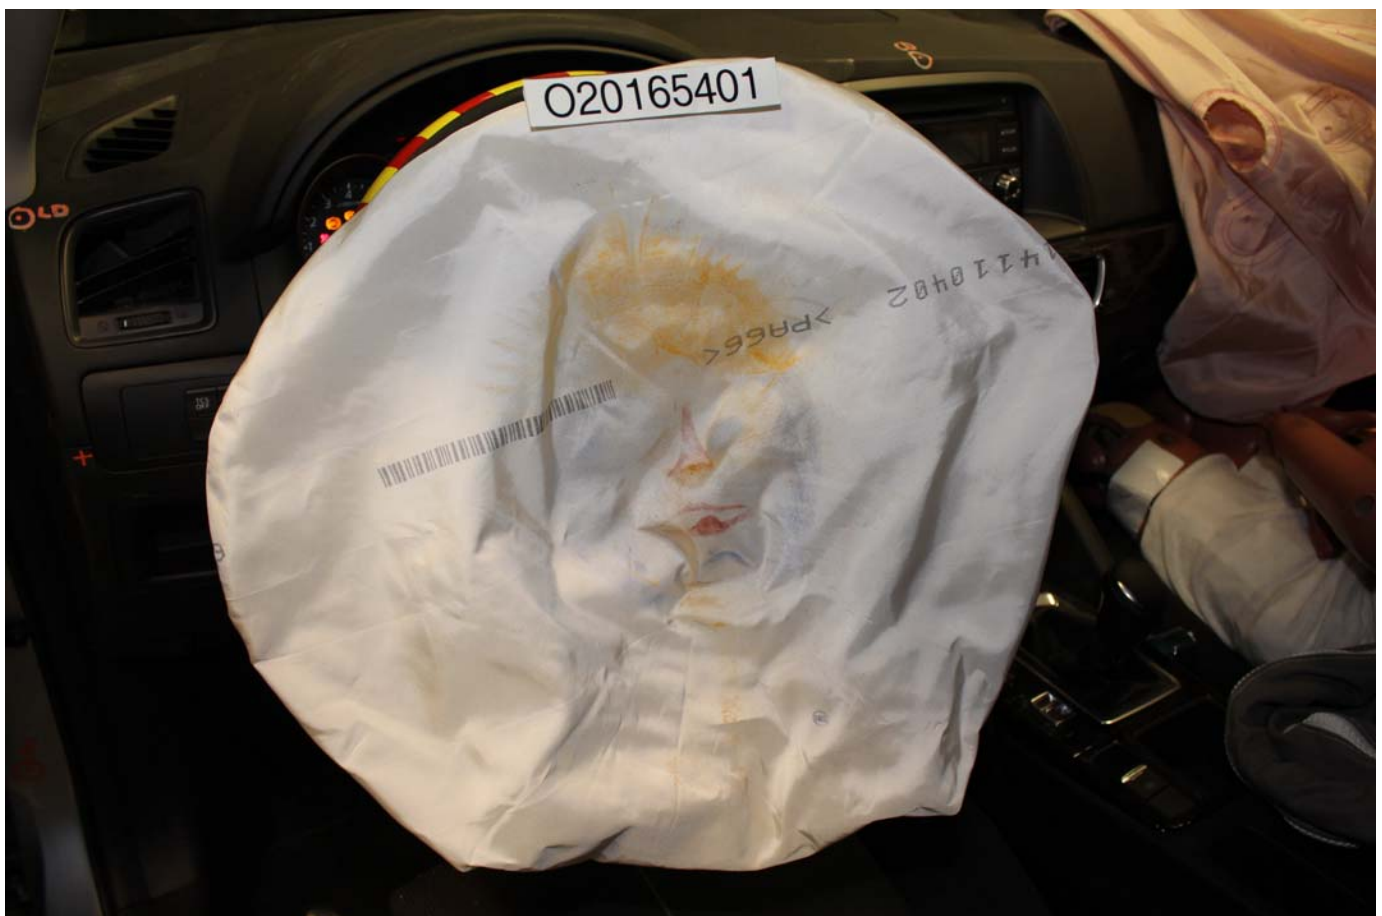
No. 050 Post-Test Driver Dummy Contact with Airbag

The driver's visible contact points were as follows: The driver's head and chest contacted the airbag. The driver's head also contacted the headrest. The driver's knees contacted the knee bolster. The passenger's visible contact points were as follows: The passenger's head and chest contacted the airbag. The passenger's head also contacted the headrest. The passenger's knees contacted the glovebox.

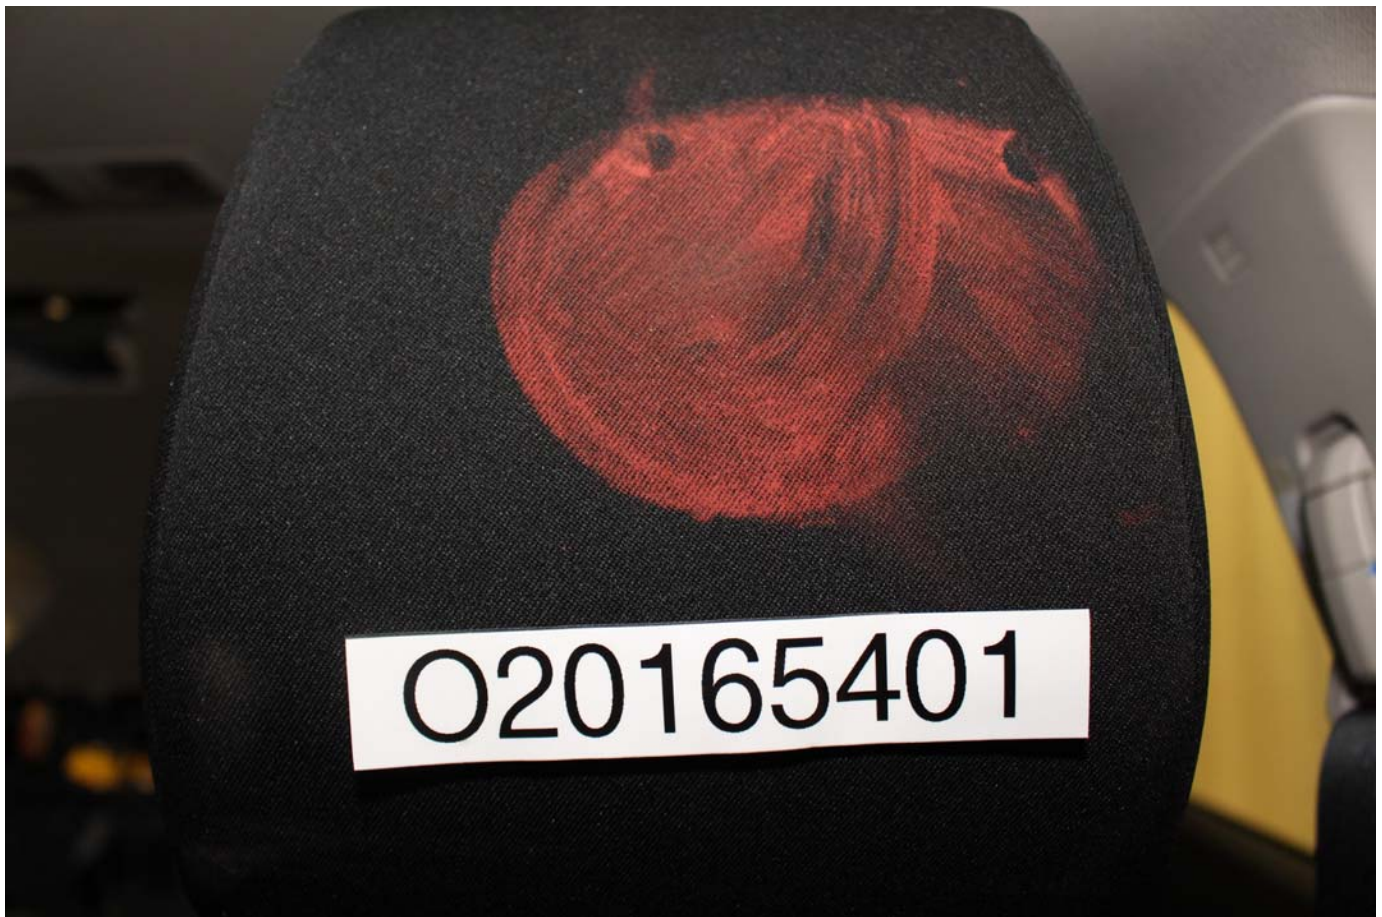
No. 051 Post-Test Driver Dummy Contact with Headrest

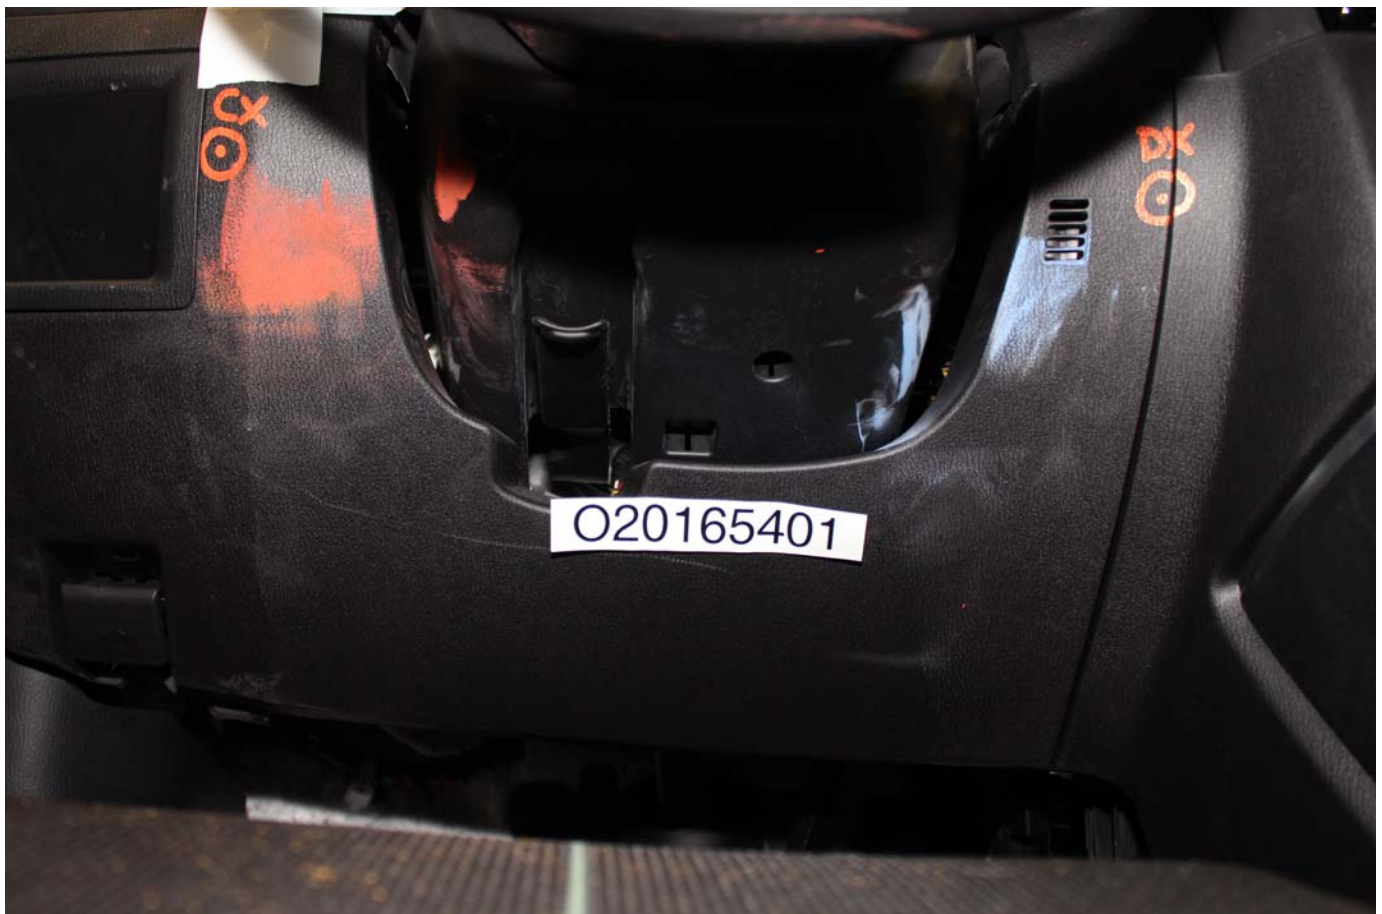
No. 052 Post-Test Driver Dummy Contact with Knee Bolster

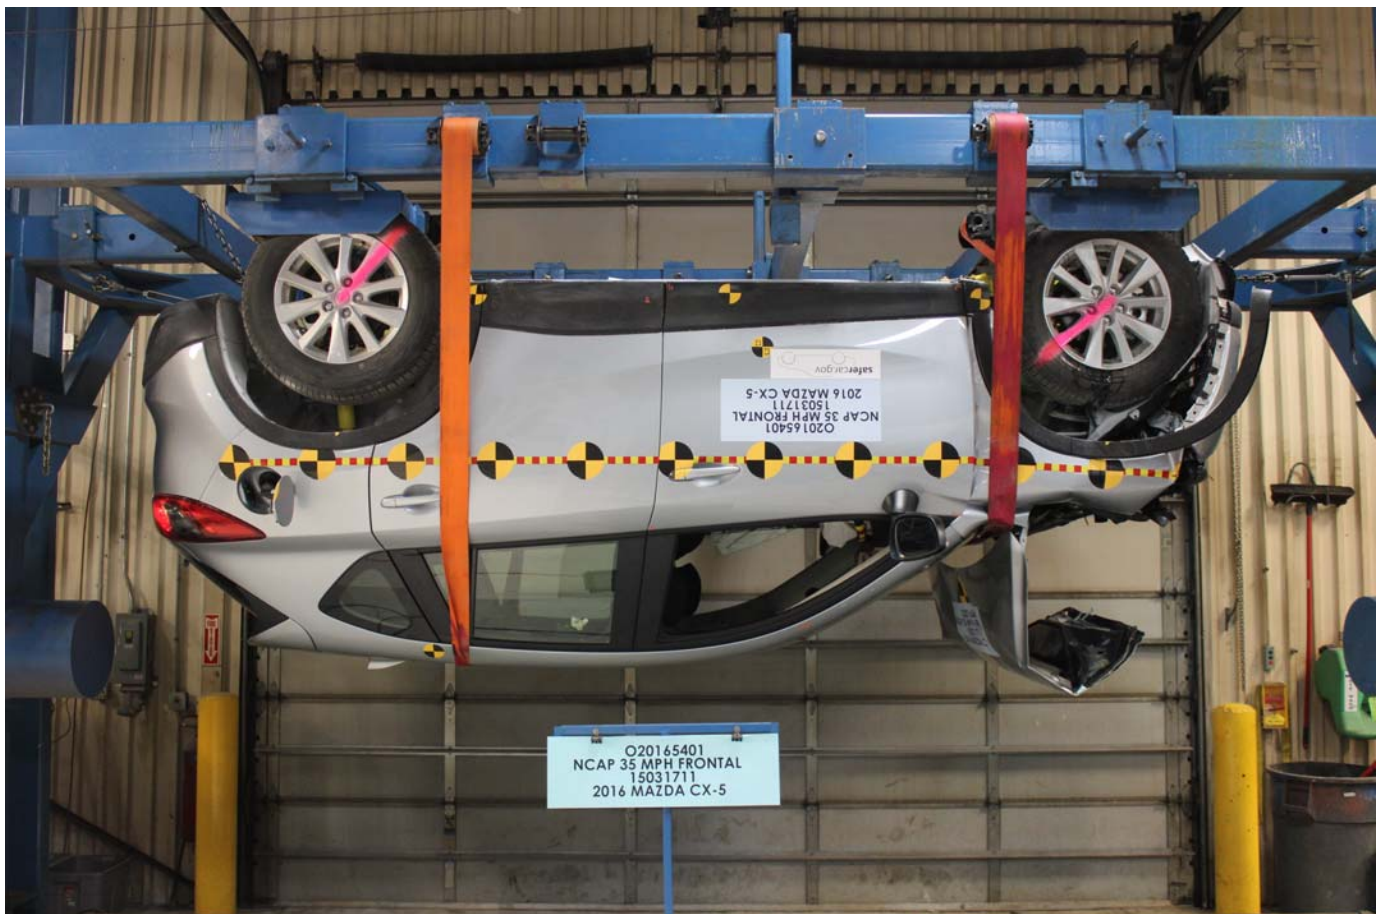
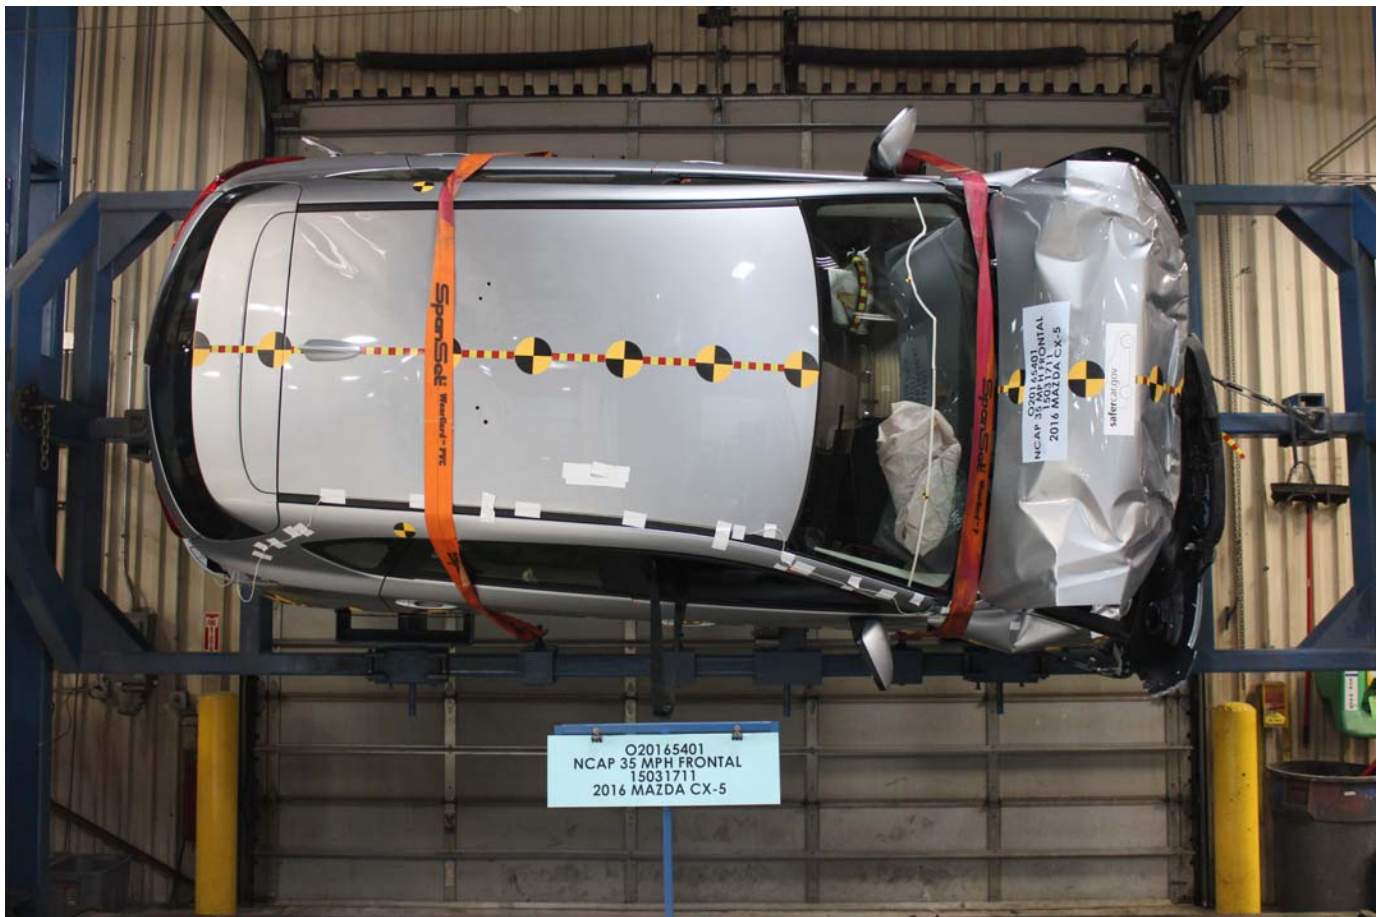
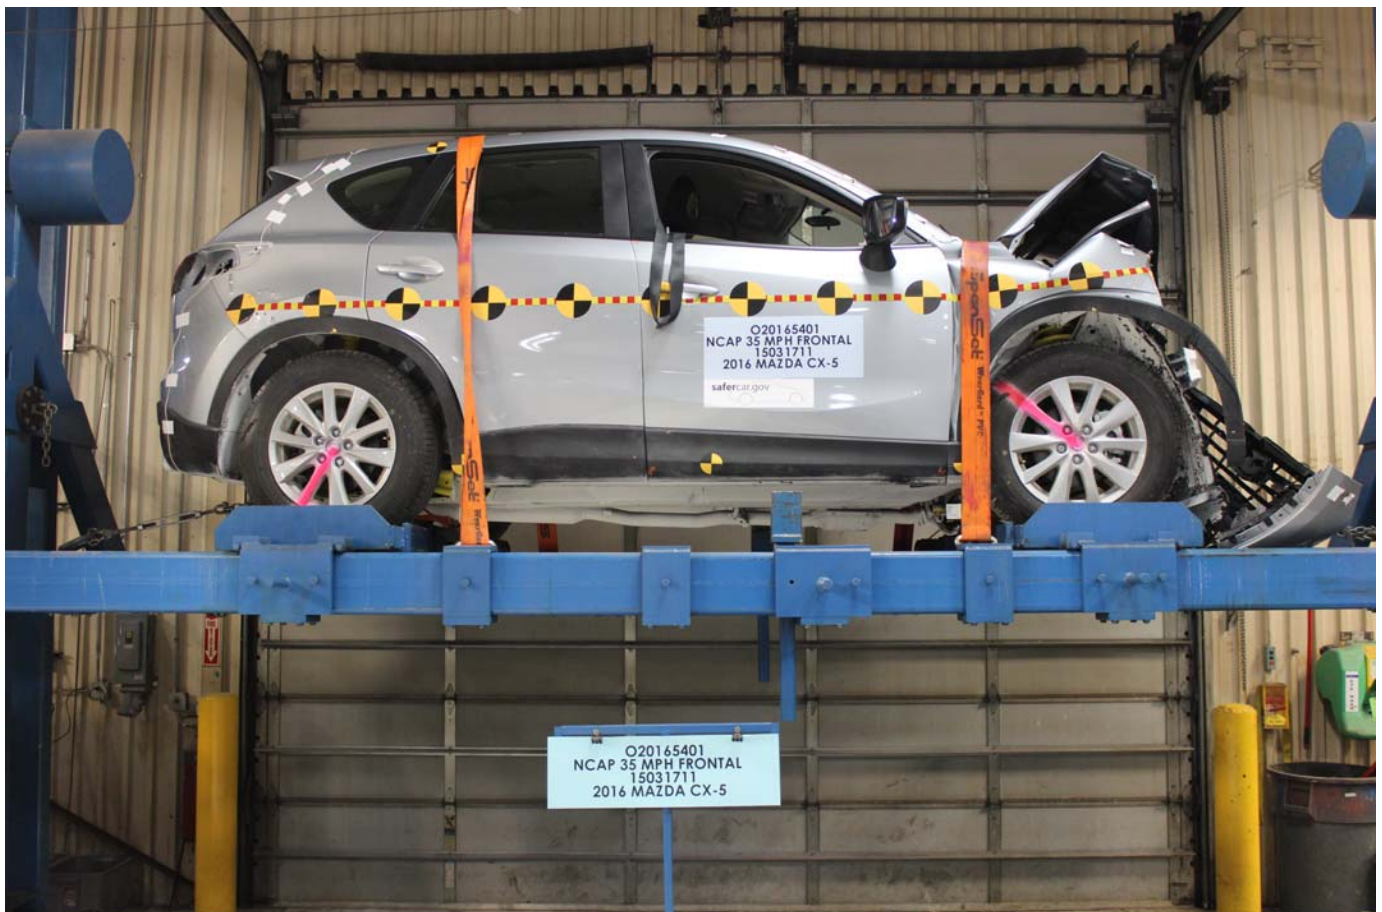
No. 078 Vehicle at 0 Degree on Static Rollover Device

No. 079 Vehicle at 90 Degrees on Static Rollover Device

No. 080 Vehicle at 180 Degrees on Static Rollover Device

No. 081 Vehicle at 270 Degrees on Static Rollover Device

There was 100 percent windshield retention and no intrusion into the protected zone of the windshield during the event. There was no Stoddard Solvent leakage after the event or during any phase of the static rollover.

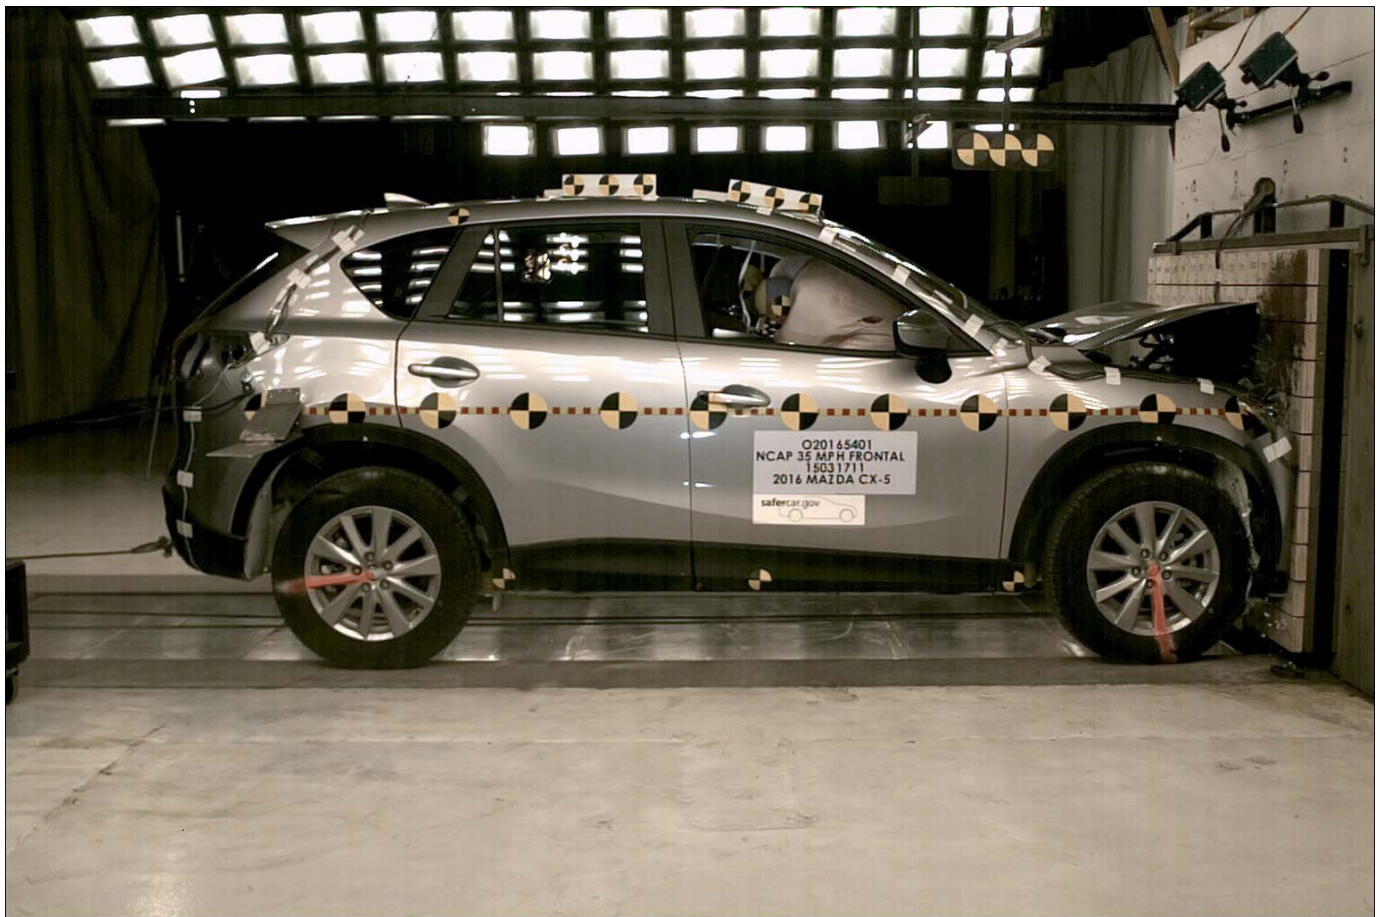
No. 083 2016 Mazda CX-5 Sport AWD Frontal Impact Event

A load cell barrier consisting of 176 load cells was impacted by a 2016 Mazda CX-5 Sport AWD 5-Dr SUV at a velocity of 56.5 km/h. The test was performed at MGA Research Corporation on March 17, 2015. Pre-test and post-test photographs of the vehicle and dummies can be found in Appendix A.
