***Frontal Oblique Offset Test  
90.1 kph, 15 degree angle, 35% overlap  
Research Vehicle 4969***

**NHTSA Code:** M3V3T1M  
**Report Number:** R&D-CAL-13-15  
**Report Date:** February 11, 2014

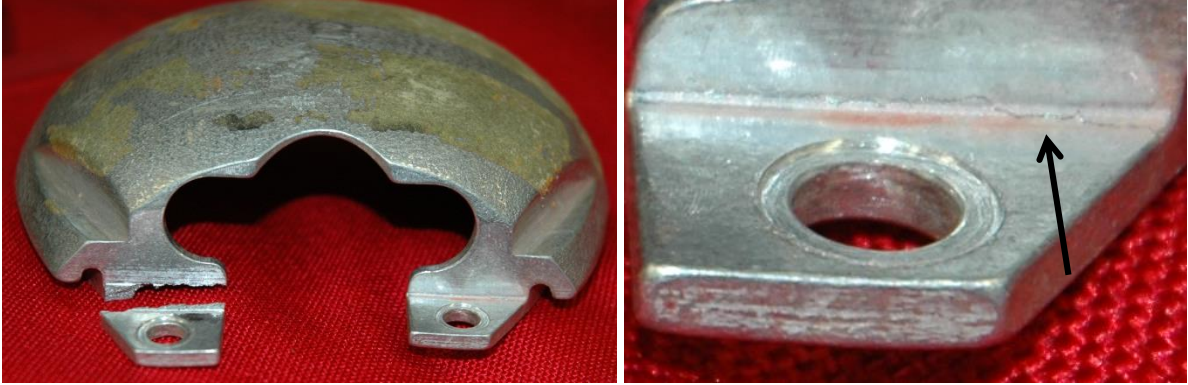
| HEAD | |
|---|---|
| Y / N | <p>Rear head cap mounts securely to head<br/> <b>1 cap tab broke. The other tab has a stress crack.</b></p> |

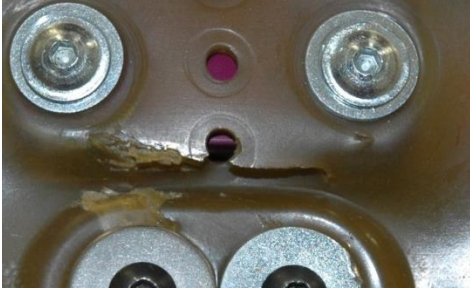
| THORAX | |
|---|---|
| Y / N | Urethane bib is securely attached to ribs with no sign of tearing or washer penetration<br> <p><b>Bib has torn in the center of sternum</b></p> |

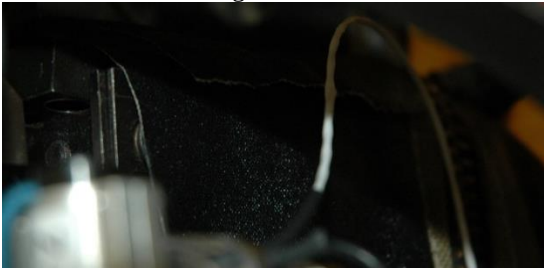
| THORAX | |
|---|---|
| Y / N | No evidence of tearing, cuts, or broken stitches in upper abdomen bag and zipper<br> <p><b>Upper abdomen came held together with black tape</b></p> |

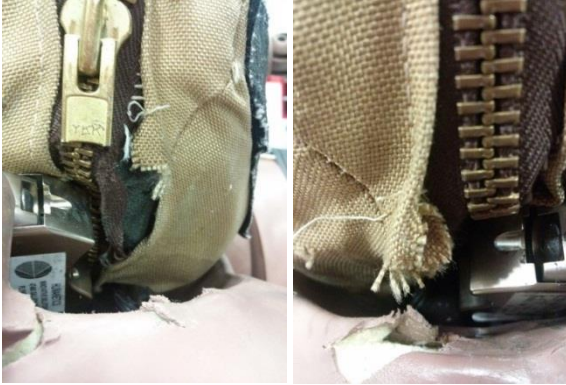
**Both sides of the Abdomen Bag have torn where the stitches had broke**

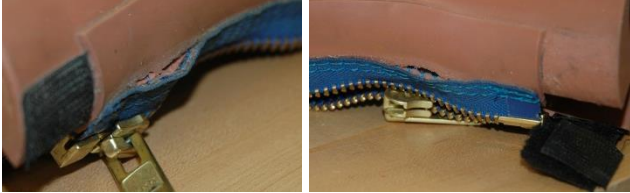
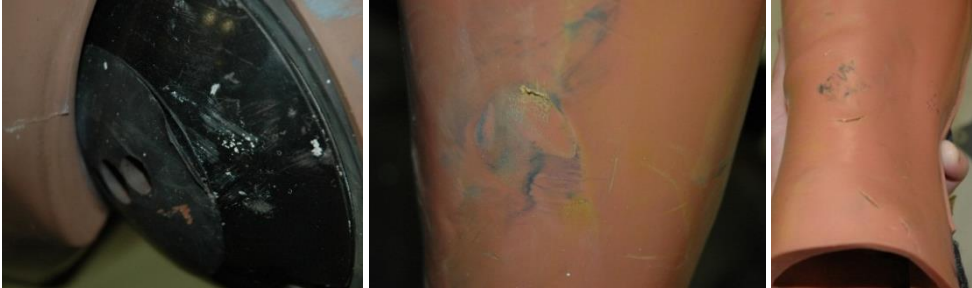
| FEMUR | |
|---|---|
| Y / N | <p>No cuts, tears, or scuffing of leg flesh<br/><b>Flesh around both lower zippers are starting to tear:</b></p> <p>Numerous minor cuts. Additional abrasion on right leg seen after CAL2660. Right outer knee cap rubber started to pull away from composite material.</p> <p>Scuff on upper left shin after CAL2665</p> <p>Zipper on right ankle is pulling away from the flesh – This became much worse during the RE5507 test. (See second photo) (Replaced flesh) Right knee has some nicks in the flesh</p> |

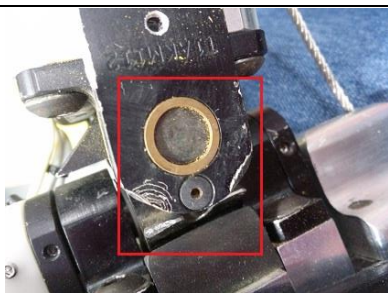
**Damage to the metal of the right ankle**

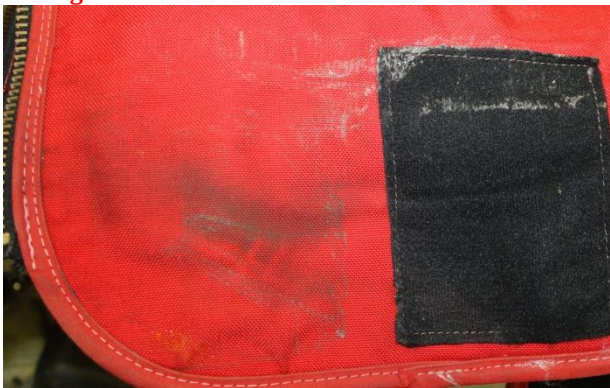
| JACKET | |
|---|---|
| Y / N | <p>No evidence of tears or holes in jacket fabric, Velcro, or zippers</p> <p><b>Jacket has tears around neck and at most seam ends as seen here on the front left shoulder.</b></p> <p><b>Airbag burn on left rear Jacket</b></p> |

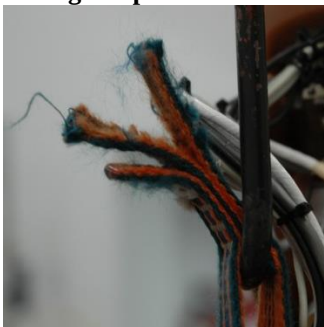
| JACKET | |
|---|---|
| OTHER | <p><b>Lifting strap torn</b></p> |

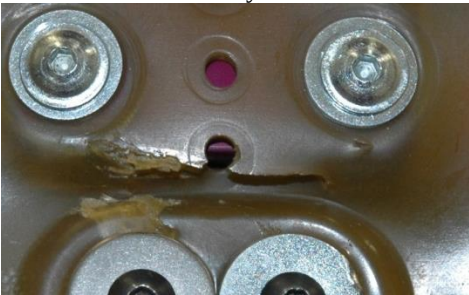
| SHOULDER | |
|---|---|
| Y / N | <p>Urethane bib is securely attached to ribs with no sign of tearing or washer penetration</p> <p><b>Bib has torn in the center of sternum</b></p> |

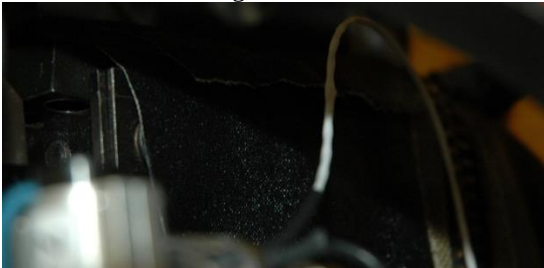
| ABDOMEN | |
|---|---|
| Y / N | <p>No evidence of tearing, cuts, or broken stitches in upper abdomen bag and zipper</p> <p><b>Upper abdomen came held together with black tape</b></p> |

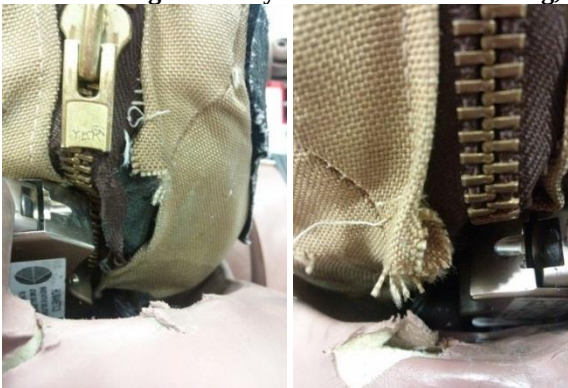
| ABDOMEN | |
|---|---|
| Y / N | <p>No evidence of tearing, cuts, or broken stitches in lower abdomen bag and zipper</p> <p><b>Abdomen bag has many broken stitches forming, but no tears occurring.</b></p> <p><b>Both sides of the Abdomen Bag have torn where the stitches had broke</b></p> |

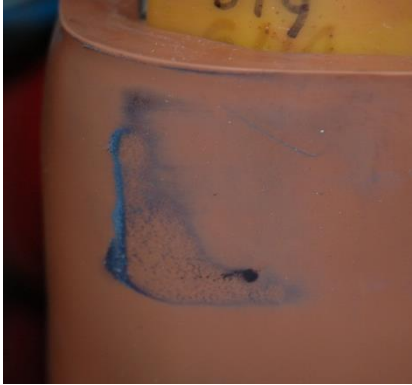
Zipper on right ankle is pulling away from the flesh – This became much worse during the RE5507 test. (See second photo) (Replaced flesh) Right knee has some nicks in the flesh

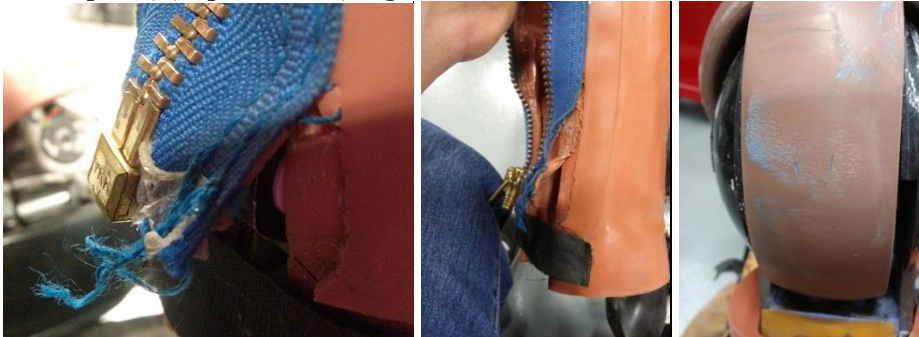
Right leg zipper is broken after CAL2672

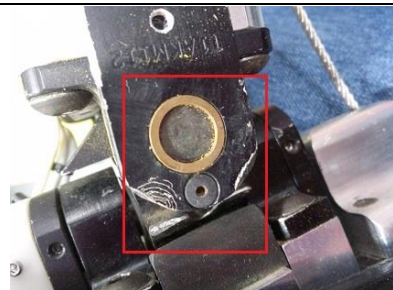
Damage to the metal of the right ankle

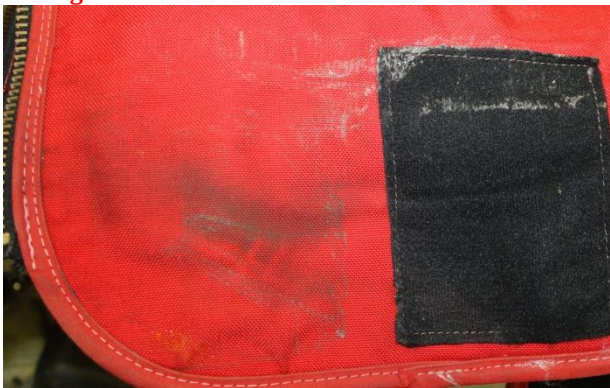
| JACKET | |
|---|---|
| Y / N | <p>No evidence of tears or holes in jacket fabric, Velcro, or zippers</p> <p><b>Jacket has tears around neck and at most seam ends as seen here on the front left shoulder.</b></p> <p><b>Airbag burn on left rear Jacket</b></p> |

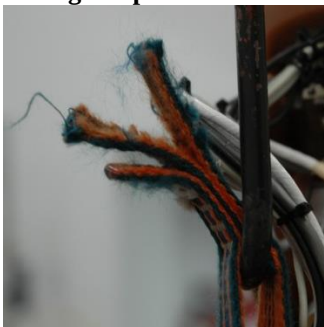
| JACKET | |
|---|---|
| OTHER | <p><b>Lifting strap torn</b></p> |

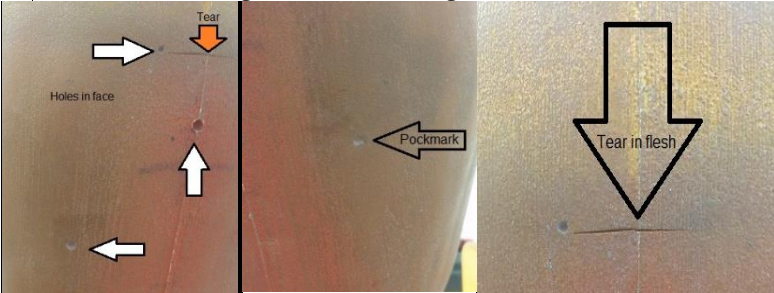
| HEAD | |
|---|---|
| Y / N | <p>Head skin shows no sign of tears or damage</p> <p>Thor has holes/pockmarks in his head skin, along with a tear</p> |

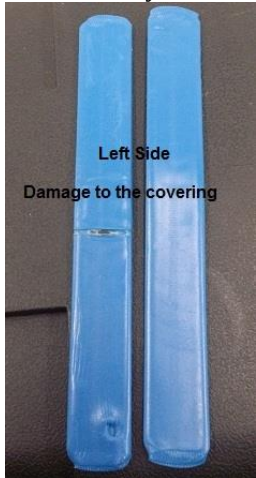
Rib stiffeners show no sign of permanent deformation  
**One of the left rib stiffeners has damage to the outer coating that goes all the way around, also, the rib stiffeners were severely bent when we received 0015.**

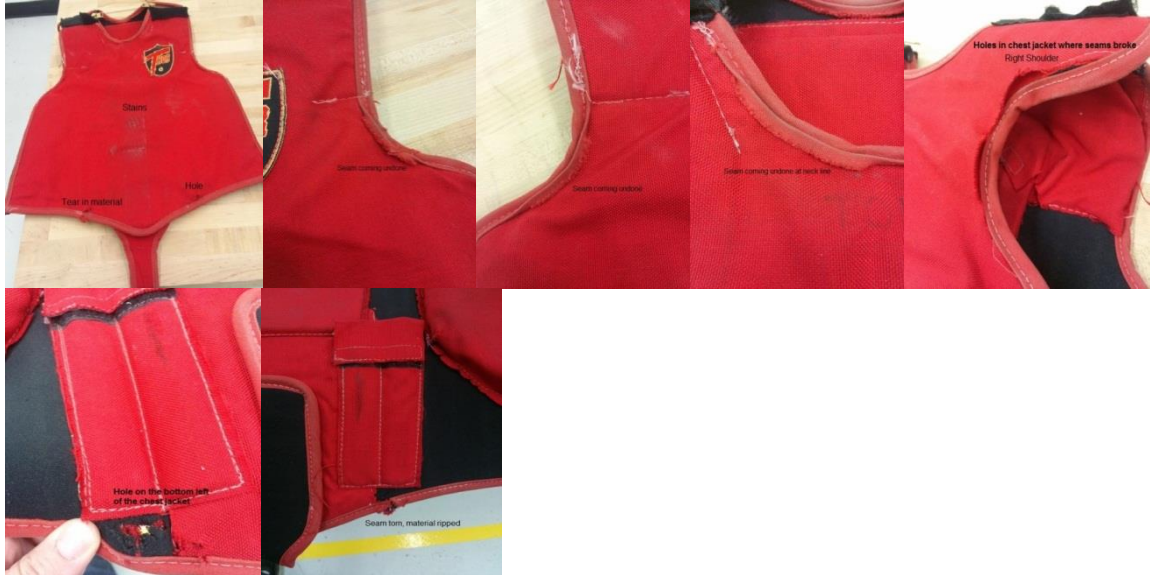
No evidence of tears or holes in jacket fabric, Velcro, or zippers  
**Many of the seams of the jacket are coming undone, and there is a hole on the bottom left side along with stains all over the jacket.**

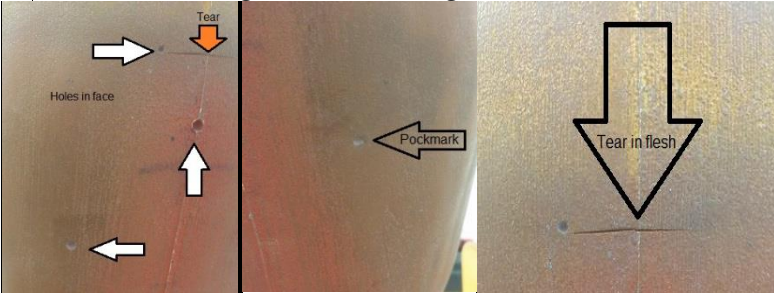
| HEAD | |
|---|---|
| Y / N | <p>Head skin shows no sign of tears or damage</p> <p>Thor has holes/pockmarks in his head skin, along with a tear</p> |

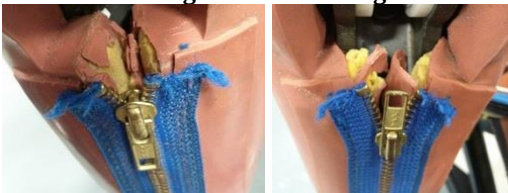
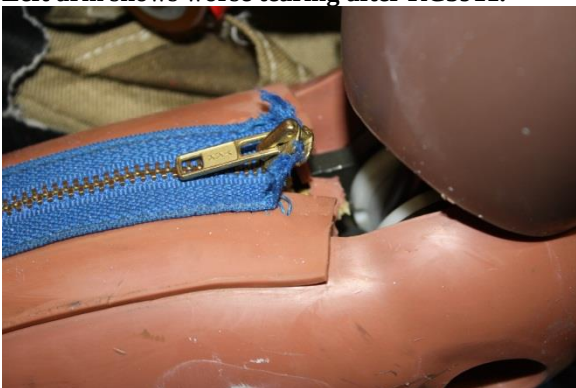
| SHOULDER | |
|---|---|
| OTHER | <b>Both left and right arms show signs of internal tearing</b><br> <b>Left arm shows worse tearing after RC5911.</b><br> |

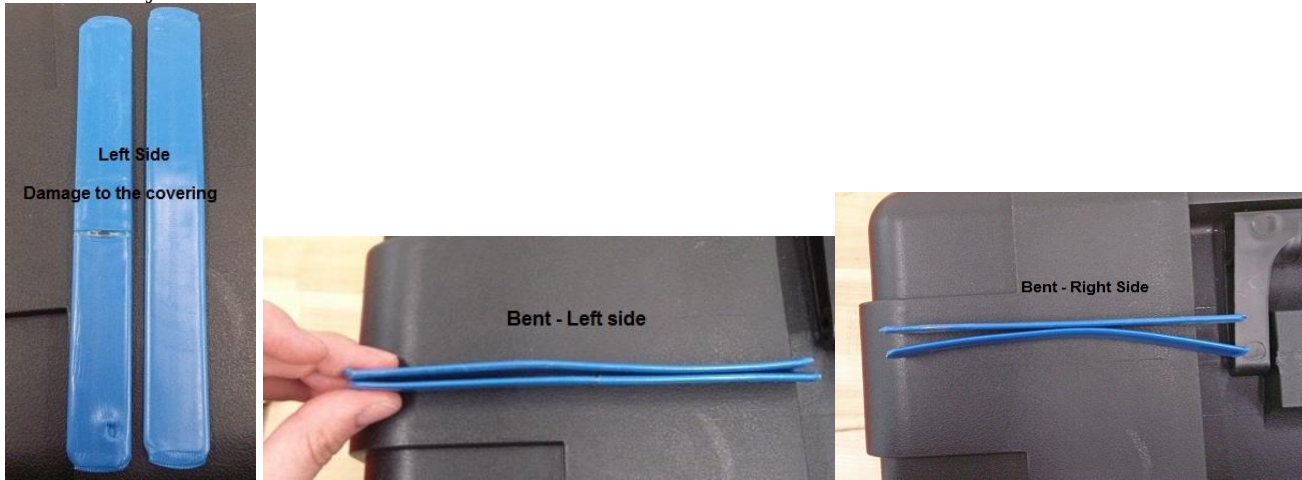
| JACKET | |
|---|---|
| | |

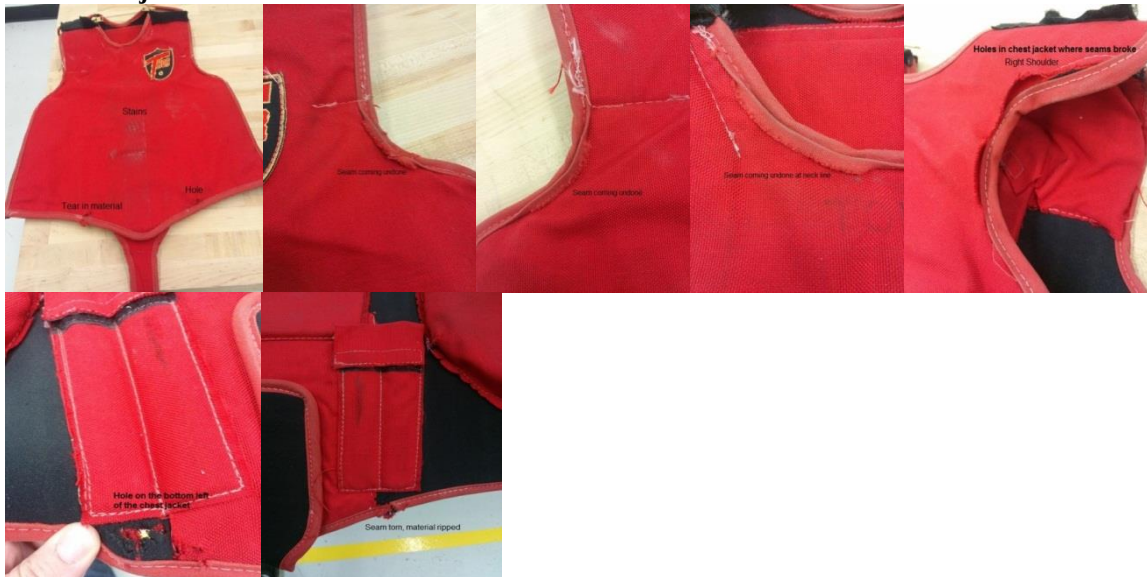
| JACKET | |
|---|---|
| | |
