**REPORT NUMBER: NCAP-MGA-2016-002**

**NEW CAR ASSESSMENT PROGRAM (NCAP)  
Frontal Barrier Impact Test**

**MAZDA MOTOR CORPORATION  
2016 Mazda6 I Sport 4-Dr Sedan  
NHTSA No.: O20165400**

**MGA RESEARCH CORPORATION  
5000 Warren Road  
Burlington, WI 53105**

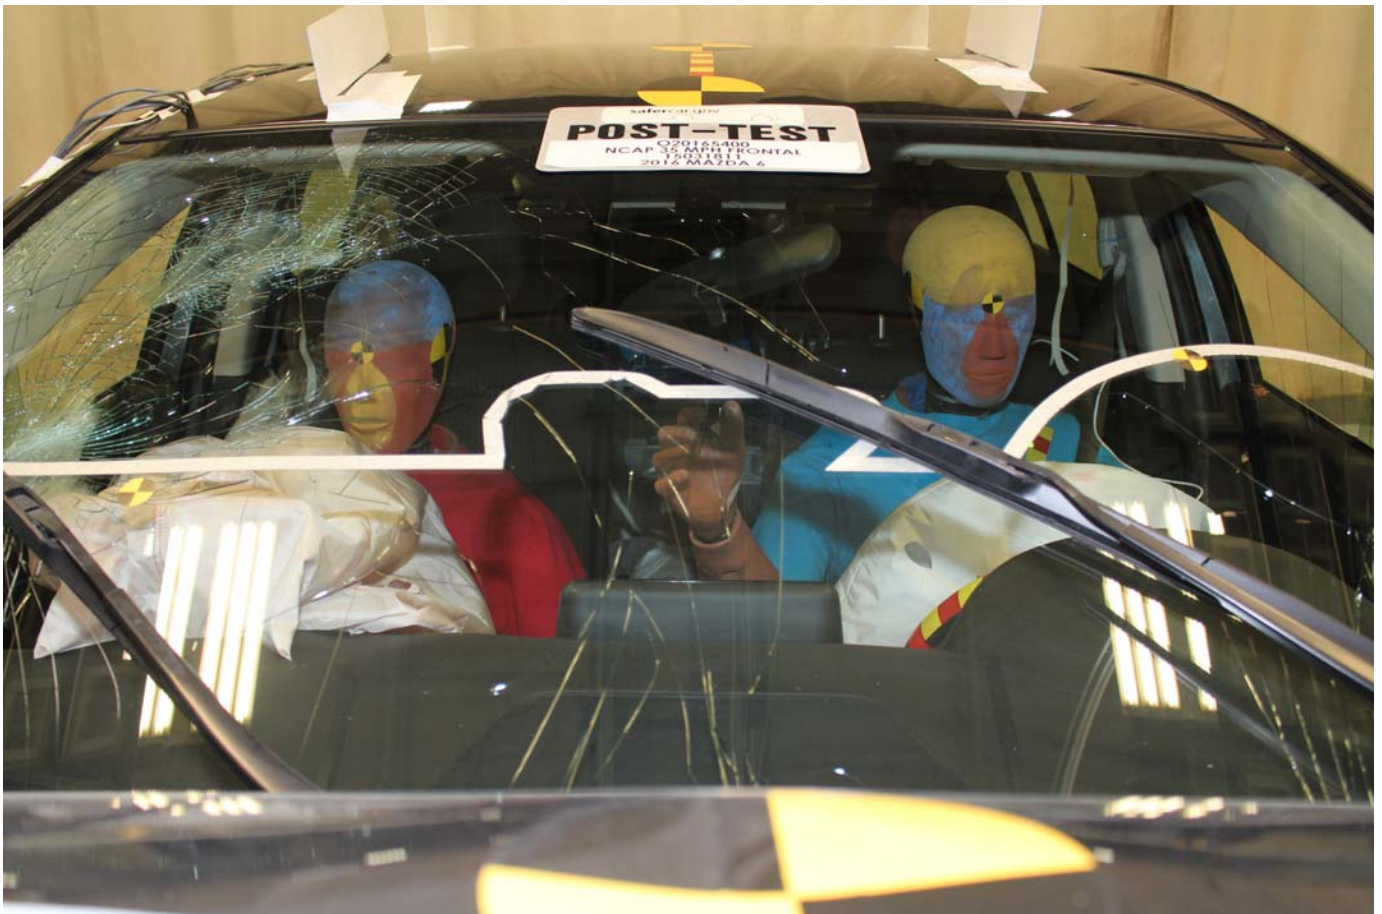
No. 018 Post-Test Windshield View

Critical Areas of Performance	Observations and Conclusions
Windshield Damage	Cracked
Window Damage	None
Other Notable Effects	None
