**REPORT NUMBER: NCAP-MGA-2016-003**

**NEW CAR ASSESSMENT PROGRAM (NCAP)  
Frontal Barrier Impact Test**

**KIA MOTORS MANUFACTURING GEORGIA, INC.  
2016 Kia Sorento LX AWD 5-Dr SUV  
NHTSA No.: O20164200**

**FINAL REPORT**

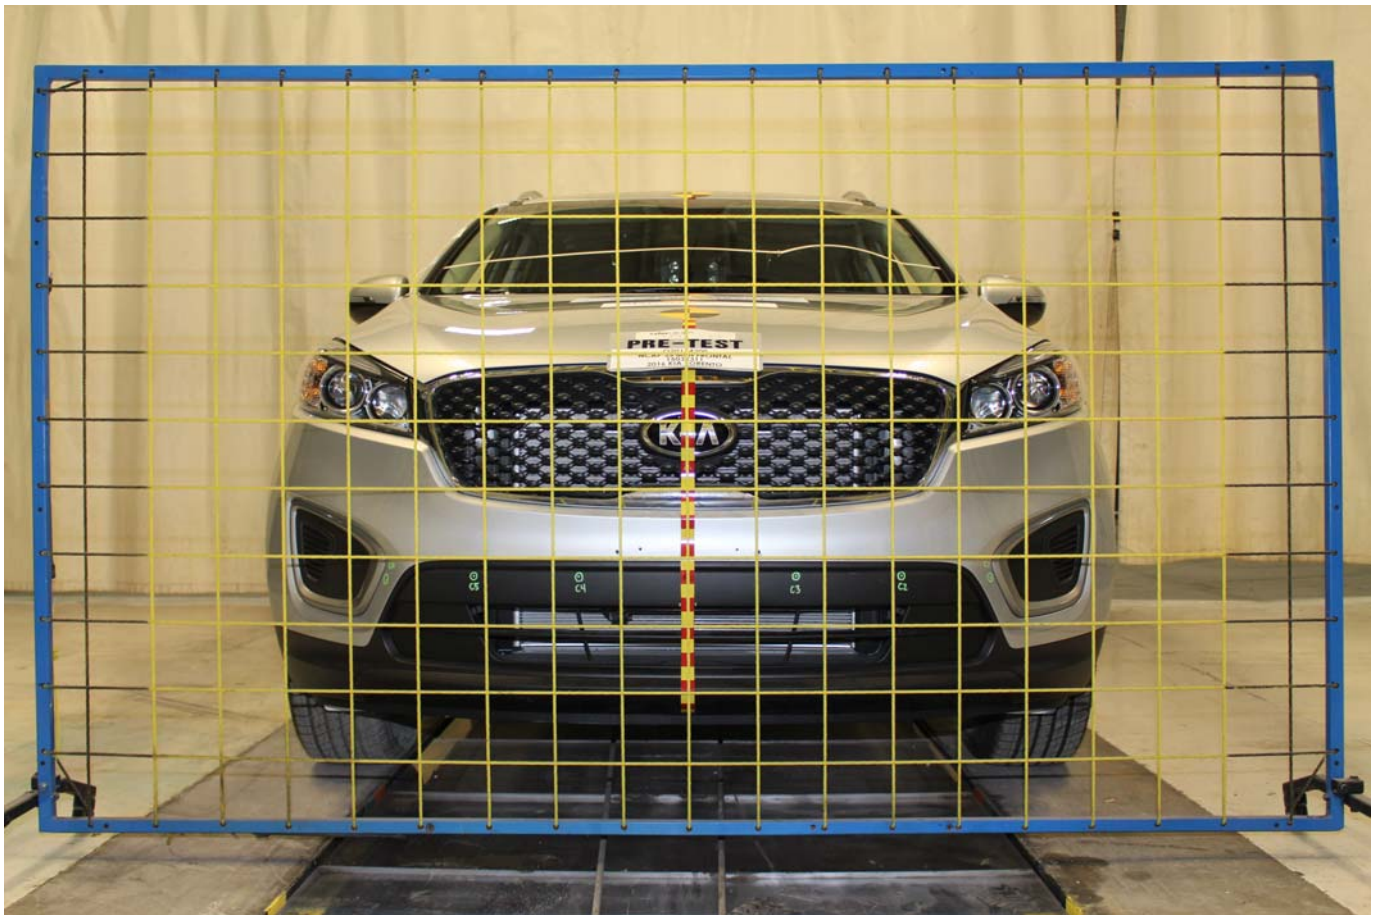
Photo No. 001. - Load Cell Location

A load cell barrier consisting of 176 load cells was impacted by a 2016 Kia Sorento LX AWD 5-Dr SUV at a velocity of 56.4 km/h. The test was performed at MGA Research Corporation on March 23, 2015. Pre-test and post-test photographs of the vehicle and dummies can be found in Appendix A.

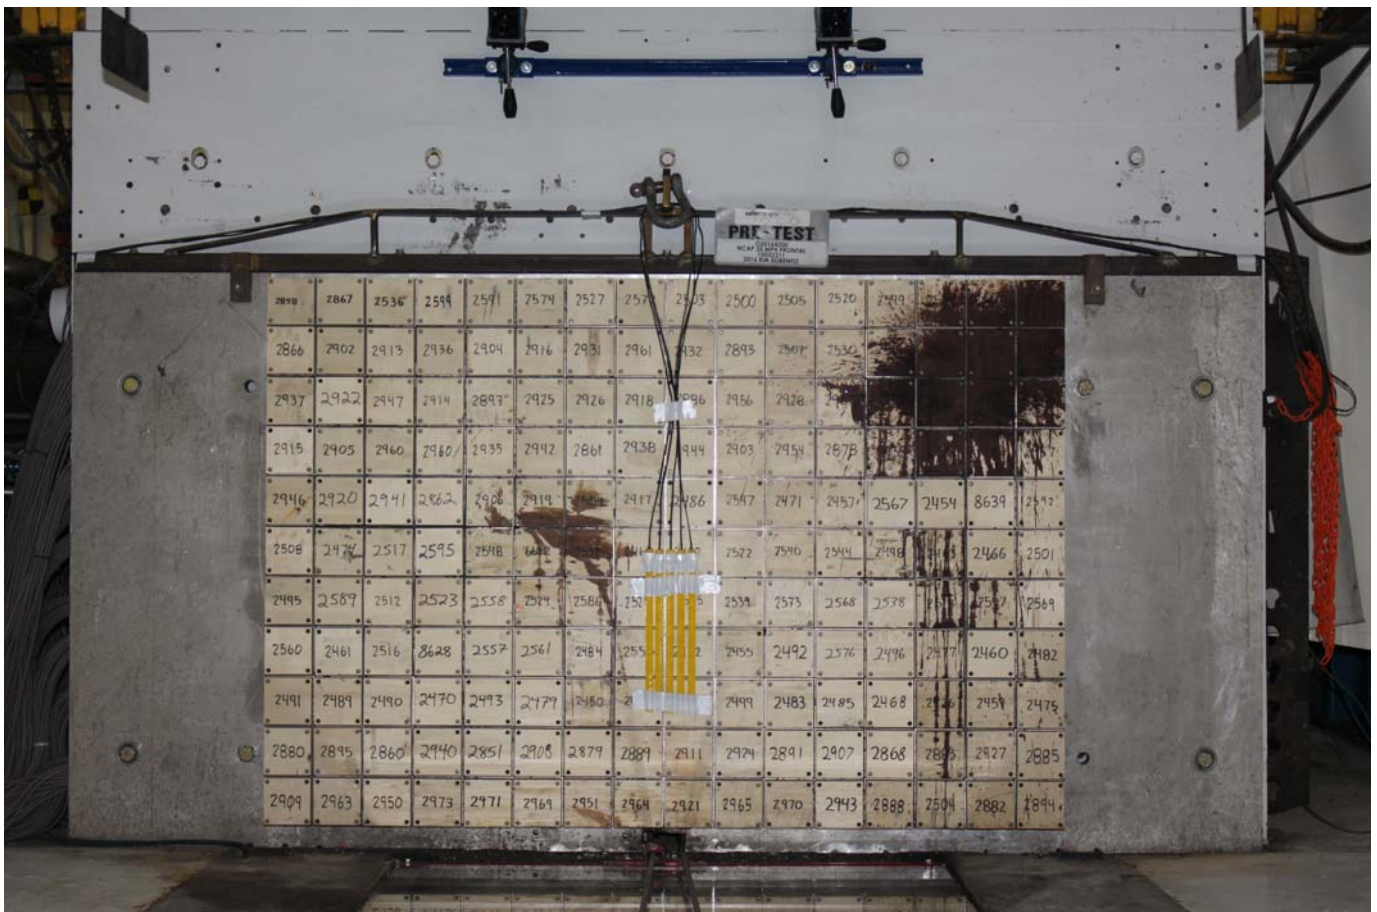
Photo No. 002. - Load Cell Wall

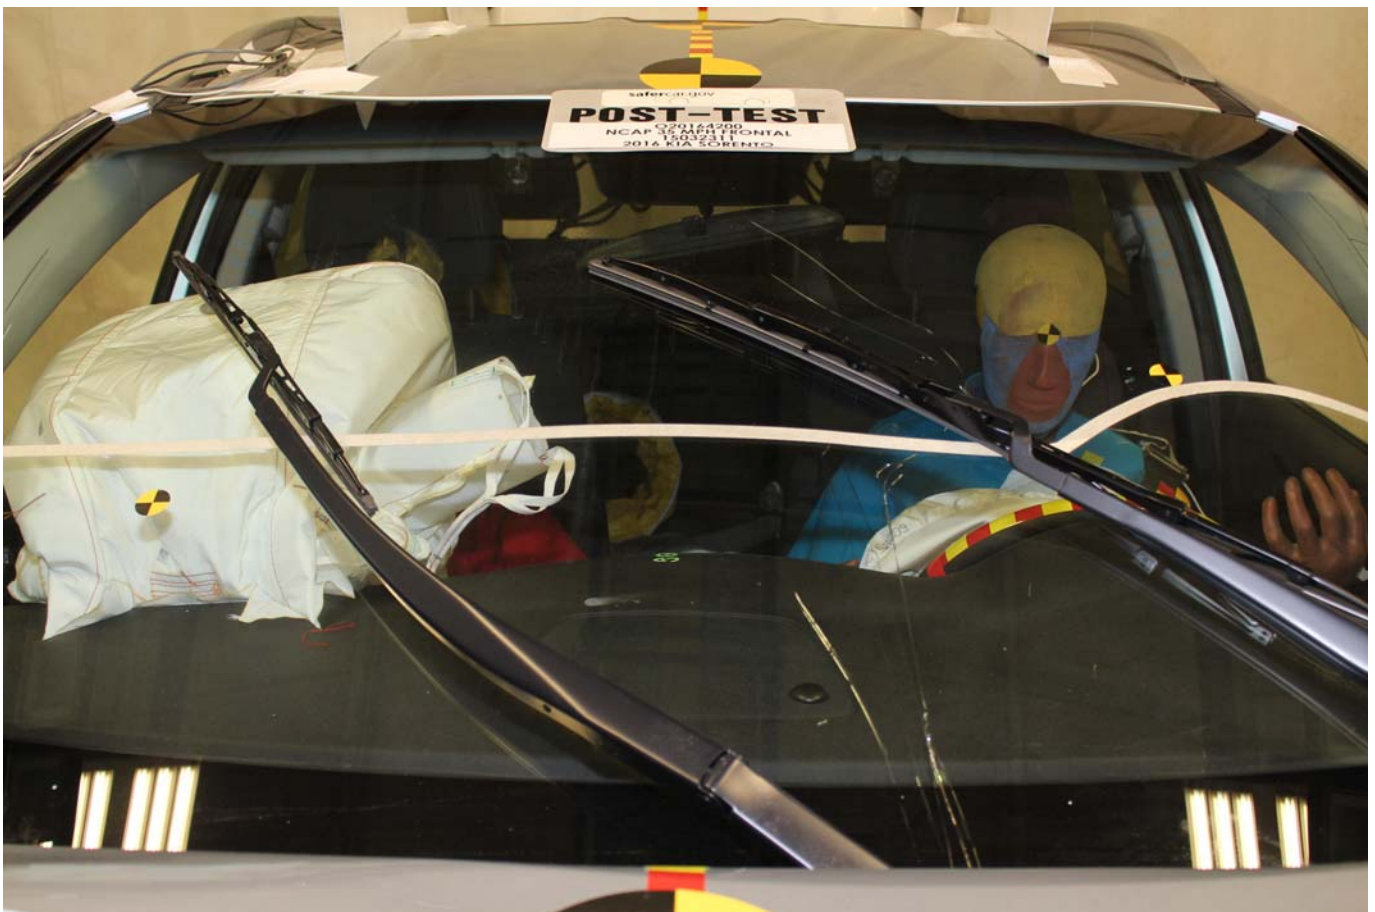
Photo No. 018. - Post-Test Windshield View

There was 100 percent windshield retention and no intrusion into the protected zone of the windshield during the event. There was no Stoddard Solvent leakage after the event or during any phase of the static rollover.

| Critical Areas of Performance | Observations and Conclusions |
|---|---|
| Windshield Damage | Cracked |

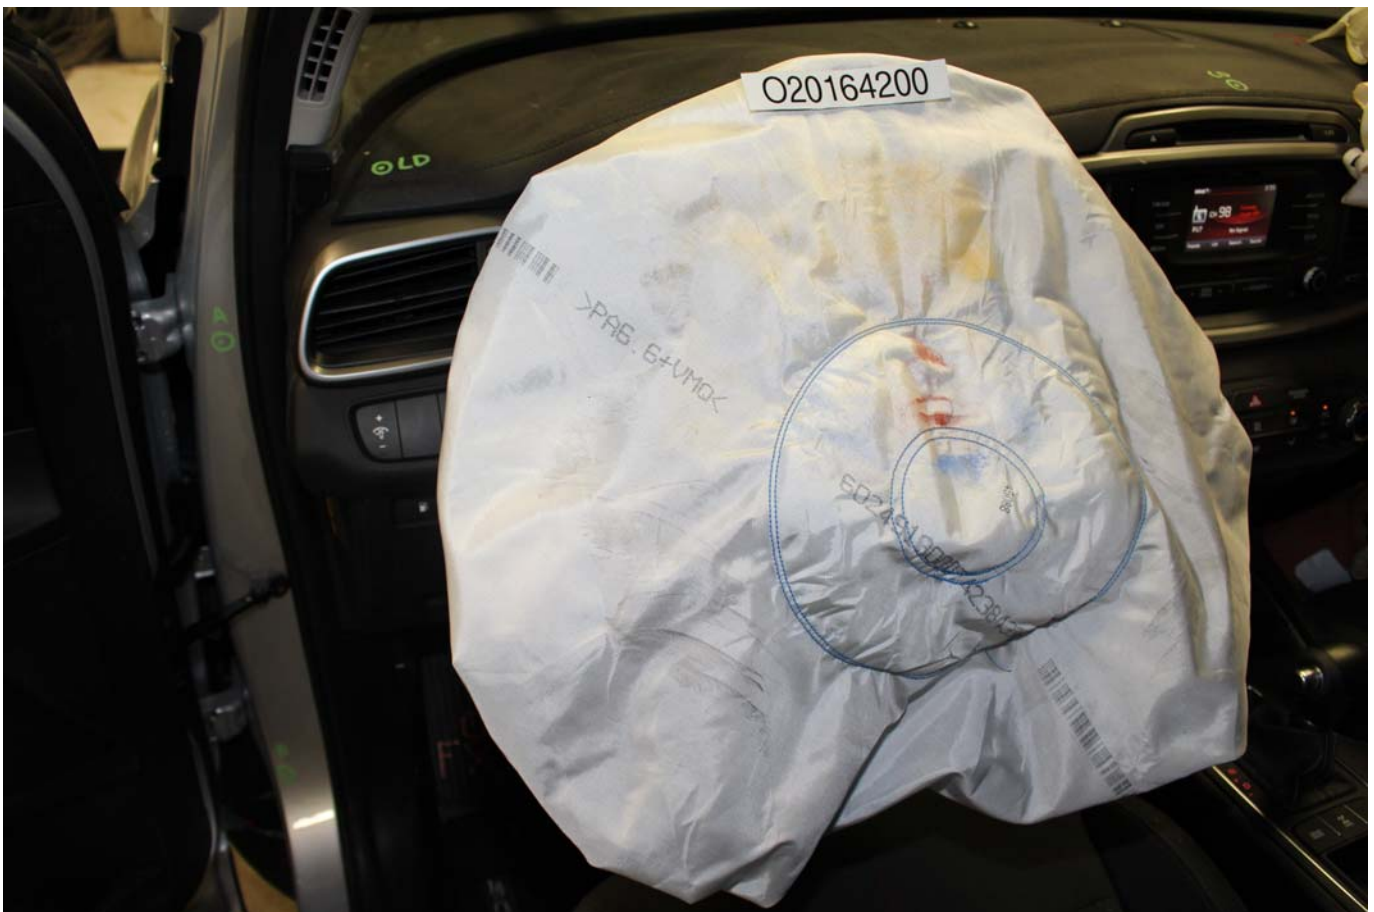
Photo No. 046. - Post-Test Driver Dummy Contact with Airbag

The driver's visible contact points were as follows: The driver's head and chest contacted the airbag. The driver's head also contacted the headrest. The driver's knees contacted the knee bolster and steering column shroud. The passenger's visible contact points were as follows: The passenger's head and chest contacted the airbag. The passenger's head also contacted the headrest. The passenger's knees contacted the glovebox.

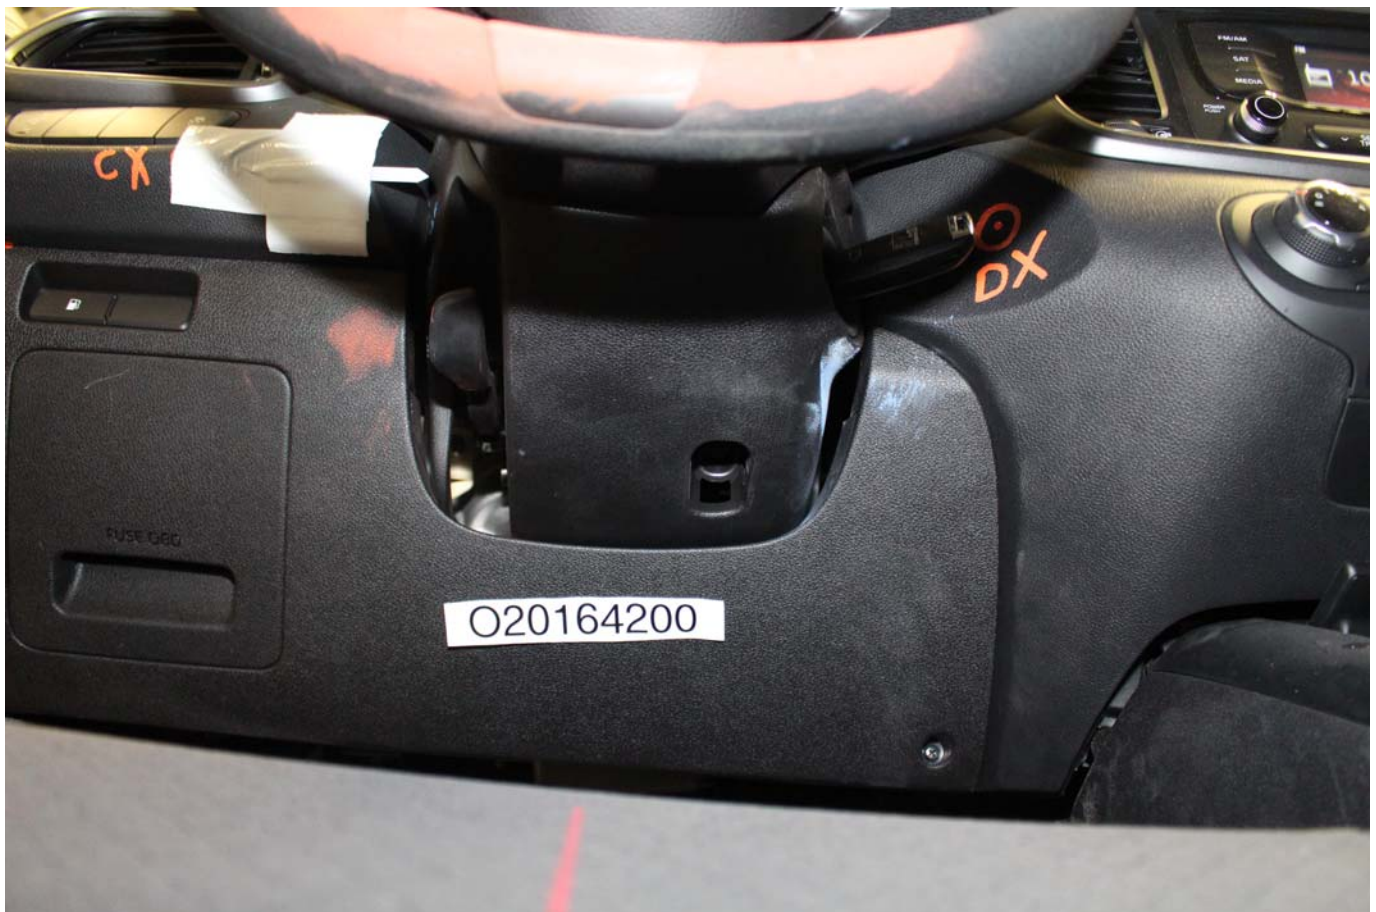
Photo No. 047a. - Post-Test Driver Dummy Contact with Knee Bolster

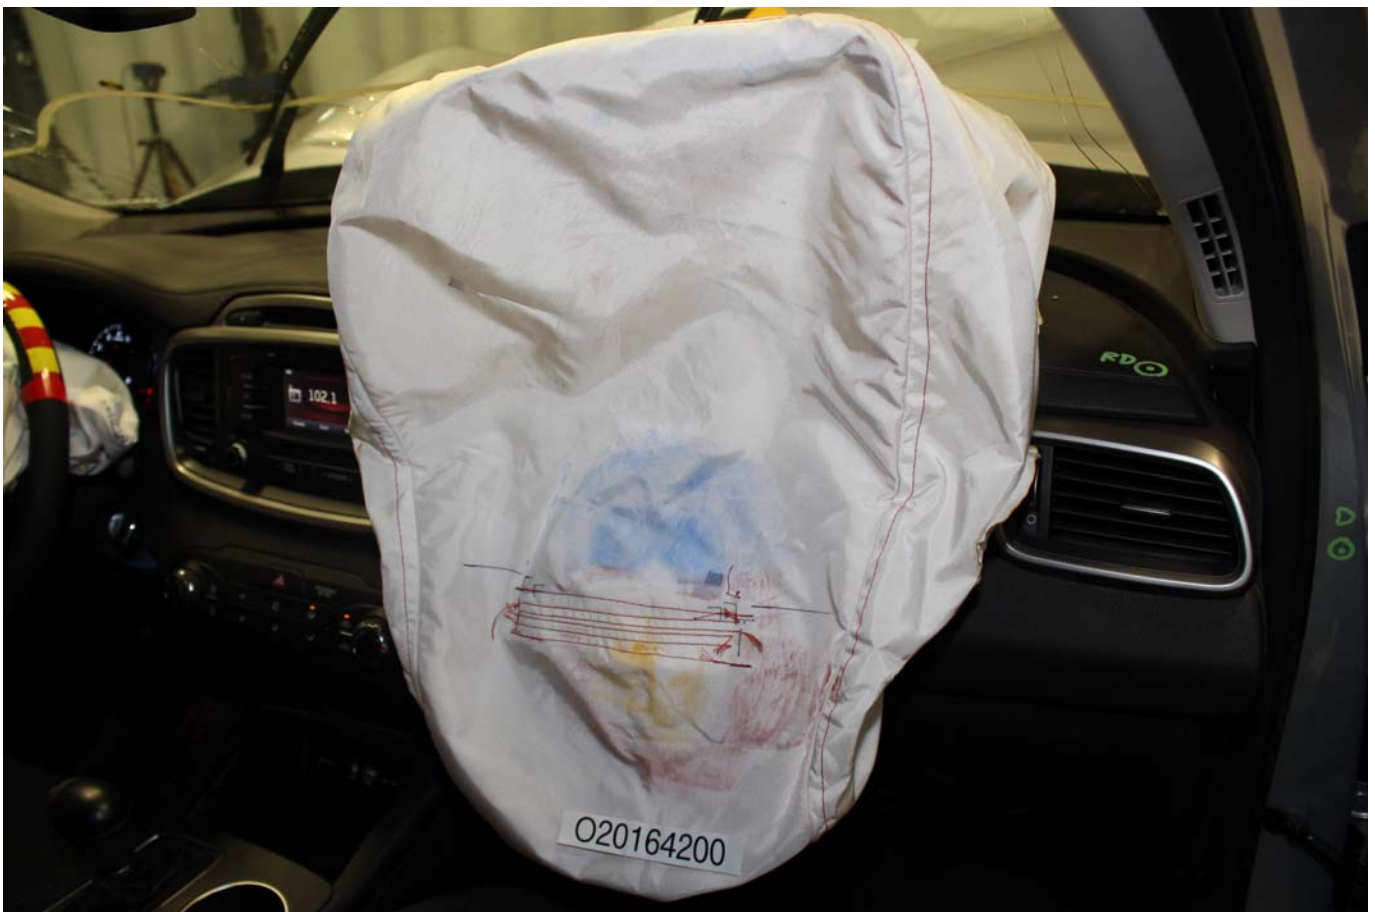
Photo No. 067. - Post-Test Passenger Dummy Contact with Airbag

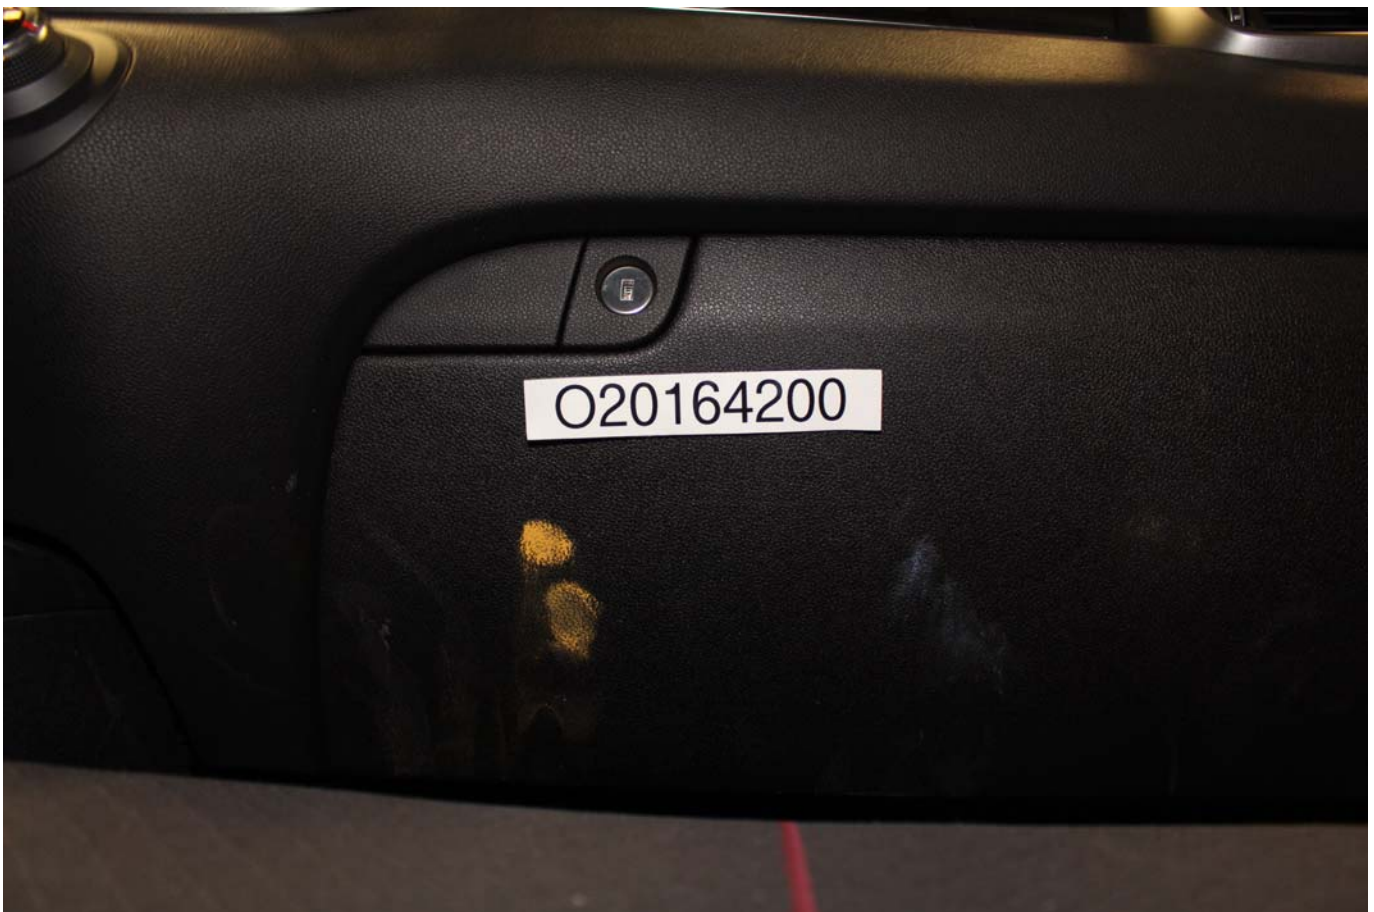
Photo No. 068a. - Post-Test Passenger Dummy Contact with Glovebox

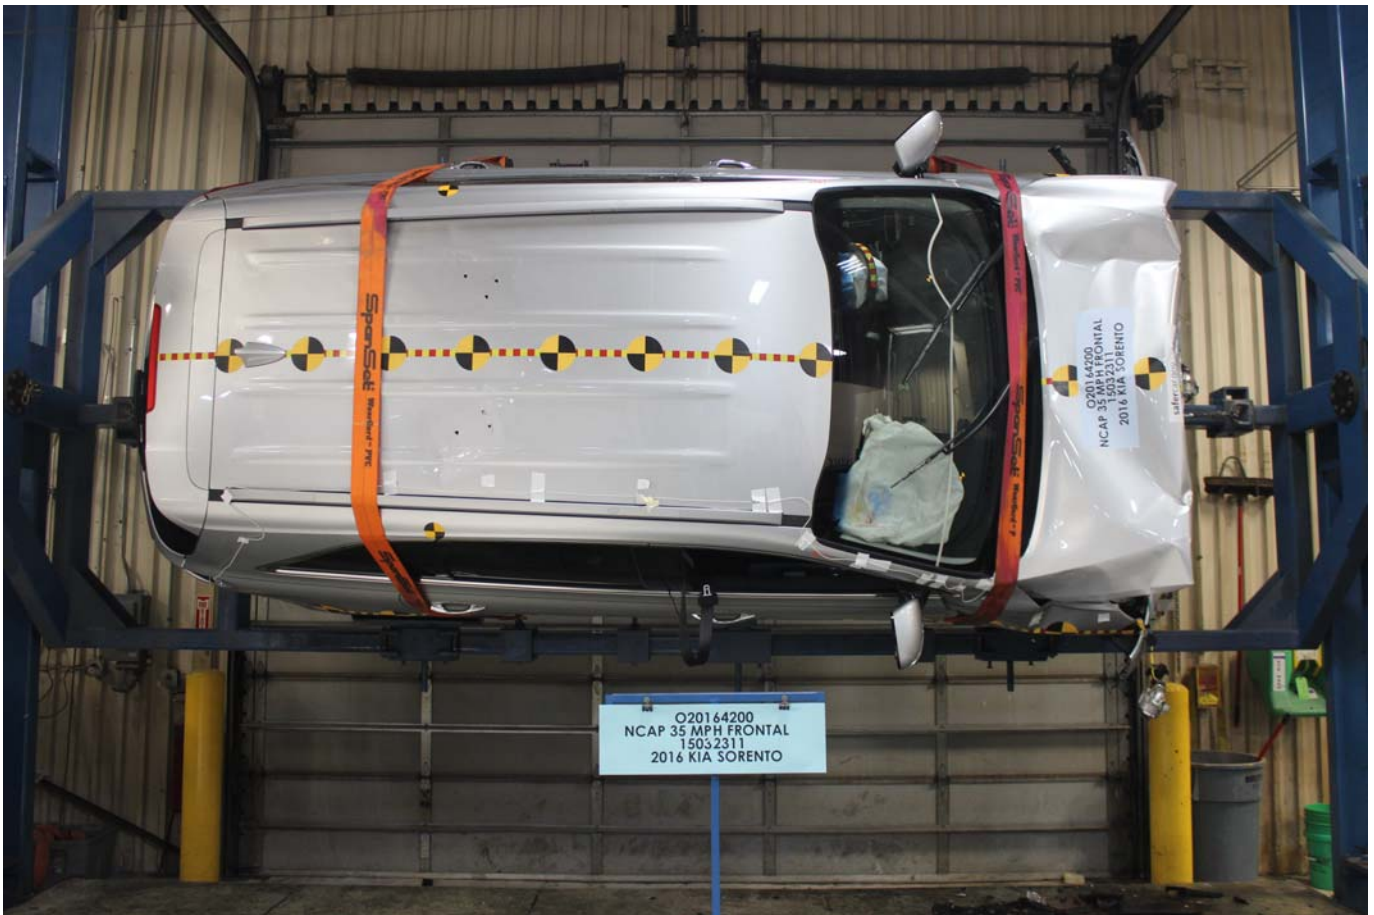
Photo No. 075. - Vehicle at 270 Degrees on Static Rollover Device
