**REPORT NUMBER: SPNCAP-MGA-2016-004**

**NEW CAR ASSESSMENT PROGRAM (NCAP)  
Side Impact Pole Test**

**KIA MOTORS MANUFACTURING GEORGIA, INC.  
2016 Kia Sorento L 5-Dr SUV  
NHTSA No.: O20164201**

**FINAL REPORT**

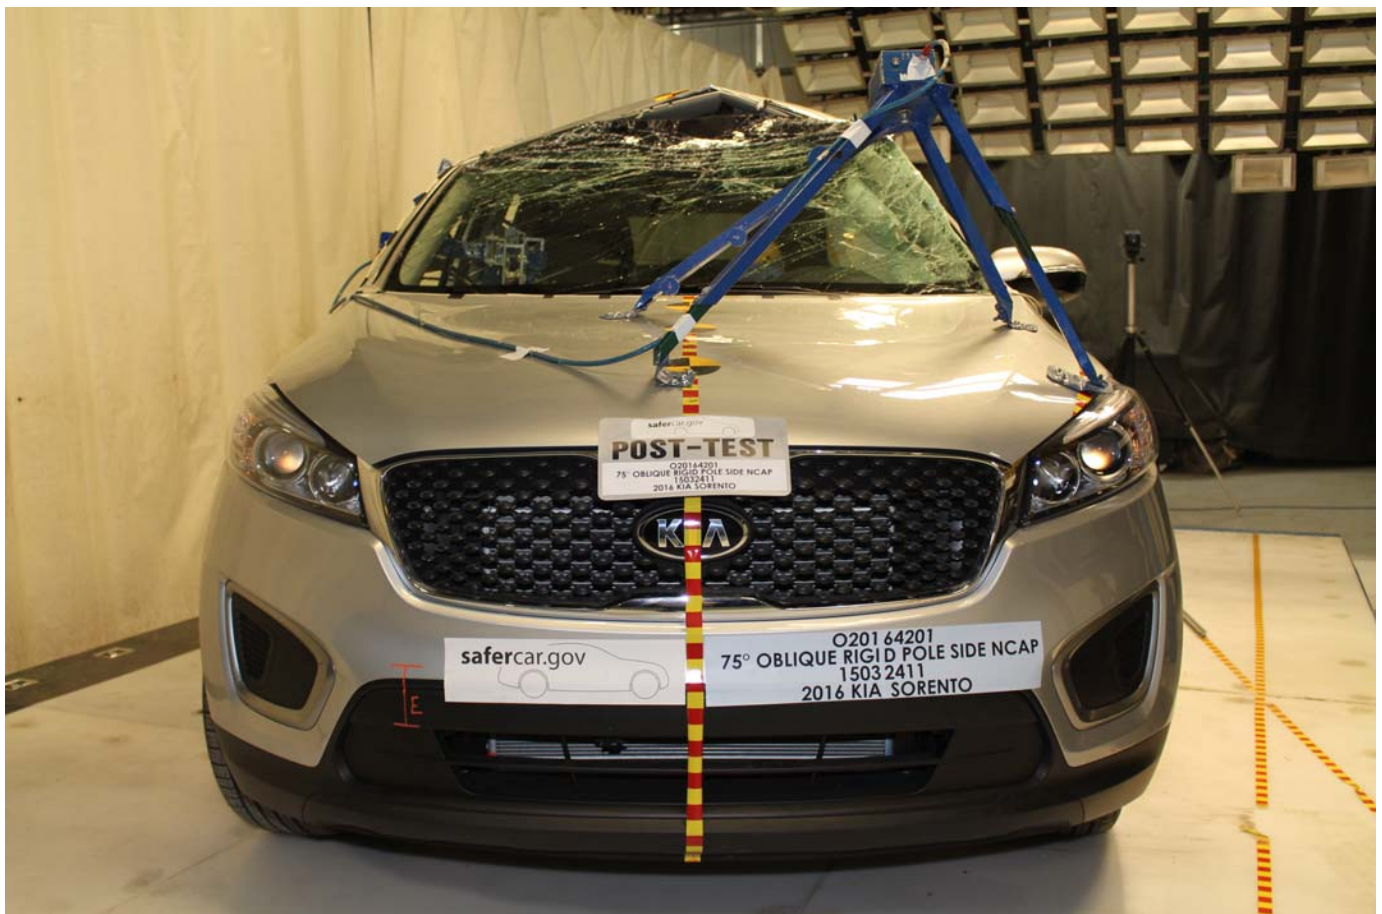
No. 004 - Post-Test Frontal View of Test Vehicle

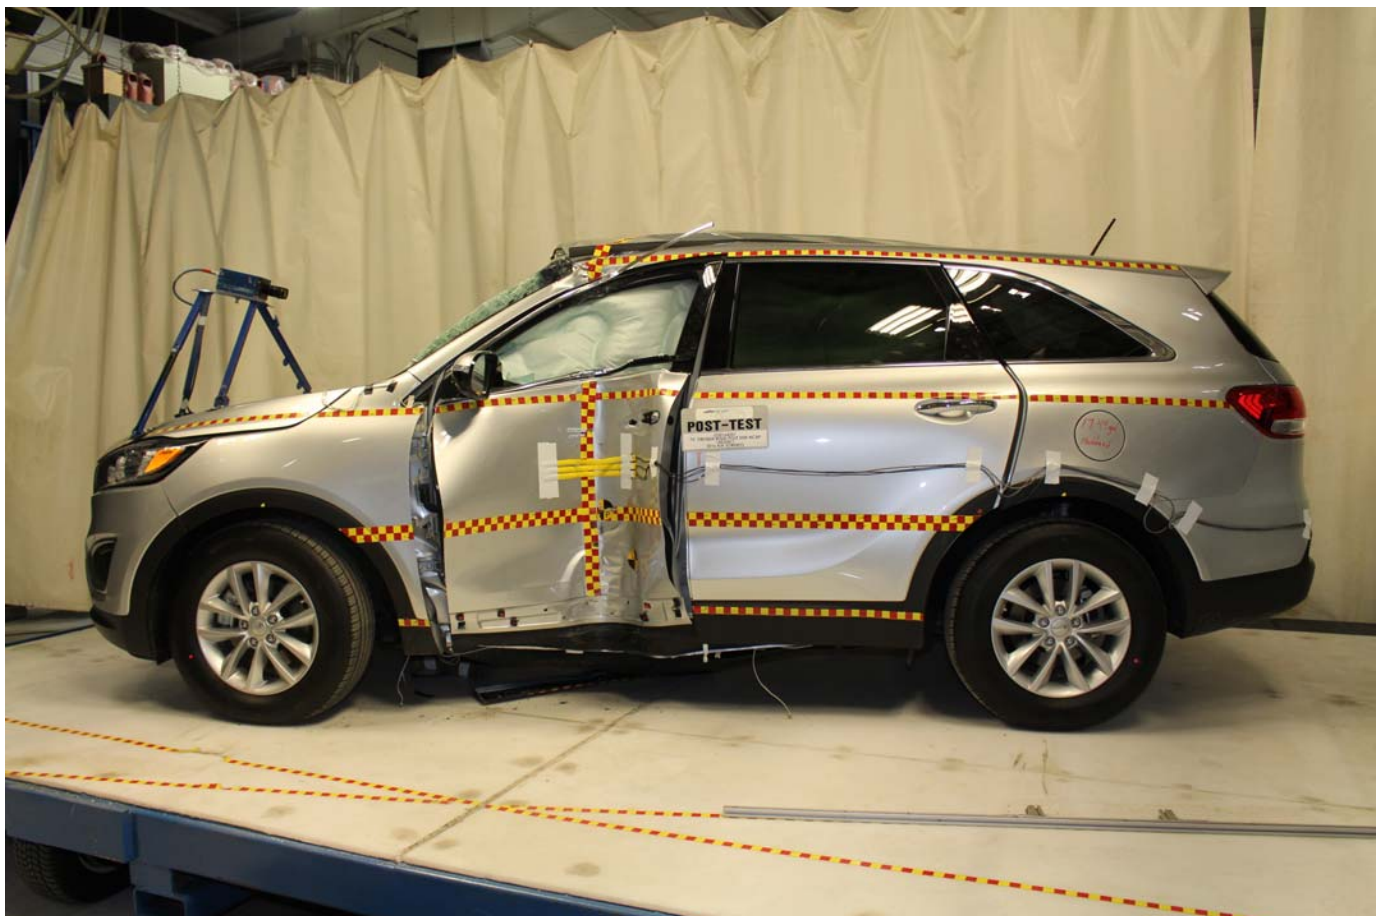
No. 008 - Post-Test Left Side View of Test Vehicle

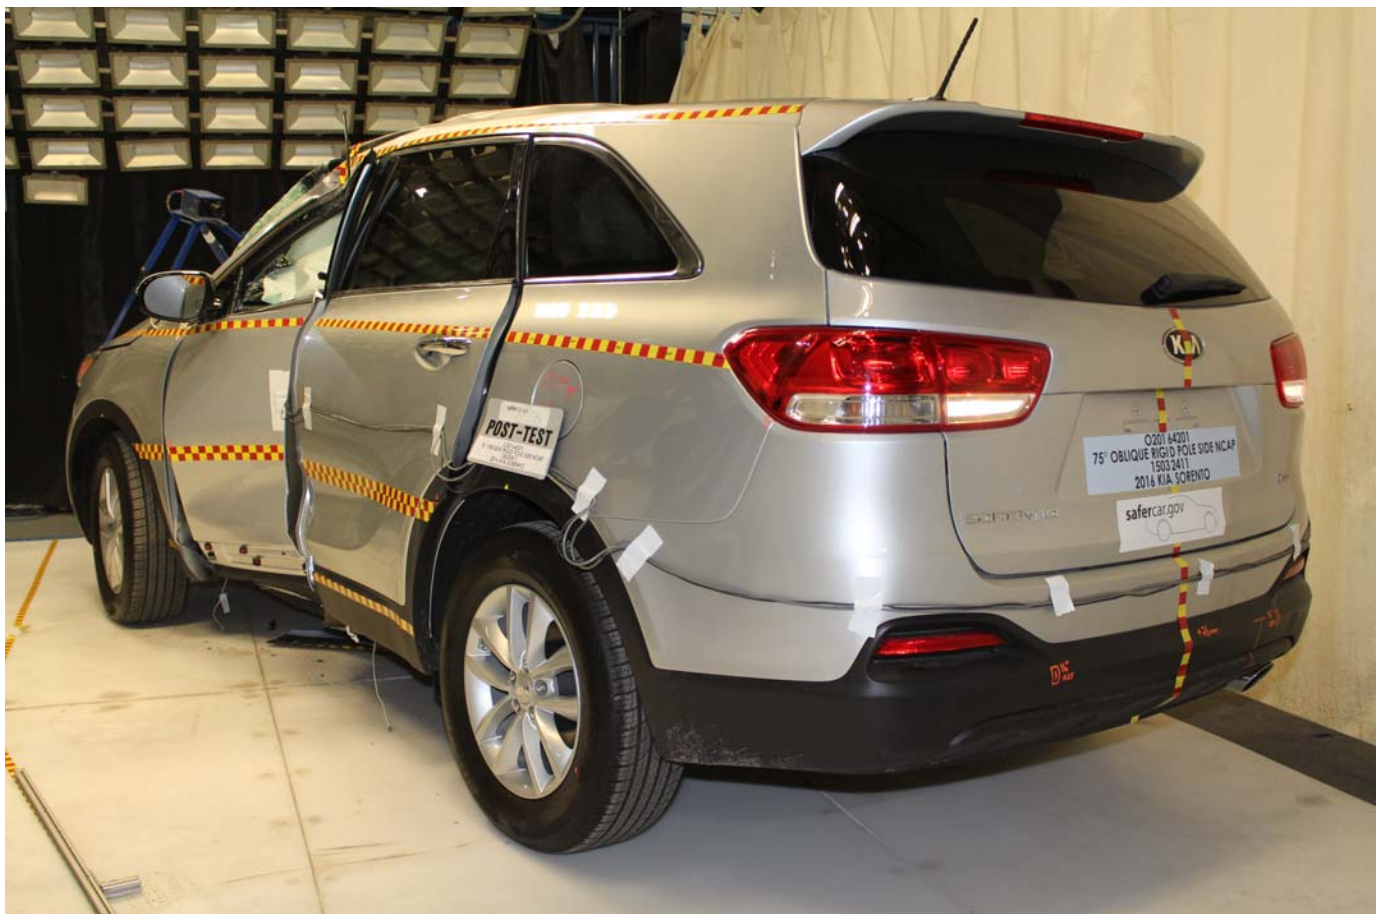
No. 010 - Post-Test Left Rear  $\frac{3}{4}$  View of Test Vehicle

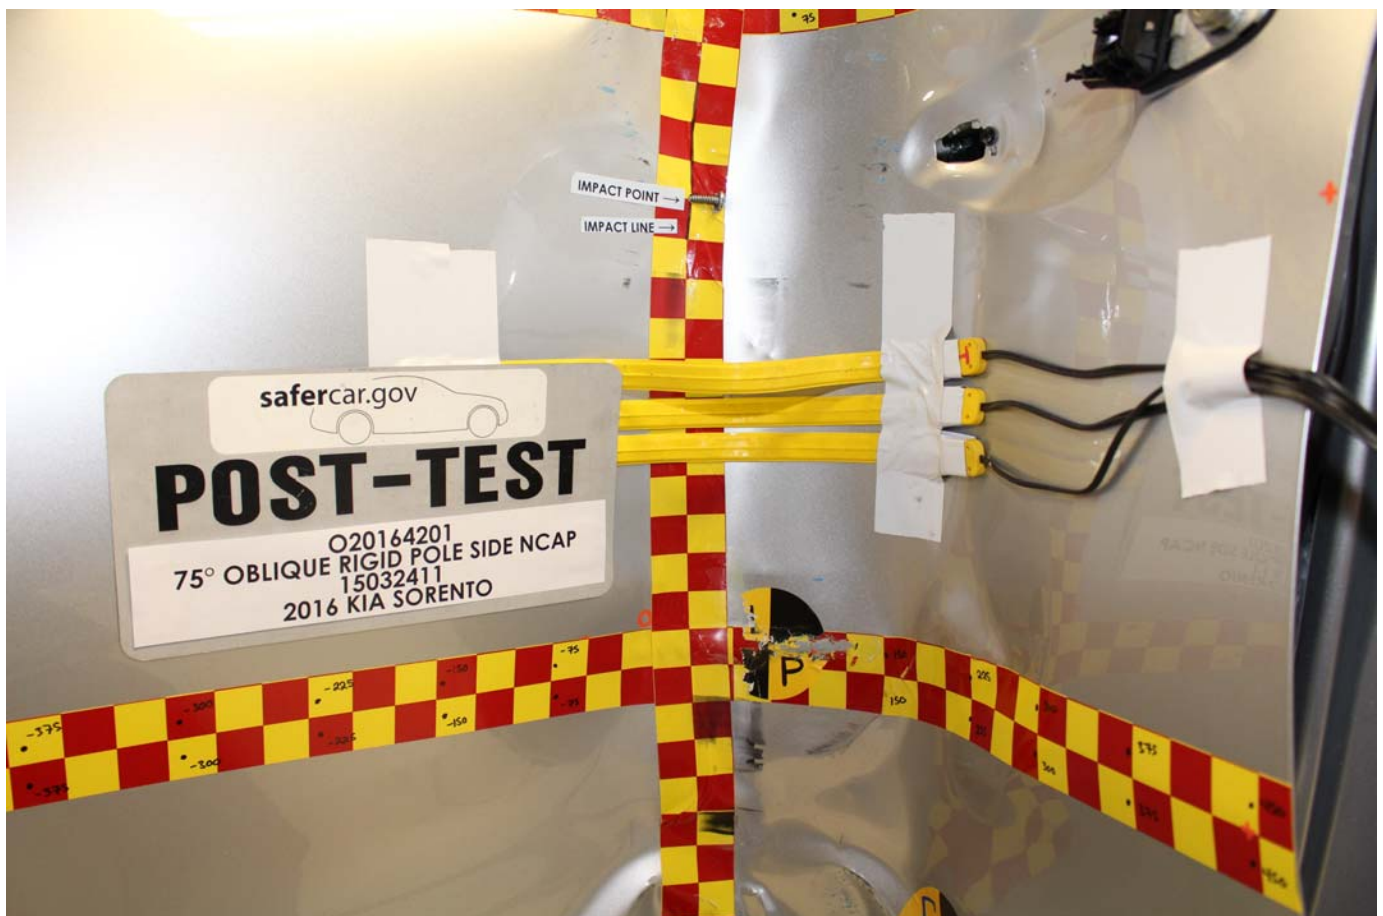
No. 020 - Post-Test Close-Up View of Impact Point Target Showing Impact Location

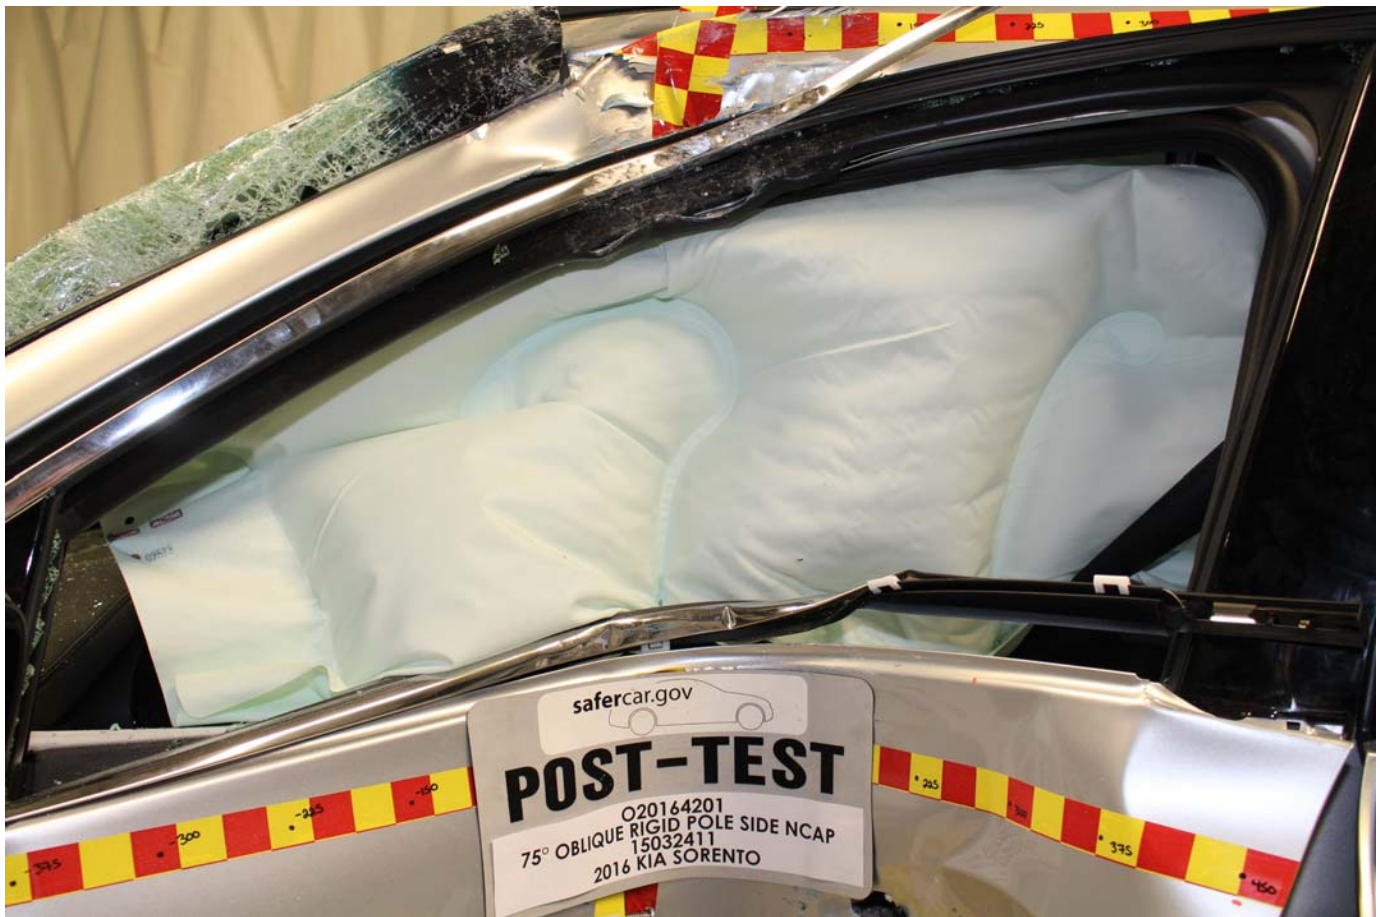
No. 025 - Post-Test Left Side View of Dummy Shoulder and Door Top View

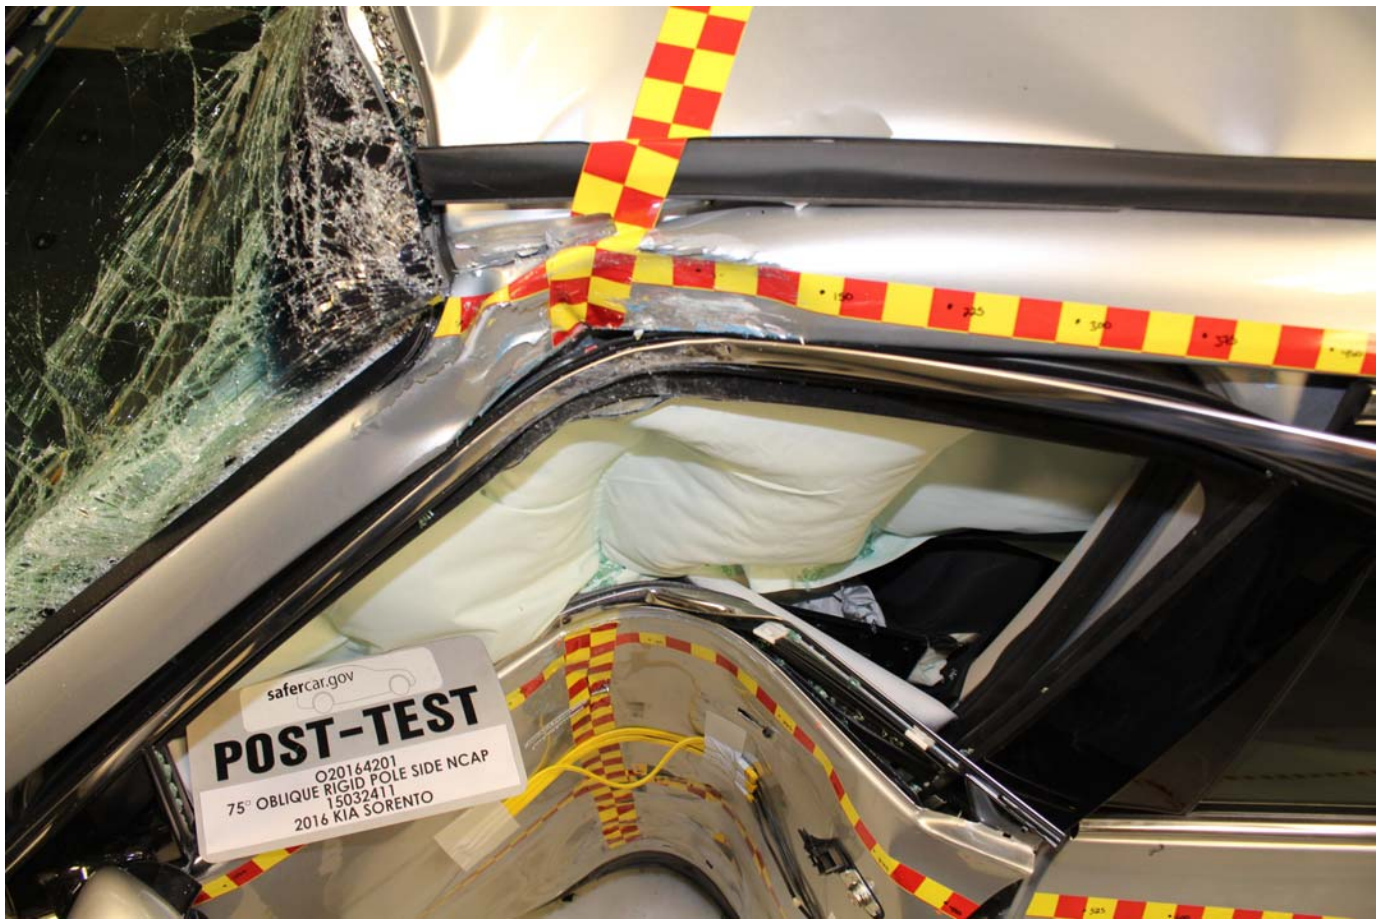
No. 041 - Post-Test Dummy and Door Clearance View

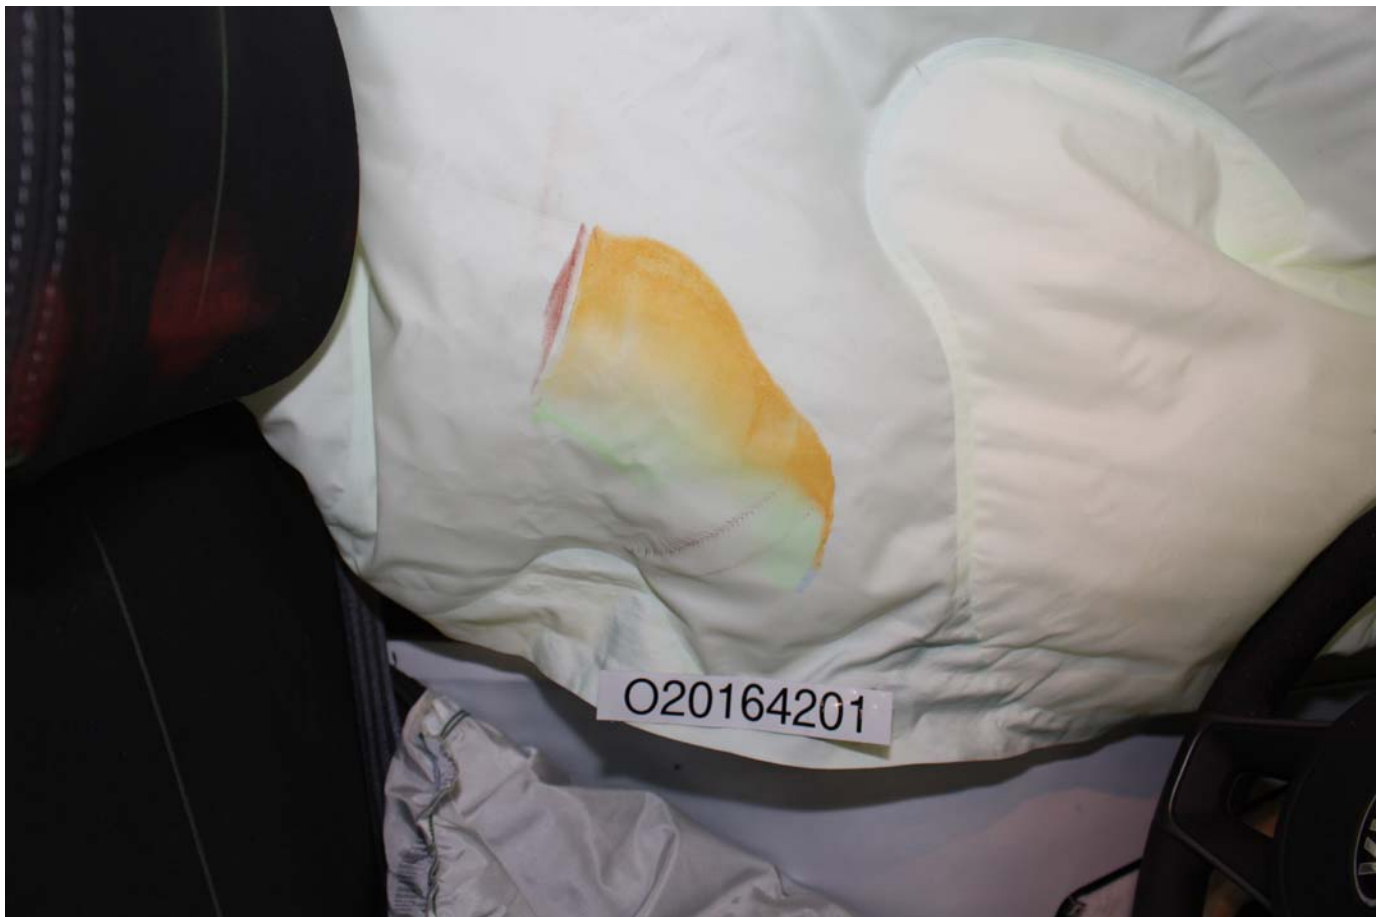
No. 047 - Post-Test Dummy Close-Up Head Contact with Side Air Bag View

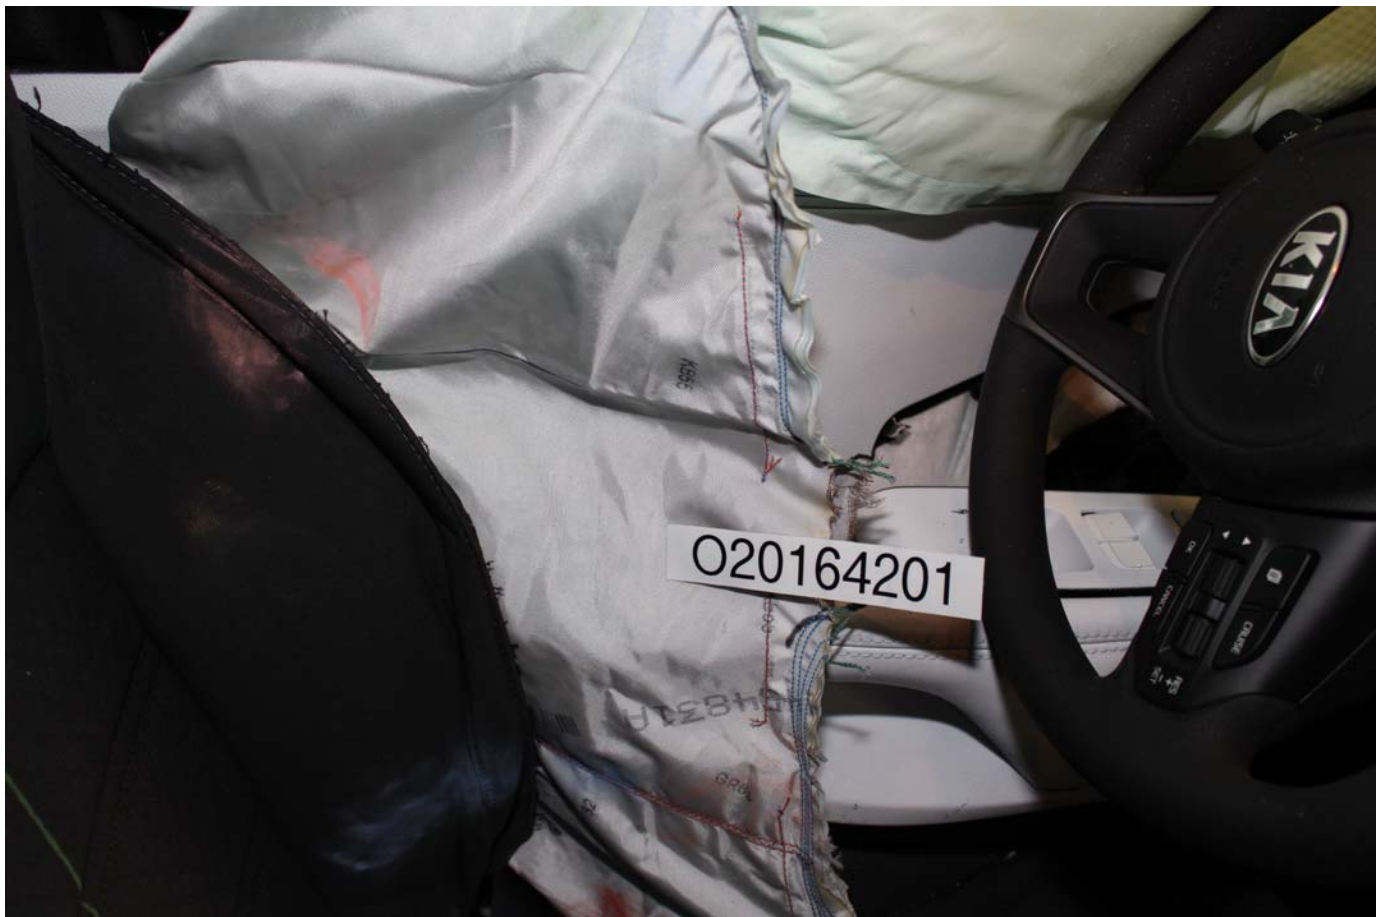
No. 049 - Post-Test Dummy Close-Up Torso Contact with Side Air Bag View

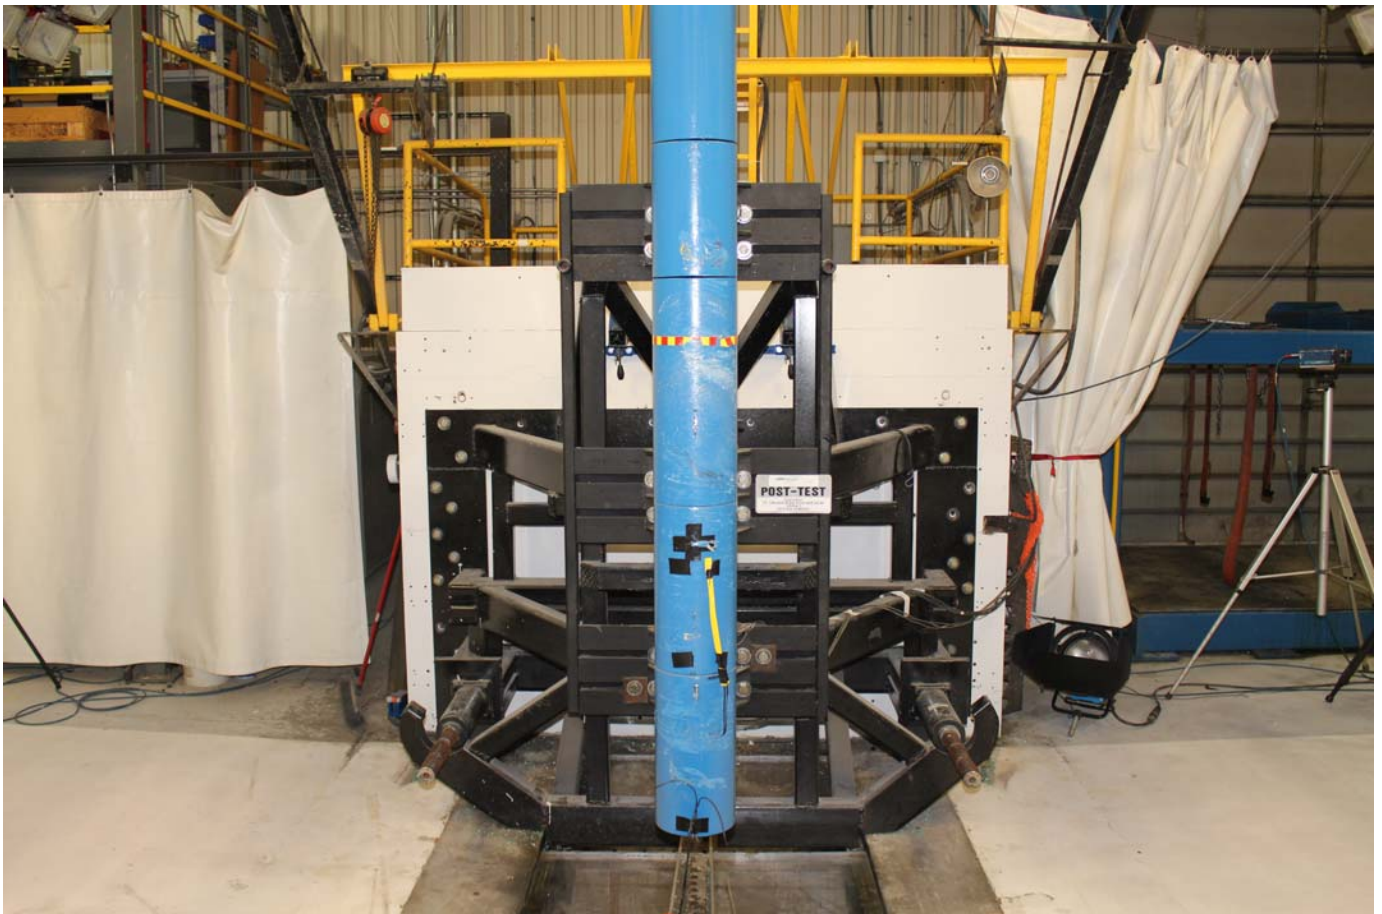
No. 058 - Post-Test Pole Barrier Front View

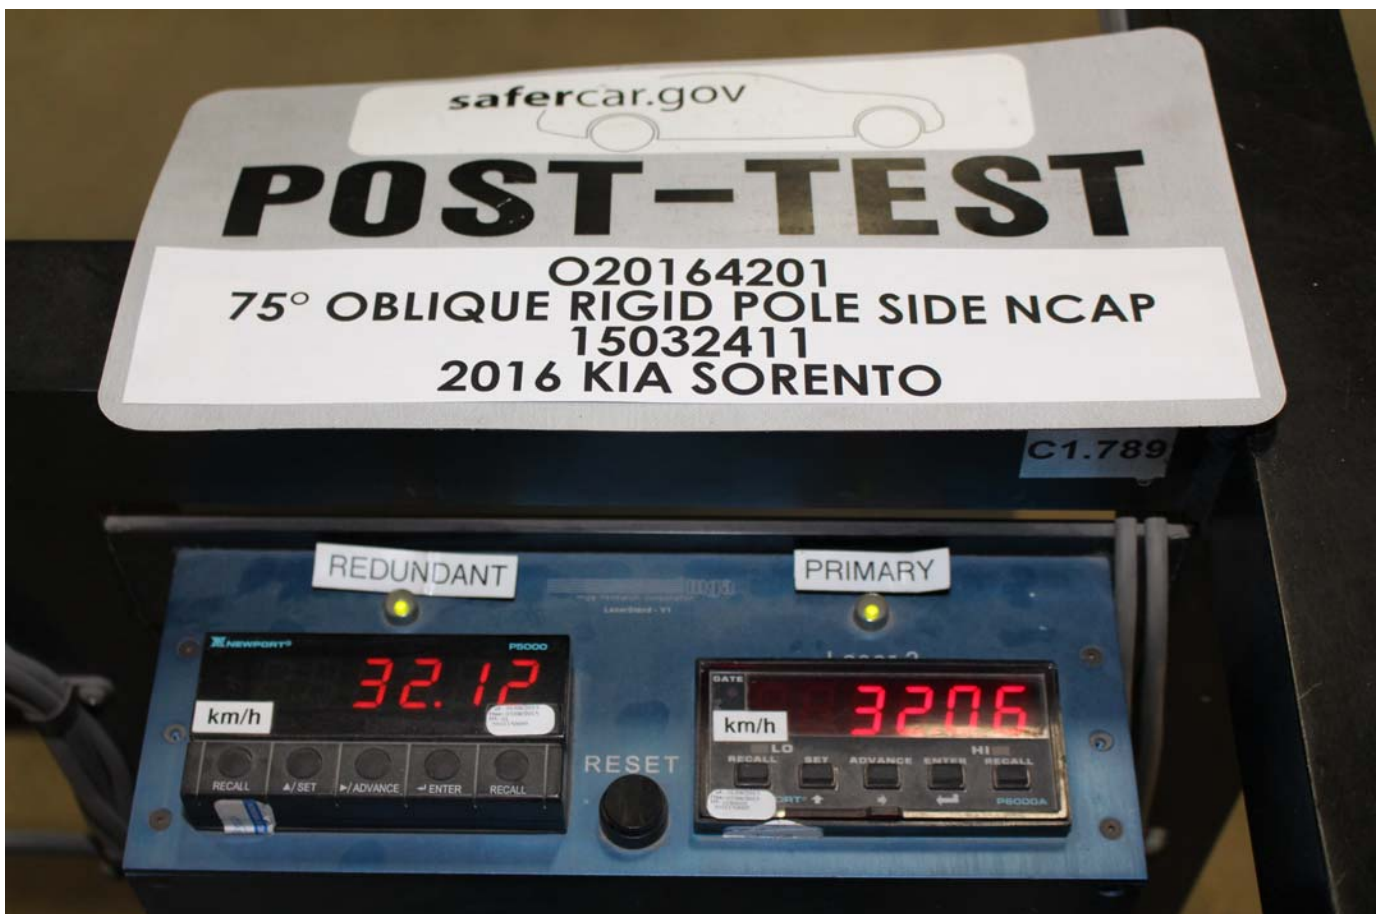
No. 062 - Post-Test Primary and Redundant Speed Trap Read-Out
