REPORT NUMBER: SINCAP-MGA-2015-063

**NEW CAR ASSESSMENT PROGRAM (NCAP)
Moving Deformable Barrier Side Impact Test**

**NISSAN MOTOR CO., LTD.
2015 Nissan Murano S 5-Dr SUV
NHTSA No.: O20155203**

**MGA RESEARCH CORPORATION
5000 Warren Road
Burlington, WI 53105**

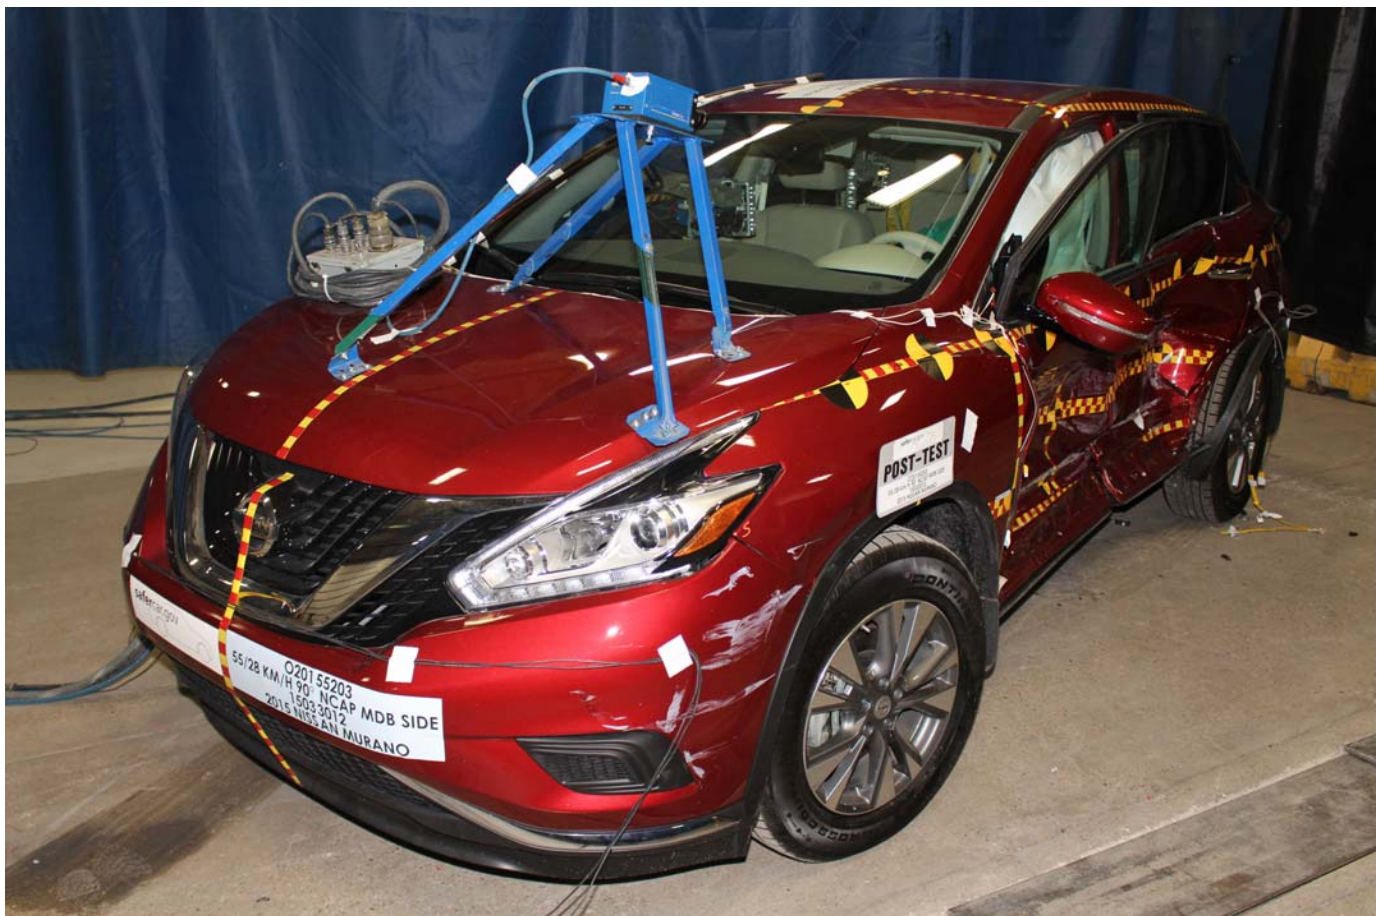
No. 006 - Post-Test Left Front Three-Quarter View of Test Vehicle

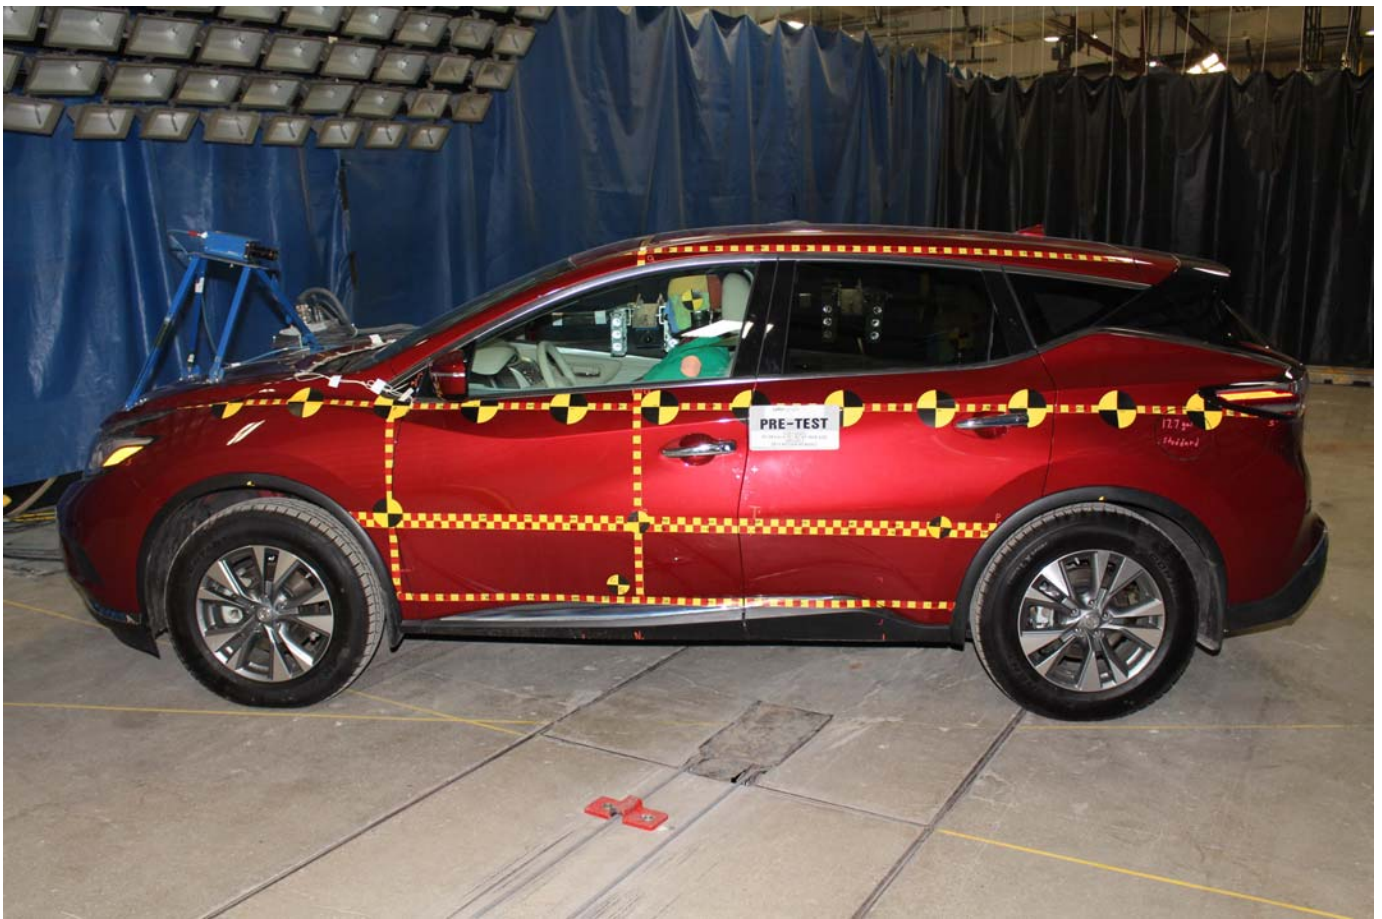
No. 007 - Pre-Test Left Side View of Test Vehicle

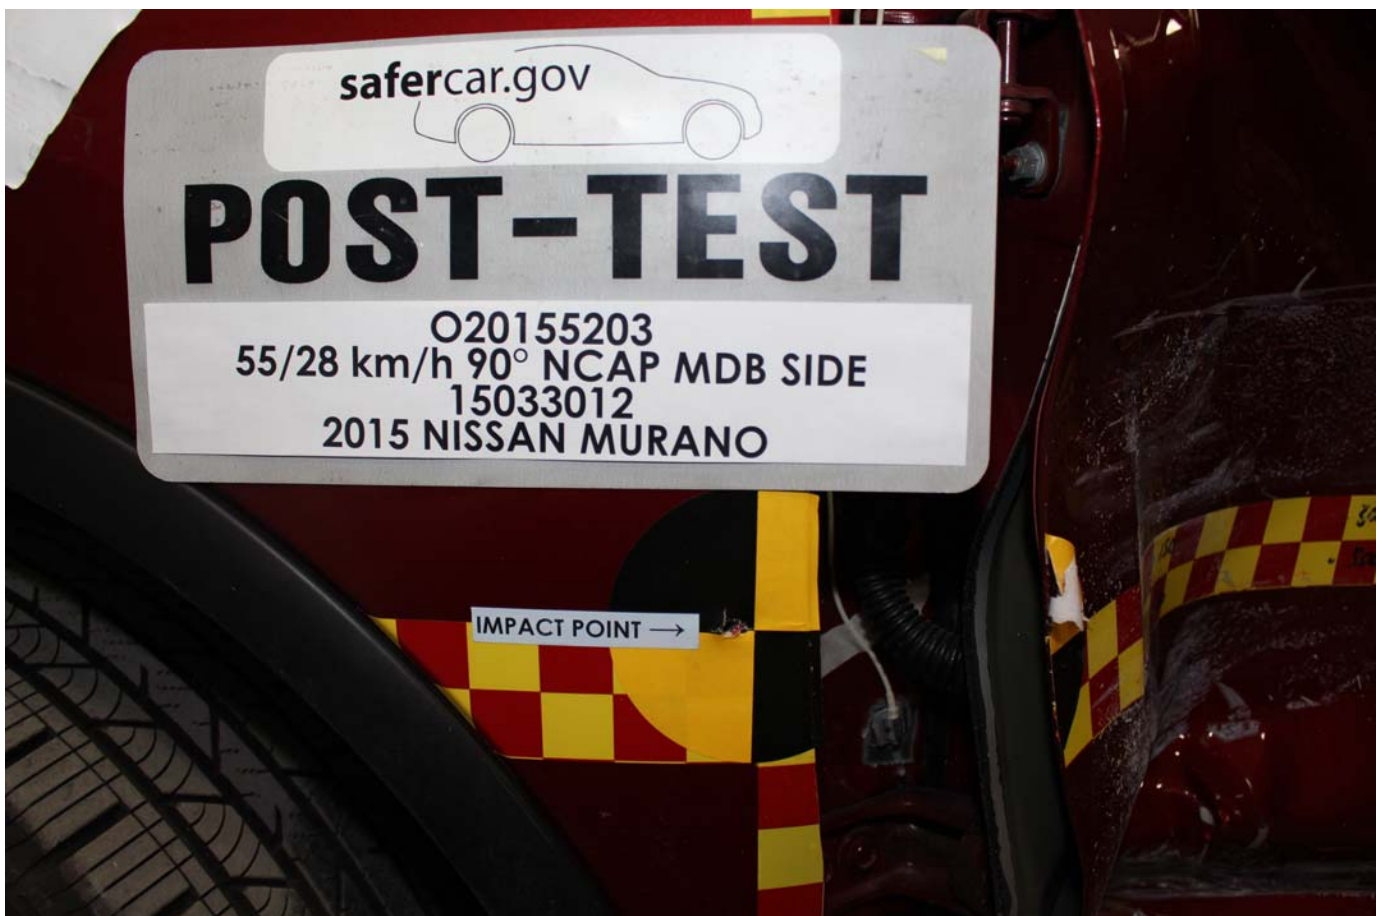
No. 020 - Post-Test Close-Up View of Impact Point Target

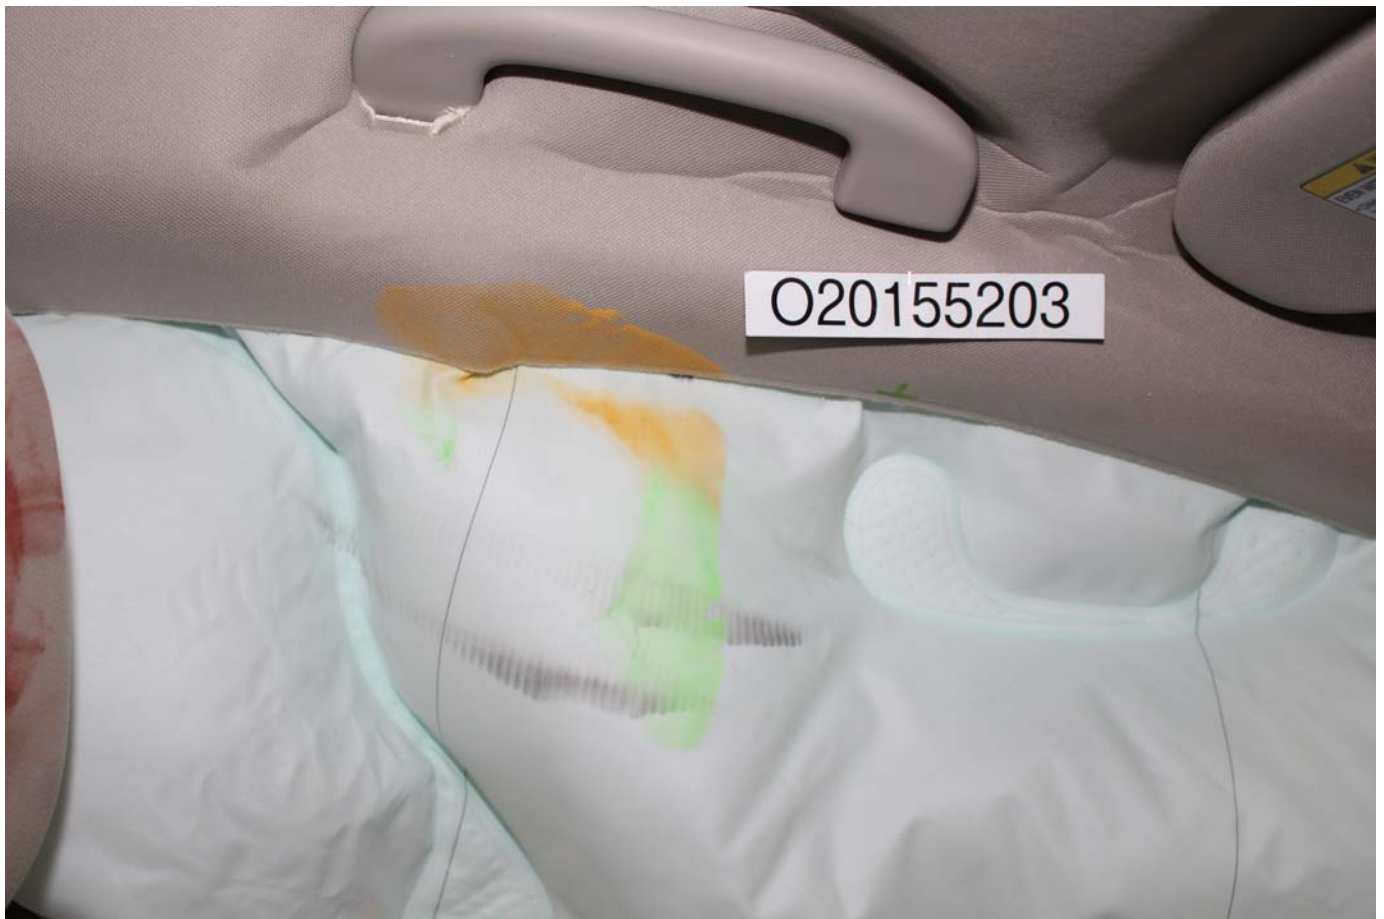
No. 049 - Post-Test Driver Dummy Close-up Head Contact with Side Airbag View

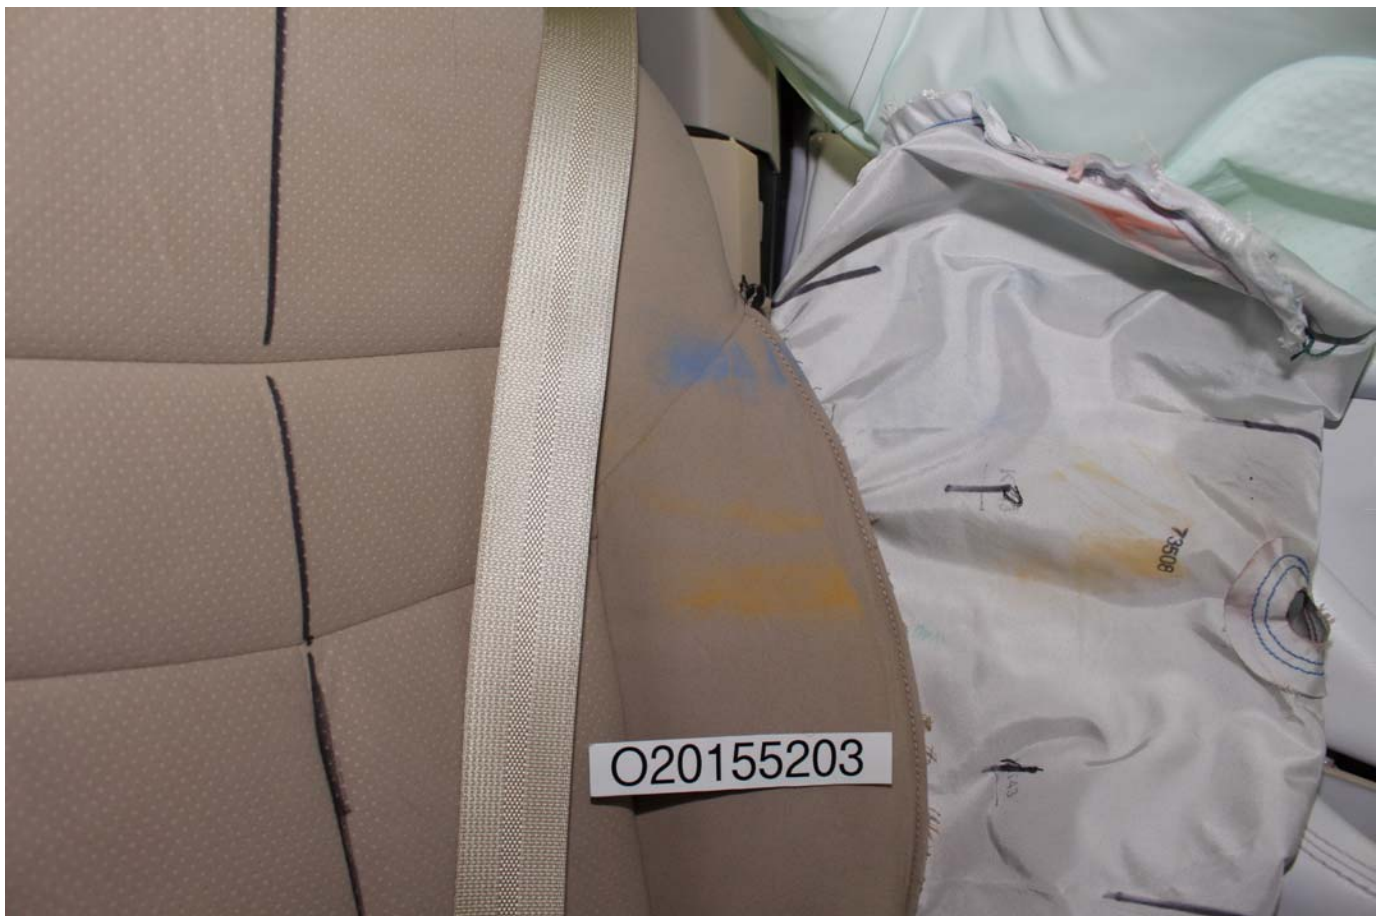
No. 050 - Post-Test Driver Dummy Close-up Torso Contact with Vehicle Interior View

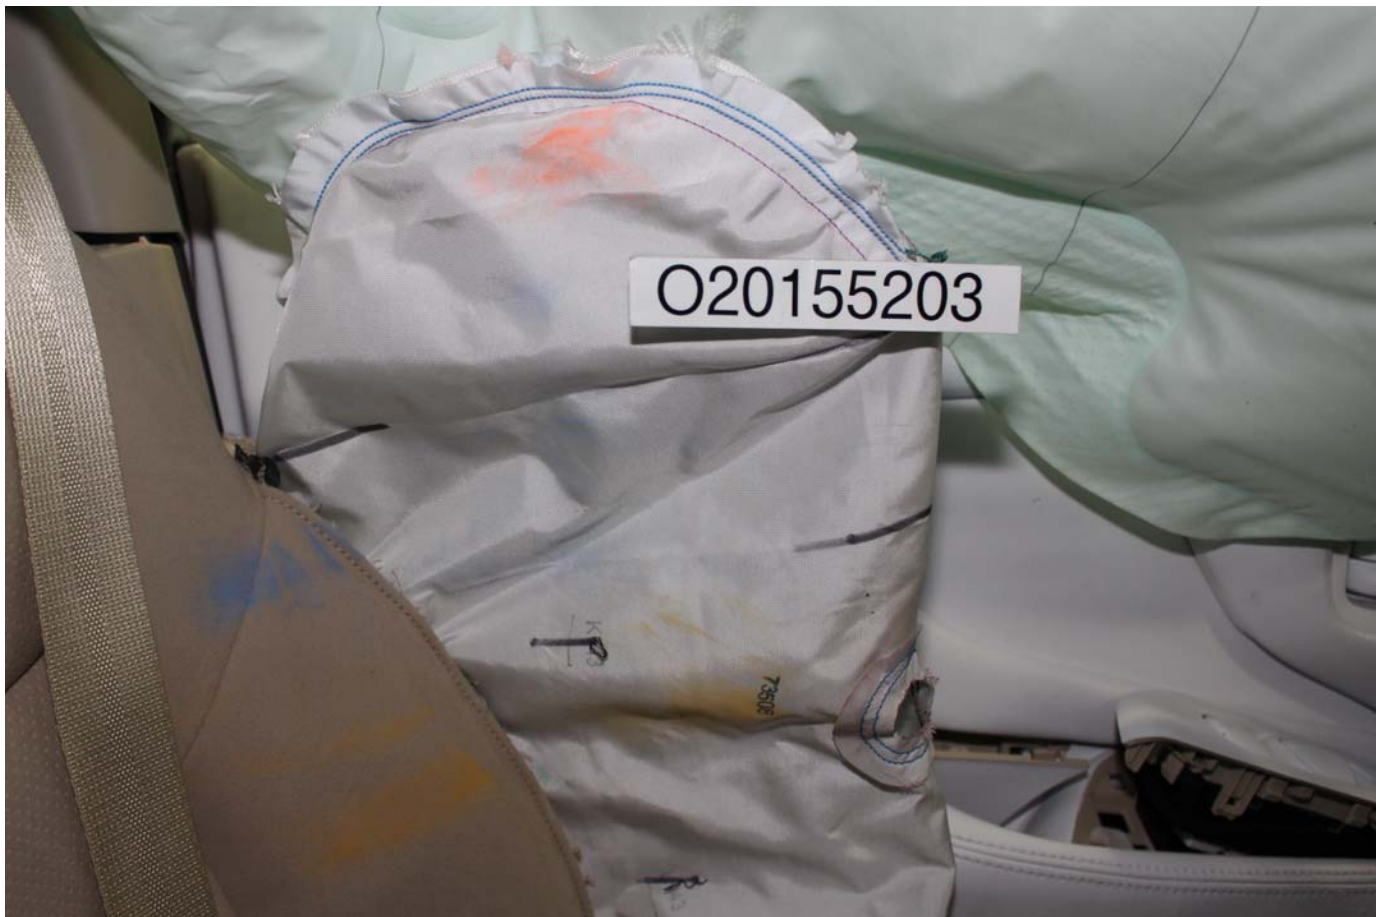
No. 051 - Post-Test Driver Dummy Close-up Torso Contact with Side Airbag View

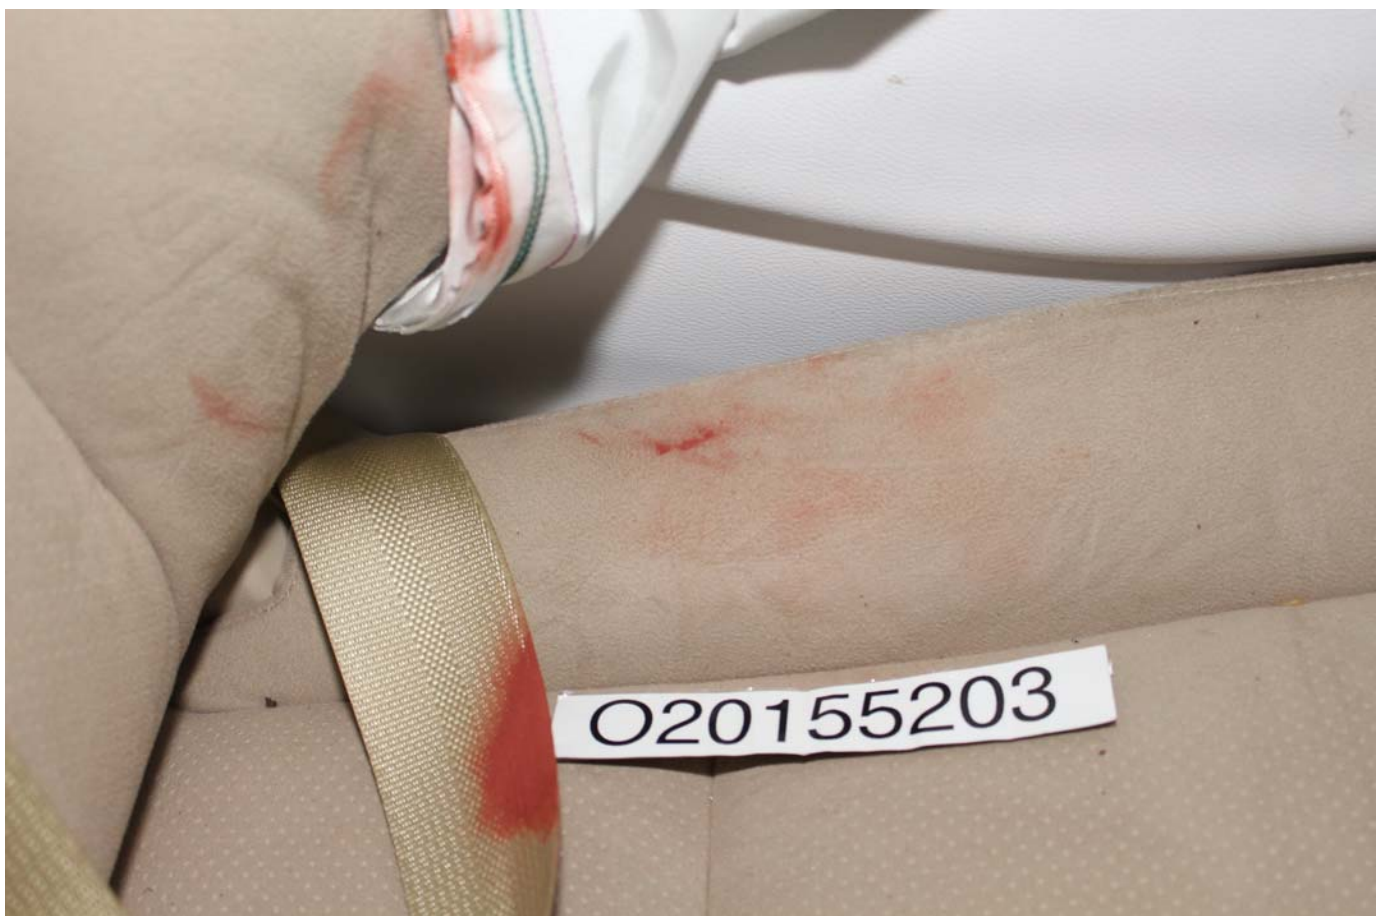
No. 052 - Post-Test Driver Dummy Close-up Pelvis Contact with Vehicle Interior View

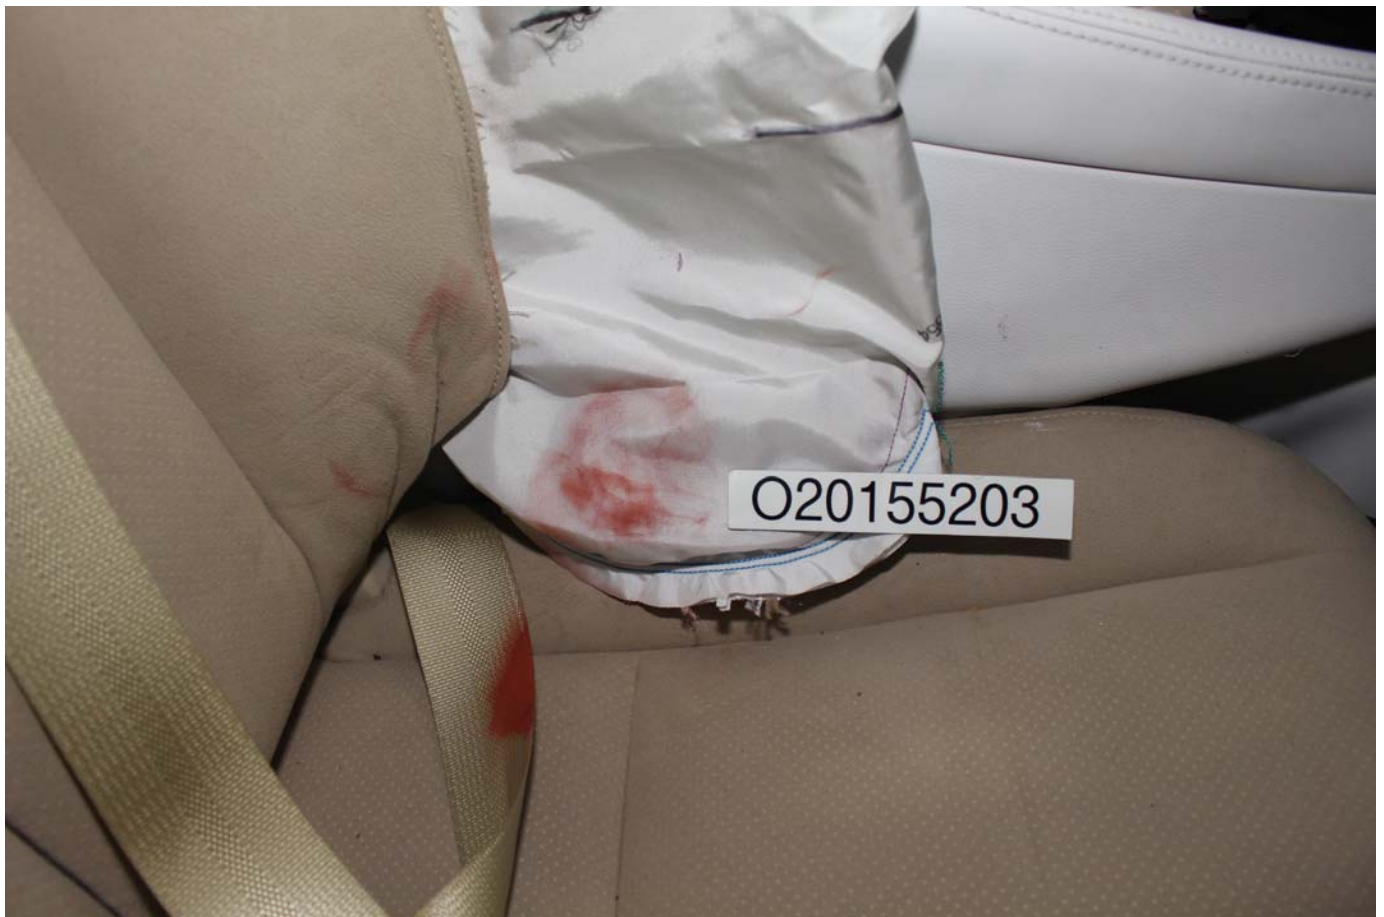
No. 053 - Post-Test Driver Dummy Close-up Pelvis Contact with Side Airbag View

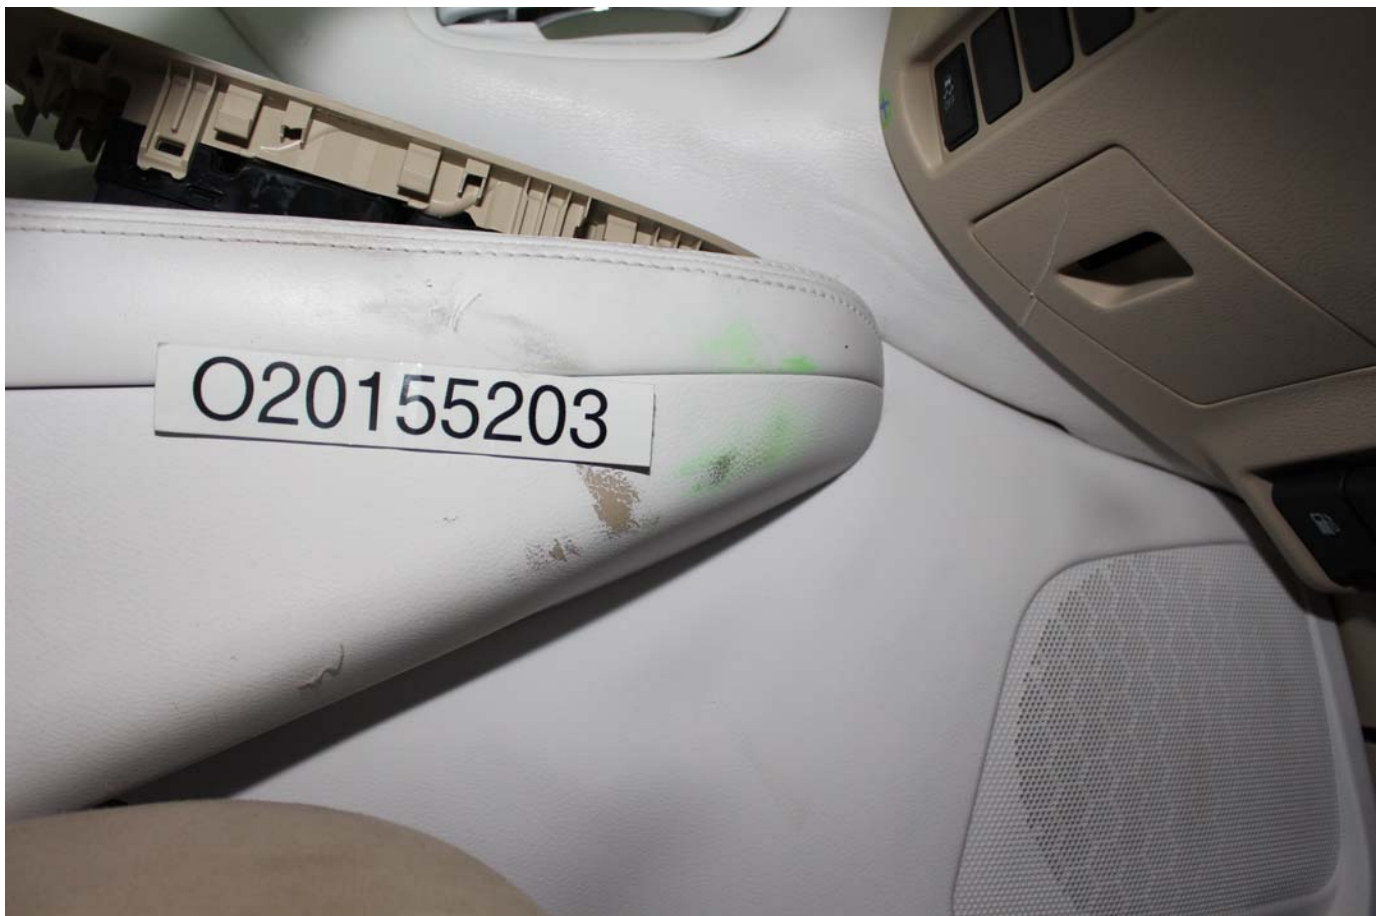
No. 054 - Post-Test Driver Dummy Close-up Knee Contact View

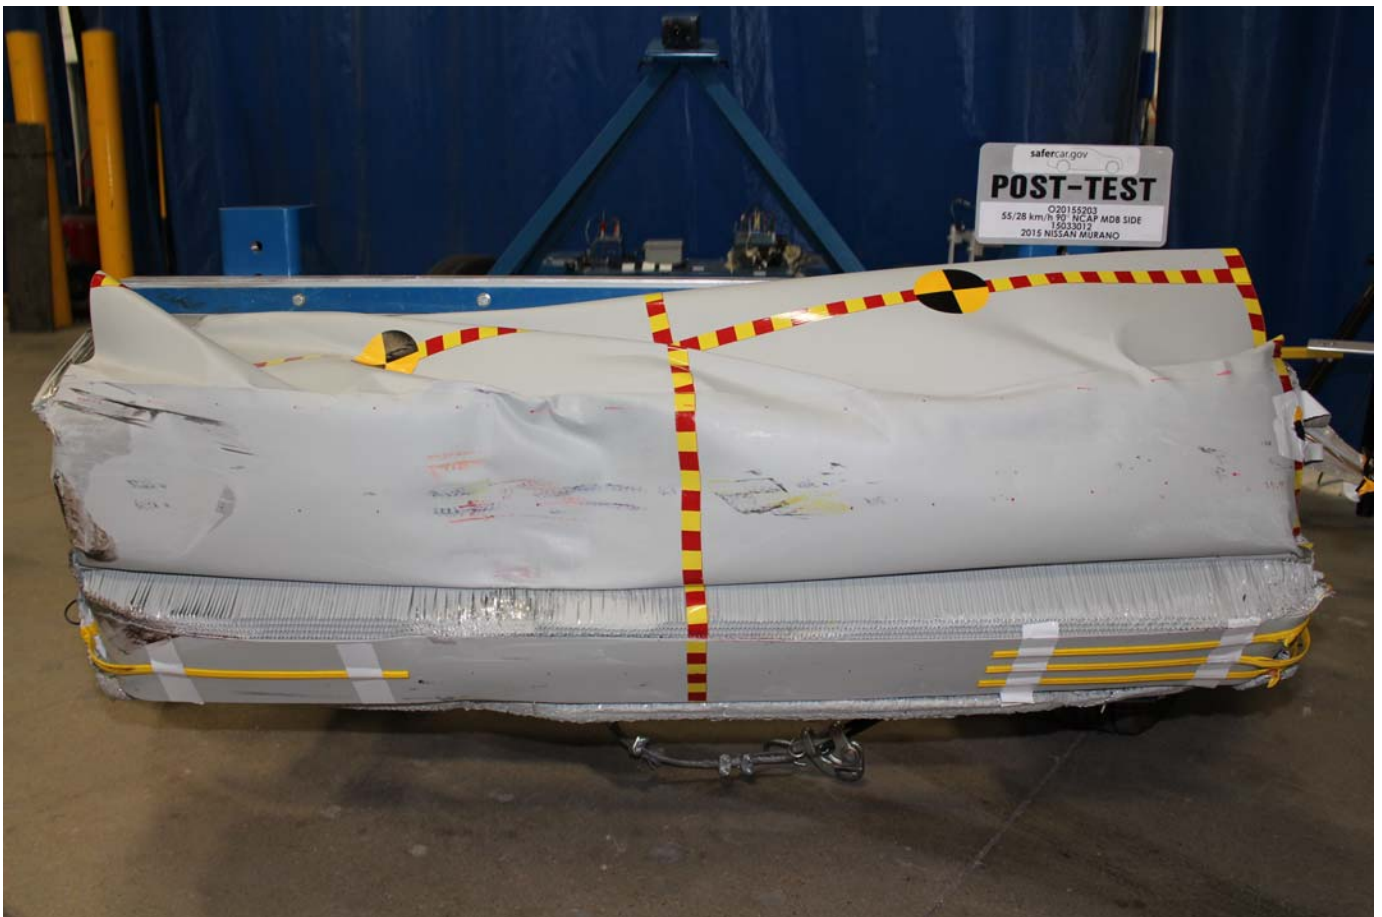
No. 085 - Post-Test Front View of MDB Impactor Face

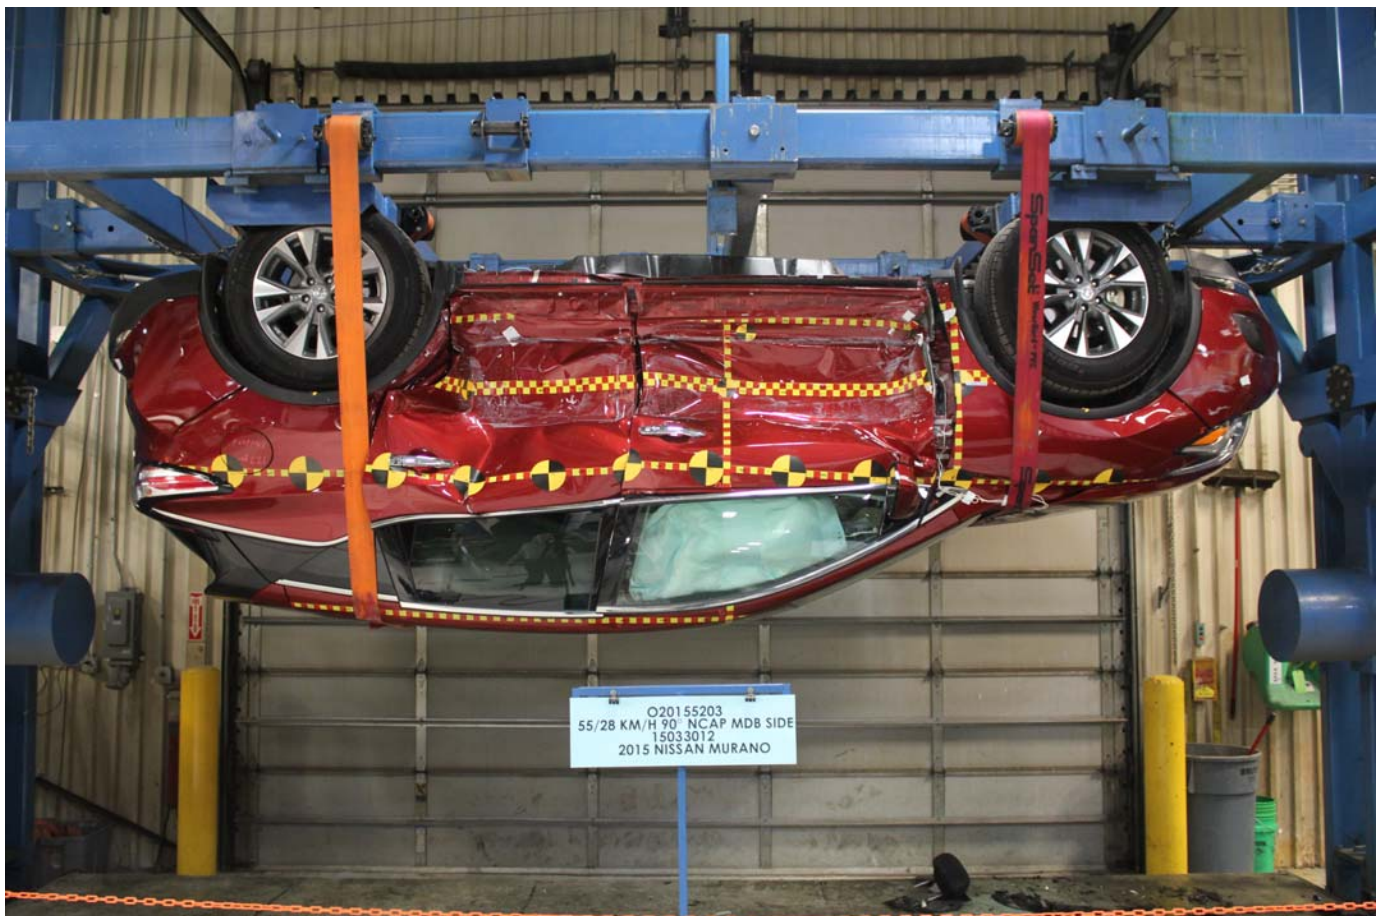
No. 098 - FMVSS No. 301 Static Rollover 180 Degrees
