**REPORT NUMBER: SPNCAP-MGA-2015-066**

**NEW CAR ASSESSMENT PROGRAM (NCAP)  
Side Impact Pole Test**

**HONDA MOTOR CO., LTD.  
2015 Acura RLX Tech 4-Dr Sedan  
NHTSA No.: O20155301**

**FINAL REPORT**

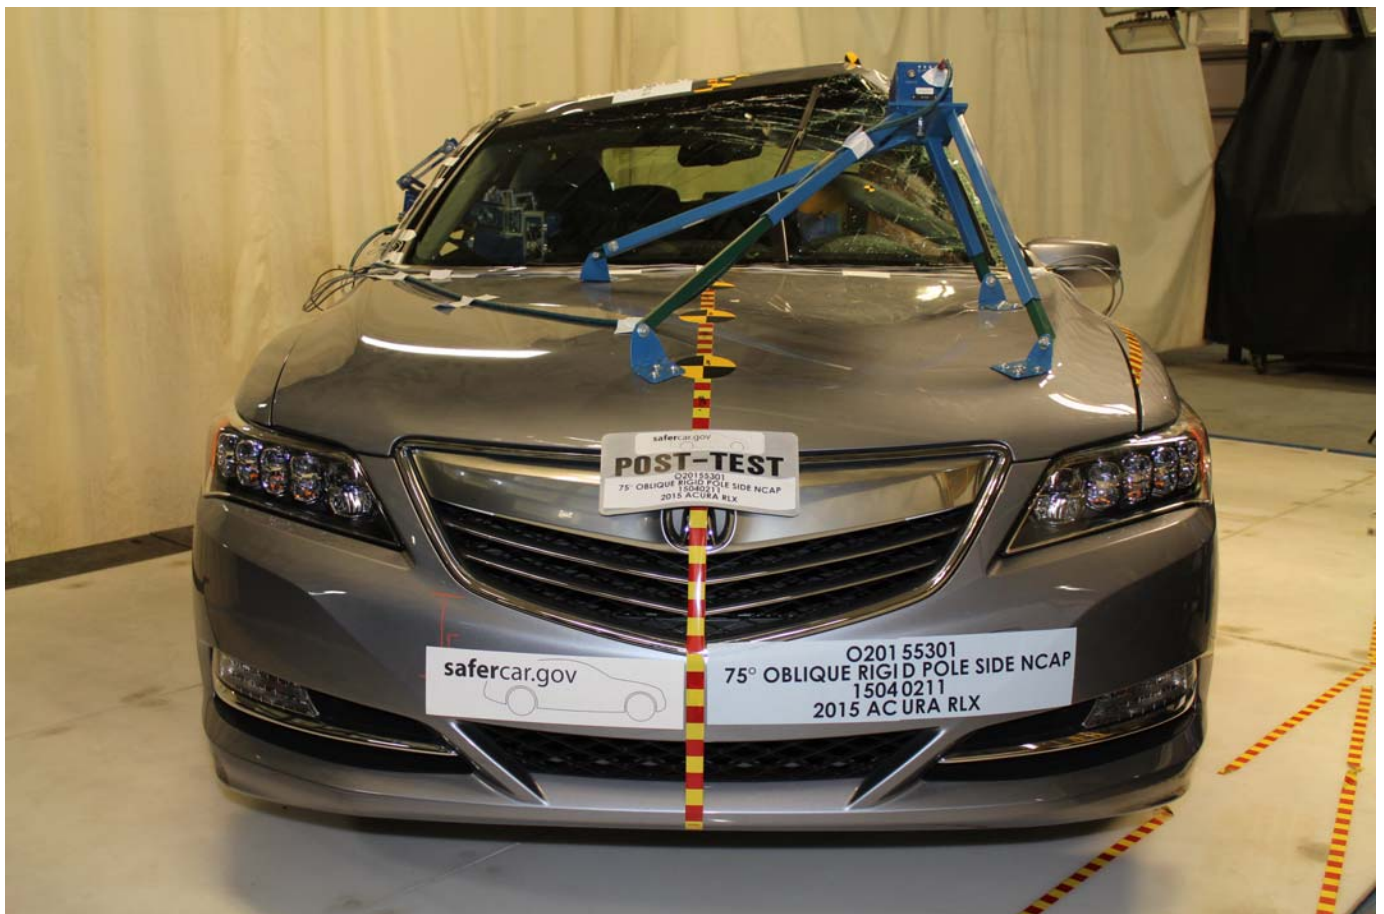
No. 004 - Post-Test Frontal View of Test Vehicle

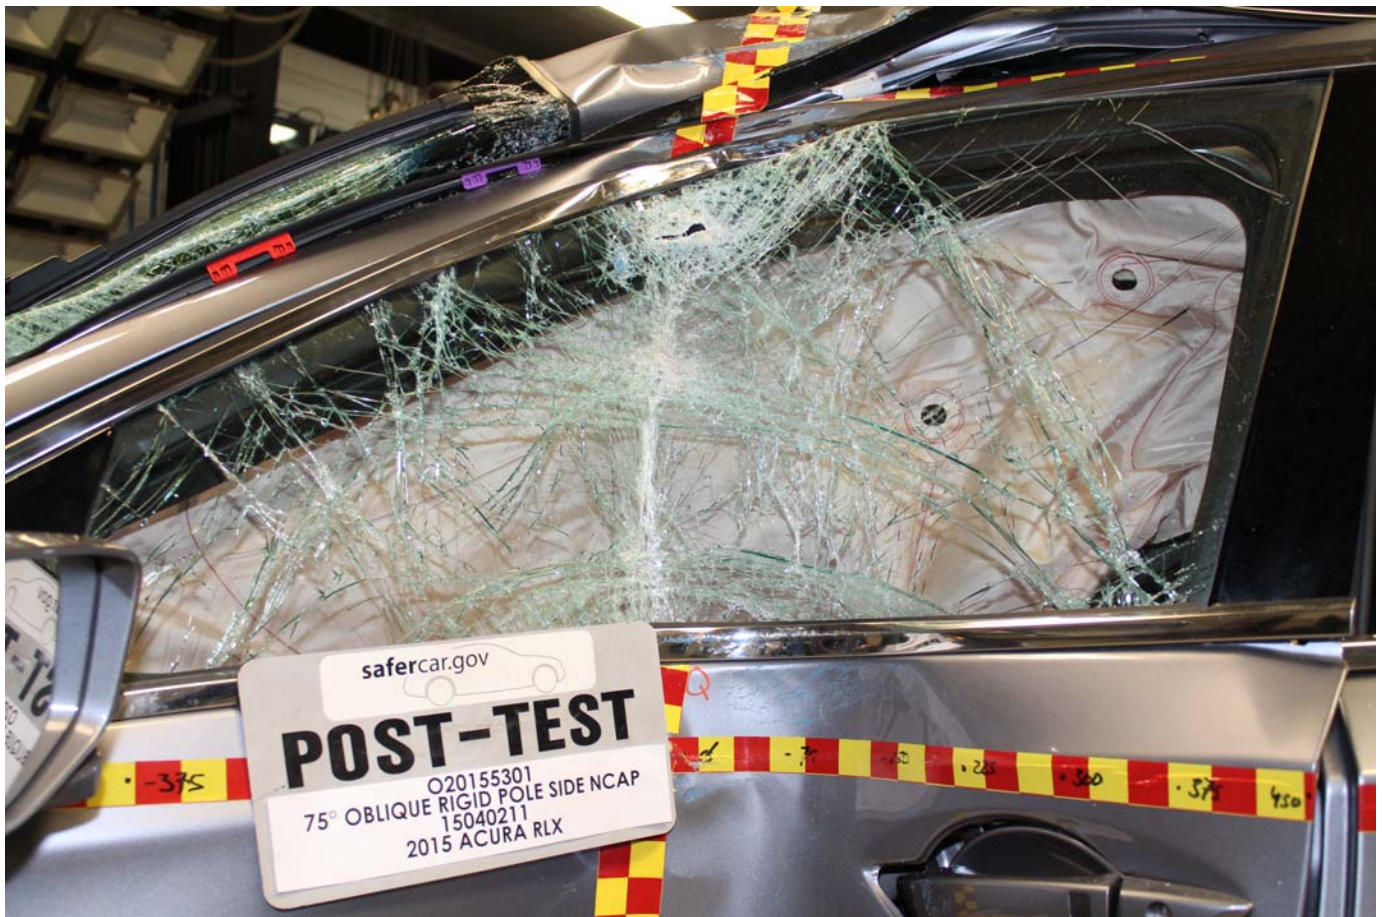
No. 025 - Post-Test Left Side View of Dummy Shoulder and Door Top View

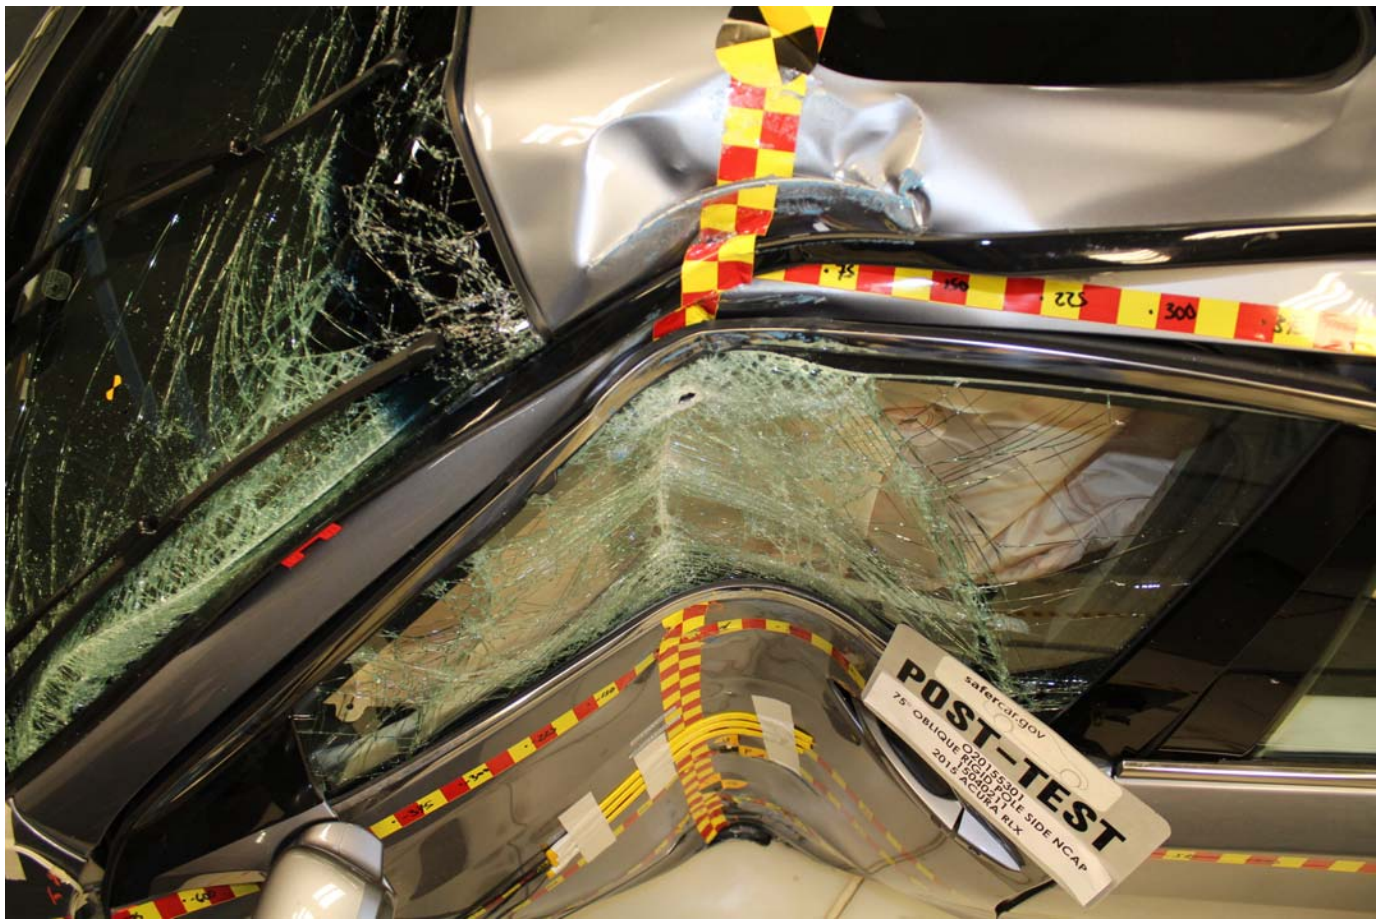
No. 041 - Post-Test Dummy and Door Clearance View

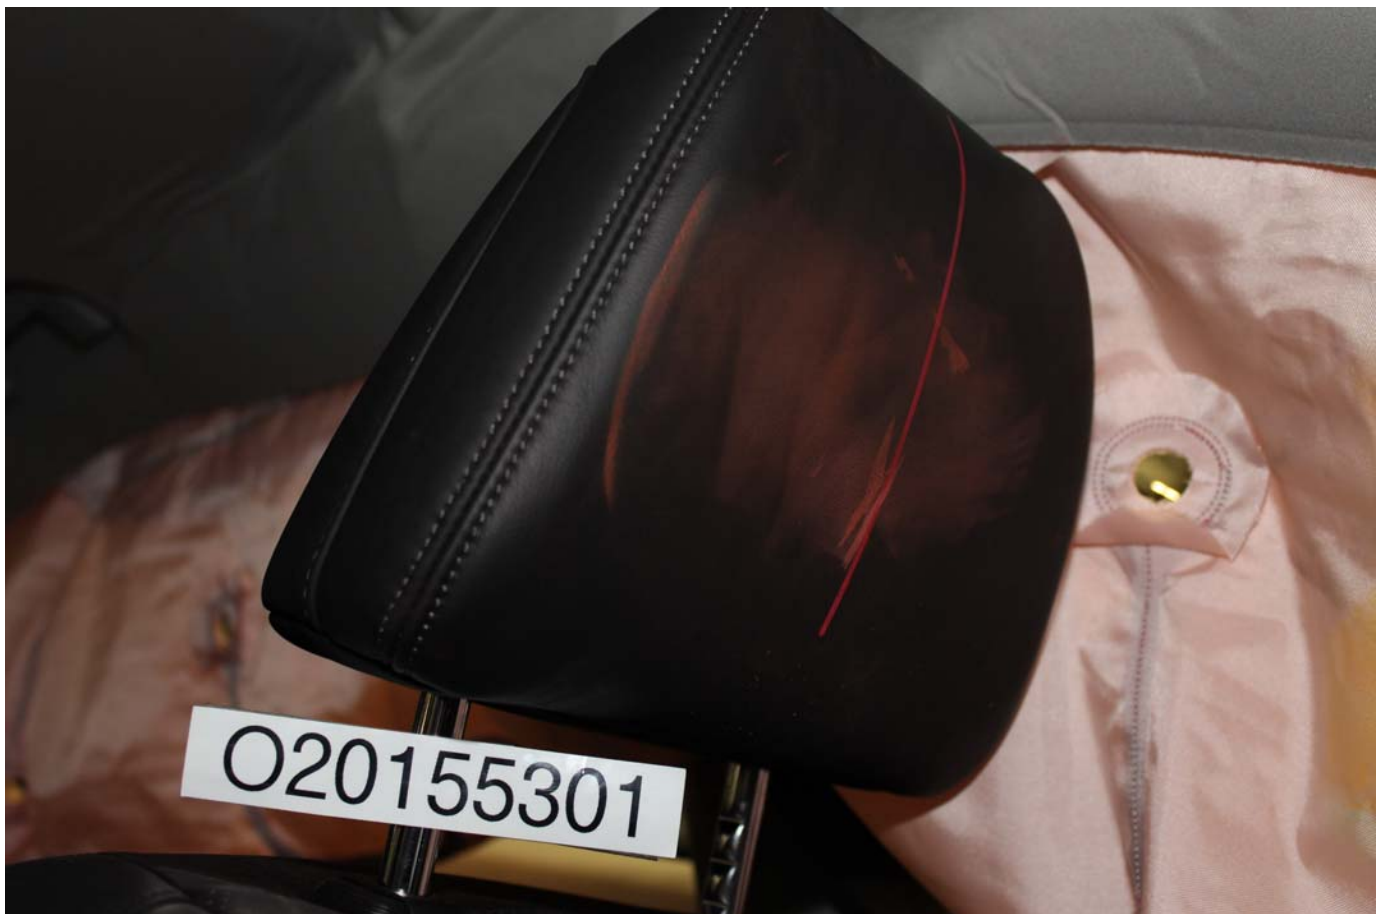
No. 046 - Post-Test Dummy Close-Up Head Contact with Vehicle Interior View

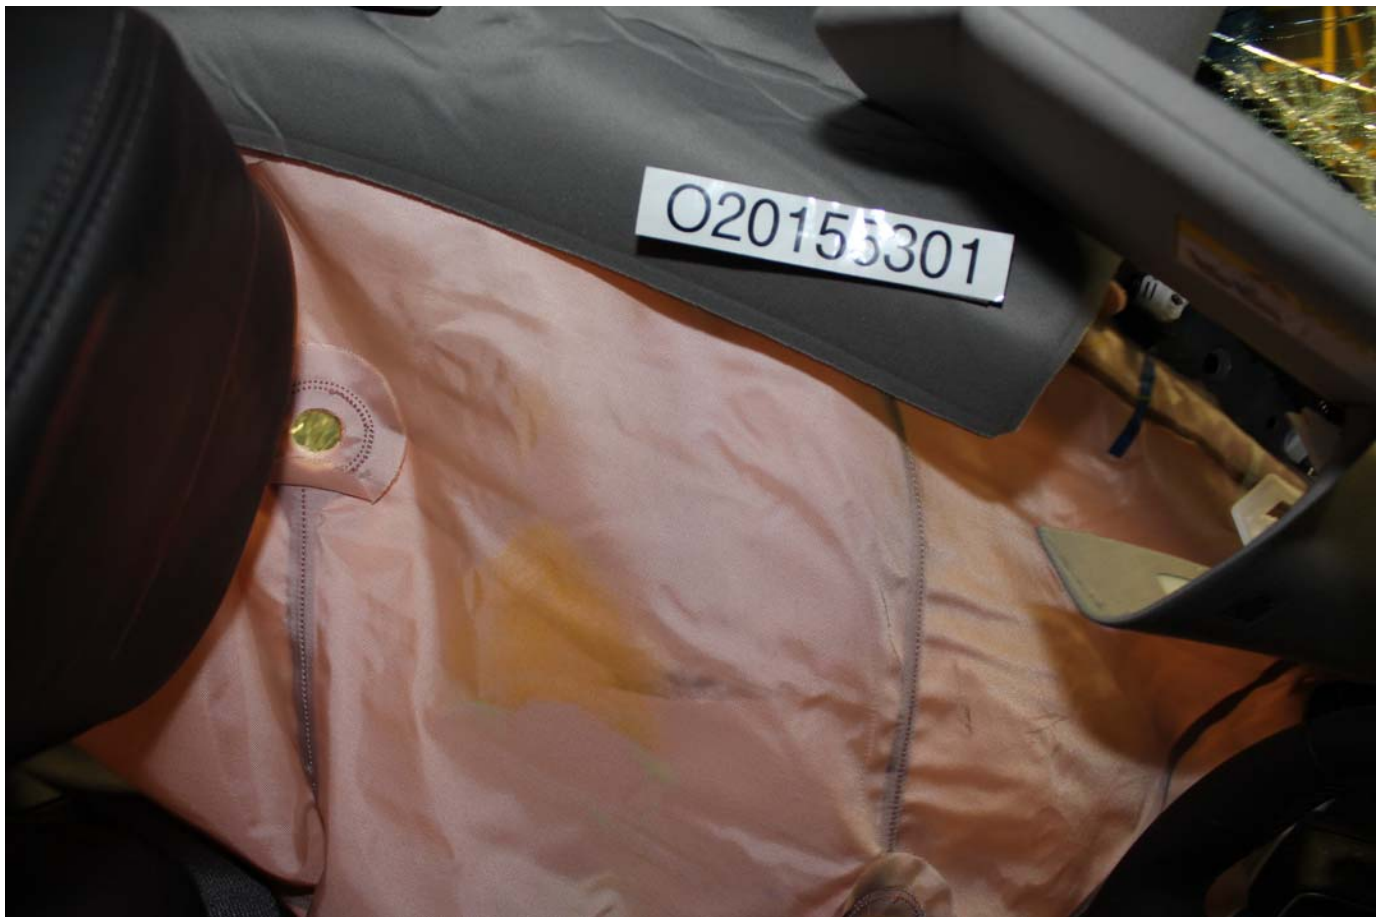
No. 047 - Post-Test Dummy Close-Up Head Contact with Side Air Bag View

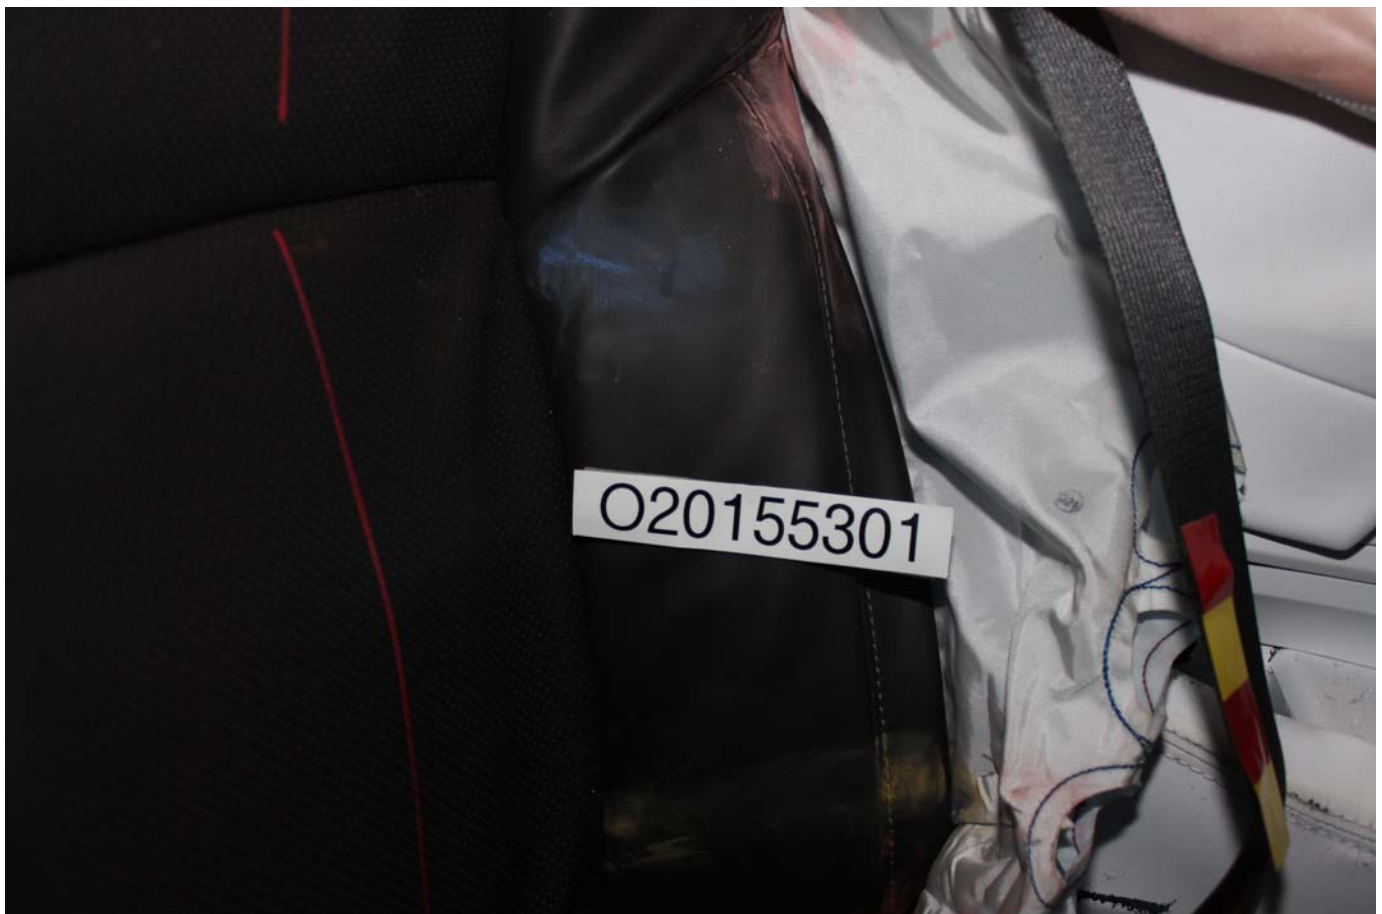
No. 048 - Post-Test Dummy Close-Up Torso Contact with Vehicle Interior View

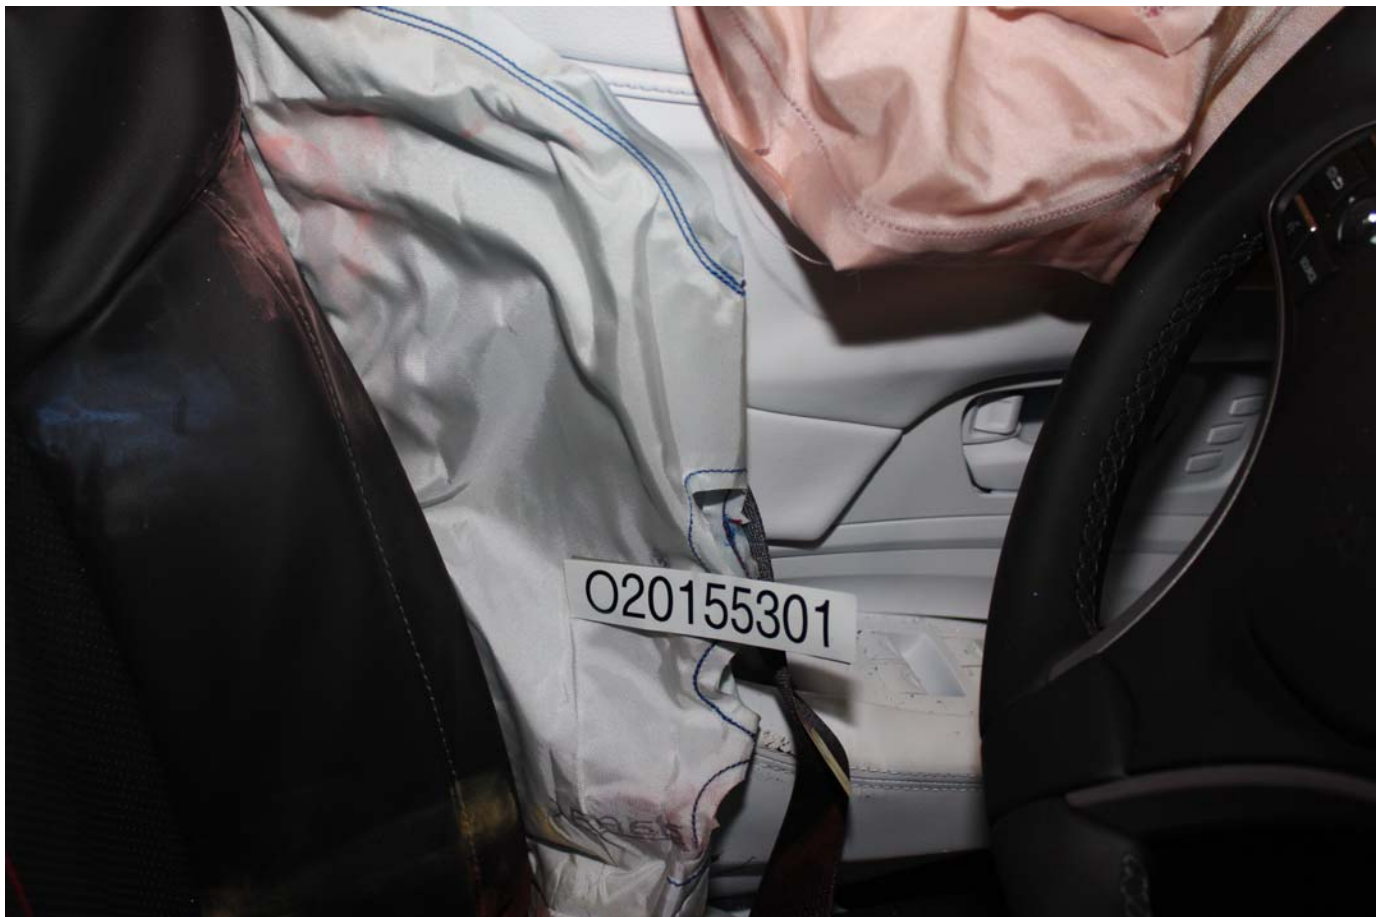
No. 049 - Post-Test Dummy Close-Up Torso Contact with Side Air Bag View

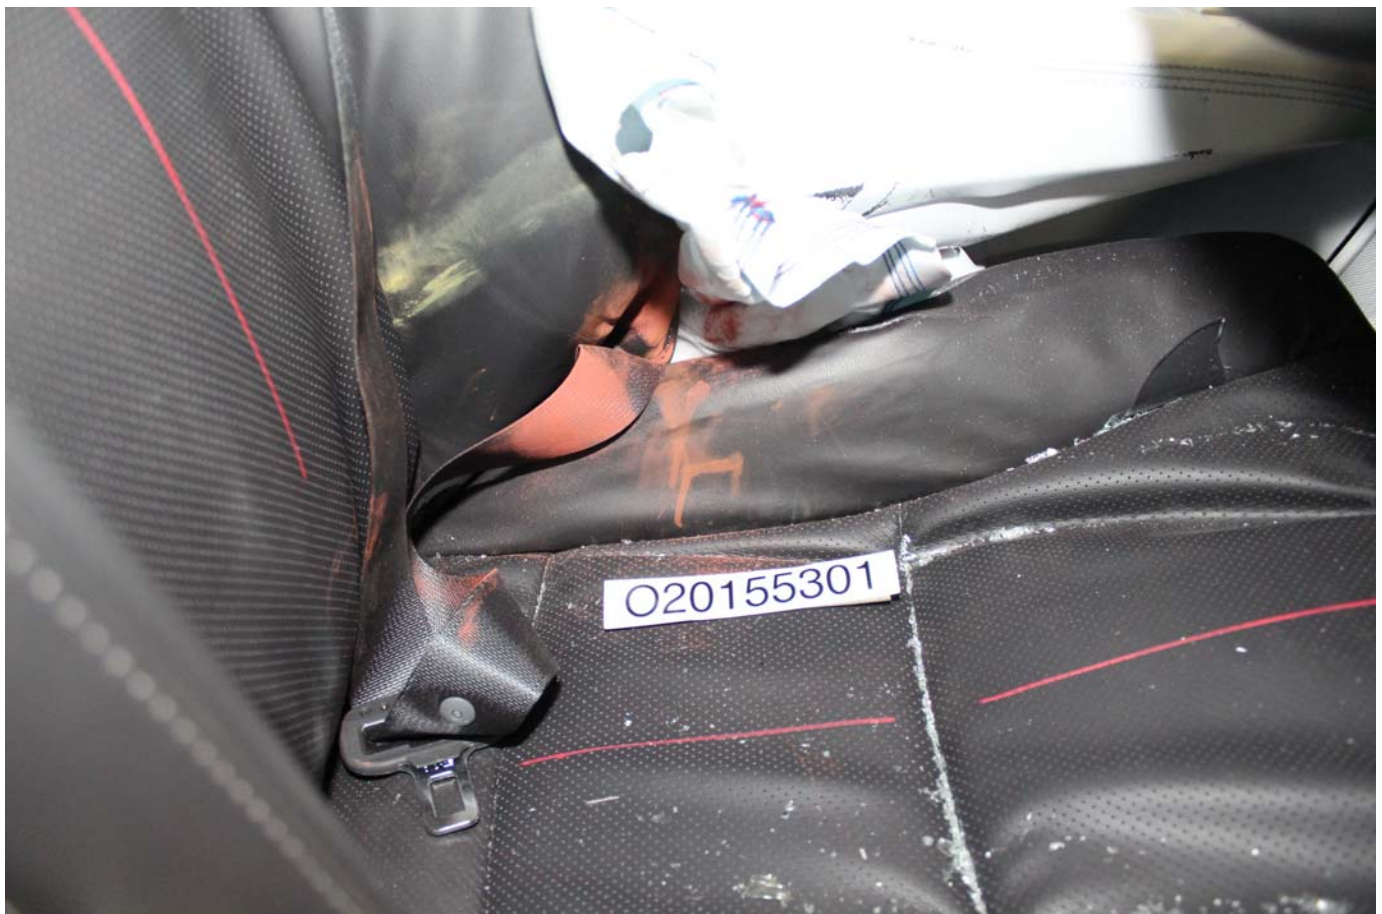
No. 050 - Post-Test Dummy Close-Up Pelvis Contact with Vehicle Interior View

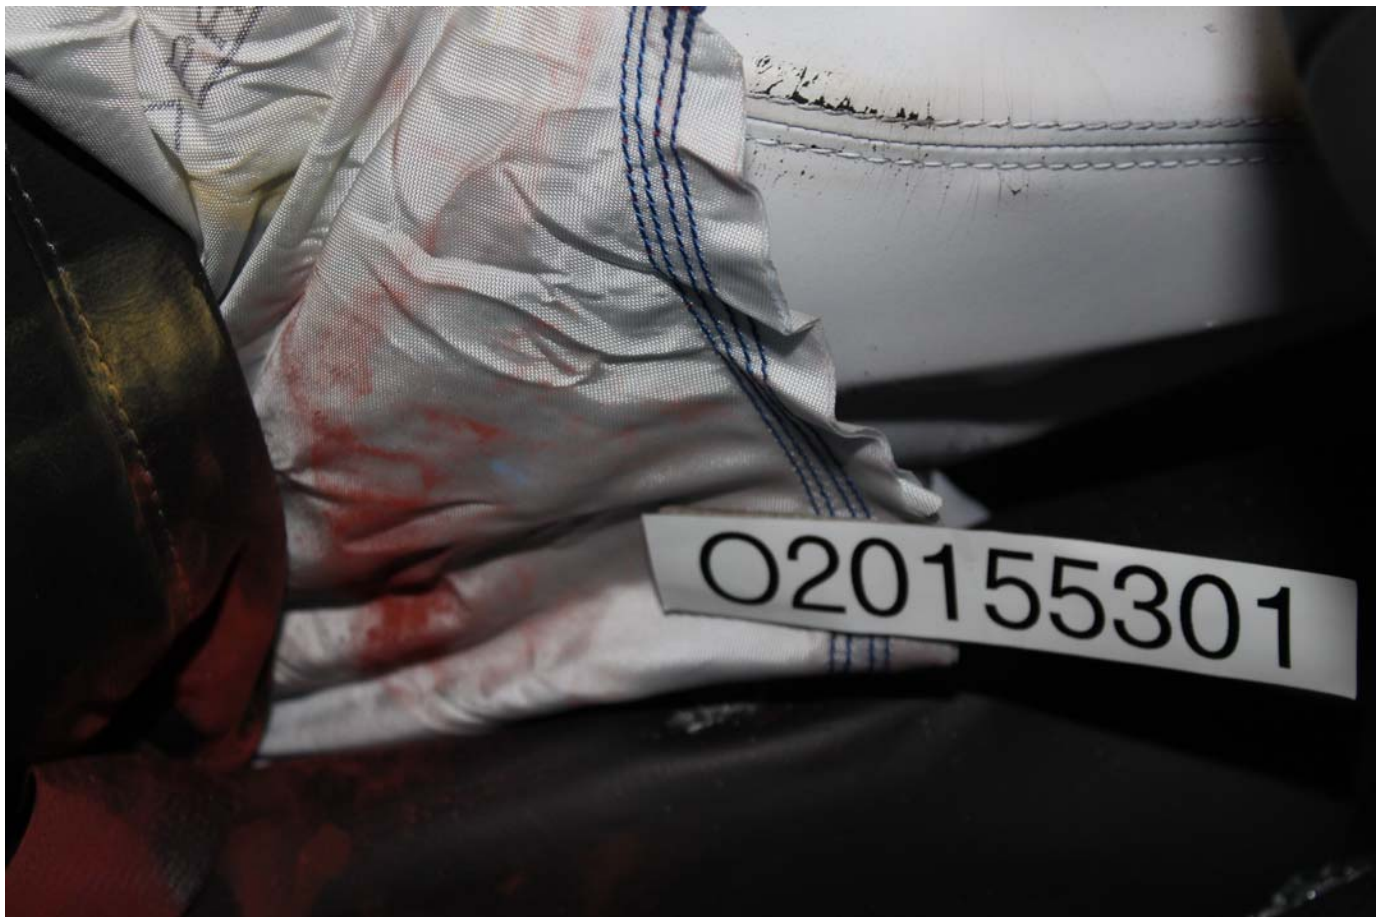
No. 051 - Post-Test Dummy Close-Up Pelvis Contact with Side Air Bag View

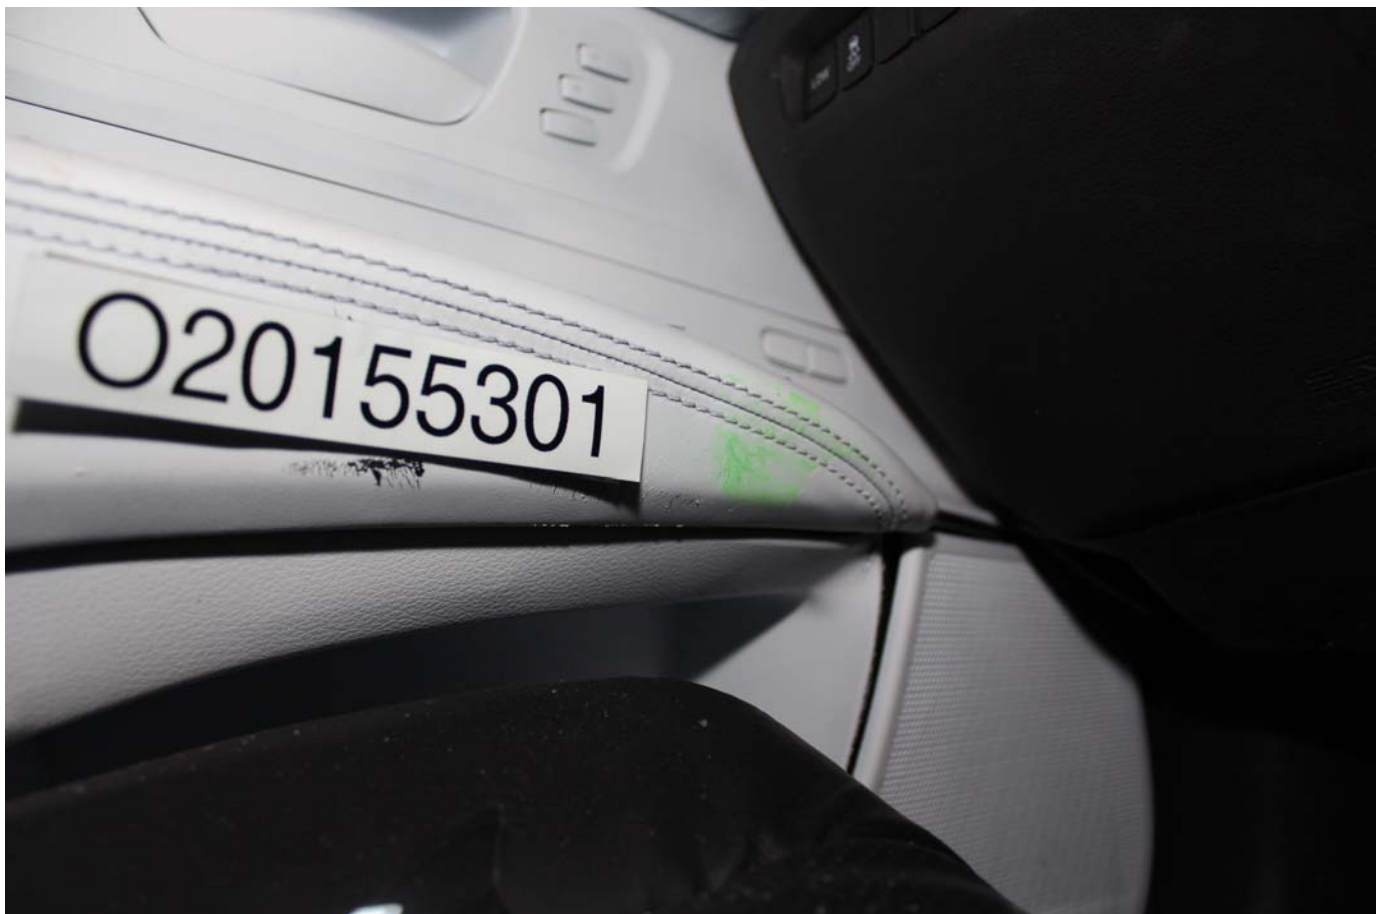
No. 052 - Post-Test Dummy Close-Up Knee Contact with Vehicle Interior View

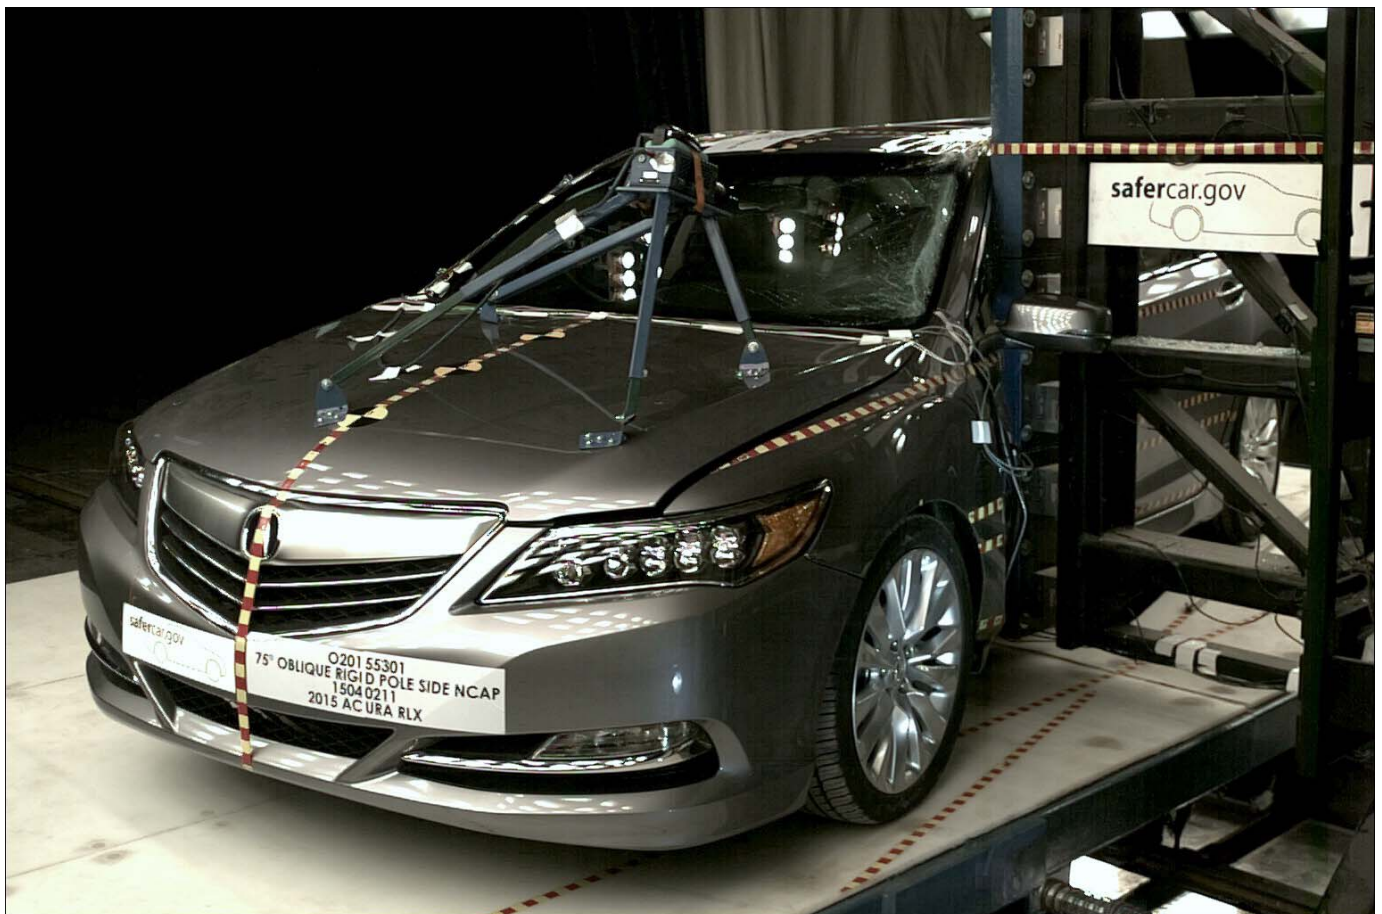
No. 068 - Impact Event
