**REPORT NUMBER: SINCAP-MGA-2015-067**

**NEW CAR ASSESSMENT PROGRAM (NCAP)  
Moving Deformable Barrier Side Impact Test**

**HONDA MOTOR CO., LTD.  
2015 Acura RLX Tech 4-Dr Sedan  
NHTSA No.: O20155302**

**MGA RESEARCH CORPORATION  
5000 Warren Road  
Burlington, WI 53105**

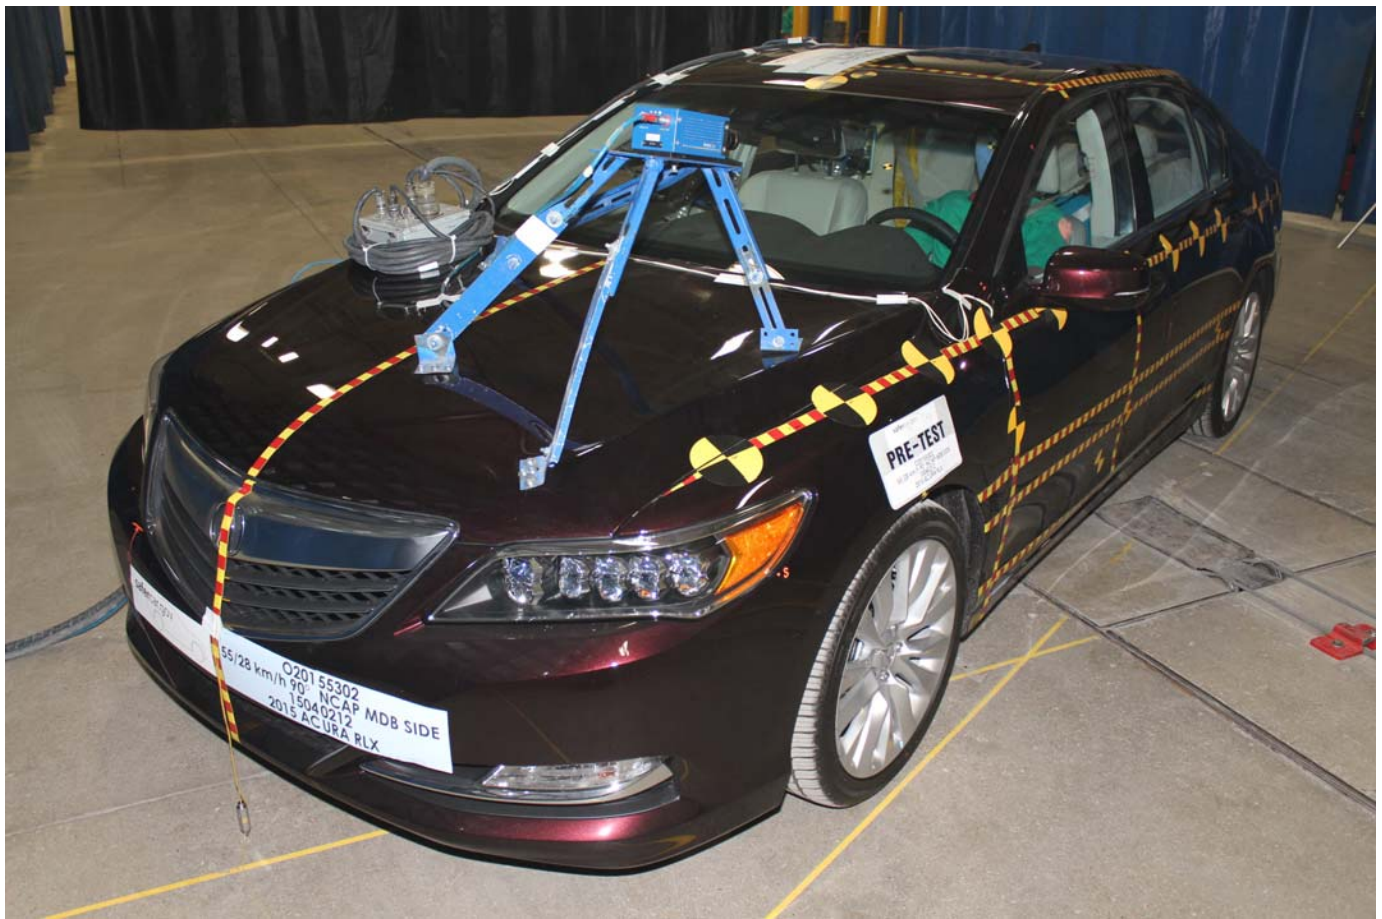
No. 004 - Post-Test Frontal View of Test Vehicle

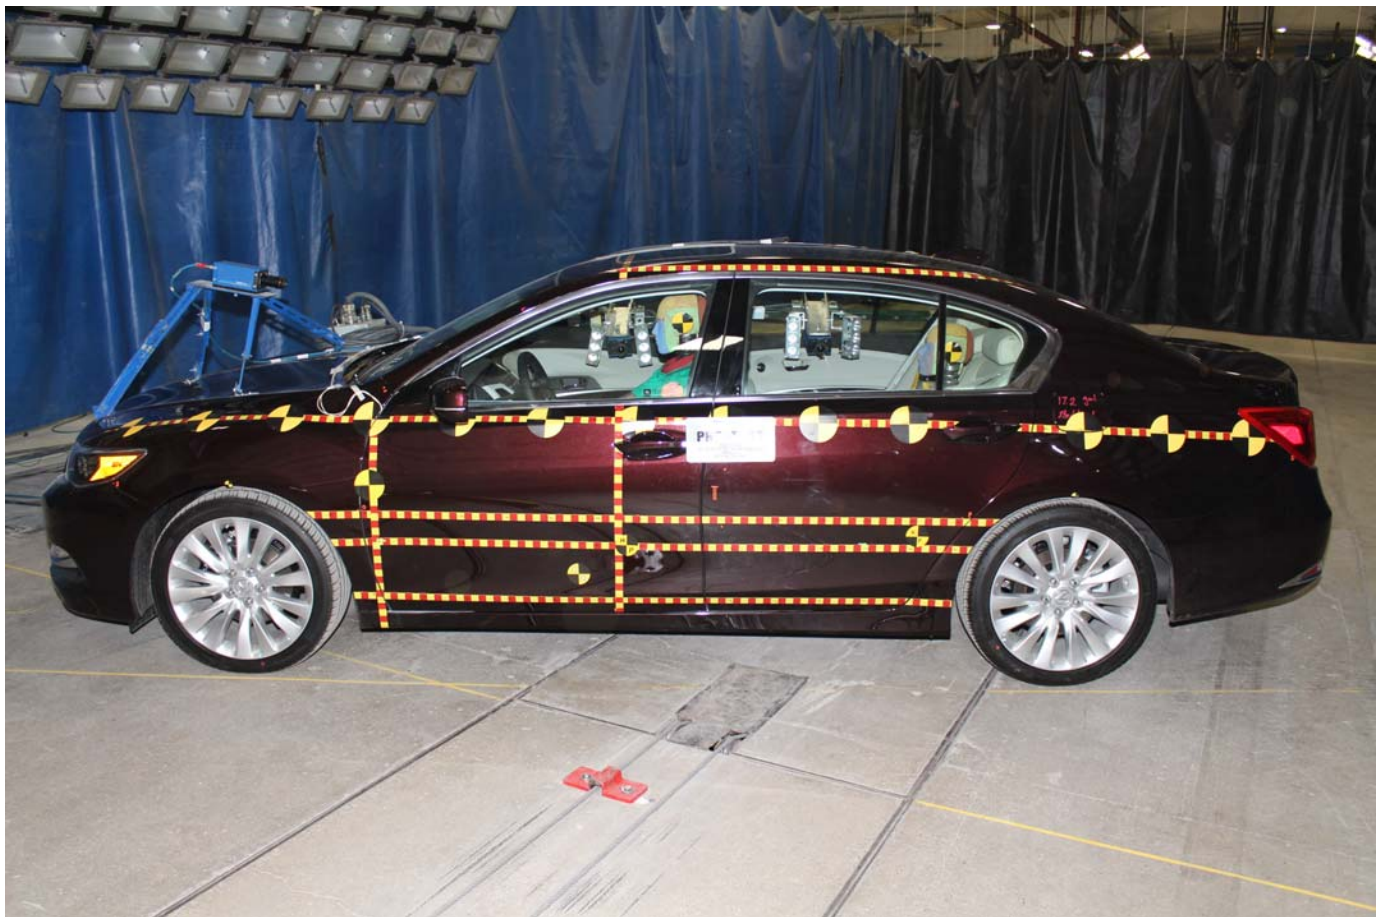
No. 006 - Post-Test Left Front Three-Quarter View of Test Vehicle

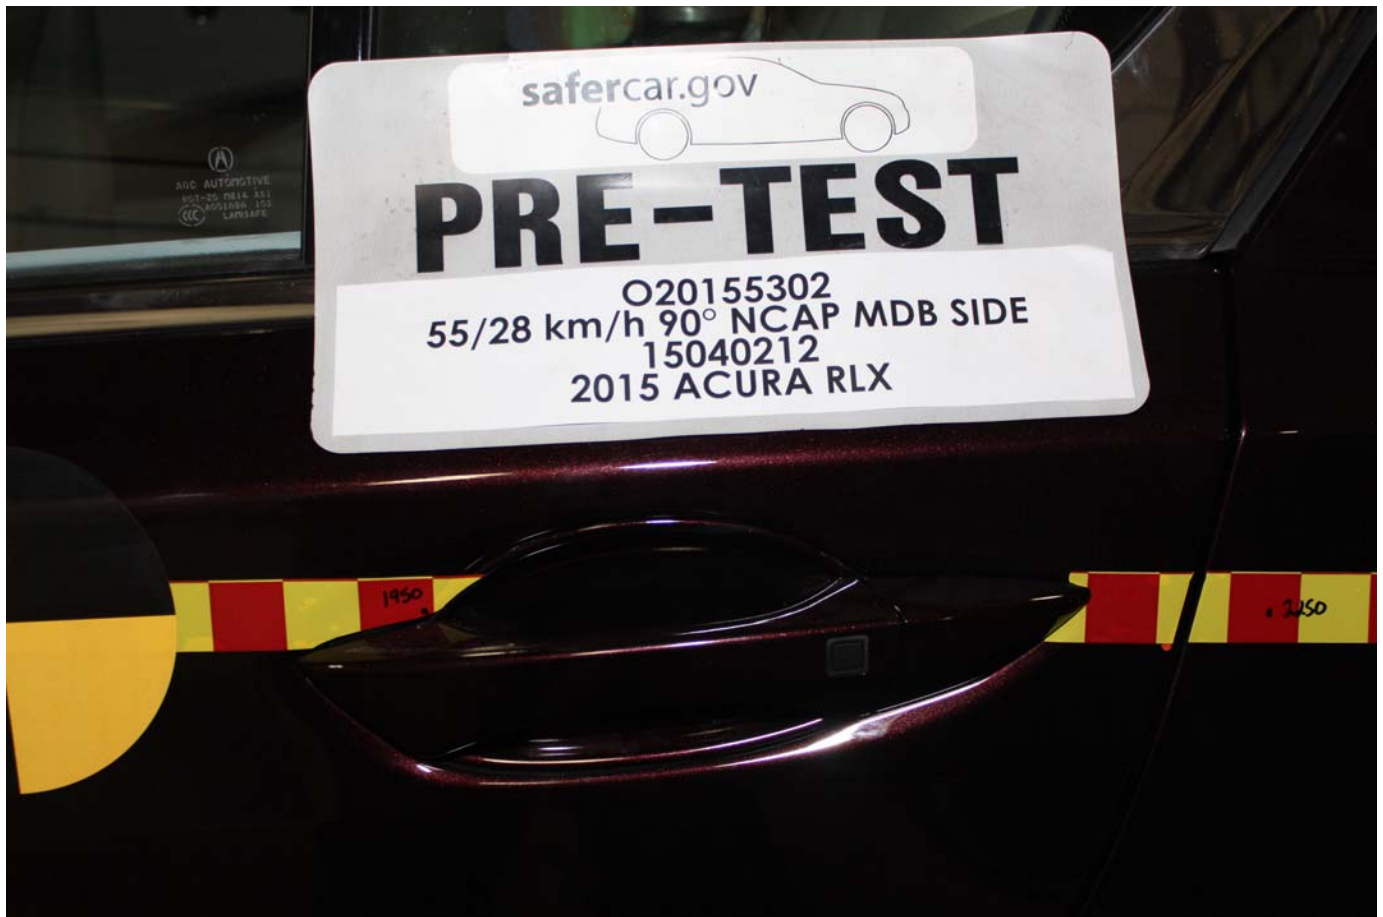
No. 022 - Post-Test Left Front Door Latch Close-Up

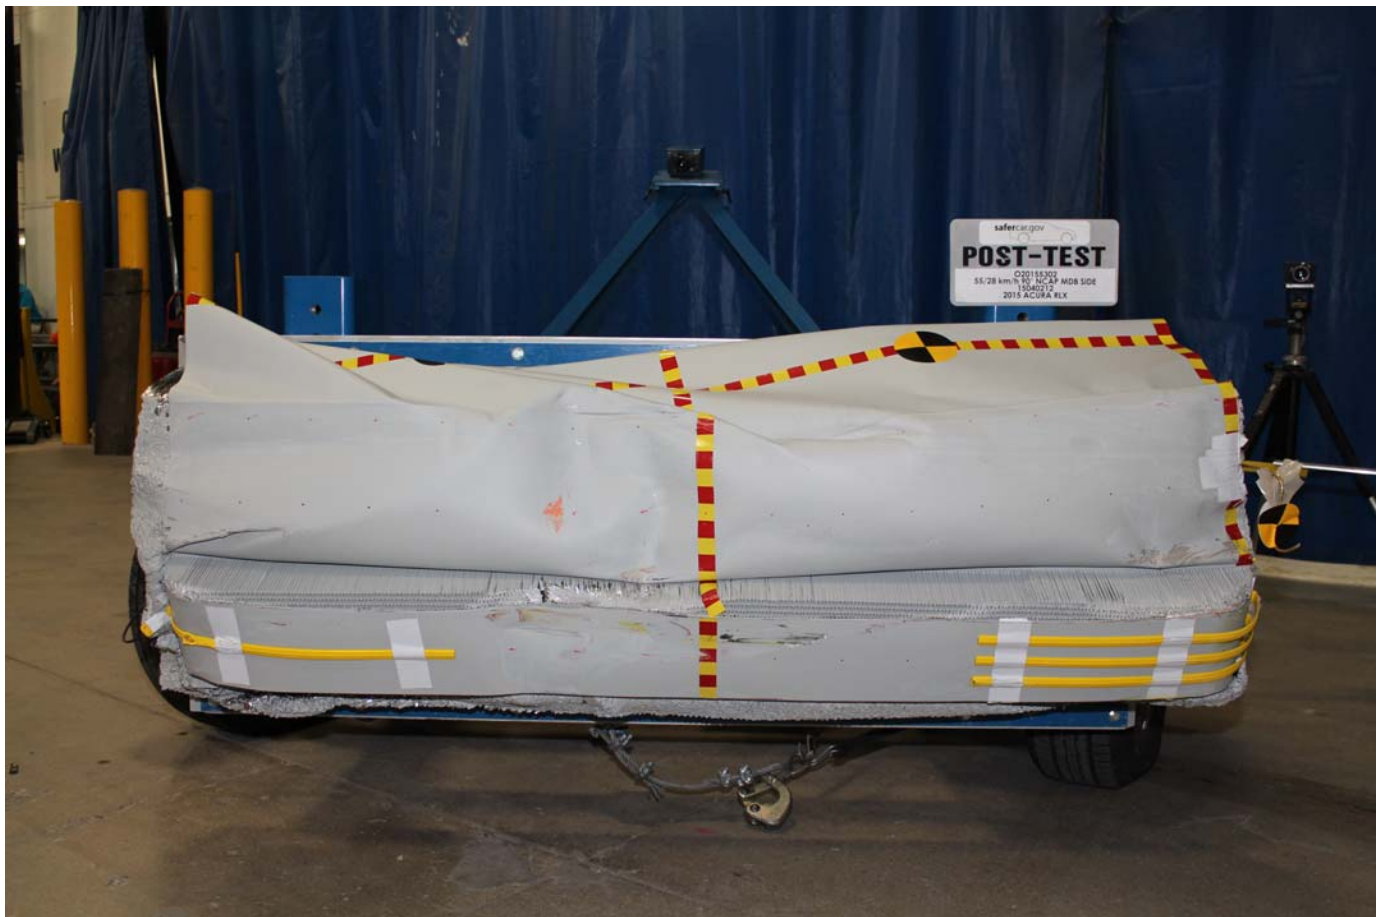
No. 084 - Pre-Test Front View of MDB Impactor Face
