REPORT NUMBER: R&D – CAL – 11 – 002

MOVING BARRIER TO VEHICLE CRASH TEST IN SUPPORT OF NHTSA'S FRONTAL
OBLIQUE OFFSET PROGRAM
RESEARCH MOVING BARRIER INTO LEFT FRONT OF A

2007 FORD TAURUS FOUR DOOR SEDAN
7° VEHICLE ANGLE AND 18% OVERLAP

TEST DATE: FEBRUARY 25, 2011
NHTSA NO: R70221

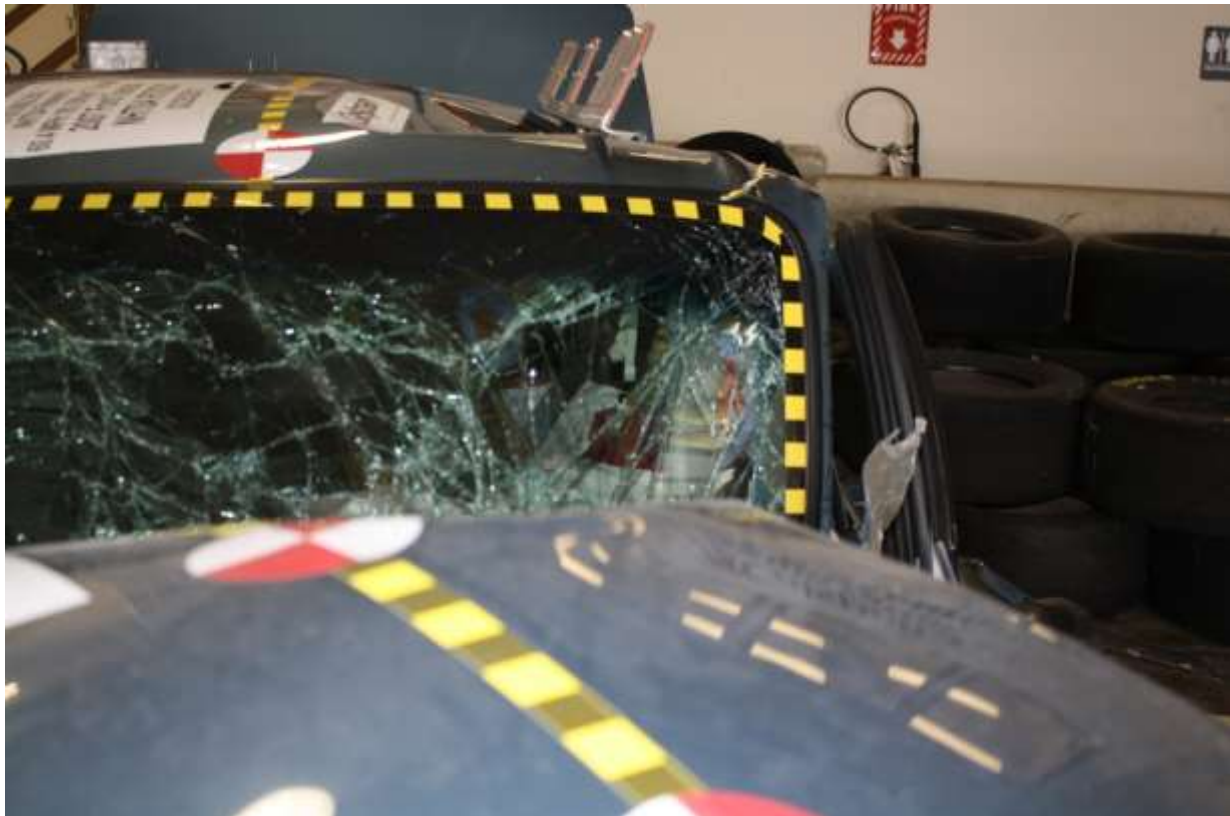
No. 029 Post-Test Windshield View

Critical Areas of Performance	Observations and Conclusions
Windshield Damage	Damaged, tear in laminate along lower left and right edges
Window Damage	NA
Other Notable Effects	A-pillar buckled due to engagement with barrier

The indicant FMVSS 212 windshield retention measurement showed 96% of the mounting was still intact after the impact; with 93% and 100% retention on the left and right sides respectively. There was minor intrusion of the hood structure into the protected zone of the windshield during the test. The maximum static crush of the vehicle was 464 mm at C1 to the left of the vehicle's centerline. The maximum crush of the lower bumper beam was 423 mm at C1, to the left of vehicle's centerline. Full vehicle measurements are presented in Section 3 of this report.

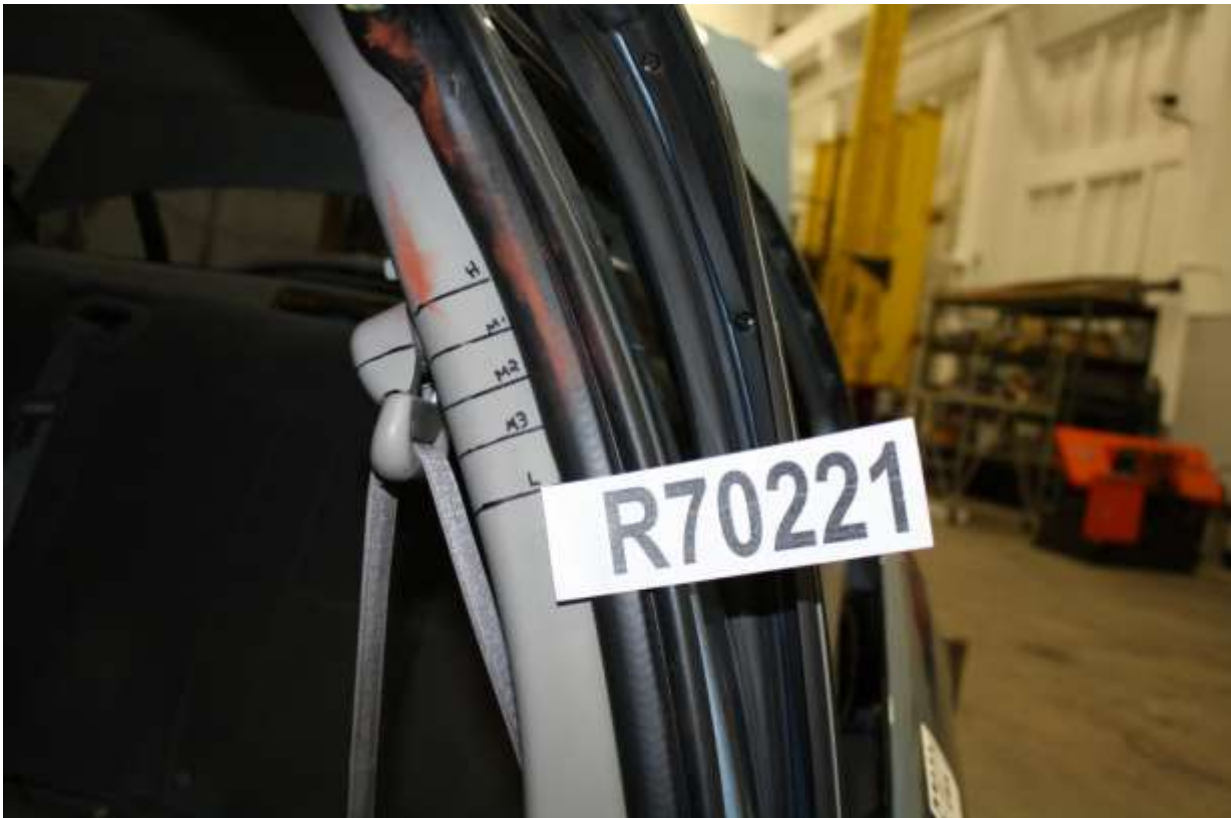
No. 082a Post-Test View of Driver Dummy Head Contact with Vehicle Interior

- Head contacted the airbag, A-pillar trim, side header and B-pillar trim
- Chest contacted the airbag and the side door trim panel
- Left and right knees contacted the knee bolster.
