REPORT NUMBER: R&D-CAL-11-003

MOVING BARRIER TO VEHICLE CRASH TEST IN SUPPORT OF NHTSA'S FRONTAL
OBLIQUE OFFSET PROGRAM
RESEARCH MOVING BARRIER INTO LEFT FRONT OF A

2007 FORD 500 FOUR DOOR SEDAN
53.9 MPH, 15 DEGREE ANGLE, 35% OVERLAP

TEST DATE: JUNE 15, 2011
NHTSA NO: R70219

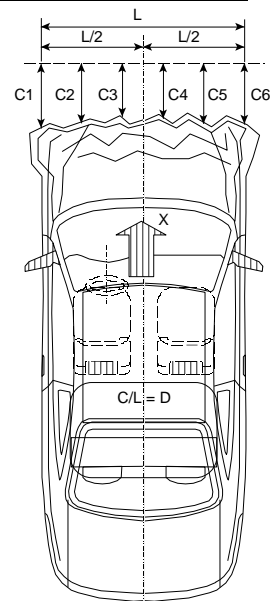
CRUSH PROFILE

Collision Deformation Classification : 12FYEW3
 Midpoint of Damage: C2
 Damage Region Length (mm): 1455
 Impact Mode: 35%offset, 15° Angle

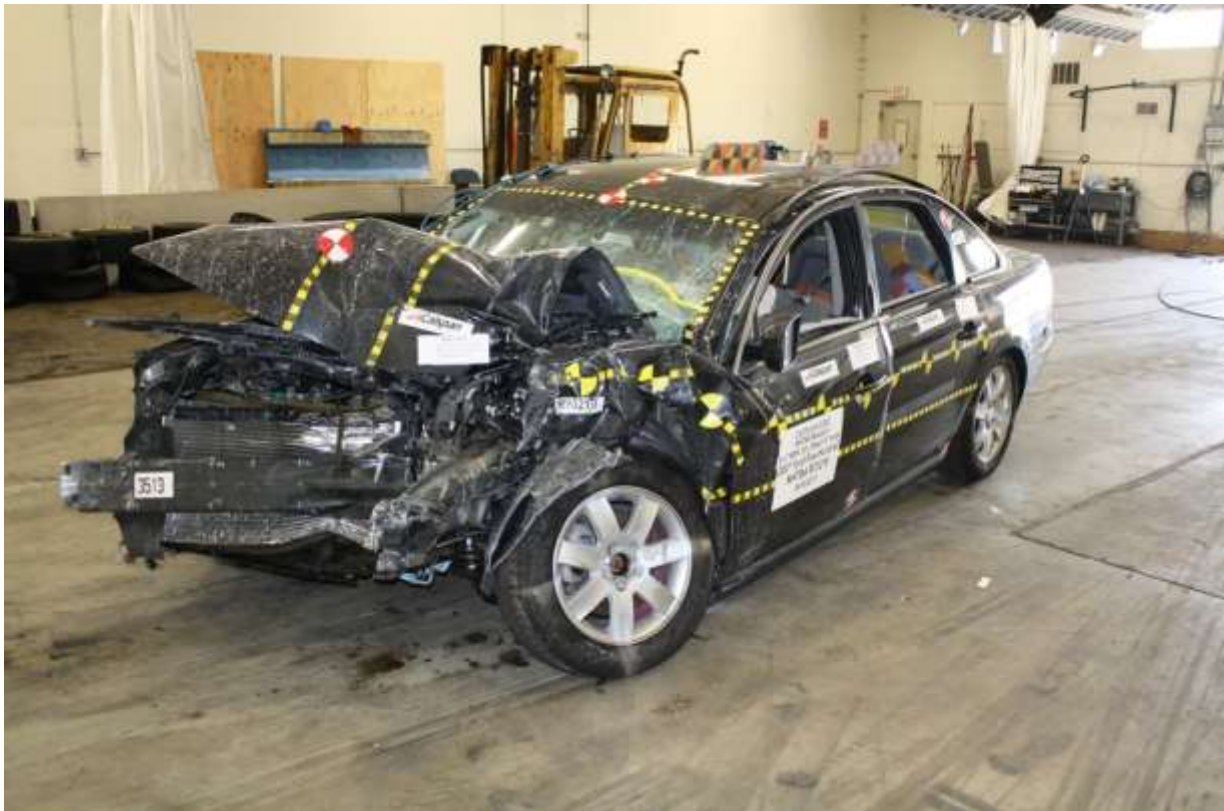
No. 008 Post-Test Left Front 3-4 View of Test Vehicle

- A-Pillar and the door sill buckled causing the lower left portion of the windshield to move backwards, and the window frame to deform.
- The left shotgun rail of the vehicle frame protruded into the barrier face.

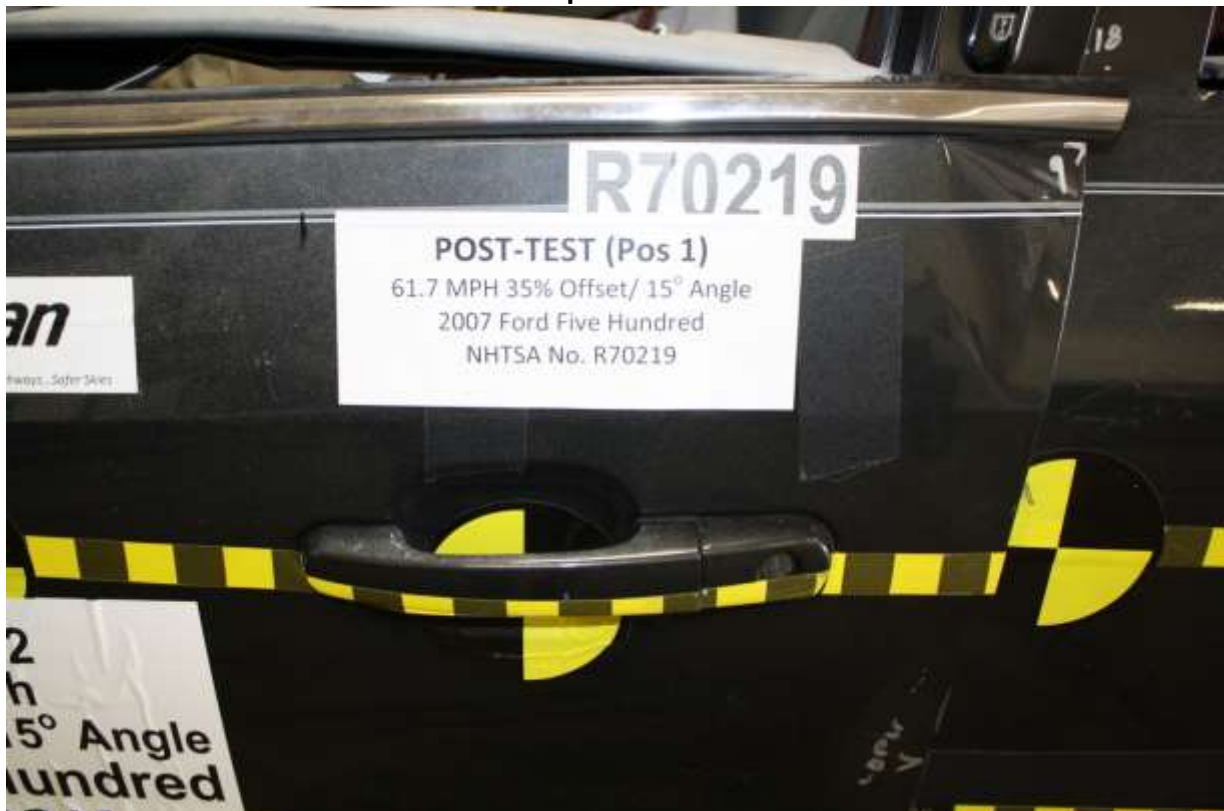
No. 025 Post-Test Close-up View of Left Front Door Latch

All four doors remained closed and latched during the test. All of the doors remained operational after the impact event.

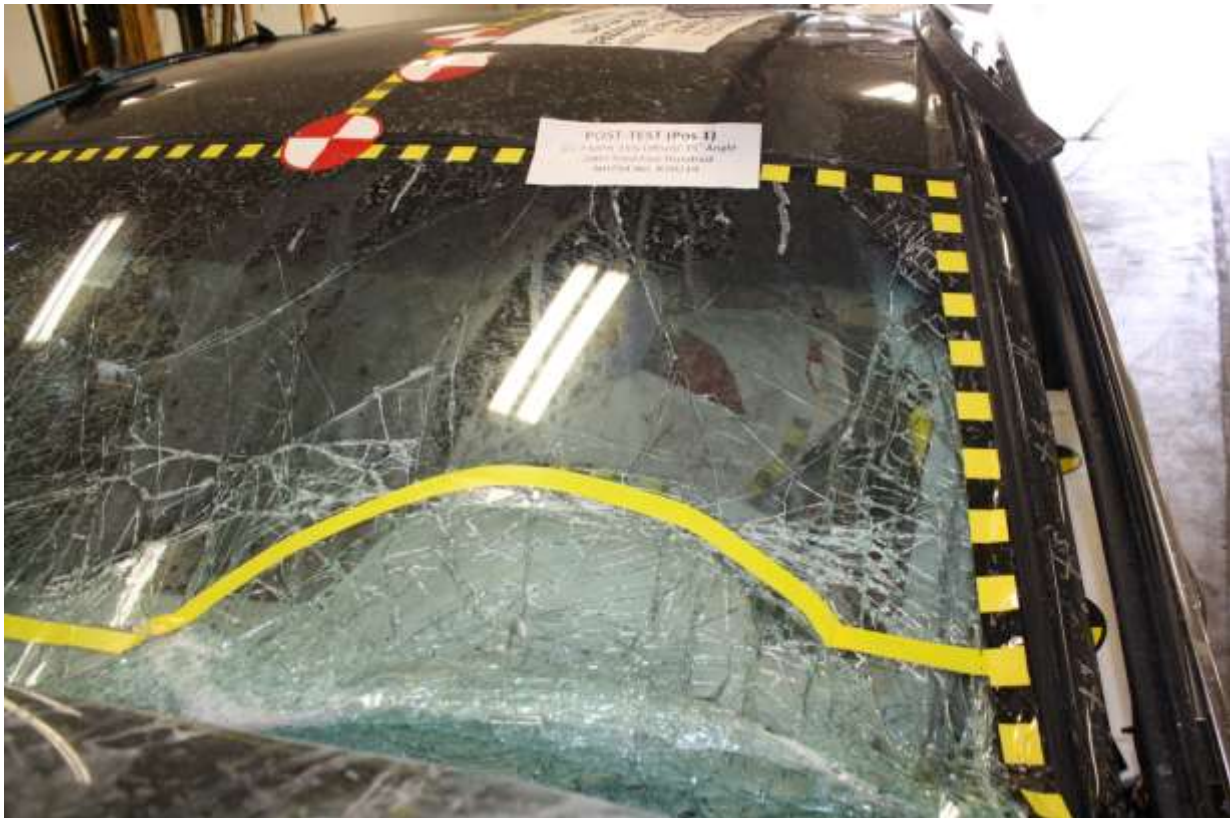
No. 029 Post-Test Windshield View

There was 98% total windshield retention, with 97% and 100% retention on the left and right sides respectively. There appeared to be no intrusion into the protected zone of the windshield during any portion of the impact test. The maximum static crush of the vehicle was 639 mm at C1 to the left of the vehicle's centerline. The maximum crush of the lower bumper beam was 623 mm at C2, to the left of vehicle's centerline. Full vehicle measurements are presented in Section 3 of this report.

Critical Areas of Performance	Observations and Conclusions	Picture Ref
Windshield Damage	Damage, minor separation on left lower side	A-21
Window Damage	None	A-36 / A-51
Other Notable Effects	Left frame rail protruded into barrier during event	-

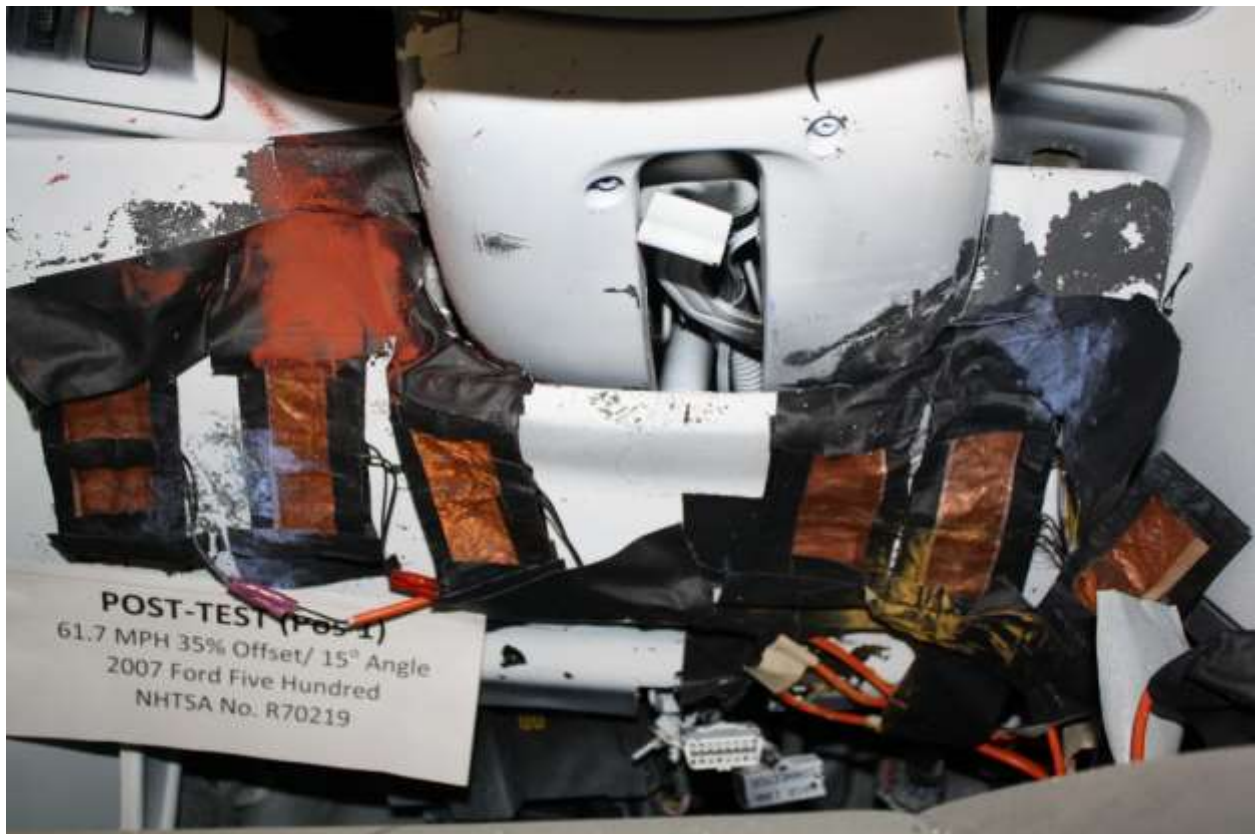
No. 039 Post-Test Overall View of Driver Knee Bolsters

- Head contacted the front airbag, and headrest
- Chest contacted the airbag.
- Both knees contacted the knee bolster.
