REPORT NUMBER: R&D-CAL-11-009

**MOVING BARRIER TO VEHICLE CRASH TEST IN SUPPORT OF NHTSA'S FRONTAL
OBLIQUE OFFSET PROGRAM
RESEARCH MOVING BARRIER DEFORMABLE BARRIER (RMDB) INTO LEFT FRONT OF
A**

**2011 FORD EXPLORER
56 MPH, 15° ANGLE, 35% OVERLAP**

**TEST DATE: SEPTEMBER 27, 2011
NHTSA NO: RB0223**

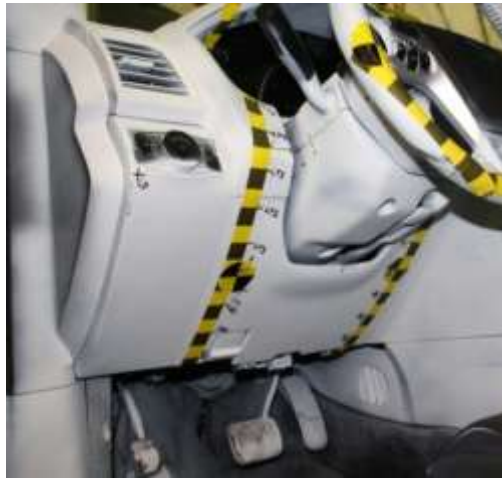
Left Profile of the Dash

Points	Pre-Test (mm)			Post-Test (mm)			Difference (mm)		
	X	Y	Z	X	Y	Z	X	Y	Z
LB3	3383.7	-529.3	-108.3	3304.5	-513.9	-97.4	-79.1	15.4	10.9
LB2	3351.9	-528.3	-148.8	3273.8	-513.6	-139.8	-78.0	14.7	9.0
LB1	3321.2	-527.8	-189.8	3244.8	-514.6	-179.7	-76.5	13.2	10.1
DIPL	3293.0	-527.0	-228.7	3216.7	-514.4	-220.0	-76.3	12.6	8.7
LT1	3264.6	-526.5	-272.1	3189.8	-515.9	-264.7	-74.8	10.7	7.4
LT2	3239.7	-526.4	-317.5	3167.7	-517.5	-310.1	-71.9	8.9	7.3
LT3	3218.0	-526.5	-361.2	3145.5	-542.1	-357.7	-72.6	-15.6	3.6
LT4	3228.0	-525.1	-408.3	3157.0	-532.4	-406.6	-71.0	-7.3	1.7
LT5	3257.9	-524.8	-445.5	3186.7	-527.5	-444.7	-71.1	-2.7	0.8
LT6	3302.3	-528.1	-434.4	3229.7	-529.8	-435.2	-72.6	-1.7	-0.8
LT7	3357.3	-531.7	-421.7	3290.0	-516.0	-411.6	-67.3	15.7	10.1
LT8	3366.1	-530.2	-469.1	3303.5	-526.4	-460.2	-62.6	3.8	8.9
LT9	3357.1	-533.9	-518.5	3297.4	-530.4	-508.4	-59.7	3.5	10.1
LT10	3325.0	-526.0	-553.1	3248.0	-526.4	-554.6	-77.0	-0.4	-1.4

LT11	3296.4	-527.5	-592.1	3235.0	-520.3	-579.5	-61.3	7.3	12.5
LT12	3383.7	-529.3	-108.3	3304.5	-513.9	-97.4	-79.1	15.4	10.9

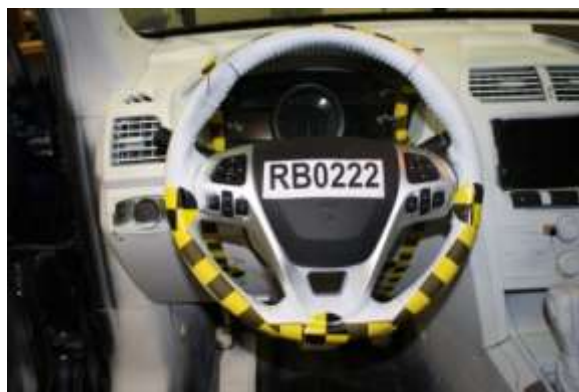
Right Profile of the Dash

Points	Pre-Test (mm)			Post-Test (mm)			Difference (mm)		
	X	Y	Z	X	Y	Z	X	Y	Z
RB3	3381.9	-231.9	-107.6	3316.7	-218.9	-119.5	-65.2	13.0	-11.8
RB2	3350.1	-231.2	-145.9	3285.2	-219.1	-156.7	-64.9	12.1	-10.8
RB1	3319.3	-230.7	-186.0	3254.1	-219.2	-198.1	-65.1	11.5	-12.0
DIPR	3288.6	-230.3	-228.5	3223.7	-222.1	-240.9	-64.9	8.3	-12.5
RT1	3262.6	-231.3	-267.7	3198.7	-222.0	-277.5	-63.8	9.2	-9.8
RT2	3236.1	-229.8	-310.1	3172.6	-223.5	-320.8	-63.5	6.2	-10.8
RT3	3210.4	-229.8	-353.1	3160.3	-215.4	-353.4	-50.1	14.4	-0.3
RT4	3231.1	-230.6	-399.8	3167.6	-212.2	-406.0	-63.5	18.4	-6.2
RT5	3259.5	-230.8	-441.9	3180.1	-234.2	-447.0	-79.5	-3.5	-5.1
RT6	3303.5	-216.9	-464.5	3221.8	-217.4	-468.5	-81.7	-0.5	-4.0
RT7	3342.2	-211.5	-488.6	3259.9	-209.5	-494.0	-82.3	1.9	-5.4
RT8	3331.3	-229.9	-540.5	3251.7	-227.5	-544.3	-79.6	2.4	-3.8
RT9	3302.8	-229.7	-577.8	3242.9	-220.6	-577.0	-59.9	9.1	0.8
RT10	3349.9	-230.3	-591.4	3289.5	-219.0	-594.1	-60.4	11.3	-2.7

RT11	3401.0	-236.5	-592.5	3340.1	-224.9	-600.8	-61.0	11.6	-8.3
RT12	3381.9	-231.9	-107.6	3316.7	-218.9	-119.5	-65.2	13.0	-11.8

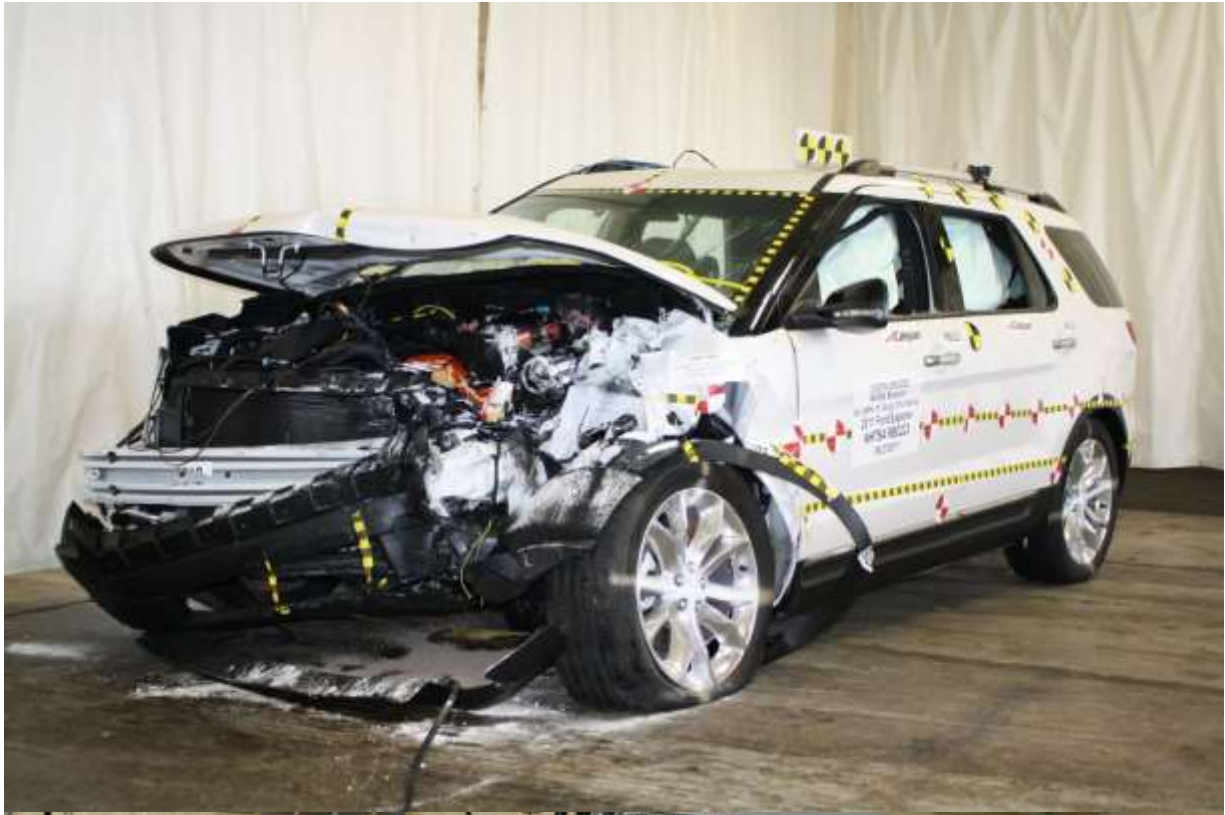
No. 008 Post-Test Left Front 3-4 View of Test Vehicle

- Left front wheel well crushed up in to the A Pillar.
- Radiator support beam was crushed and measurement points were unrecoverable post-test.

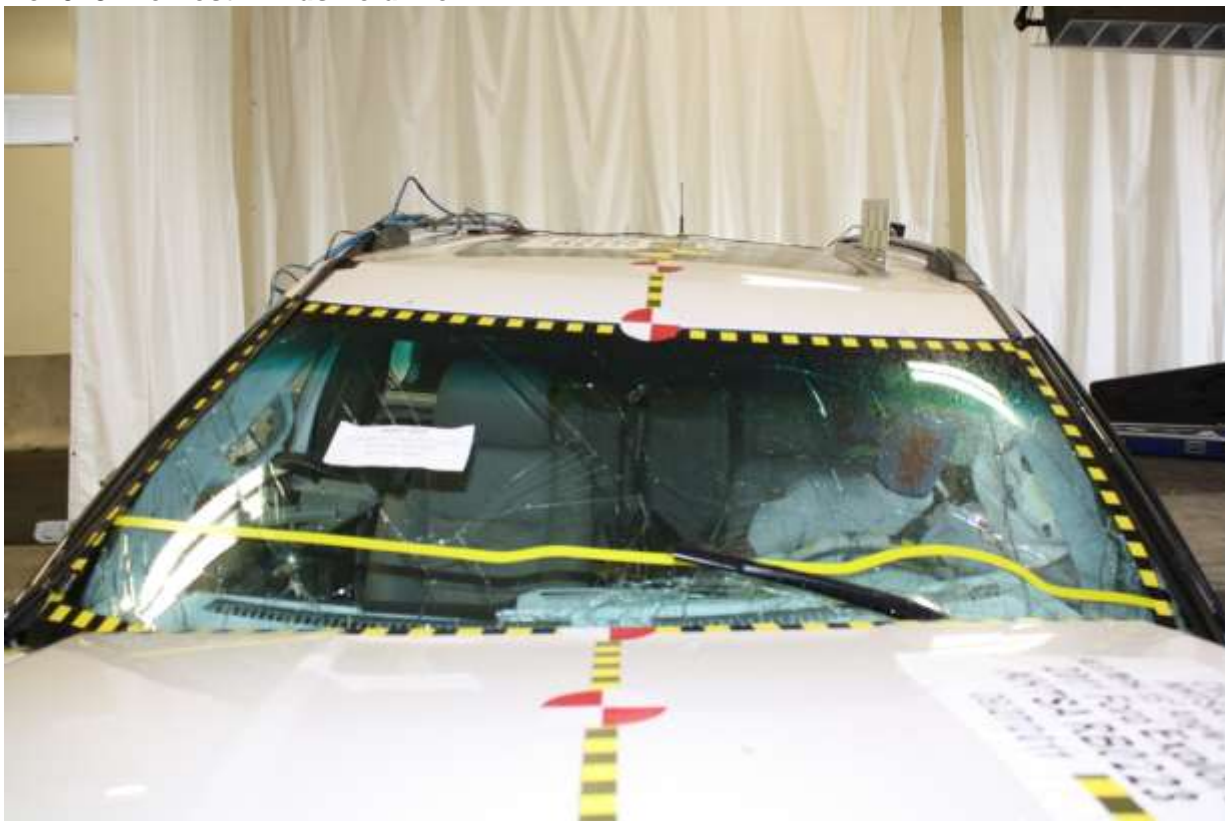
No. 029 Post-Test Windshield View

Critical Areas of Performance	Observations and Conclusions	Picture Ref
Windshield Damage	Shattered, some separation in front of Driver	A-21
Window Damage	Shattered, Rolled down	A-36 / A-51
Other Notable Effects	None	-

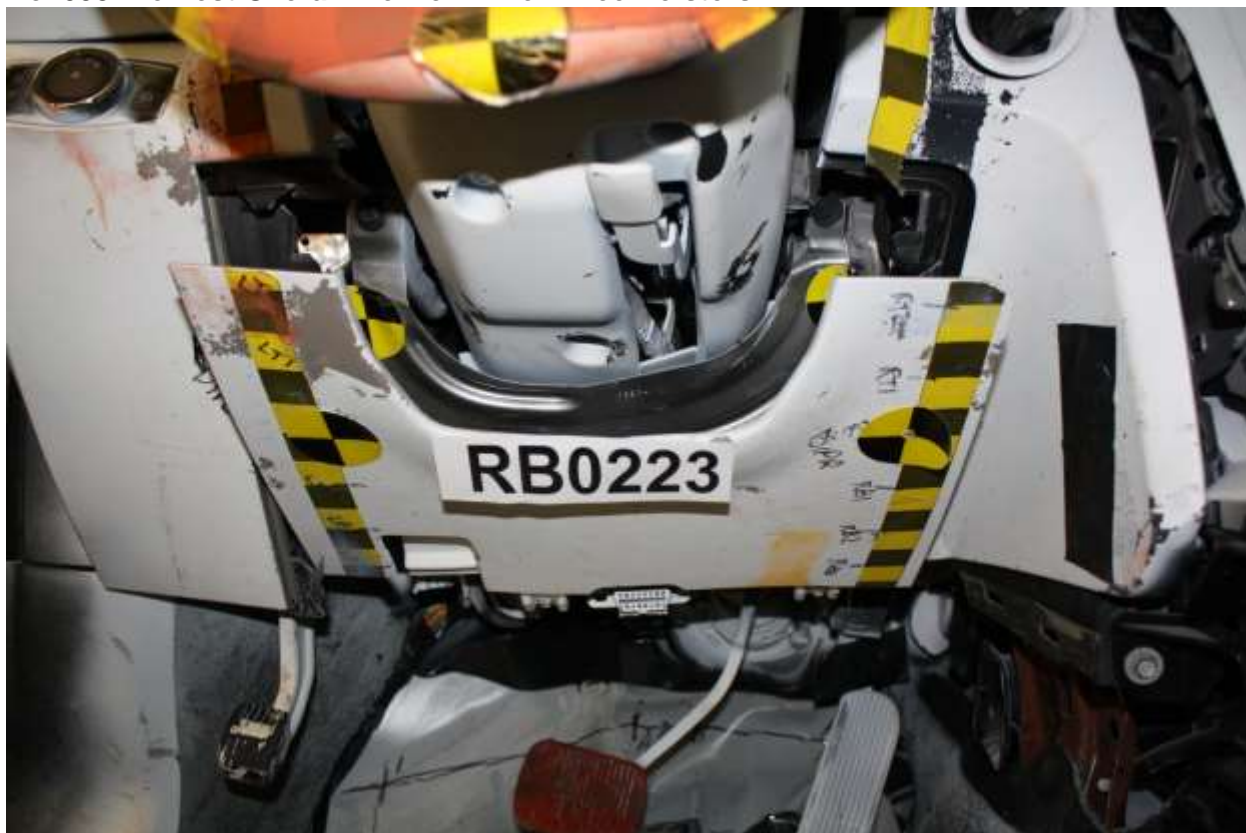
No. 039 Post-Test Overall View of Driver Knee Bolsters

- Head contacted the steering wheel airbag, curtain airbag, and door frame.
- Torso contacted the torso airbag
- Chest contacted the airbag
- Both the left and right knees contacted the knee bolster.
