REPORT NUMBER: R&D-CAL-11-010

**MOVING BARRIER TO VEHICLE CRASH TEST IN SUPPORT OF NHTSA'S FRONTAL
OBLIQUE OFFSET PROGRAM
RESEARCH MOVING BARRIER DEFORMABLE BARRIER INTO LEFT FRONT OF A**

**2011 FORD EXPLORER
56 MPH, 7° ANGLE, 20% OVERLAP**

**TEST DATE: JULY 19, 2011
NHTSA NO: RB0222**

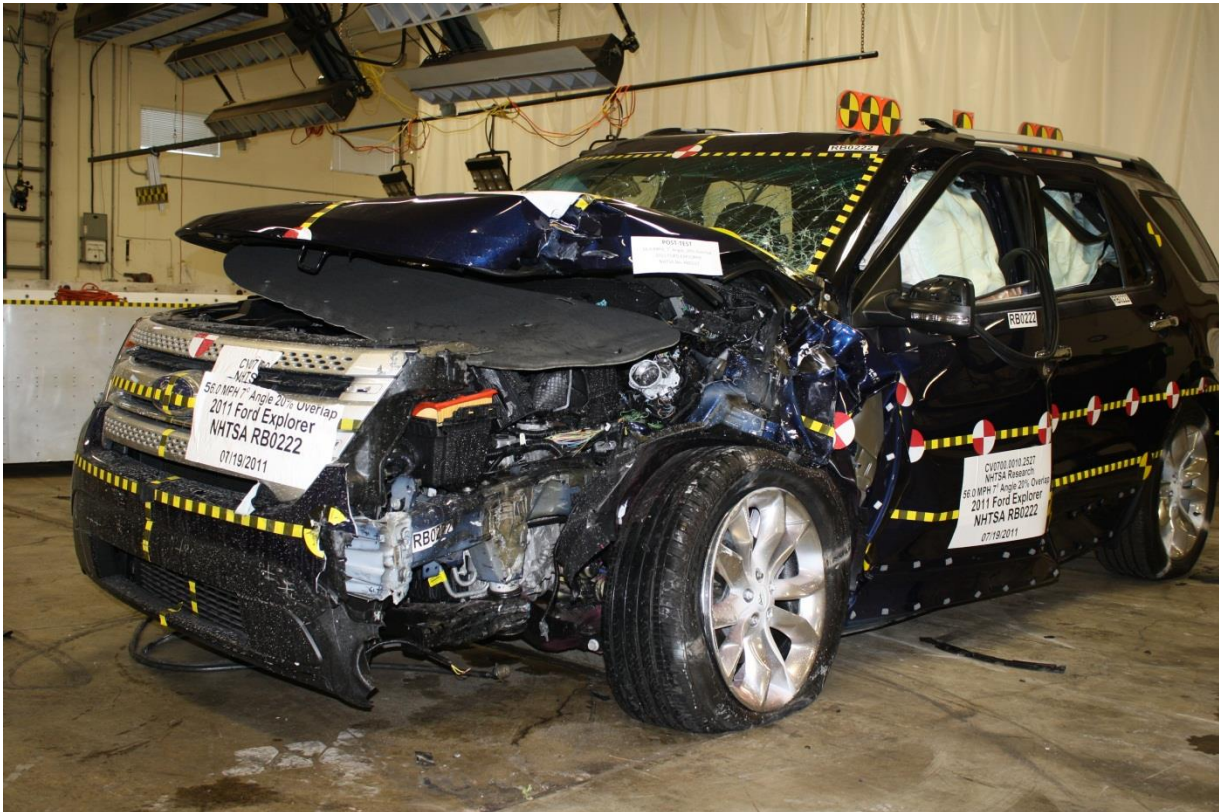
No. 008 Post-Test Left Front 3-4 View of Test Vehicle

- A-Pillar and the door sill buckled
- Left side of the front of the vehicle was sheered along the frame rail into the firewall.
- Left front wheel rim shattered as a result of the impact, and fell apart upon removal from the vehicle.
