**REPORT NUMBER: R&D-CAL-11-011**

**MOVING BARRIER TO VEHICLE CRASH TEST IN SUPPORT OF NHTSA'S FRONTAL  
OBLIQUE OFFSET PROGRAM  
RESEARCH MOVING DEFORMABLE BARRIER INTO LEFT FRONT OF A**

**2011 FORD FIESTA  
56 MPH, 7 DEGREE ANGLE, 20% OVERLAP**

**TEST DATE: JULY 23, 2011  
NHTSA NO: RB0224**

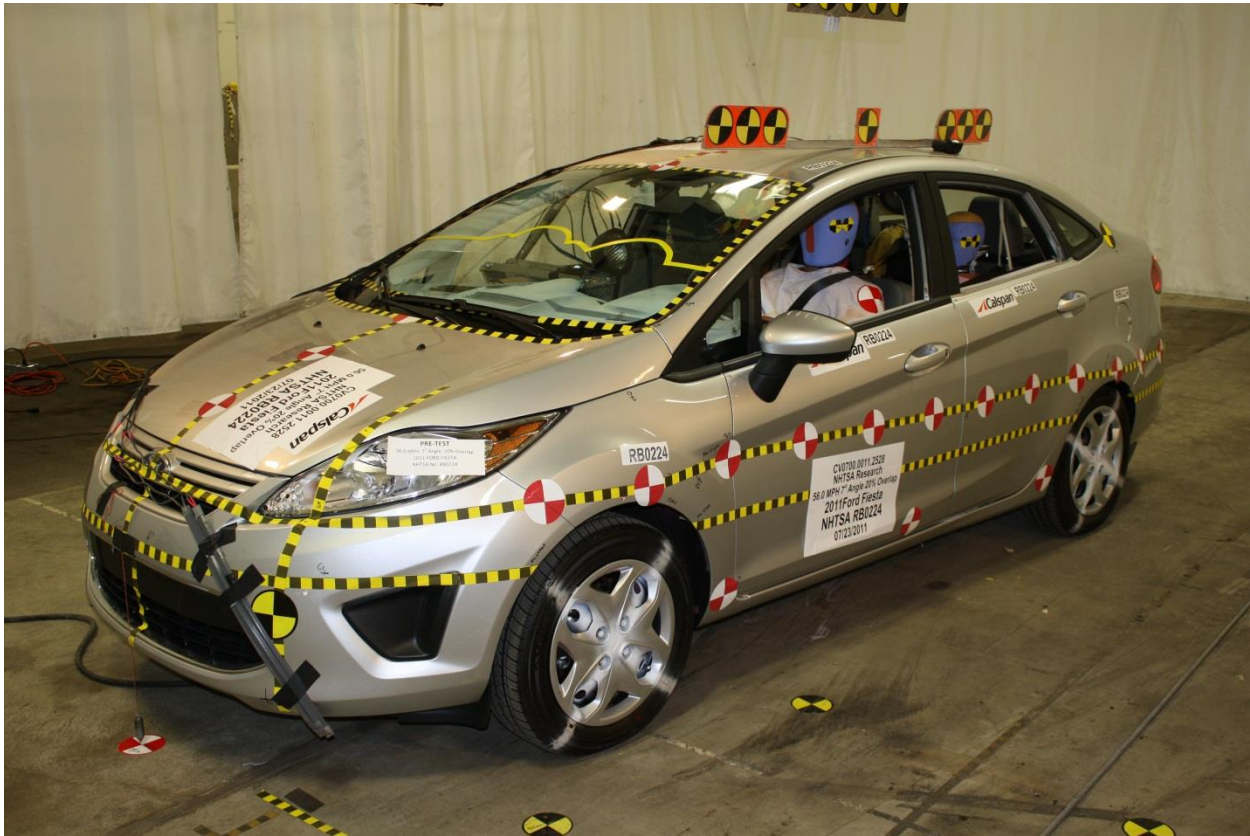
No. 007 Pre-Test Left Front 3-4 View of Test Vehicle

No. 008 Post-Test Left Front 3-4 View of Test Vehicle

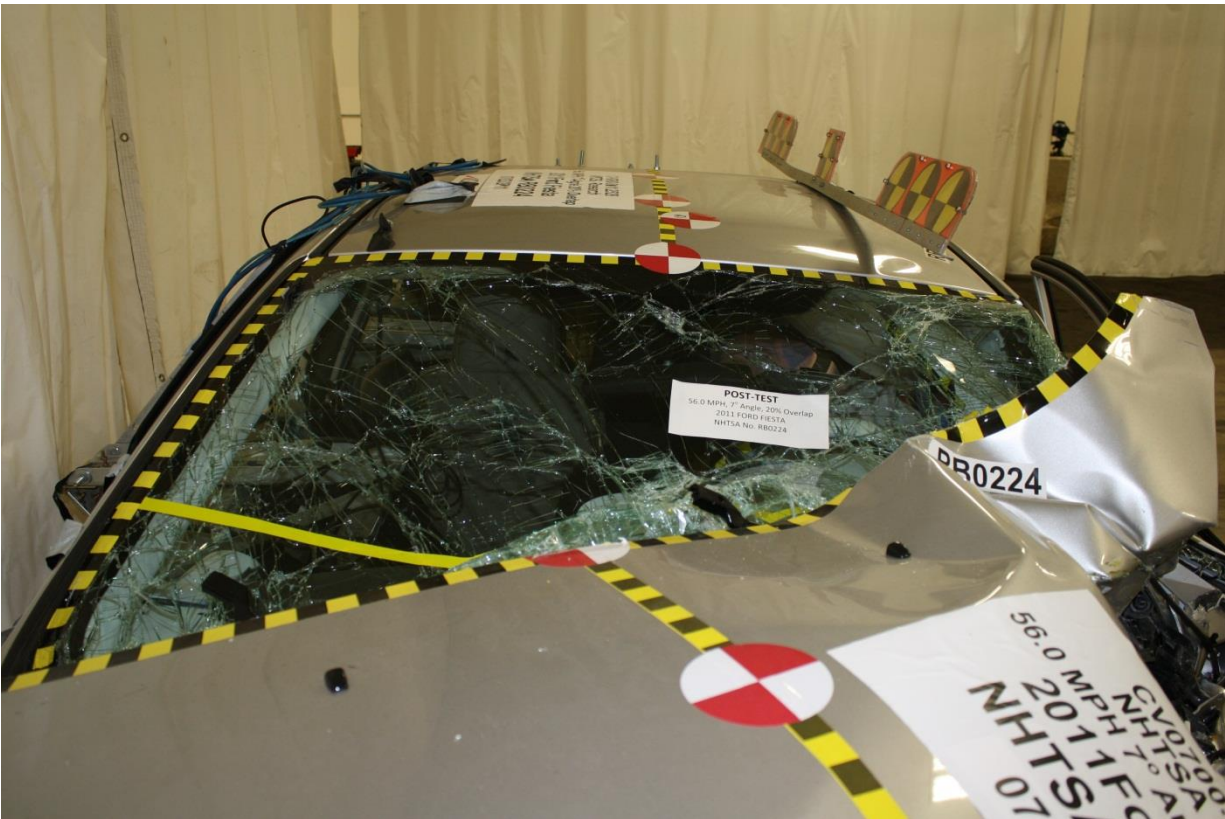
No. 029 Post-Test Windshield View

There was 100% total windshield retention, with 100% and 100% retention on the left and right sides respectively. The left rear section of hood caused intrusion into the lower left corner of windshield below protected zone during the impact test. The maximum static crush of the vehicle was 703 mm at C1 to the left of the vehicle's centerline. The maximum crush of the lower bumper beam was 166 mm at C1, to the left of vehicle's centerline. Full vehicle measurements are presented in Section 3 of this report. All four vehicle doors remained closed and latched during the test. The left front door was jammed shut, but was able to be opened. The left rear, right front, and right rear doors all remained operational after the test.

- A-Pillar and the door sill buckled
- Some tears of the windshield along the driver A-pillar, and along the bottom of the windshield in front of the driver.

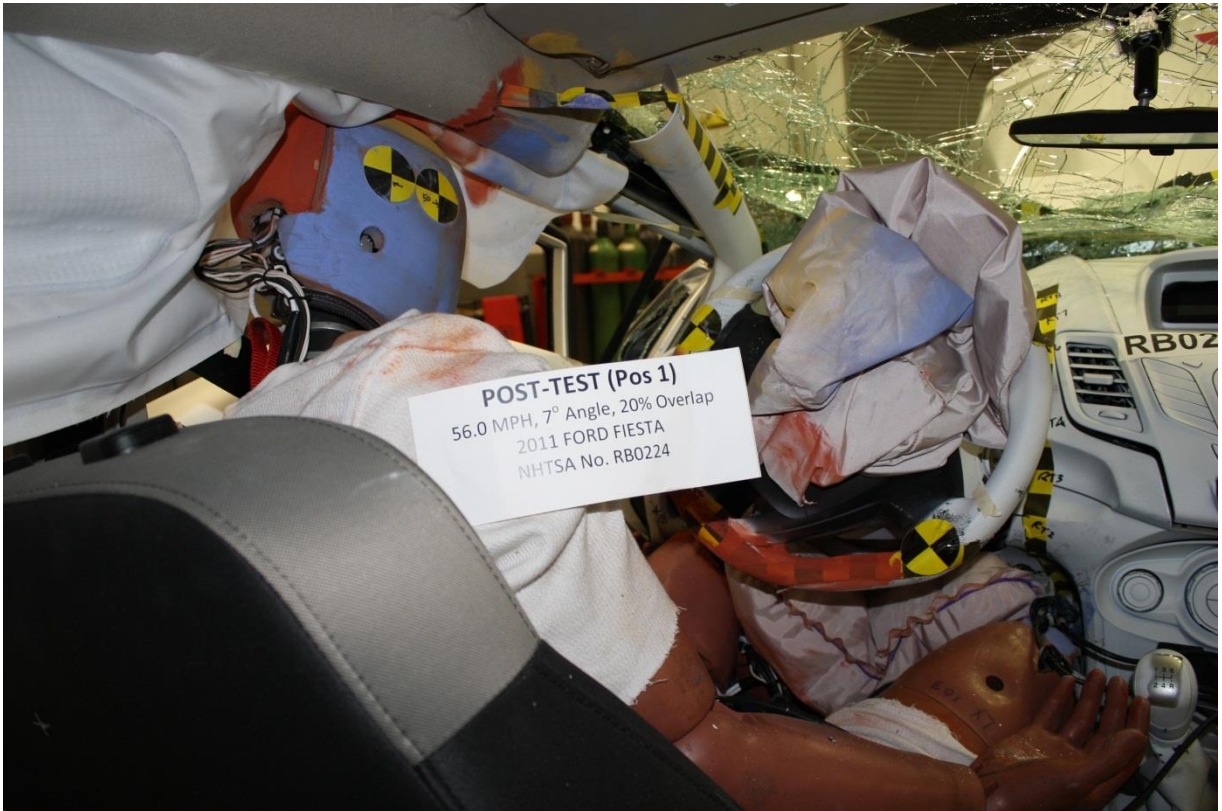
**No. 081 Post-Test View of Driver Dummy Head Contact with Airbag**

**No. 082 Post-Test View of Driver Dummy Head Contact with Vehicle Interior (a, b, c, etc)**

- Head contacted the steering wheel airbag, curtain airbag, and the interior A-Pillar head liner door frame.
- Chest contacted the airbag
- Both the left and right knees contacted the knee bolster airbag.

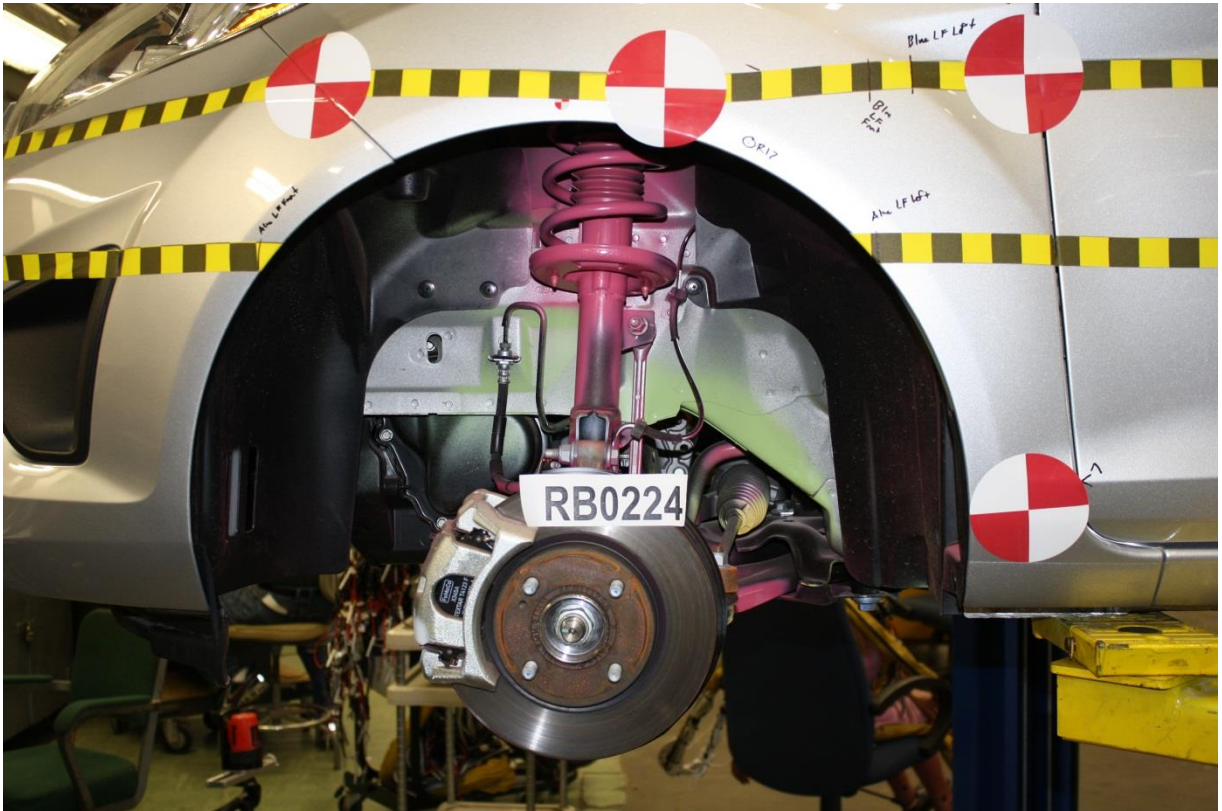
**No. 117 Pre-Test Frame Rail with tire removed**

**No. 118 Post-Test Frame Rail with tire removed**

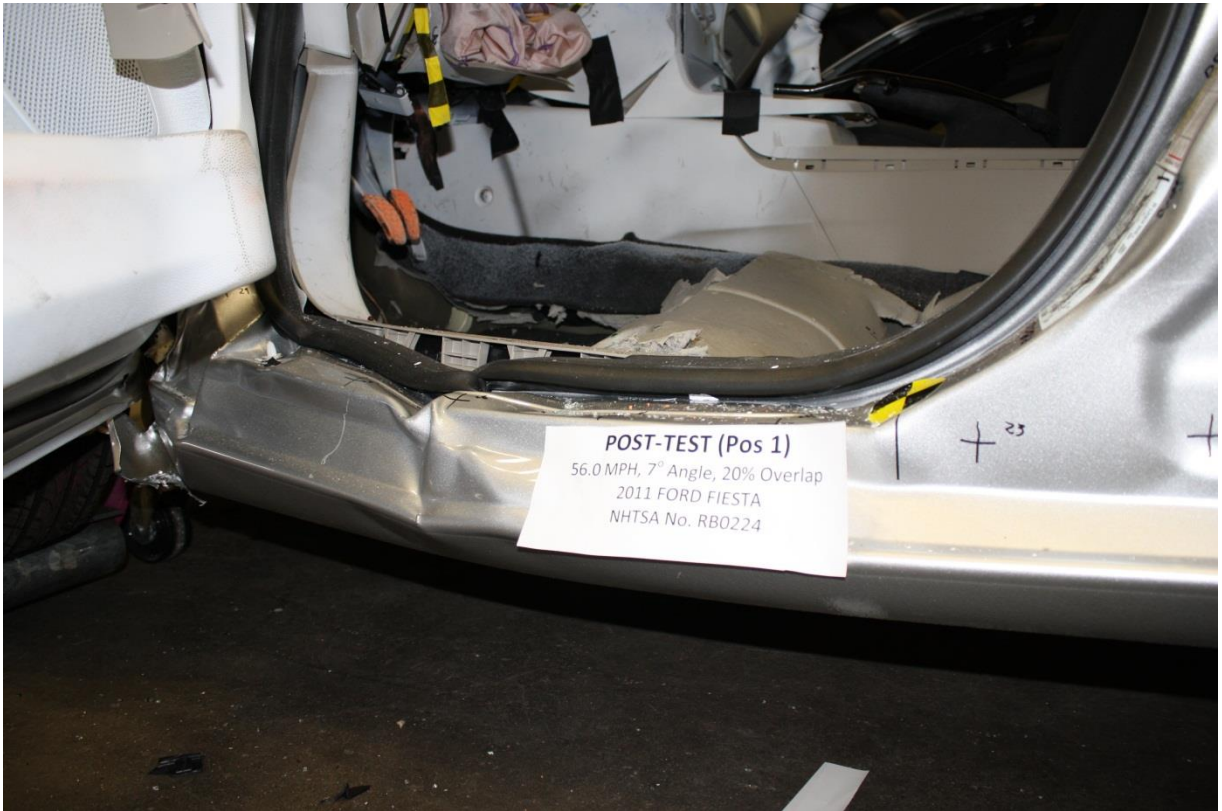
No. 121 Post-Test View of Door Sill with door open

No. 122 Post-Test View of Deformation of A pillar

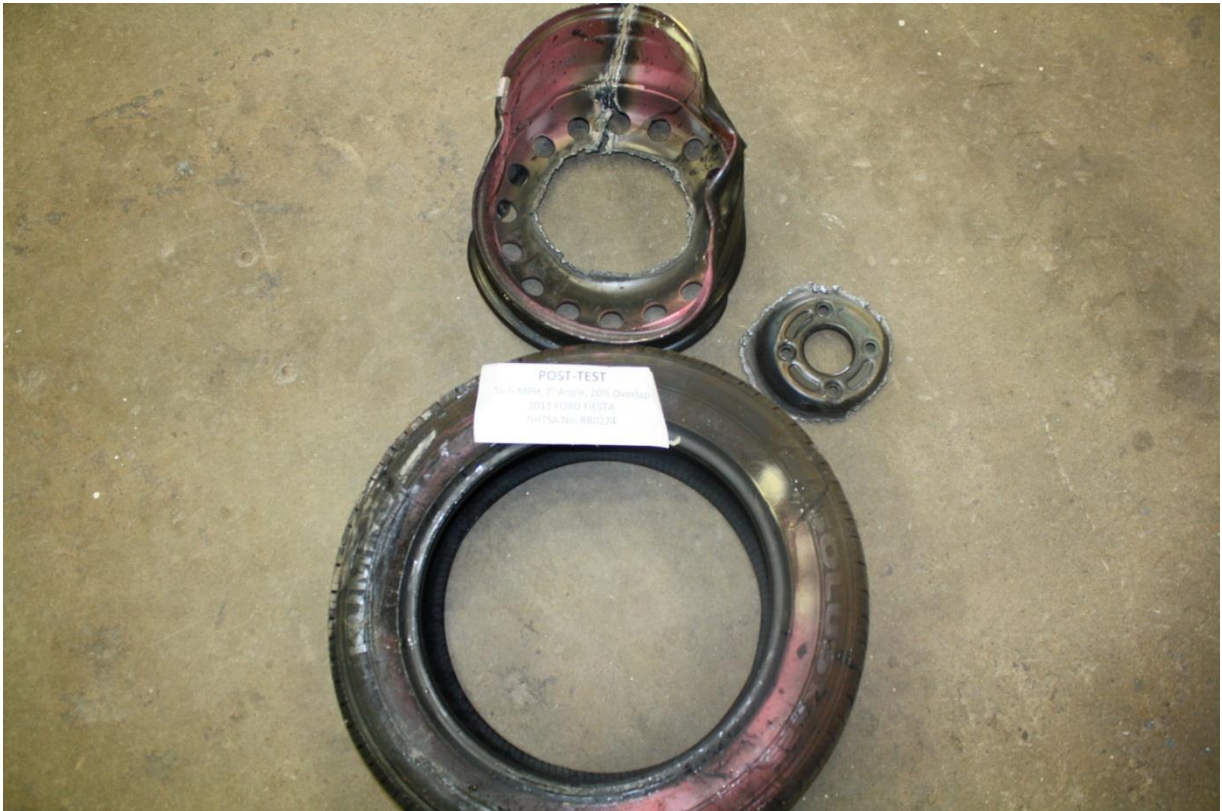
**No. 125 Post-Test View of Wheel and or Tire Deformation**

**No. 126 Post-Test View of Deformation of Rocker or Post**

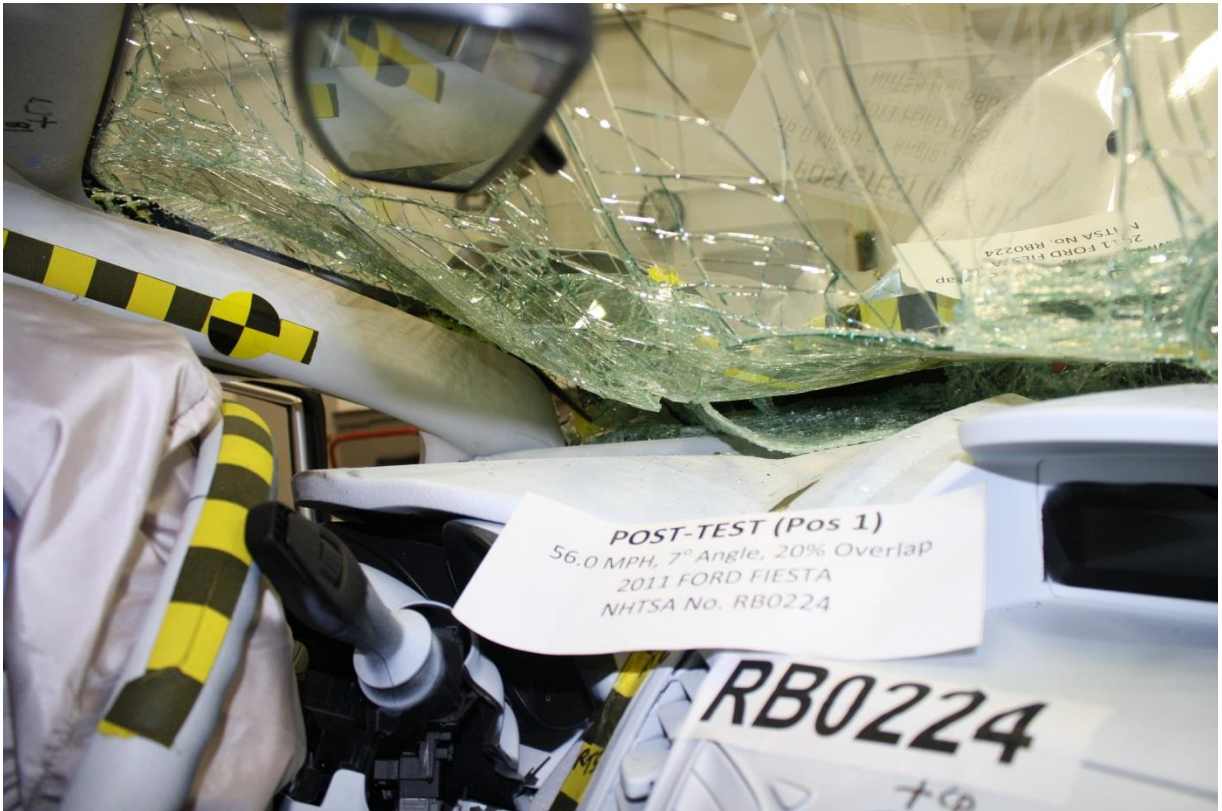
No. 127 Post-Test View of Windshield Separation
