**REPORT NUMBER: R&D – CAL – 11 - 013**

**MOVING BARRIER TO VEHICLE CRASH TEST IN SUPPORT OF NHTSA'S FRONTAL  
OBLIQUE OFFSET PROGRAM  
RESEARCH MOVING BARRIER INTO LEFT FRONT OF A**

**2011 SMART FOR TWO  
56 MPH, 15 DEGREE ANGLE, 35% OVERLAP**

**TEST DATE: AUGUST 29<sup>th</sup> 2011  
NHTSA NO: RB0526**

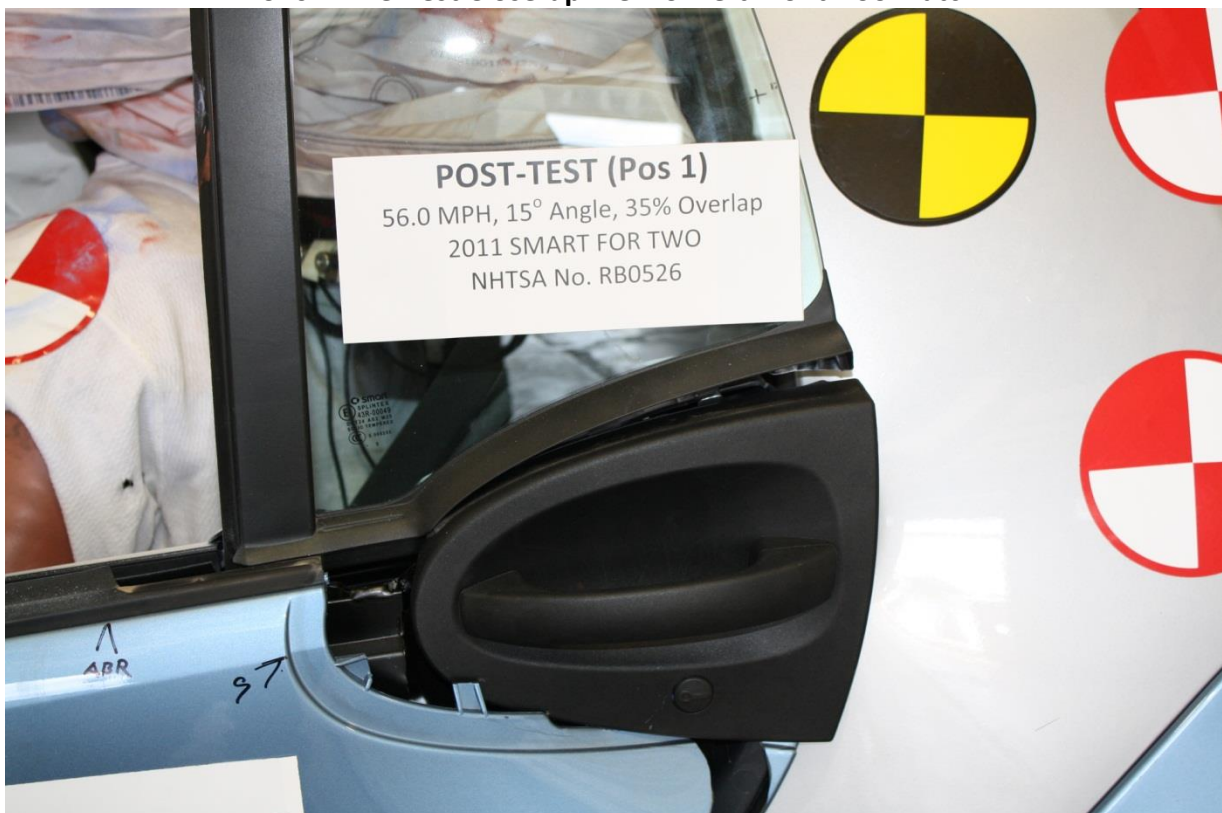
**No. 025 Post-Test Close-up View of Left Front Door Latch**

Both vehicle doors remained closed and latched during the test. The left front door was jammed shut, but was able to be opened. The Right front door remained operational after the test.

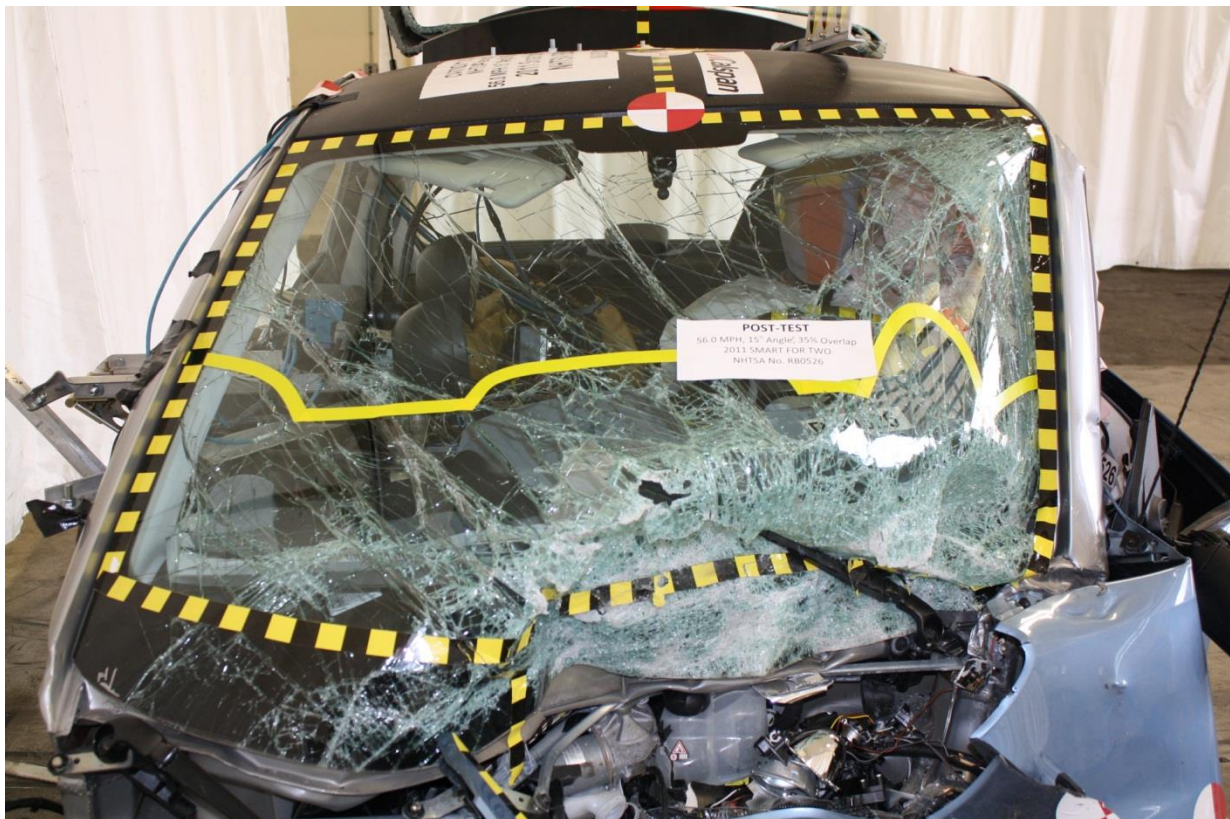
**No. 029 Post-Test Windshield View**

| Critical Areas of Performance | Observations and Conclusions | Picture Ref |
|---|---|---|
| Windshield Damage | Tears in the center of the windshield with separation at the lower left corner | A-21 |

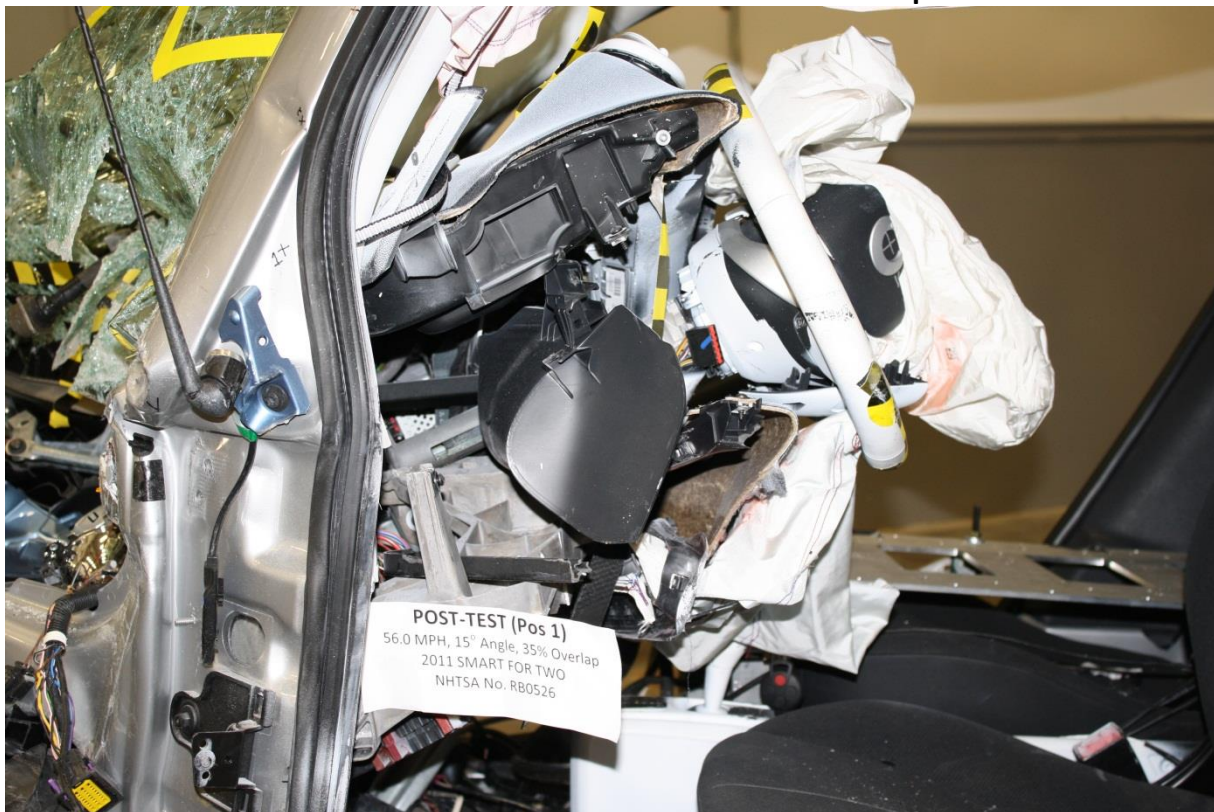
**No. 045 Post-Test Left Side View of Driver Knee Bolsters with panel removed**

| | Driver (P1) | Picture Ref. | Passenger (P4) | Picture Ref. |
|---|---|---|---|---|
| Lower Torso Contact | Driver's Side Door | A-46<br>A-47 | | |

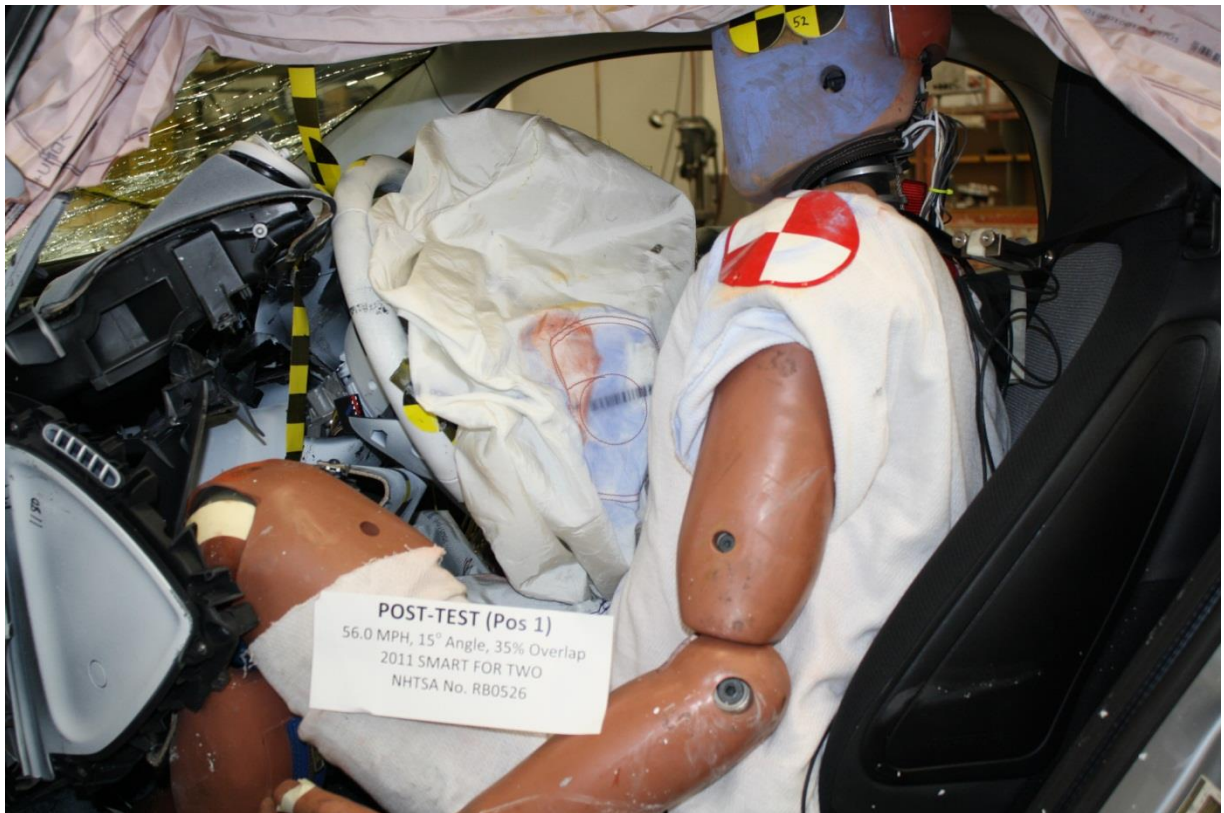
**No. 081 Post-Test View of Driver Dummy Head Contact with Airbag**

- The head contacted the steering wheel airbag and the bottom of the driver's side window frame.
- The torso contacted the front airbag, bottom of the steering wheel, and the door.
- The knees contacted the knee airbag.
