**REPORT NUMBER: R&D – CAL – 11 – 019**

**MOVING BARRIER TO VEHICLE CRASH TEST IN SUPPORT OF NHTSA'S FRONTAL  
OBLIQUE OFFSET PROGRAM  
RESEARCH MOVING BARRIER INTO LEFT FRONT OF A**

**2011 DODGE RAM 1500  
56 MPH, 7 DEGREE ANGLE, 20% OVERLAP**

**TEST DATE: SEPTEMBER 14<sup>th</sup> 2011  
NHTSA NO: RB0330**

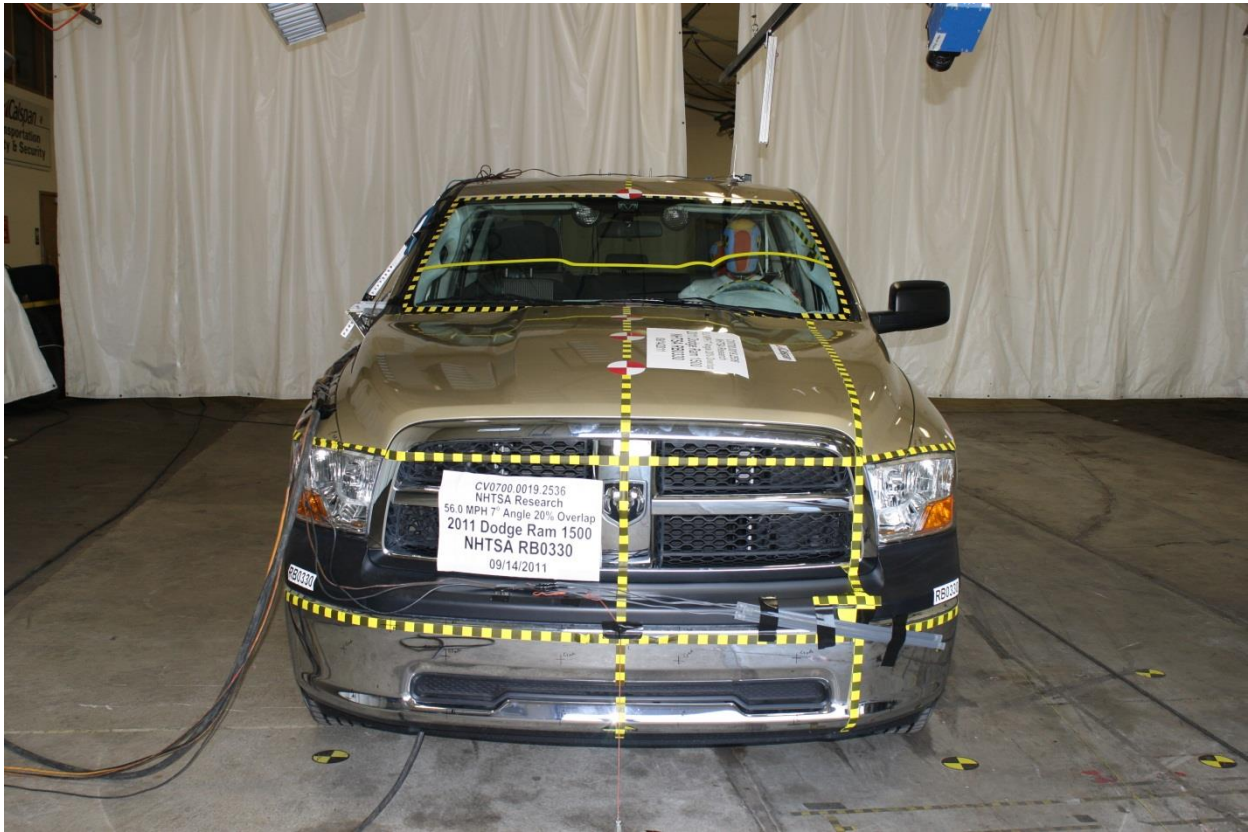
**No. 005 Pre-Test Front View of Test Vehicle**

**No. 006 Post-Test Front View of Test Vehicle**

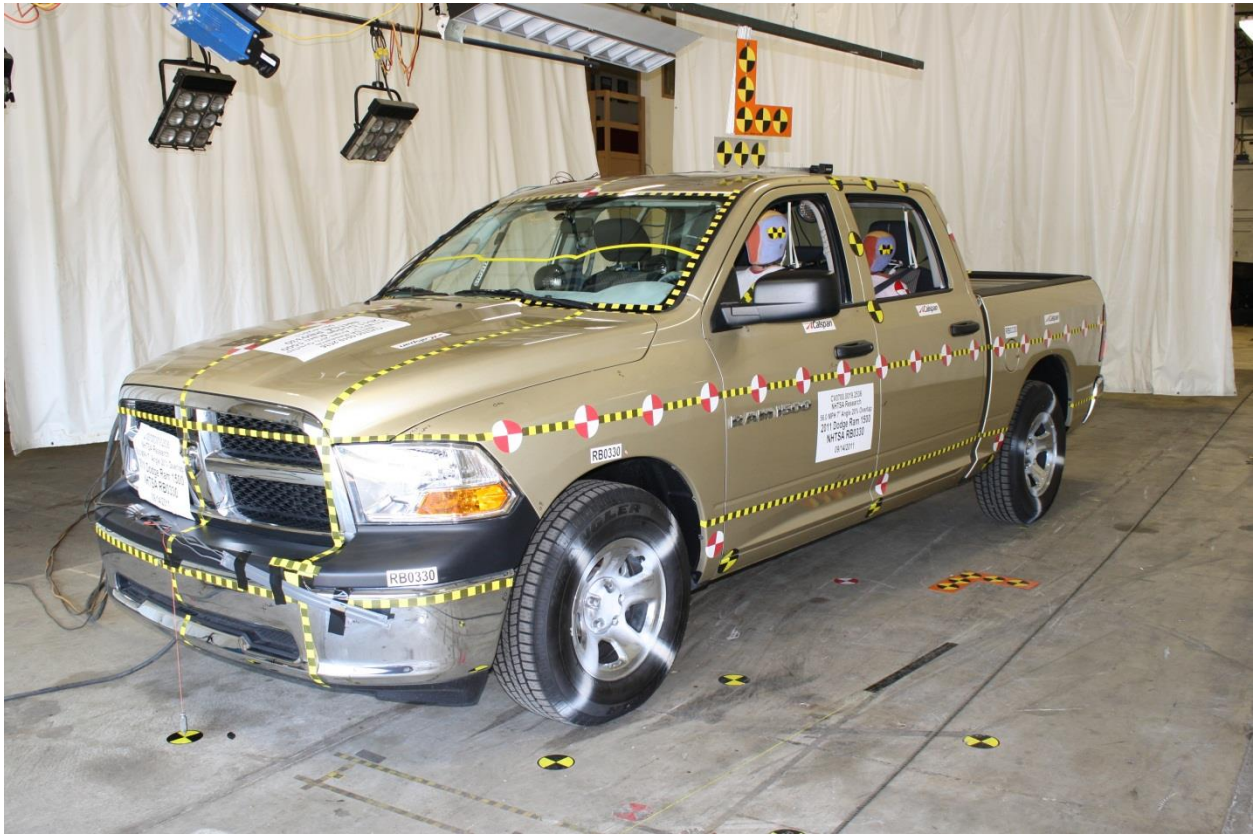
No. 007 Pre-Test Left Front 3-4 View of Test Vehicle

No. 008 Post-Test Left Front 3-4 View of Test Vehicle

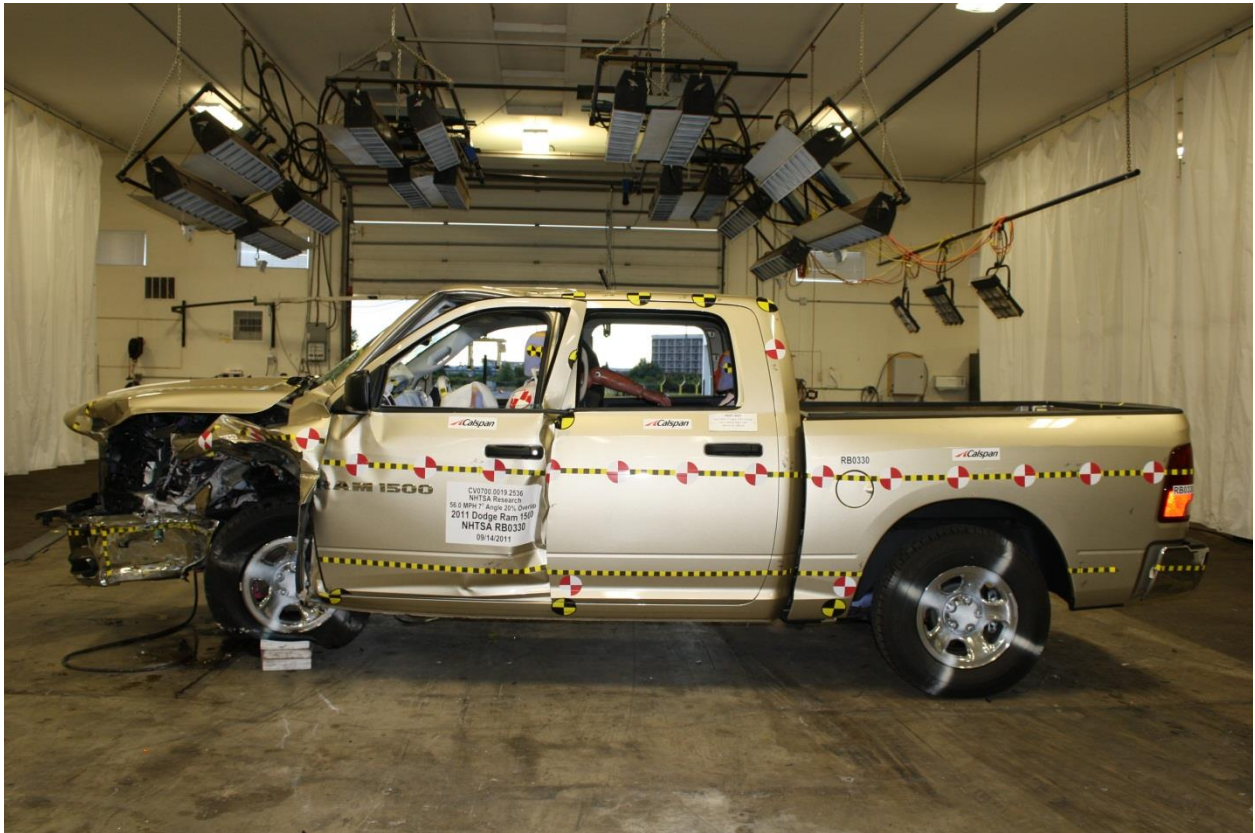
**No. 010 Post-Test Left Side View of Test Vehicle**

The A-Pillar and the door sill buckled, causing some separation at the top of the door from the vehicle.

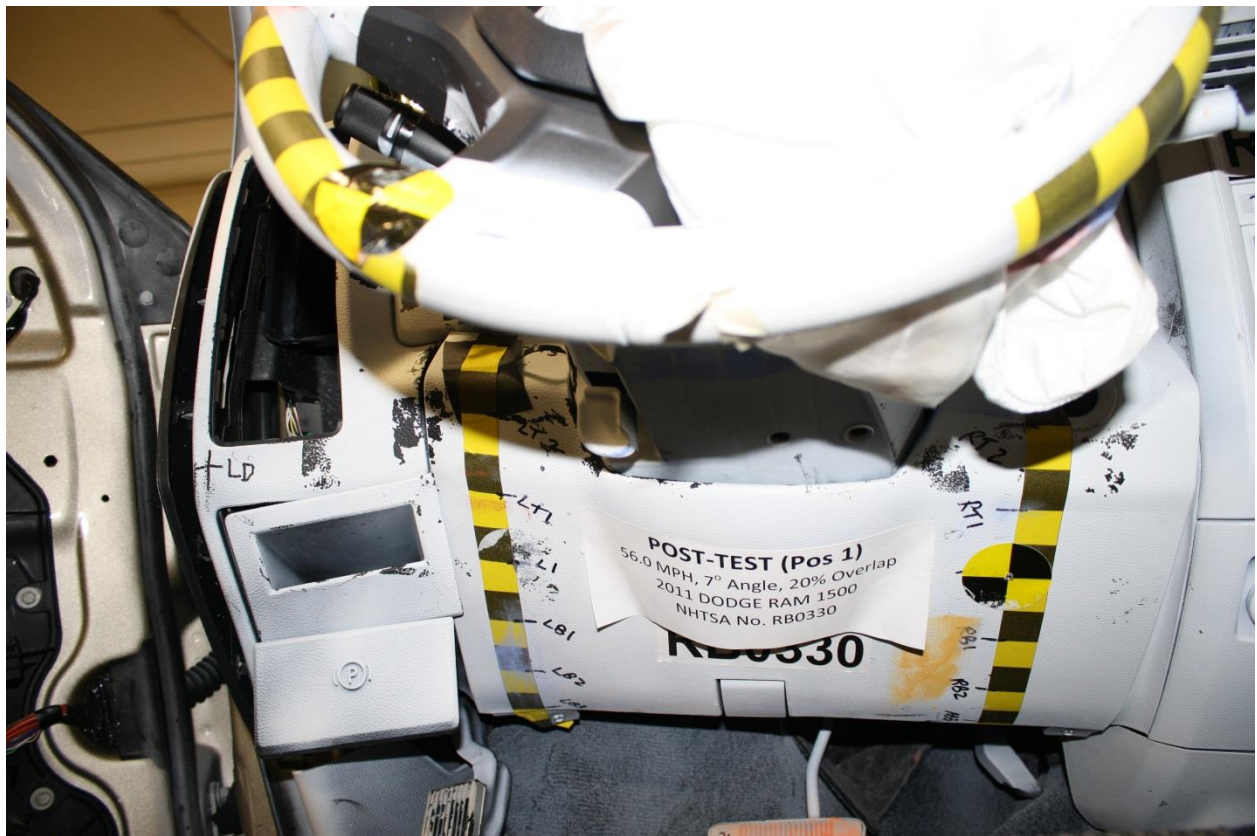
Knees contacted the knee bolsters.

No. 039 Post-Test Overall View of Driver Knee Bolsters

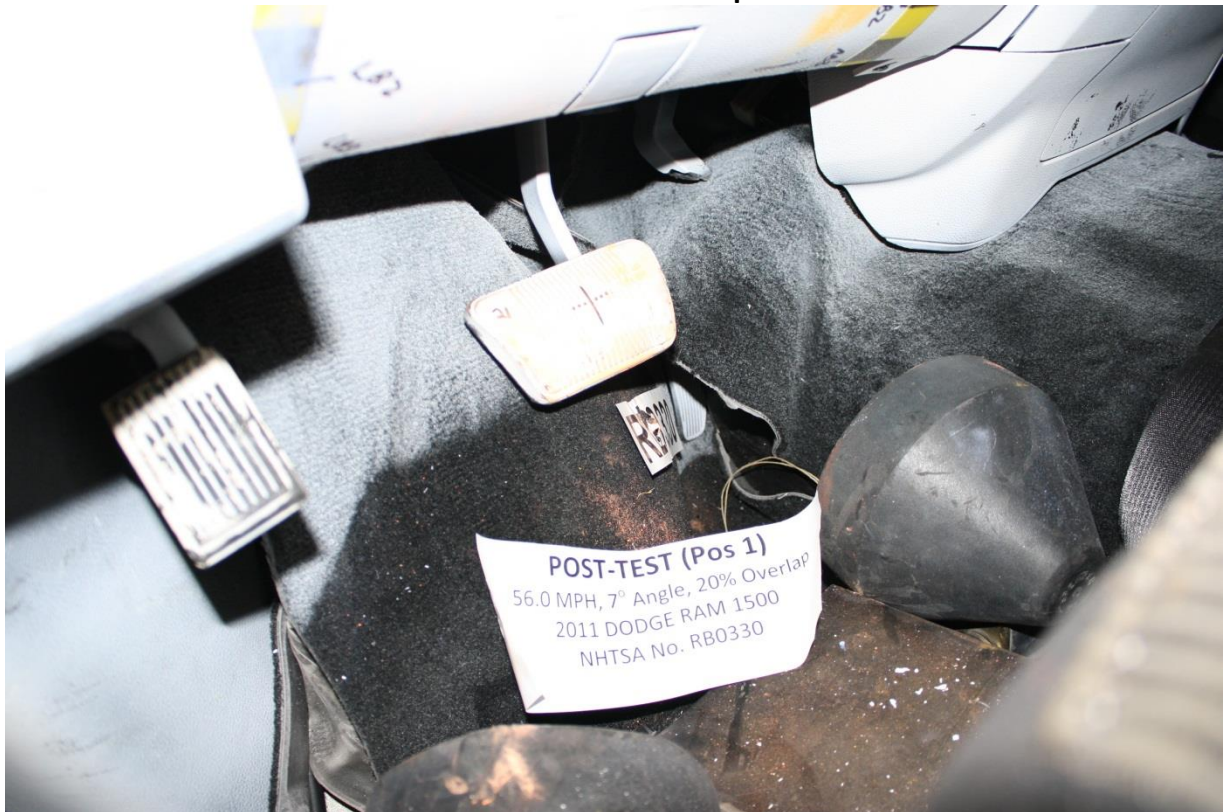
Critical Areas of Performance	Observations and Conclusions	Picture Ref
Windshield Damage	Separation at the front left corner	A-21
Window Damage	None - Windows were open	A-36 / A-51
Other Notable Effects	Left front tire drove into the drivers floor pan	-

No. 051 Post-Test View of Driver Floor pan at Left sill level

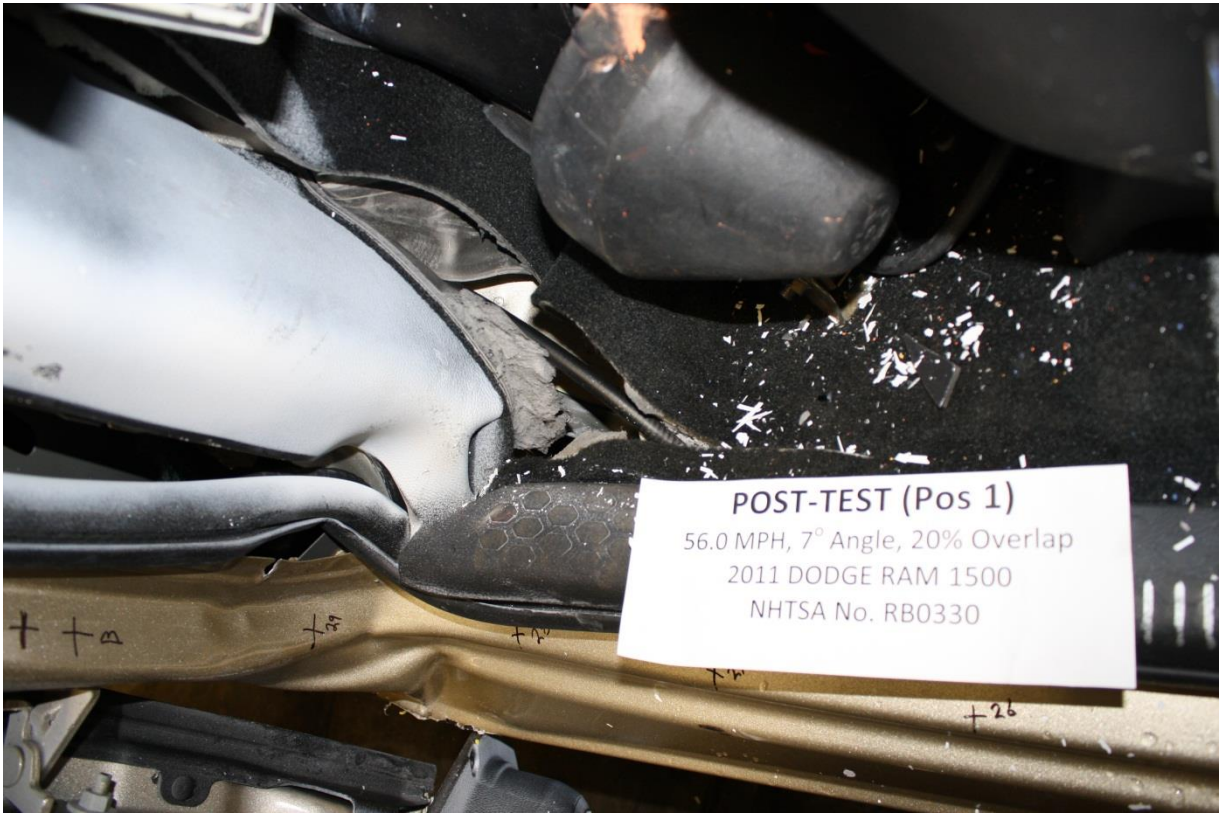
**No. 121 Post-Test View of Door Sill with door open**

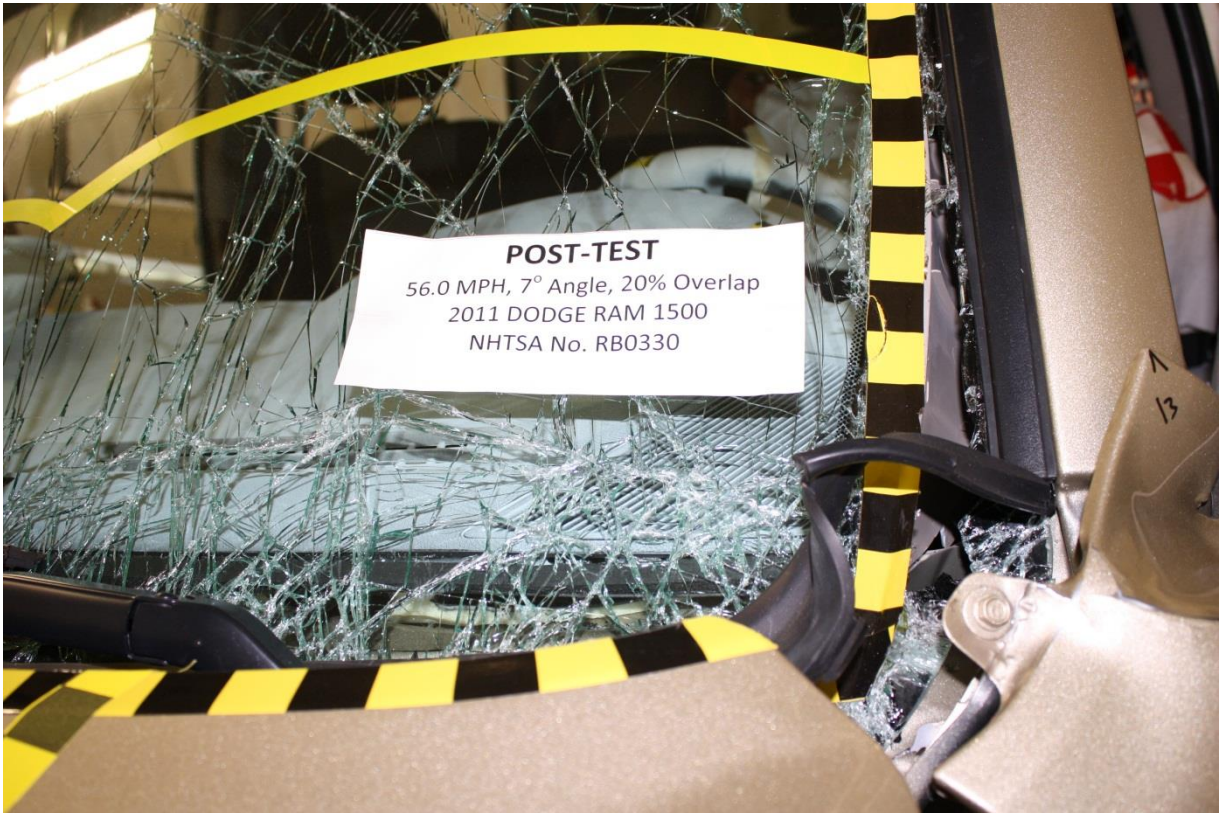
**No. 127 Post-Test View of Windshield Separation**
