**REPORT NUMBER: R&D – CAL-11-018**

**MOVING BARRIER TO VEHICLE CRASH TEST IN SUPPORT OF NHTSA'S  
FRONTAL OBLIQUE OFFSET PROGRAM  
RESEARCH MOVING DEFORMABLE BARRIER INTO LEFT FRONT OF A**

**2011 BUICK LACROSSE  
56 MPH, 7 DEGREE ANGLE, 20% OVERLAP**

**TEST DATE: SEPTEMBER 23<sup>rd</sup> 2011  
NHTSA NO: RB0180**

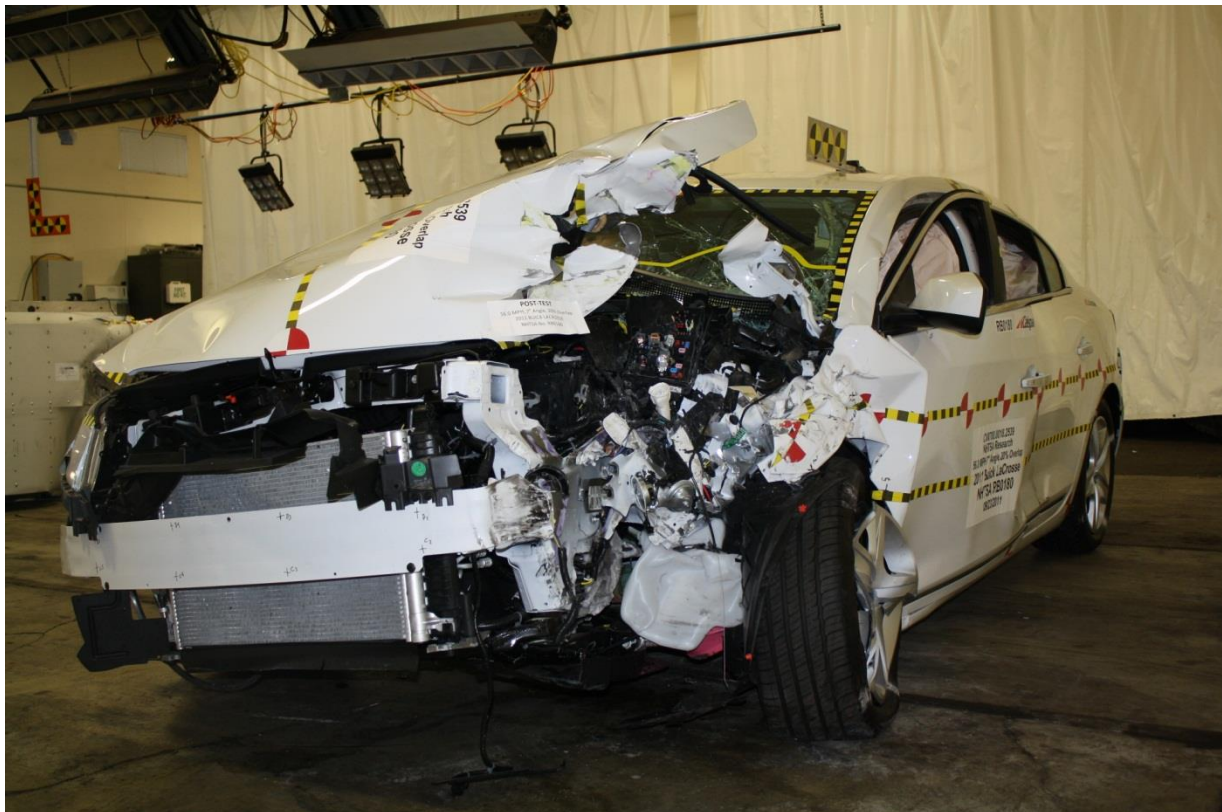
**No. 008 Post-Test Left Front 3-4 View of Test Vehicle**

- A-Pillar and the door sill buckled, causing some separation at the top of the door from the vehicle.
- The hood also opened as a result of the crash.

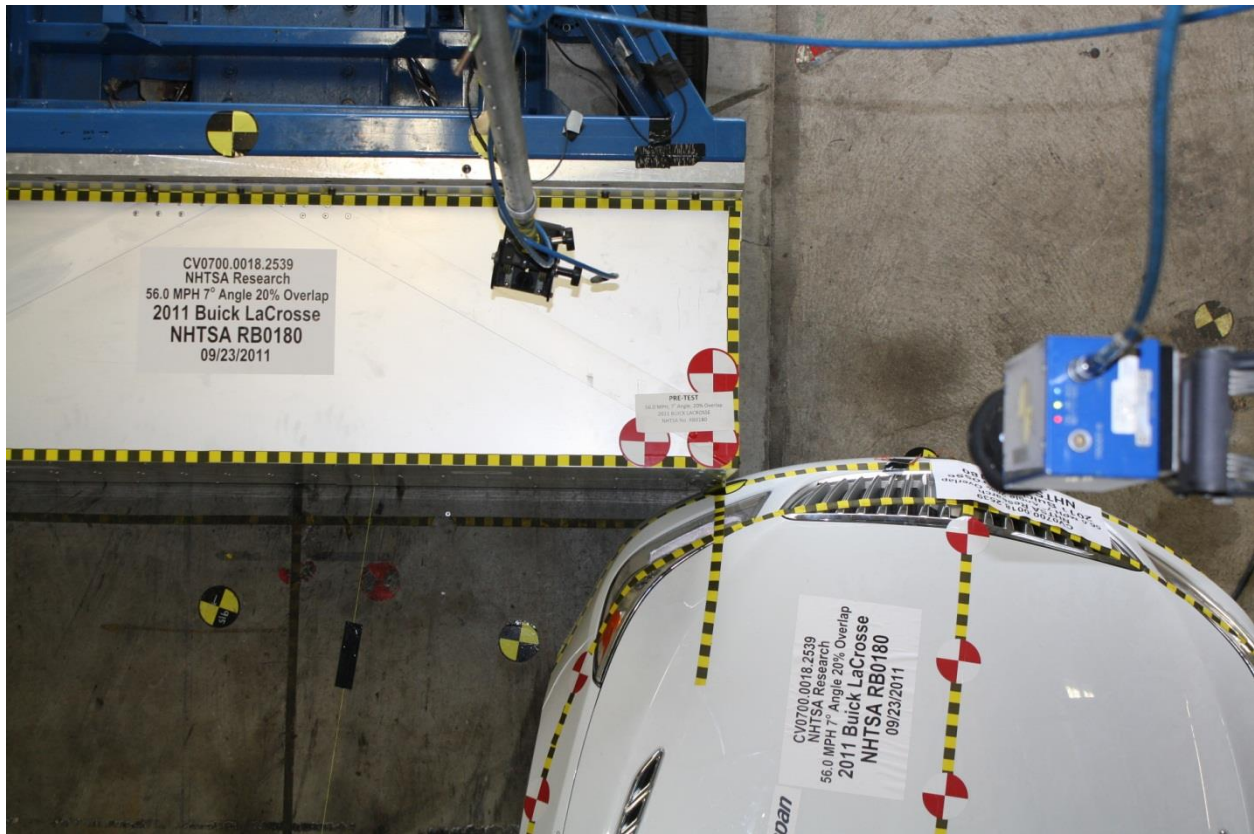
**No. 019 Pre-Test Overhead View of RMDB against target vehicle at ideal Impact Point**

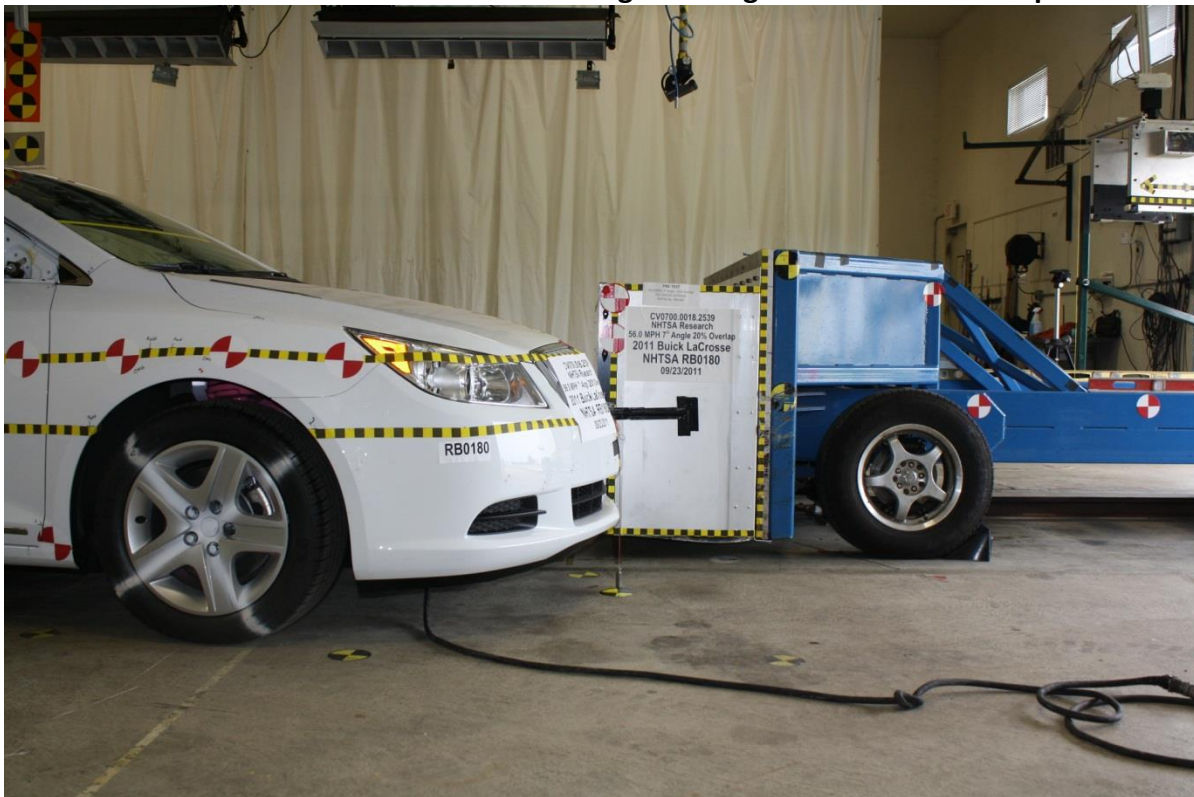
**No. 020 Pre-Test Left Side View of RMDB against target vehicle at ideal Impact Point**

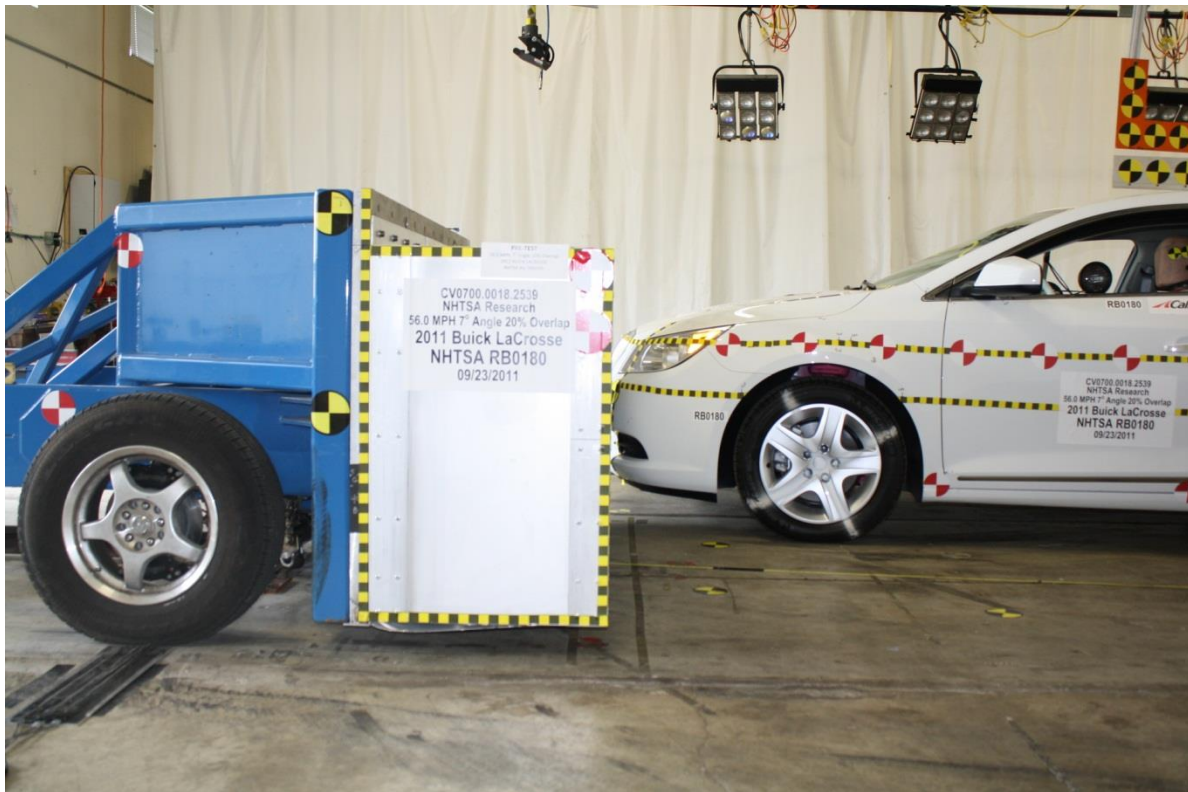
**No. 021 Pre-Test Right Side View of RMDB against target vehicle at ideal Impact Point**

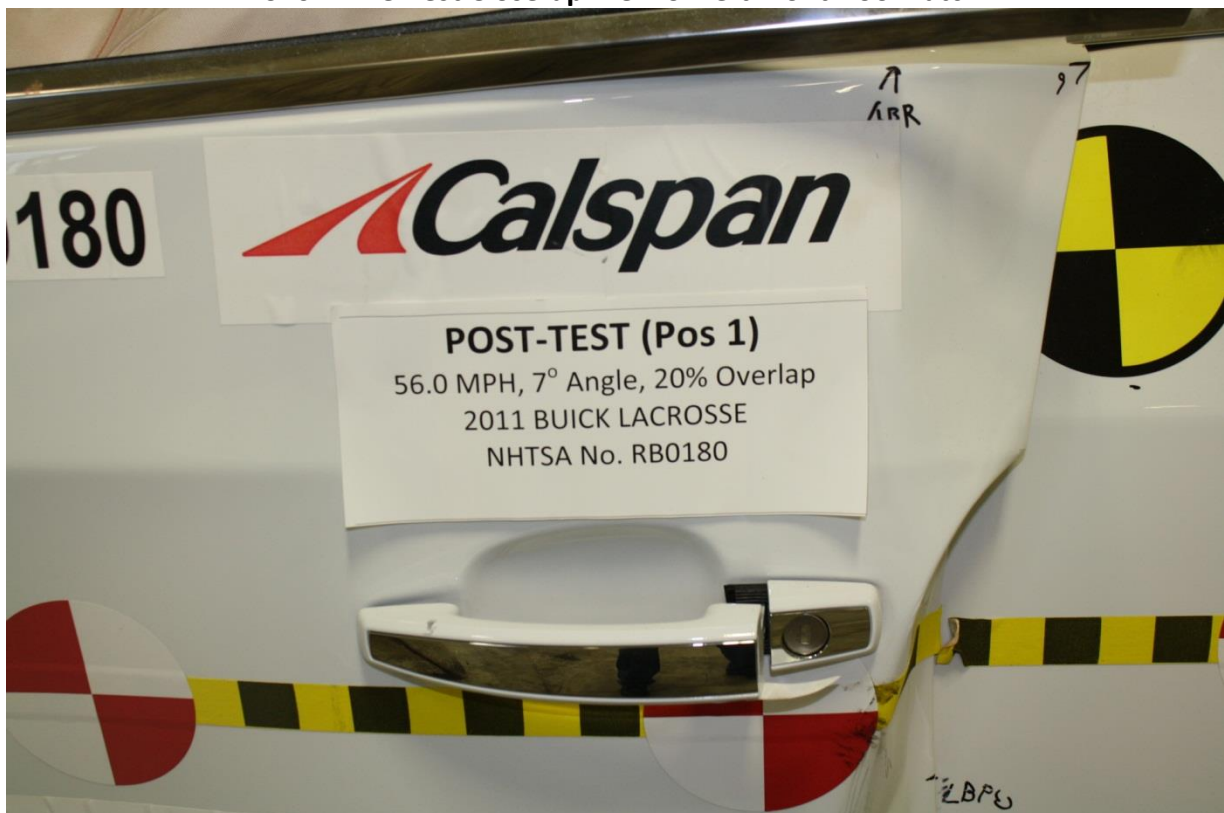
No. 025 Post-Test Close-up View of Left Front Door Latch

All four vehicle doors remained closed and latched during the test. The left front door was jammed shut, but was able to be opened. The left rear, right front, and right rear doors all remained operational after the test.

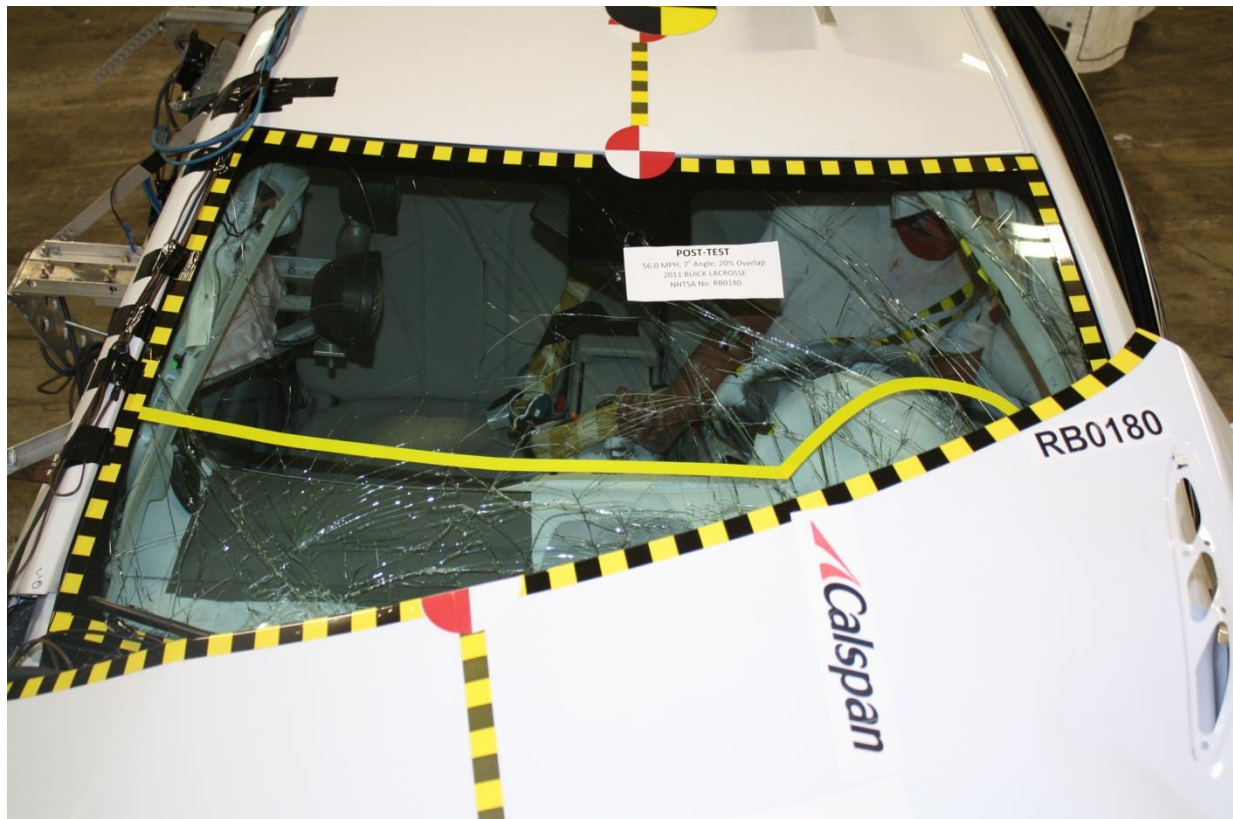
**No. 029 Post-Test Windshield View**

| Critical Areas of Performance | Observations and Conclusions | Picture Ref |
|---|---|---|
| Windshield Damage | Cracks along the bottom and Driver's side A-Pillar | A-21 |

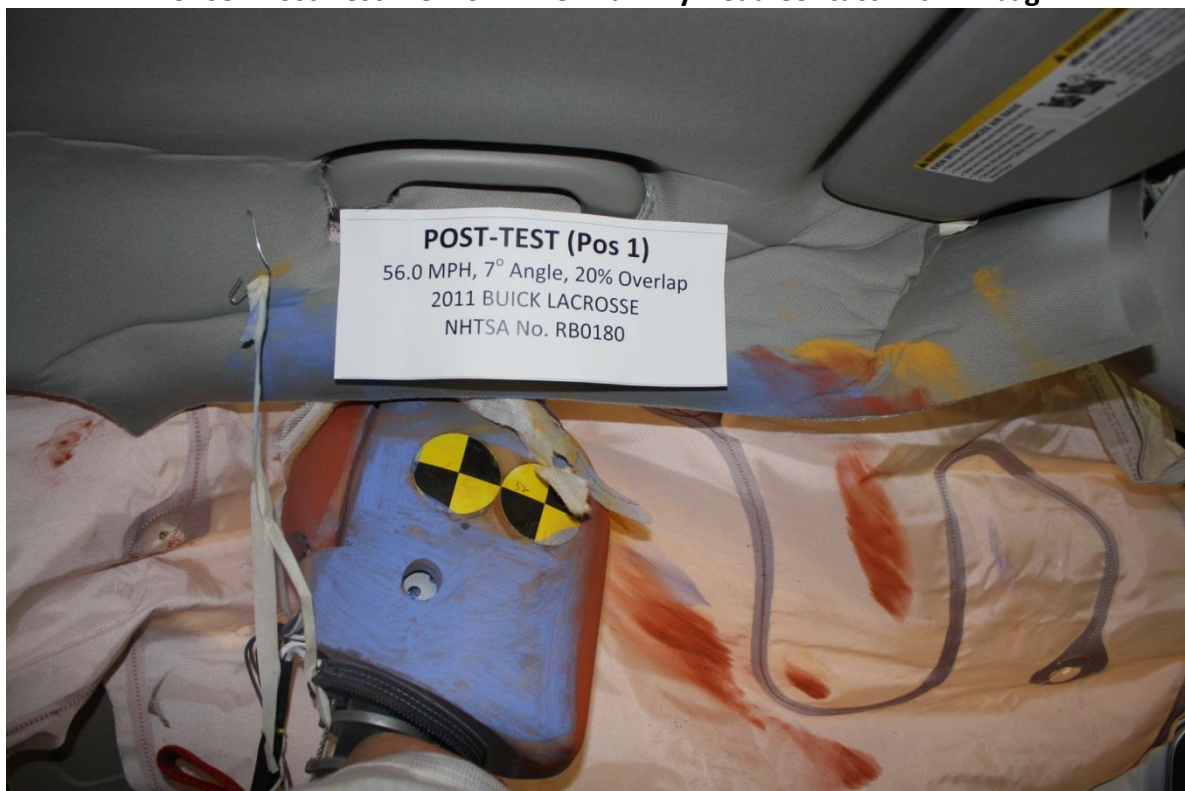
**No. 082 Post-Test View of Driver Dummy Head Contact with Vehicle Interior (a, b, c, etc)**

| HEAD | |
|---|---|
| Y / <input checked="" type="radio"/> N | Head skin shows no sign of tears or damage <ul style="list-style-type: none"> <li>Gouge left side of the forehead</li> </ul> |

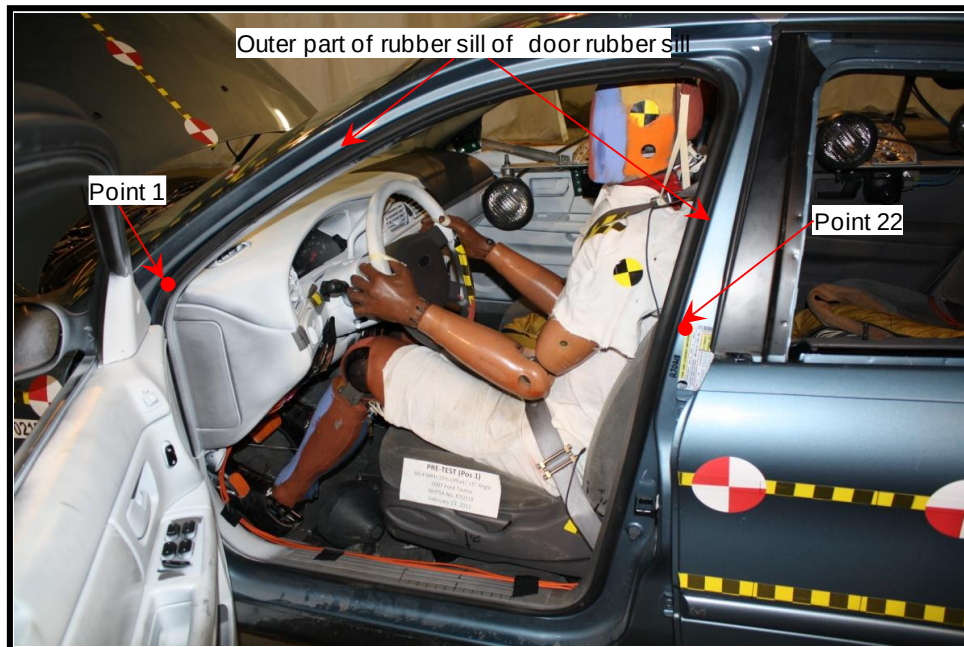
6. Measure points using CMM
7. Record in the appropriate data sheet and calculate the difference by subtracting the post-test minus the pre-test. A picture with the points labeled shall be included on the data sheet. All points shall be visible in the pictures.

8. Repeat on the passenger door.

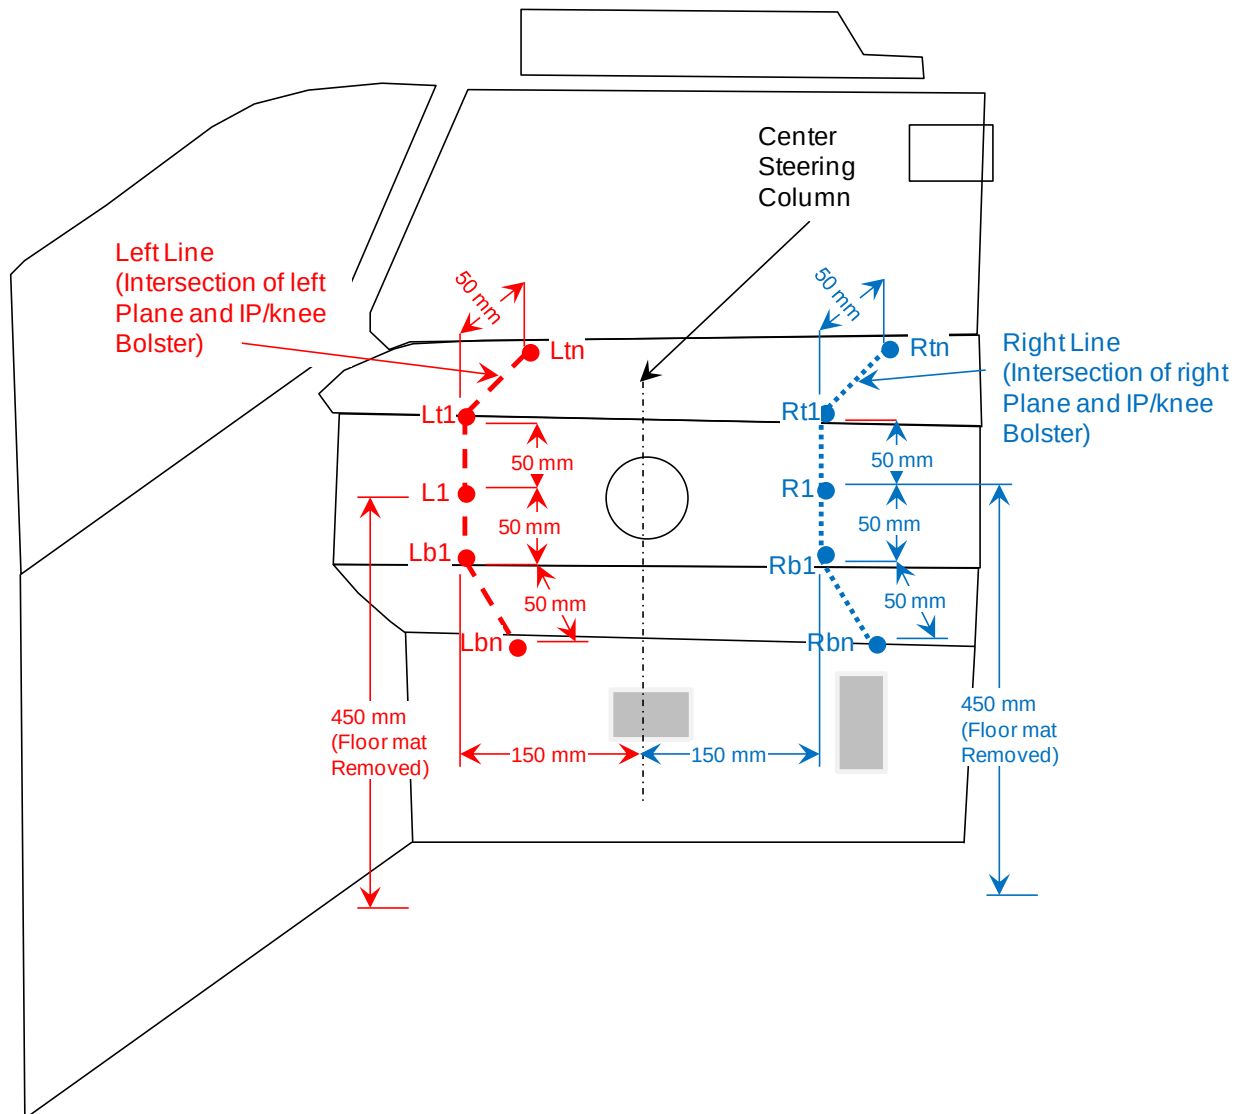
16. Rb1: From R1 move down the Right Line 50 mm
17. Rb2: From Rb1 move down the Right Line 50 mm
18. Rbn: Mark points at 50 mm increments along Right Line until the bottom of the IP/Knee Bolster is reached.

19. If dash panel or knee bolster loosens or breaks away in the crash, the post-test measurements are taken by pressing and holding the panel against the underlying structure. Record in the appropriate data sheet and calculate the difference by subtracting the post-test minus the pre-test. A picture with the points labeled shall be included on the data sheet. All points shall be visible in the picture.
