REPORT NUMBER: R&D-CAL-12-006

**MOVING BARRIER TO VEHICLE CRASH TEST IN SUPPORT OF NHTSA'S
FRONTAL OBLIQUE OFFSET PROGRAM
RESEARCH MOVING DEFORMABLE BARRIER INTO LEFT FRONT OF A**

2012 FIAT 500

56MPH, 7 DEGREE ANGLE, 20% OVERLAP

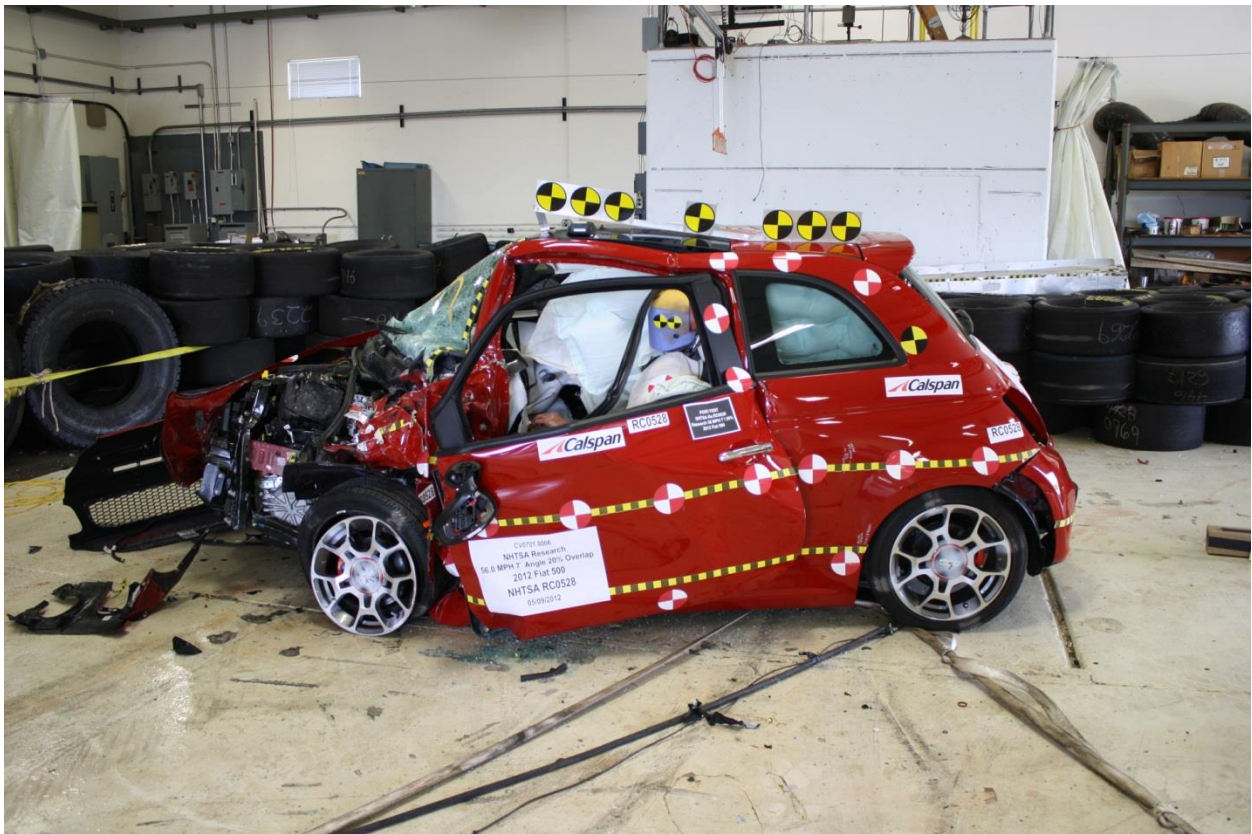
No. 010 Post-Test Left Side View of Test Vehicle

- A-pillar and B-pillar buckled causing the door to separate from its hinge
- Windshield cracked throughout with multiple points of separation along the bottom and driver's side A-pillar.
- Hood separated from the driver's side hinge causing it to open during the impact event

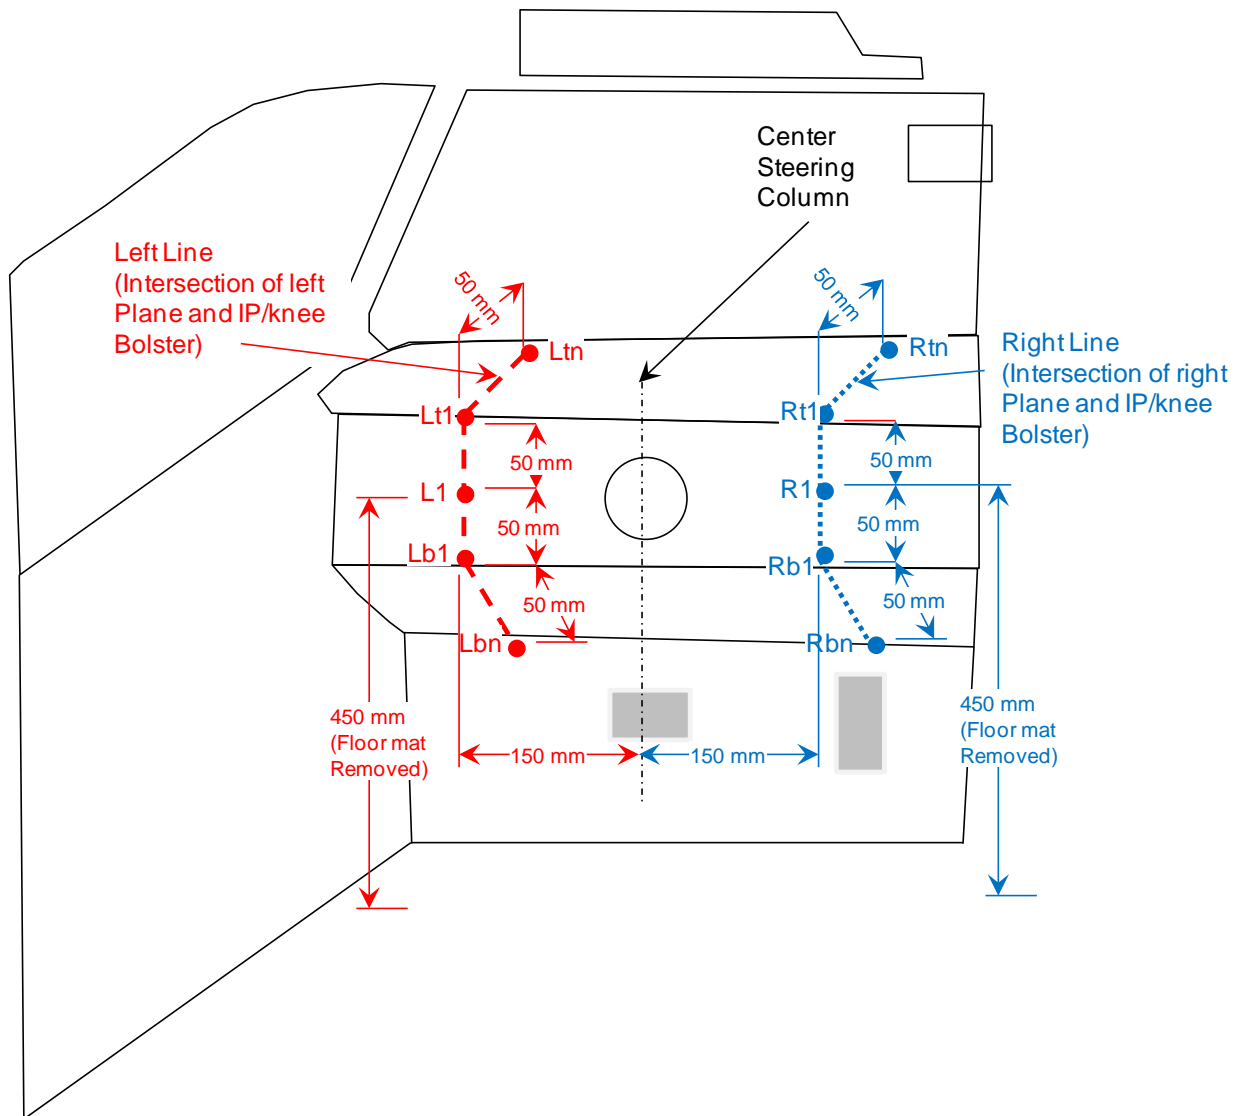
19. If dash panel or knee bolster loosens or breaks away in the crash, the post-test measurements are taken by pressing and holding the panel against the underlying structure. Record in the appropriate data sheet and calculate the difference by subtracting the post-test minus the pre-test. A picture with the points labeled shall be included on the data sheet. All points shall be visible in the picture.
