**REPORT NUMBER: SPNCAP-KAR-15-035**

**NEW CAR ASSESSMENT PROGRAM (NCAP)  
SIDE IMPACT POLE TEST**

**FORD MOTOR CO.  
2015 FORD EDGE SEL FWD 5-DOOR MPV**

**FINAL REPORT**

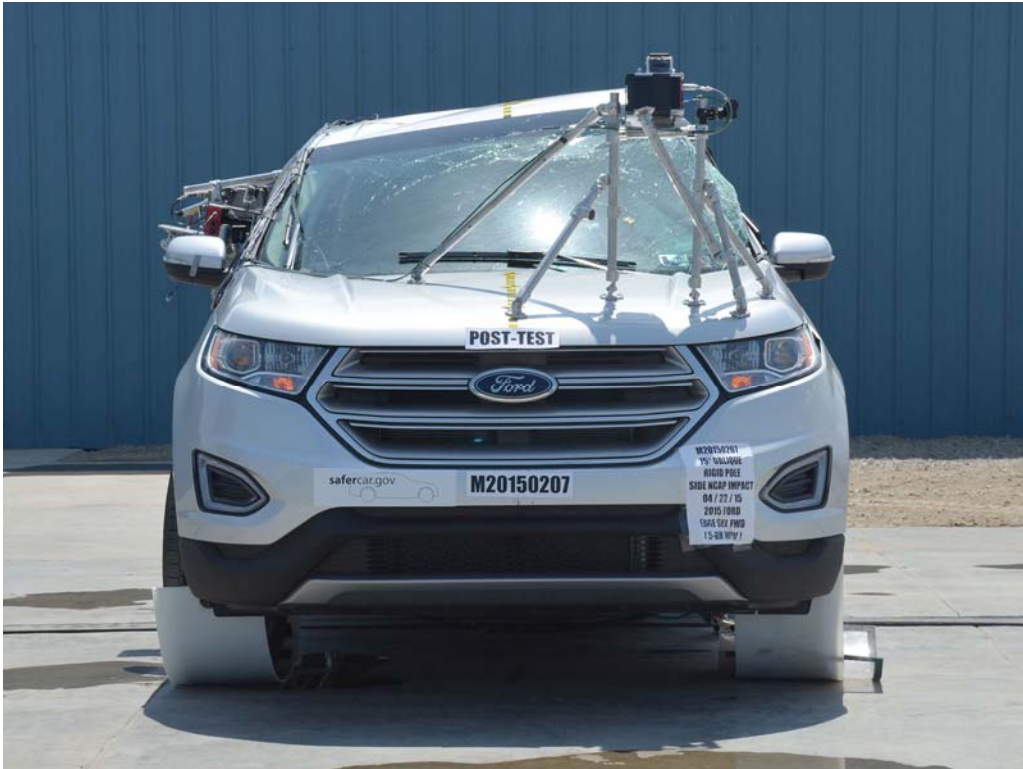
FIGURE 4. Post-Test Frontal View of Test Vehicle

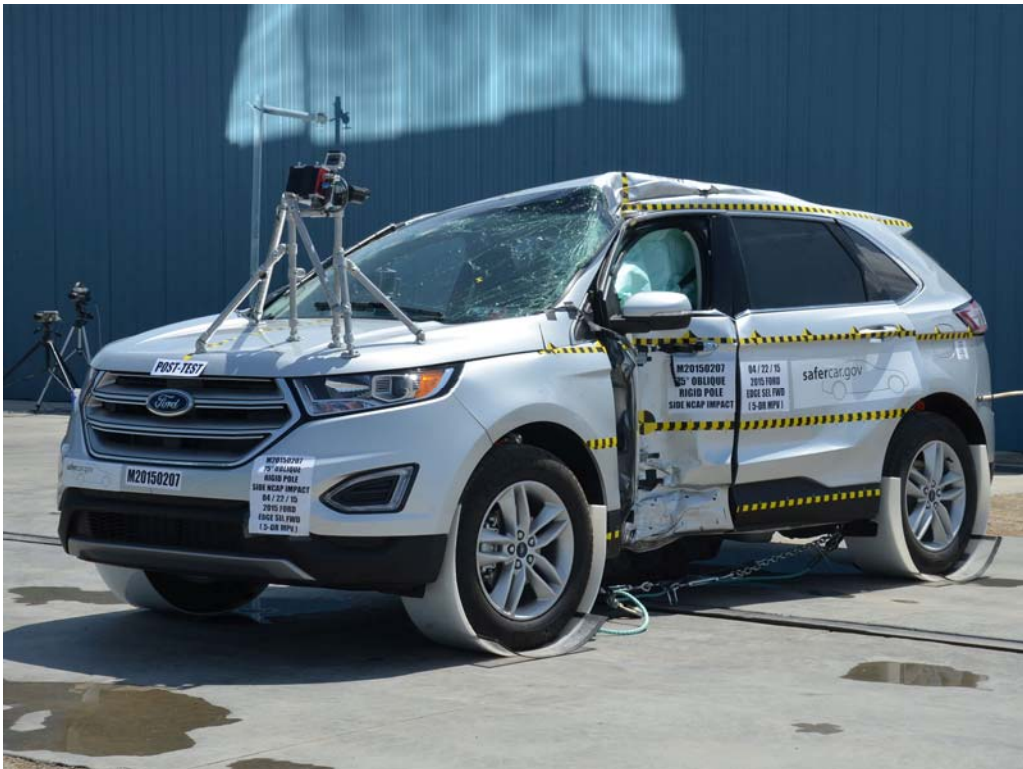
FIGURE 6. Post-Test Left Front  $\frac{3}{4}$  View of Test Vehicle

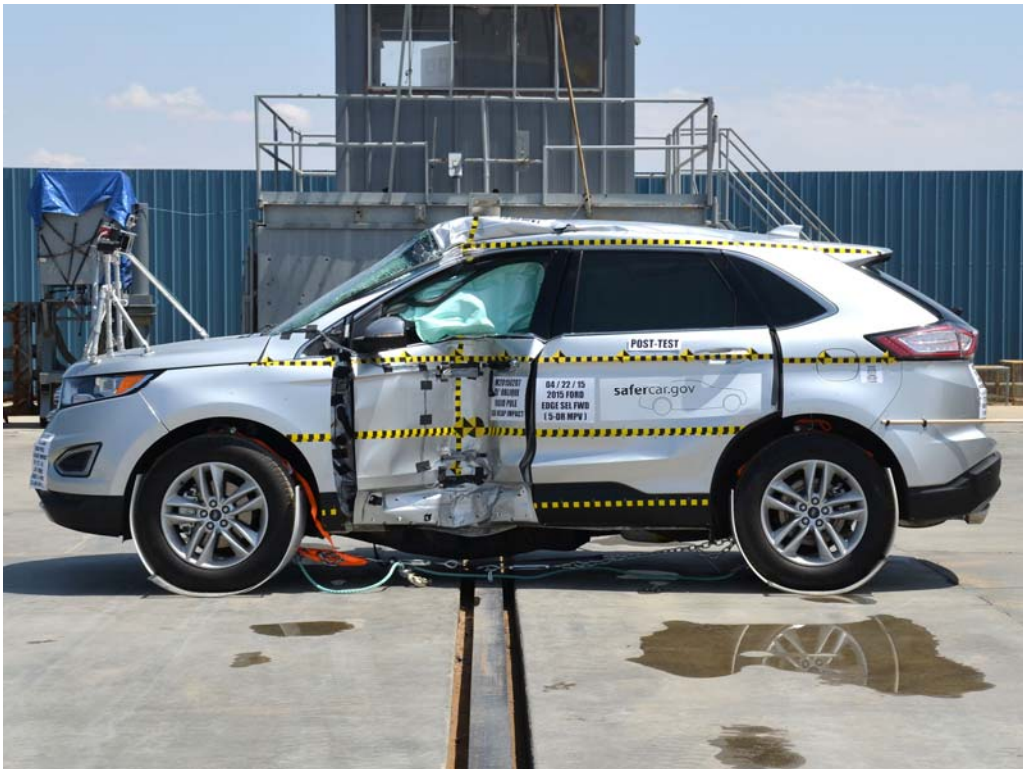
FIGURE 8. Post-Test Left Side View of Test Vehicle

Critical Areas of Performance	Observations and Conclusions
Pillar Performance	No separation occurred
Sill Separation	No separation occurred
Windshield Damage	Broken
Side Window Damage	Left front window broken
Other Notable Effects	None

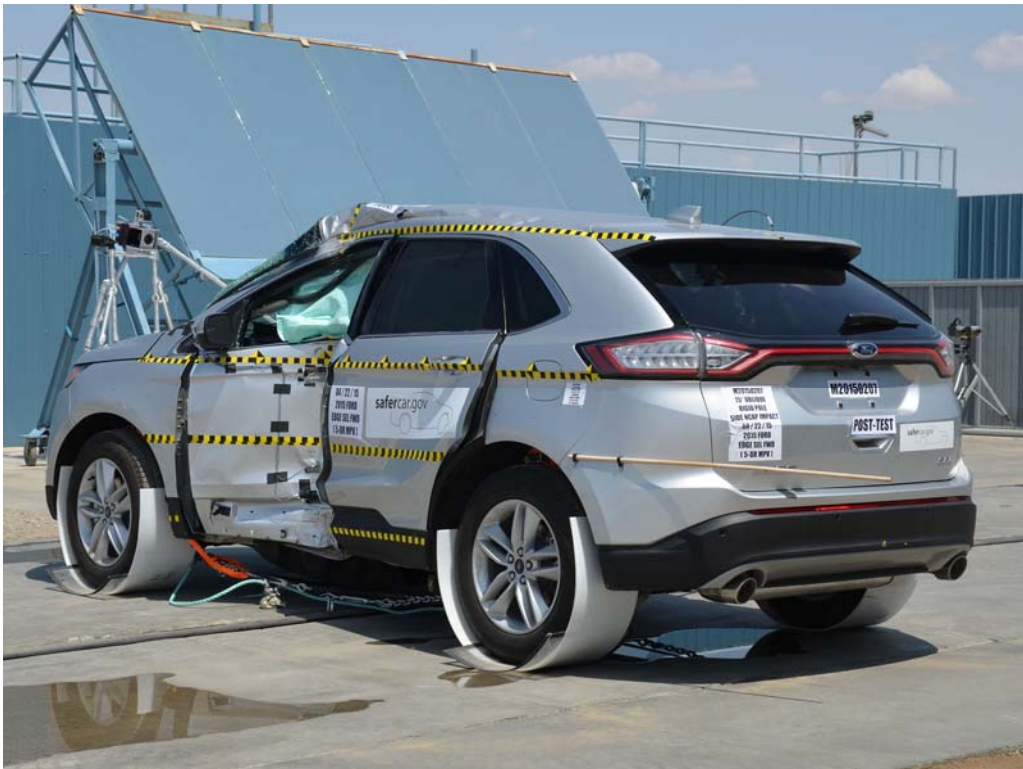
FIGURE 10. Post-Test Left Rear  $\frac{3}{4}$  View of Test Vehicle

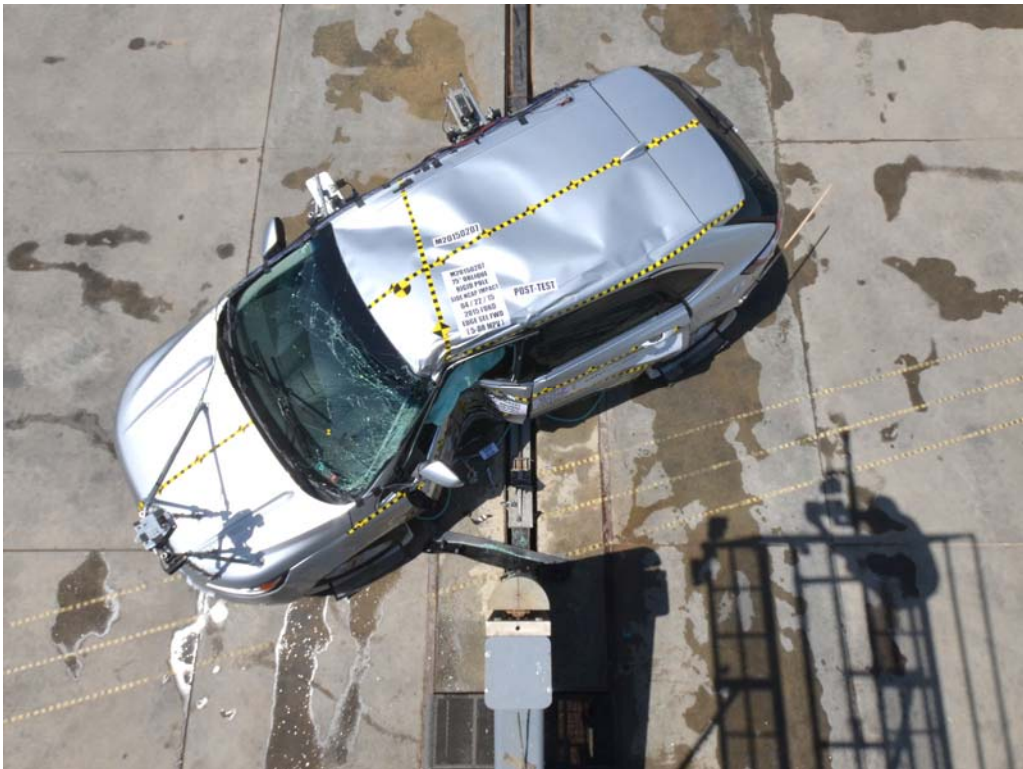
FIGURE 16. Post-Test Overhead View of Test Area

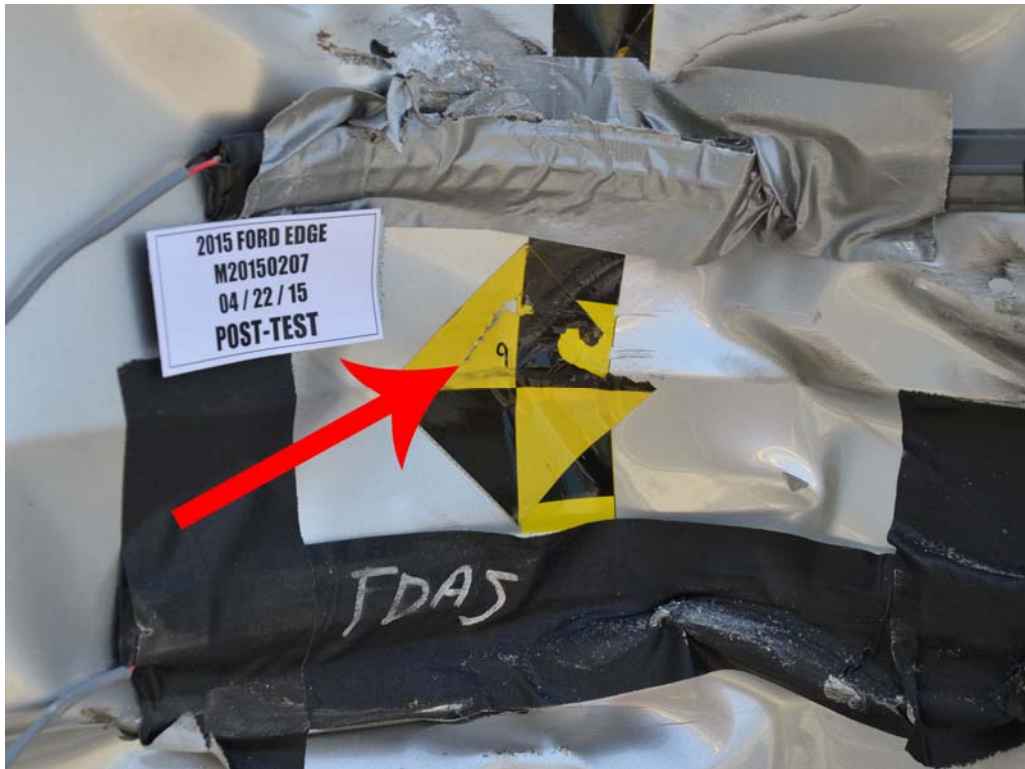
FIGURE 20. Post-Test Close-Up View of Impact Point Target  
Showing Impact Location

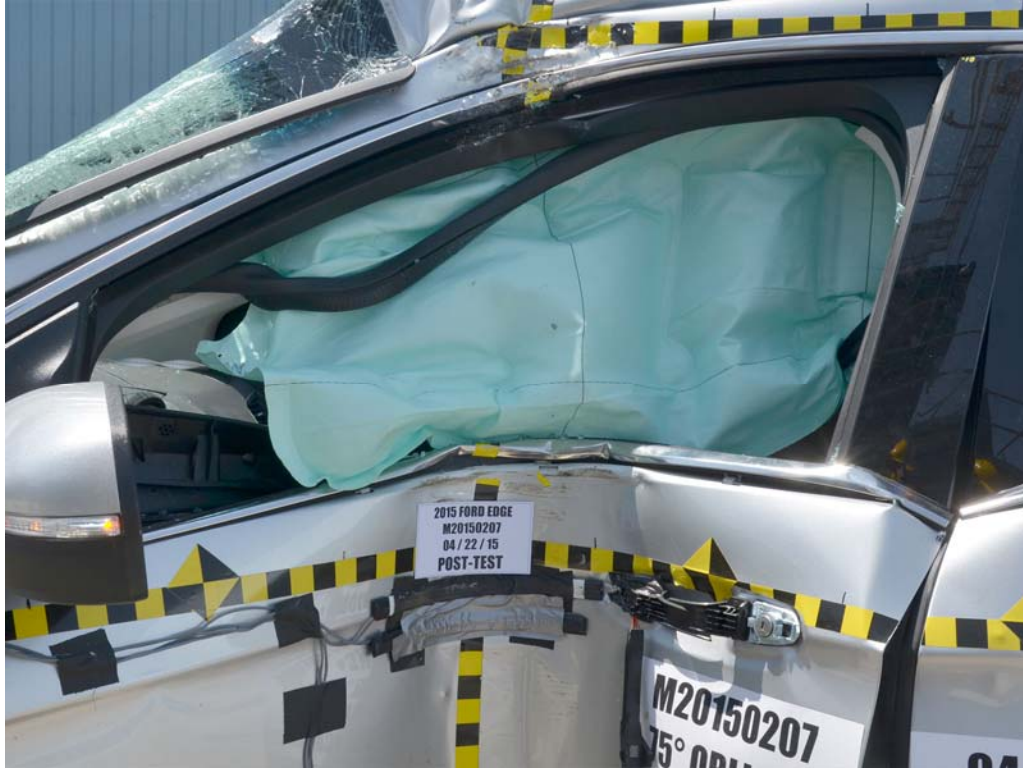
FIGURE 25. Post-Test Left Side View of Dummy Shoulder and Door Top View

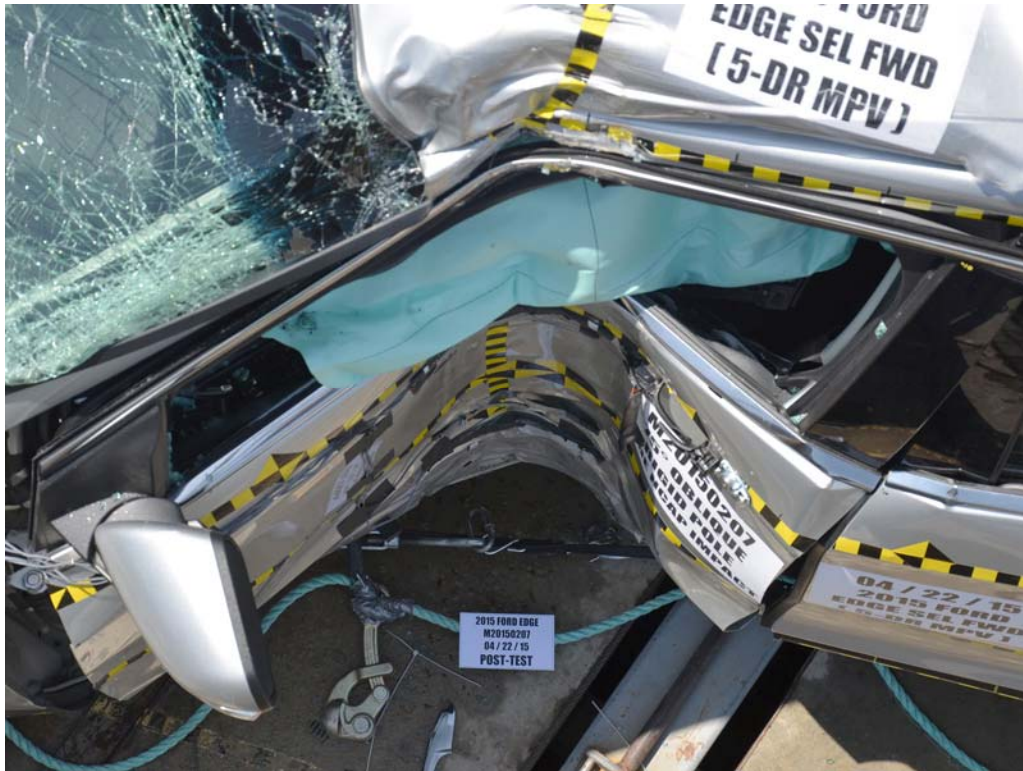
FIGURE 41. Post-Test Dummy and Door Clearance View

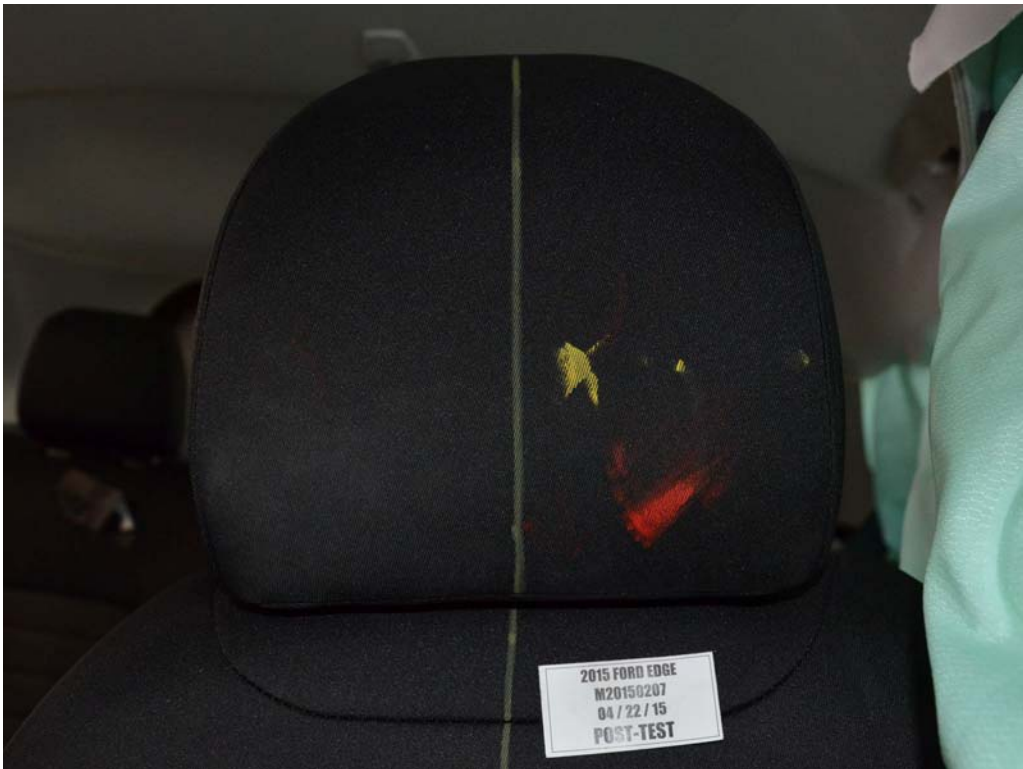
FIGURE 46. Post-Test Dummy Close-Up Head Contact with Vehicle Interior View

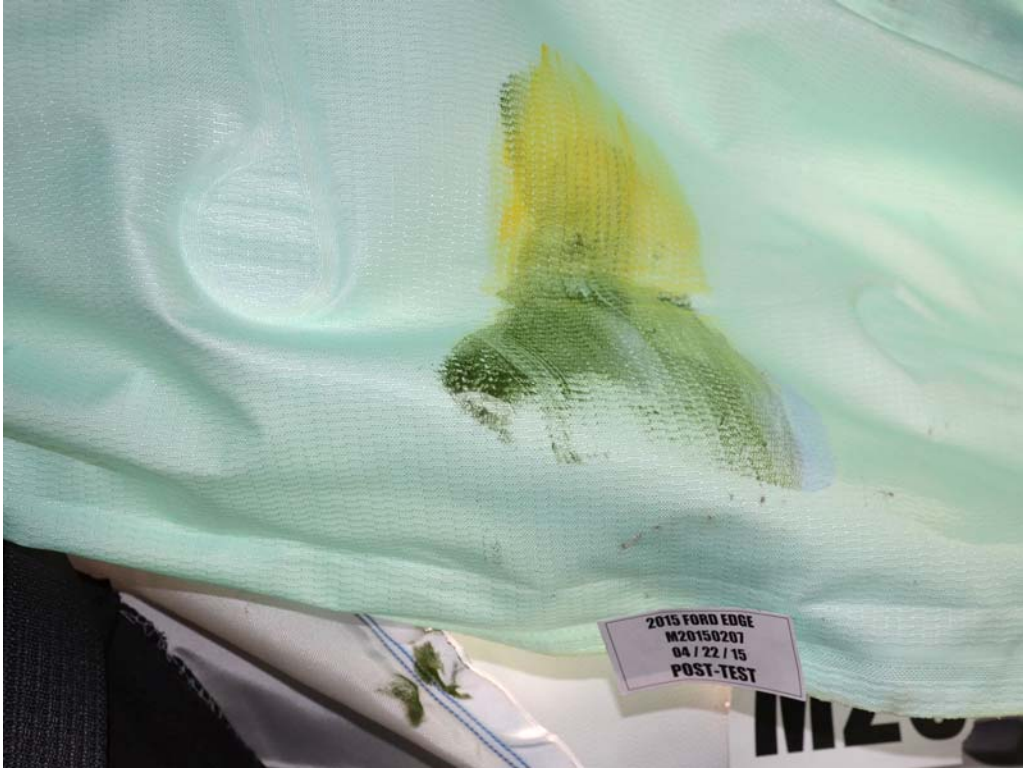
FIGURE 47. Post-Test Dummy Close-Up Head Contact With Side Airbag View

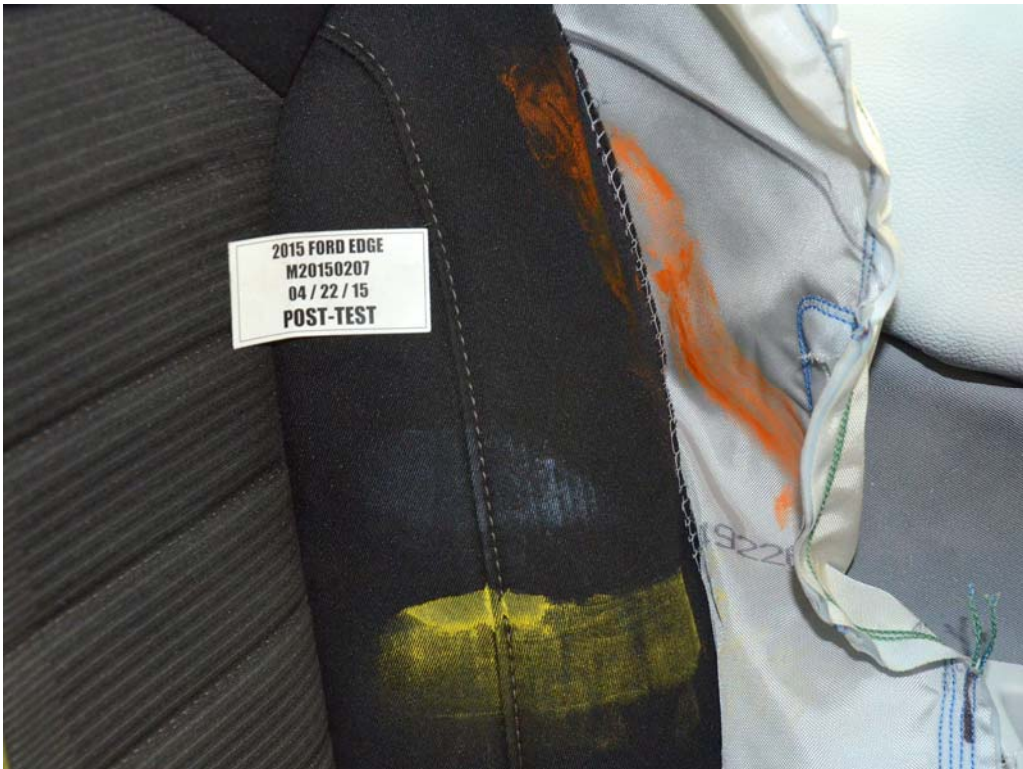
FIGURE 48. Post-Test Dummy Close-Up Torso Contact With Vehicle Interior View

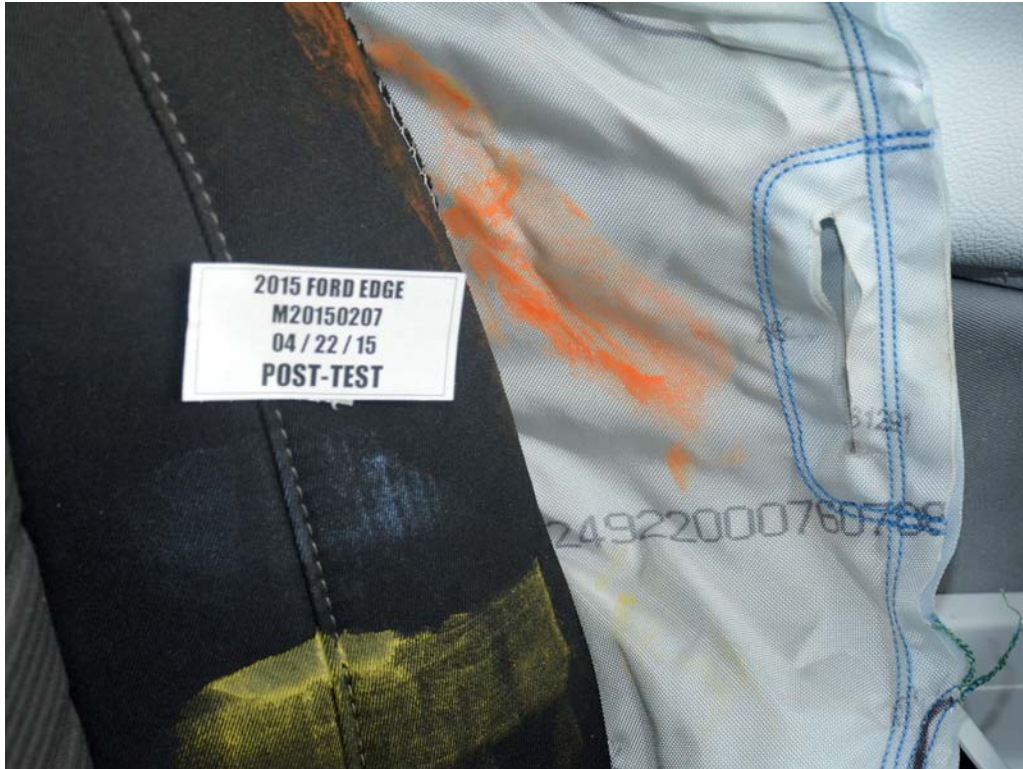
FIGURE 49. Post-Test Dummy Close-Up Torso Contact With Side Airbag View

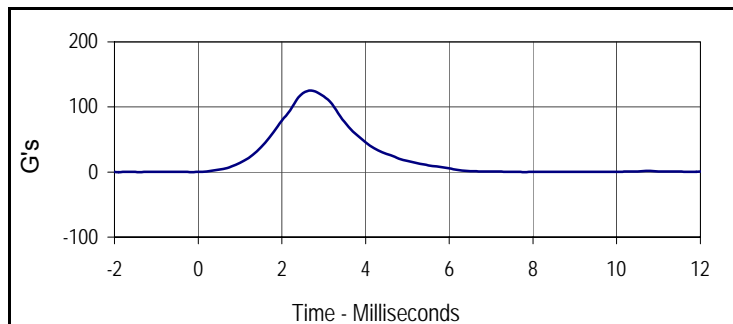
Curve Description			
Head Resultant			
Plot No.	Type	SAE Class	Units
001	RES	1000	G's
Max	Time	Min	Time
125.0	2.7	0.0	-18.8

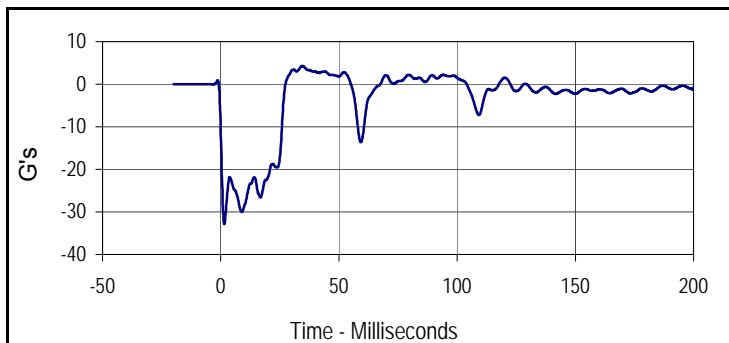
Curve Description			
Pendulum Deceleration			
Plot No.	Type	SAE Class	Units
001	FIL	180	G's
Max	Time	Min	Time
4.3	0.0	-32.8	0.0

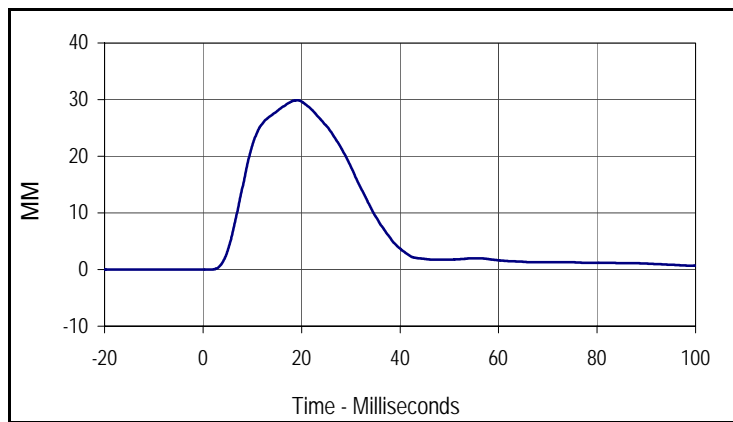
Curve Description			
Shoulder Deflection			
Plot No.	Type	SAE Class	Units
001	FIL	600	MM
Max	Time	Min	Time
29.9	19.2	0.0	-18.9

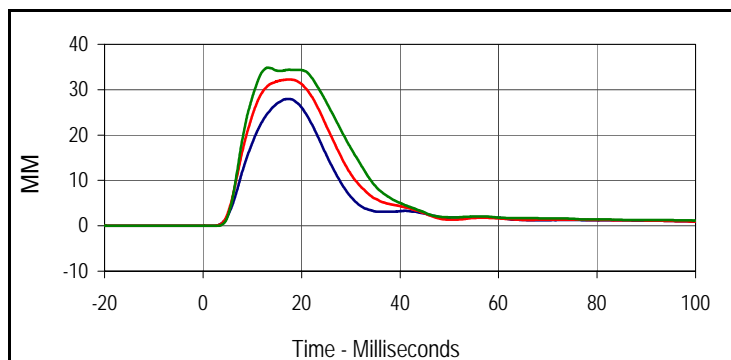
Curve Description			
<b>Upper Thorax Deflection</b>			
Plot No.	Type	SAE Class	Units
001	FIL	600	MM
Max	Time	Min	Time
27.9	17.4	0.0	-5.3
<b>Middle Thorax Deflection</b>			
Max	Time	Min	Time
32.2	17.5	0.0	1.4
<b>Lower Thorax Deflection</b>			
Max	Time	Min	Time
34.8	13.2	0.0	-6.5

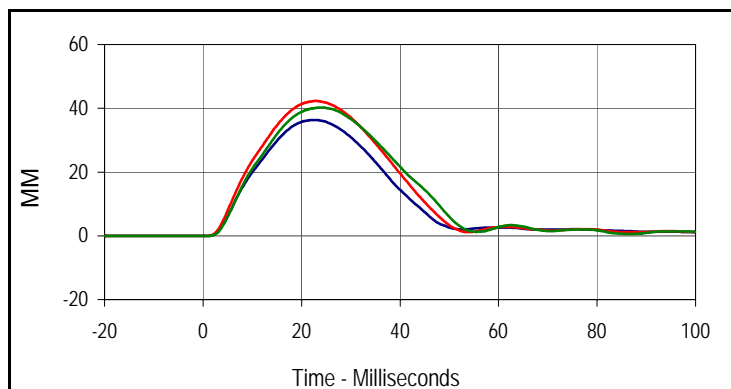
Curve Description			
Upper Thorax Deflection			
Plot No.	Type	SAE Class	Units
001	FIL	600	MM
Max	Time	Min	Time
36.3	22.6	0.0	-11.5
Middle Thorax Deflection			
Max	Time	Min	Time
42.3	22.9	0.0	-16.6
Lower Thorax Deflection			
Max	Time	Min	Time
40.2	24.0	0.0	-16.4

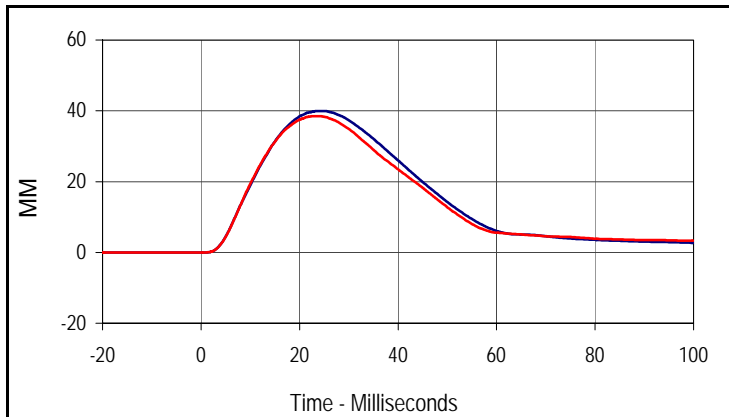
Curve Description			
Upper Abdominal Rib Deflection			
Plot No.	Type	SAE Class	Units
001	FIL	600	MM
Max	Time	Min	Time
40.0	24.2	0.0	-12.4

Curve Description			
Lower Abdominal Rib Deflection			
Plot No.	Type	SAE Class	Units
002	FIL	600	MM
Max	Time	Min	Time
38.5	23.3	0.0	-12.4

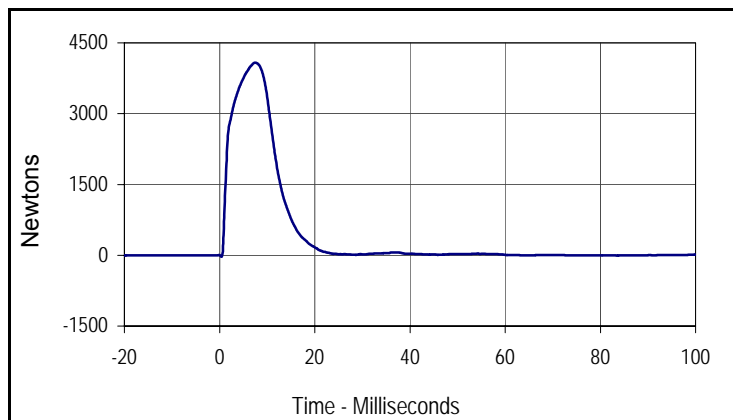
Curve Description			
Pelvis Acetabulum Force			
Plot No.	Type	SAE Class	Units
001	FIL	600	Newtons
Max	Time	Min	Time
4081.0	7.4	-26.7	0.4

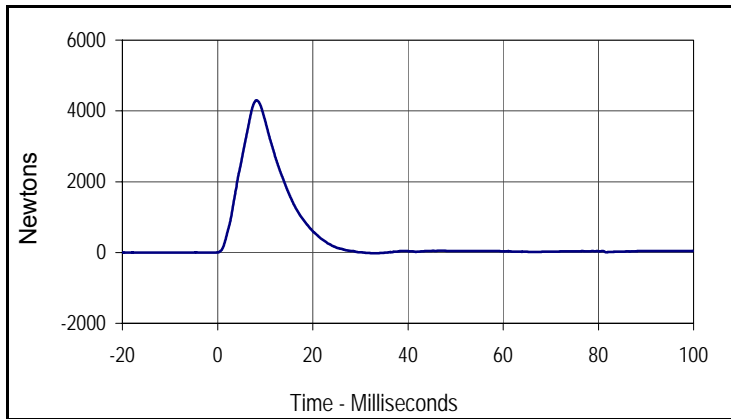
Curve Description			
Pelvis Iliac Force			
Plot No.	Type	SAE Class	Units
001	FIL	600	Newtons
Max	Time	Min	Time
4298.3	8.2	-19.7	33.0

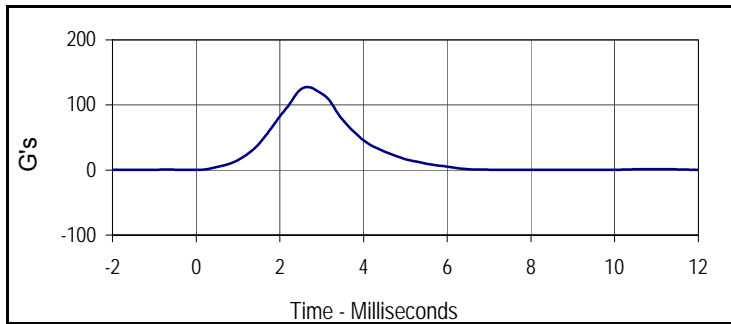
Curve Description			
Head Resultant			
Plot No.	Type	SAE Class	Units
001	RES	1000	G's
Max	Time	Min	Time
127.2	2.6	0.0	-7.0

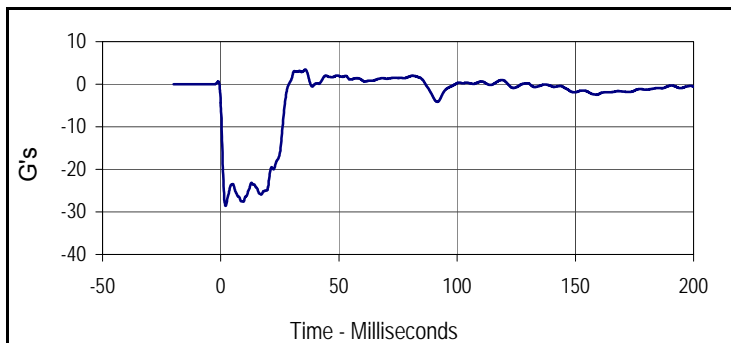
Curve Description			
Pendulum Deceleration			
Plot No.	Type	SAE Class	Units
001	FIL	180	G's
Max	Time	Min	Time
3.5	0.0	-28.6	0.0

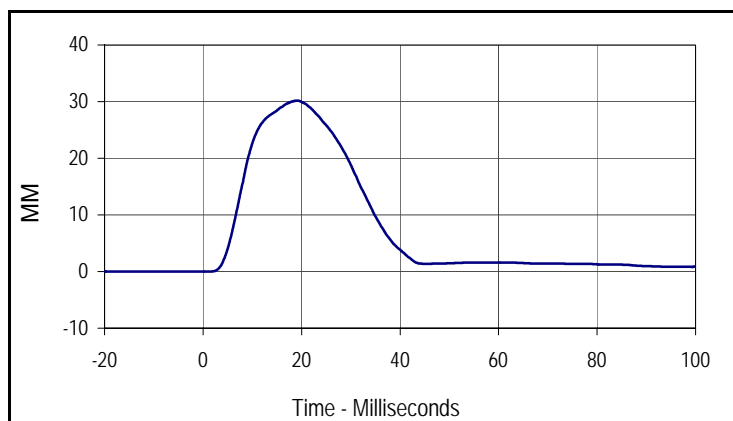
Curve Description			
Shoulder Deflection			
Plot No.	Type	SAE Class	Units
001	FIL	600	MM
Max	Time	Min	Time
30.2	19.1	0.0	-19.6

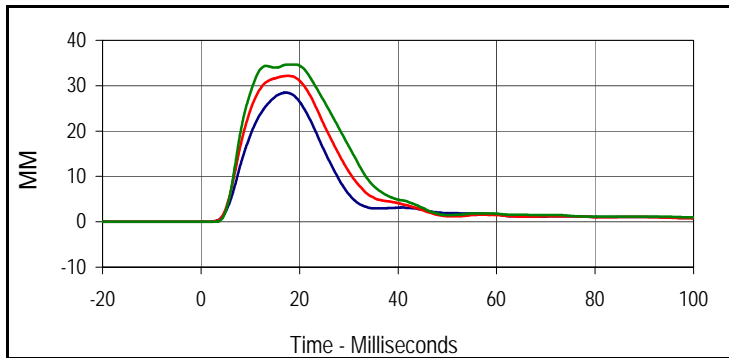
Curve Description			
<b>Upper Thorax Deflection</b>			
Plot No.	Type	SAE Class	Units
001	FIL	600	MM
Max	Time	Min	Time
28.5	17.2	0.0	-16.2
<b>Middle Thorax Deflection</b>			
Max	Time	Min	Time
32.2	17.7	0.0	-15.2
<b>Lower Thorax Deflection</b>			
Max	Time	Min	Time
34.6	17.5	0.0	-20.0

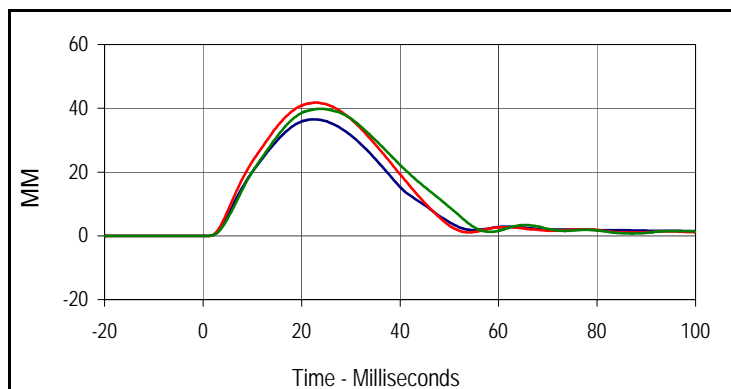
Curve Description			
Upper Thorax Deflection			
Plot No.	Type	SAE Class	Units
001	FIL	600	MM
Max	Time	Min	Time
36.5	22.5	0.0	-16.8
Middle Thorax Deflection			
Max	Time	Min	Time
41.8	22.9	-0.1	-16.6
Lower Thorax Deflection			
Max	Time	Min	Time
39.8	23.7	0.0	-19.0

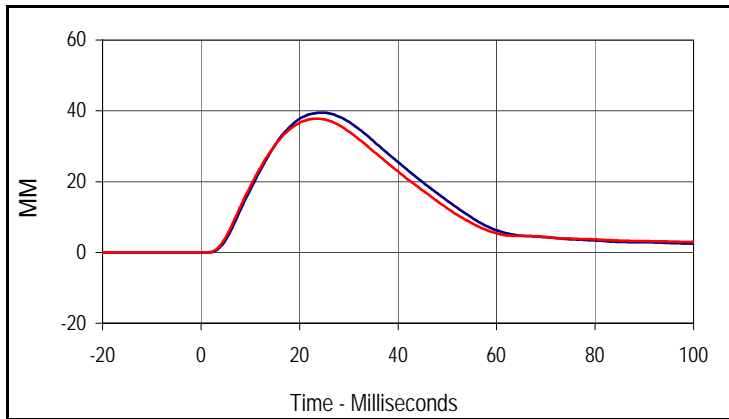
Curve Description			
Upper Abdominal Rib Deflection			
Plot No.	Type	SAE Class	Units
001	FIL	600	MM
Max	Time	Min	Time
39.5	24.4	0.0	-15.7
Curve Description			
Lower Abdominal Rib Deflection			
Plot No.	Type	SAE Class	Units
002	FIL	600	MM
Max	Time	Min	Time
37.7	23.2	0.0	-16.5

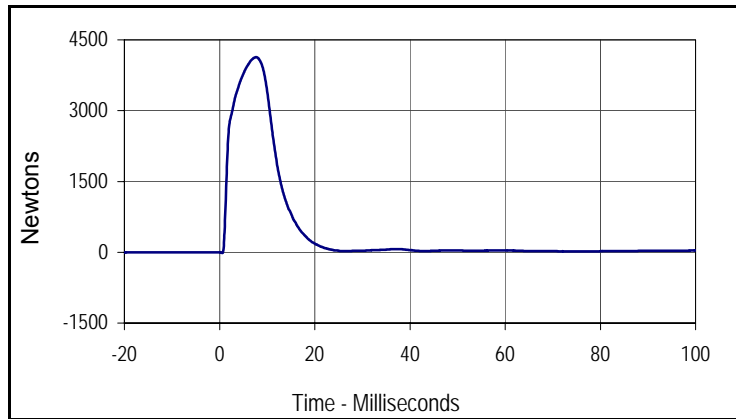
Curve Description			
Pelvis Acetabulum Force			
Plot No.	Type	SAE Class	Units
001	FIL	600	Newtons
Max	Time	Min	Time
4133.1	7.6	-18.3	0.6

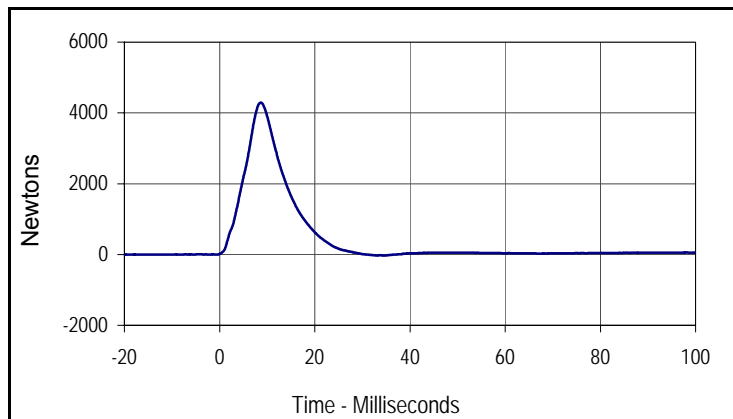
Curve Description			
Pelvis Iliac Force			
Plot No.	Type	SAE Class	Units
001	FIL	600	Newtons
Max	Time	Min	Time
4291.8	8.7	-28.1	33.2
