**REPORT NUMBER: NCAP-MGA-2016-006**

**NEW CAR ASSESSMENT PROGRAM (NCAP)  
Frontal Barrier Impact Test**

**HONDA OF AMERICA MFG., INC.  
2016 Acura ILX AcuraWatch Plus 4-Dr Sedan  
NHTSA No.: O20165300**

**FINAL REPORT**

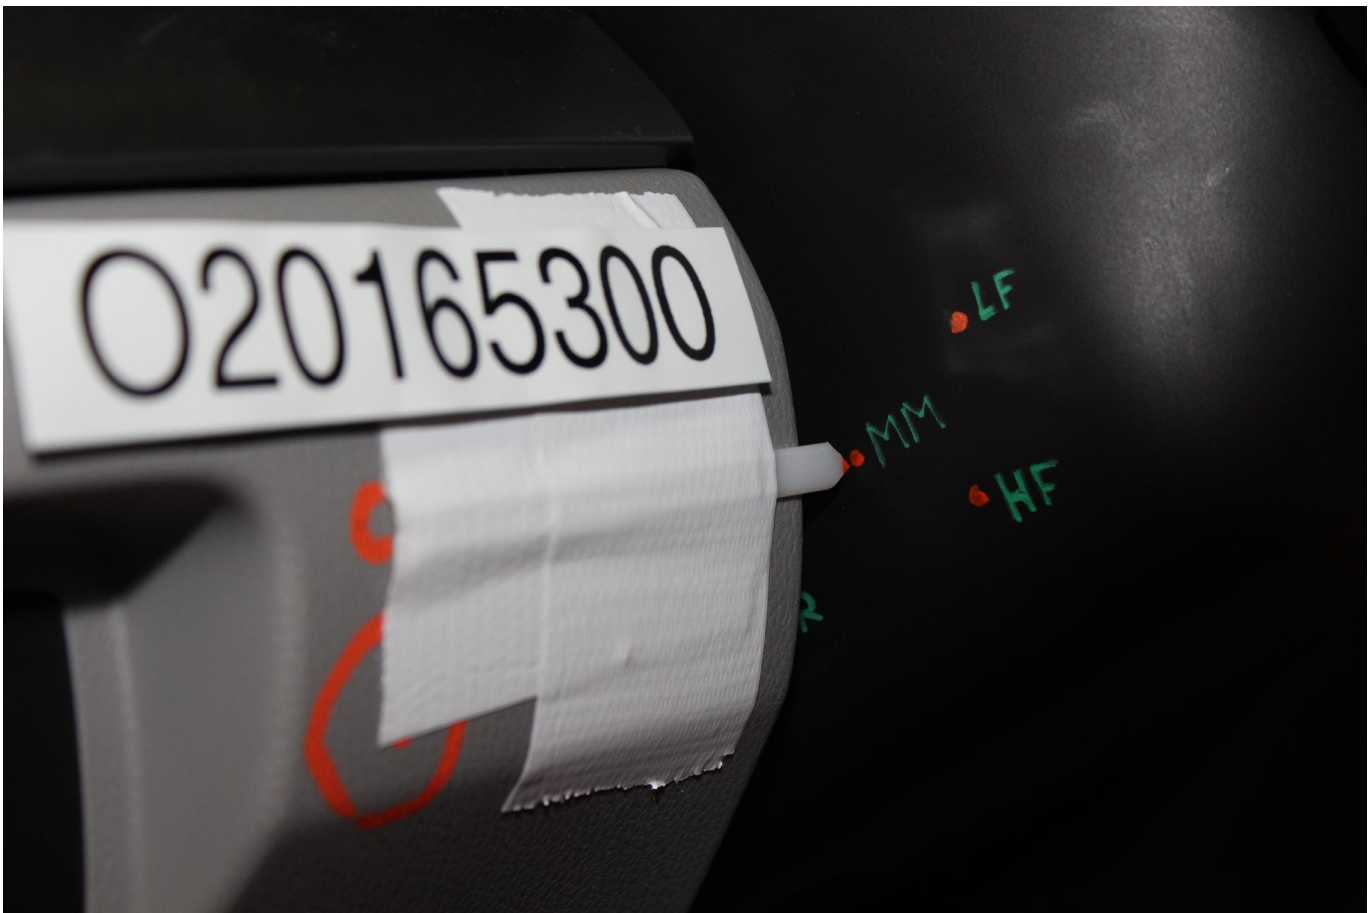
Photo No. 047a - Post-Test Driver Dummy Contact with Knee Bolster

The driver's visible contact points were as follows: The driver's head and chest contacted the airbag. The driver's head also contacted the headrest. The driver's knees contacted the knee bolster. The passenger's visible contact points were as follows: The passenger's head and chest contacted the airbag. The passenger's head also contacted the headrest. The passenger's knees contacted the glovebox.

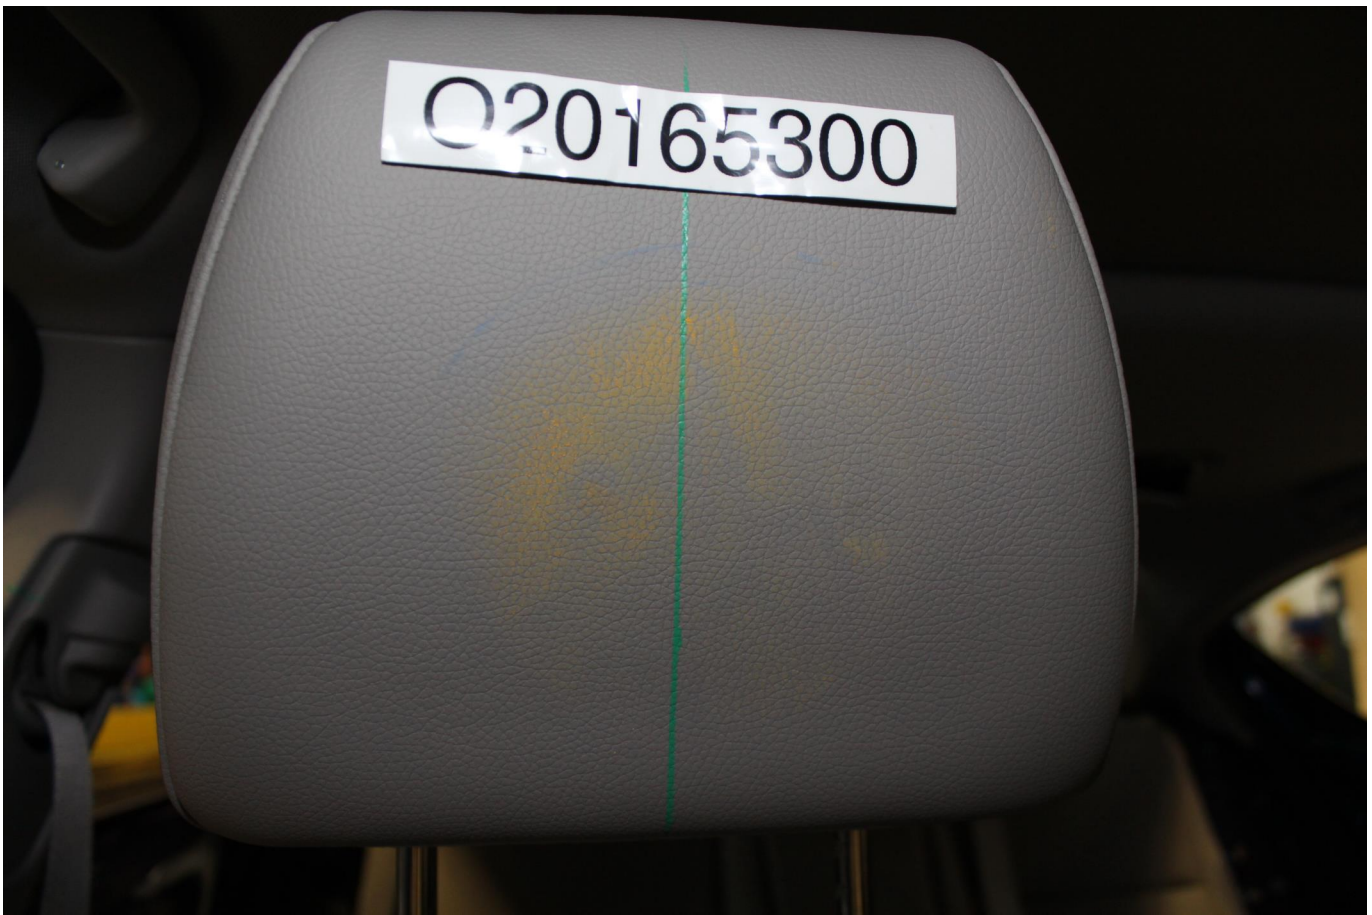
Photo No. 067 - Post-Test Passenger Dummy Contact with Airbag

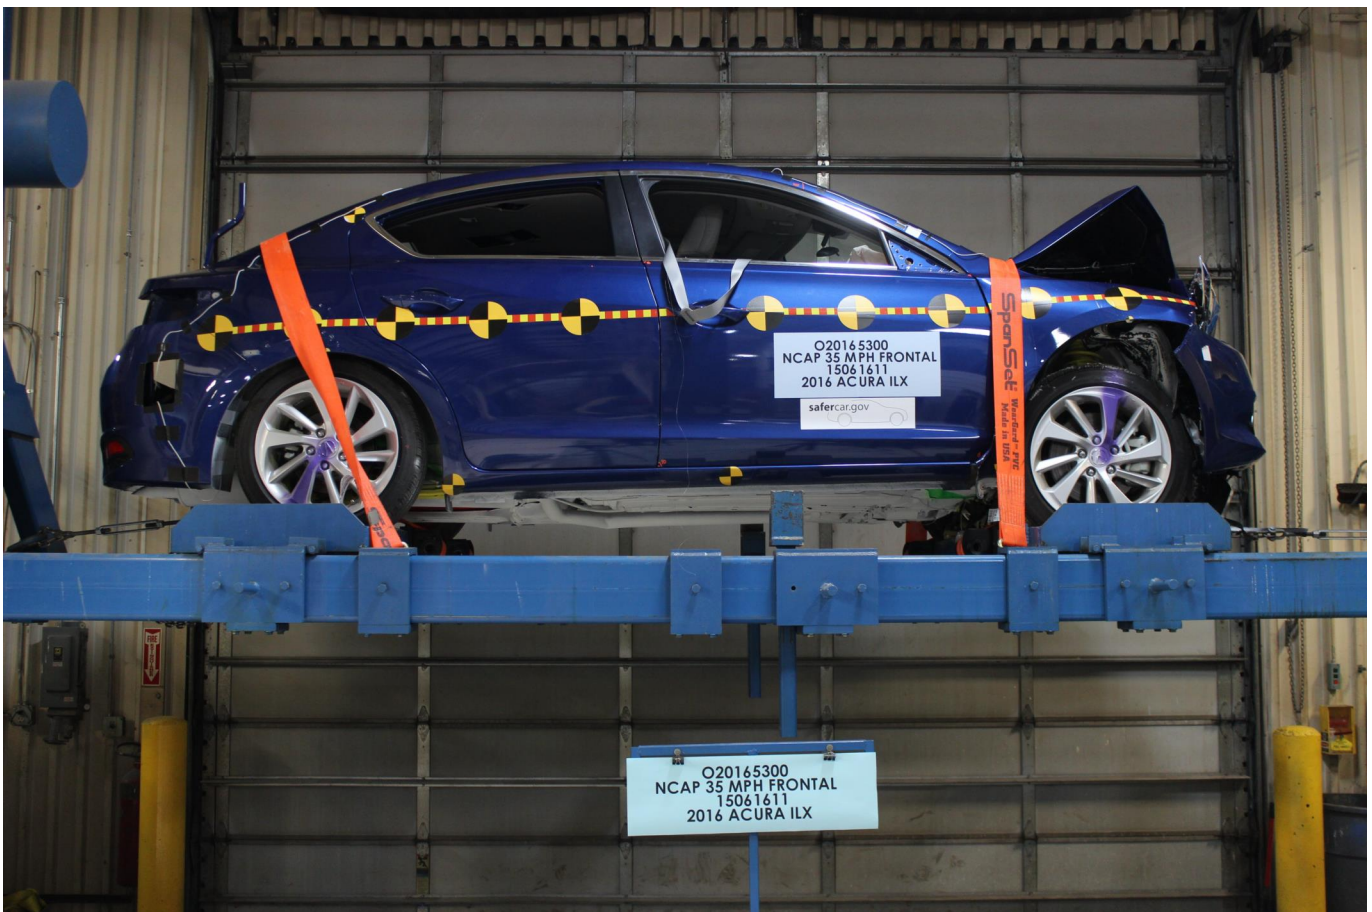
Photo No. 075 - Vehicle at 270 Degrees on Static Rollover Device

There was 100 percent windshield retention and no intrusion into the protected zone of the windshield during the event. There was no Stoddard Solvent leakage after the event or during any phase of the static rollover.

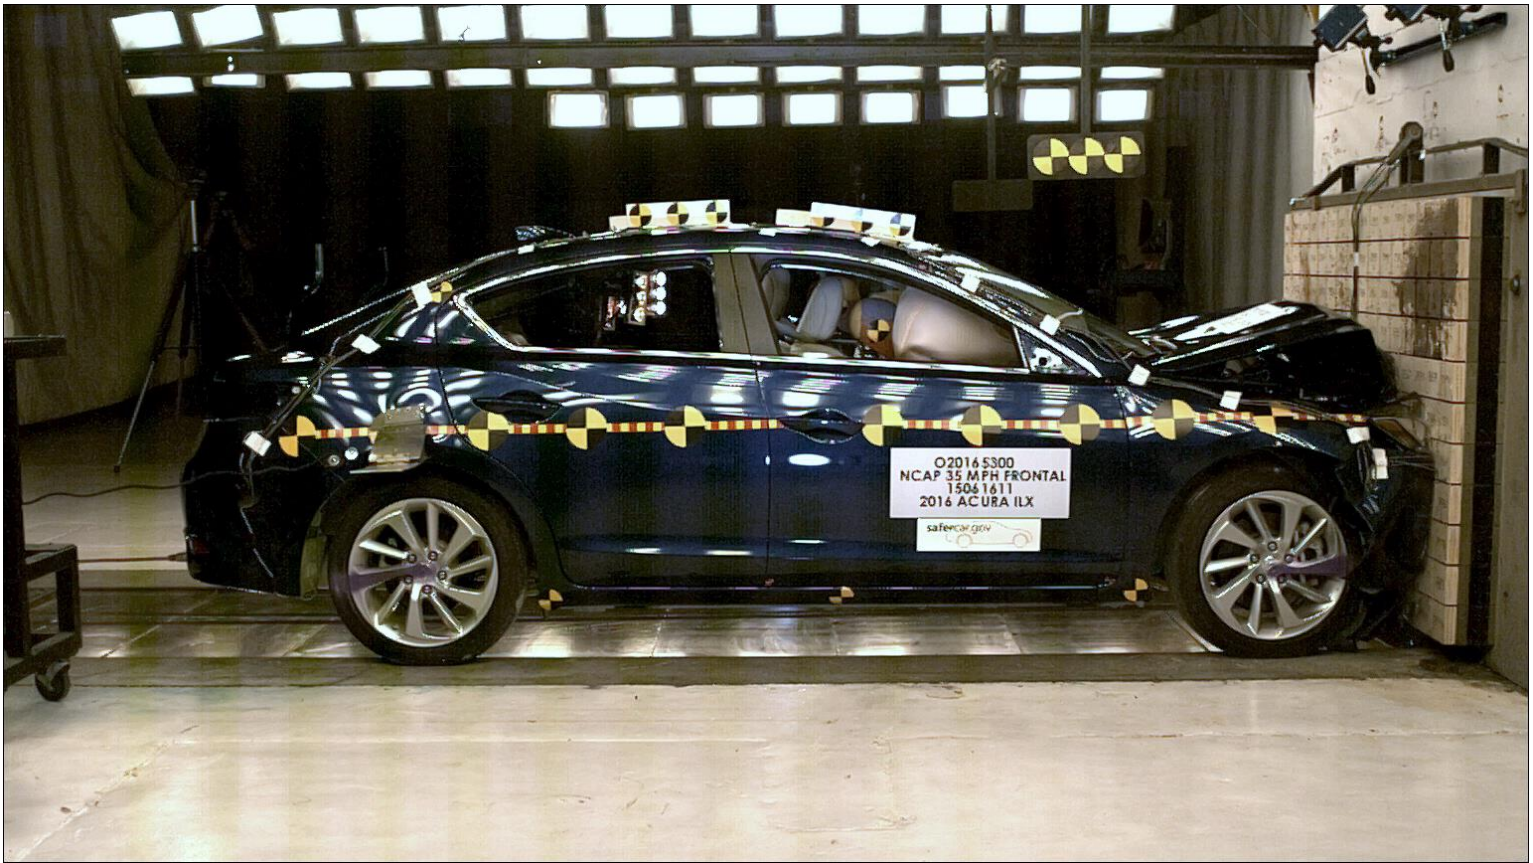
Photo No. 076 - Vehicle at 360 Degrees on Static Rollover Device
