**REPORT NUMBER: SINCAP-MGA-2016-008**

**NEW CAR ASSESSMENT PROGRAM (NCAP)  
Moving Deformable Barrier Side Impact Test**

**HONDA OF AMERICA MFG., INC.  
2016 Acura ILX AcuraWatch Plus 4-Dr Sedan  
NHTSA No.: O20165302**

**MGA RESEARCH CORPORATION  
5000 Warren Road  
Burlington, WI 53105**

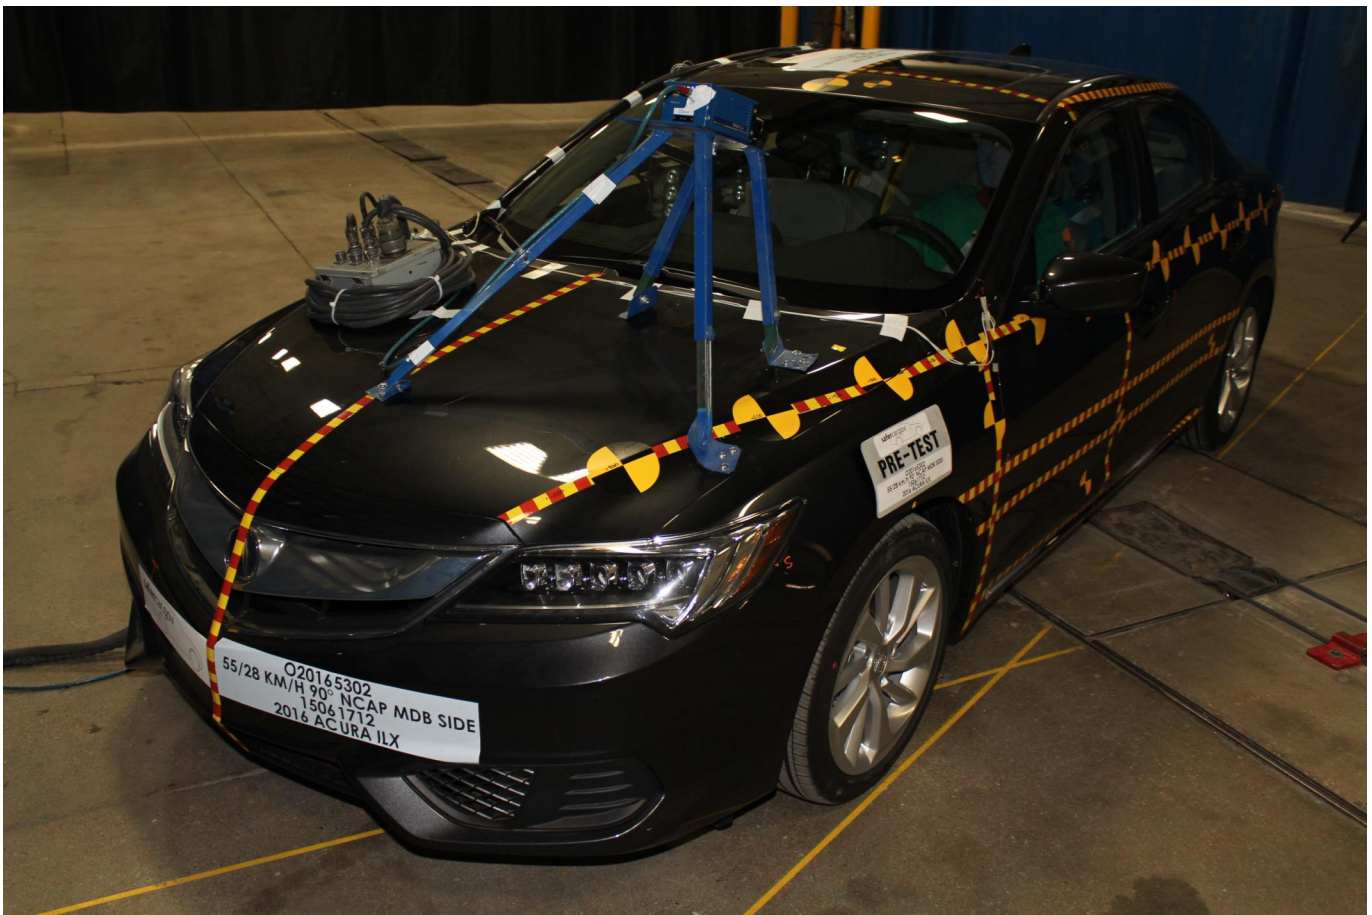
Photo No. 004 - Post-Test Frontal View of Test Vehicle

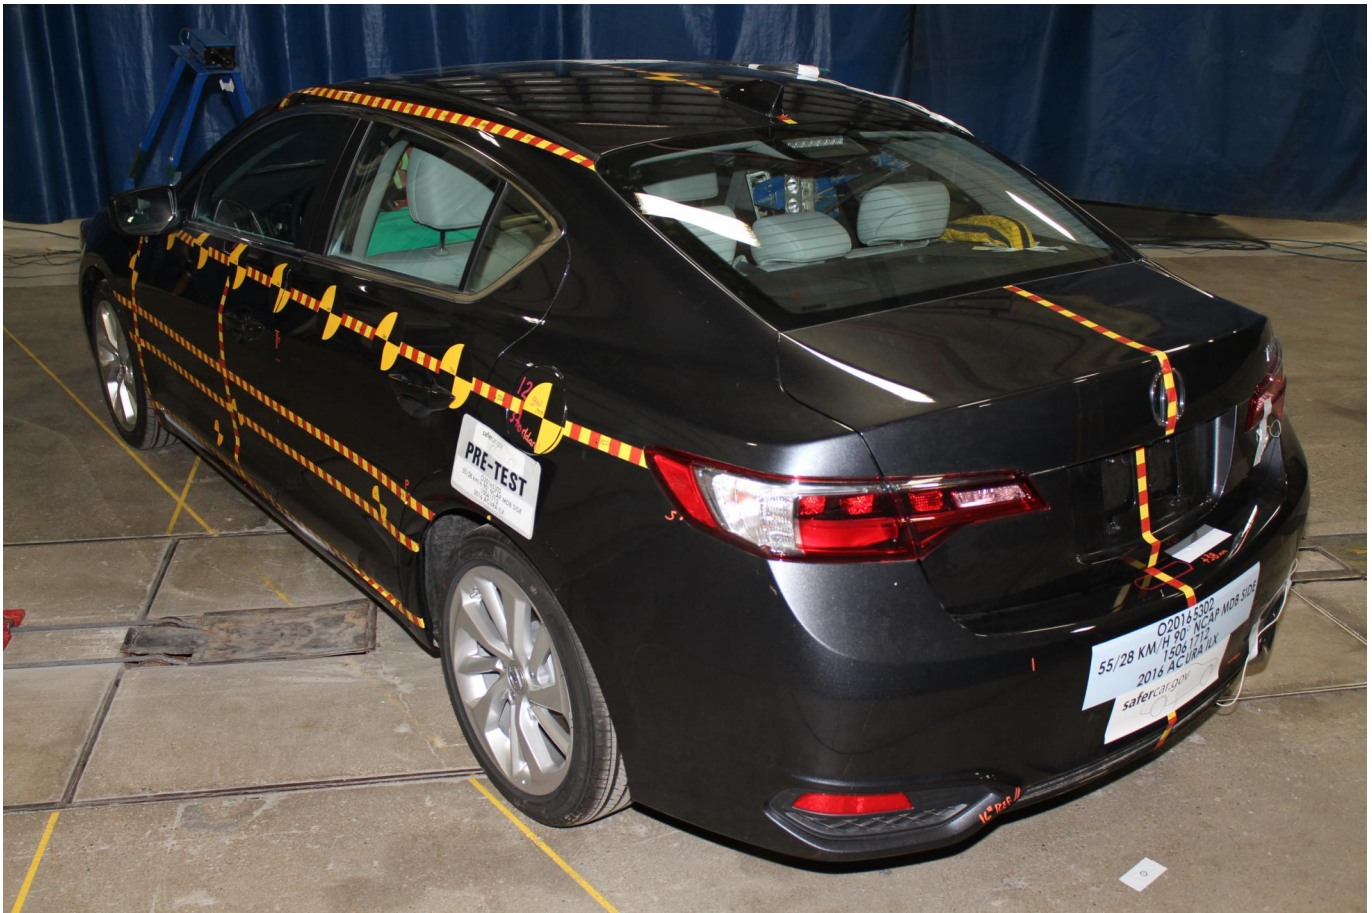
Photo No. 008 - Post-Test Left Side View of Test Vehicle

| Critical Areas of Performance | Observations and Conclusions |
|---|---|
| Side Window Damage | Left Front Window Broken |

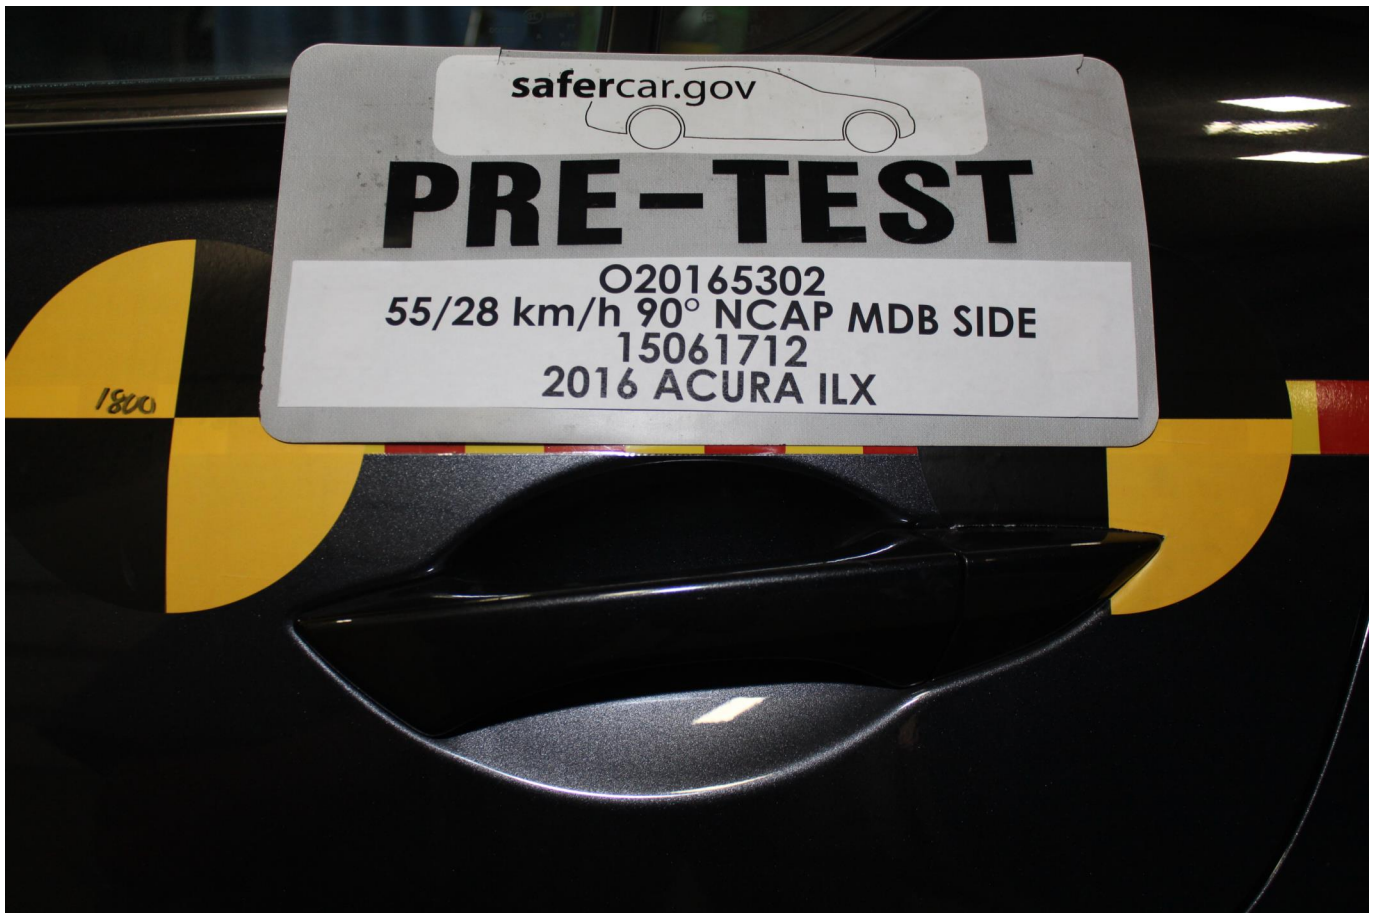
Photo No. 022 - Post-Test Left Front Door Latch Close-Up

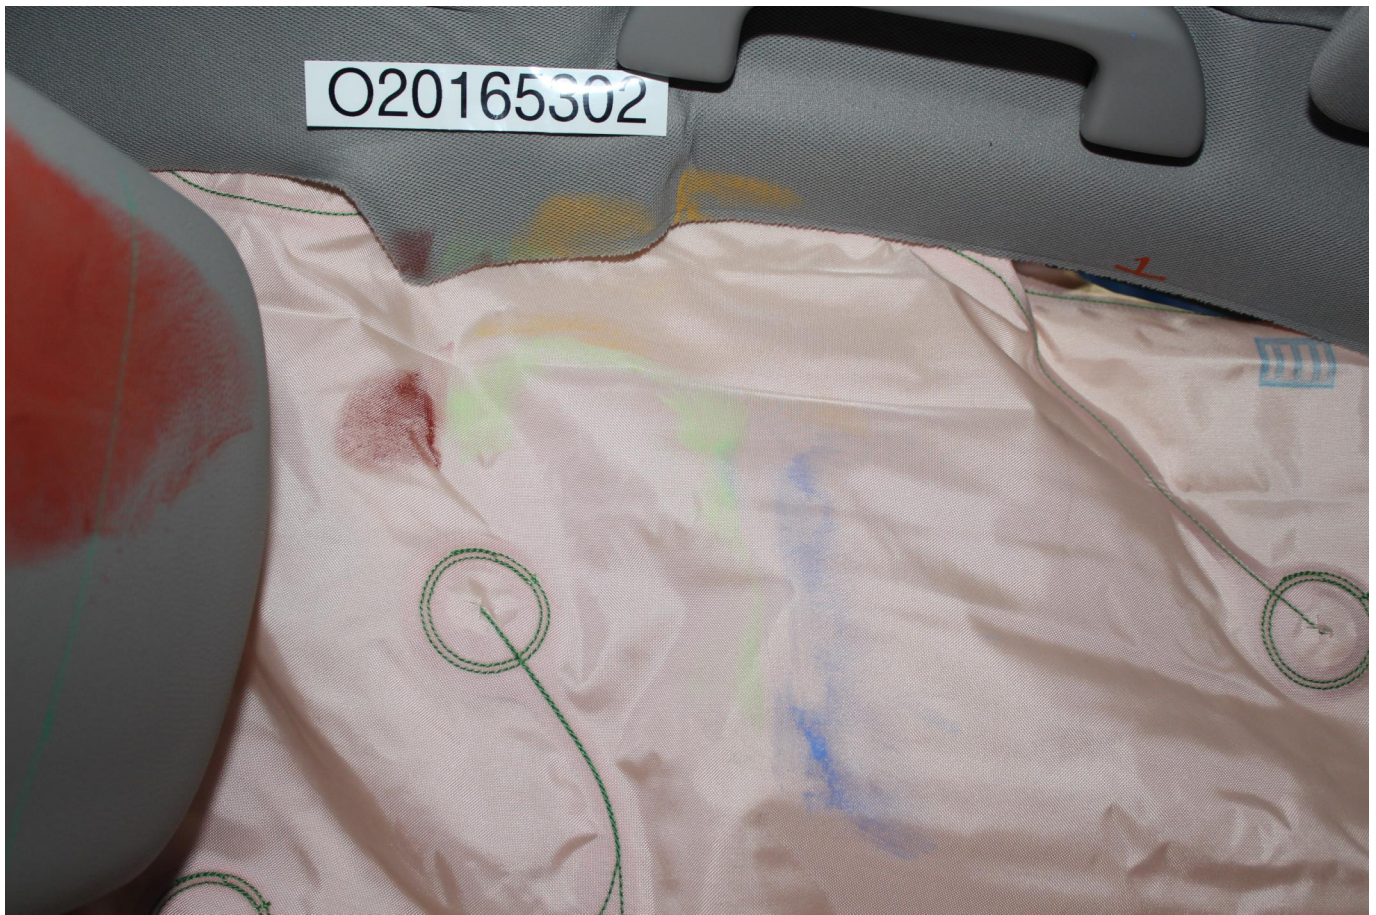
Photo No. 048 - Post-Test Driver Dummy Close-up Head Contact with Vehicle Interior View

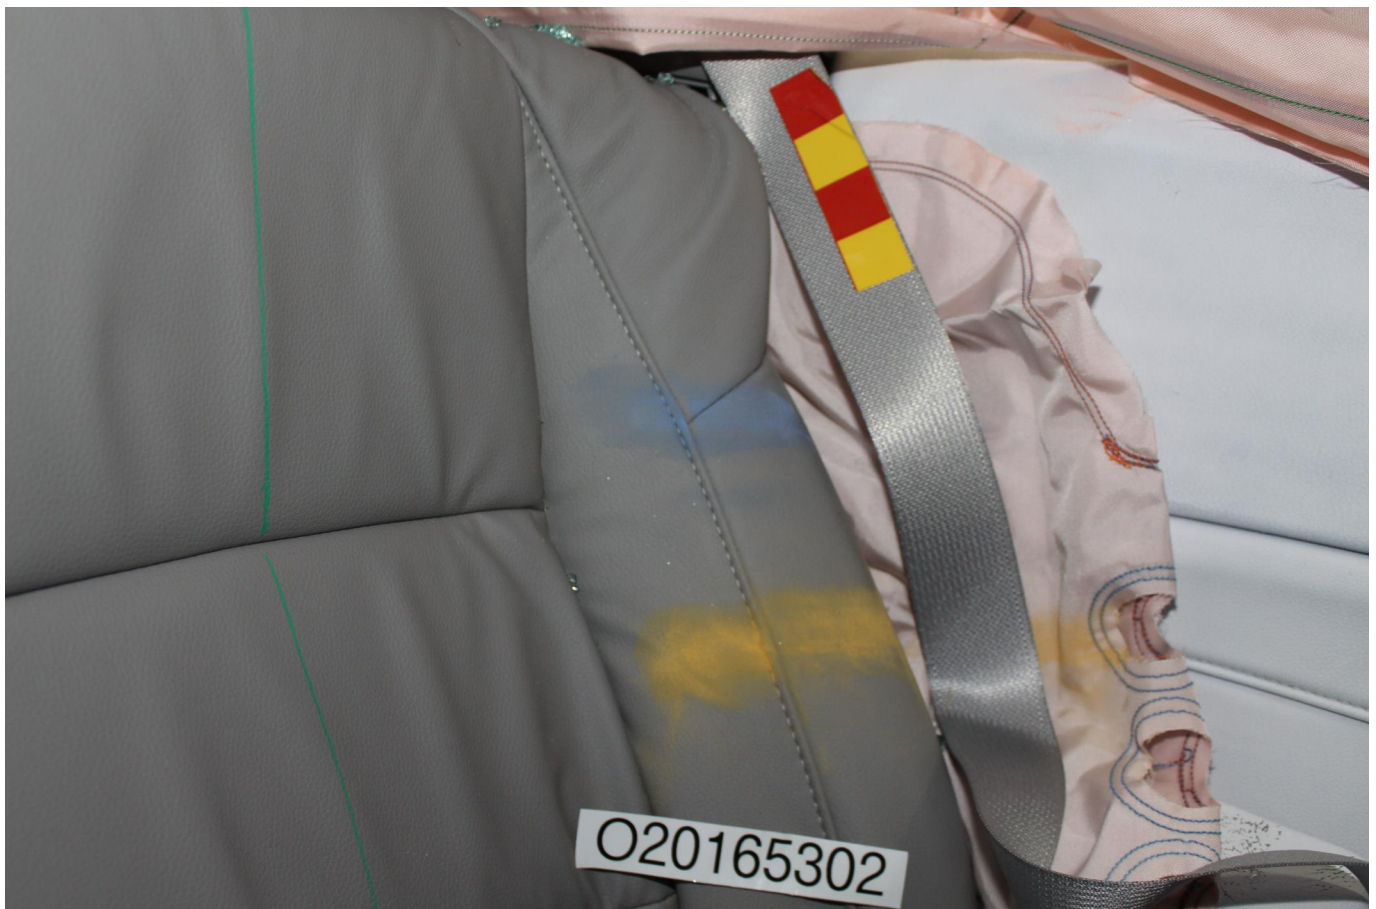
Photo No. 049 - Post-Test Driver Dummy Close-up Head Contact with Side Airbag View

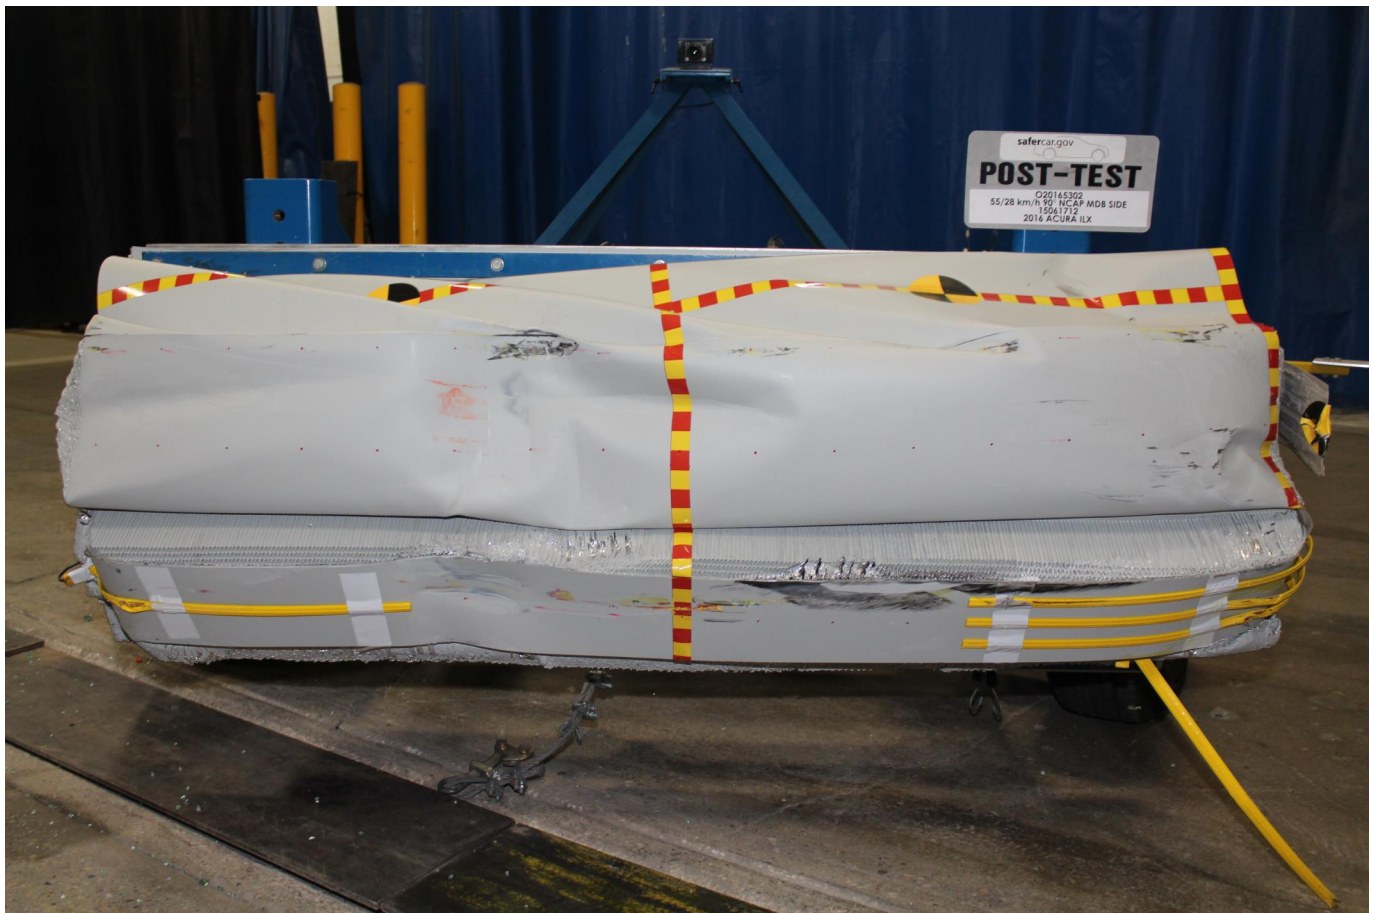
Photo No. 084 - Pre-Test Front View of MDB Impactor Face
