**REPORT NUMBER: TR-P35007-05-NC**

**SIDE AIRBAG OCCUPANT RISK PROGRAM  
OCCUPANT OUT-OF-POSITION TESTS**

**BAYERISCHE MOTOREN WERKE AG  
2015 MINI COOPER HARDTOP  
3-DOOR HATCHBACK**

**PREPARED BY:  
KARCO ENGINEERING, LLC.  
9270 HOLLY ROAD  
ADELANTO, CA 92301**

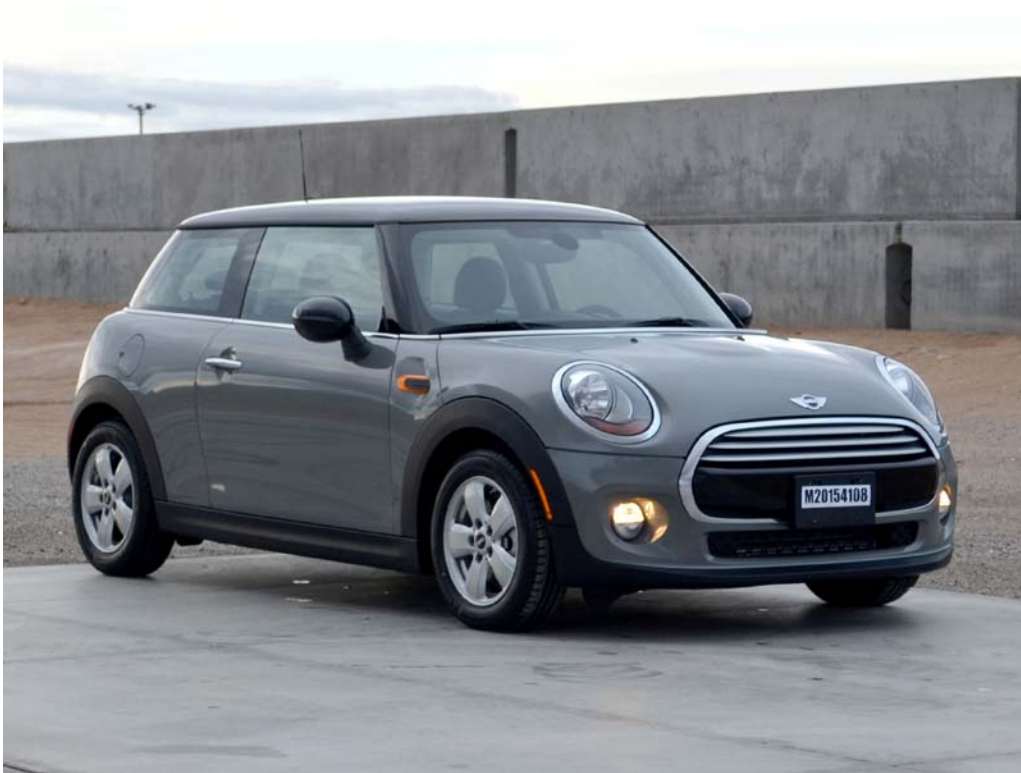
FIGURE 1. Right Front ¾ View, As Received

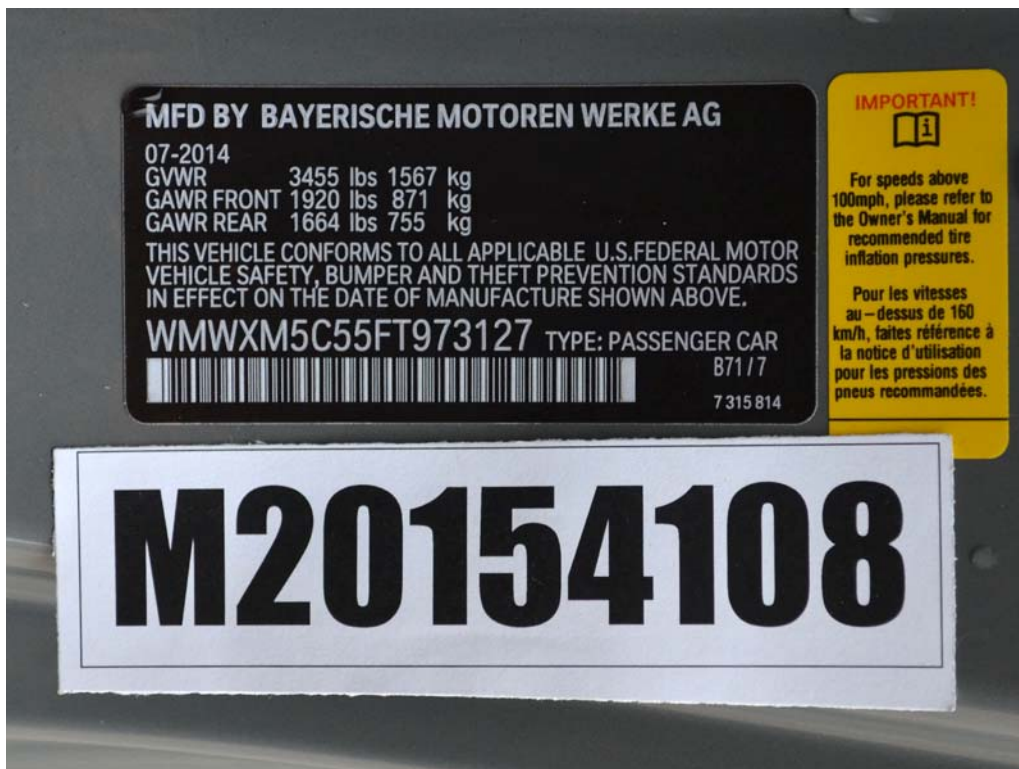
FIGURE 2. Vehicle Certification Label

### DATA FROM CERTIFICATION LABEL

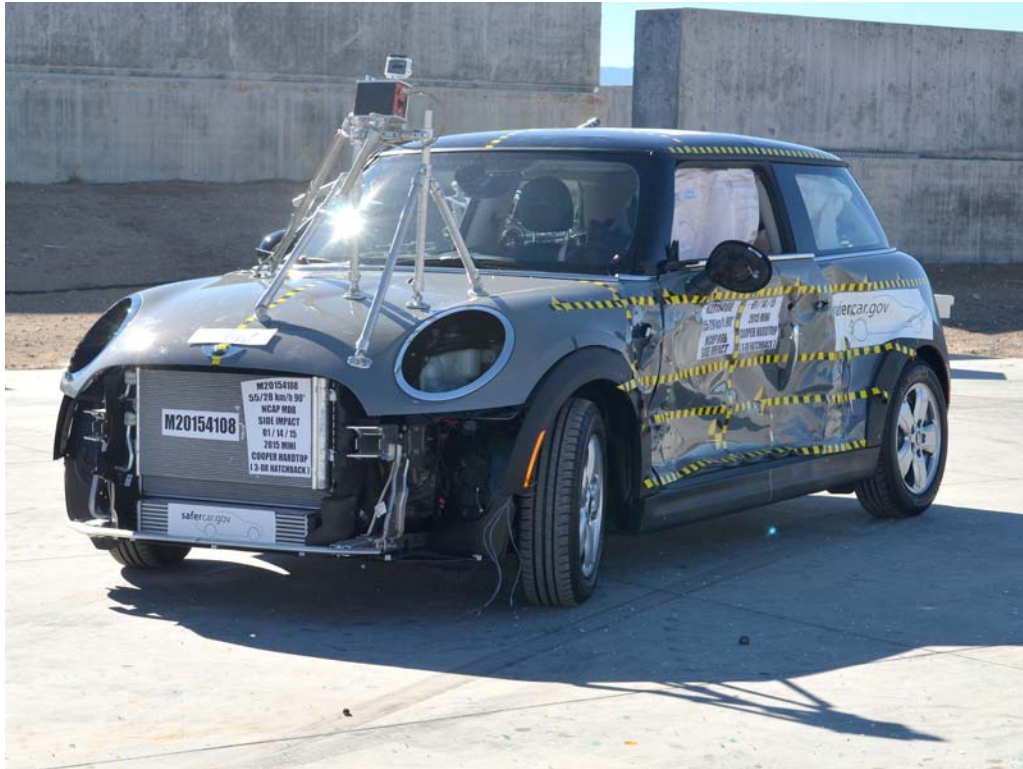
FIGURE 3. Post-Test Left Front 3/4 View of NCAP Side MDB Impact Test

\*Vehicle underwent New Car Assessment Program MDB Side Impact Testing on January 14, 2015.

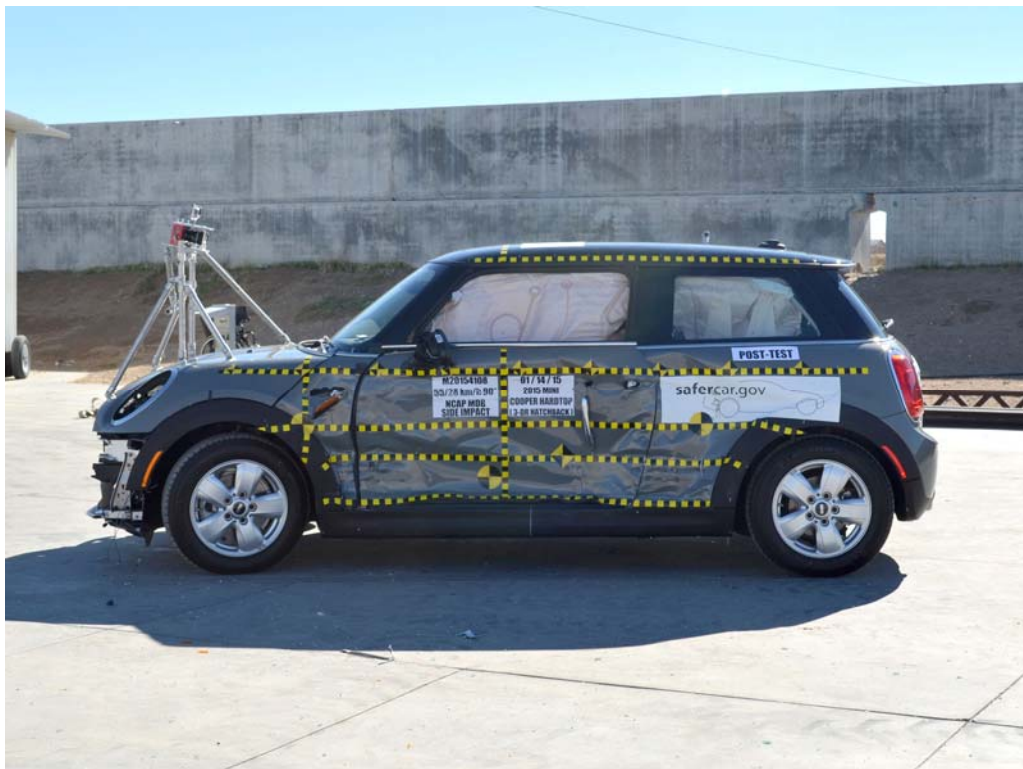
FIGURE 4. Post-Test Left Side View of NCAP Side MDB Impact Test

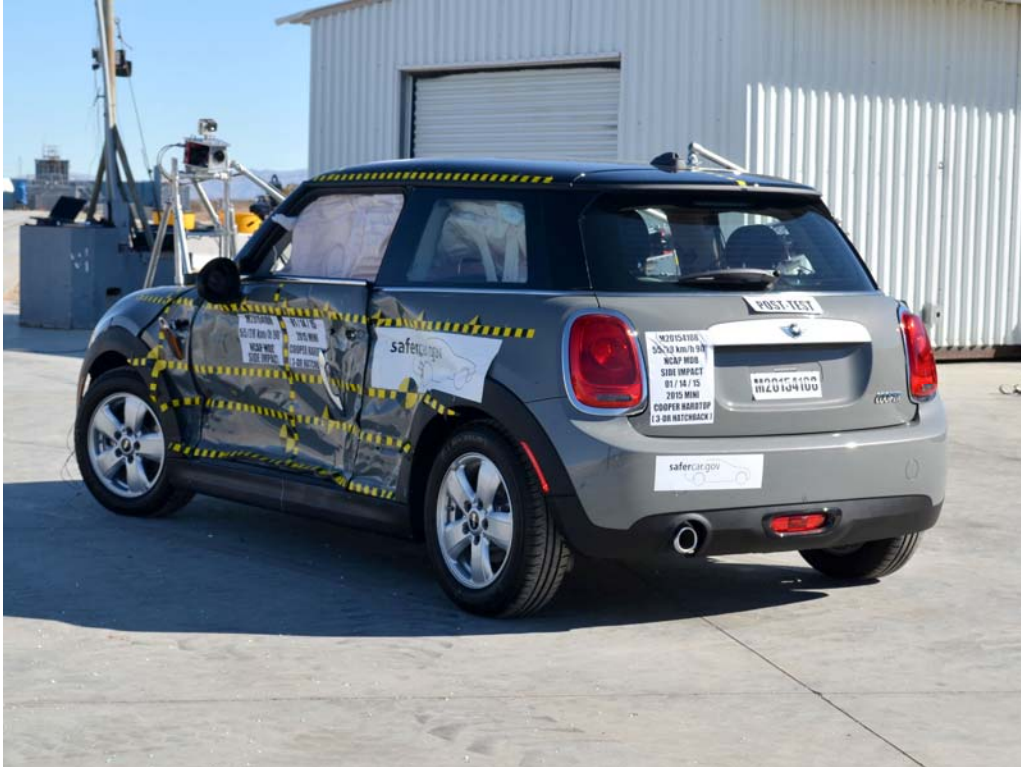
FIGURE 5. Post-Test Left Rear ¾ View of NCAP Side MDB Impact Test

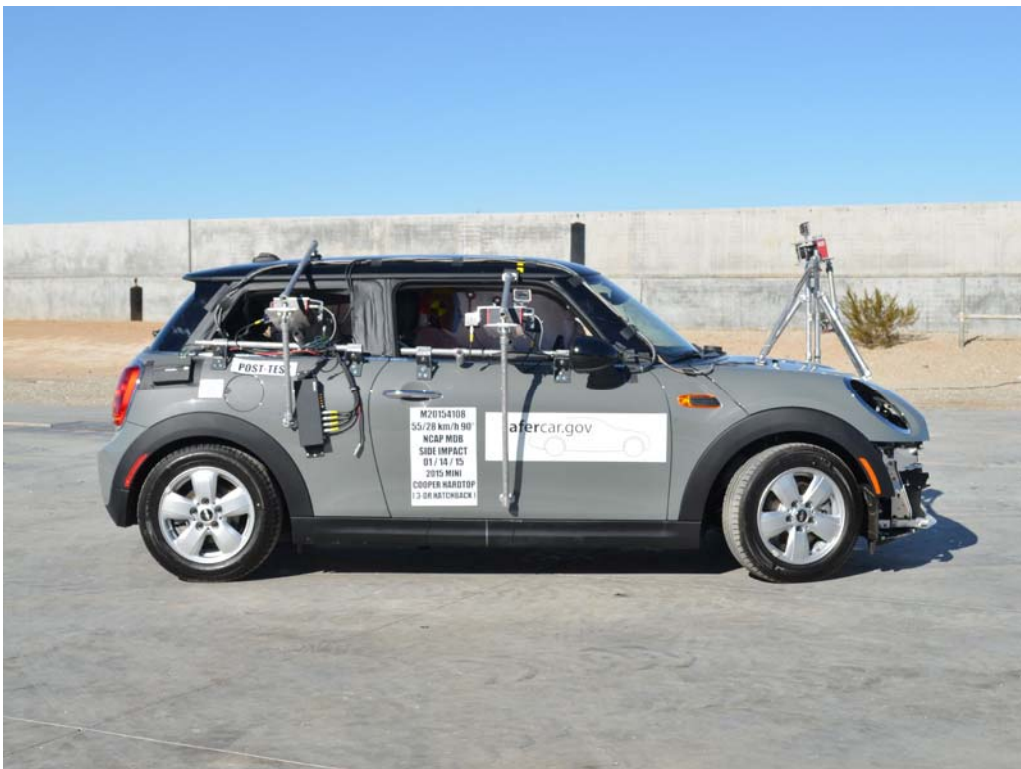
FIGURE 6. Post-Test Right Side View of NCAP Side MDB Impact Test

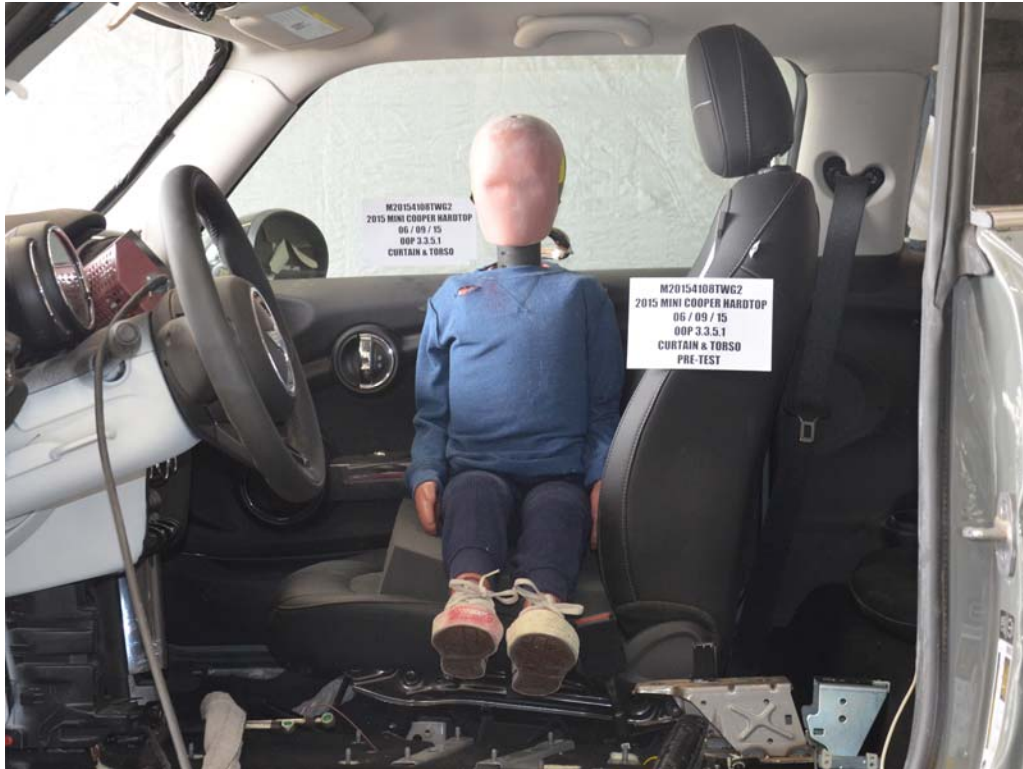
FIGURE 7. Pre-Test Dummy Position, Left Side View

Orientation of the 6-year old dummy was with the dummy facing forward. The seat is adjusted to its highest position. The dummy is placed on the foam block facing inboard with its arms hanging at its sides and its legs extended. The seat track is adjusted forward to minimize the vertical distance between the dummy's head and the roof module and to maximize the cushion to head interaction. The dummy's pelvis is slid outboard until its back contacts the door trim panel or armrest and the head is centered in the deployment trajectory of the curtain airbag with its shoulder bolts parallel to the vehicle centerline. This orientation complies with section 3.3.5.1 of the Technical Working Group (TWG) recommendation in the Recommended Procedures for Evaluating Occupant Injury Risk from Deploying Side Airbags.

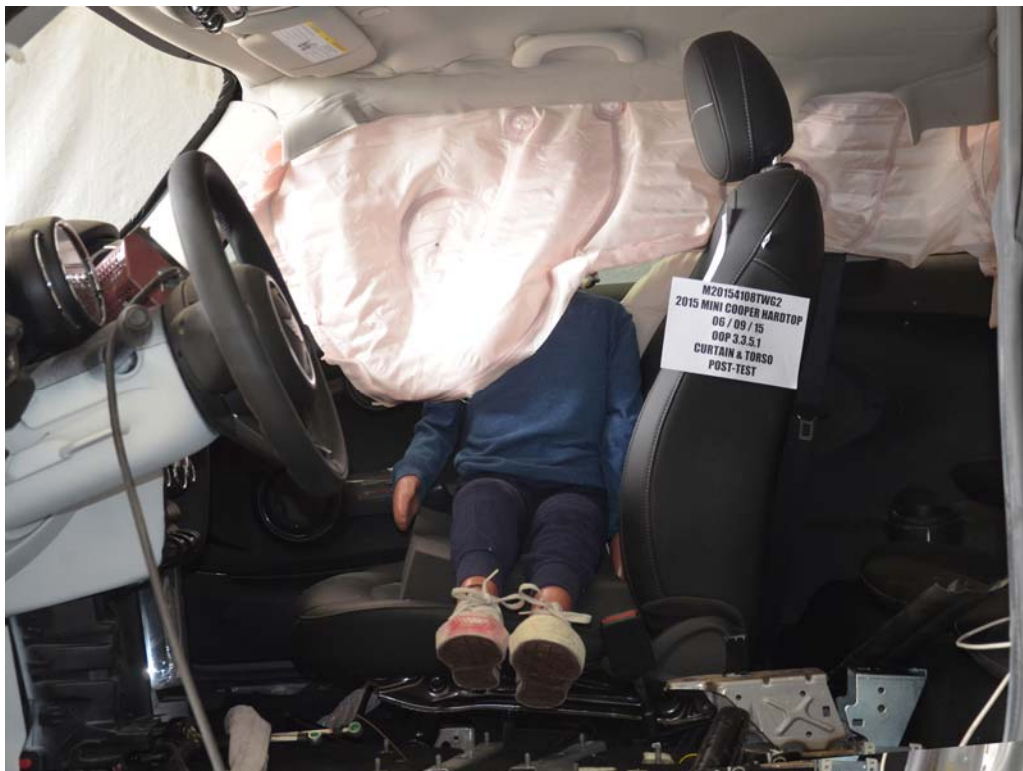
FIGURE 8. Post-Test Dummy Position, Left Side View

The 6-year old dummy's visible contact points were as follows: The ATD's head contacted the curtain airbag. The ATD's back and pelvis contacted the torso/pelvis airbag.

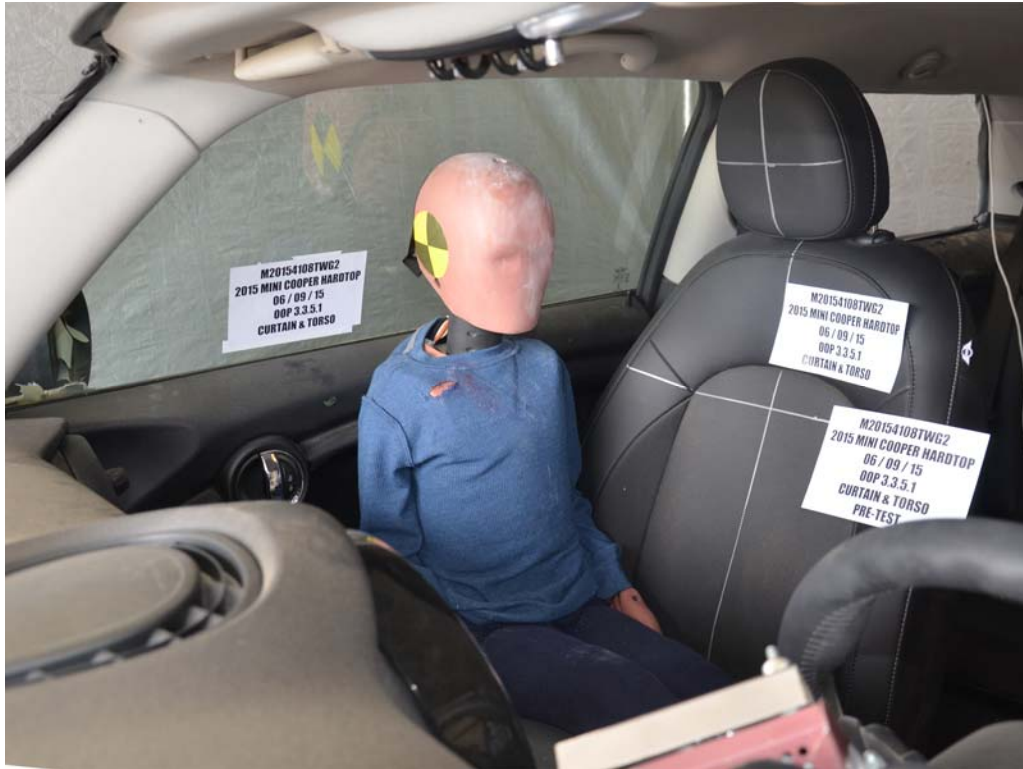
FIGURE 9. Pre-Test Dummy Position, ¾ View

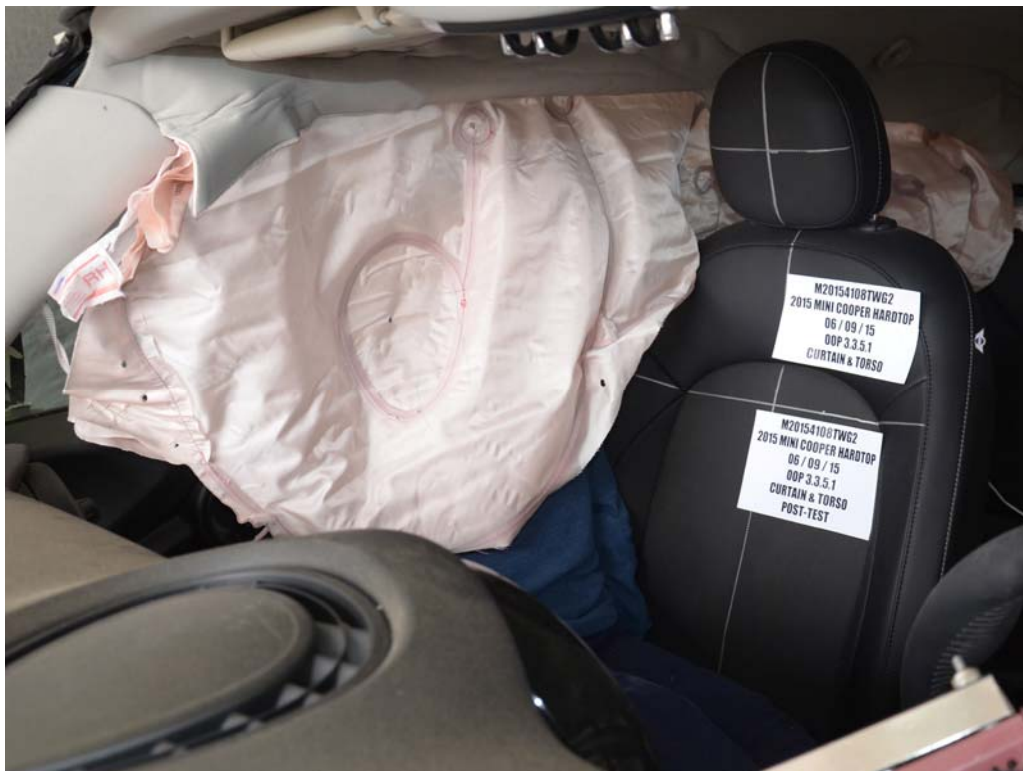
FIGURE 10. Post-Test Dummy Position, ¾ View

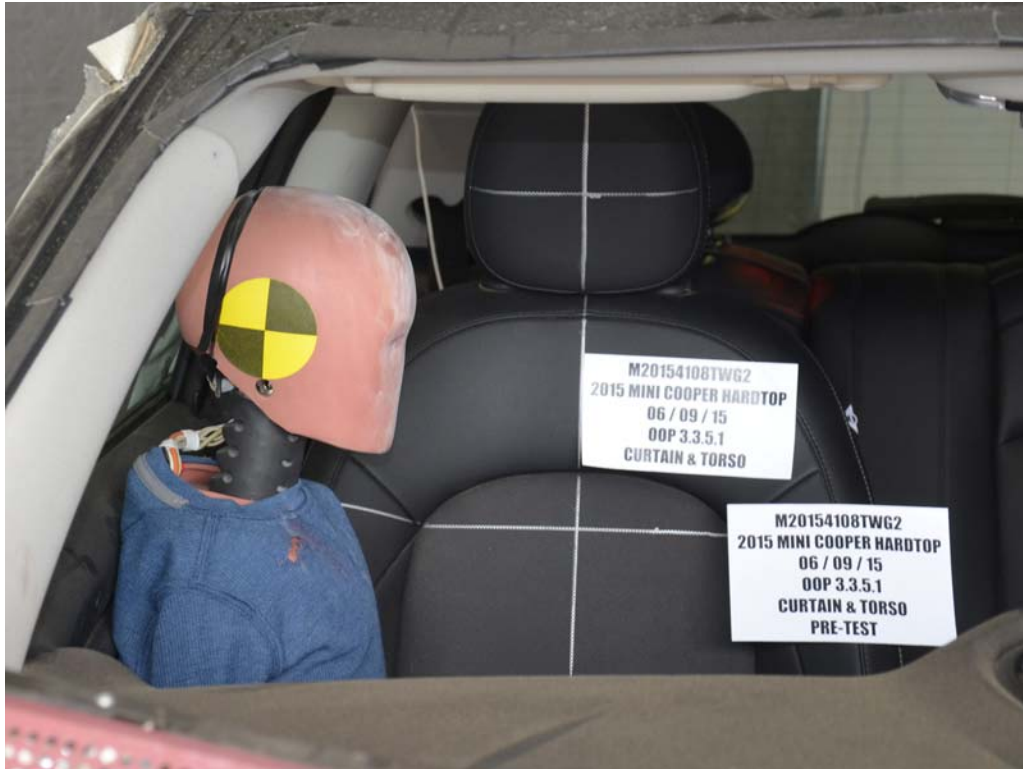
FIGURE 11. Pre-Test Dummy Position, Front View

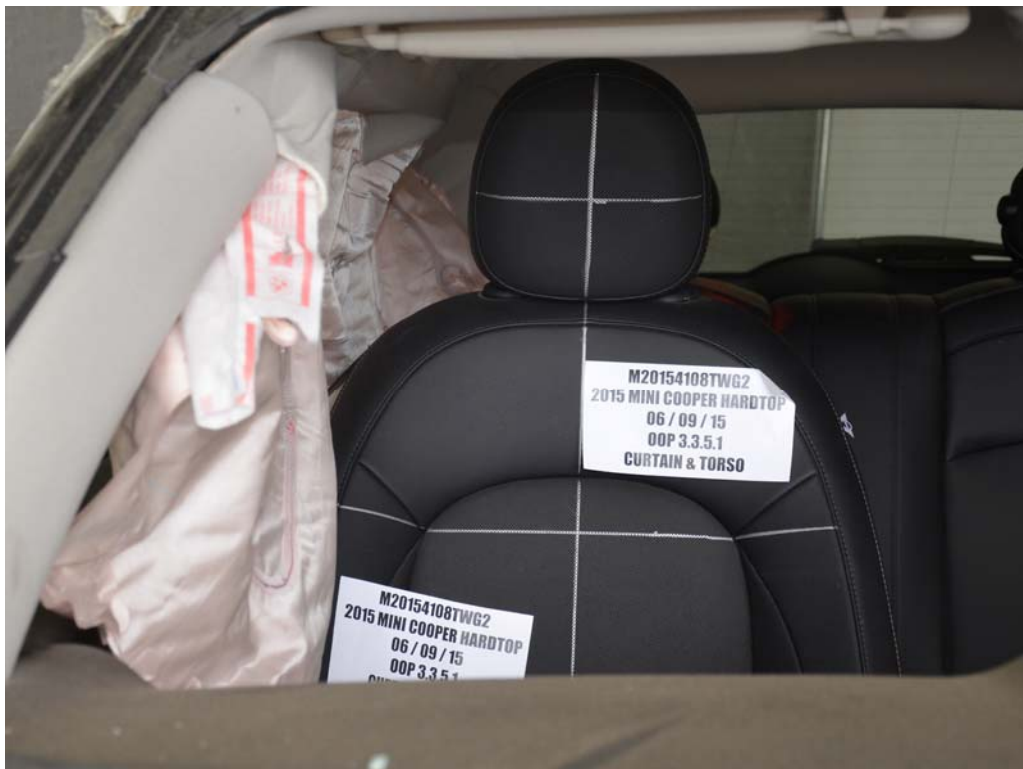
FIGURE 12. Post-Test Dummy Position, Front View

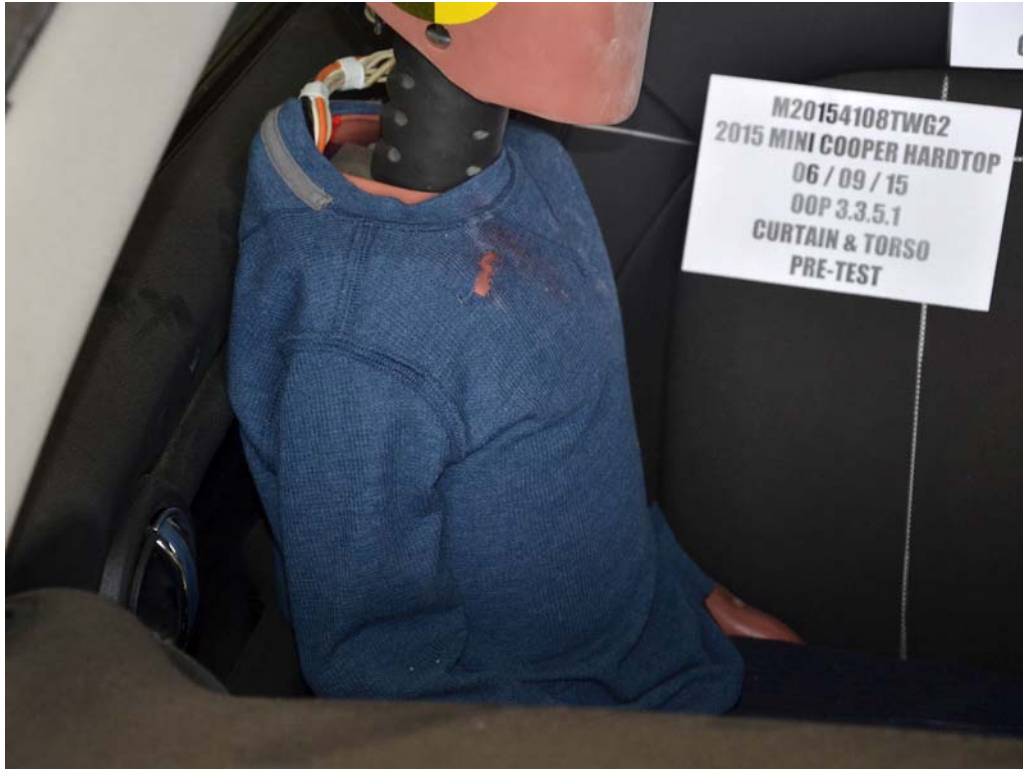
FIGURE 13. Pre-Test Dummy Position, Close-Up Front View

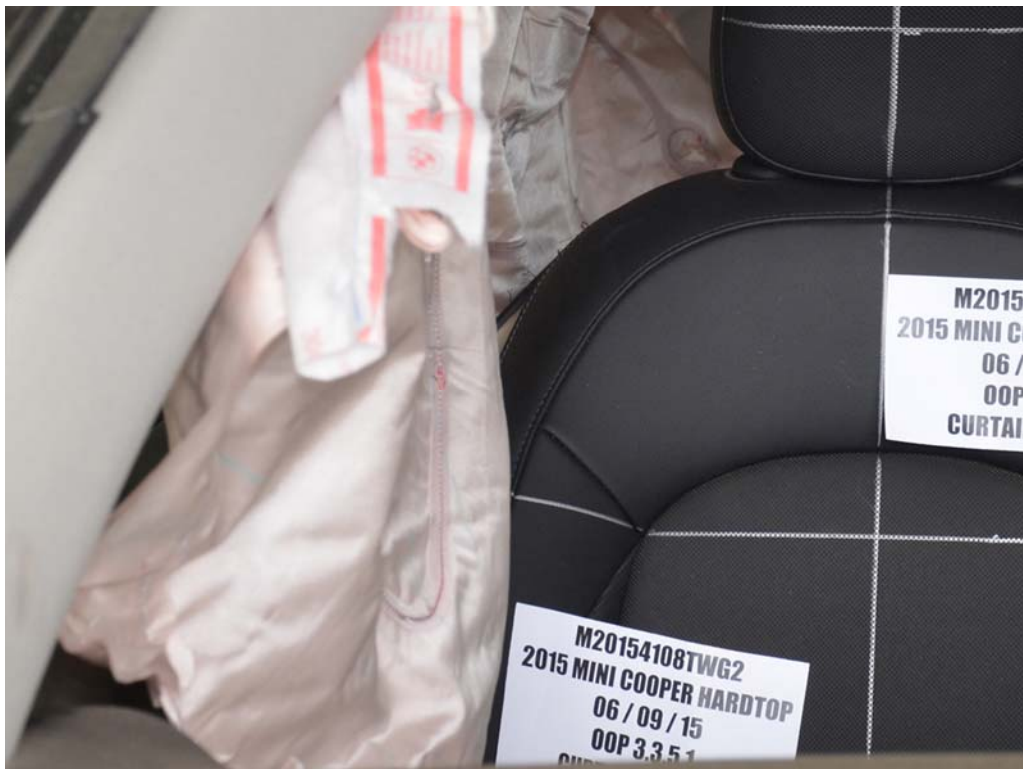
FIGURE 14. Post-Test Dummy Position, Close-Up Front View

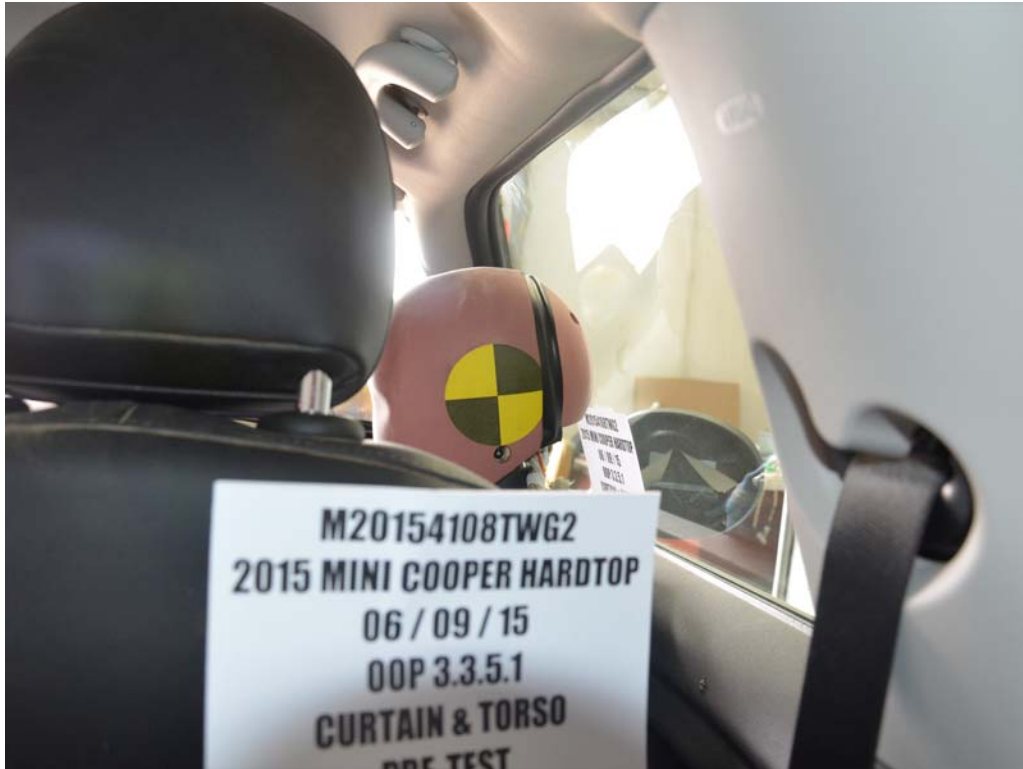
FIGURE 15. Pre-Test Dummy Position, Close-Up Rear View

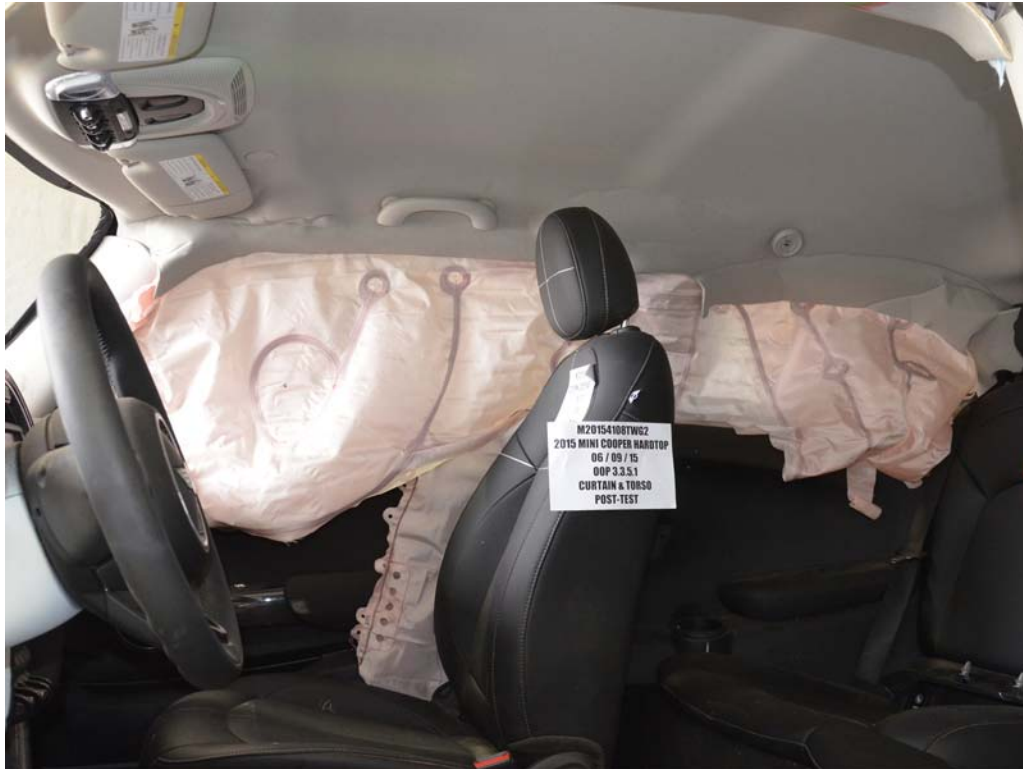
FIGURE 17. Post-Test Airbags, Left Side View

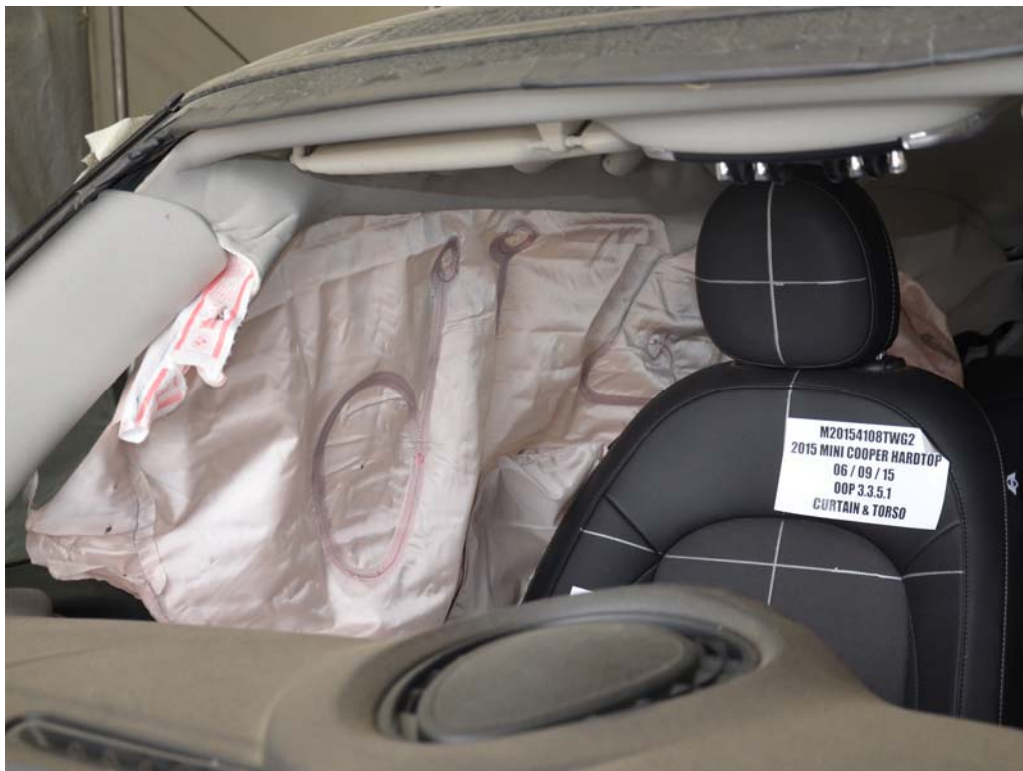
FIGURE 18. Post-Test Airbags, Left Front  $\frac{3}{4}$  View
