**REPORT NUMBER: TR-P35007-06-NC**

**SIDE AIRBAG OCCUPANT RISK PROGRAM  
OCCUPANT OUT-OF-POSITION TESTS**

**MERCEDES-BENZ U.S. INTL., INC.  
2015 MERCEDES-BENZ C300 4MATIC  
4-DOOR SEDAN**

**NHTSA NUMBER: M20154300TWG2**

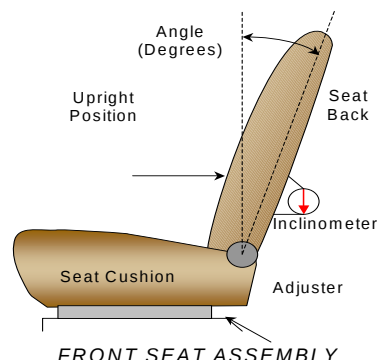
The passenger seat back is positioned per section 3.3.5.1 of the TWG recommendation in the Recommended Procedures for Evaluating Occupant Injury Risk from Deploying Side Airbags. Seat back angle is measured at the seat back.

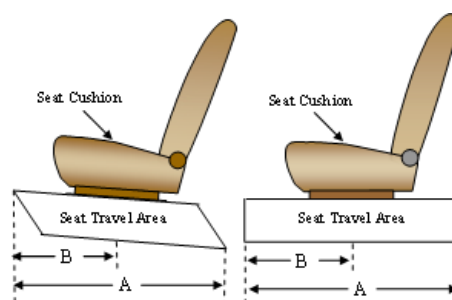
The passenger seat track travel is set per section 3.3.5.1 of the TWG recommendation in the Recommended Procedures for Evaluating Occupant Injury Risk from Deploying Side Airbags. The first or forward most position is counted as zero (0)

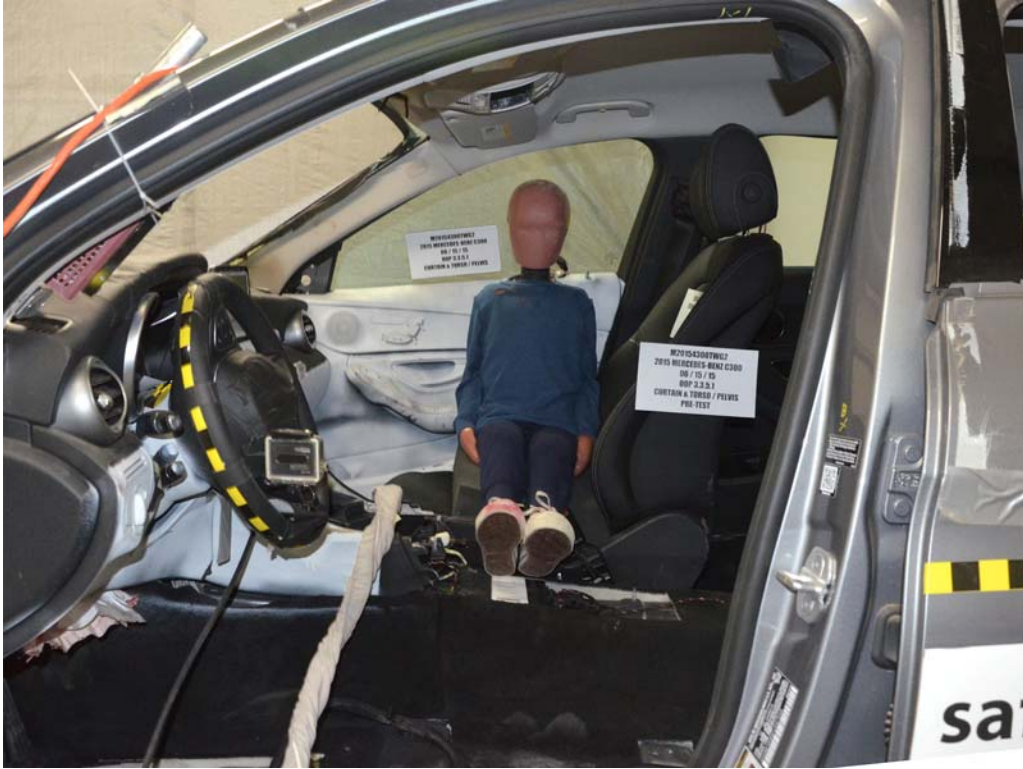
FIGURE 7. Pre-Test Dummy Position, Left Side View

Orientation of the 6-year old dummy was with the dummy facing forward. The seat is adjusted to its highest position. The dummy is placed on the foam block facing inboard with its arms hanging at its sides and its legs extended. The seat track is adjusted forward to minimize the vertical distance between the dummy's head and the roof module and to maximize the cushion to head interaction. The dummy's pelvis is slid outboard until its back contacts the door trim panel or armrest and the head is centered in the deployment trajectory of the curtain airbag with its shoulder bolts parallel to the vehicle centerline. This orientation complies with section 3.3.5.1 of the Technical Working Group (TWG) recommendation in the Recommended Procedures for Evaluating Occupant Injury Risk from Deploying Side Airbags.

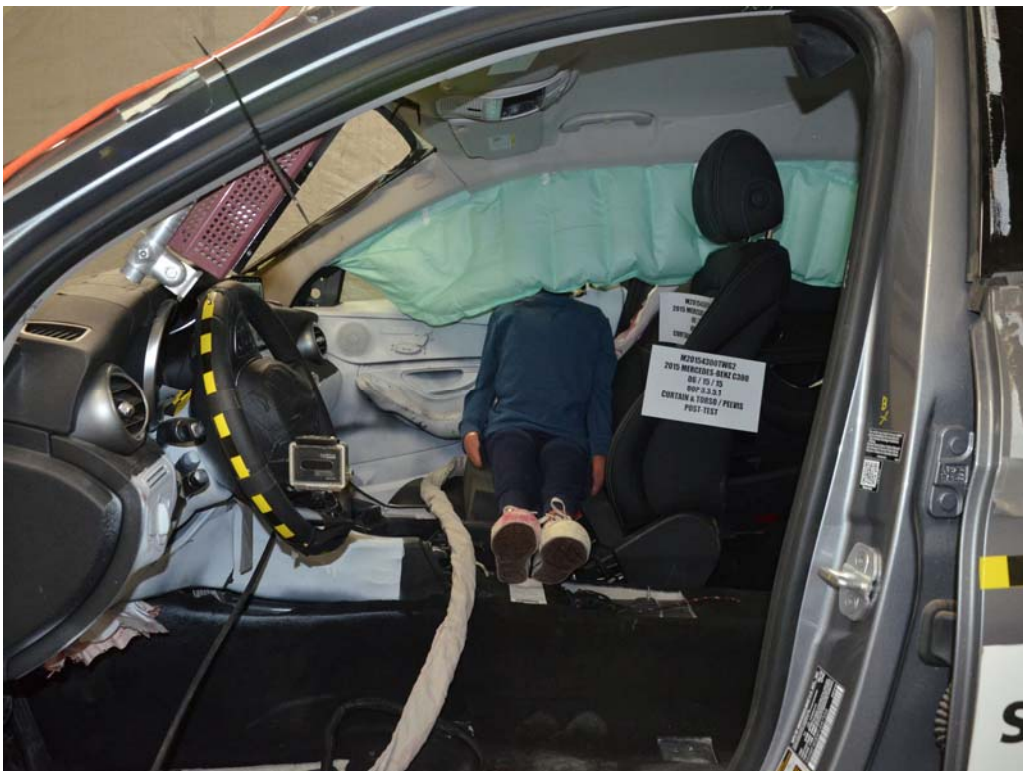
FIGURE 8. Post-Test Dummy Position, Left Side View

The 6-year old dummy's visible contact points were as follows: The ATD's head contacted the curtain airbag. The ATD's back and pelvis contacted the torso/pelvis airbag.

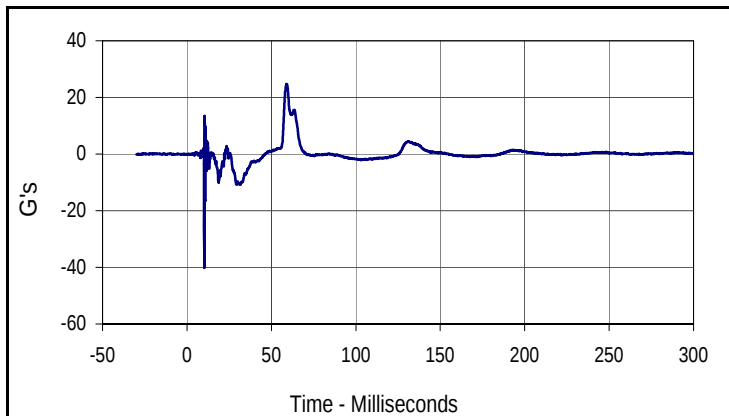
| Curve Description | | | |
|---|---|---|---|
| 6 Yr. Old Head X | | | |

| Curve Description | | | |
|---|---|---|---|
| 24.8 | 59.1 | -40.1 | 10.3 |

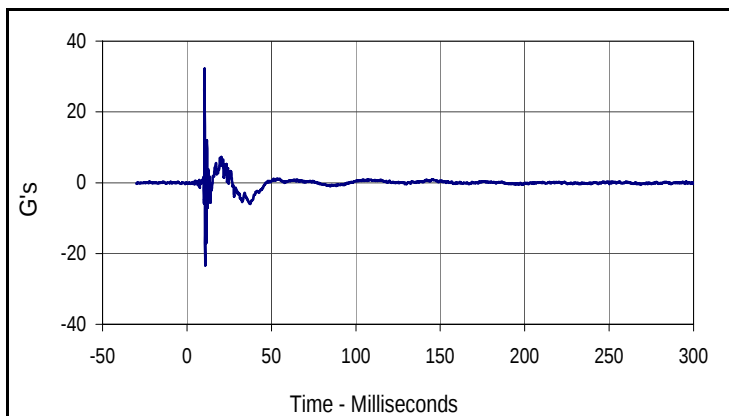
| Curve Description | | | |
|---|---|---|---|
| 6 Yr. Old Head Y | | | |

| Curve Description | | | |
|---|---|---|---|
| 32.2 | 10.4 | -23.4 | 10.8 |

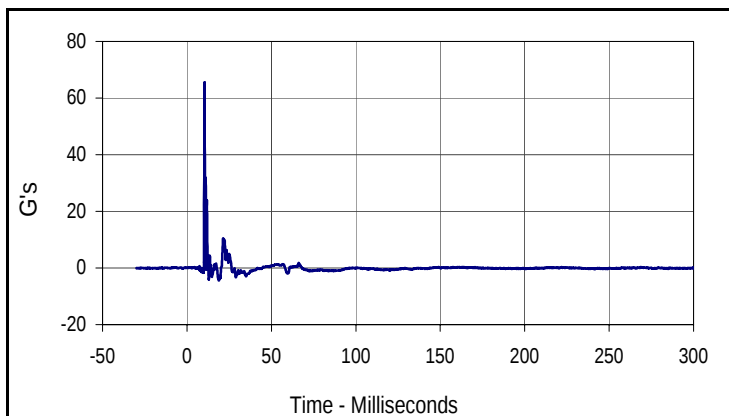
| Curve Description | | | |
|---|---|---|---|
| 6 Yr. Old Head Z | | | |

| Curve Description | | | |
|---|---|---|---|
| 65.4 | 10.4 | -4.4 | 18.9 |

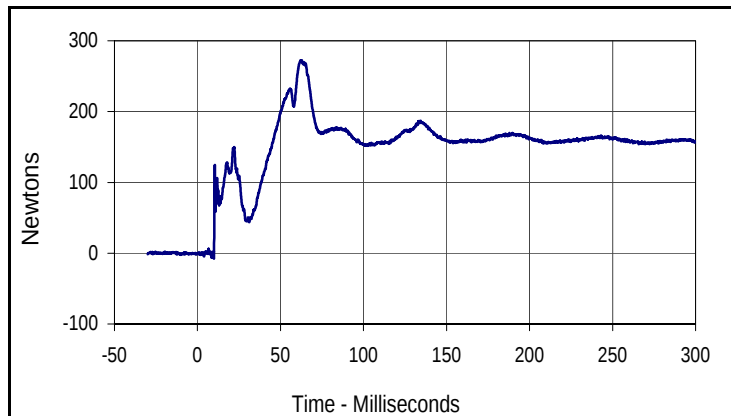
| Curve Description | | | |
|---|---|---|---|
| 6 Yr. Old Upper Neck Force X | | | |

| Curve Description | | | |
|---|---|---|---|
| 272.5 | 62.8 | -7.3 | 9.9 |

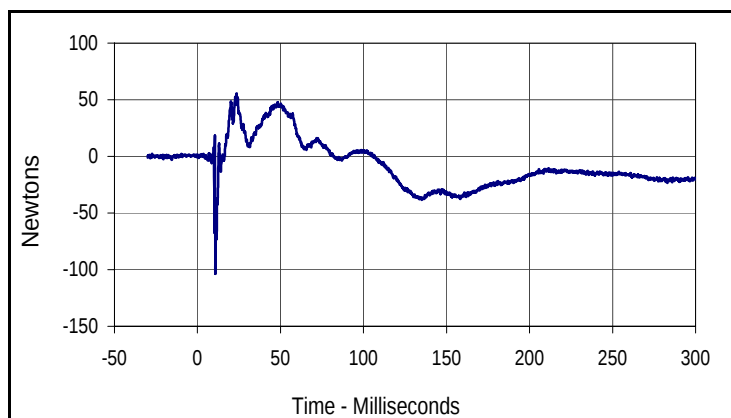
| Curve Description | | | |
|---|---|---|---|
| 6 Yr. Old Upper Neck Force Y | | | |

| Curve Description | | | |
|---|---|---|---|
| 55.5 | 23.6 | -103.8 | 10.8 |

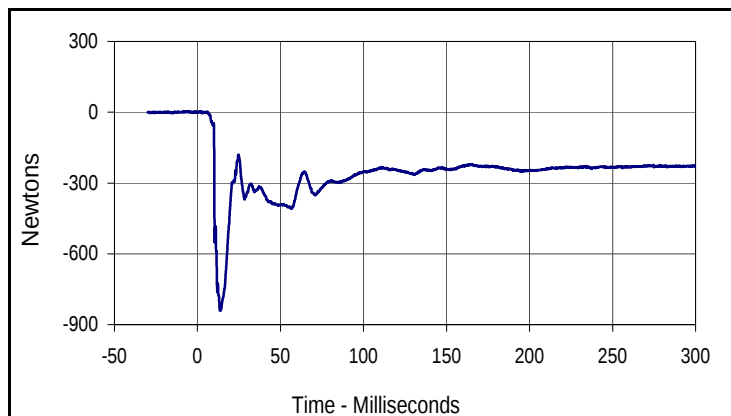
| Curve Description | | | |
|---|---|---|---|
| 6 Yr. Old Upper Neck Force Z | | | |

| Curve Description | | | |
|---|---|---|---|
| 3.4 | 1.1 | -840.9 | 13.6 |

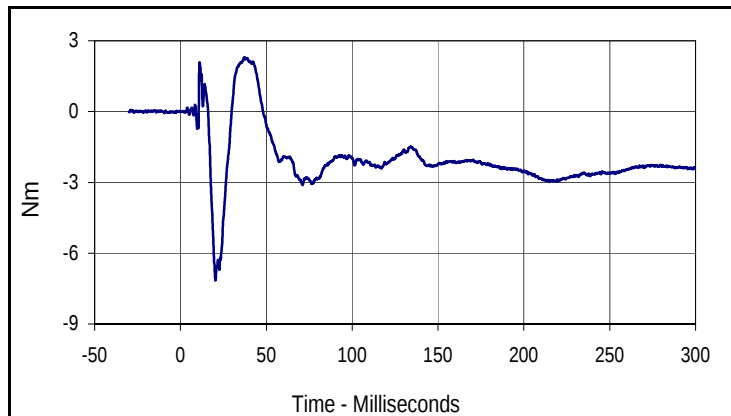
| Curve Description | | | |
|---|---|---|---|
| 6 Yr. Old Upper Neck Moment X | | | |

| Curve Description | | | |
|---|---|---|---|
| 2.3 | 37.5 | -7.2 | 20.4 |

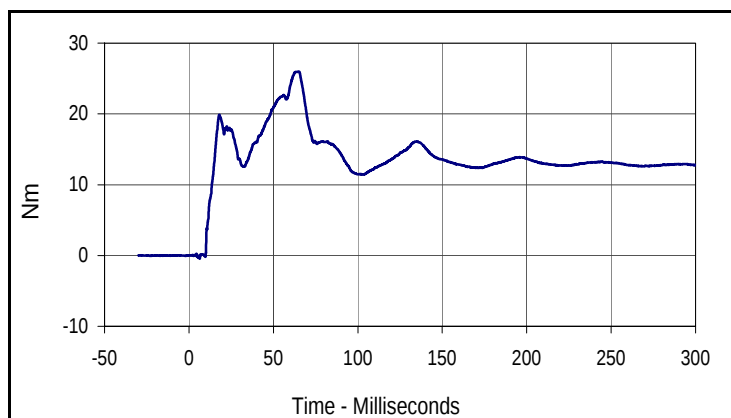
| Curve Description | | | |
|---|---|---|---|
| 6 Yr. Old Upper Neck Moment Y | | | |

| Curve Description | | | |
|---|---|---|---|
| 26.0 | 65.2 | -0.4 | 6.3 |

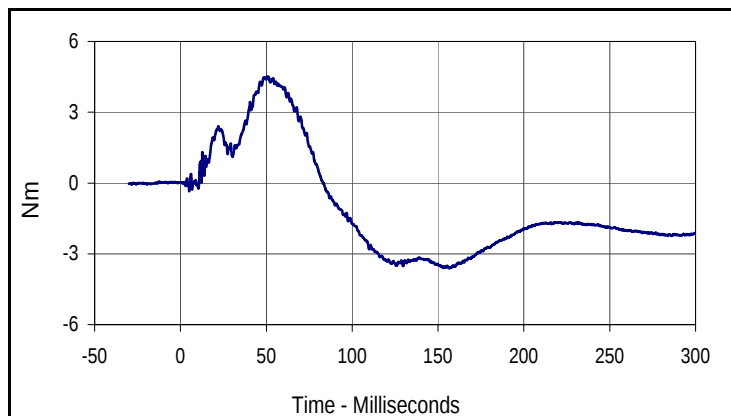
| Curve Description | | | |
|---|---|---|---|
| 6 Yr. Old Upper Neck Moment Z | | | |

| Curve Description | | | |
|---|---|---|---|
| 4.5 | 50.7 | -3.6 | 156.7 |

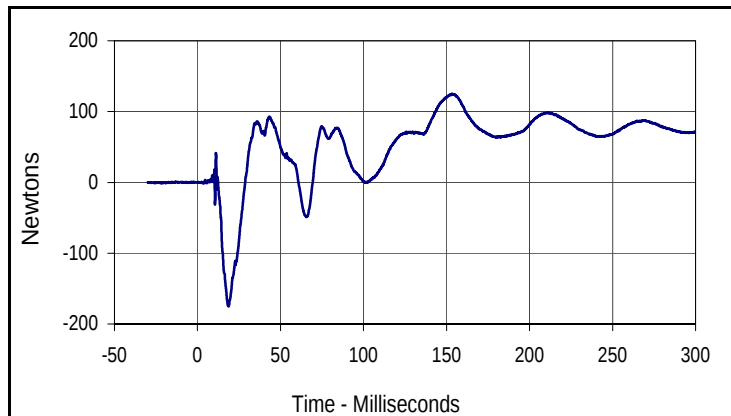
| Curve Description | | | |
|---|---|---|---|
| 6 Yr. Old Lower Neck Force X | | | |

| Curve Description | | | |
|---|---|---|---|
| 125.5 | 153.4 | -175.2 | 18.8 |

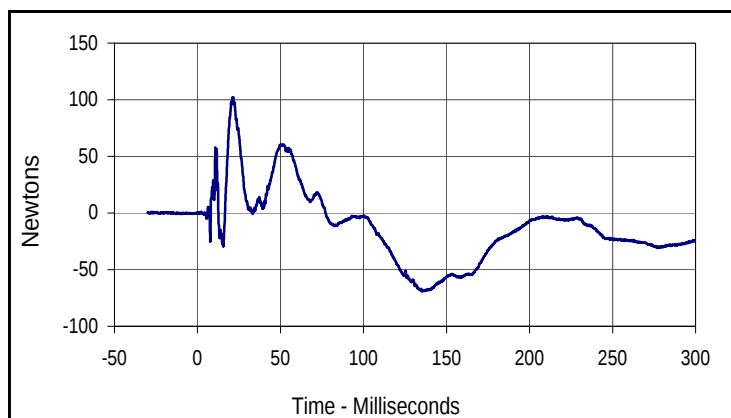
| Curve Description | | | |
|---|---|---|---|
| 6 Yr. Old Lower Neck Force Y | | | |

| Curve Description | | | |
|---|---|---|---|
| 102.4 | 21.5 | -69.1 | 135.2 |

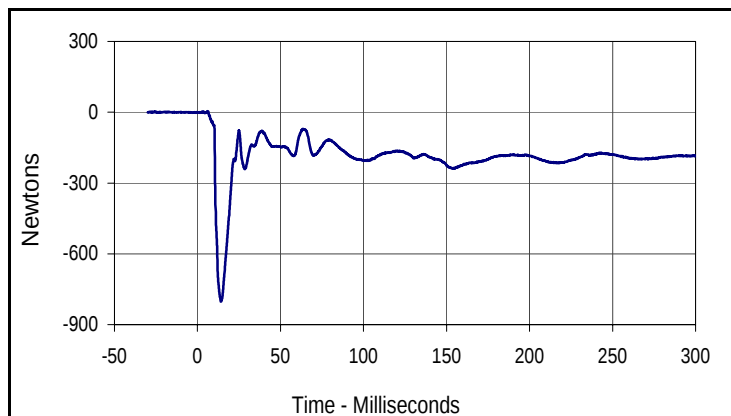
| Curve Description | | | |
|---|---|---|---|
| 6 Yr. Old Lower Neck Force Z | | | |

| Curve Description | | | |
|---|---|---|---|
| 3.9 | 6.3 | -802.6 | 14.1 |

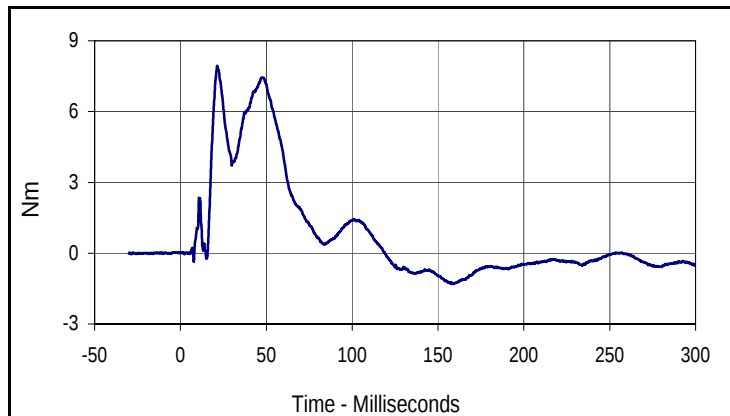
| Curve Description | | | |
|---|---|---|---|
| 6 Yr. Old Lower Neck Moment X | | | |

| Curve Description | | | |
|---|---|---|---|
| 7.9 | 21.4 | -1.3 | 159.1 |

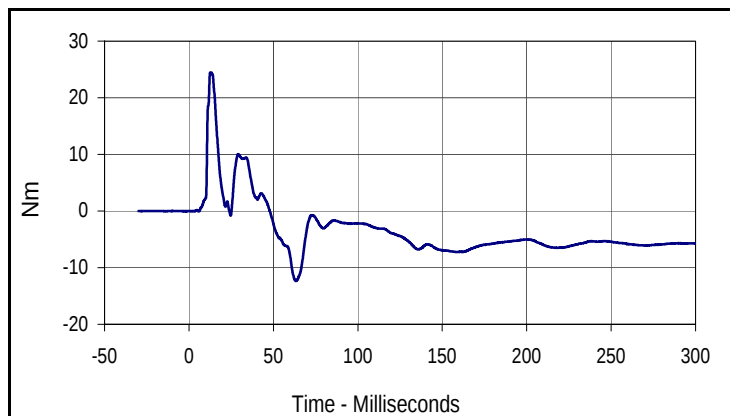
| Curve Description | | | |
|---|---|---|---|
| 6 Yr. Old Lower Neck Moment Y | | | |

| Curve Description | | | |
|---|---|---|---|
| 24.5 | 13.1 | -12.3 | 63.3 |

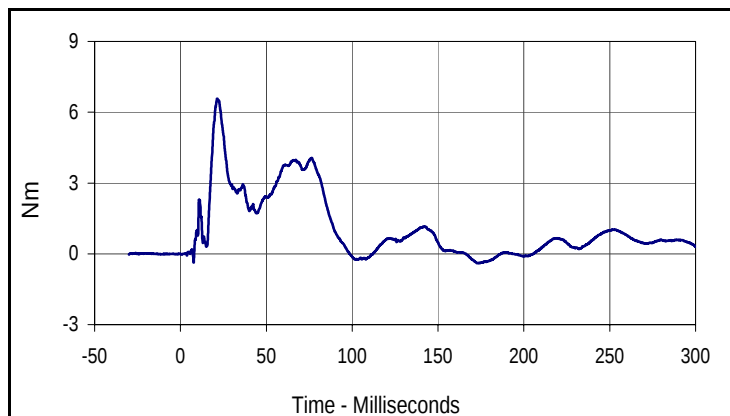
| Curve Description | | | |
|---|---|---|---|
| 6 Yr. Old Lower Neck Moment Z | | | |

| Curve Description | | | |
|---|---|---|---|
| 6.6 | 21.4 | -0.4 | 173.3 |

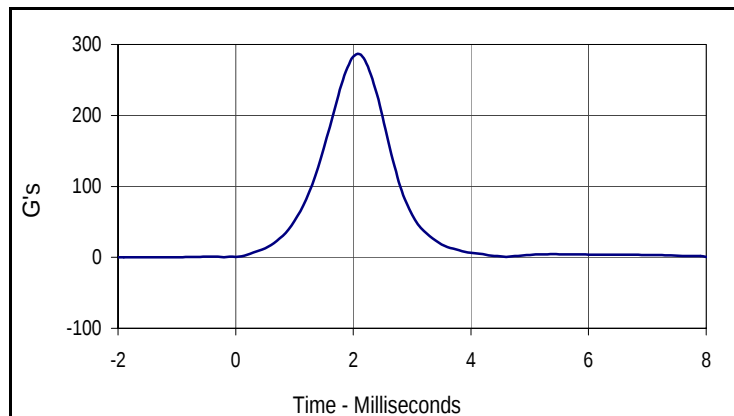
| Curve Description | | | |
|---|---|---|---|
| Head Resultant | | | |

| Curve Description | | | |
|---|---|---|---|
| 286.4 | 2.1 | 0.2 | -1.0 |

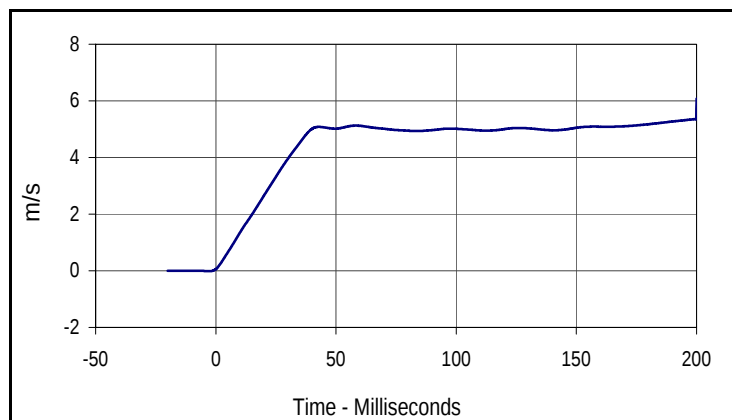
| Curve Description | | | |
|---|---|---|---|
| Pendulum Velocity | | | |

| Curve Description | | | |
|---|---|---|---|
| 6.1 | 200.0 | 0.0 | -2.8 |

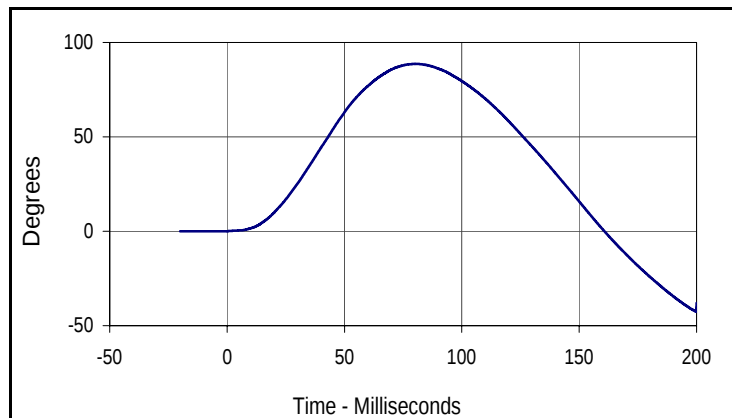
| Curve Description | | | |
|---|---|---|---|
| "D" Plane Rotation | | | |

| Curve Description | | | |
|---|---|---|---|
| 88.6 | 80.6 | -42.5 | 199.9 |

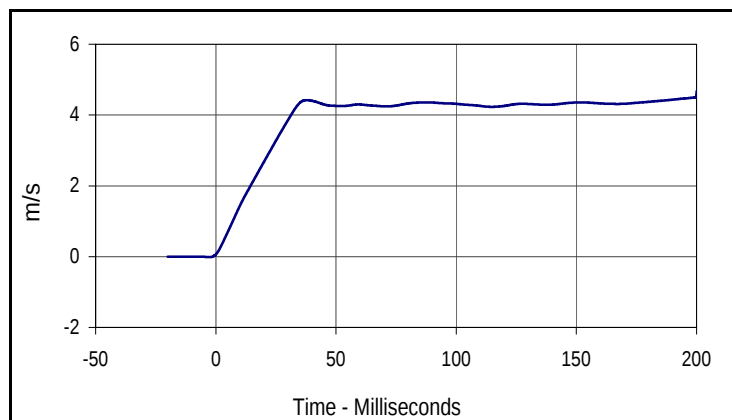
| Curve Description | | | |
|---|---|---|---|
| Pendulum Velocity | | | |

| Curve Description | | | |
|---|---|---|---|
| 4.7 | 200.0 | 0.0 | -2.8 |

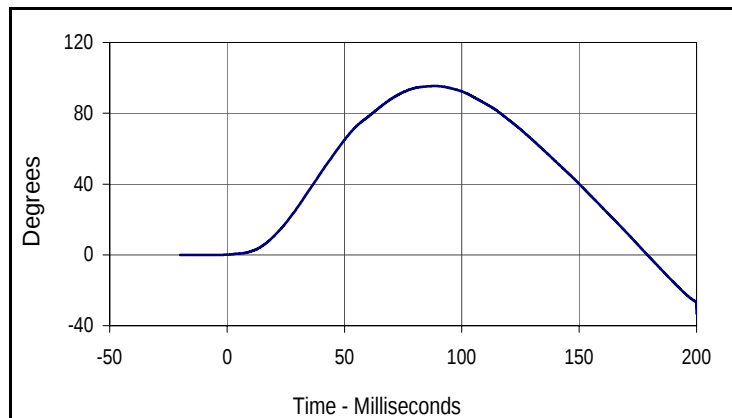
| Curve Description | | | |
|---|---|---|---|
| "D" Plane Rotation | | | |

| Curve Description | | | |
|---|---|---|---|
| 95.4 | 88.7 | -33.3 | 200.0 |
