REPORT NUMBER: TWG-CAL-14-04

NEW CAR ASSESSMENT PROGRAM (NCAP)
SIDE AIRBAG OUT-OF-POSITION INJURY TESTING

Ford Motor Co.
2015 Ford Focus

NHTSA NUMBER: M20150222TWG2
CALSPAN TEST NUMBER: CT2014-04

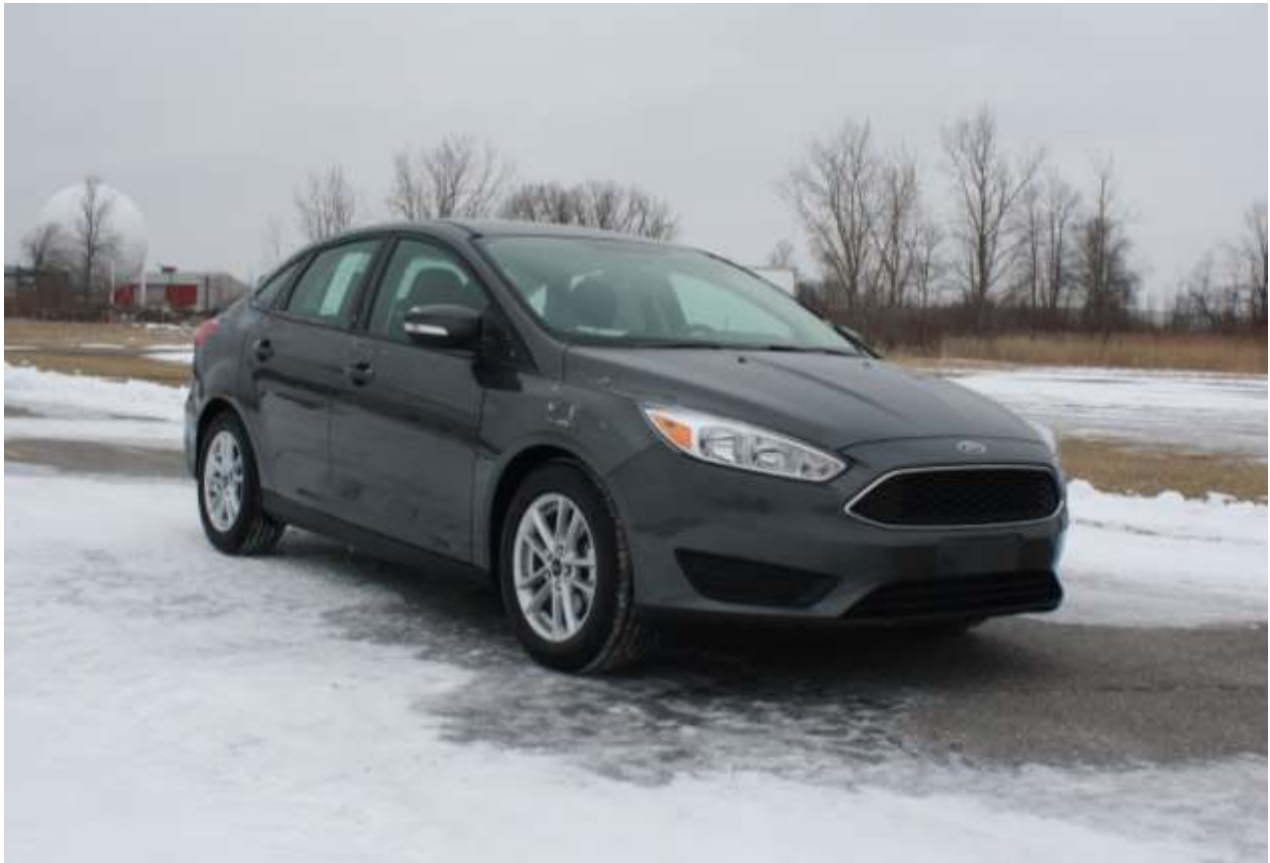
Figure A-1: Right ¾ Front View of Vehicle, As Received

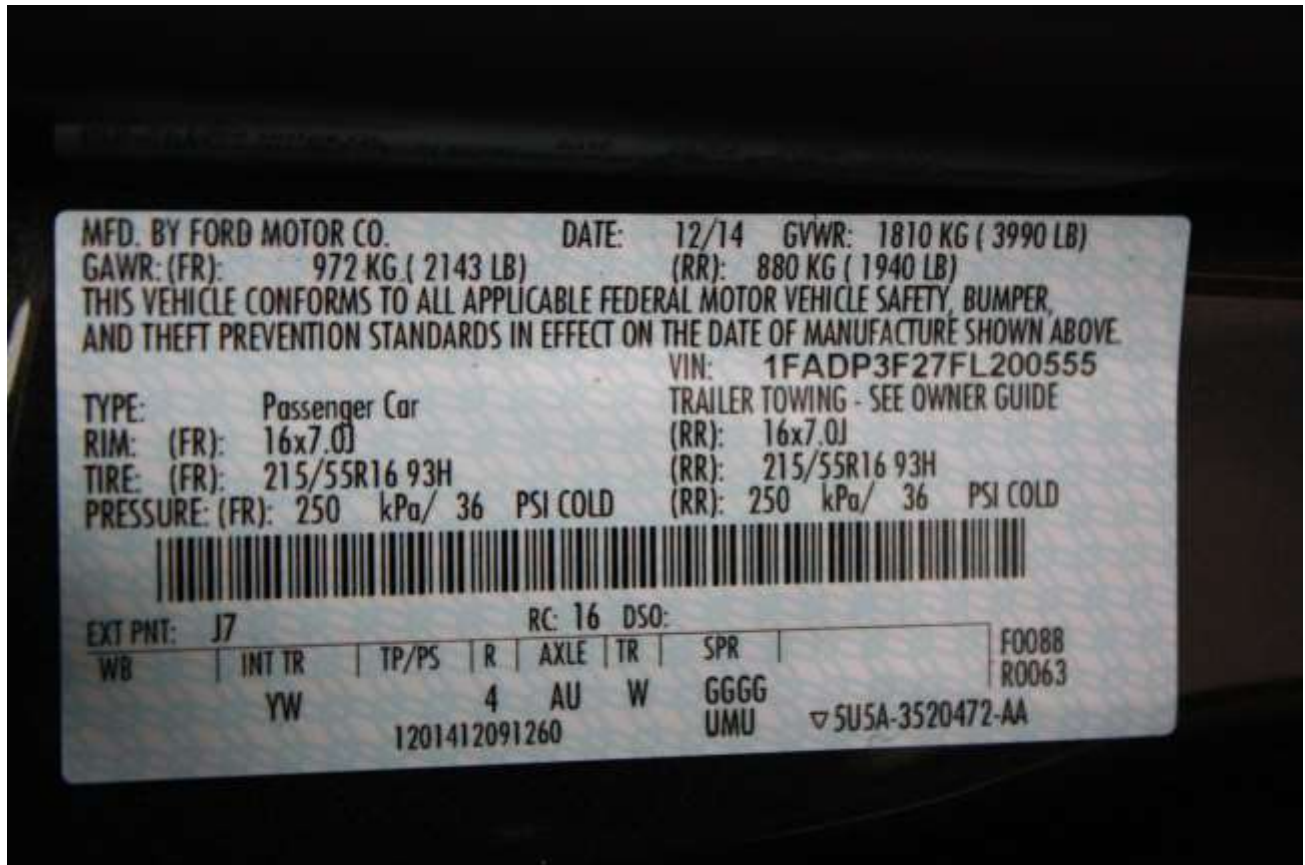
Figure A-2: Vehicle Certification Placard

DATA FROM TIRE VEHICLE'S CERTIFICATION LABEL:

Vehicle Manufactured by: Ford Motor Co.

Date of Manufacture 12/2014

GVWR: 1810 kg; GAWR: 972 kg FRONT; 880 kg REAR

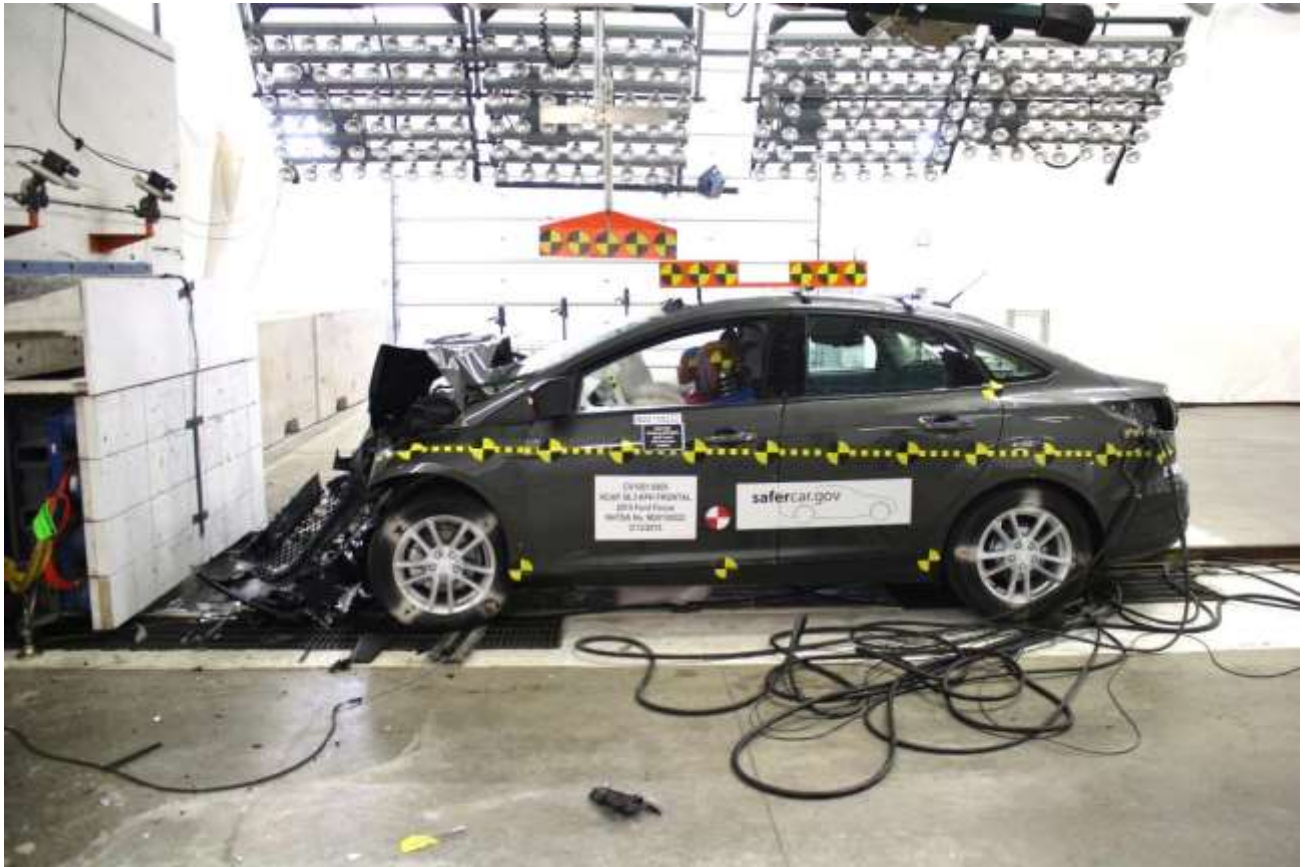
Figure A-3: Pre-Test Vehicle Left Side View

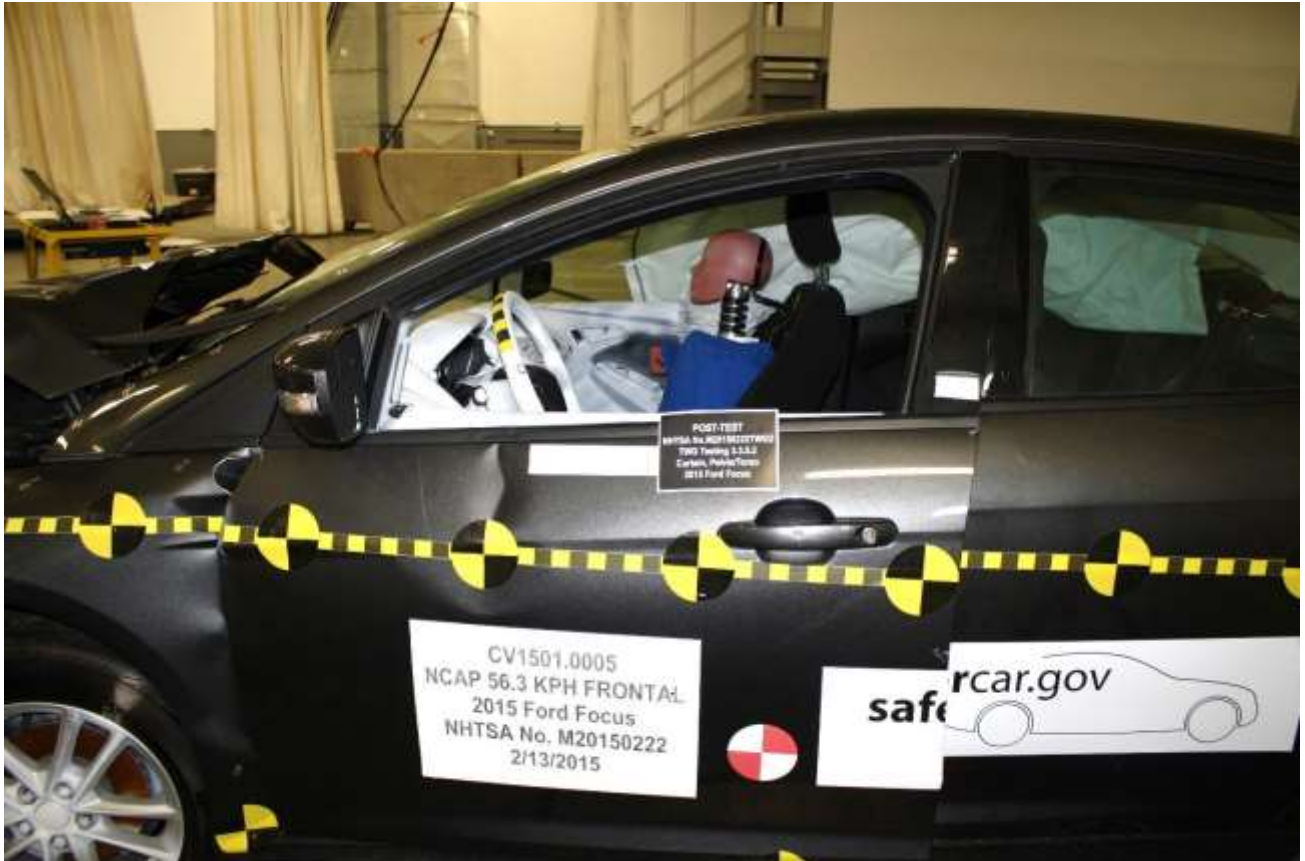
Figure A-4: Post-Test Vehicle Left Side View

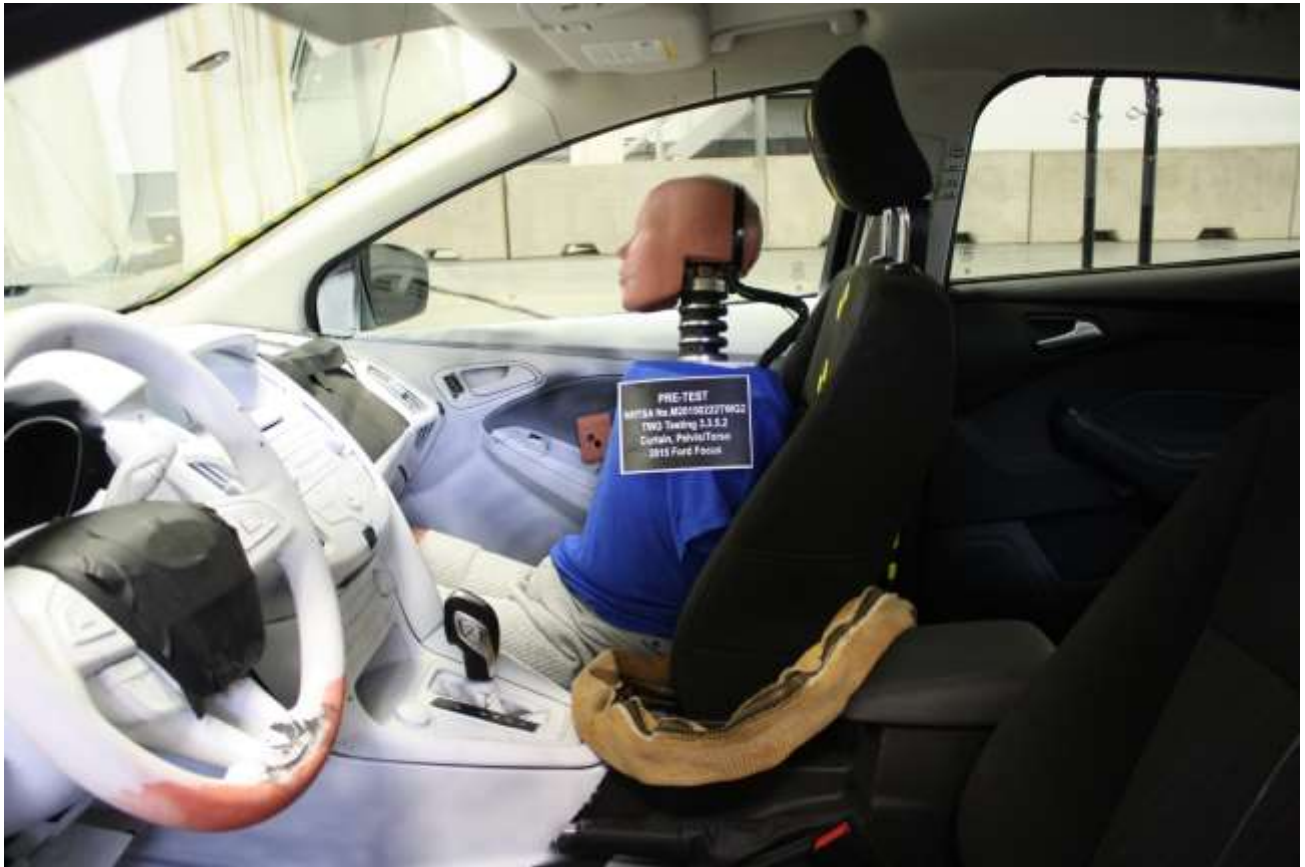
Figure A-5: Pre-Test SID-IIs Dummy Left Side View

PRE-TEST VISIBLE DUMMY CONTACT POINTS

Head Contact:	None
Upper Torso Contact:	Seat Back
Lower Torso Contact:	Seat Back
Knee Contact:	None
Foot Contact:	None

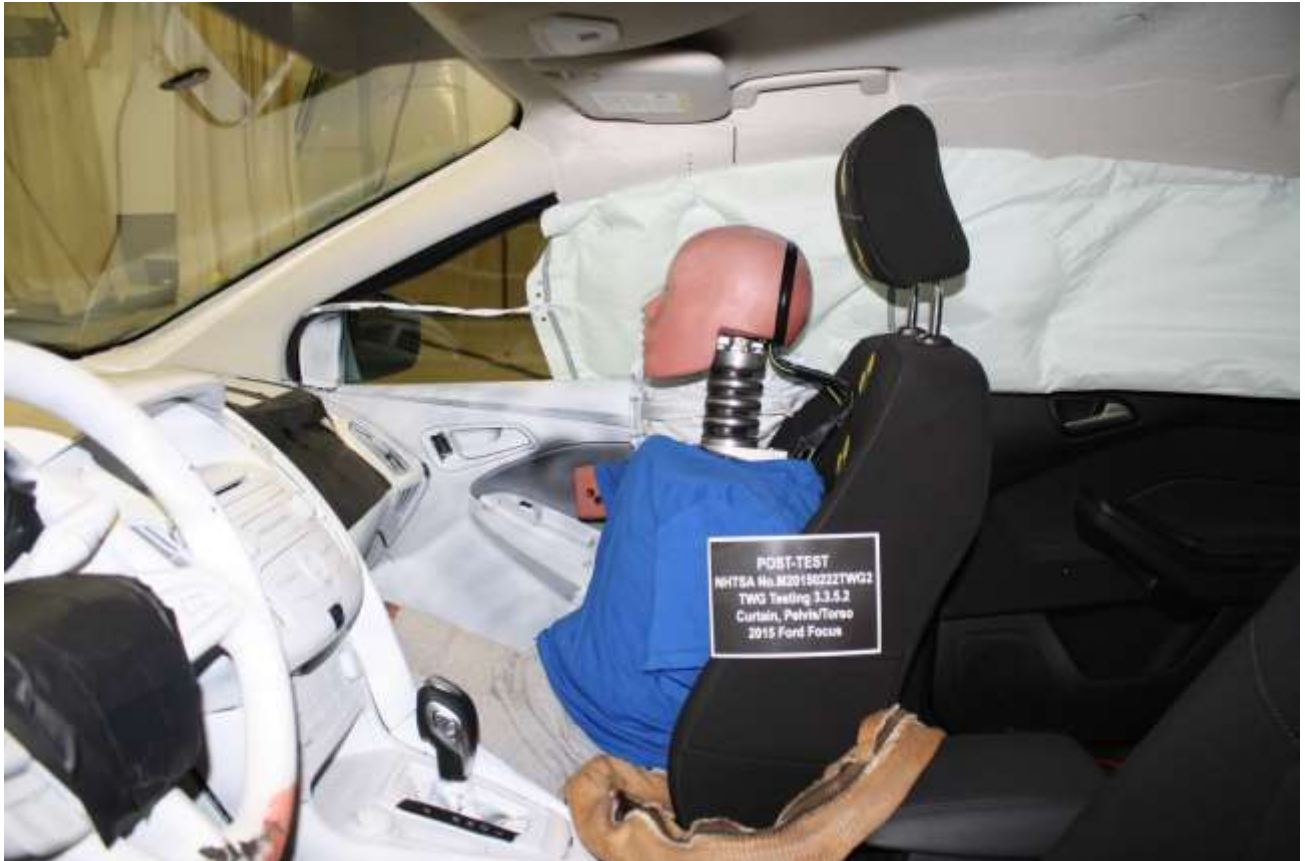
Figure A-6: Post-Test SID-IIs Dummy Left Side View

POST-TEST VISIBLE DUMMY CONTACT POINTS

Head Contact:	Curtain Airbag
Upper Torso Contact:	Seat/Torso Airbag, Seat Back
Lower Torso Contact:	Seat/Torso Airbag, Seat Back
Knee Contact:	None
Foot Contact:	None

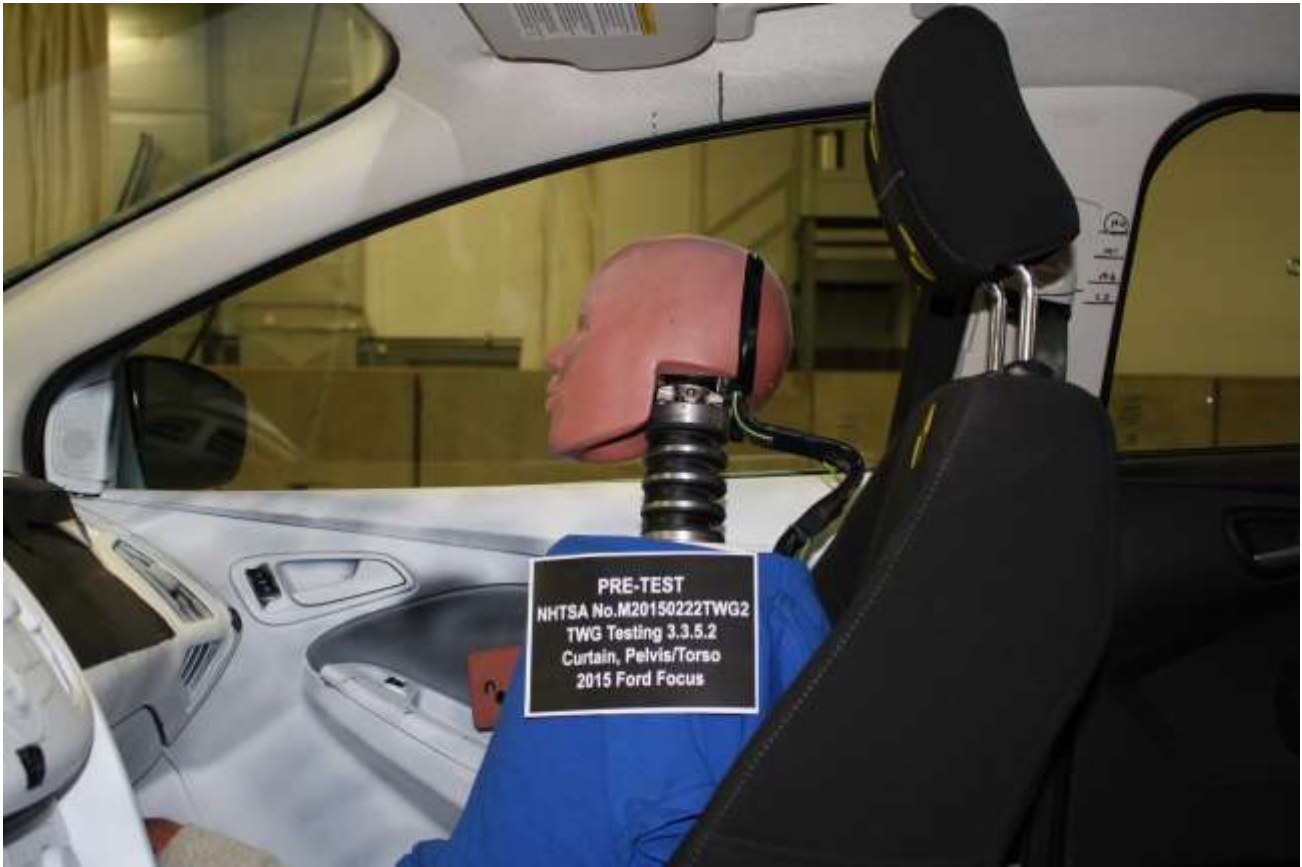
Figure A-7: Pre-Test SID-IIs Dummy Left Side Close-up View

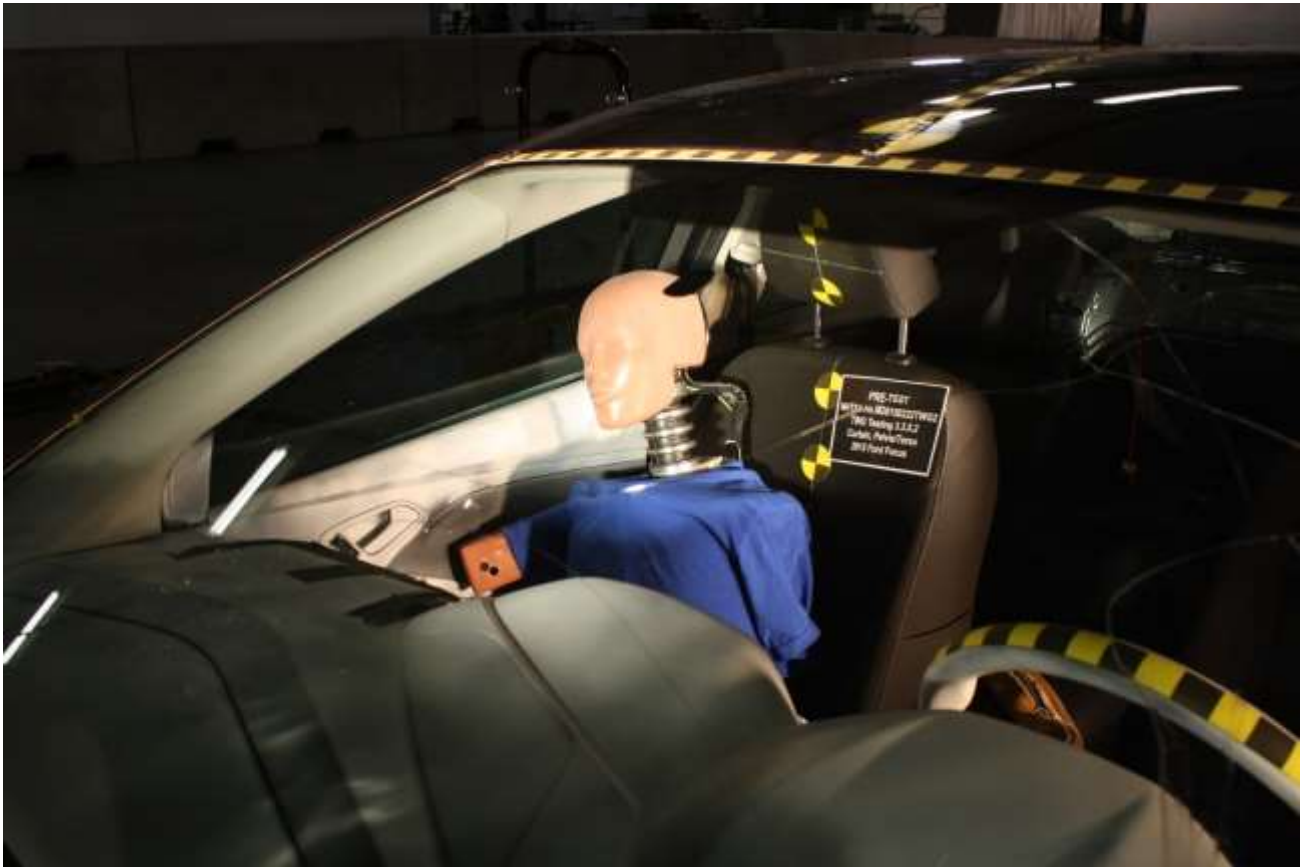
Figure A-9: Pre-Test SID-IIs Dummy Left $\frac{3}{4}$ Front View

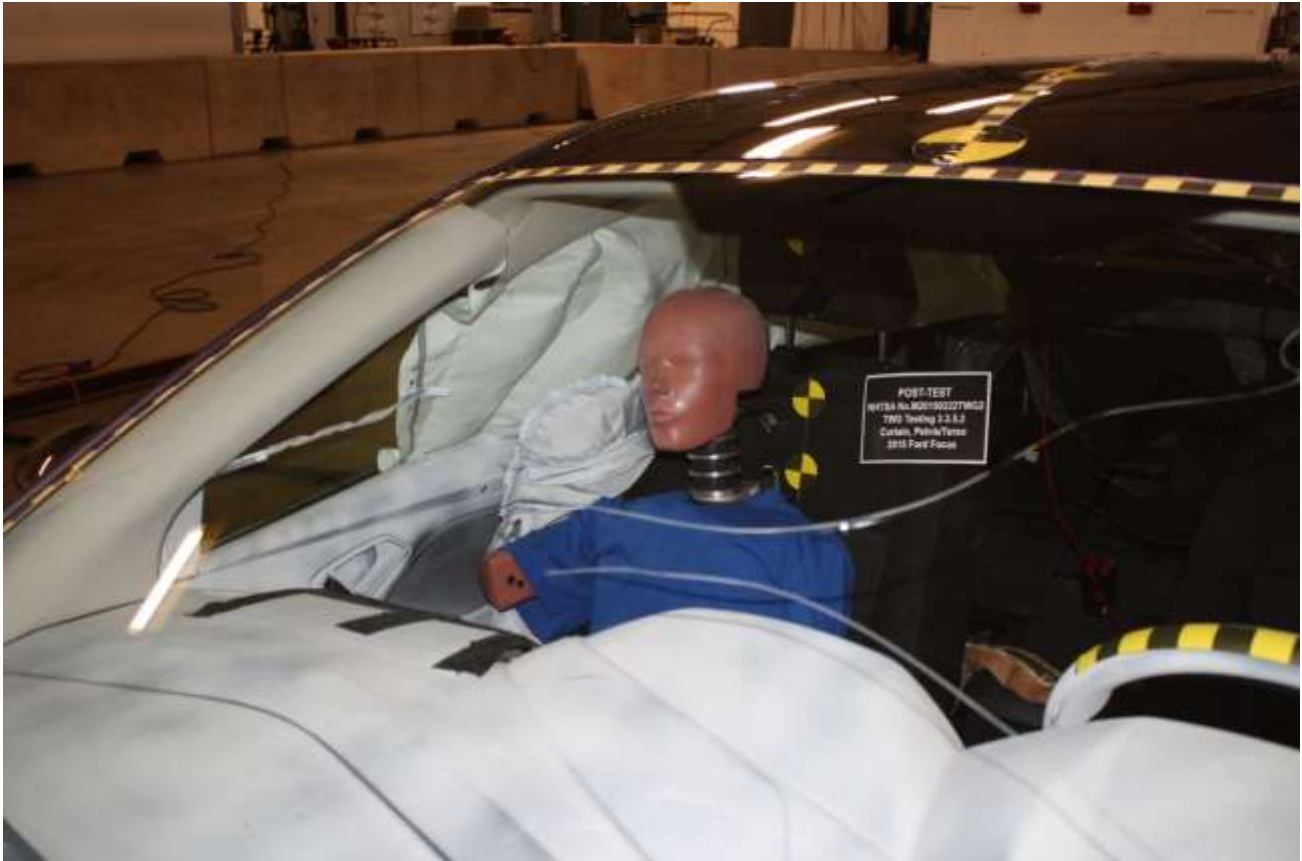
Figure A-10: Post-Test SID-IIs Dummy Left $\frac{3}{4}$ Front View

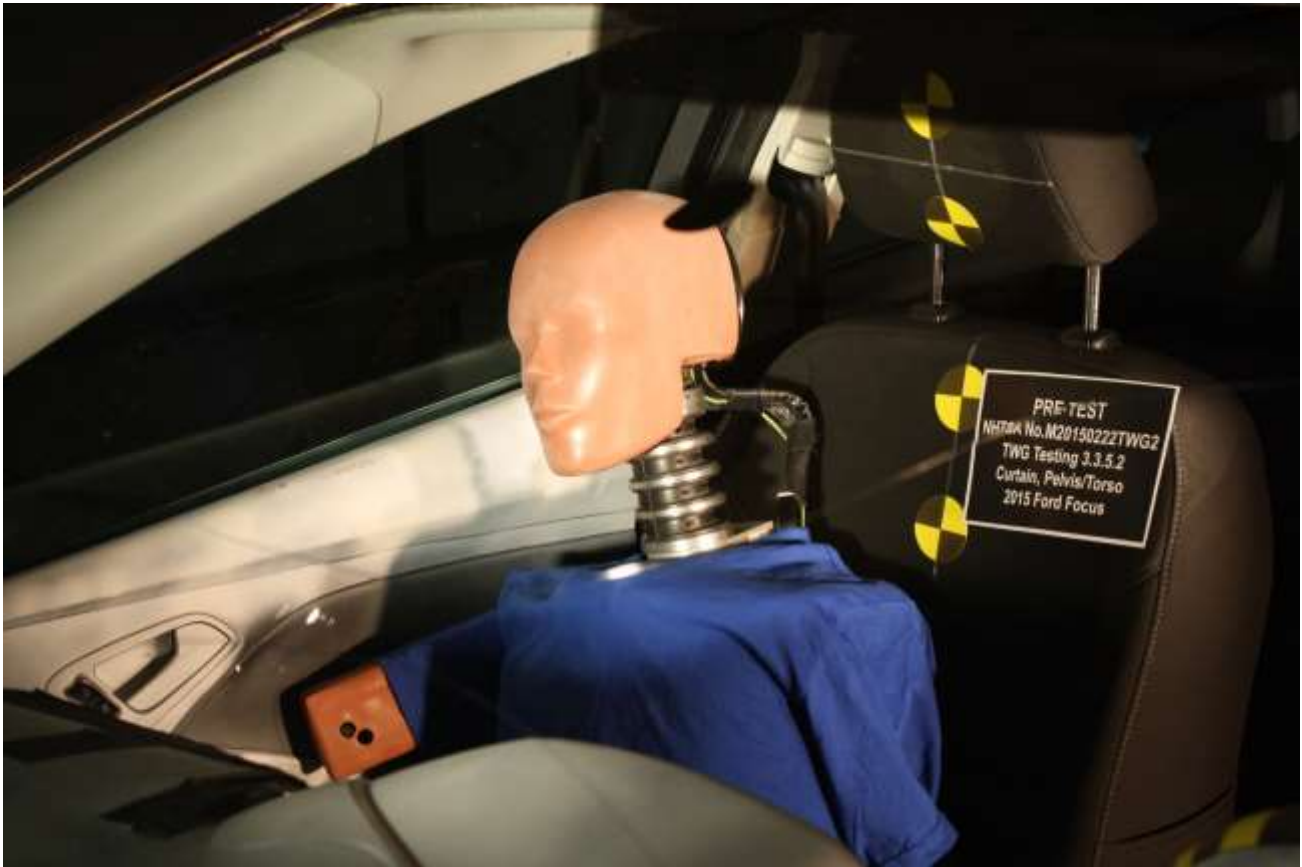
Figure A-11: Pre-Test SID-IIs Dummy Left $\frac{3}{4}$ Front Close-up View

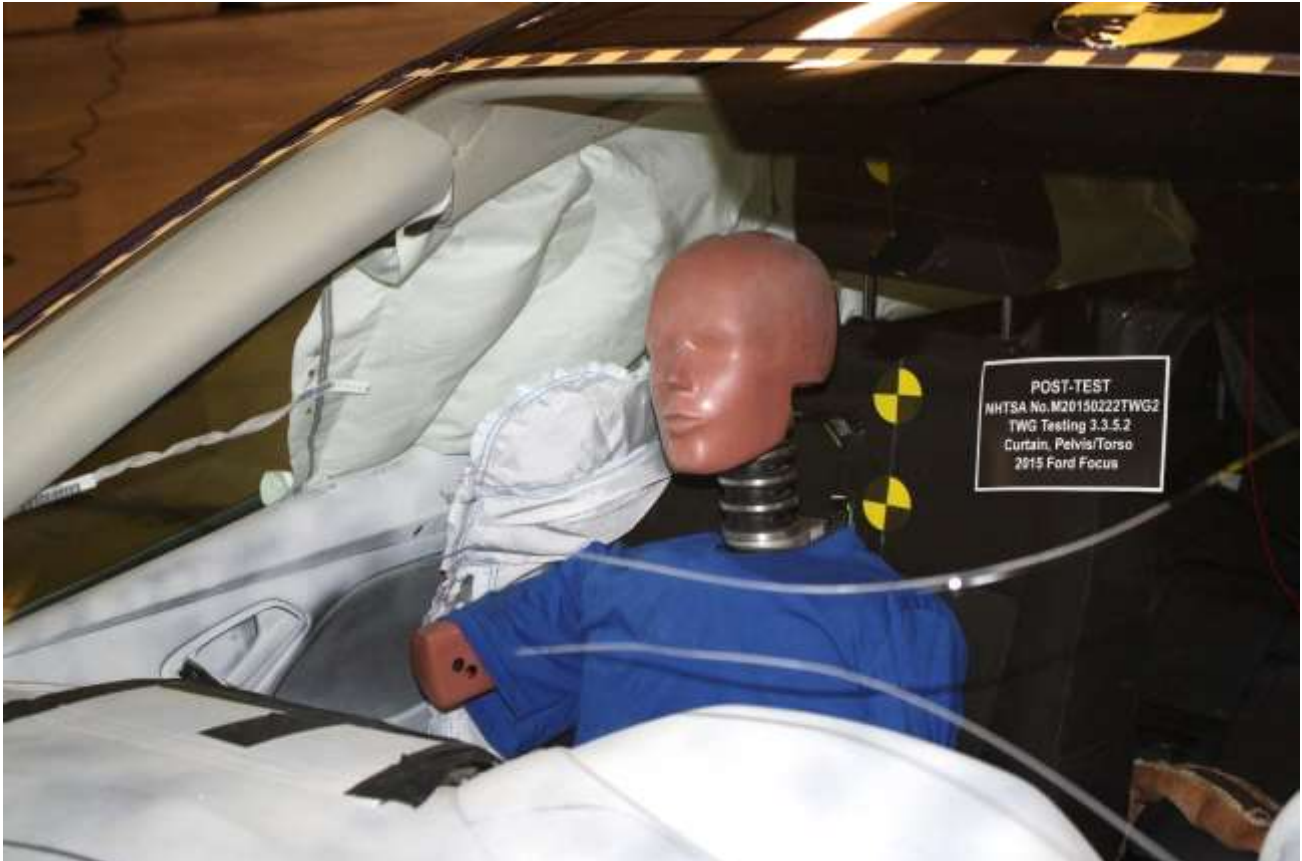
Figure A-12: Post-Test SID-IIs Dummy Left $\frac{3}{4}$ Front Close-up View

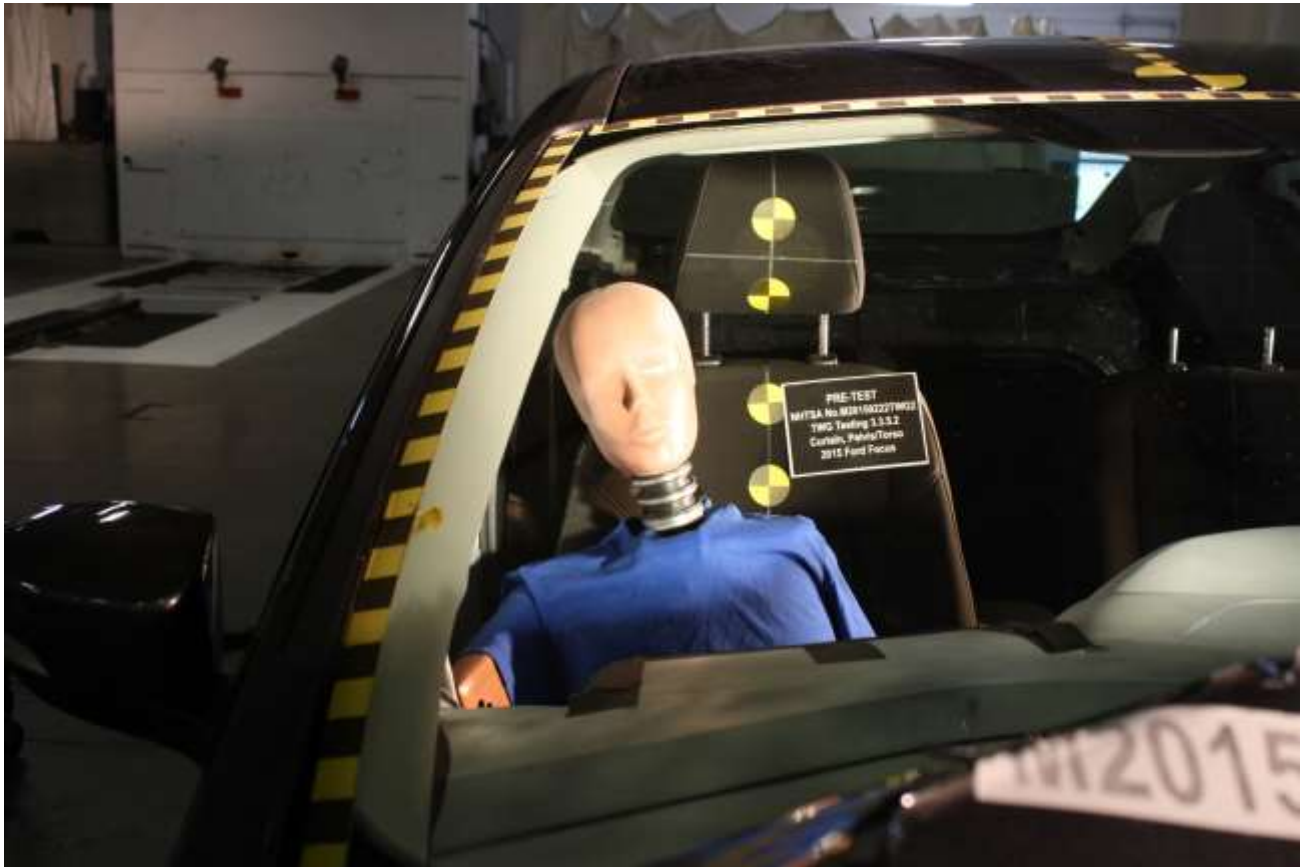
Figure A-13: Pre-Test SID-IIs Dummy Front View

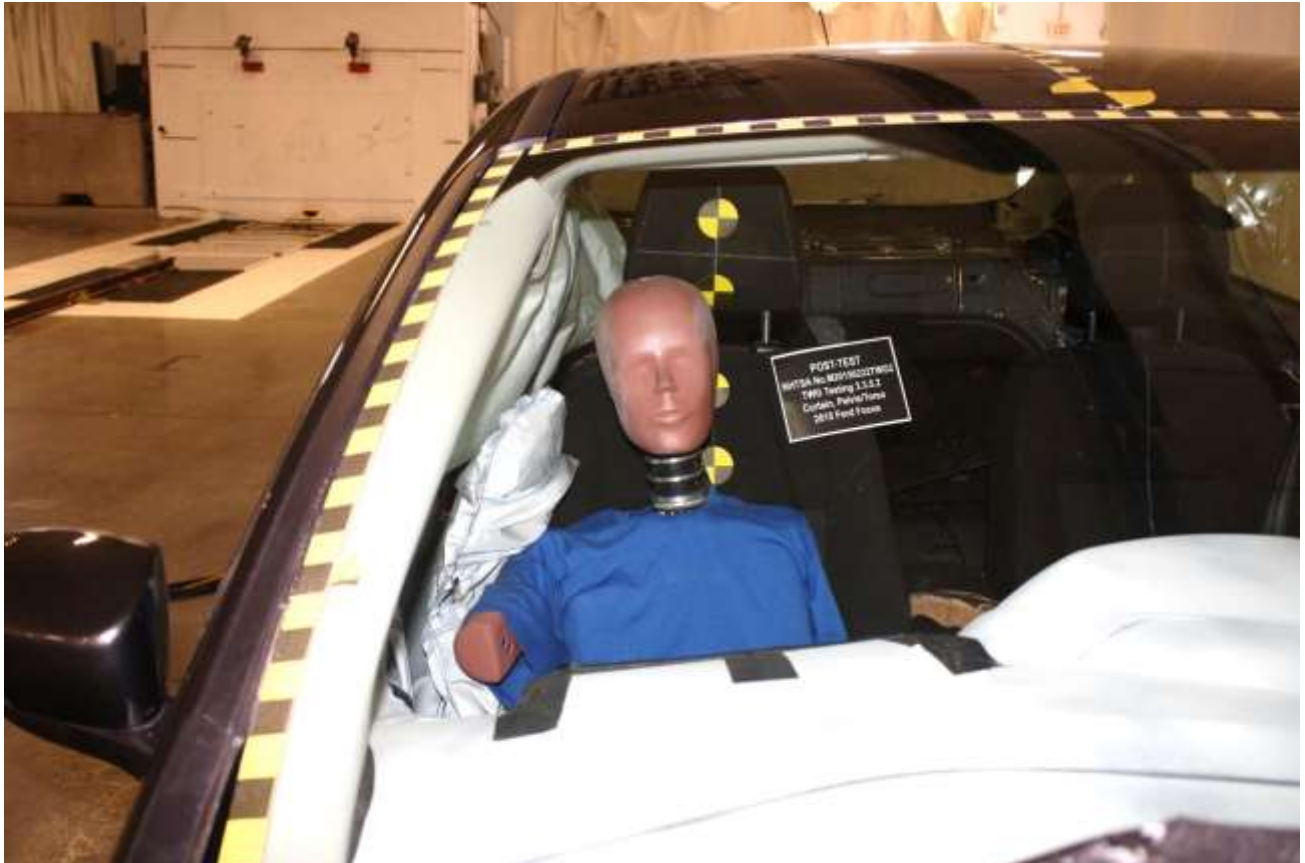
Figure A-14: Post-Test SID-IIs Dummy Front View

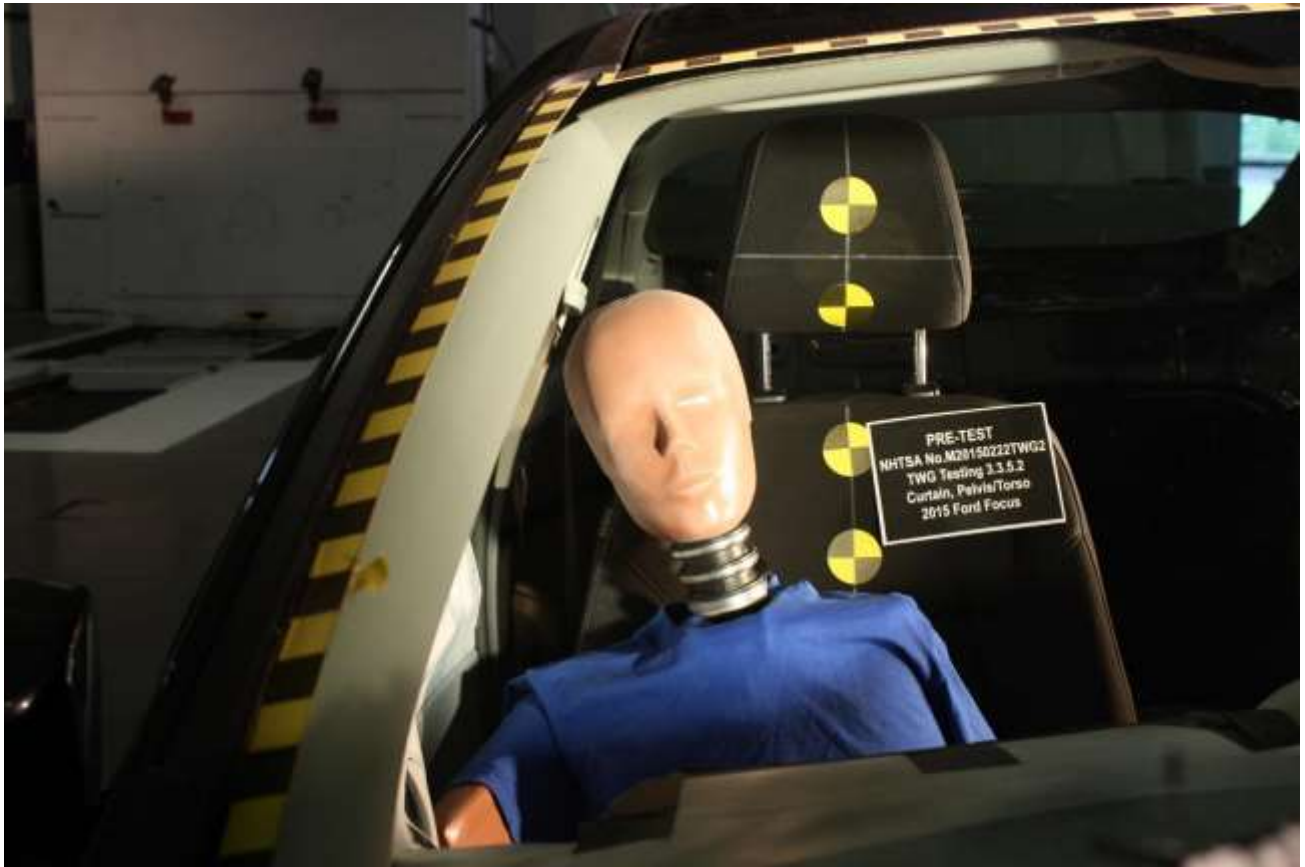
Figure A-15: Pre-Test SID-IIs Dummy Front Close-up View

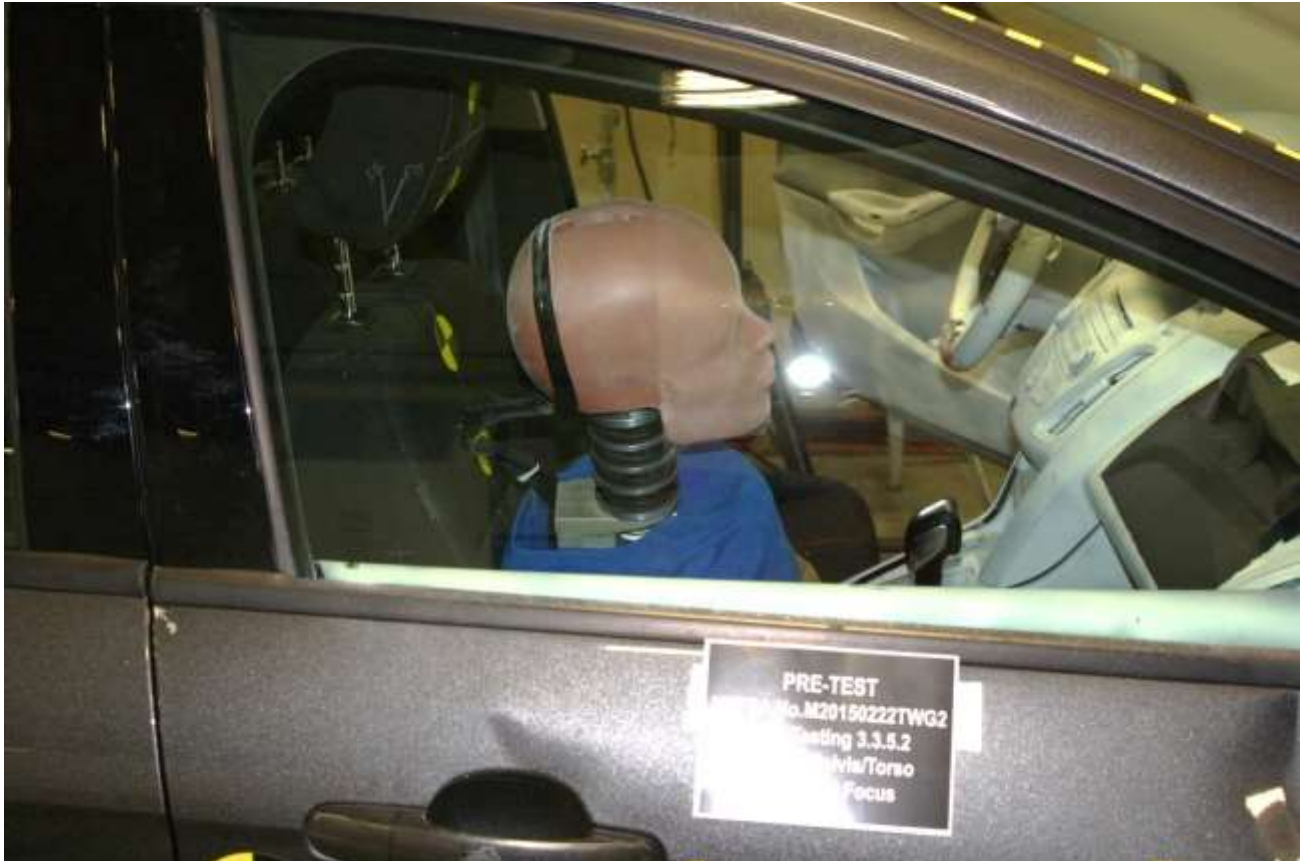
Figure A-16: Pre-Test SID-IIs Dummy Right Side View

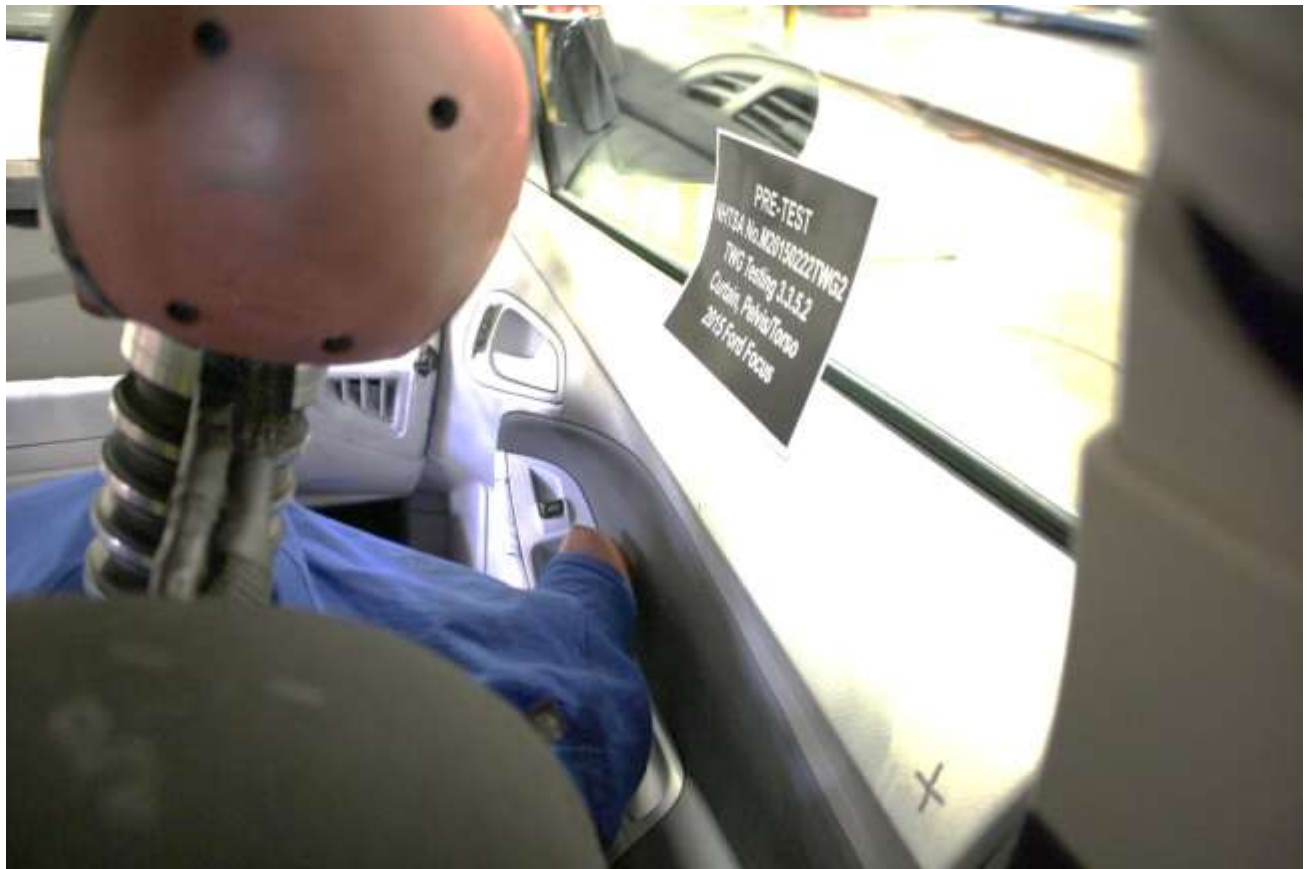
Figure A-17: Pre-Test SID-IIs Dummy Right Side Clearance View

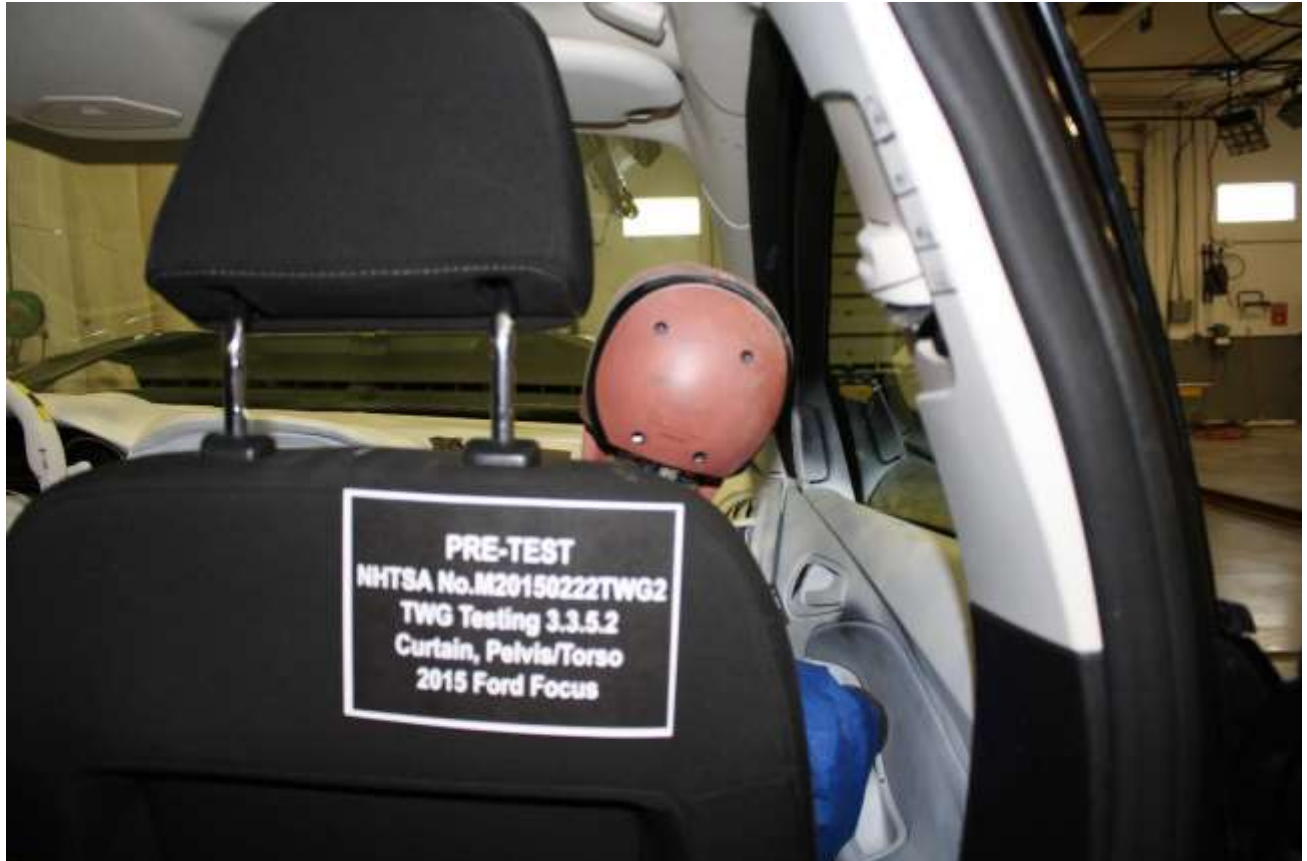
Figure A-18: Pre-Test SID-IIs Dummy Rear Right Side Clearance View

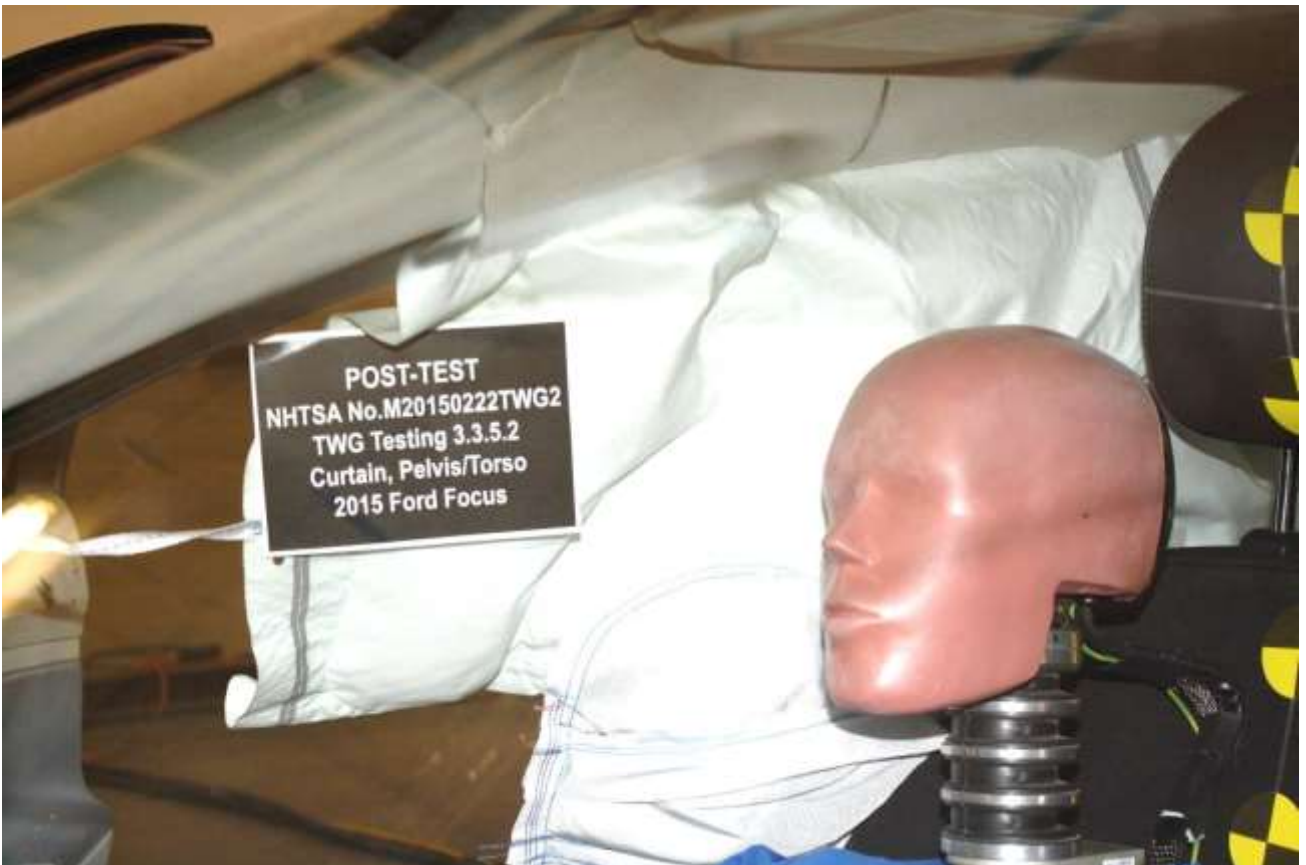
Figure A-20: Post-Test Curtain Airbag Left $\frac{3}{4}$ Front View

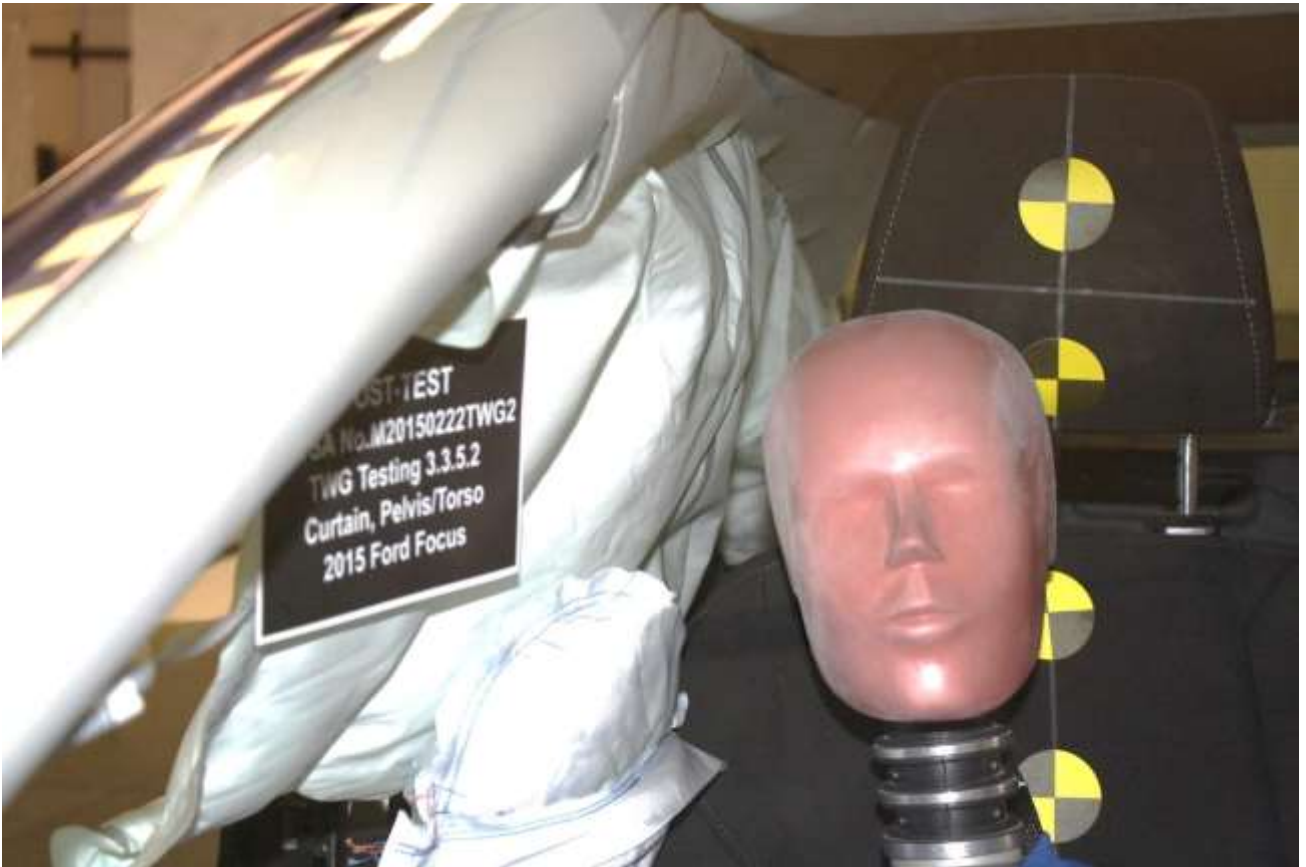
Figure A-21: Post-Test Curtain Airbag Front View

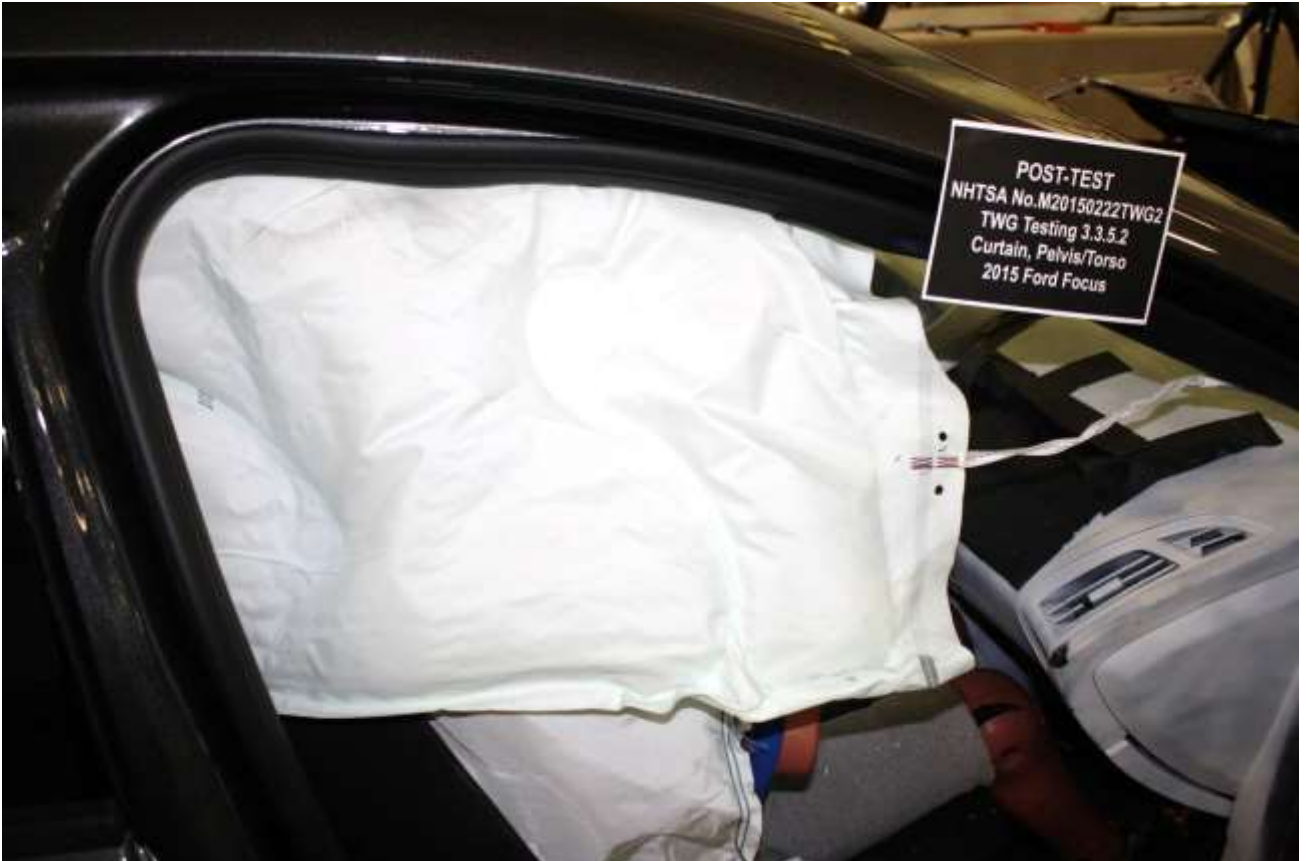
Figure A-22: Post-Test Curtain Airbag Right Side View
