REPORT NUMBER: TWG-CAL-14-04

NEW CAR ASSESSMENT PROGRAM (NCAP)
SIDE AIRBAG OUT-OF-POSITION INJURY TESTING

Ford Motor Co.
2015 Ford Focus

NHTSA NUMBER: M20150222TWG2
CALSPAN TEST NUMBER: CT2014-04

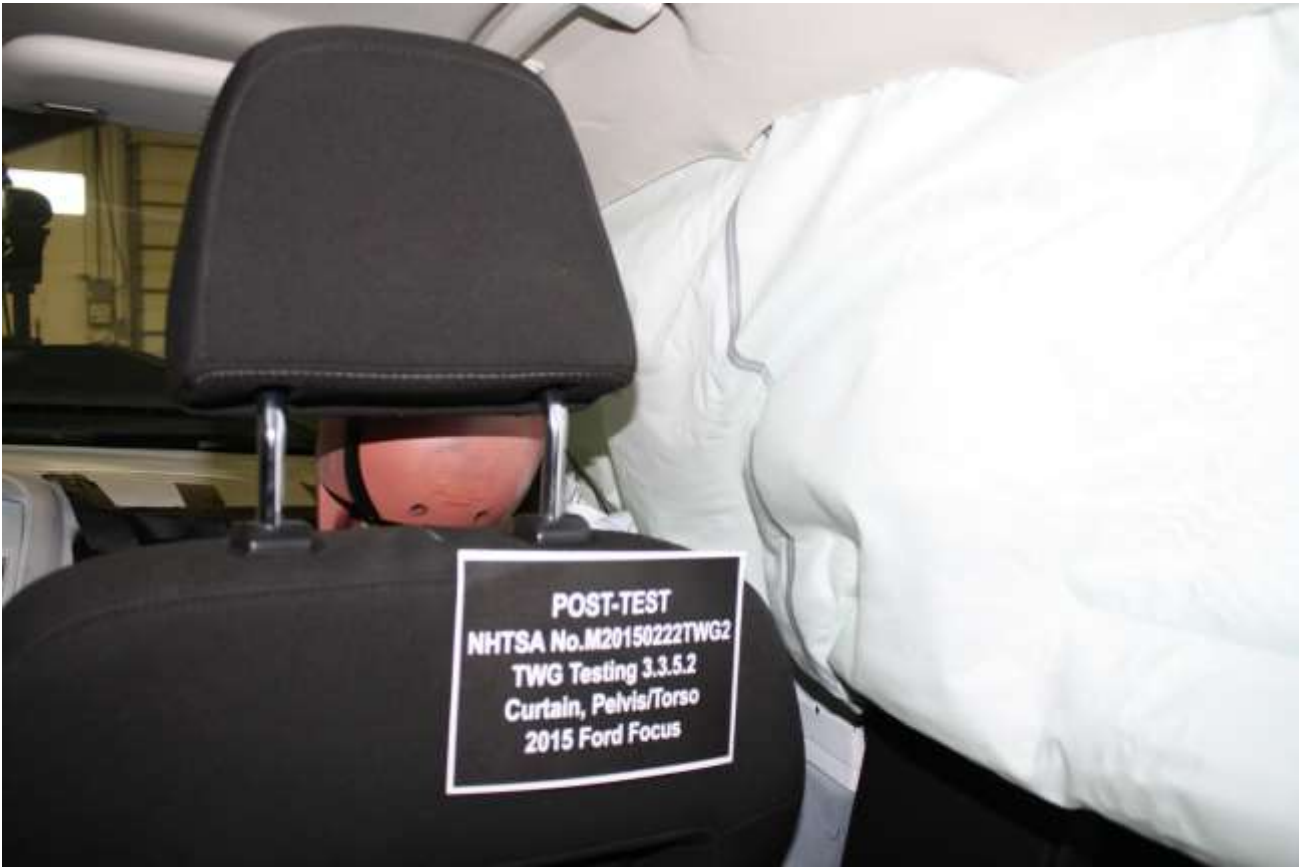
Figure A-23: Post-Test Curtain Airbag Rear Right Side View

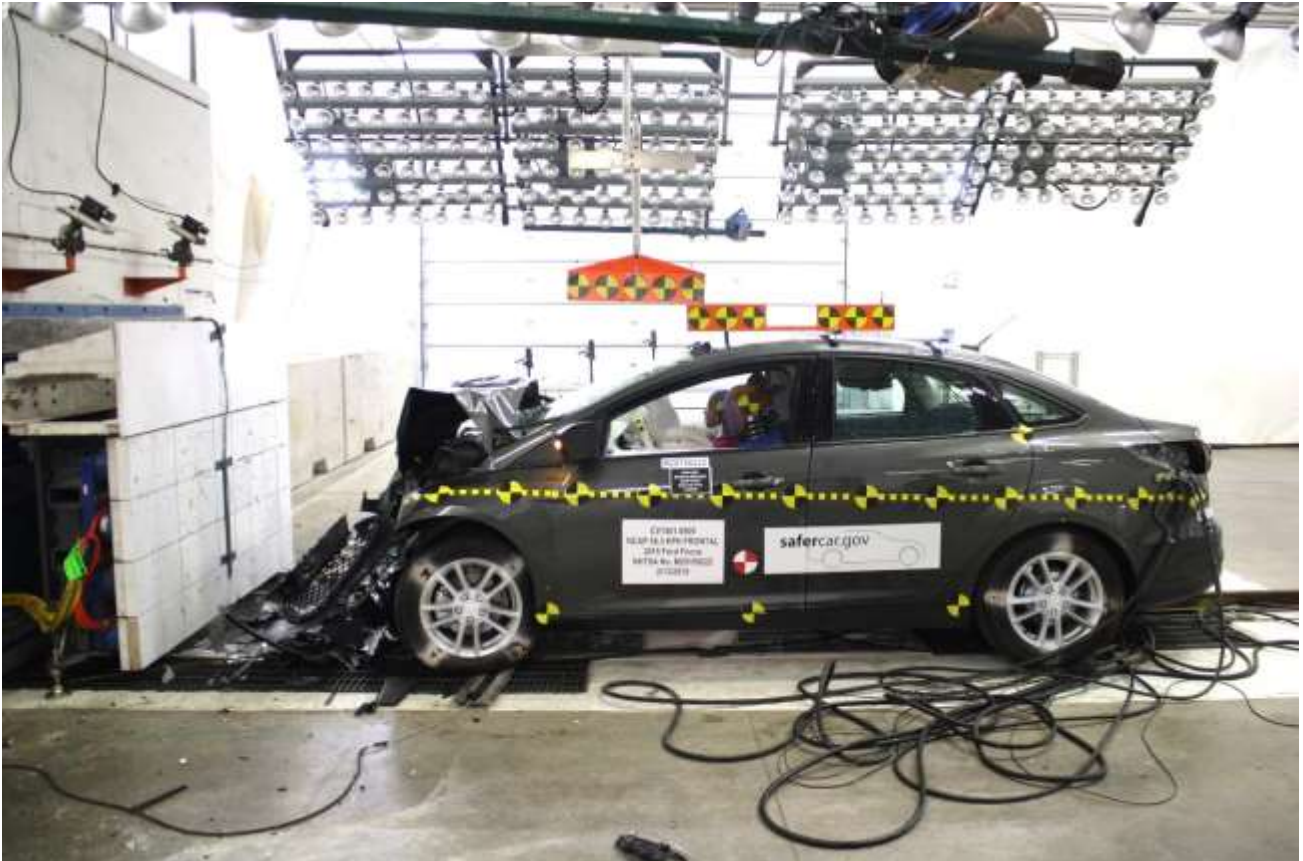
Figure A-24: Post NCAP Left Side View
