**REPORT NUMBER: TWG-MGA-2015-011**

**SIDE AIRBAG OUT-OF-POSITION INJURY  
TECHNICAL WORKING GROUP**

**HONDA OF AMERICA MFG., INC.  
2015 Acura TLX AWD 4-Dr Sedan  
NHTSA No.: M20155312TWG2**

**FINAL REPORT**

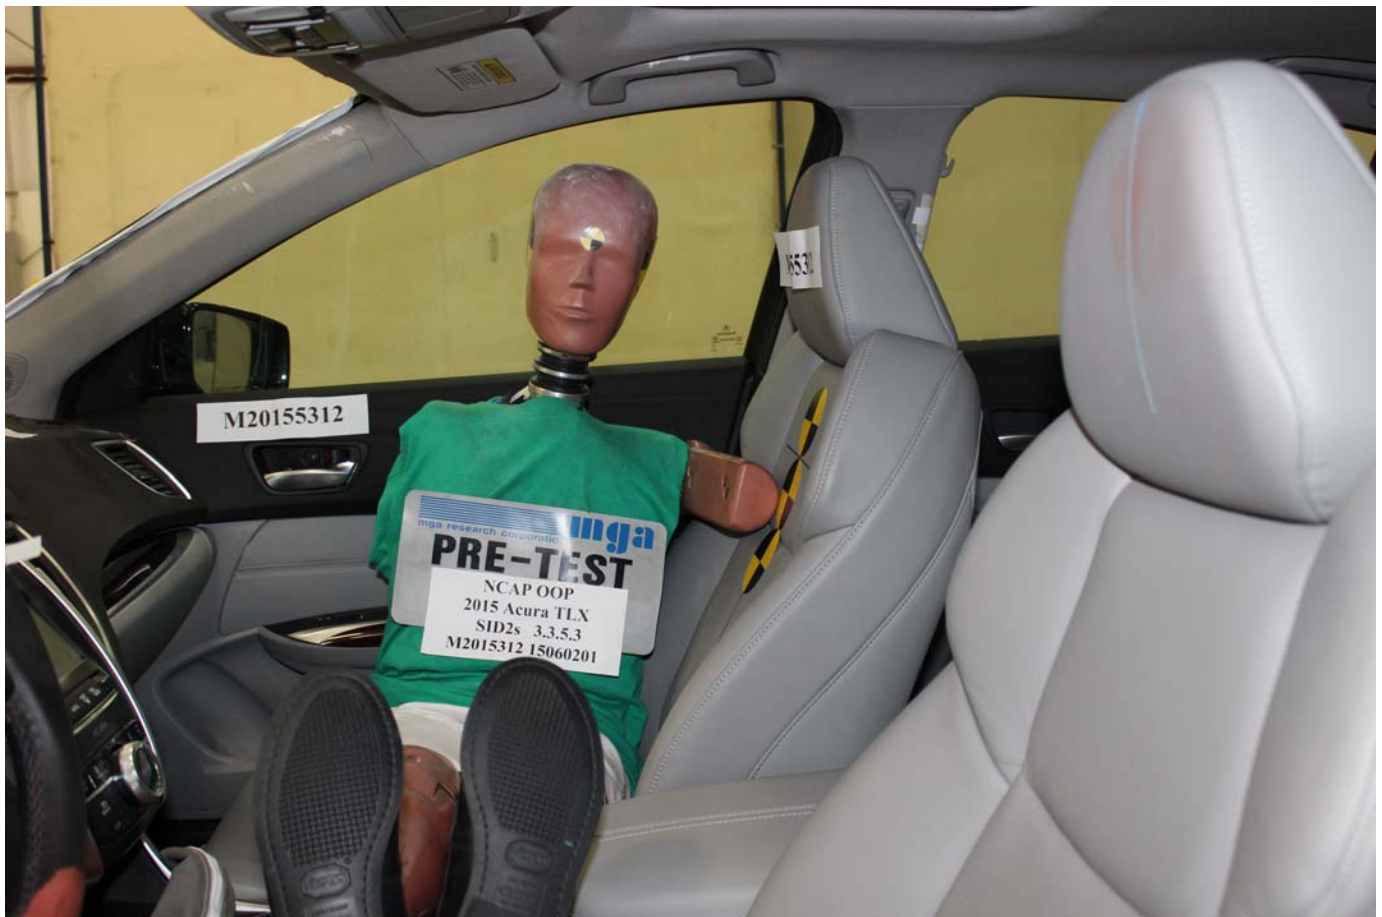
Photo No. 5 - Pre-Test SID-II's Dummy Left Side View

The SID-IIs dummy was placed in the right front passenger seat facing toward the center of the vehicle with its arm against the seatback. The arm was rotated horizontally in the forward direction with respect to the dummy. The seat track was adjusted forward to minimize the vertical distance between the dummy's head and curtain airbag. The dummy's pelvis was slid outboard until the dummy's back contacted the door trim panel or armrest and the CG of the head was centered in the deployment trajectory of the airbag. The vertical plane through the centerline of the dummy's rib-stiffener and shoulder bolt was parallel to the centerline of the vehicle. Masking tape was wrapped around the dummy's neck bracket to hold the dummy in place.

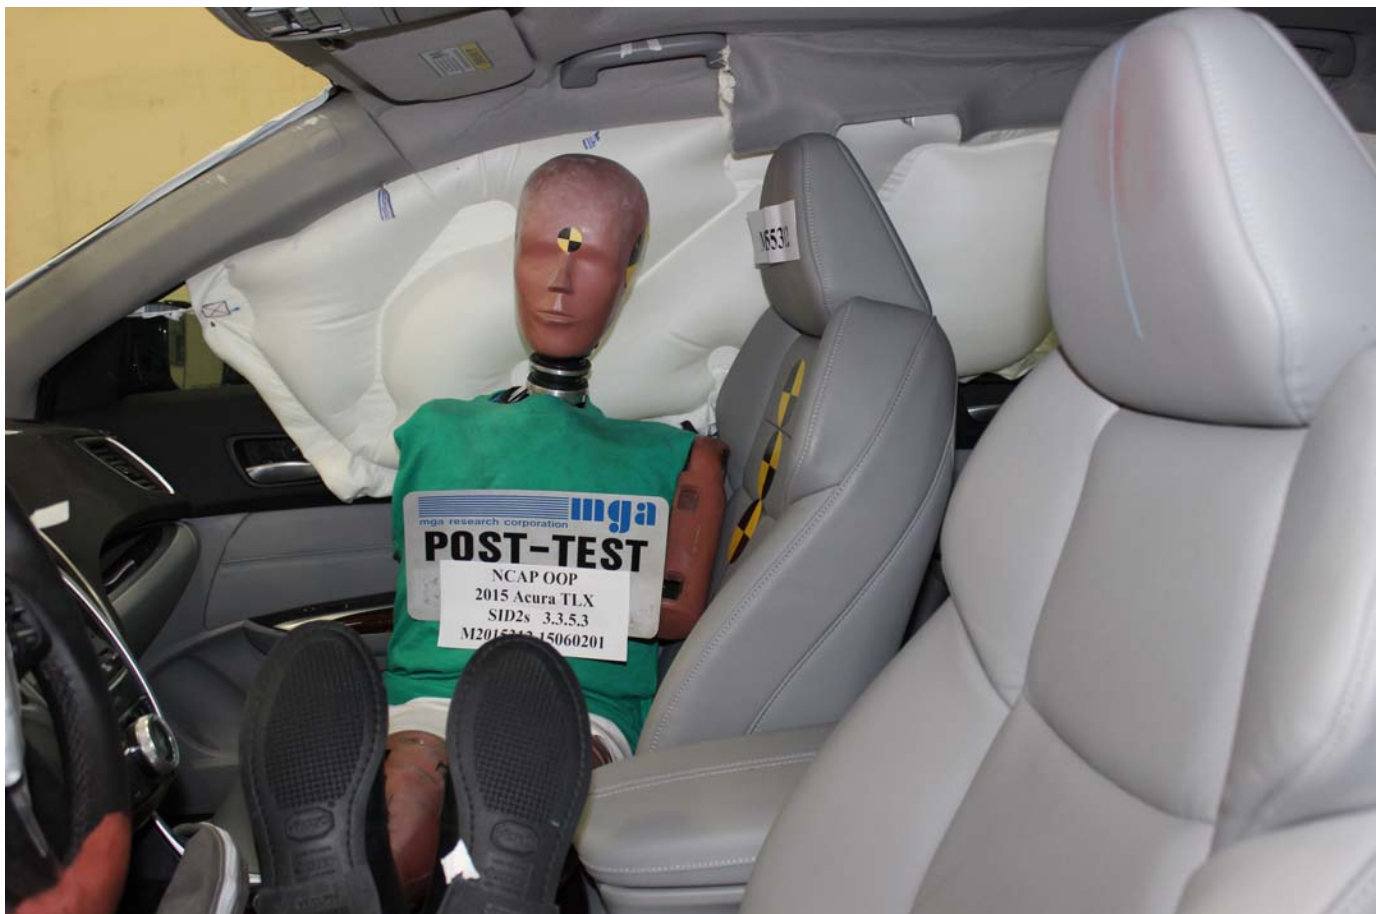
Photo No. 6 - Post-Test SID-II's Dummy Left Side View

- Curtain airbag to top and back of head
- Torso bag to left shoulder, left torso and left pelvis

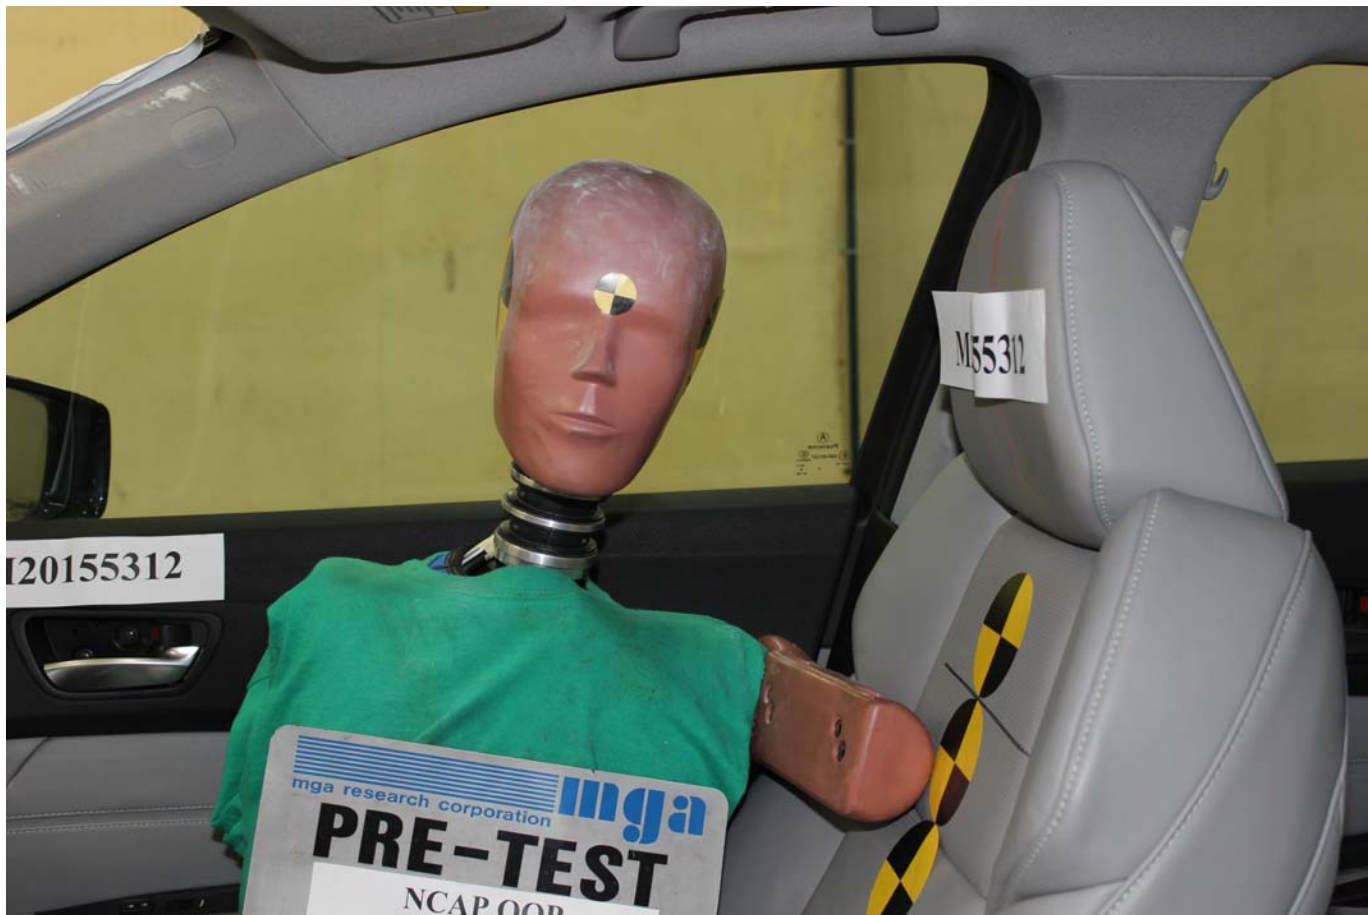
Photo No. 7 - Pre-Test SID-III Dummy Left Side Closeup View

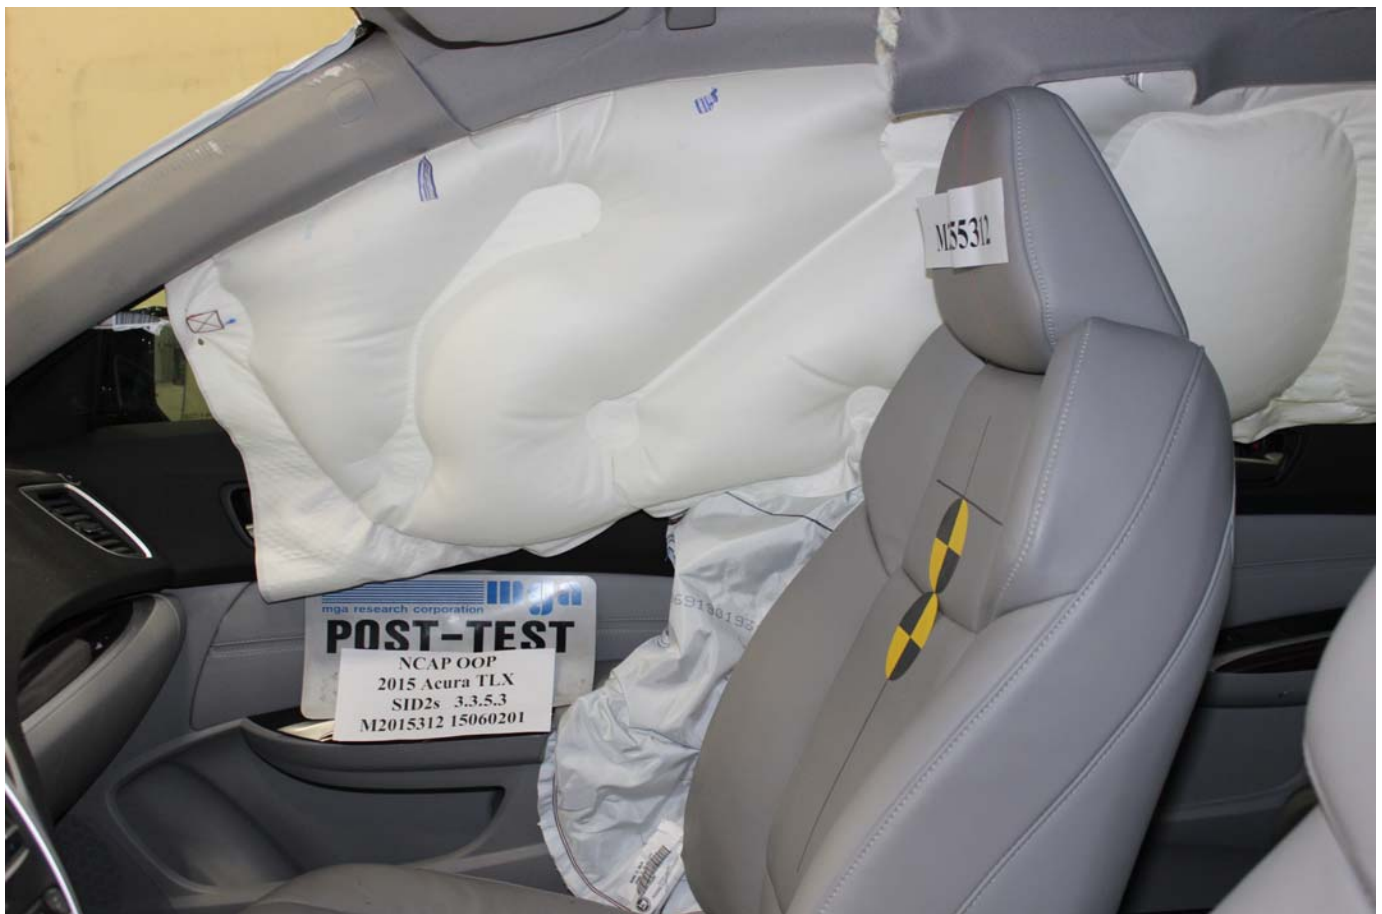
Photo No. 22 - Post-Test Curtain Airbag Left Side View

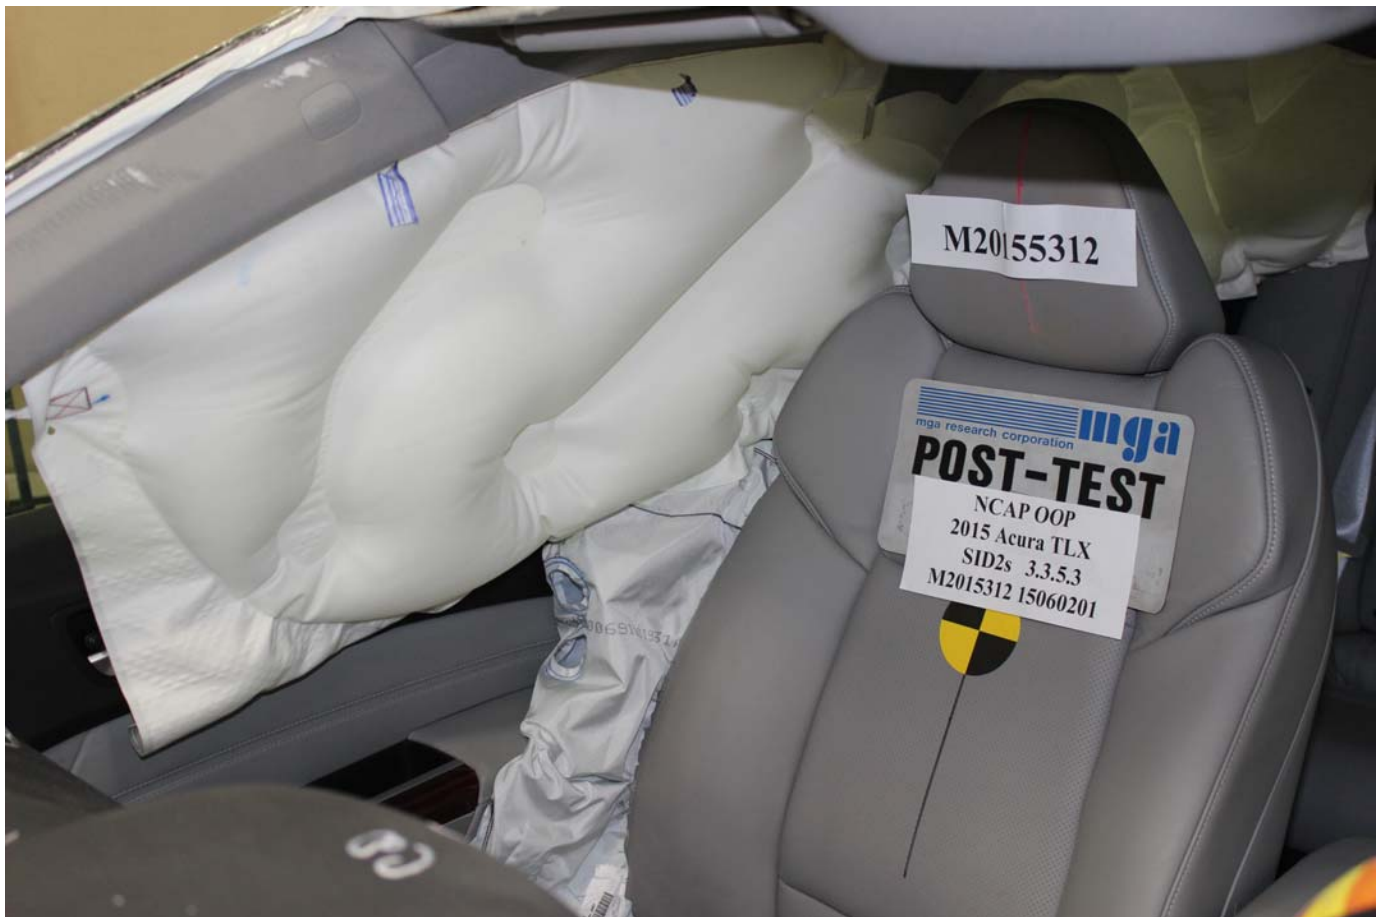
Photo No. 23 - Post-Test Curtain Airbag Left ¾ Front View

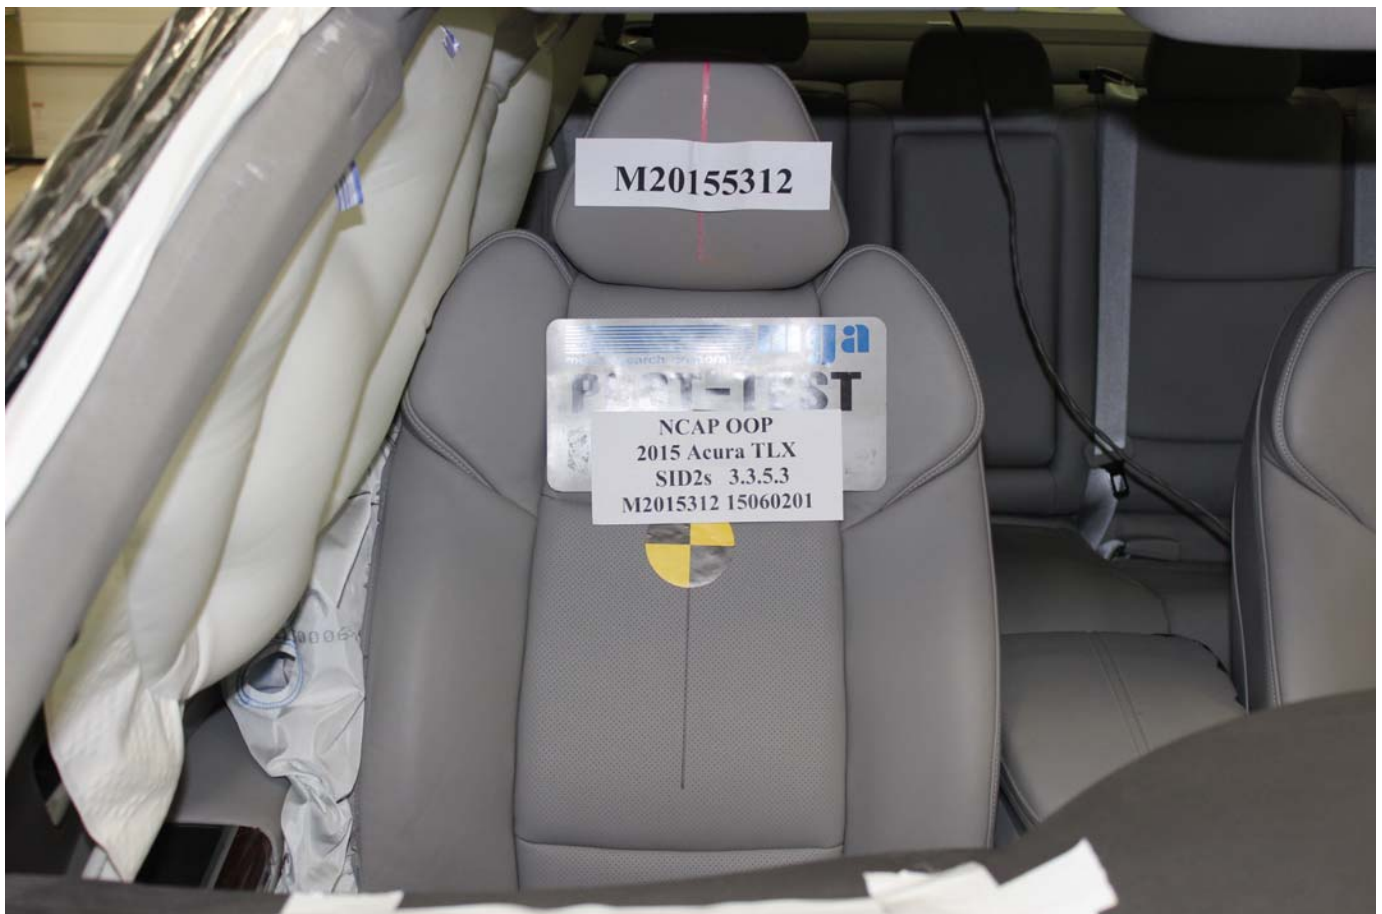
Photo No. 24 - Post-Test Curtain Airbag Front View

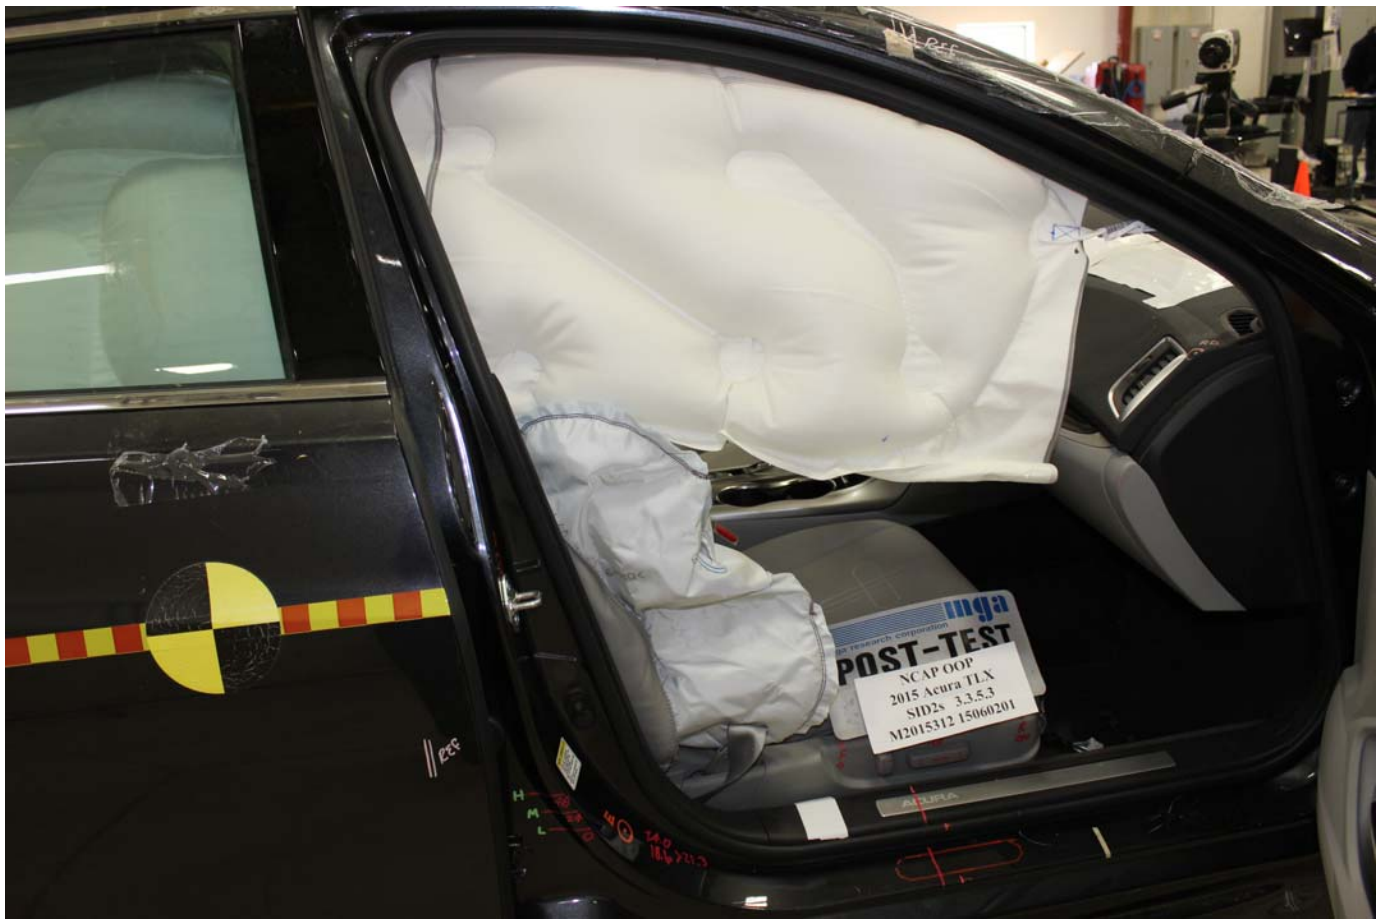
Photo No. 25 - Post-Test Curtain Airbag Right Side View (Door Open)

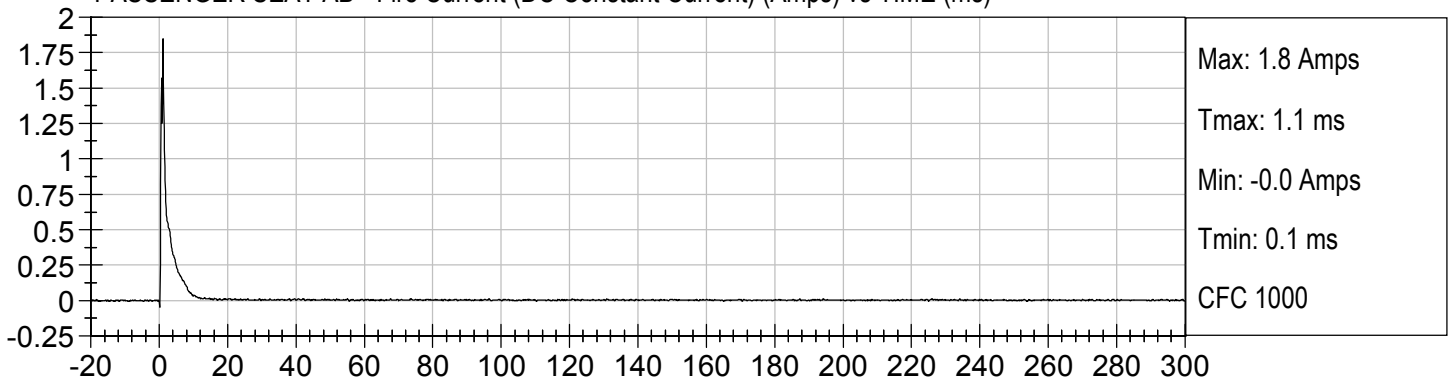
PASSENGER SEAT AB - Fire Current (DC Constant Current) (Amps) vs TIME (ms)
