**REPORT NUMBER: SINCAP-MGA-2016-010**

**NEW CAR ASSESSMENT PROGRAM (NCAP)  
Moving Deformable Barrier Side Impact Test**

**NISSAN MOTOR CO., LTD.  
2016 Nissan Maxima S 4-Dr Sedan  
NHTSA No.: M20165202**

**MGA RESEARCH CORPORATION  
5000 Warren Road  
Burlington, WI 53105**

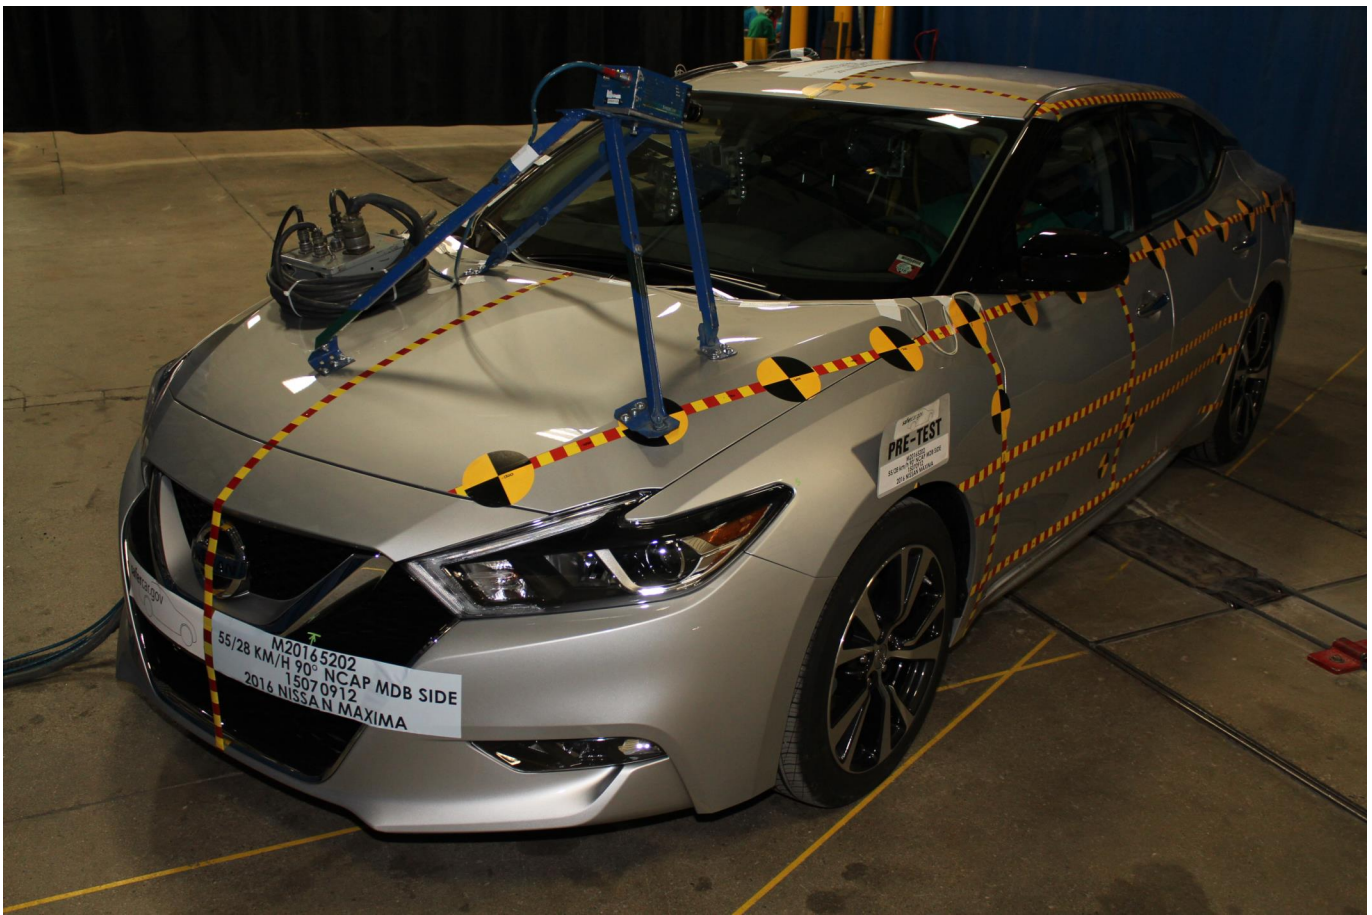
Photo No. 005 - Pre-Test Left Front Three-Quarter View of Test Vehicle

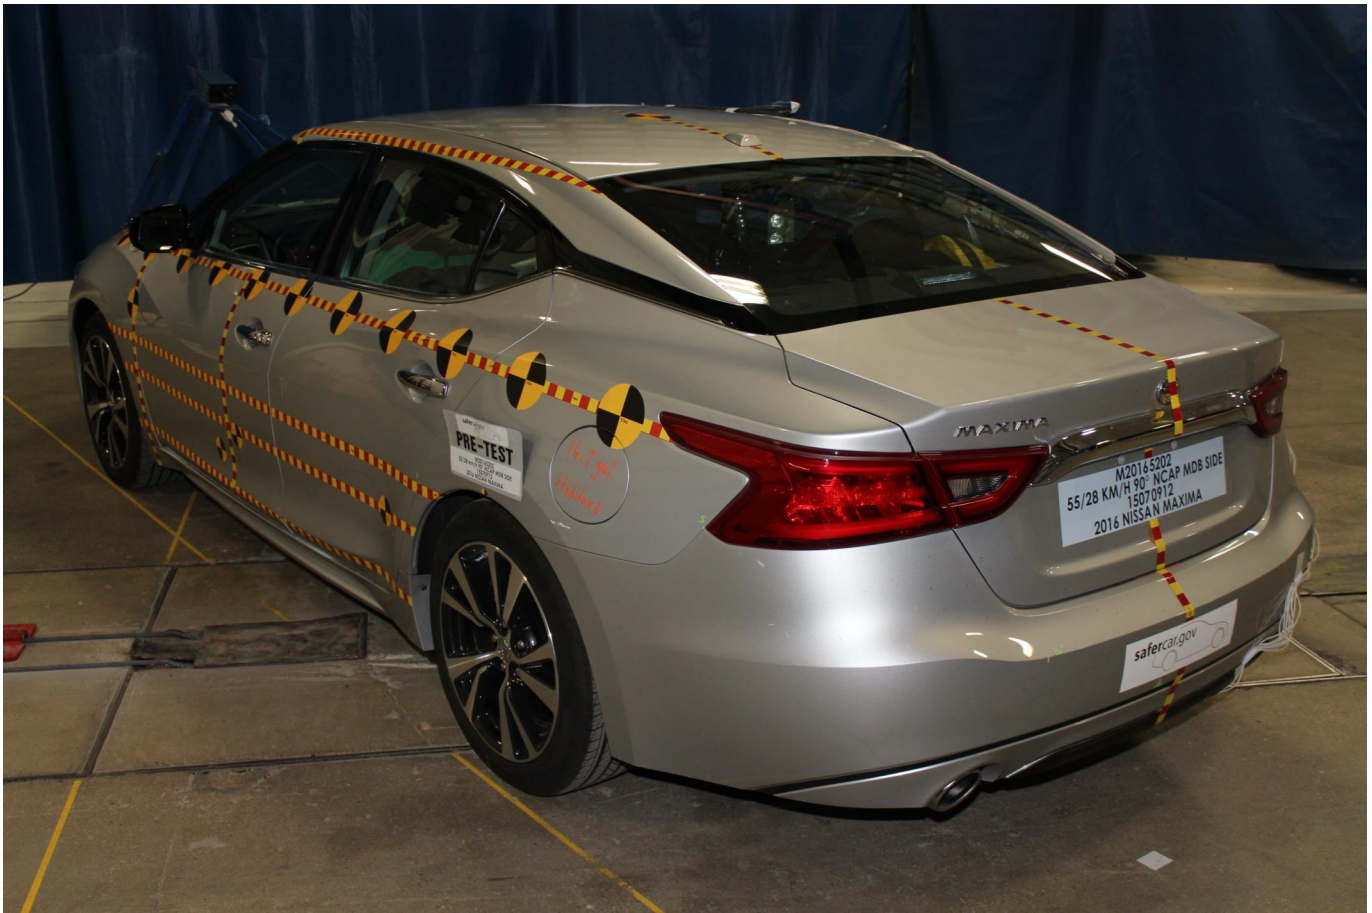
Photo No. 009 - Pre-Test Left Three-Quarter Rear View of Test Vehicle

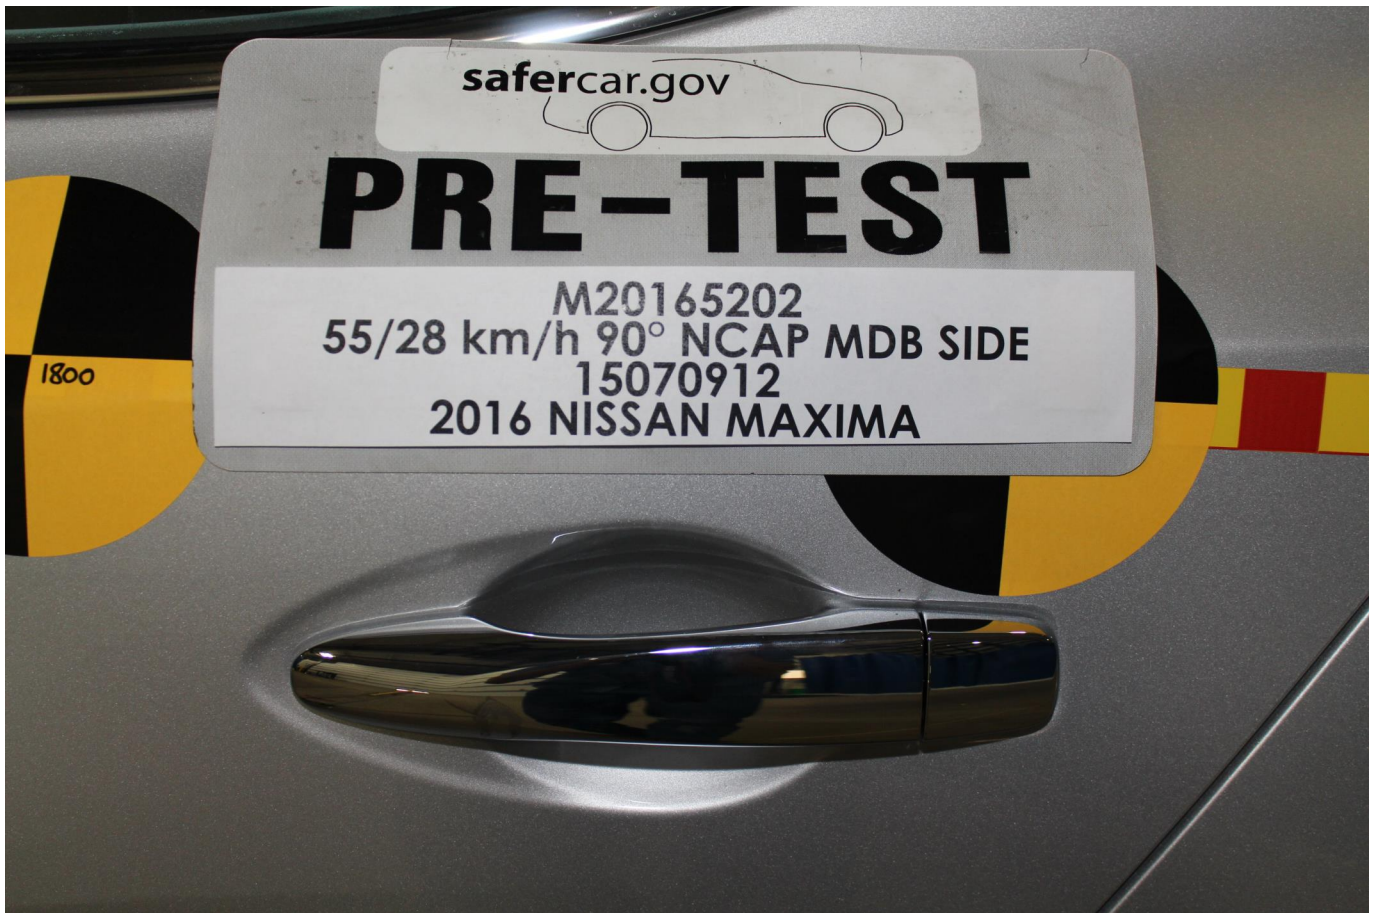
Photo No. 023 - Pre-Test Left Rear Door Latch Close-Up

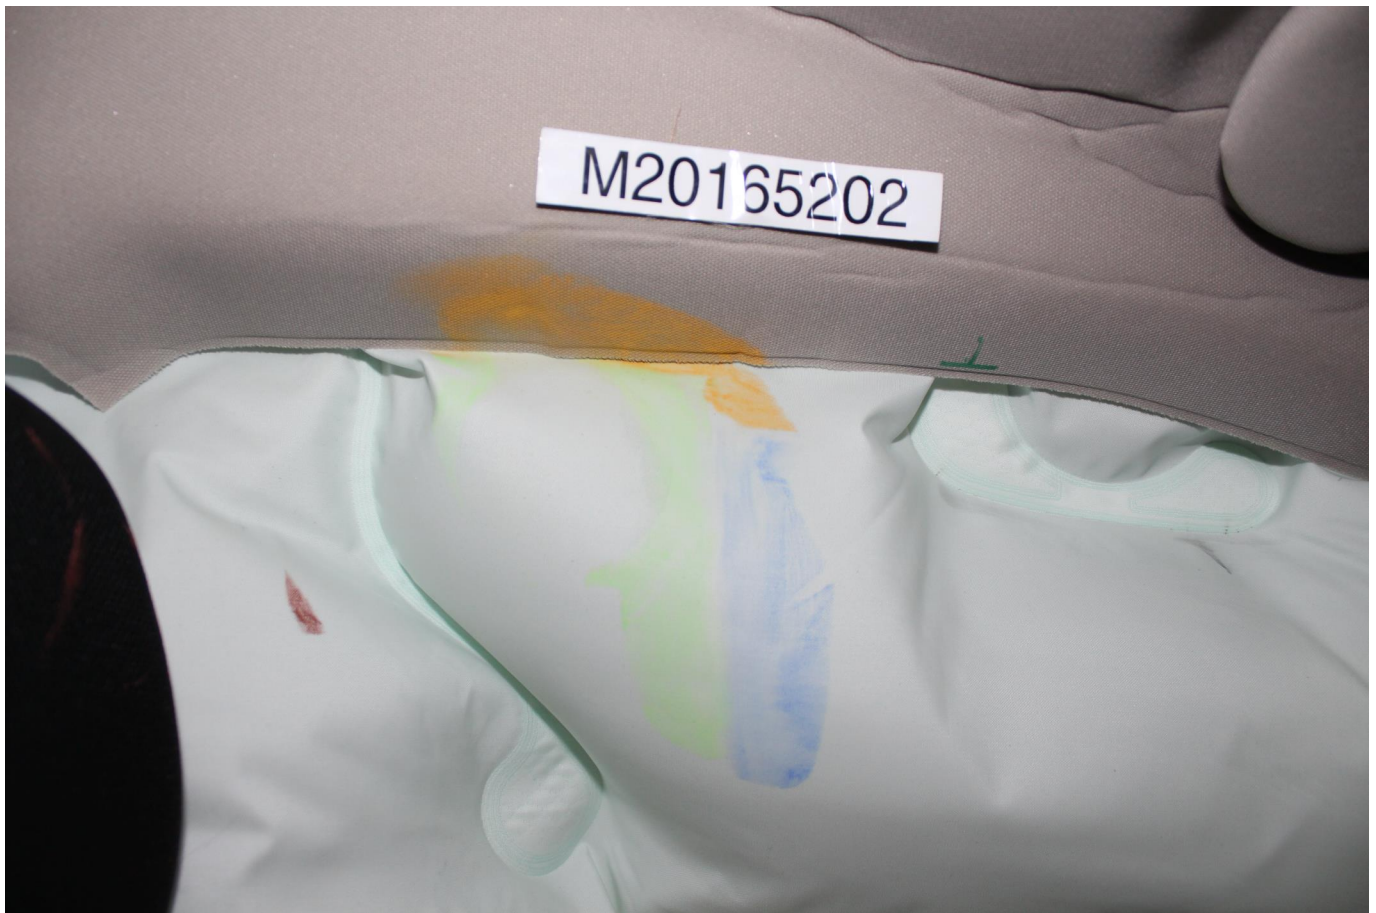
Photo No. 049 - Post-Test Driver Dummy Close-up Head Contact with Side Airbag View
