**REPORT NUMBER: NCAP-MGA-2016-011**

**NEW CAR ASSESSMENT PROGRAM (NCAP)  
Frontal Barrier Impact Test**

**NISSAN MOTOR CO., LTD.  
2016 Nissan Maxima S 4-Dr Sedan  
NHTSA No.: M20165200**

**MGA RESEARCH CORPORATION  
5000 Warren Road  
Burlington, WI 53105**

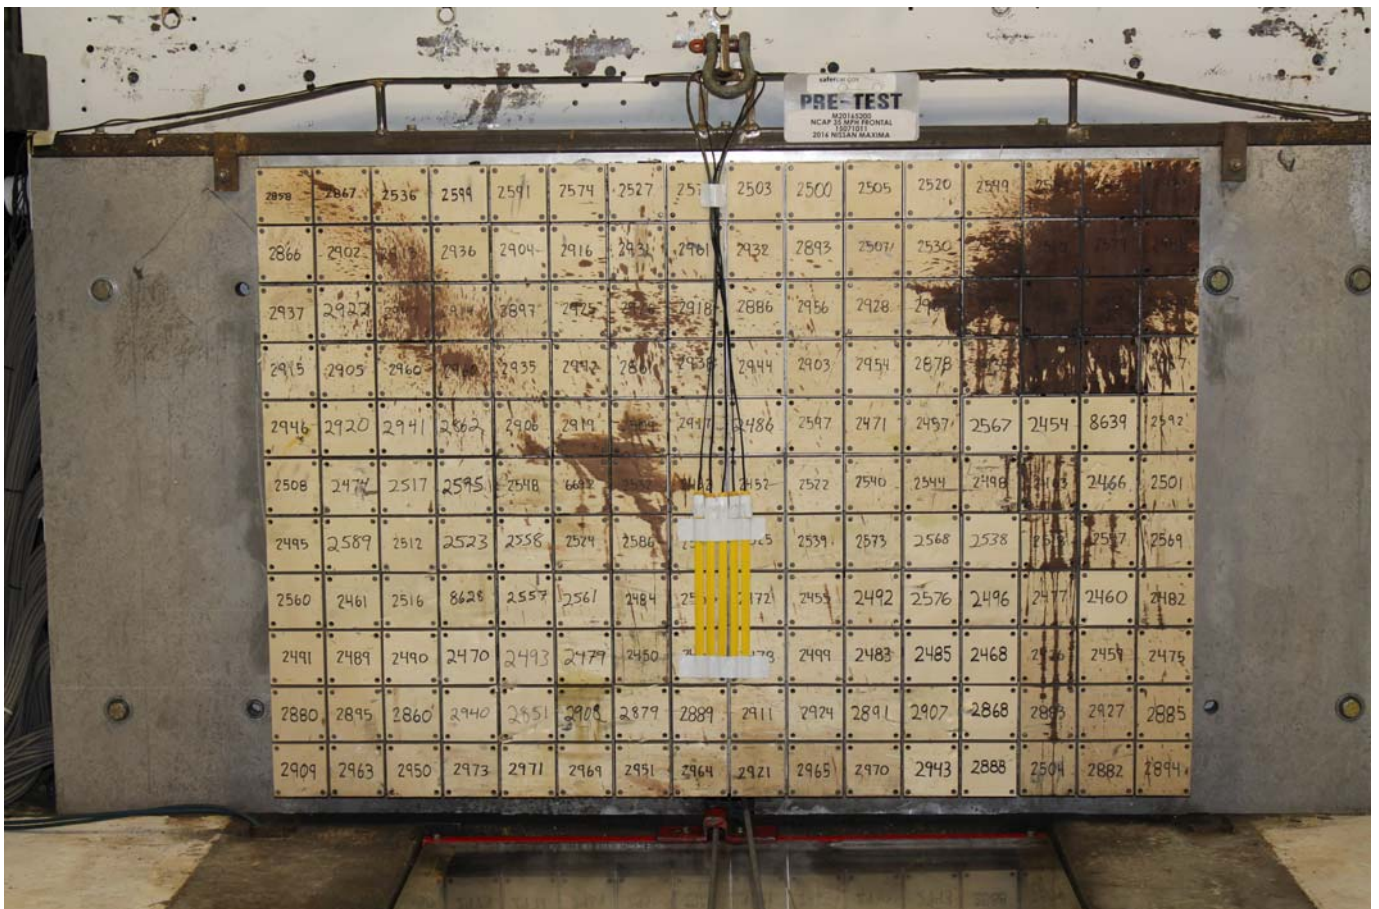
Photo No. 002 - Load Cell Wall

A load cell barrier consisting of 176 load cells was impacted by a 2016 Nissan Maxima S 4-Dr Sedan at a velocity of 56.3 km/h. The test was performed at MGA Research Corporation on July 10, 2015. Pre-test and post-test photographs of the vehicle and dummies can be found in Appendix A.

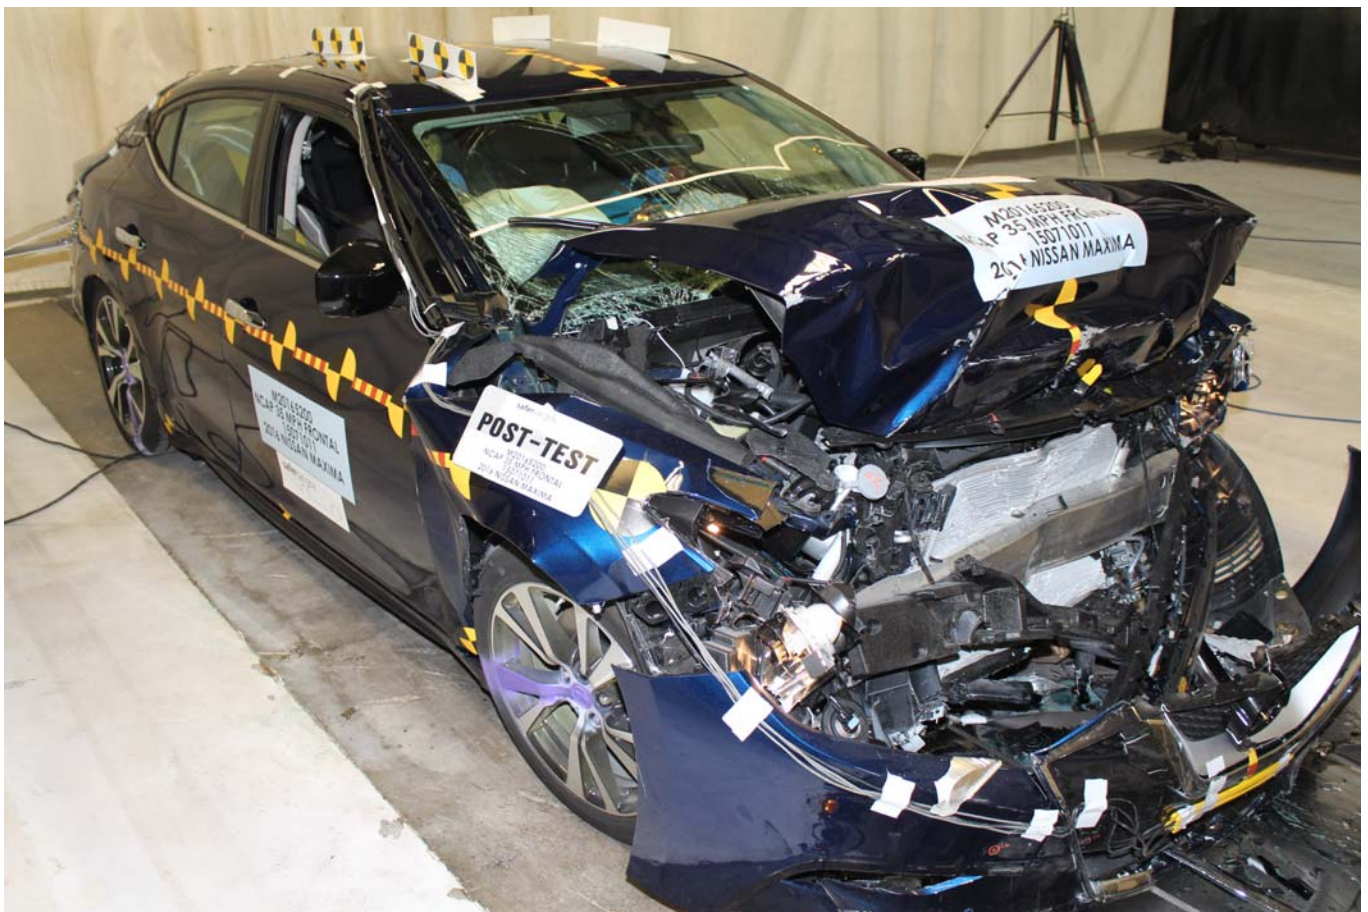
Photo No. 014 - Post-Test Right Front 3-4 View

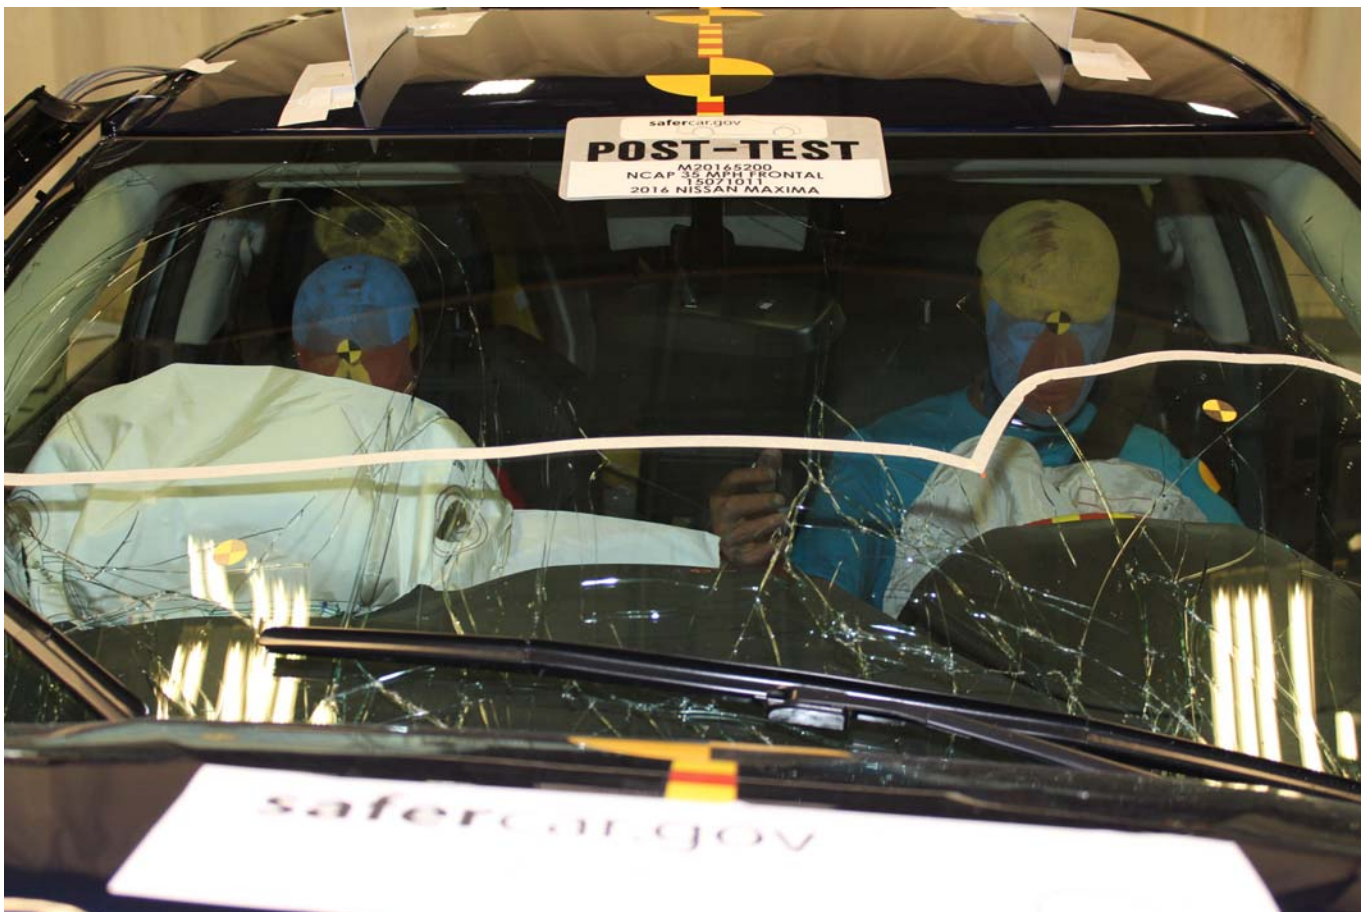
Photo No. 018 - Post-Test Windshield View

There was 100 percent windshield retention and no intrusion into the protected zone of the windshield during the event. 20.0 oz. of Stoddard Solvent leakage was collected during the first 5 minutes of the 0° to 90° phase of the static rollover. Additionally, 4.6 oz. and 4.2 oz. were collected during the sixth and seventh minute from the onset of rotation, respectively. The static rollover was terminated after the 0° to 90° phase.

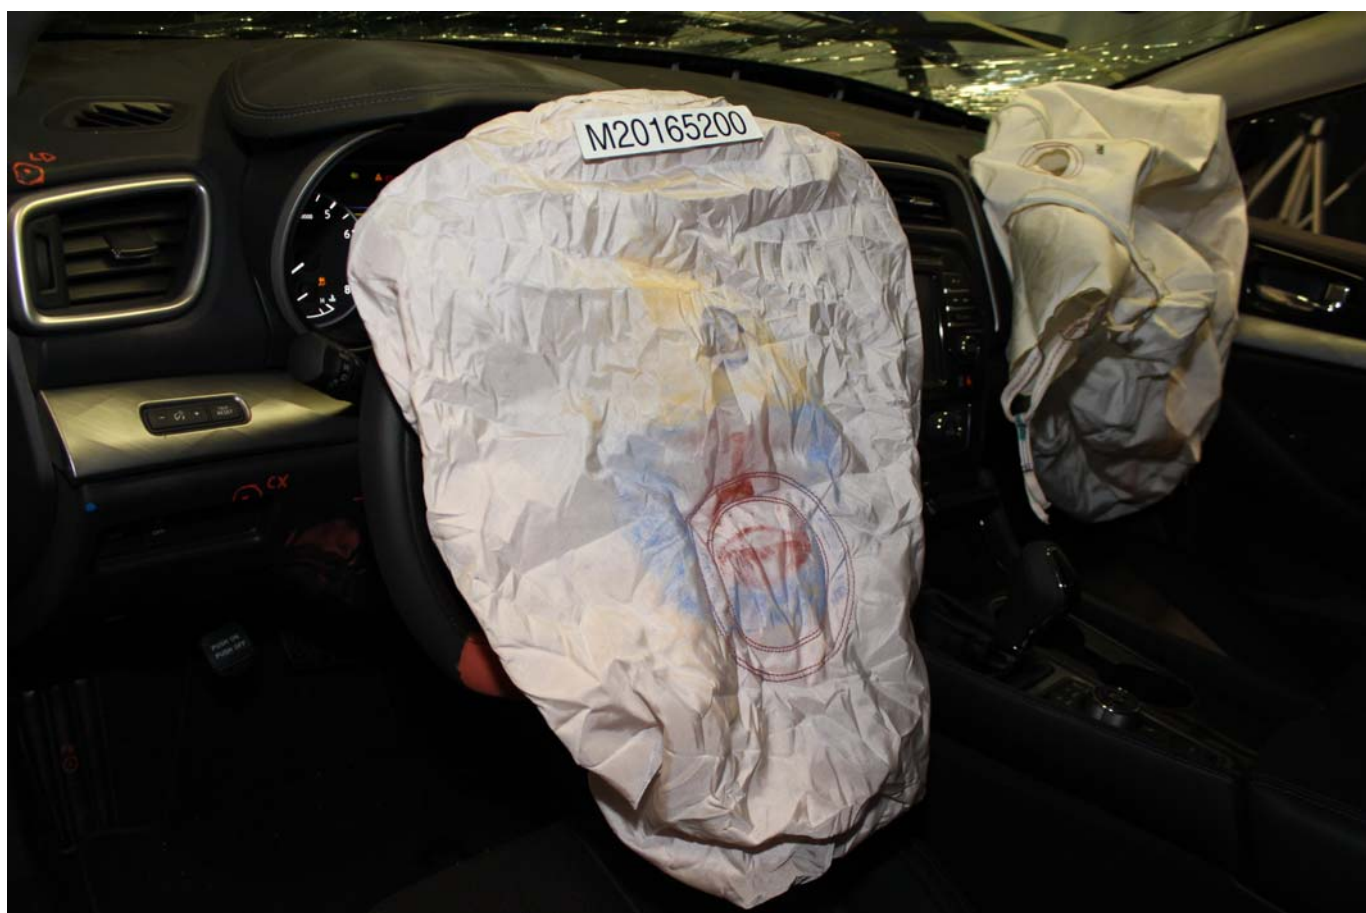
Photo No. 046 - Post-Test Driver Dummy Contact with Airbag

The driver's visible contact points were as follows: The driver's head contacted the airbag. The driver's head also contacted the headrest. The driver's knees contacted the knee bolster. The passenger's visible contact points were as follows: The passenger's head contacted the airbag. The passenger's head also contacted the headrest. The passenger's knees contacted the glovebox.

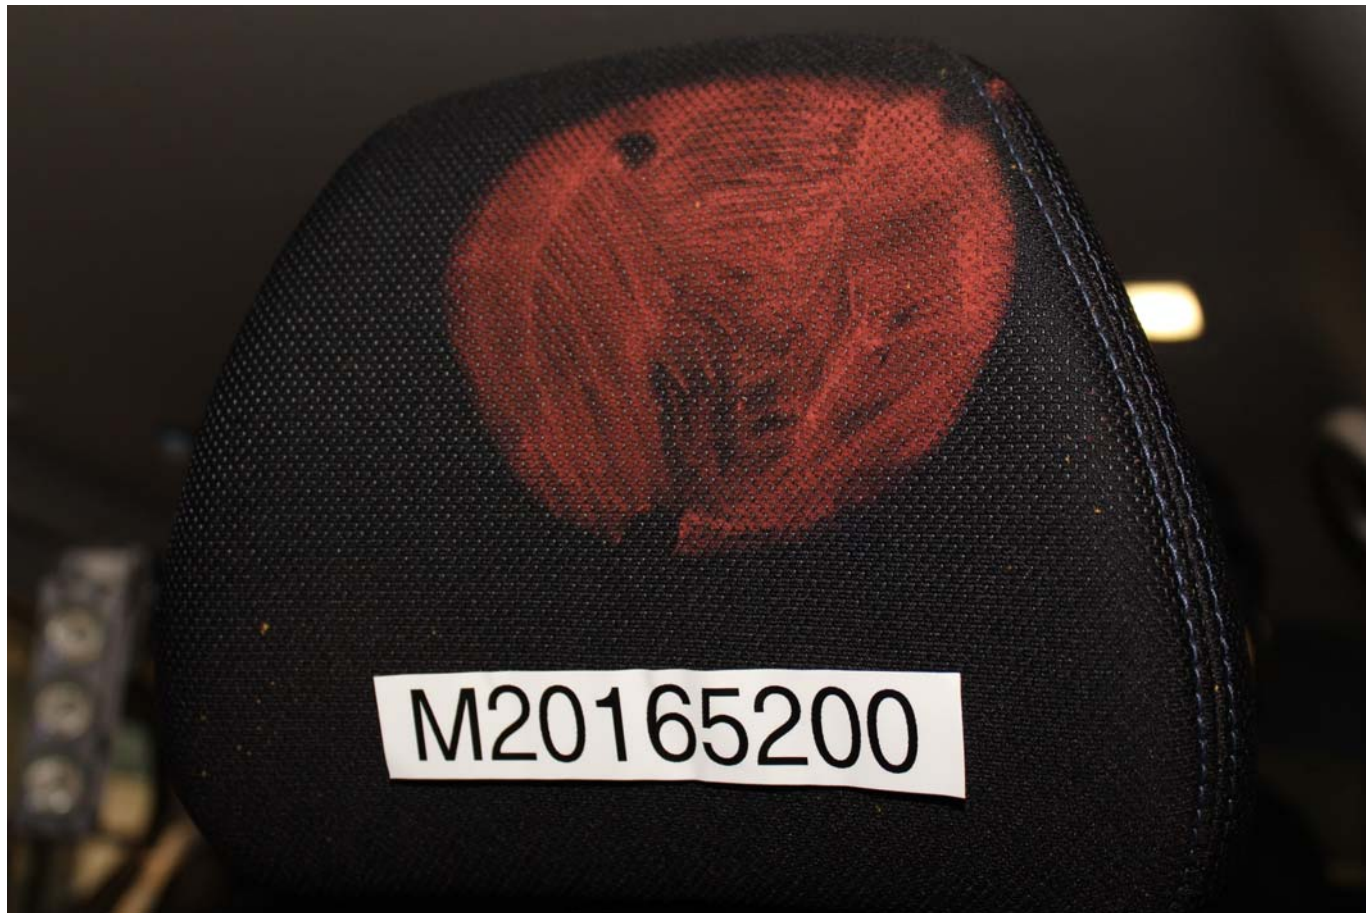
Photo No. 047 - Post-Test Driver Dummy Contact with Headrest

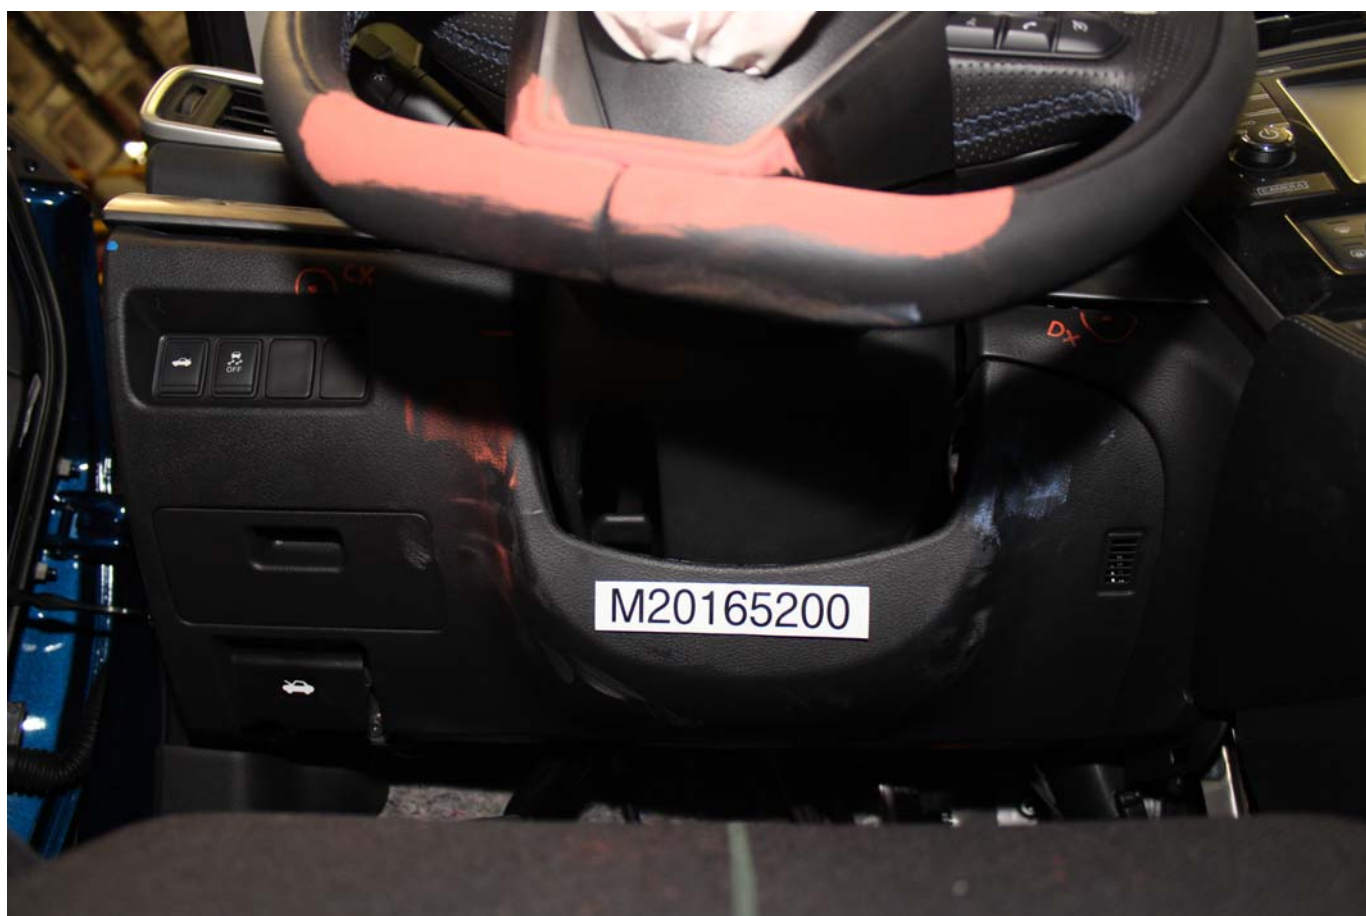
Photo No. 047a - Post-Test Driver Dummy Contact with Knee Bolster

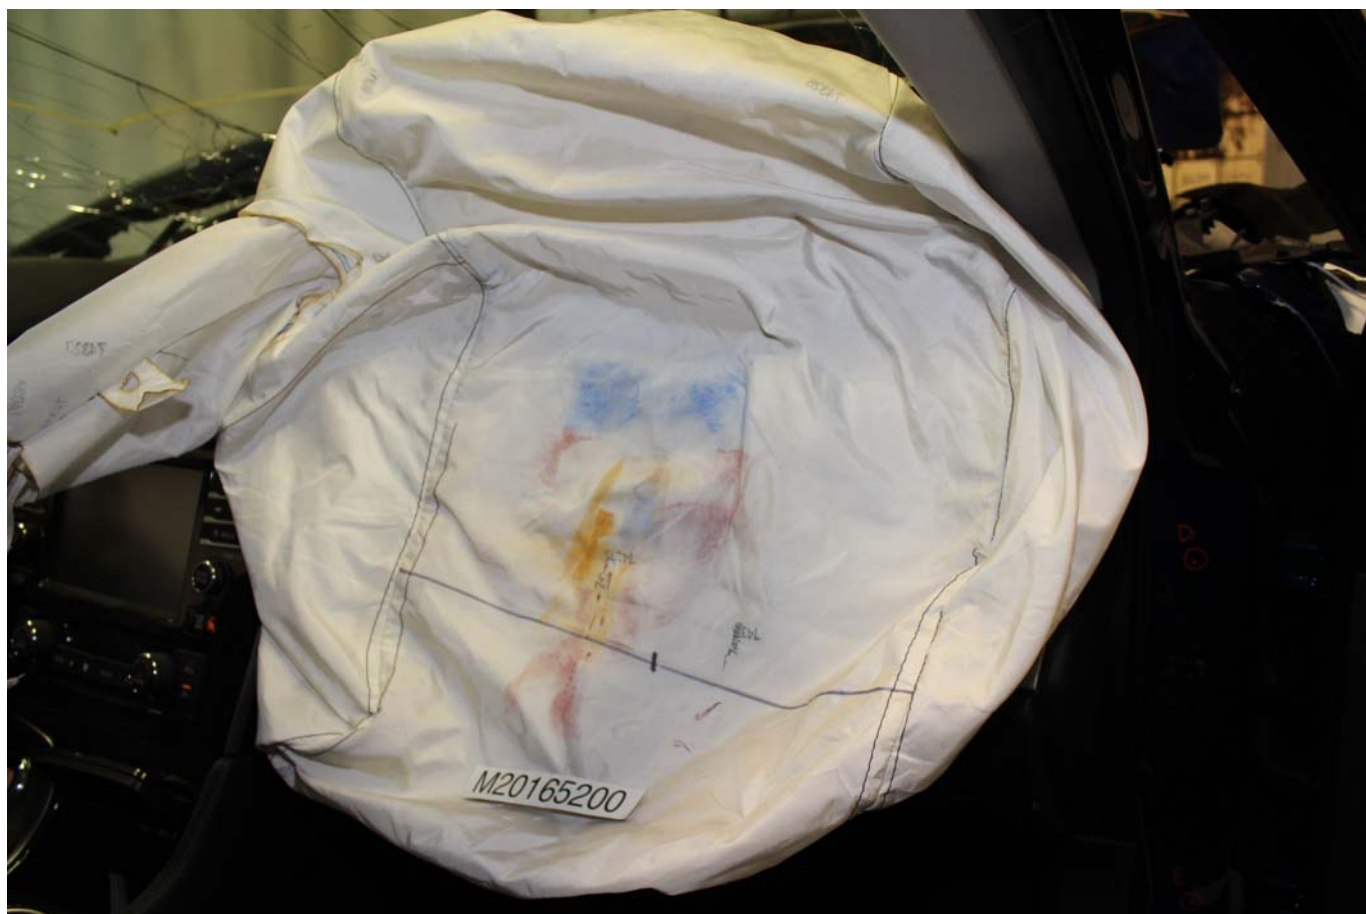
Photo No. 067 - Post-Test Passenger Dummy Contact with Airbag

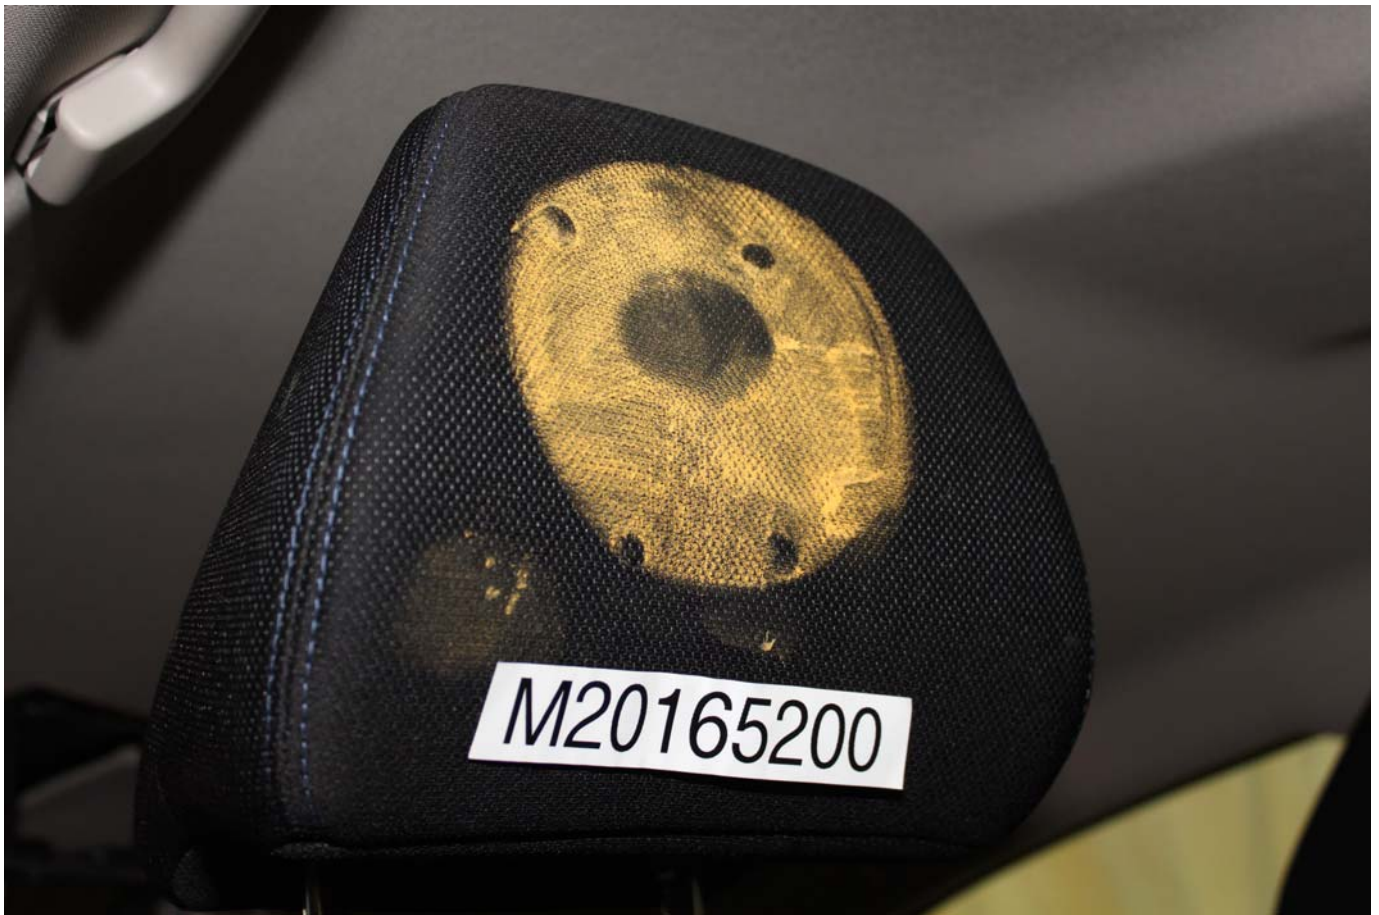
Photo No. 068 - Post-Test Passenger Dummy Contact with Headrest

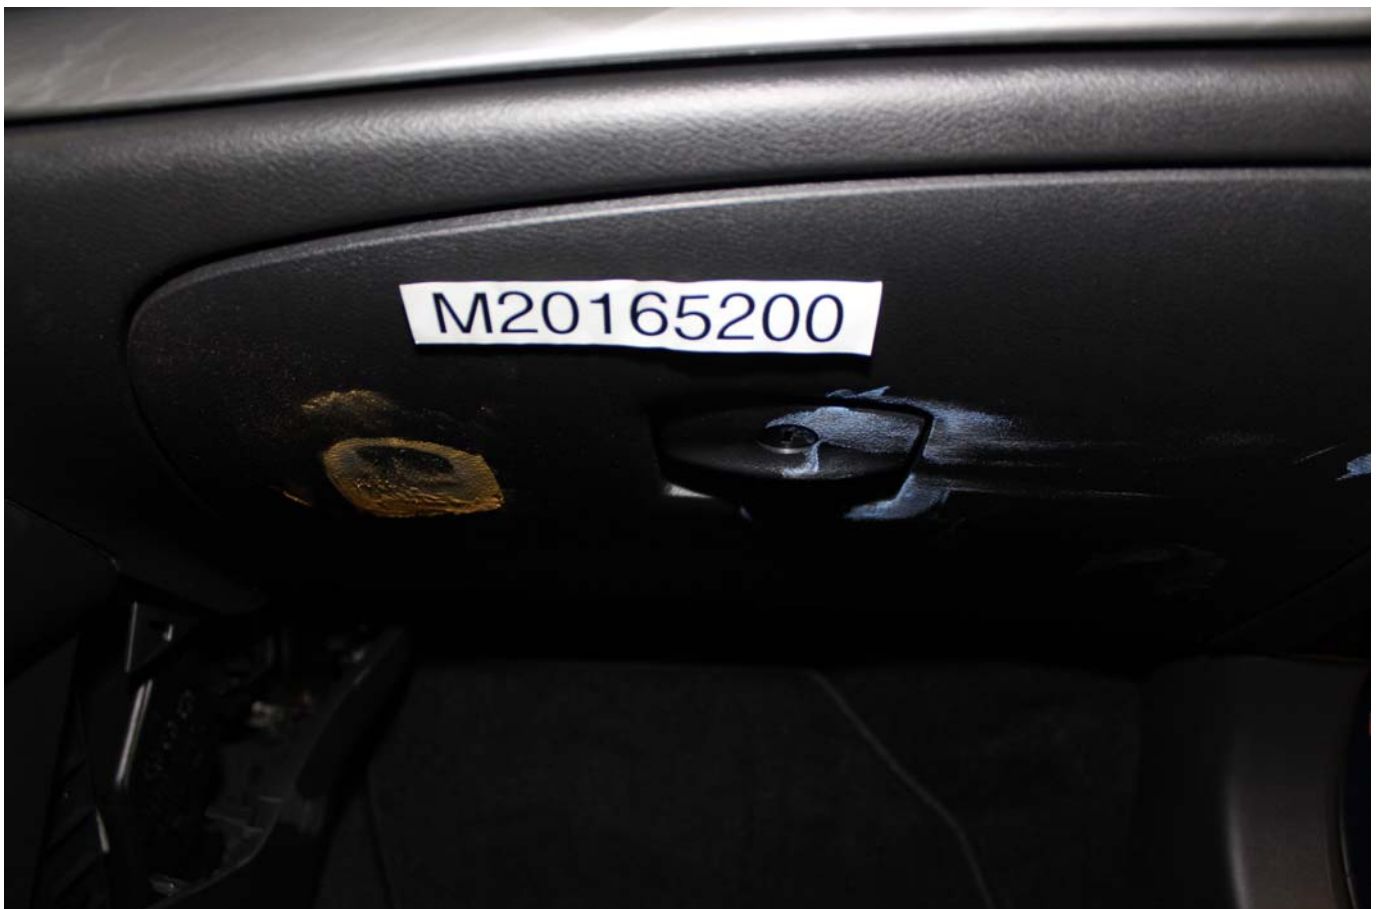
Photo No. 068a - Post-Test Passenger Dummy Contact with Glovebox

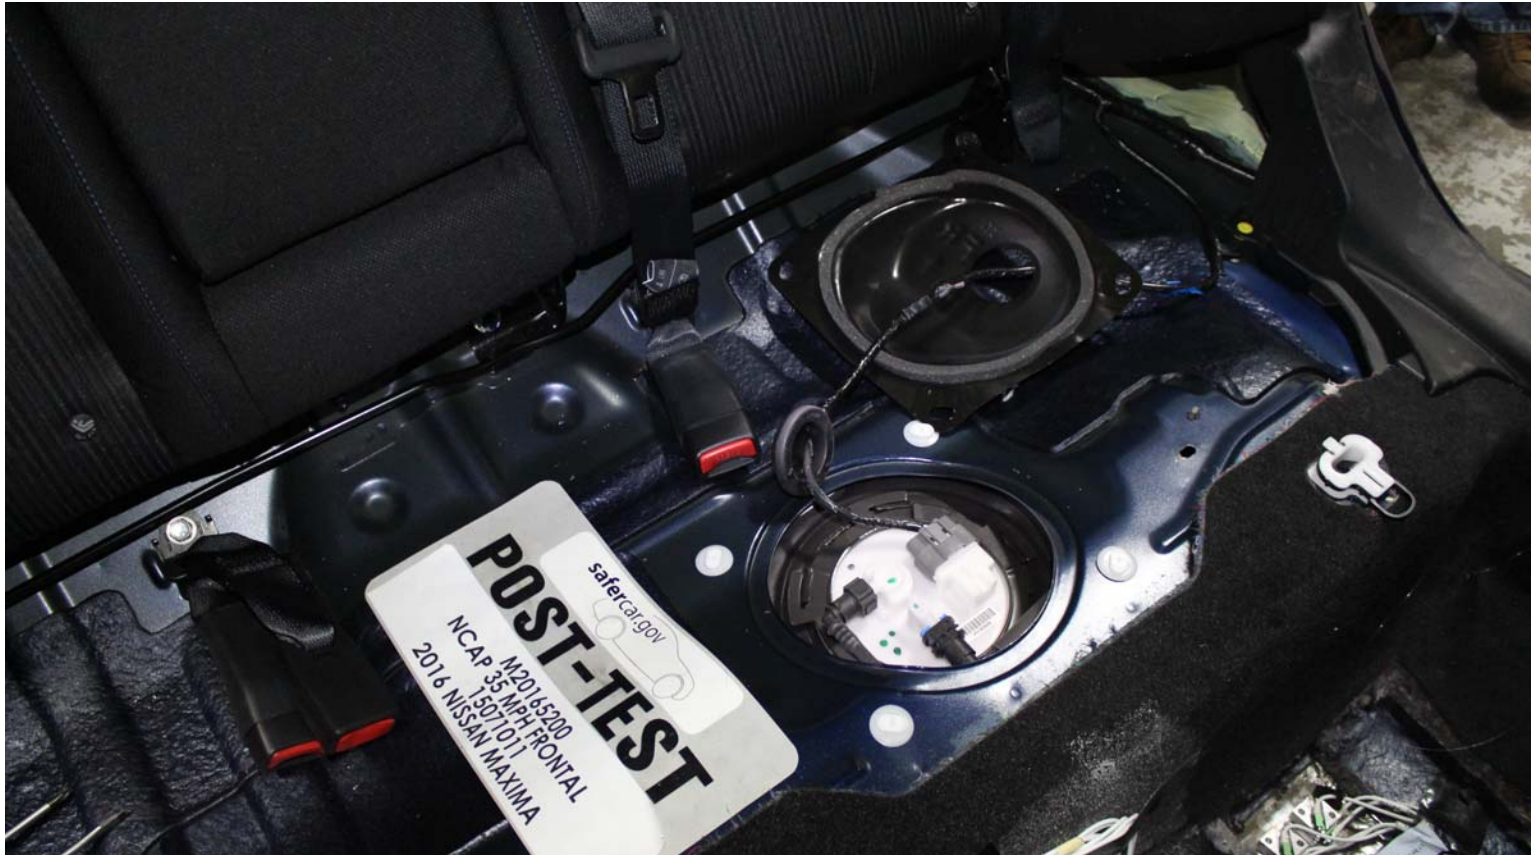
Photo No. 070 - Post-Test Stoddard Solvent Spillage Location View

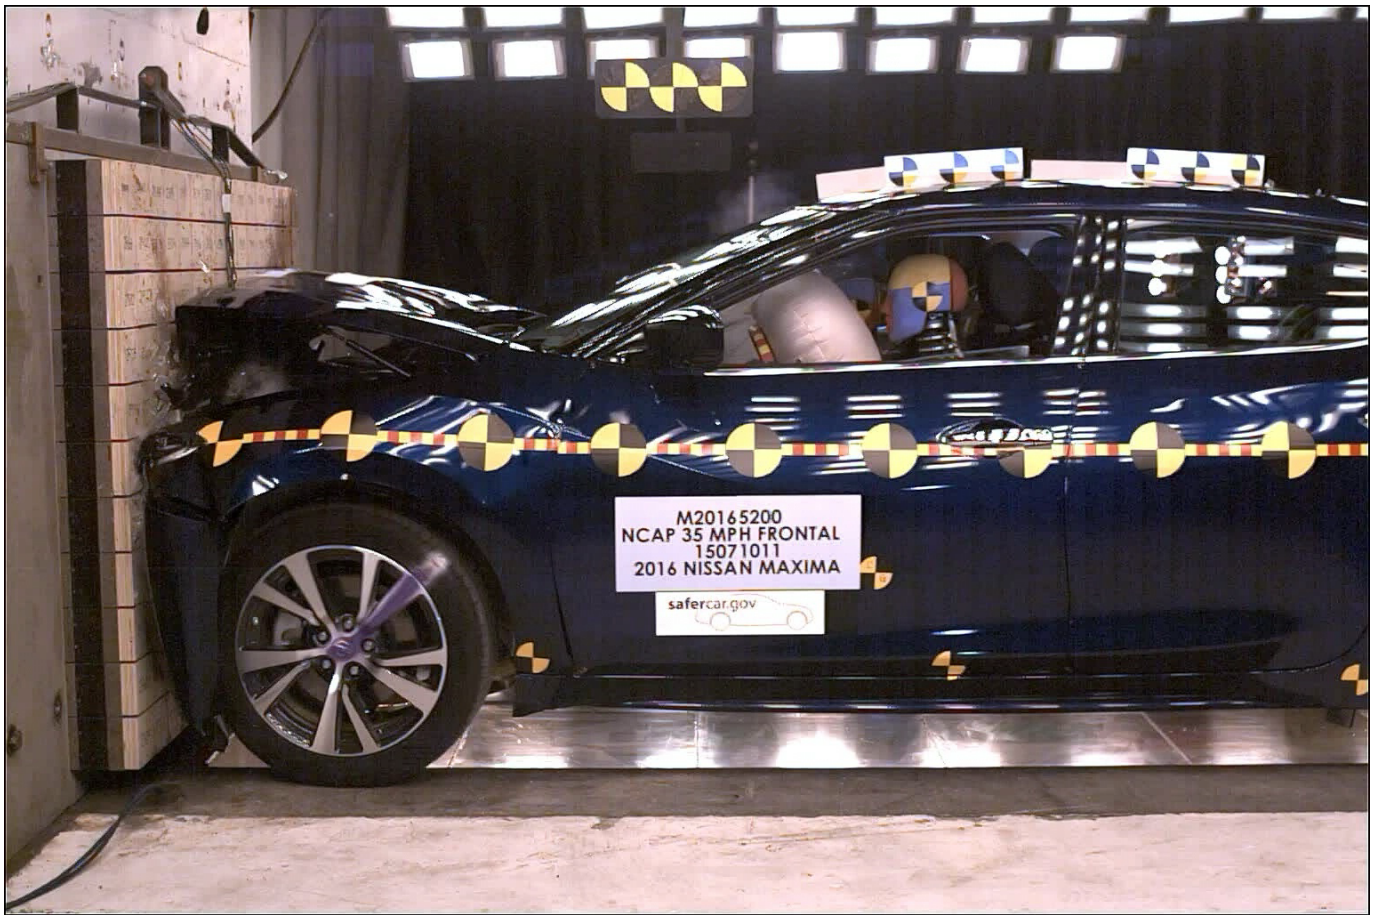
Photo No. 077 - 2016 Nissan Maxima Frontal Impact Event
