REPORT NUMBER: NCAP-MGA-2016-012

**NEW CAR ASSESSMENT PROGRAM (NCAP)
Frontal Barrier Impact Test**

**HONDA DE MEXICO S.A. DE C.V.
2016 Honda HR-V AWD LX 5-Dr SUV
NHTSA No.: O20165305**

**MGA RESEARCH CORPORATION
5000 Warren Road
Burlington, WI 53105**

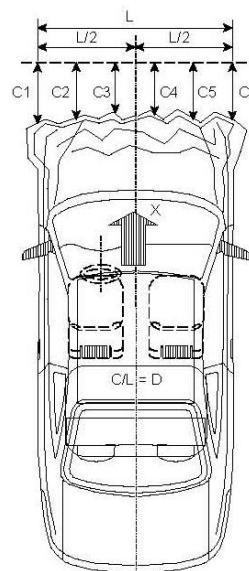
Midpoint of Damage: Centerline

Damage Region Length (mm): 1100

Impact Mode: Frontal

No.	Measurement Description	Units	Pre-Test	Post-Test	Difference
C1	Crush zone 1 at left side	mm	4176	3755	421
C2	Crush zone 2 at left side	mm	4239	3831	408
C3	Crush zone 3 at left side	mm	4248	3830	418
C4	Crush zone 4 at right side	mm	4248	3803	445
C5	Crush zone 5 at right side	mm	4239	3810	429
C6	Crush zone 6 at right side	mm	4176	3805	371
L	C1 TO C6	mm	1100	958	142

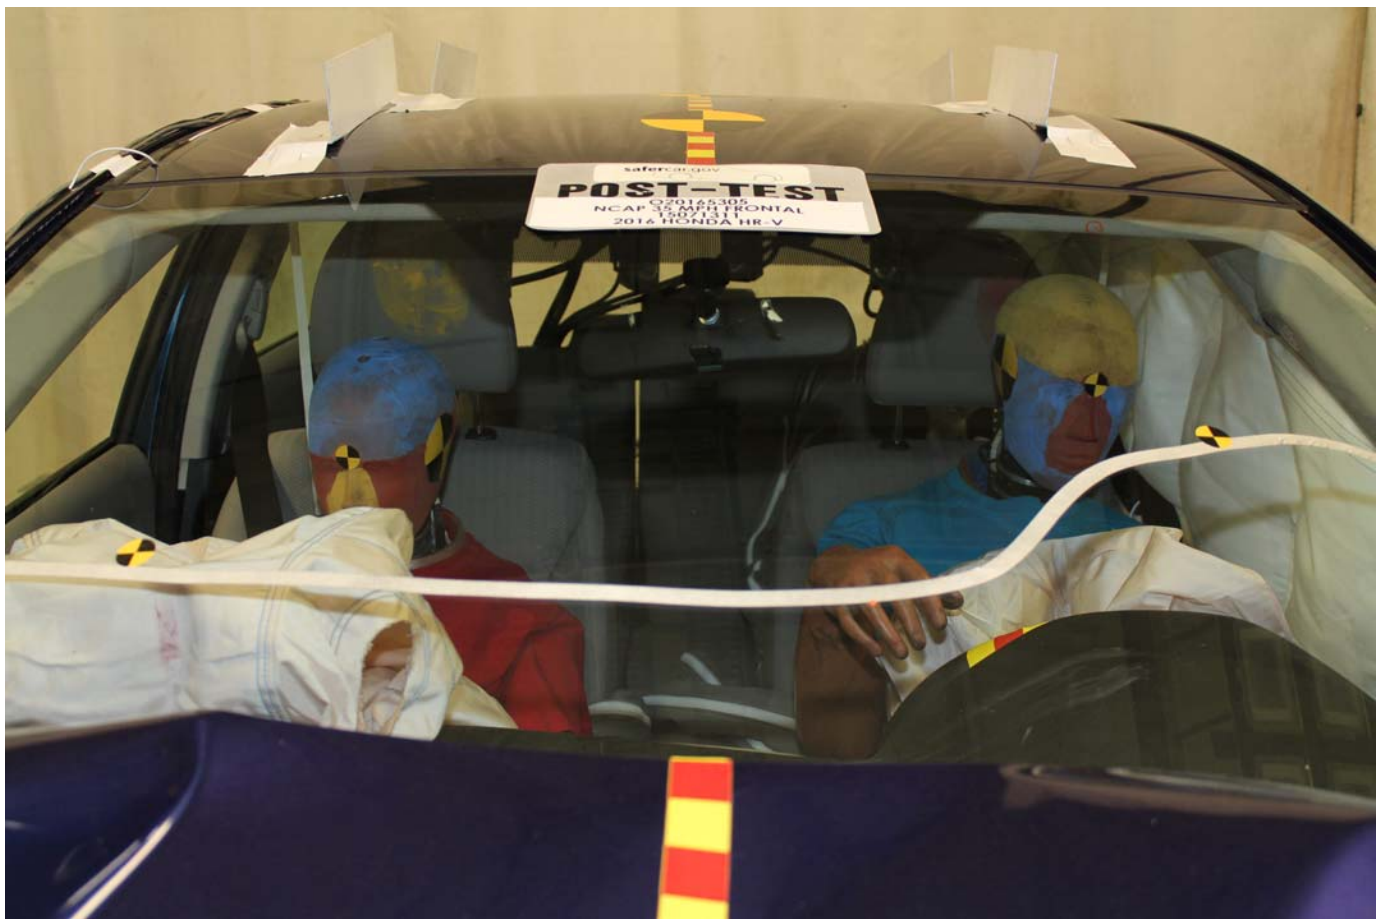
Photo No. 018 - Post-Test Windshield View

There was 100 percent windshield retention and no intrusion into the protected zone of the windshield during the event. There was no Stoddard Solvent leakage after the event or during any phase of the static rollover.

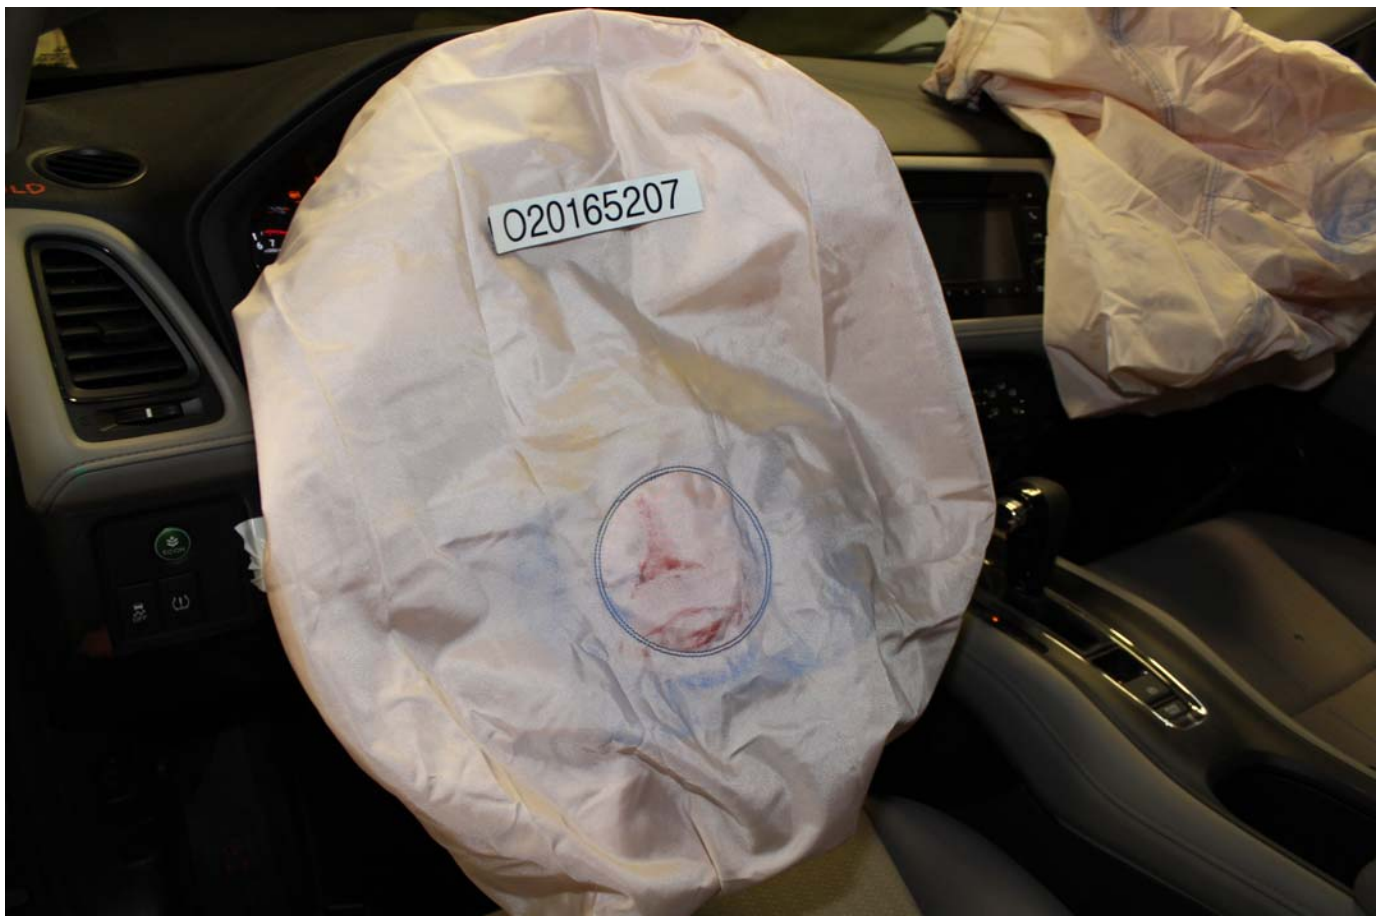
Photo No. 046 - Post-Test Driver Dummy Contact with Airbag

The driver's visible contact points were as follows: The driver's head contacted the airbag. The driver's head also contacted the headrest. The driver's knees contacted the knee bolster. The passenger's visible contact points were as follows: The passenger's head contacted the airbag. The passenger's head also contacted the headrest. The passenger's knees contacted the glovebox.
