**REPORT NUMBER: SINCAP-MGA-2016-014**

**NEW CAR ASSESSMENT PROGRAM (NCAP)  
Moving Deformable Barrier Side Impact Test**

**HONDA DE MEXICO S.A. DE C.V.  
2016 Honda HR-V 2WD LX 5-Dr SUV  
NHTSA No.: O20165307**

**FINAL REPORT**

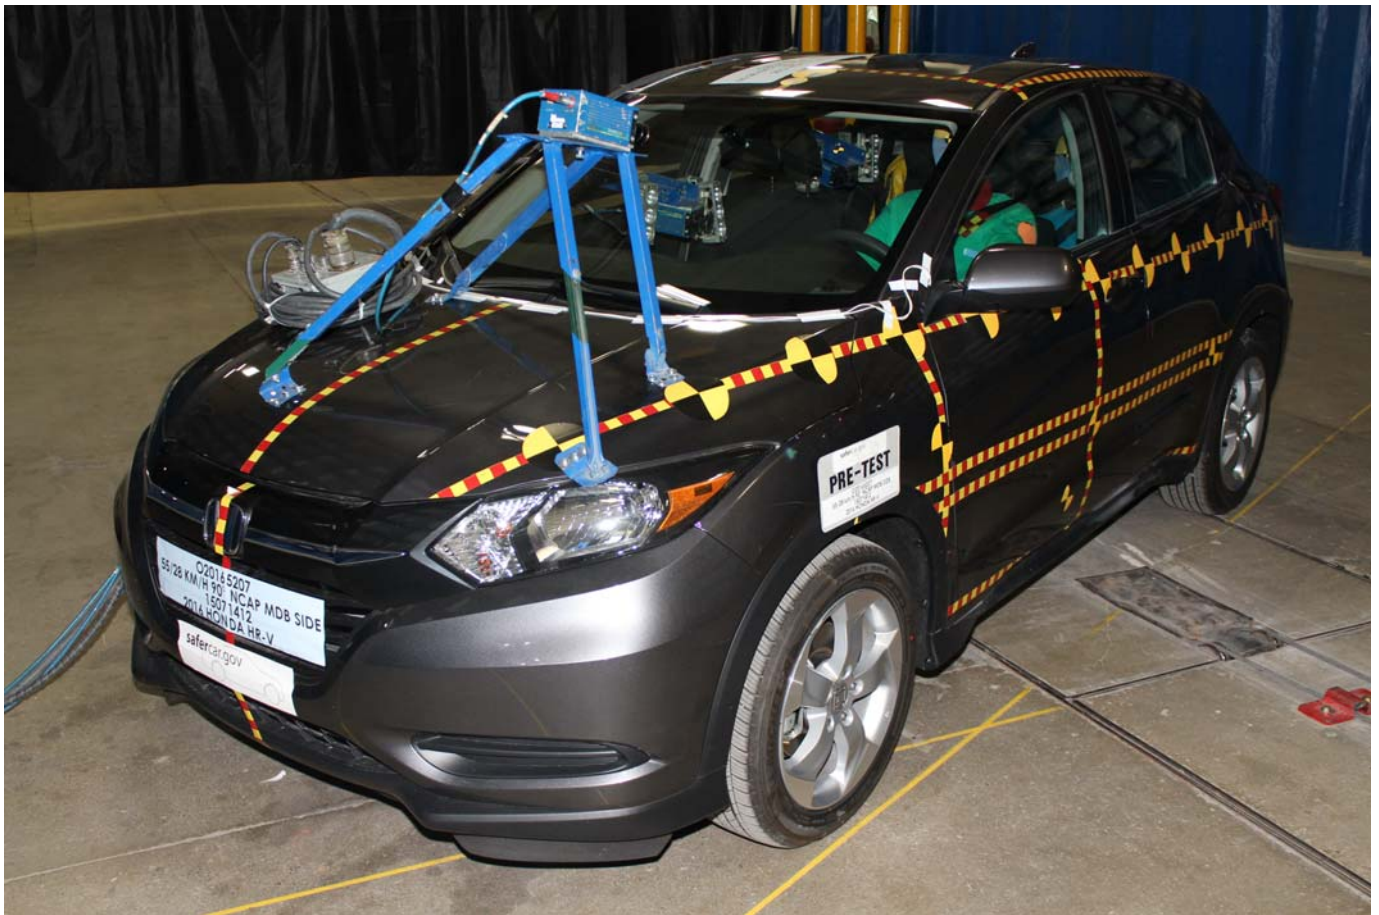
Photo No. 005 - Pre-Test Left Front Three-Quarter View of Test Vehicle

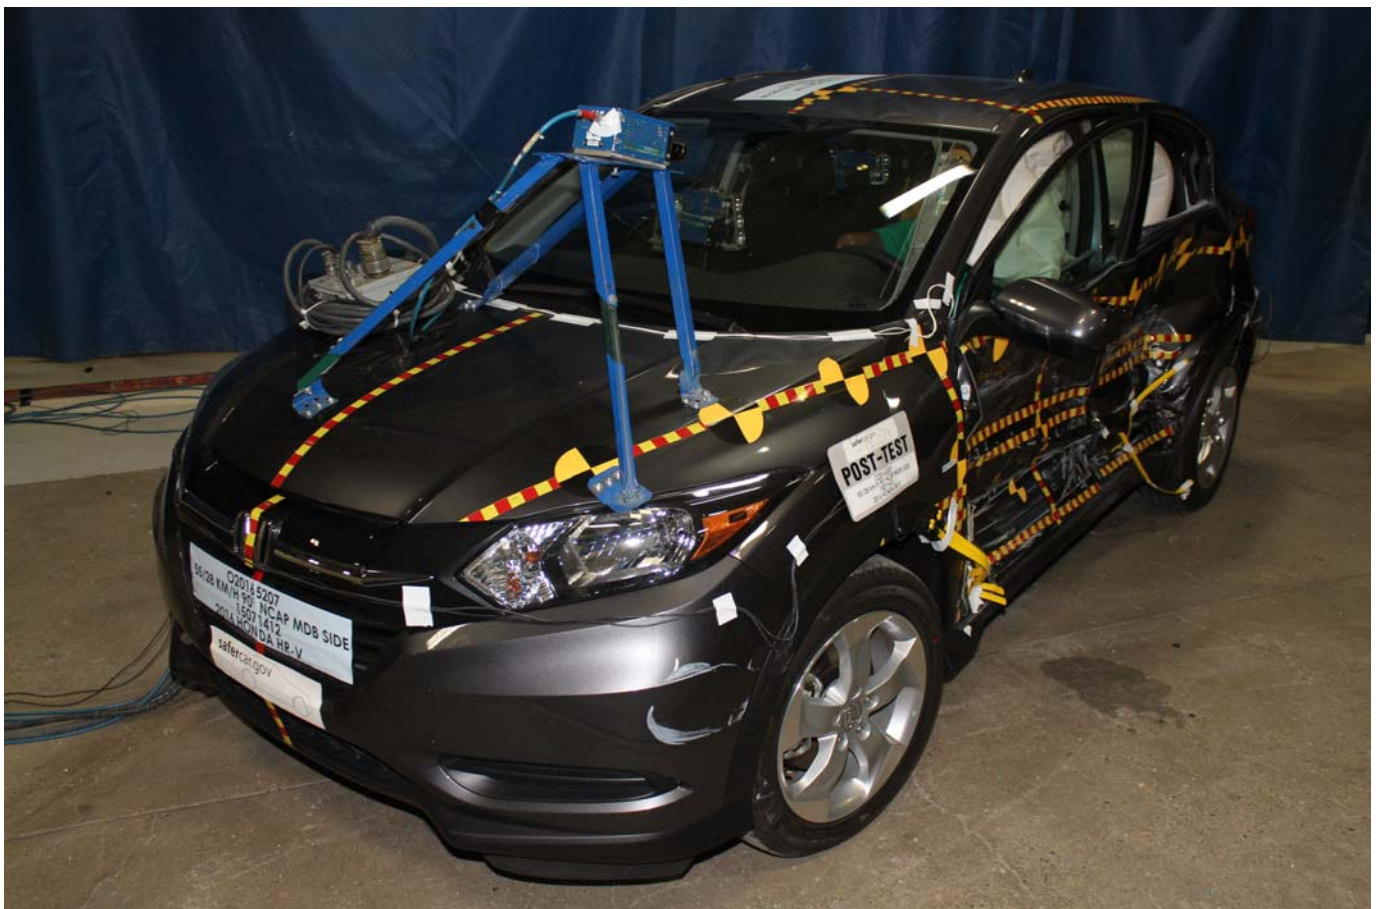
Photo No. 006 - Post-Test Left Front Three-Quarter View of Test Vehicle

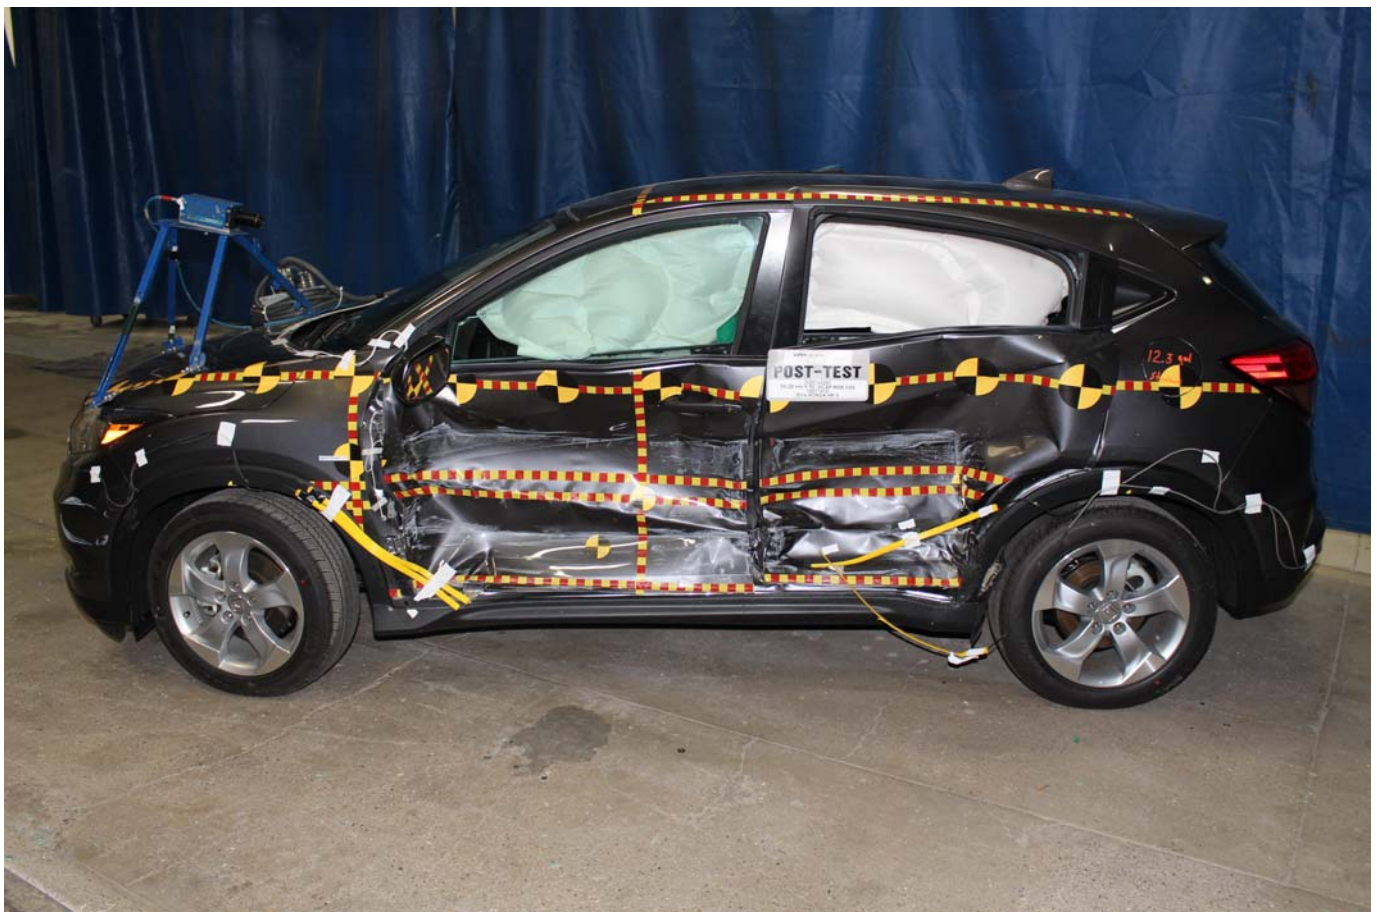
Photo No. 008 - Post-Test Left Side View of Test Vehicle

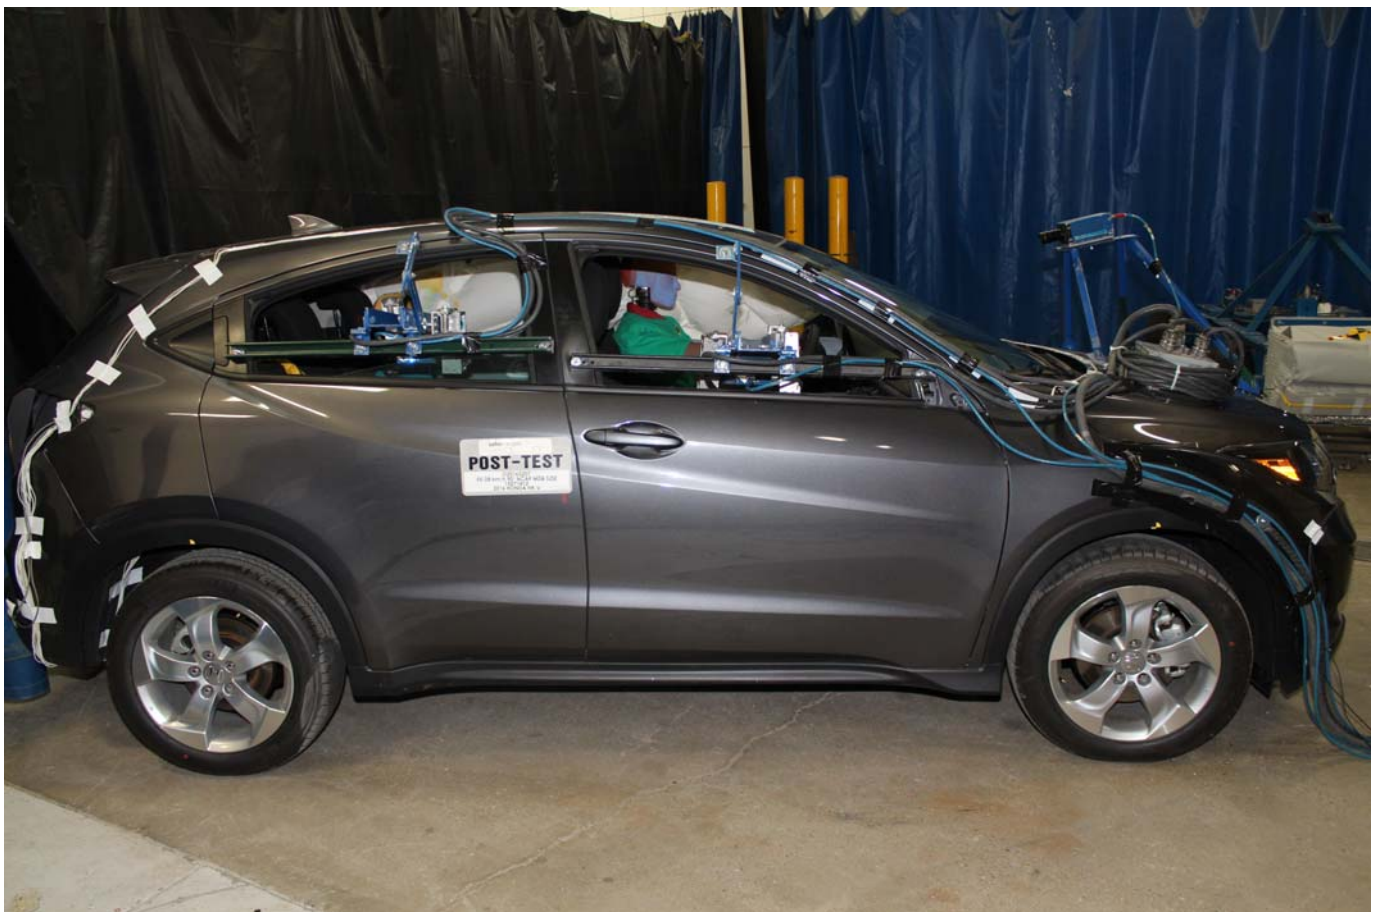
Photo No. 014 - Post-Test Right Side View of Test Vehicle

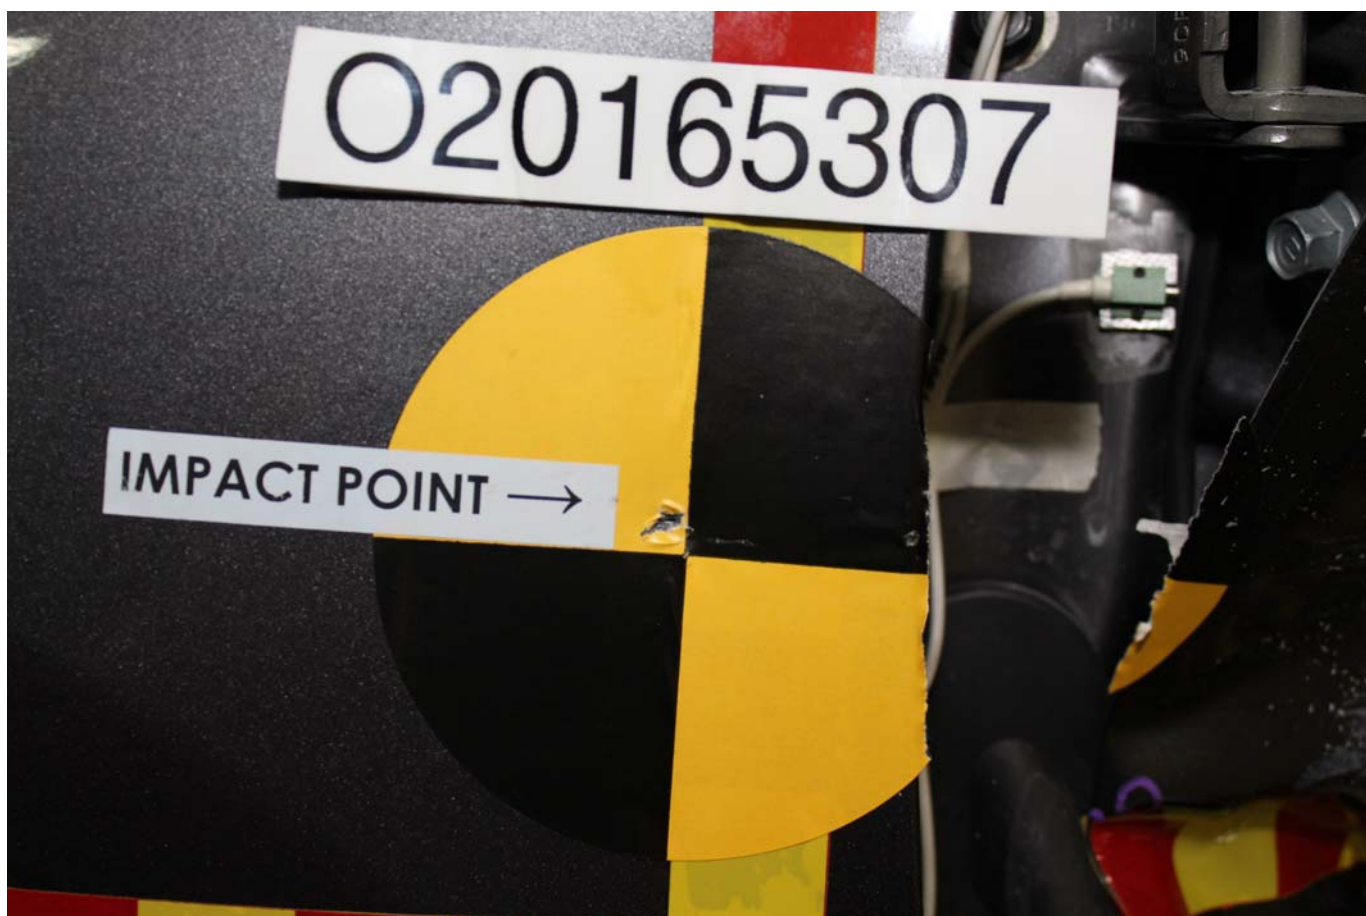
Photo No. 020 - Post-Test Close-Up View of Impact Point Target

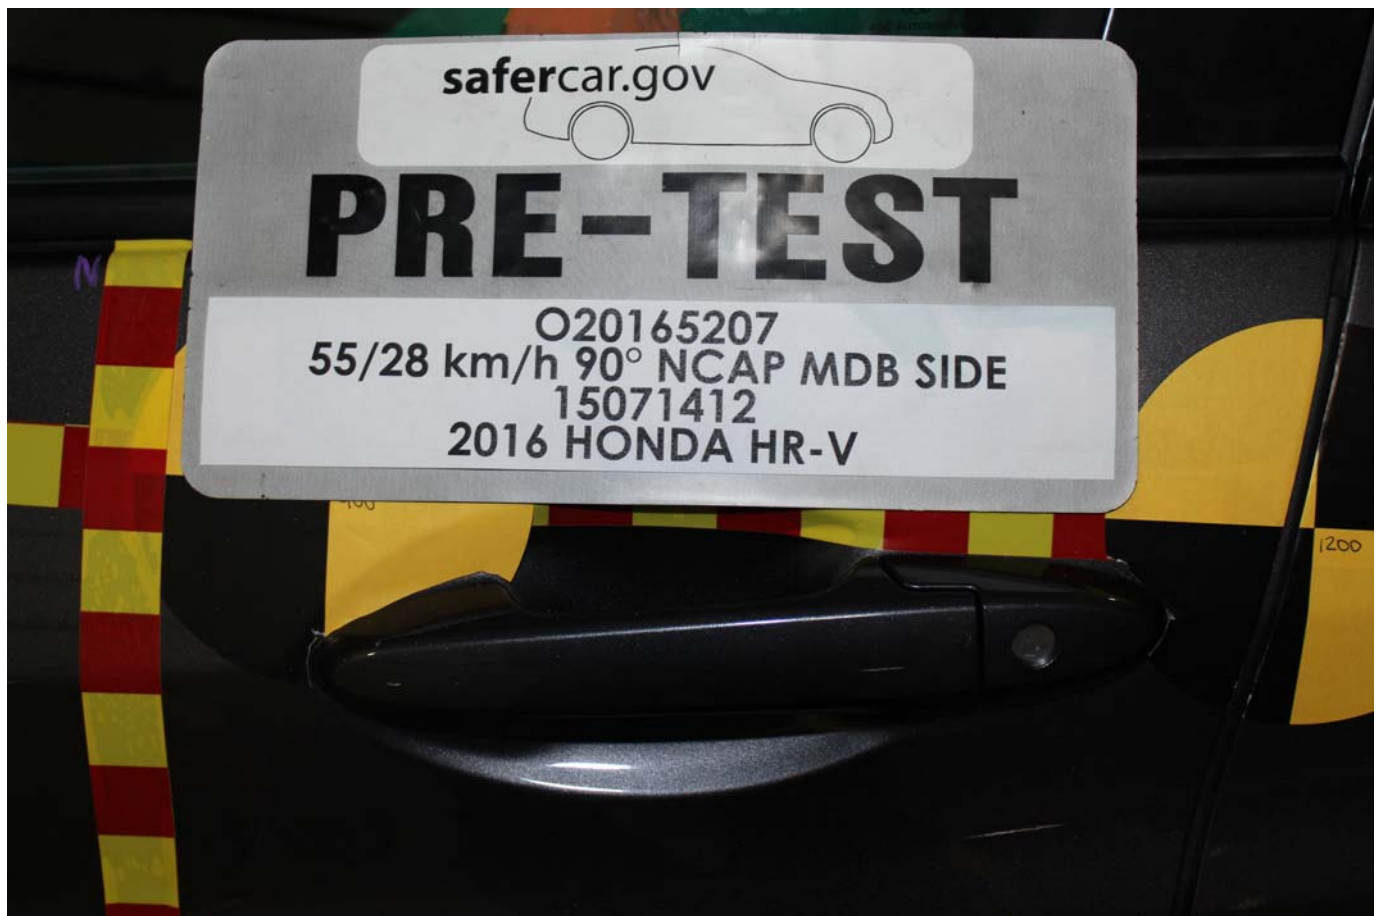
Photo No. 021 - Pre-Test Left Front Door Latch Close-Up

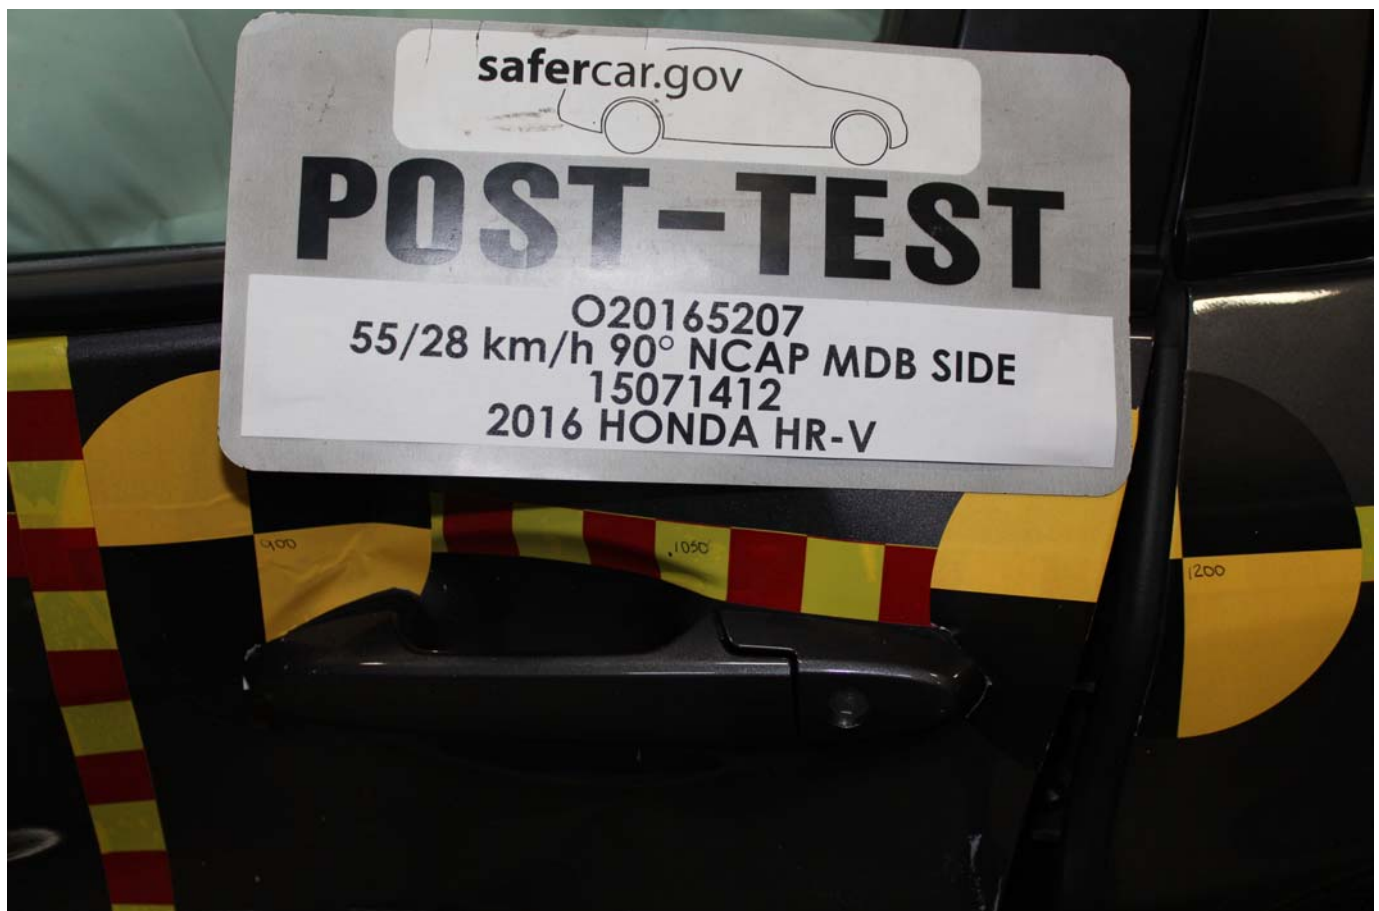
Photo No. 022 - Post-Test Left Front Door Latch Close-Up

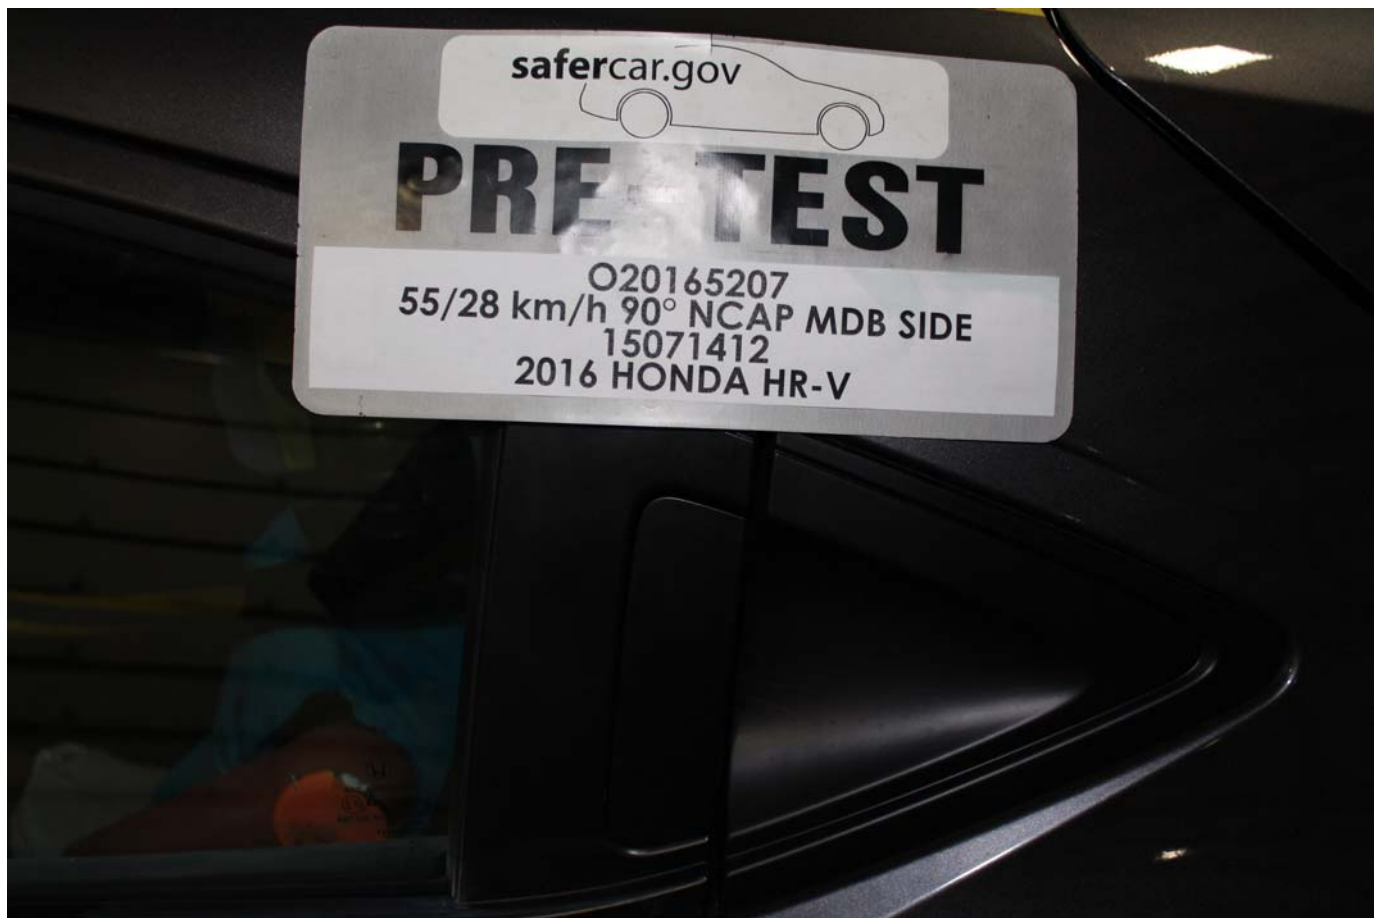
Photo No. 023 - Pre-Test Left Rear Door Latch Close-Up

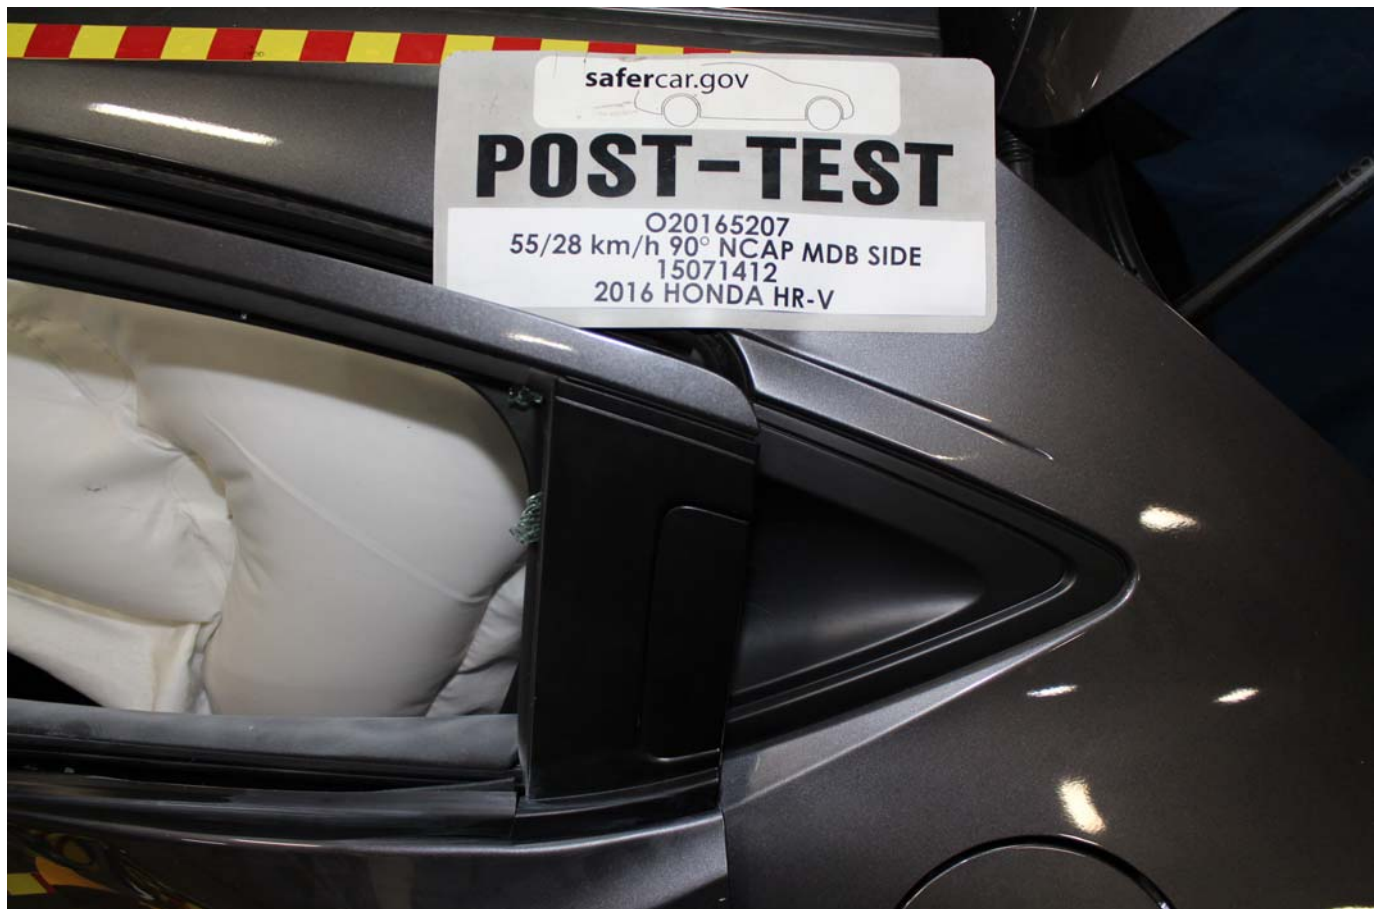
Photo No. 024 - Post-Test Left Rear Door Latch Close-Up

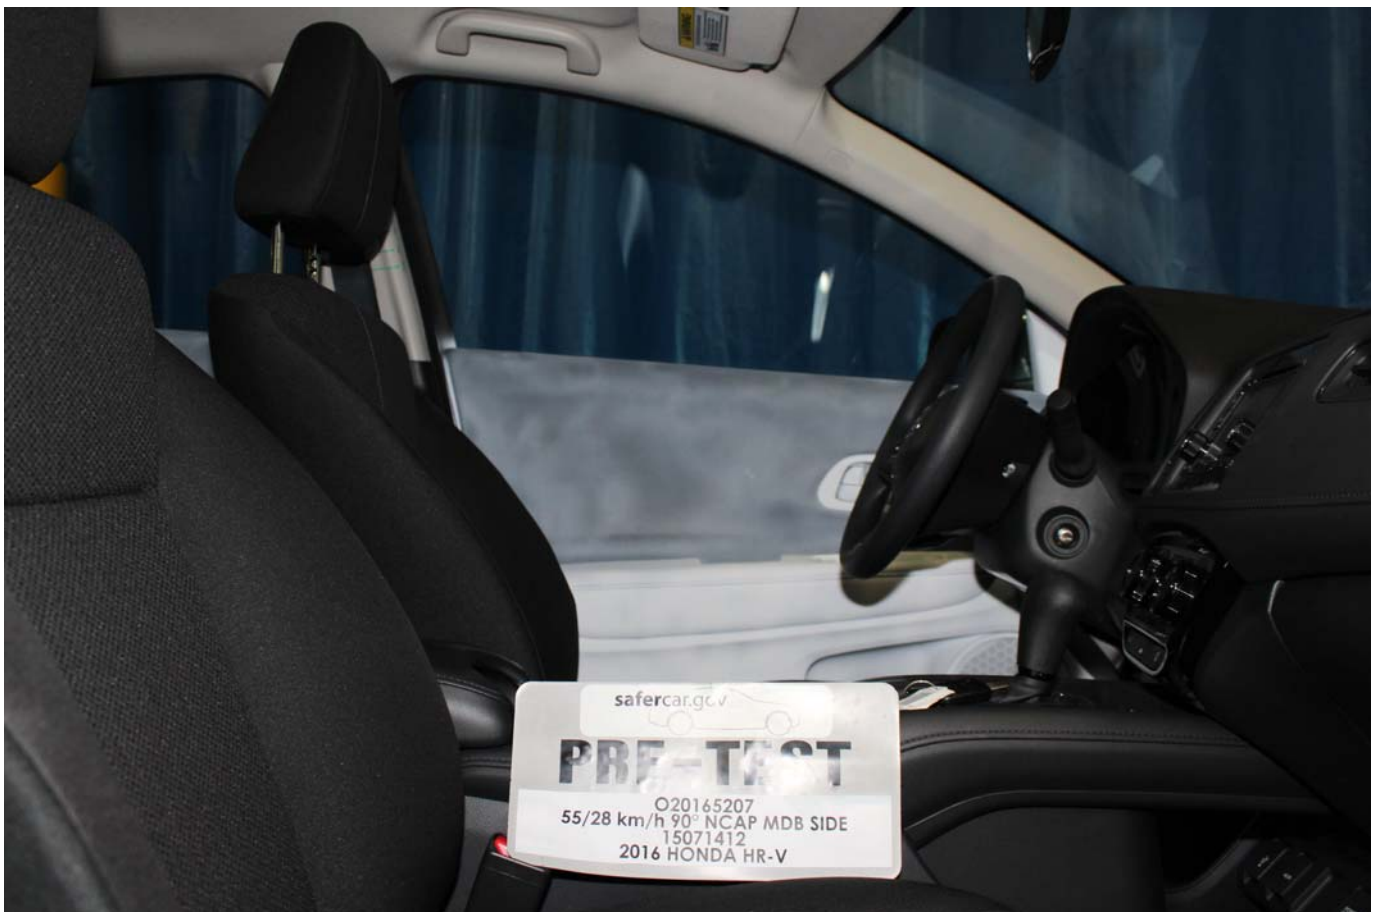
Photo No. 046 - Pre-Test Driver Inner Door Panel View

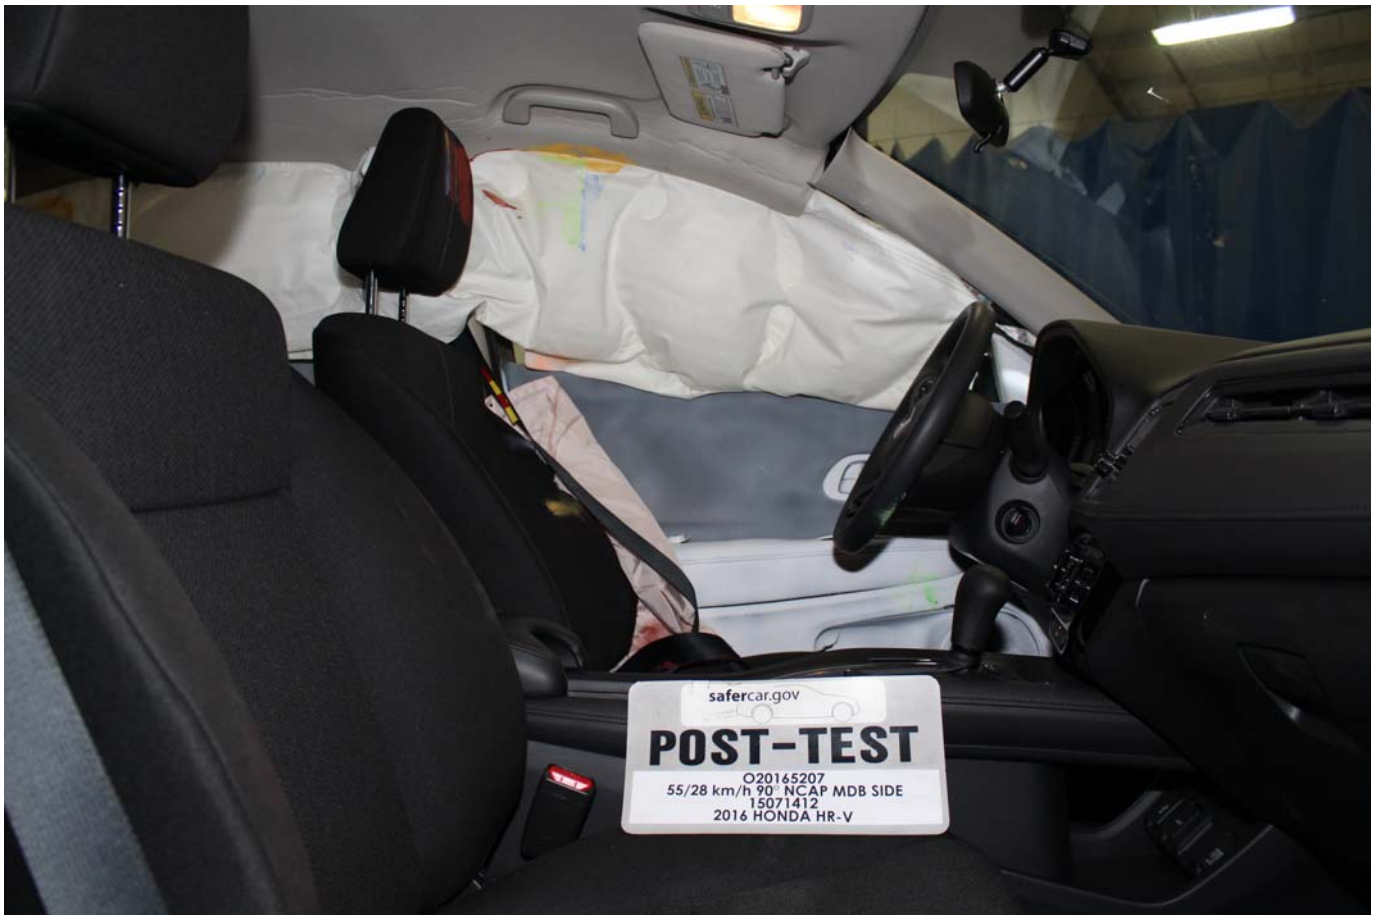
Photo No. 047 - Post-Test Driver Inner Door Panel View

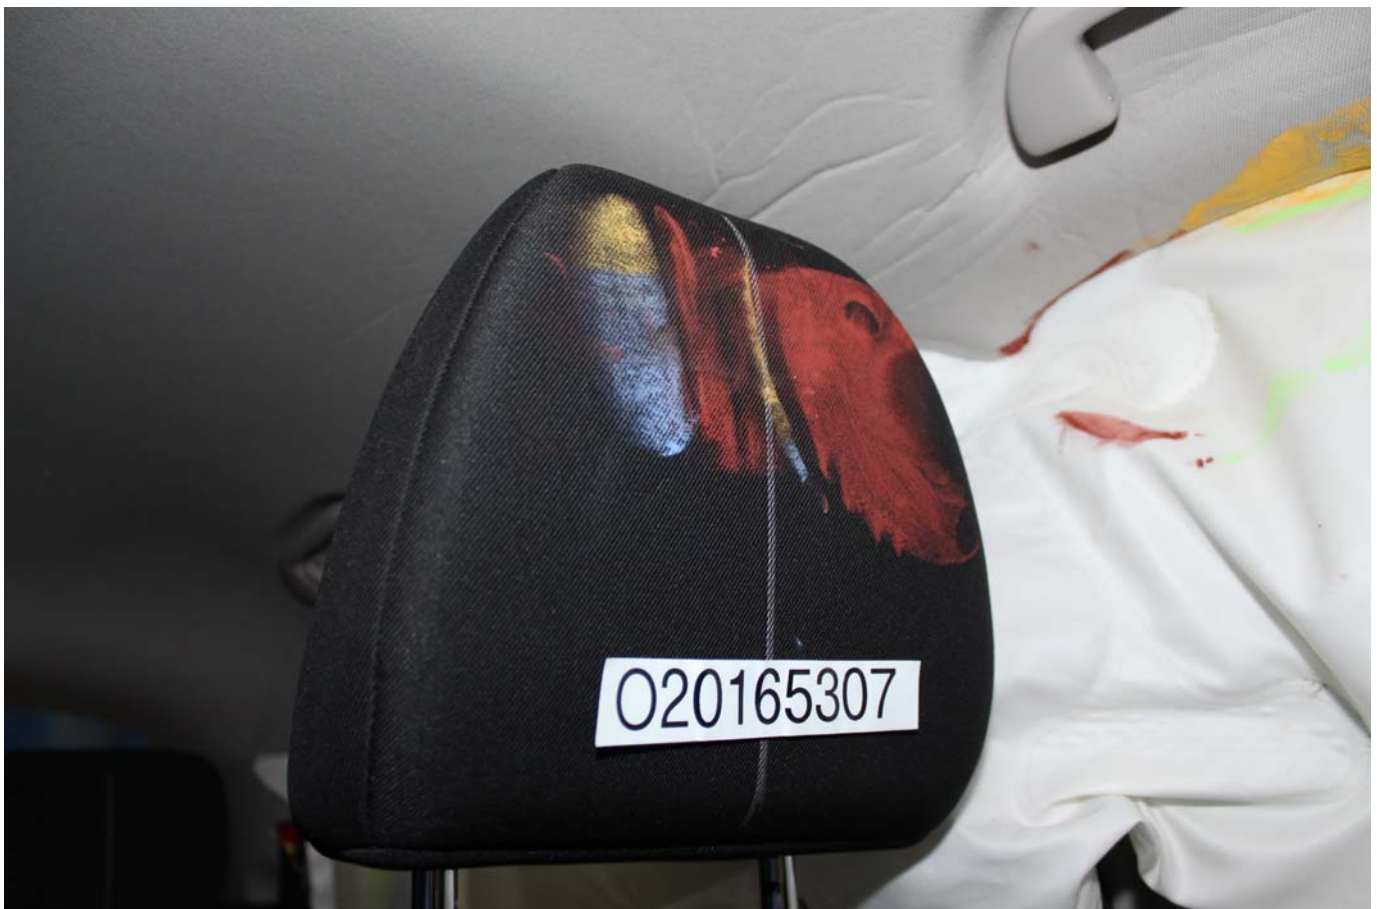
Photo No. 048 - Post-Test Driver Dummy Close-up Head Contact with Vehicle Interior View

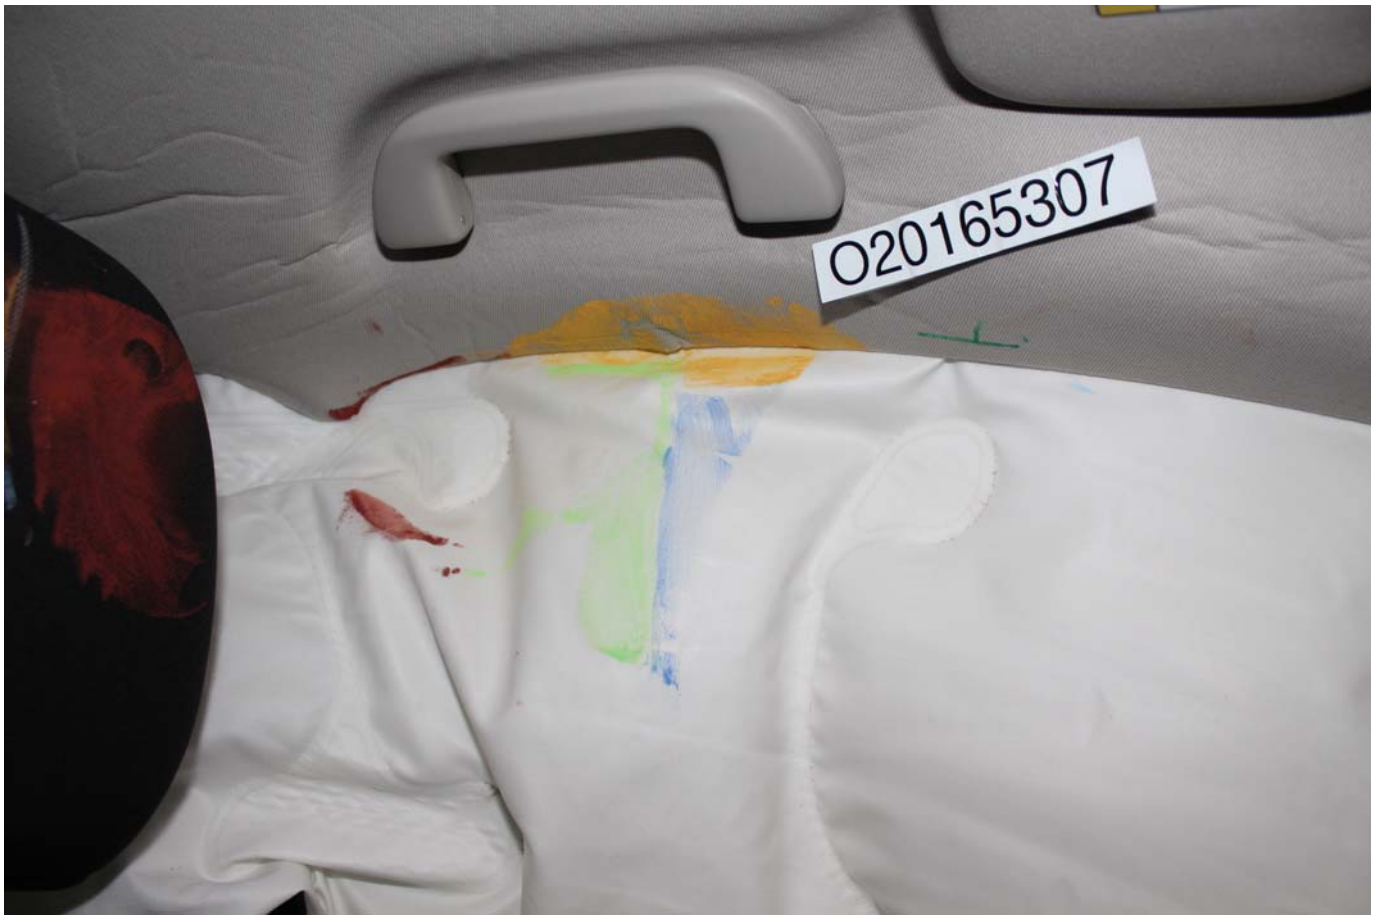
Photo No. 049 - Post-Test Driver Dummy Close-up Head Contact with Side Airbag View

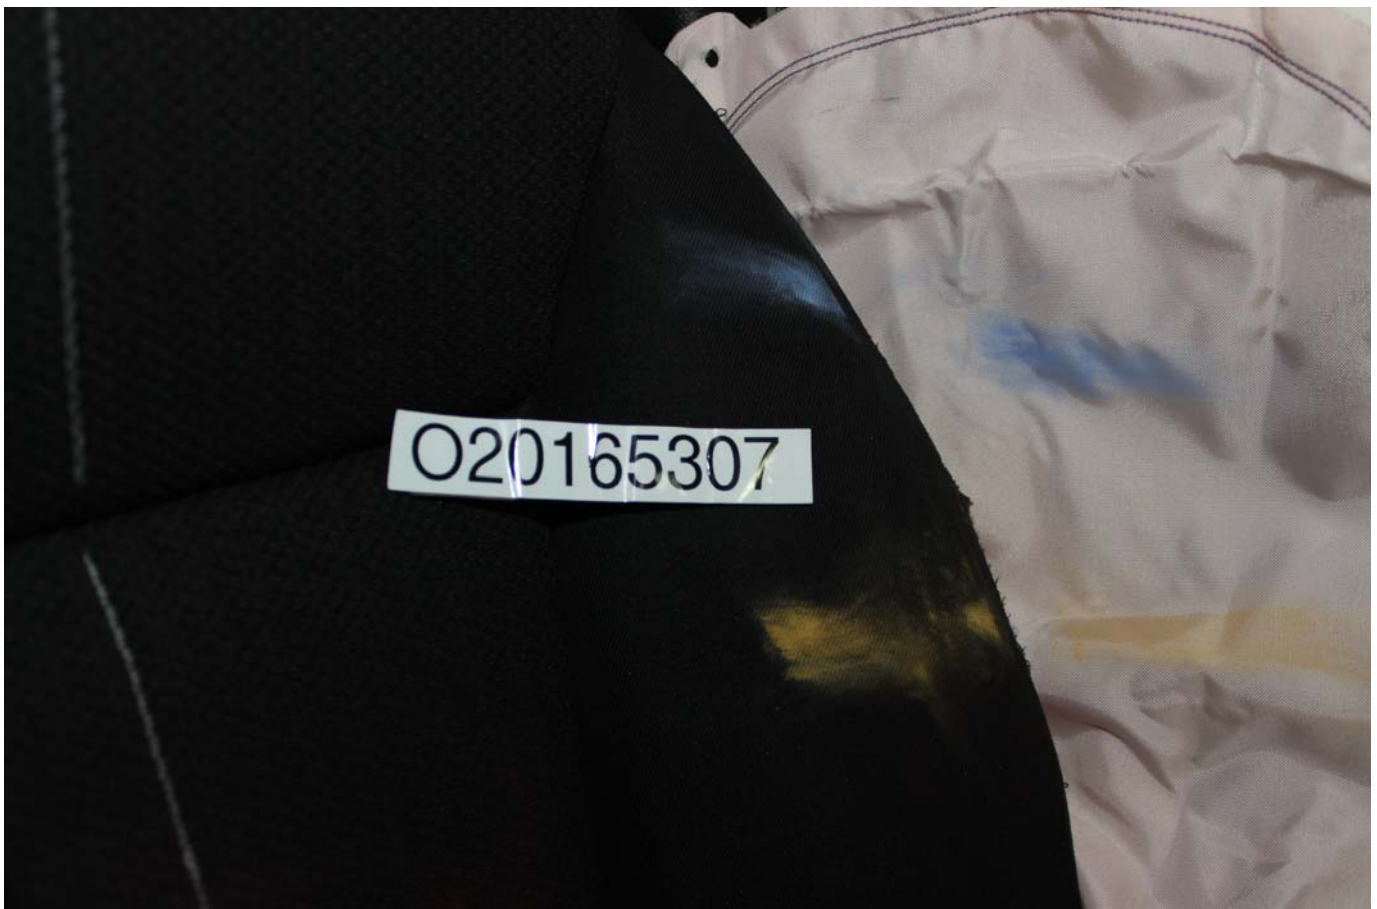
Photo No. 050 - Post-Test Driver Dummy Close-up Torso Contact with Vehicle Interior View

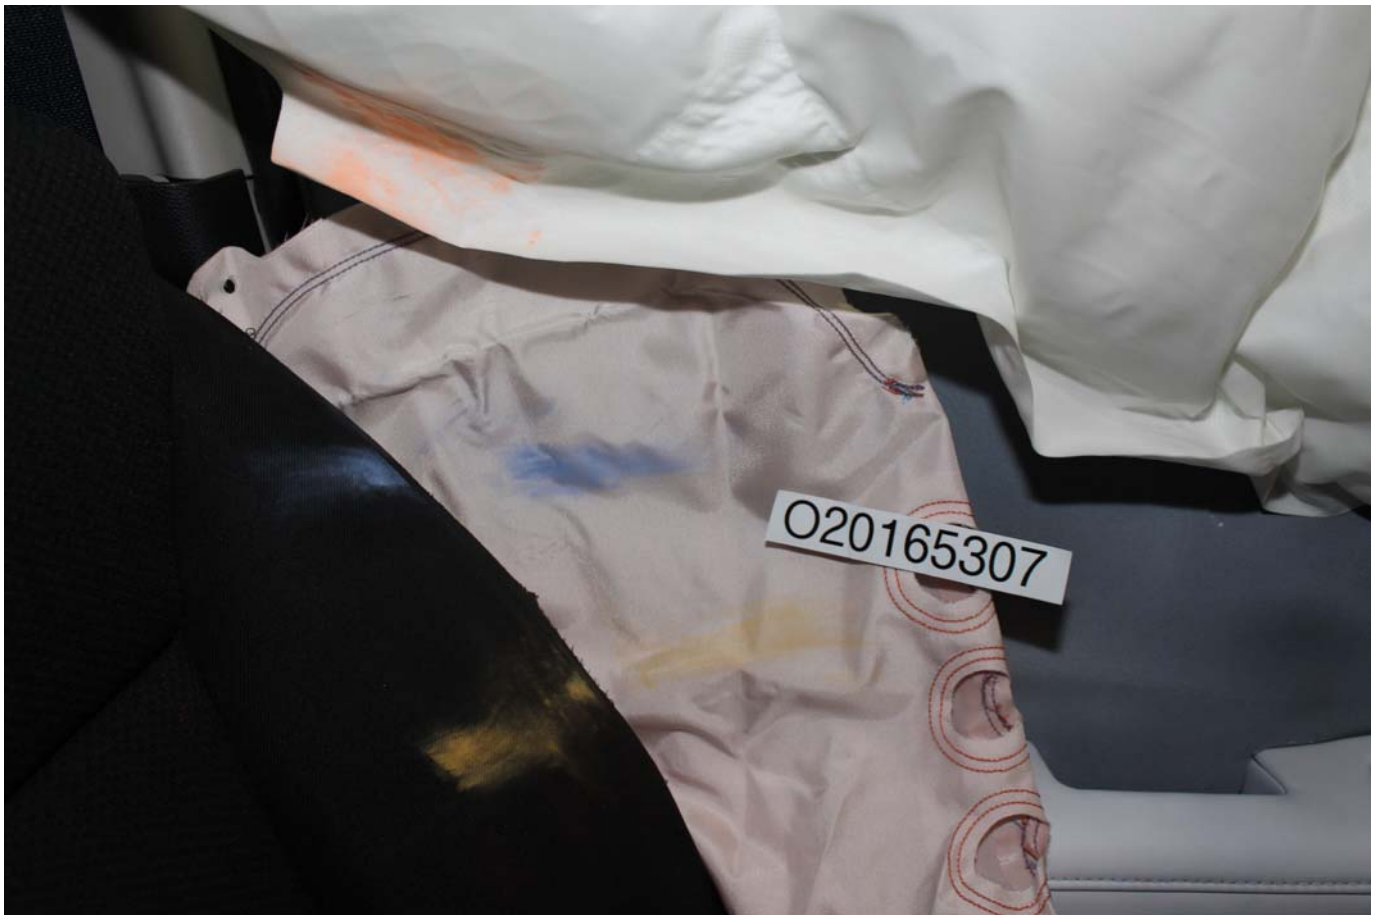
Photo No. 051 - Post-Test Driver Dummy Close-up Torso Contact with Side Airbag View

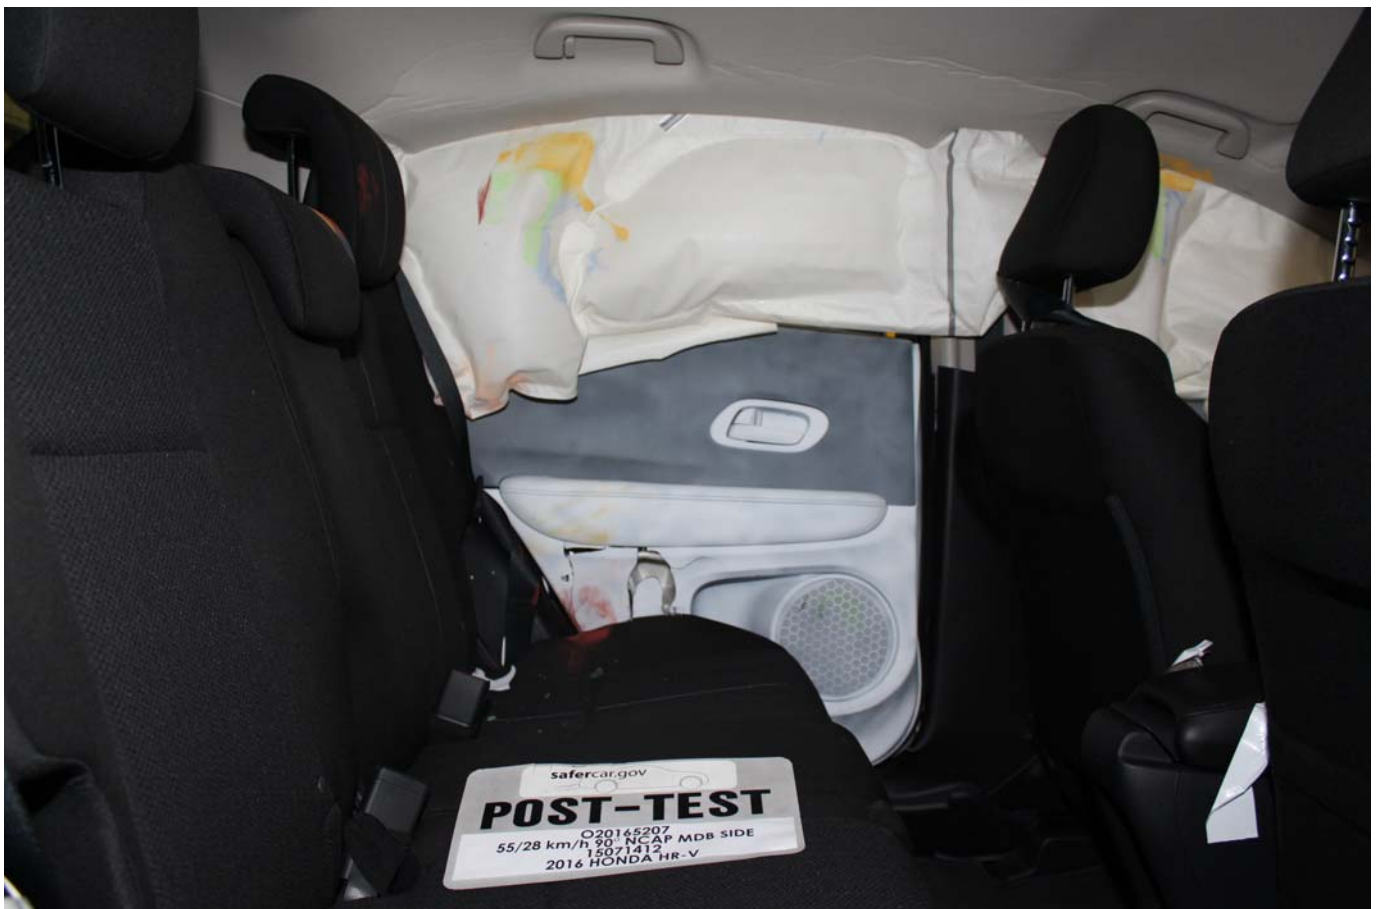
Photo No. 074 - Post-Test Rear Passenger Inner Door Panel View

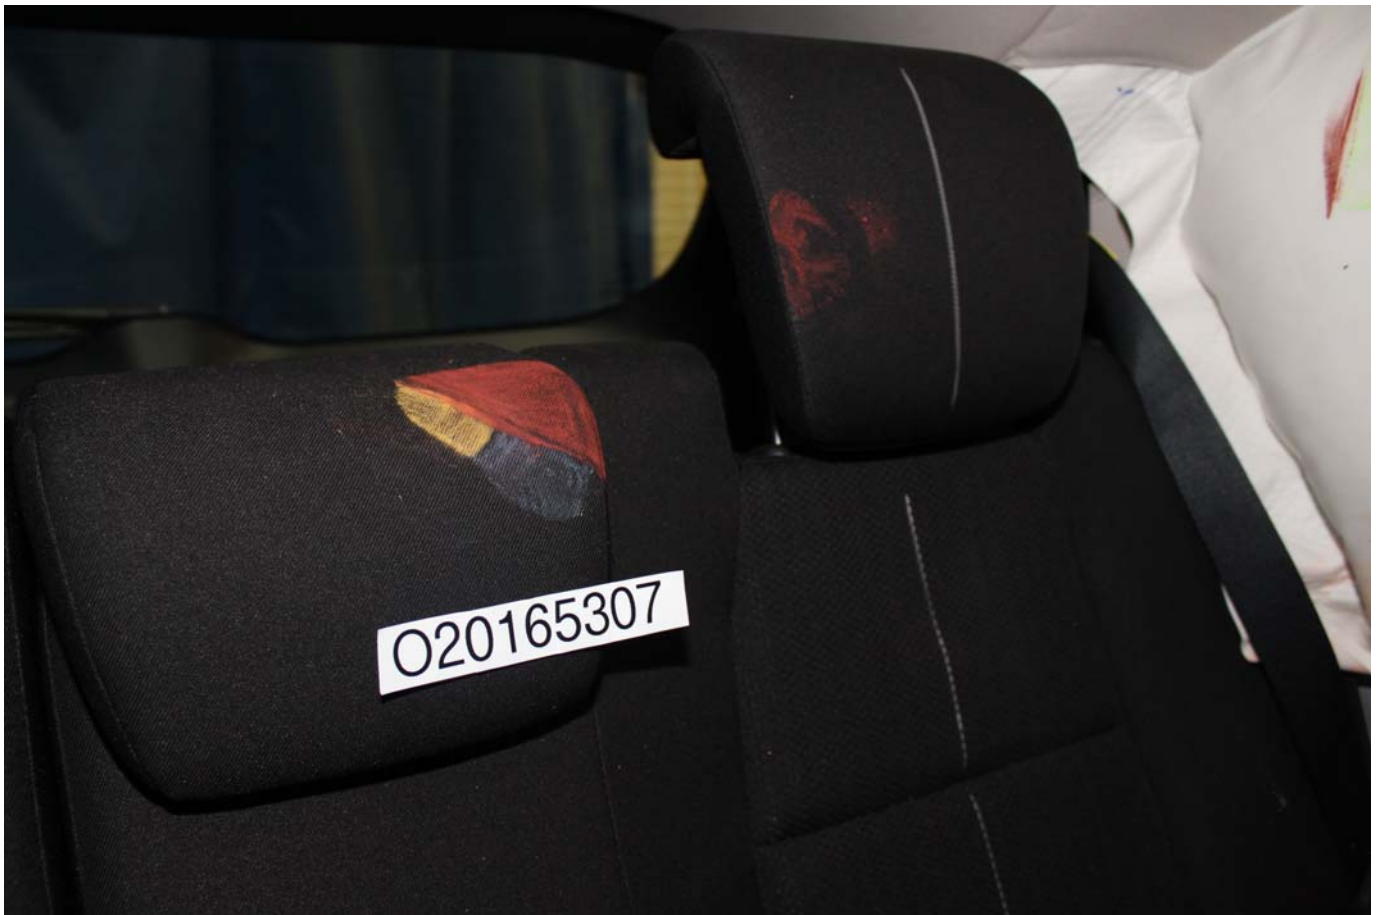
Photo No. 075 - Post-Test Rear Passenger Dummy Close-up Head Contact with Vehicle Interior View

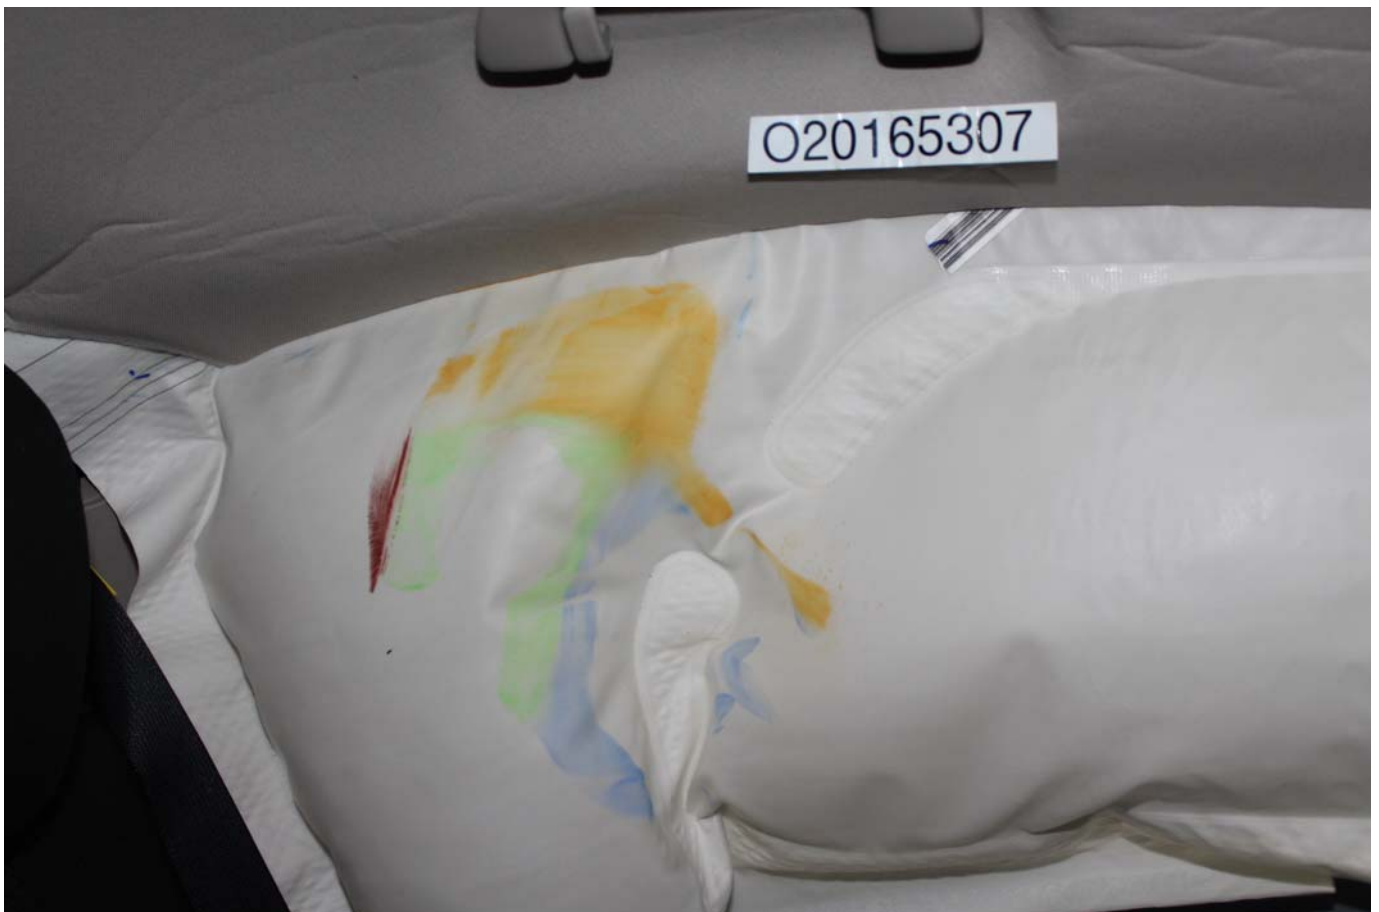
Photo No. 076 - Post-Test Rear Passenger Dummy Close-up Head Contact with Side Airbag View
