**REPORT NUMBER: SINCAP-MGA-2016-014**

**NEW CAR ASSESSMENT PROGRAM (NCAP)  
Moving Deformable Barrier Side Impact Test**

**HONDA DE MEXICO S.A. DE C.V.  
2016 Honda HR-V 2WD LX 5-Dr SUV  
NHTSA No.: O20165307**

**FINAL REPORT**

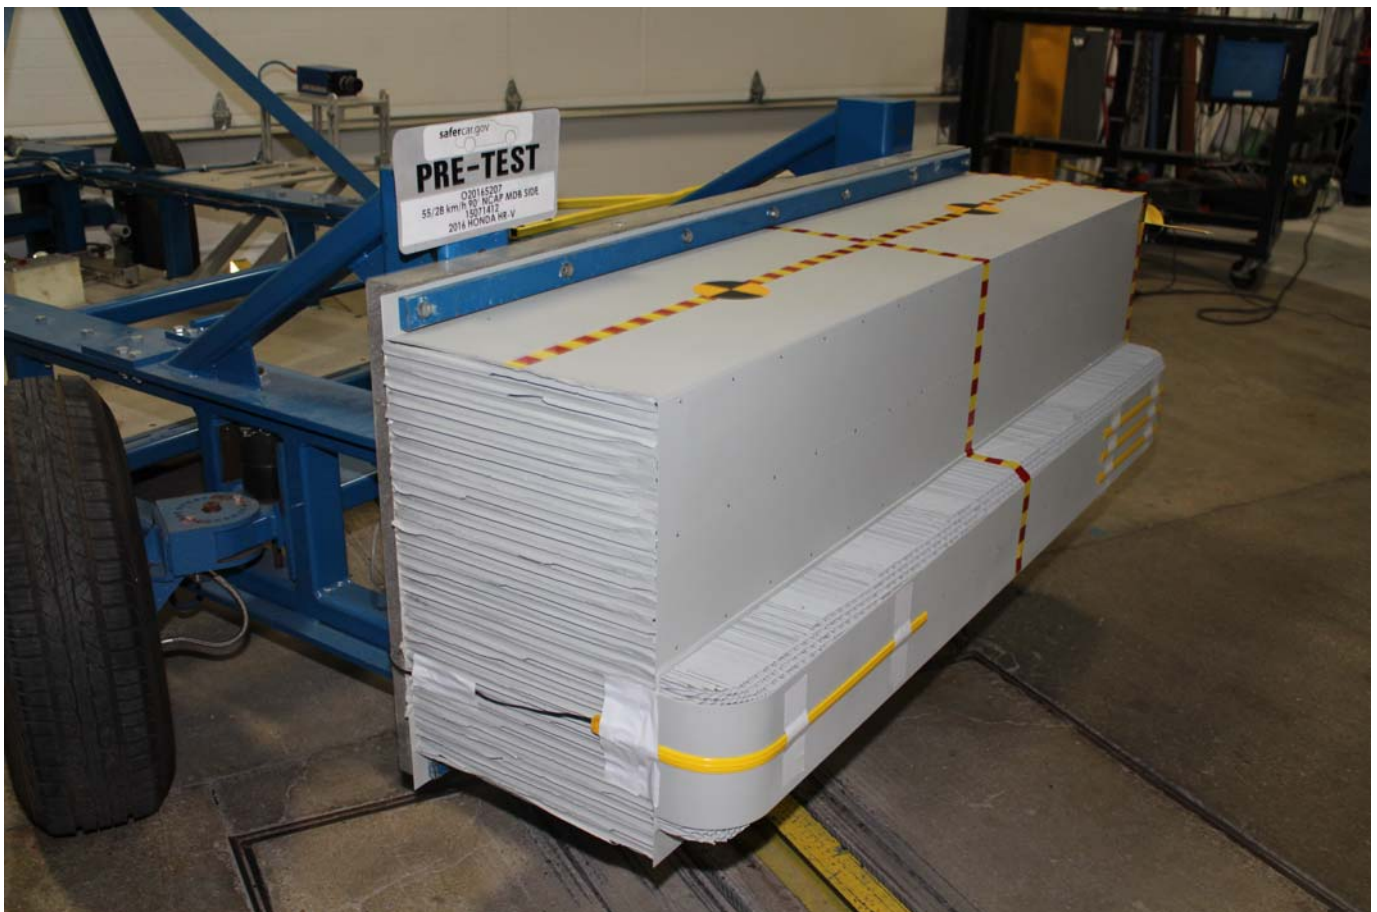
Photo No. 089 - Post-Test Left Side View of MDB Impactor Face
