**REPORT NUMBER: SPNCAP-MGA-2016-015**

**NEW CAR ASSESSMENT PROGRAM (NCAP)  
Side Impact Pole Test**

**HONDA OF AMERICA MFG., INC.  
2016 Acura RDX 5-Dr SUV  
NHTSA No.: O20165303**

**FINAL REPORT**

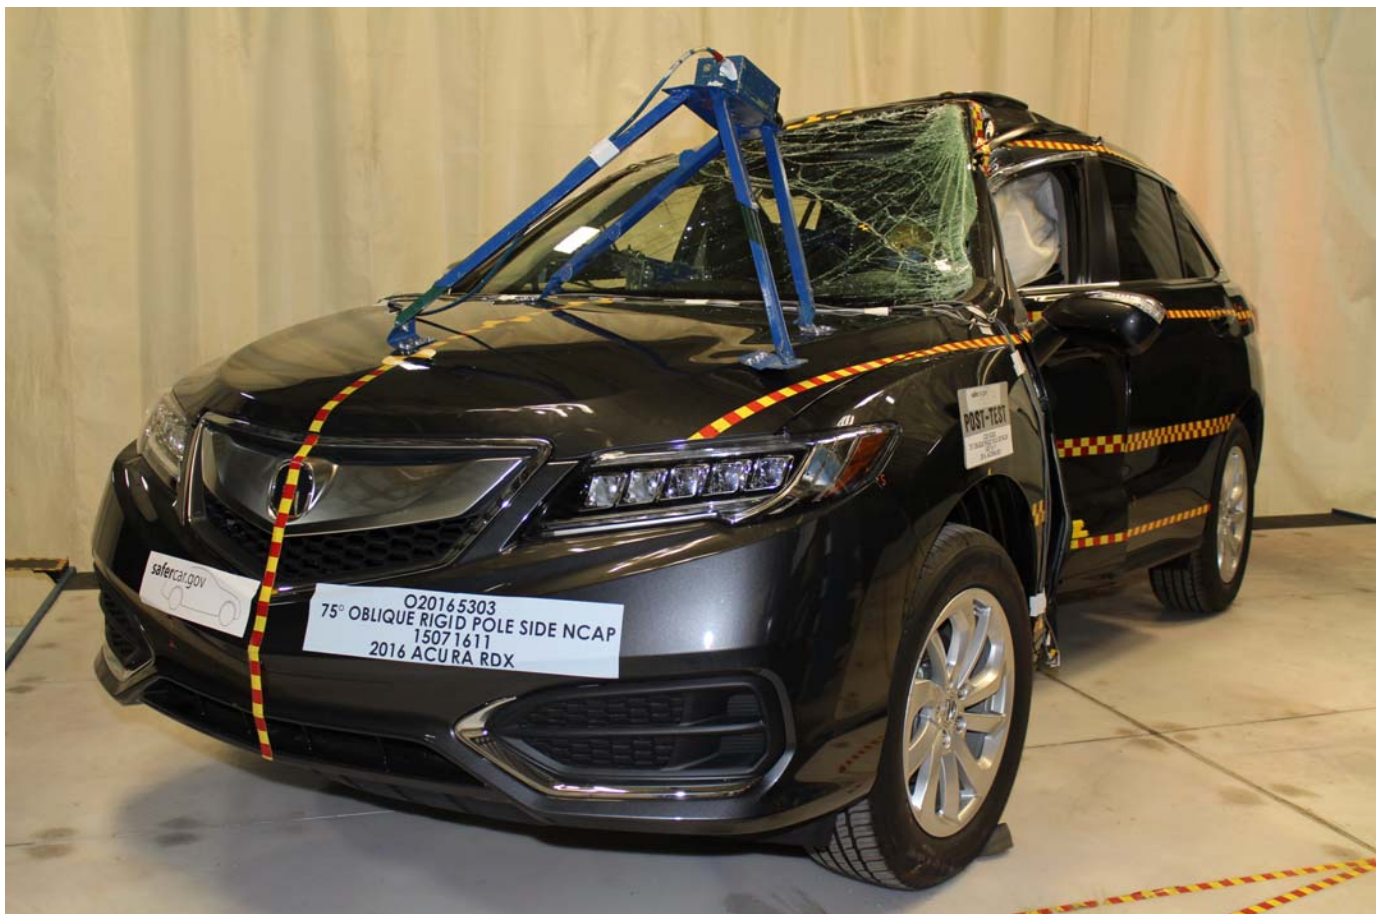
Photo No. 006 - Post-Test Left Front  $\frac{3}{4}$  View of Test Vehicle

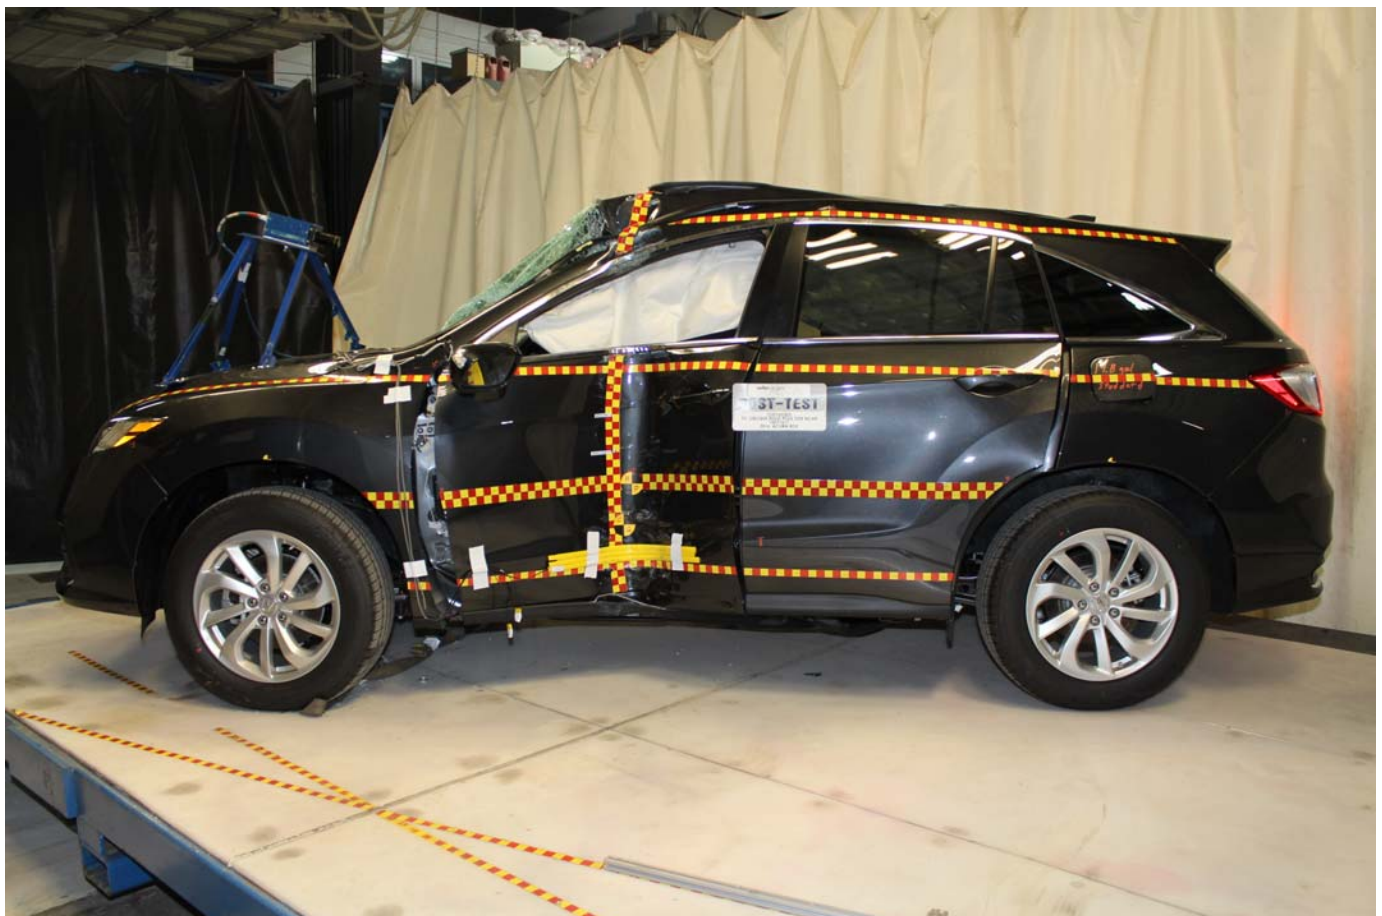
Photo No. 008 - Post-Test Left Side View of Test Vehicle

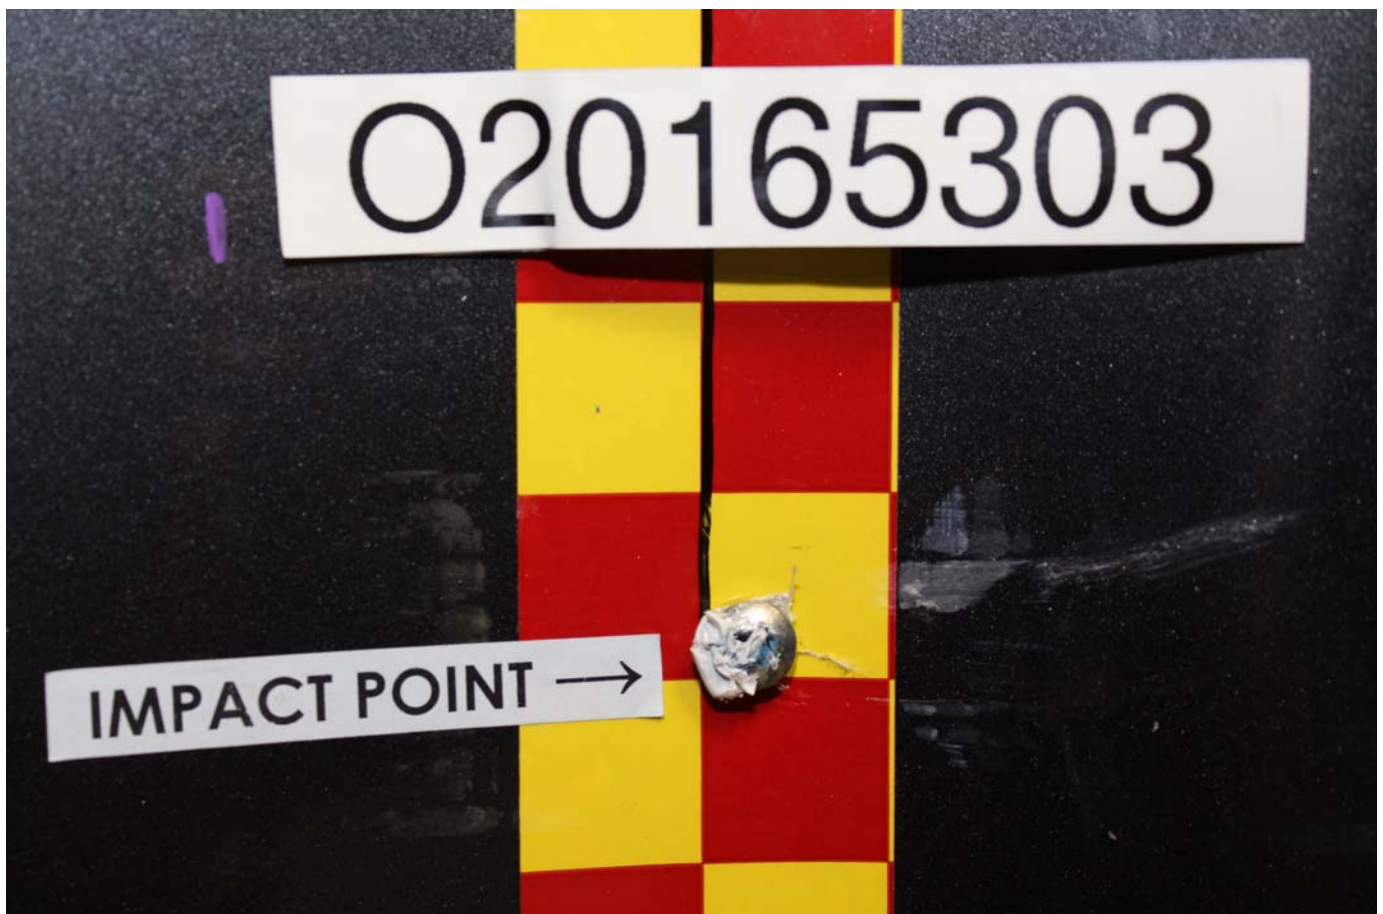
Photo No. 020 - Post-Test Close-Up View of Impact Point Target Showing Impact Location

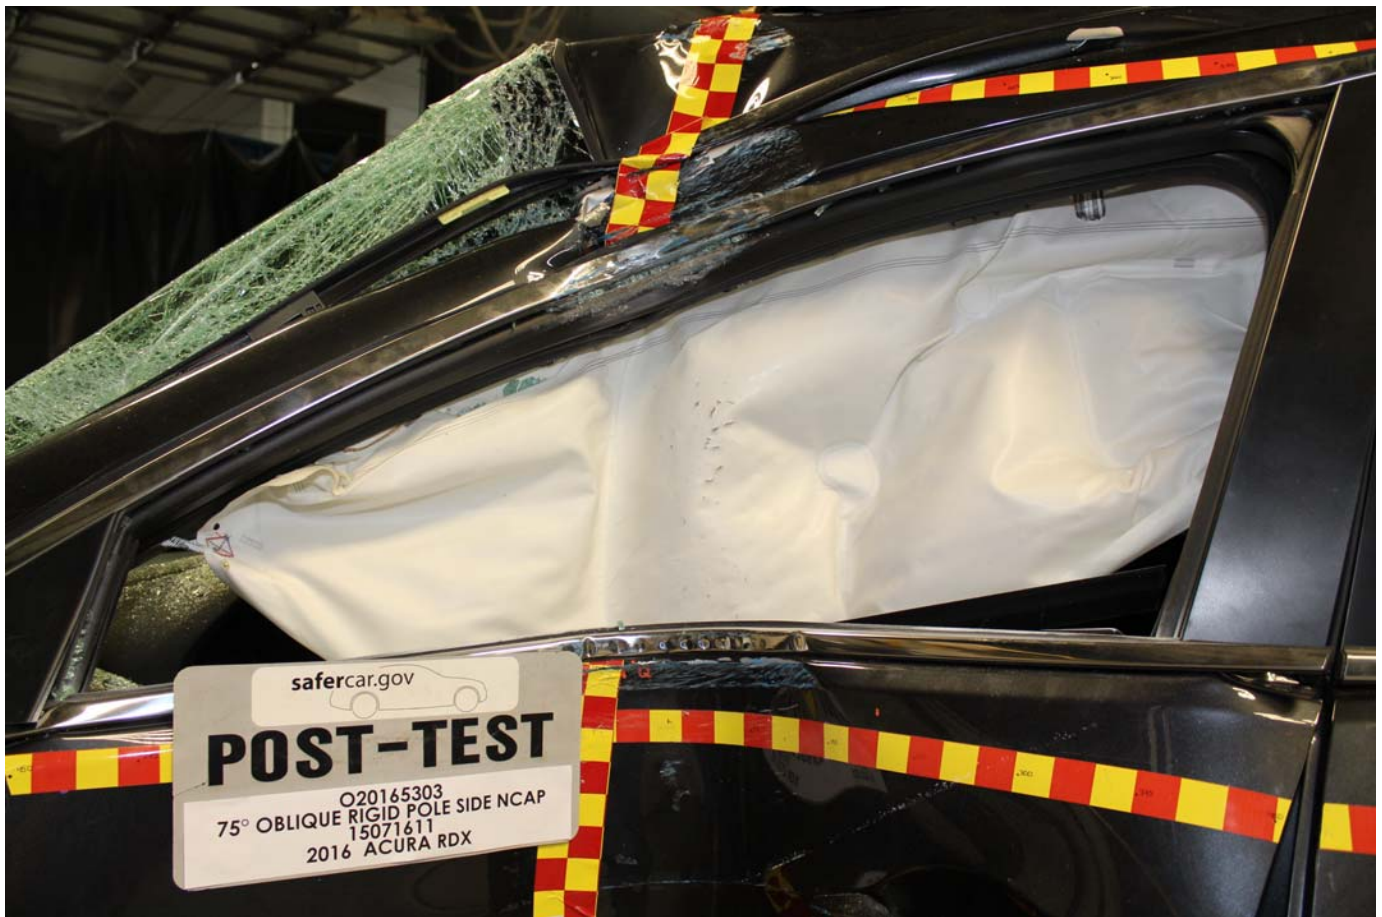
Photo No. 025 - Post-Test Left Side View of Dummy Shoulder and Door Top View

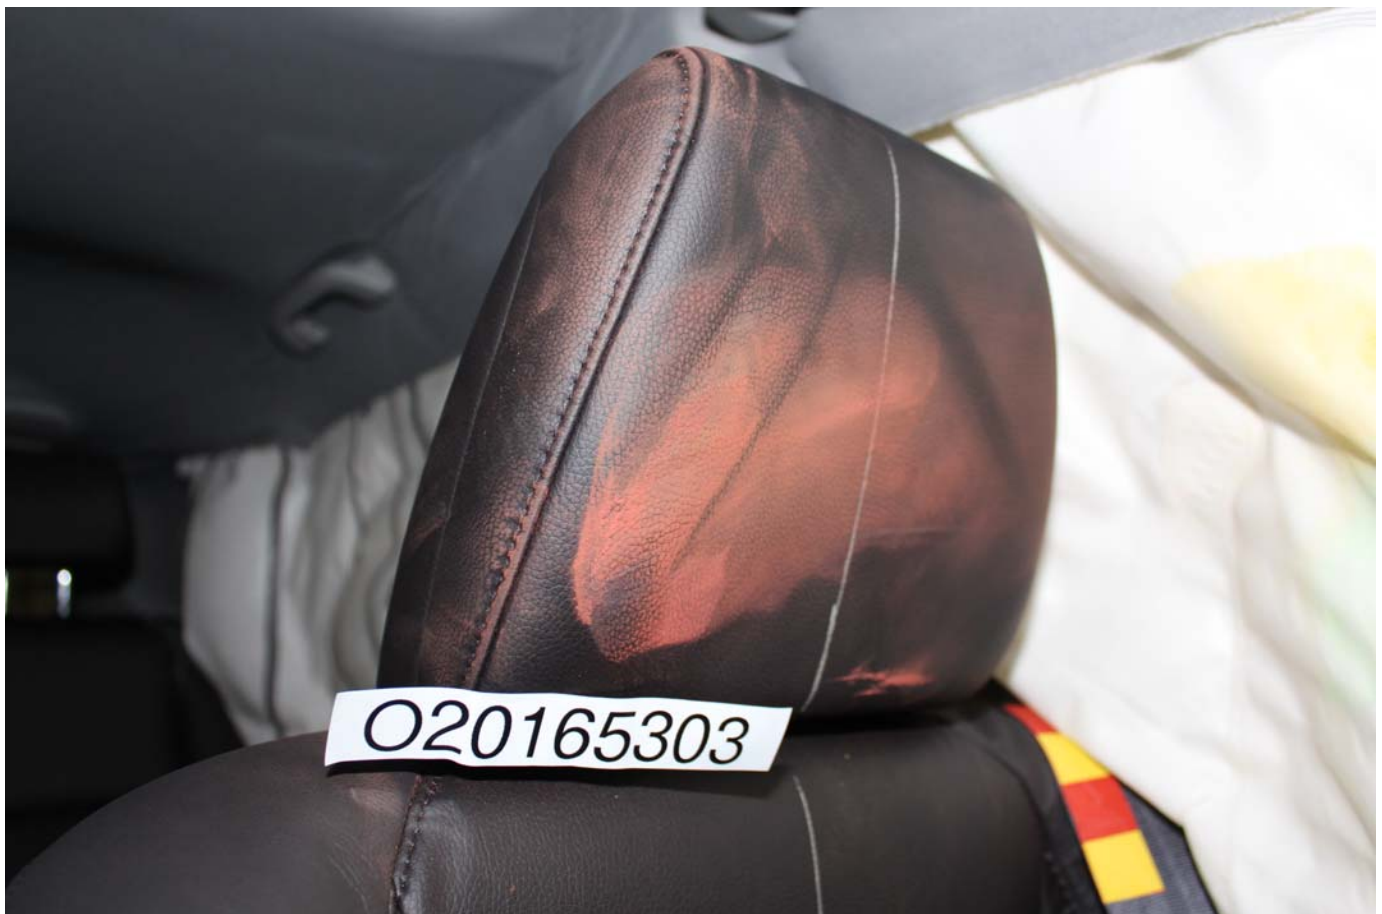
Photo No. 046 - Post-Test Dummy Close-Up Head Contact with Vehicle Interior View

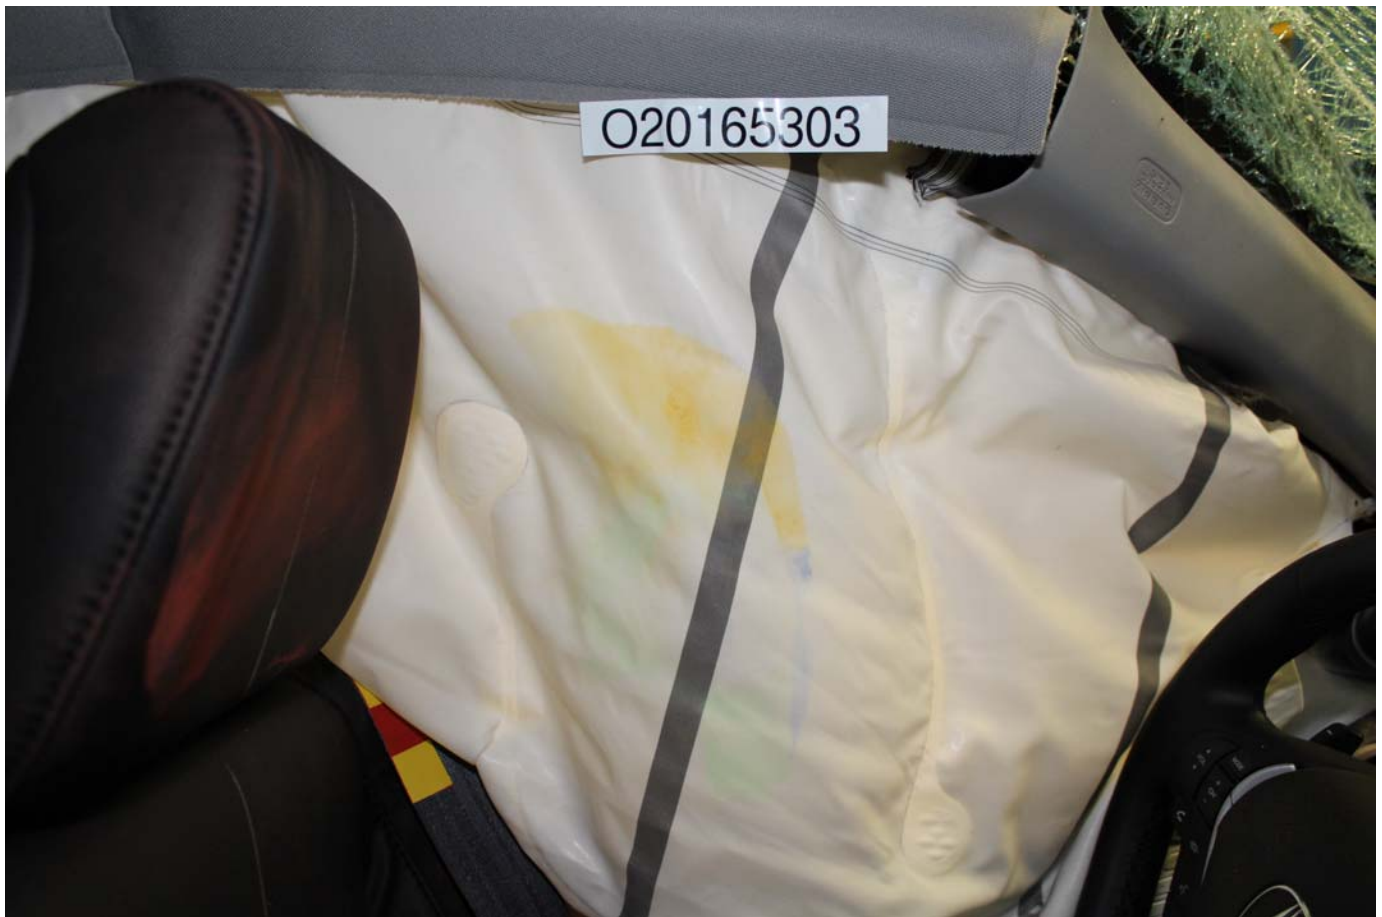
Photo No. 047 - Post-Test Dummy Close-Up Head Contact with Side Air Bag View
