REPORT NUMBER: TWG-CAL-14-06

**NEW CAR ASSESSMENT PROGRAM (NCAP)**  
SIDE AIRBAG OUT-OF-POSITION INJURY TESTING

**Honda of Canada Mfg.**  
**2015 Honda CR-V**

NHTSA NUMBER: M20155317TWG2  
CALSPAN TEST NUMBER: CT2014-06

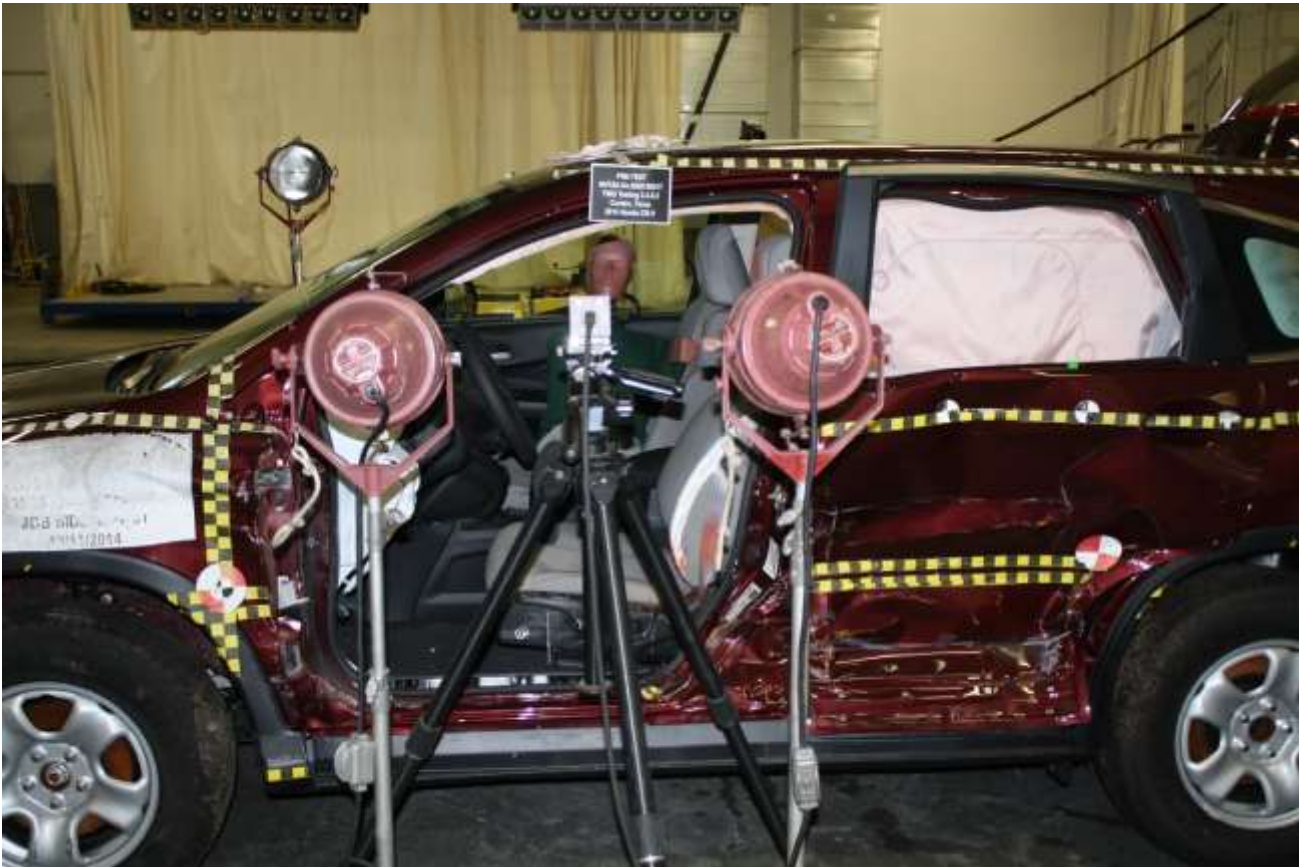
**Figure A-3: Pre-Test Vehicle Left Side View**

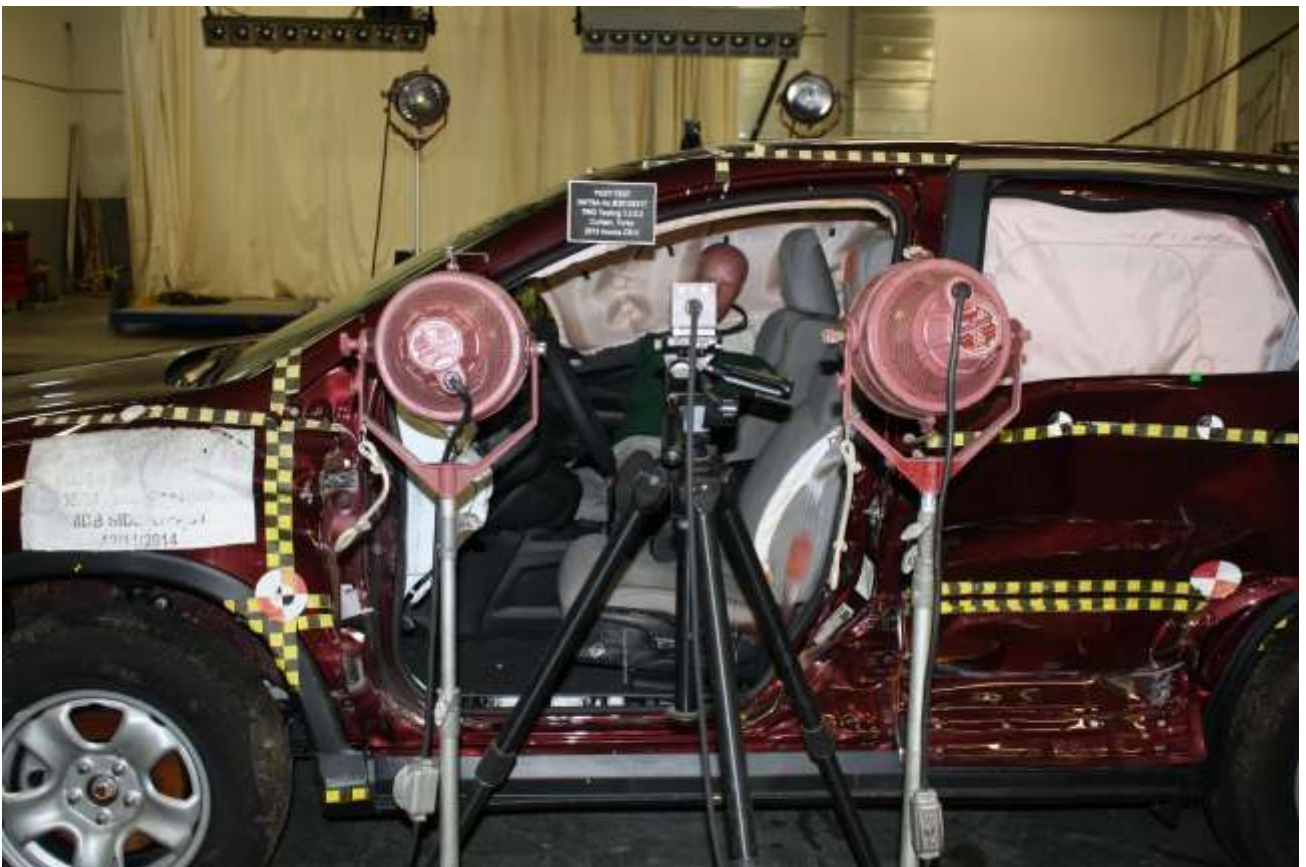
**Figure A-4: Post-Test Vehicle Left Side View**

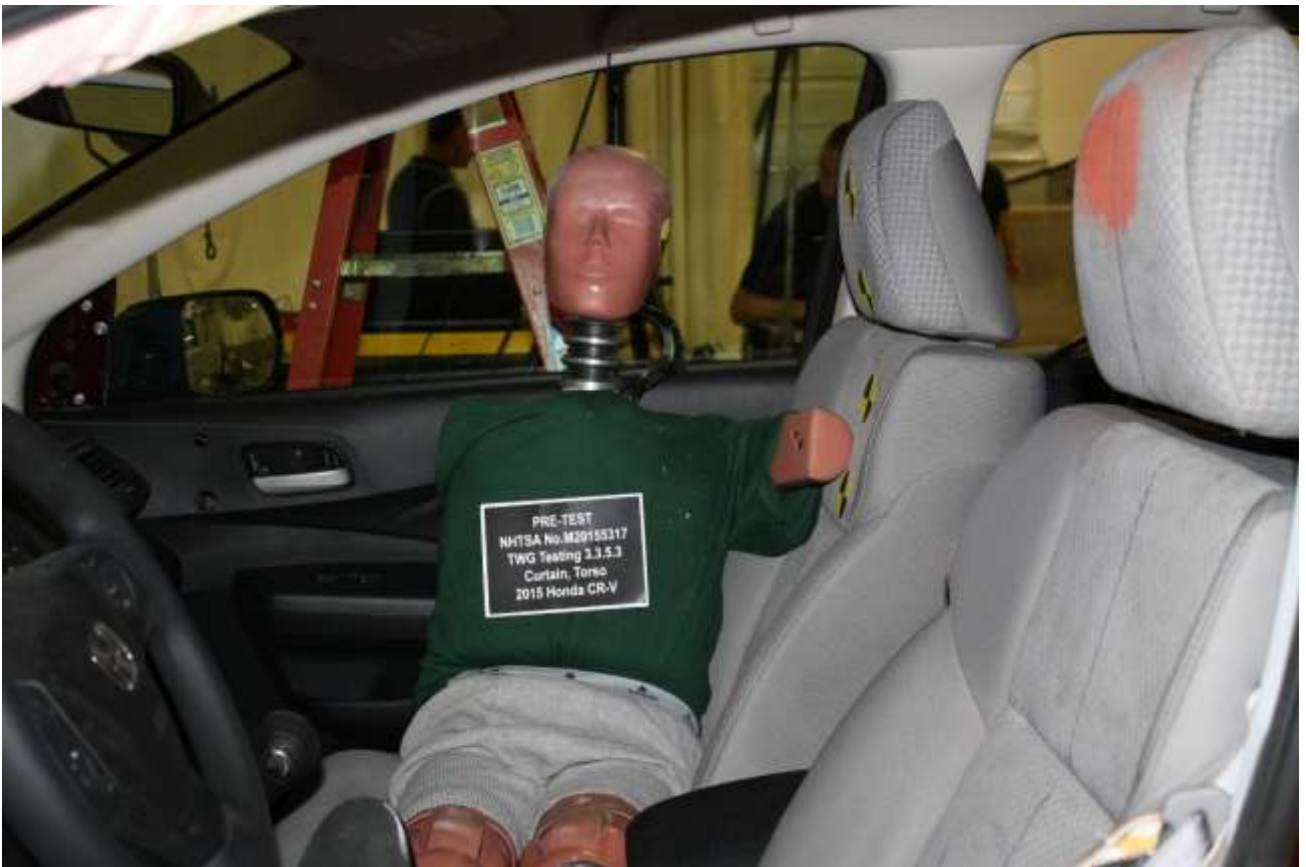
**Figure A-5: Pre-Test SID-II 5th Female Left Side View**

| <b>Upper Torso Contact:</b> | Door Panel, Passenger Seat Back |
| <b>Lower Torso Contact:</b> | Passenger Seat Pan |
| <b>Foot Contact:</b> | Driver Seat Pan |

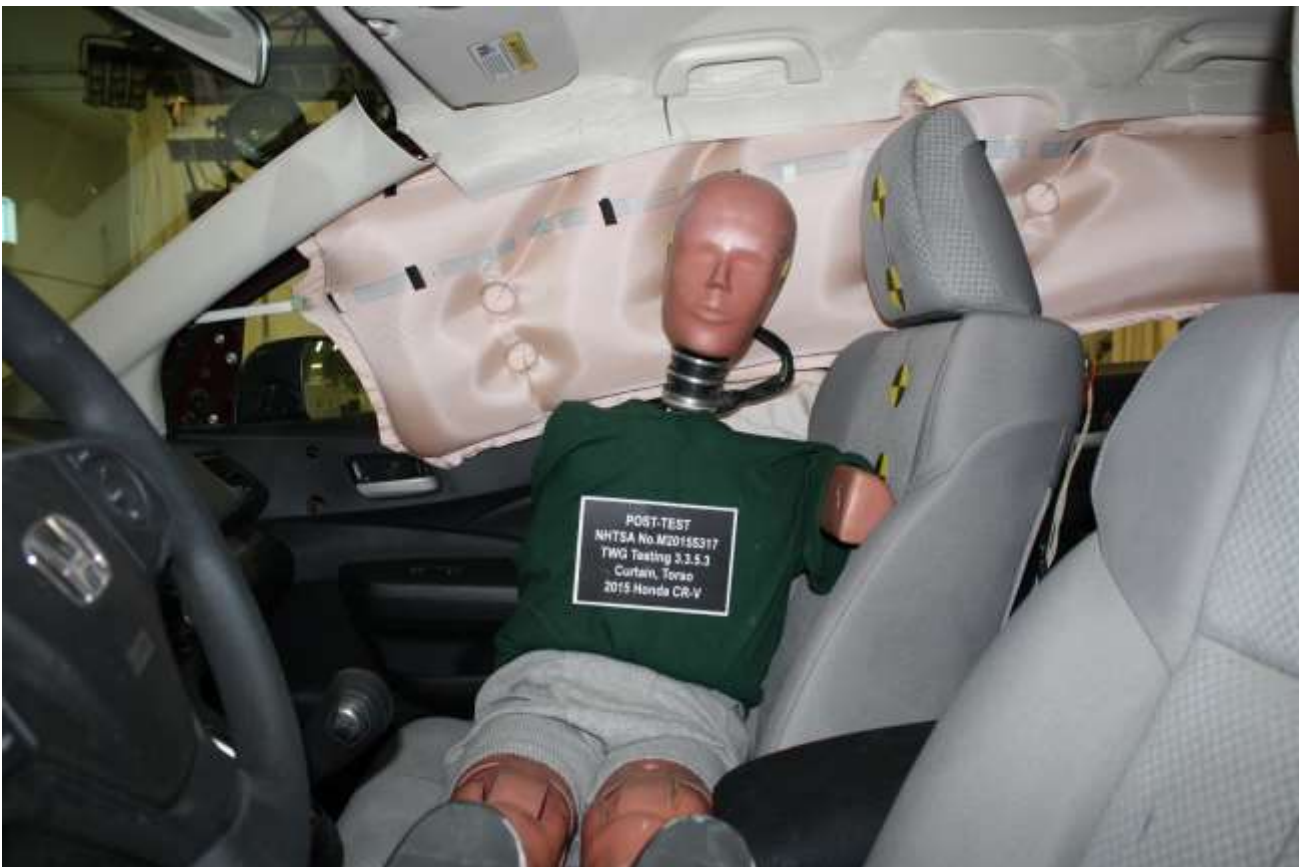
**Figure A-6: Post-Test SID-II 5th Female Left Side View**

| <b>Head Contact:</b> | Curtain Airbag |
| <b>Upper Torso Contact:</b> | Seat/Torso Airbag, Passenger Seat Back |

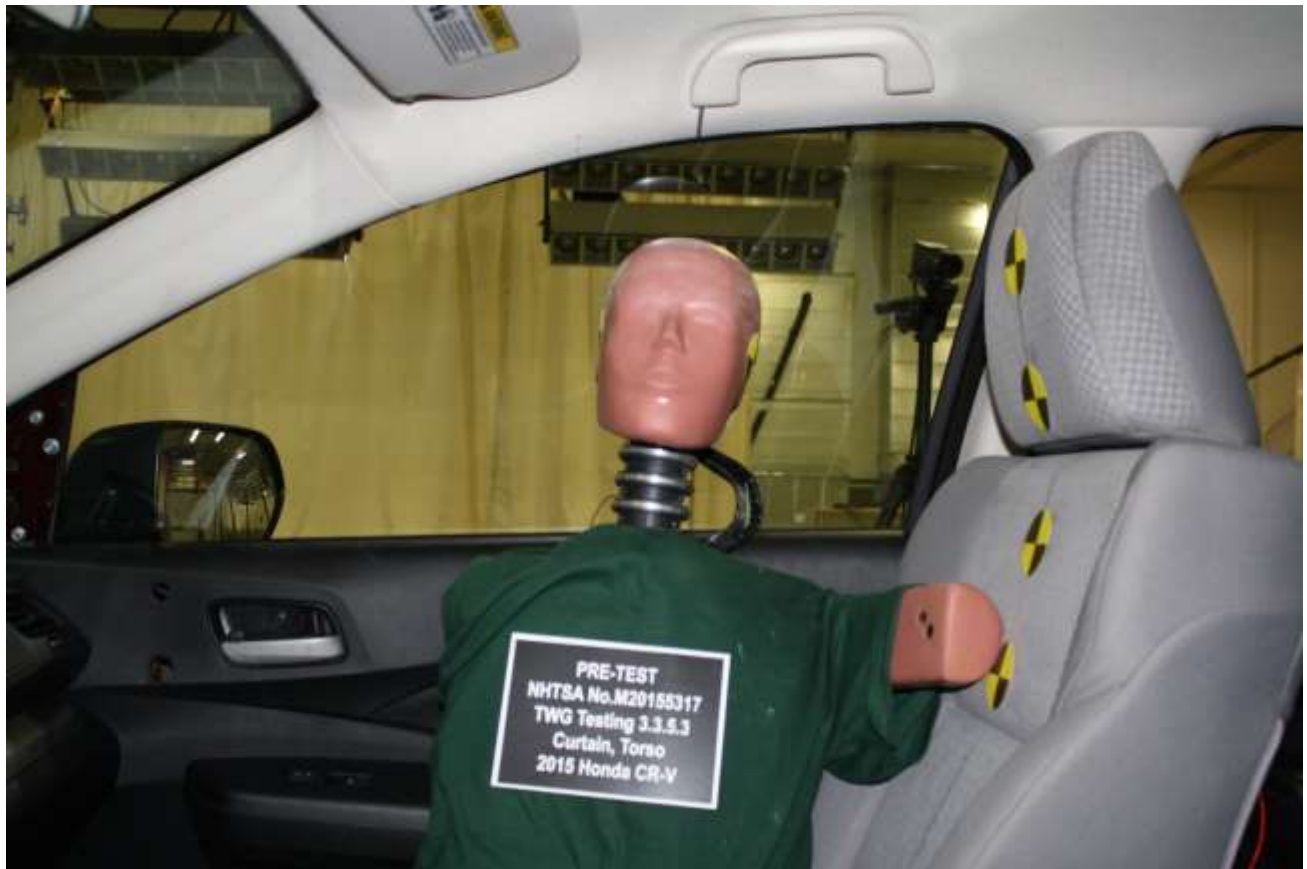
**Figure A-7: Pre-Test SID-IIs 5th Female Left Side Close-up View**

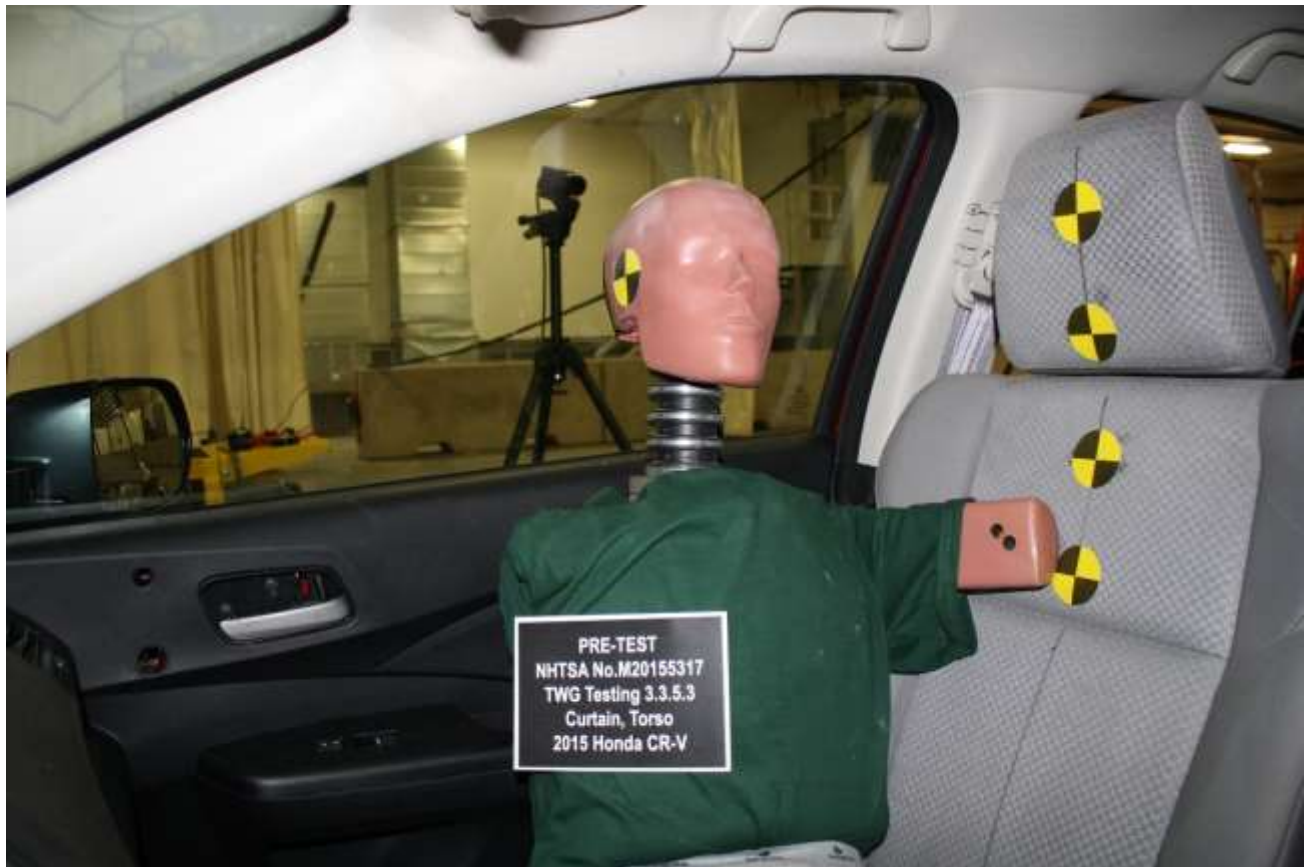
**Figure A-9: Pre-Test SID-IIs 5th Female Left  $\frac{3}{4}$  Front View**

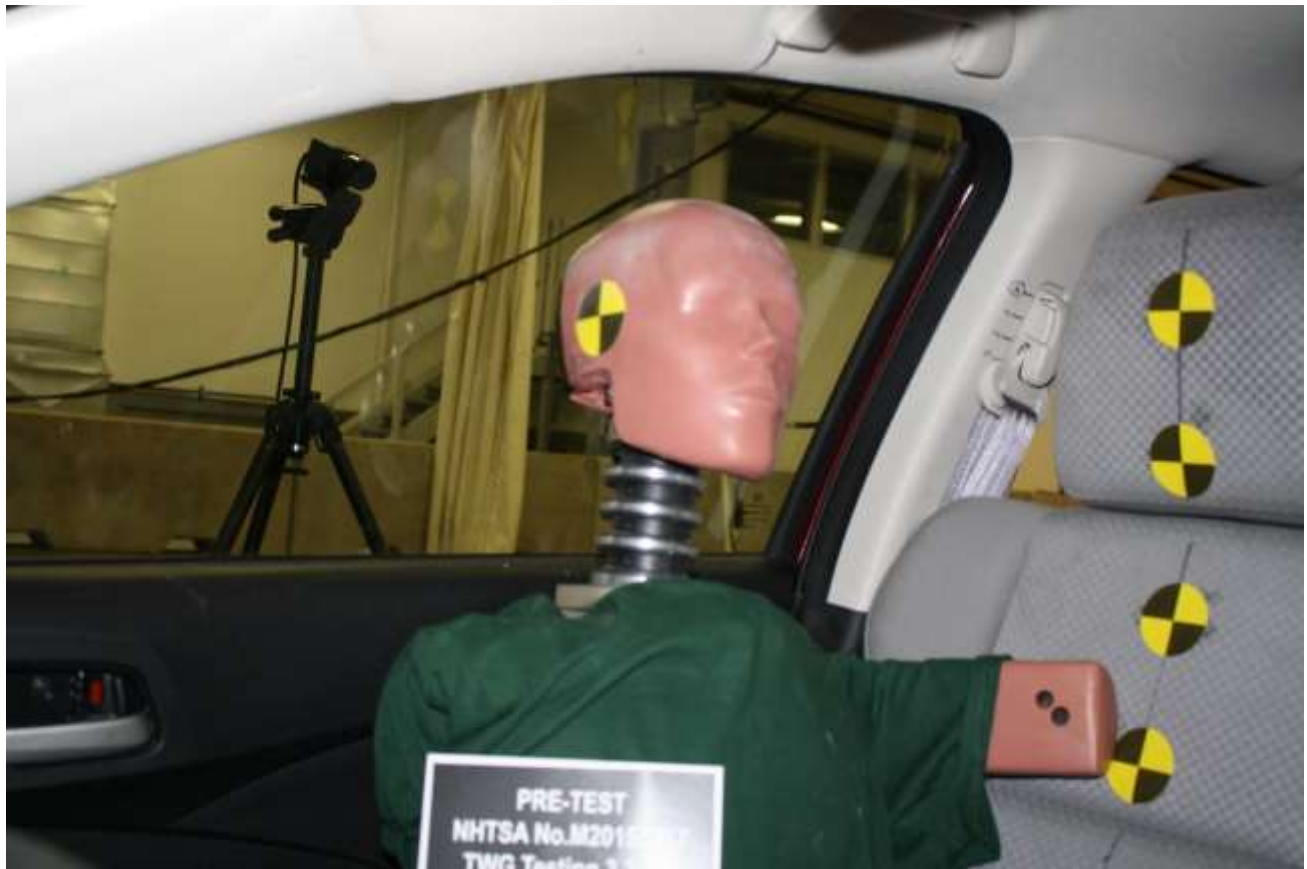
**Figure A-11: Pre-Test SID-IIs 5th Female Left ¾ Front Close-up View**

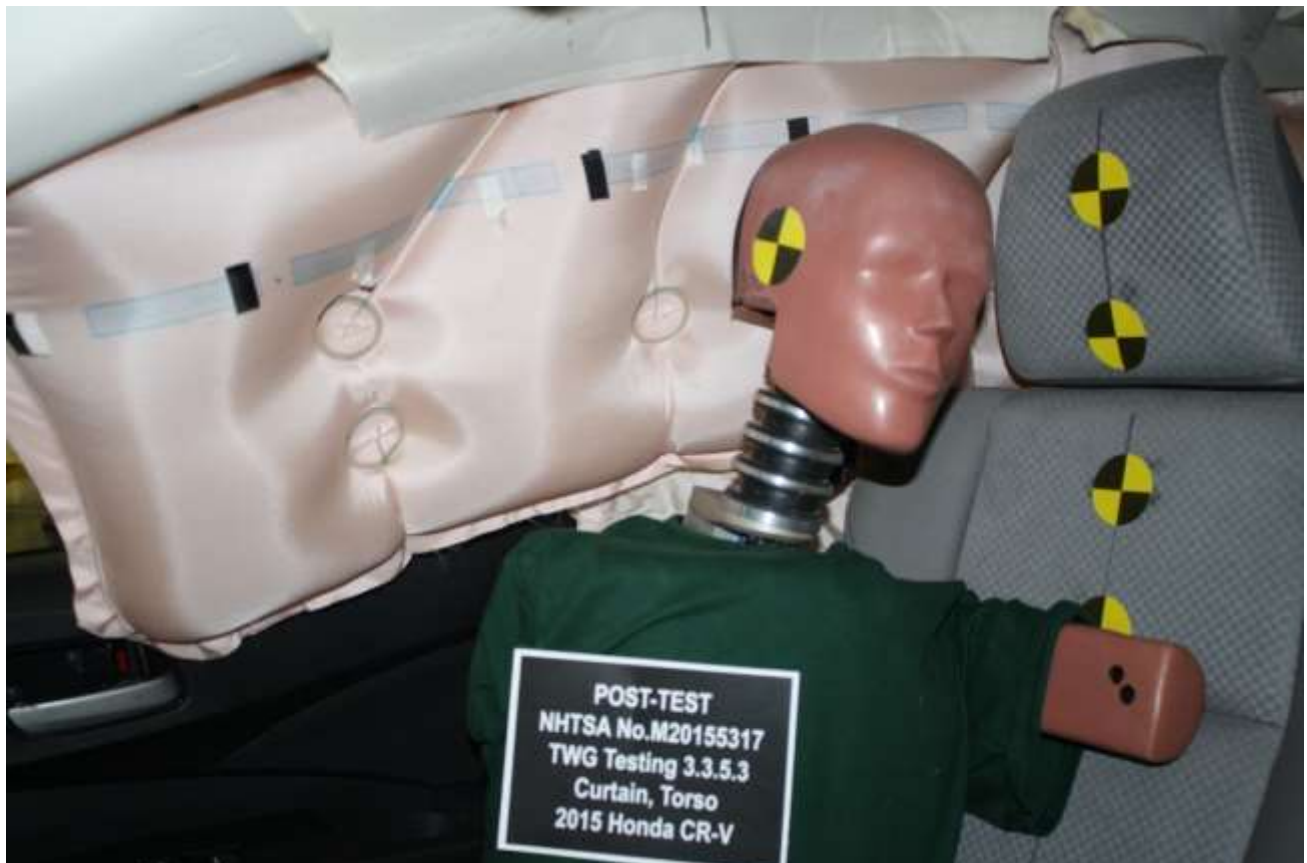
**Figure A-12: Post-Test SID-IIs 5th Female Left ¾ Front Close-up View**

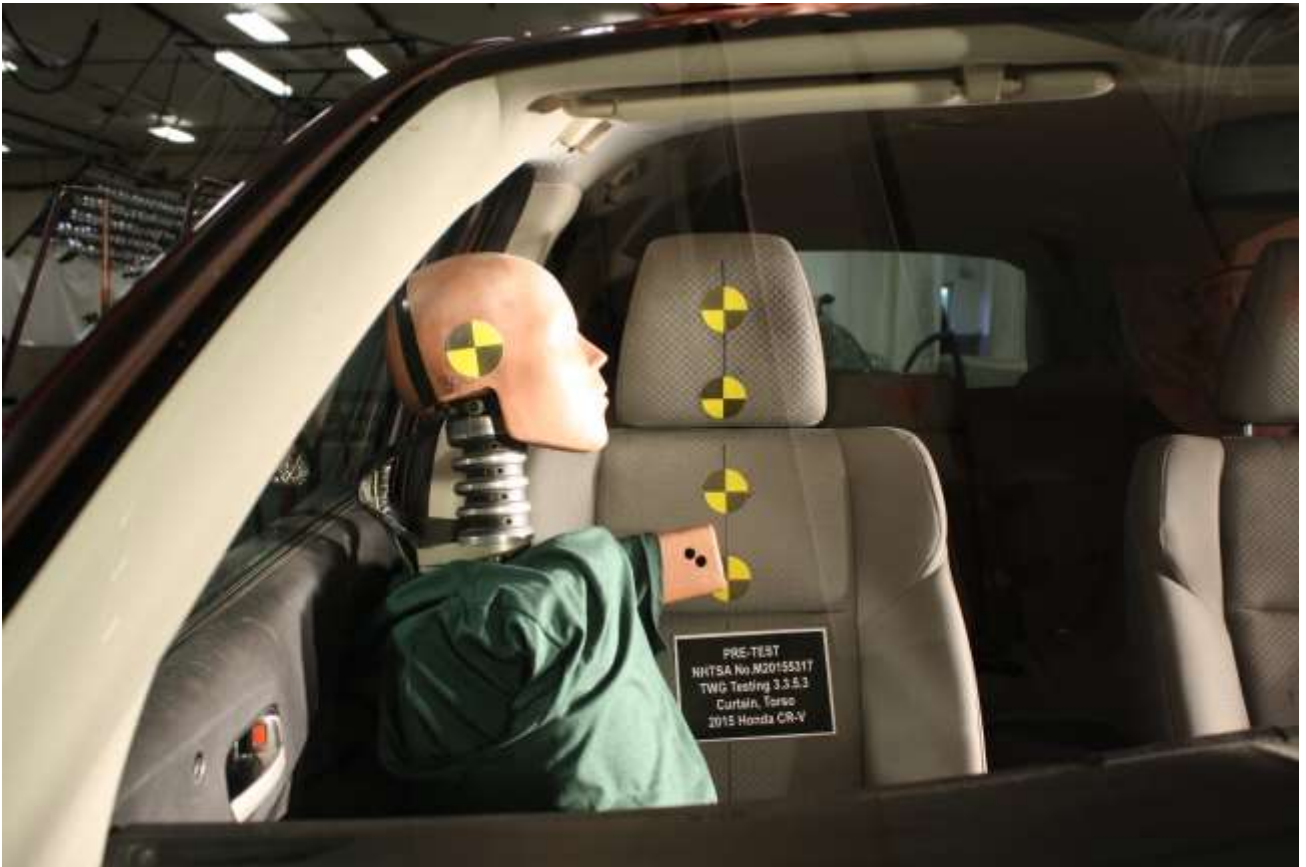
**Figure A-13: Pre-Test SID-IIs 5th Female Front View**

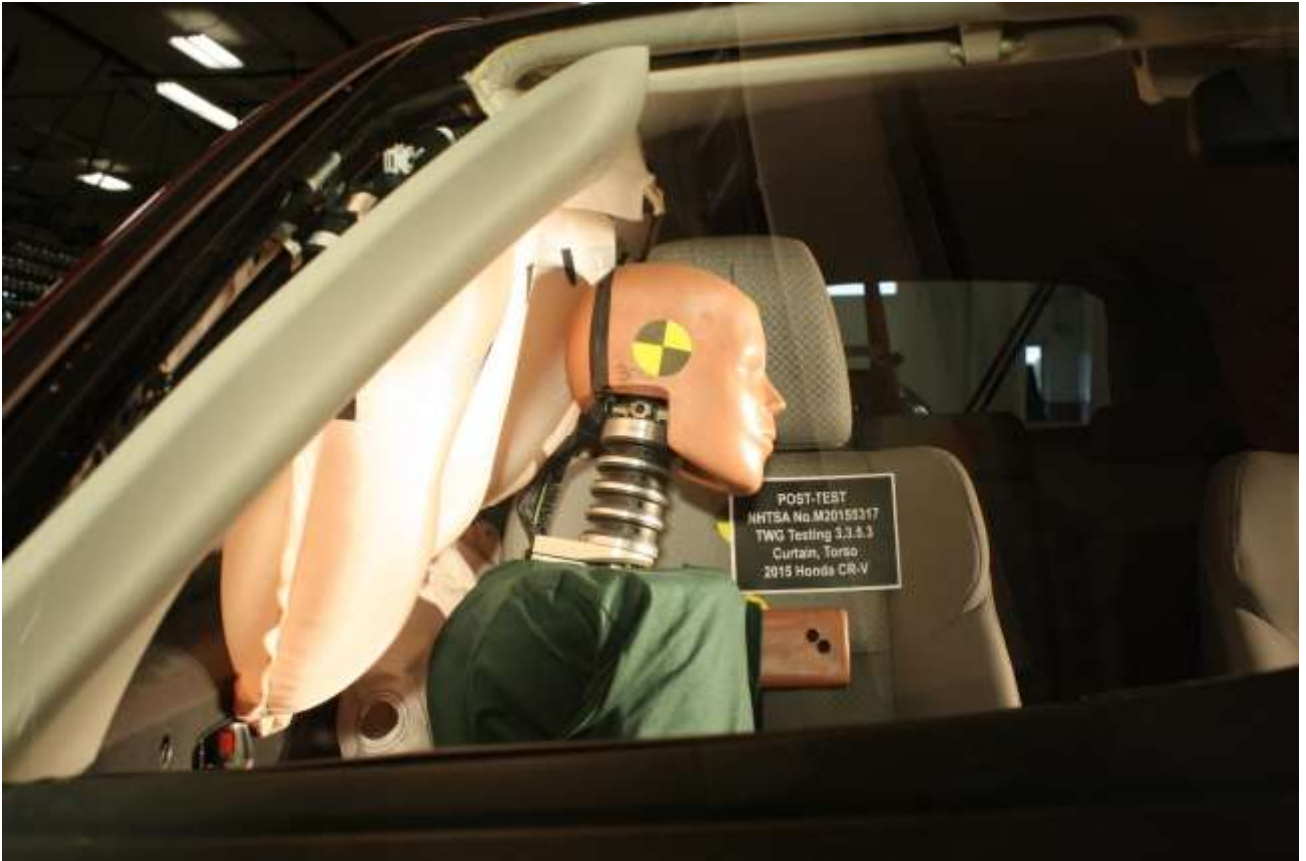
**Figure A-14: Post-Test SID-IIs 5th Female Front View**

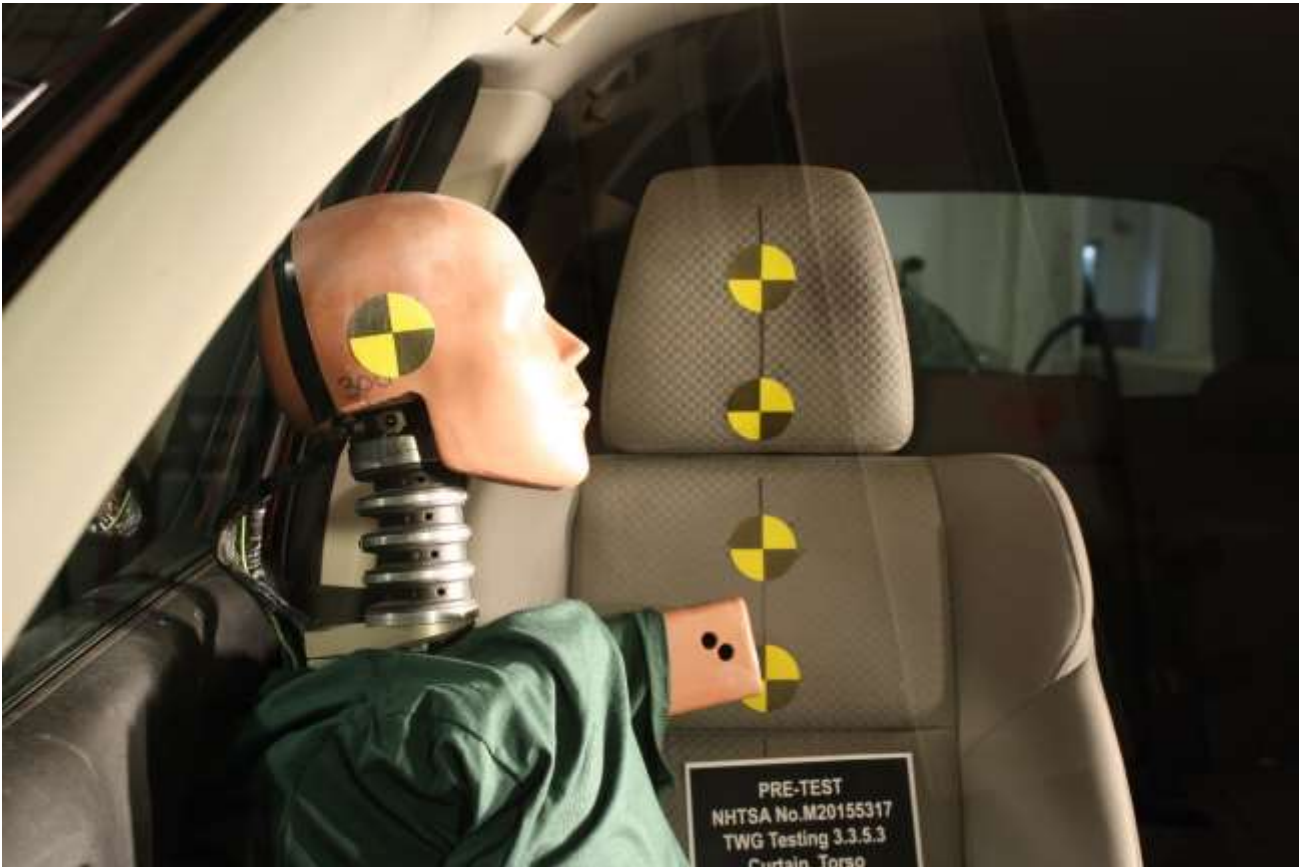
**Figure A-15: Pre-Test SID-IIs 5th Female Front Close-up View**

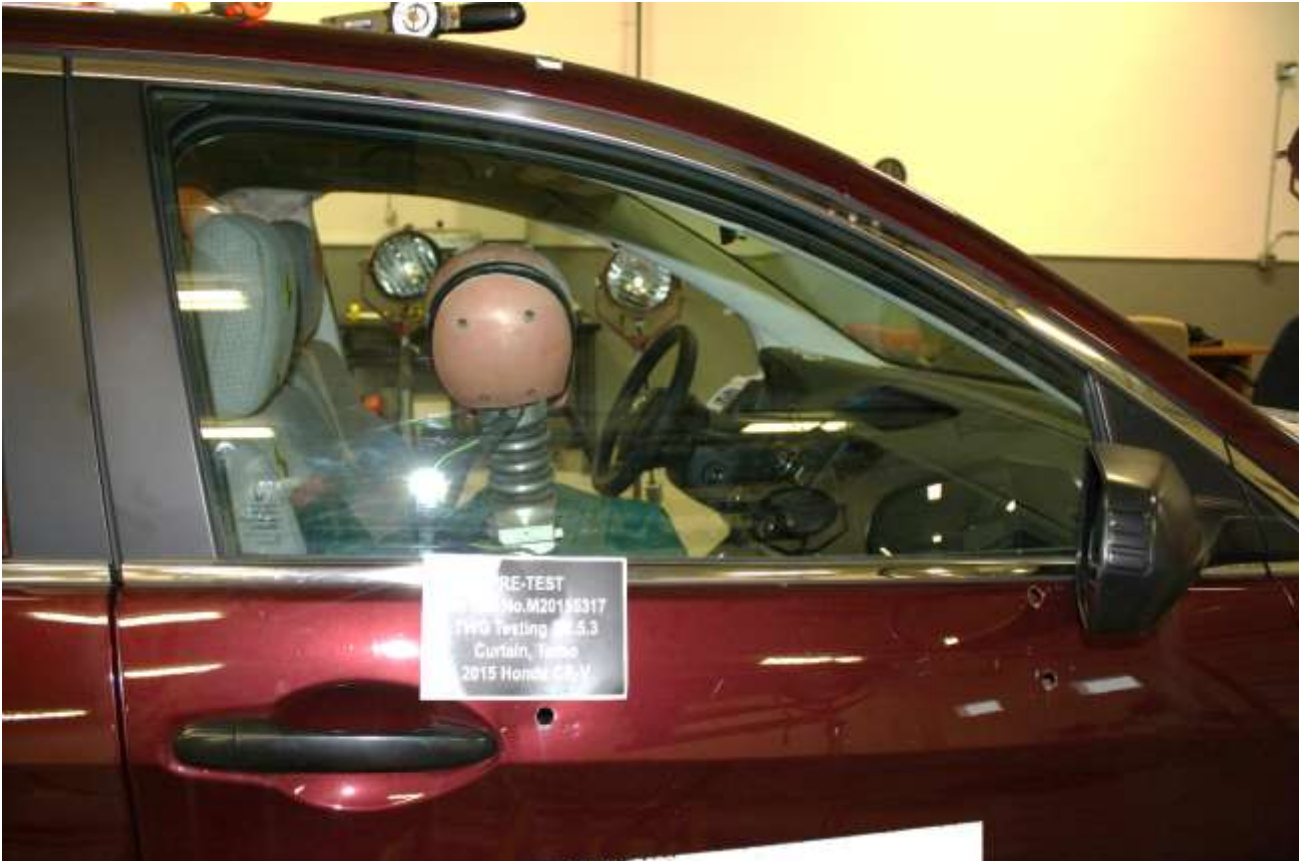
**Figure A-16: Pre-Test SID-IIs 5th Female Right Side View**

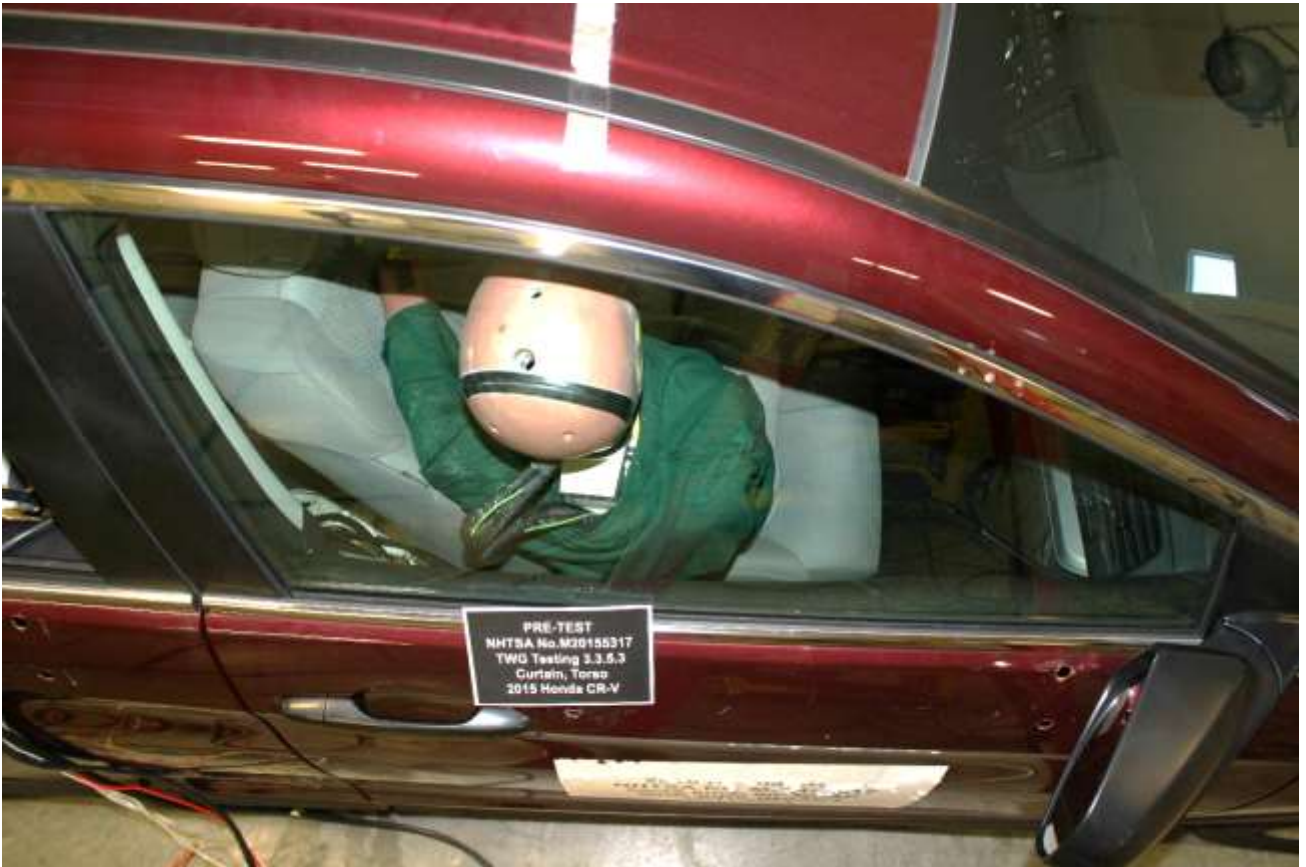
**Figure A-17: Pre-Test SID-IIs 5th Female Right Side Clearance View**

| Seat Back Angle | SA ( 9° ) | Value |
|---|---|---|
| Head CG to Door Panel/Side Window | HD (mm) | 77 |
| Head to B-Pillar (cg) | HB (mm) | 240 |
| Head to Roof, Z (top of the head) | HZ (mm) | 90 |

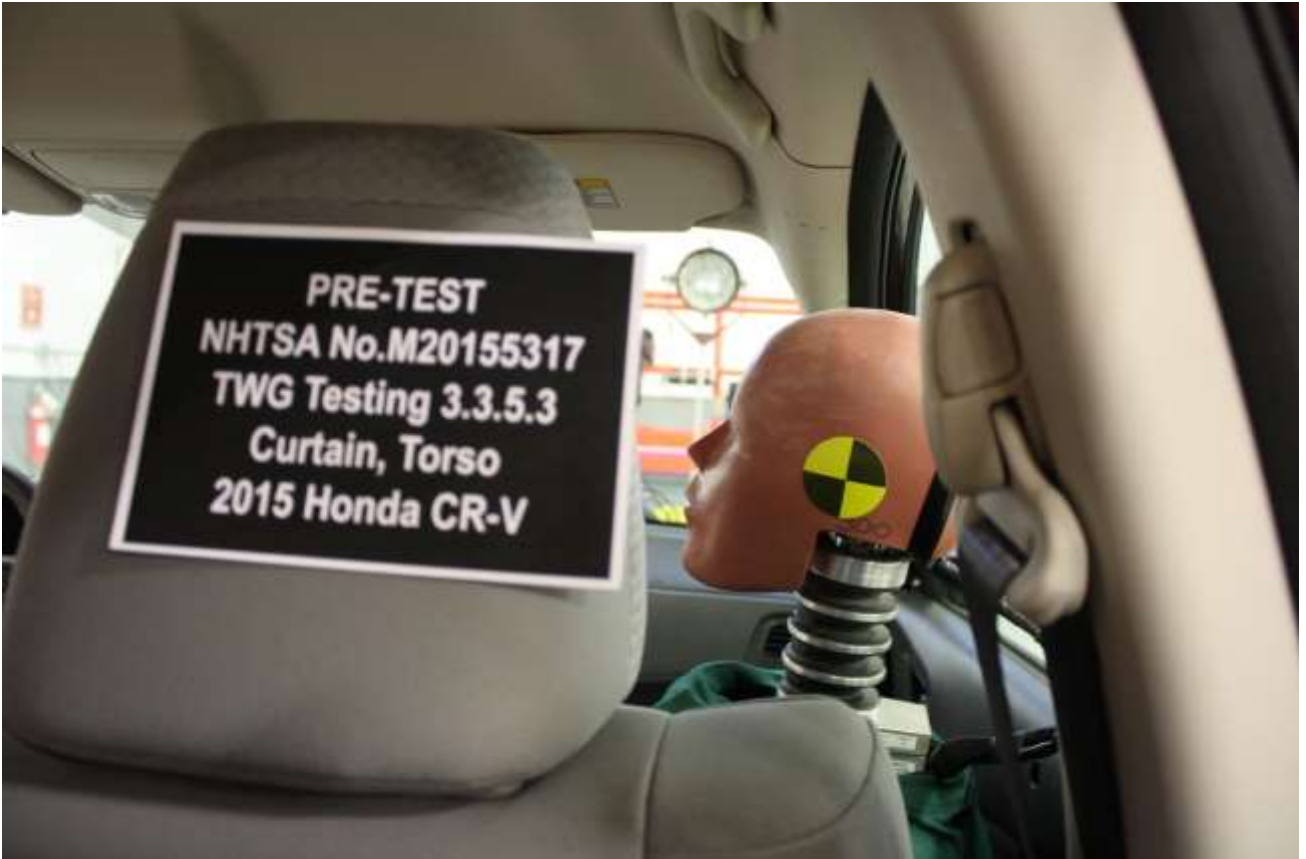
**Figure A-18: Pre-Test SID-IIs 5th Female Rear Right Side Clearance View**

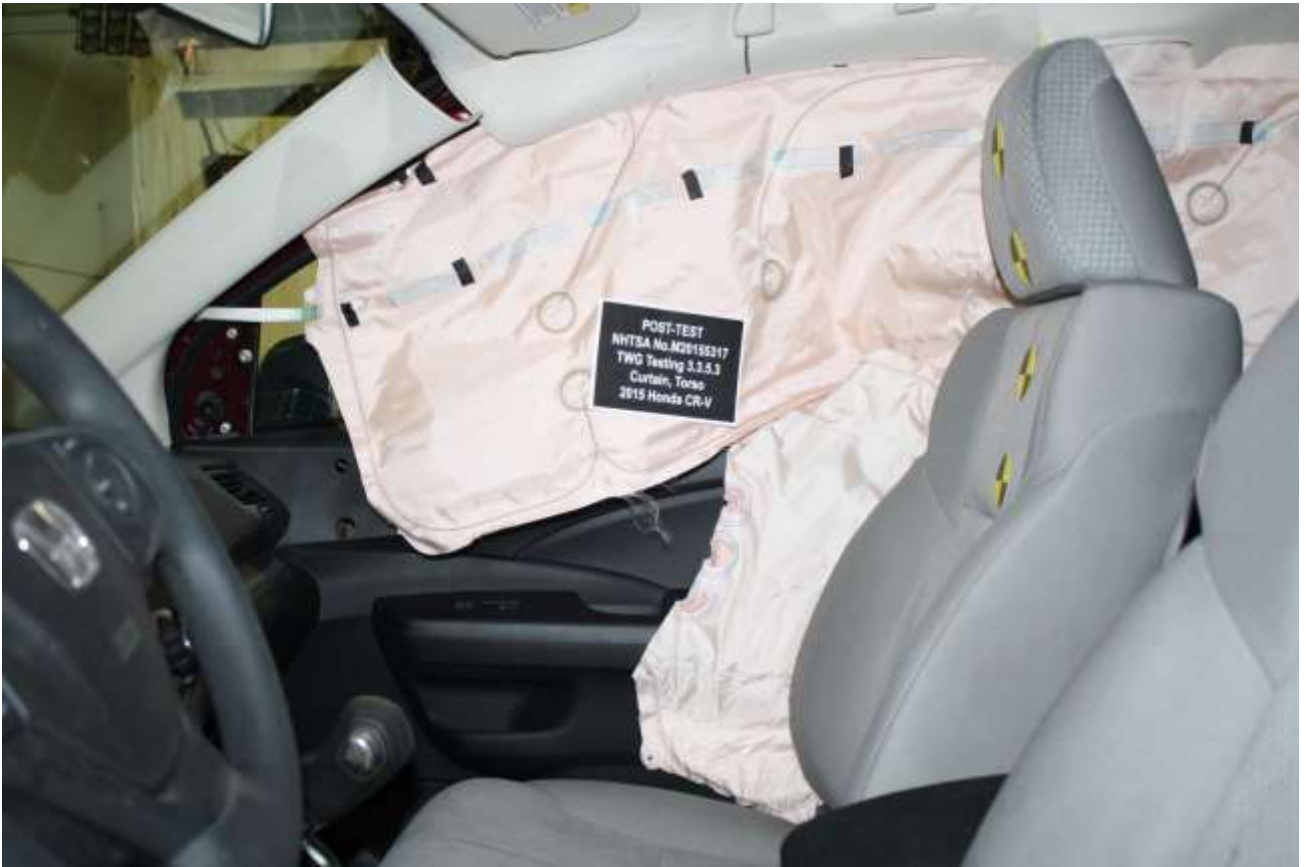
**Figure A-19: Post-Test Curtain Airbag Left Side View**

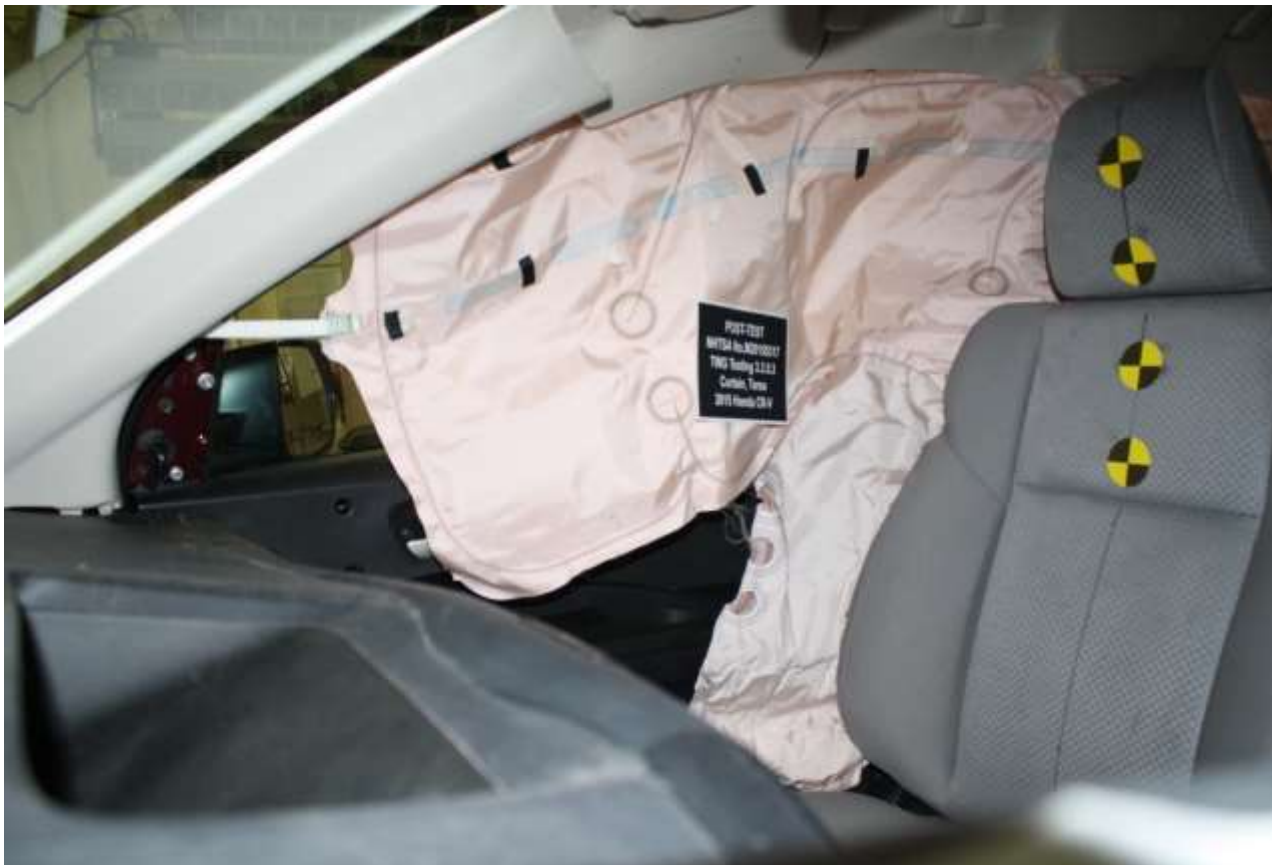
**Figure A-20: Post-Test Curtain Airbag Left  $\frac{3}{4}$  Front View**

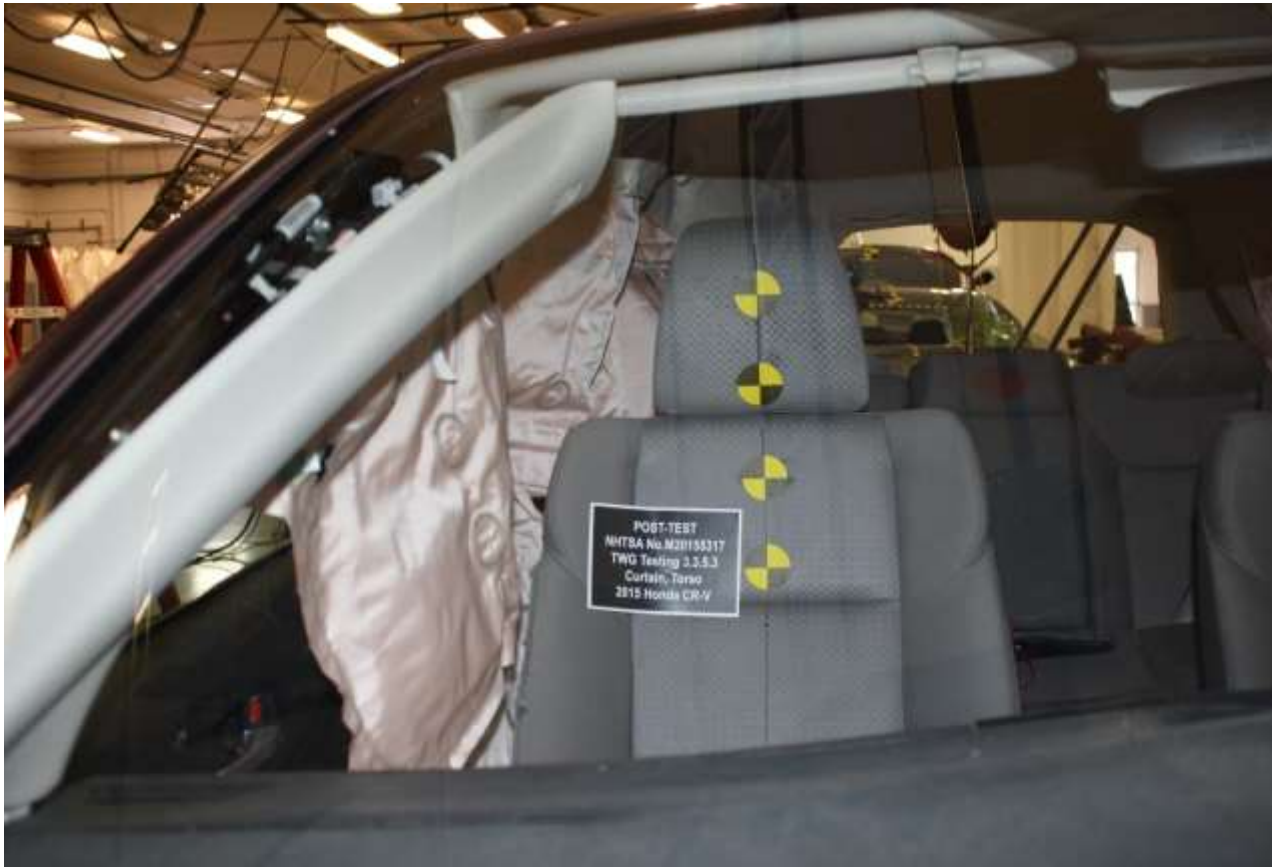
**Figure A-21: Post-Test Curtain Airbag Front View**

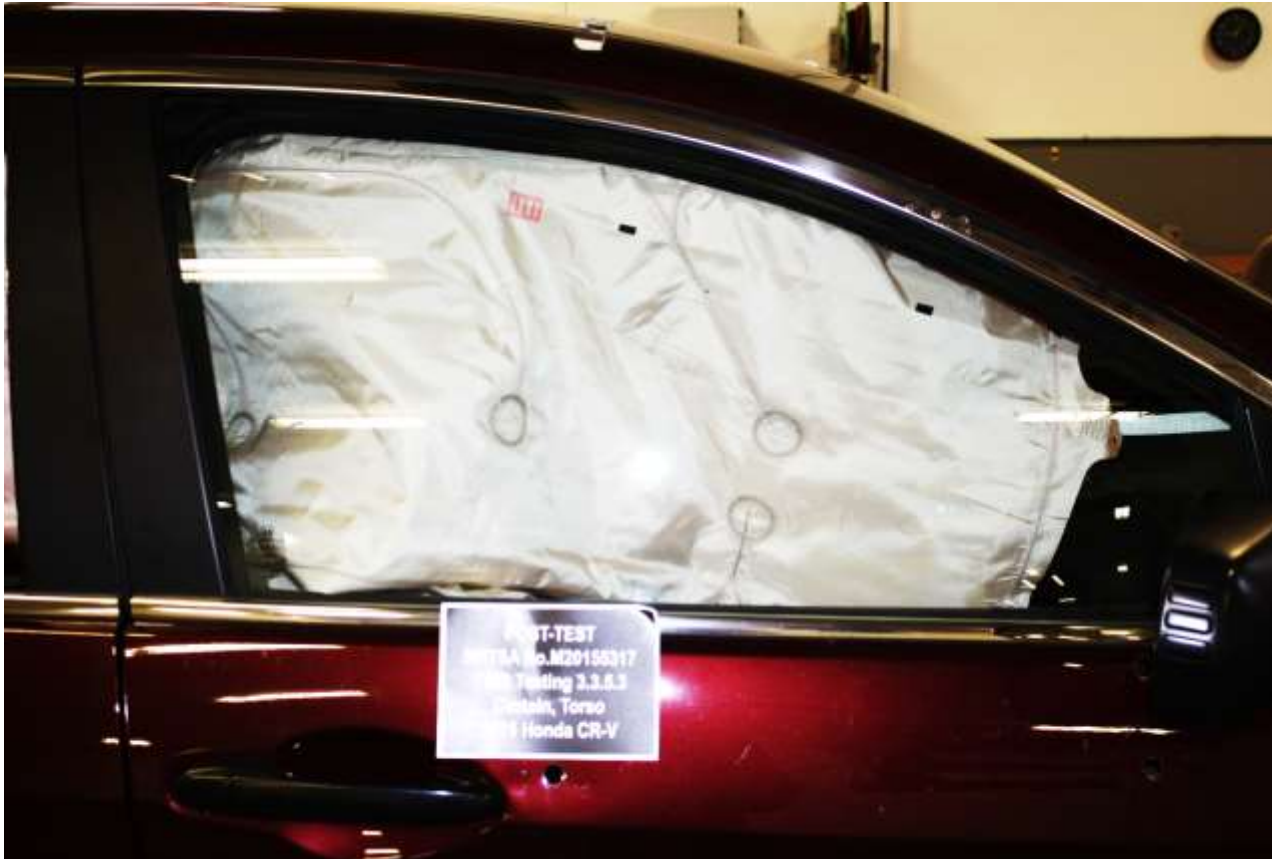
**Figure A-22: Post-Test Curtain Airbag Right Side View**

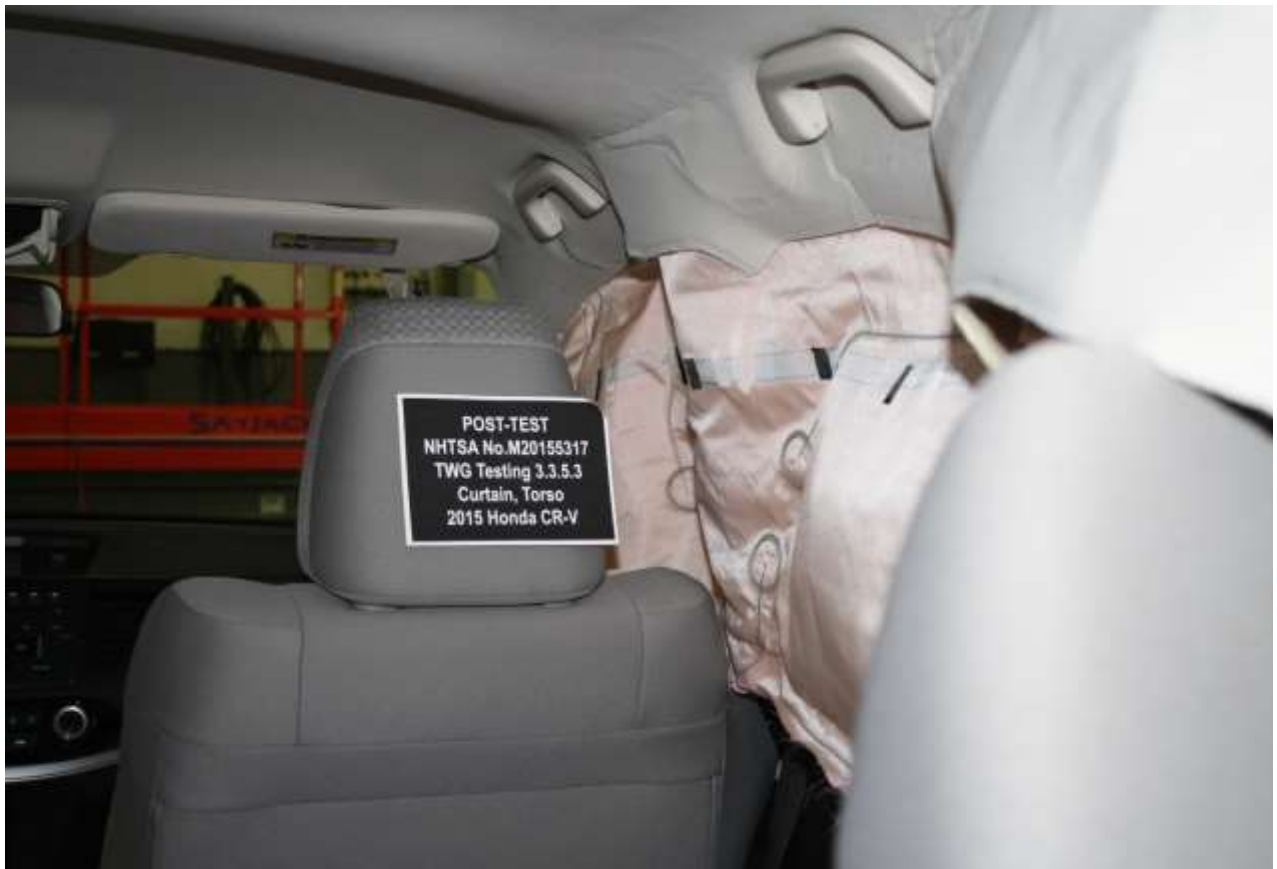
**Figure A-23: Post-Test Curtain Airbag Rear Right Side View**
