**REPORT NUMBER: R&D-CAL-15-001**

**VEHICLE TO FRONTAL BARRIER CRASH TEST IN SUPPORT OF NHTSA'S  
FRONTAL RESEARCH PROGRAM**

**2015 Chevrolet Malibu**

**56.3 KPH RIGID BARRIER FRONTAL**

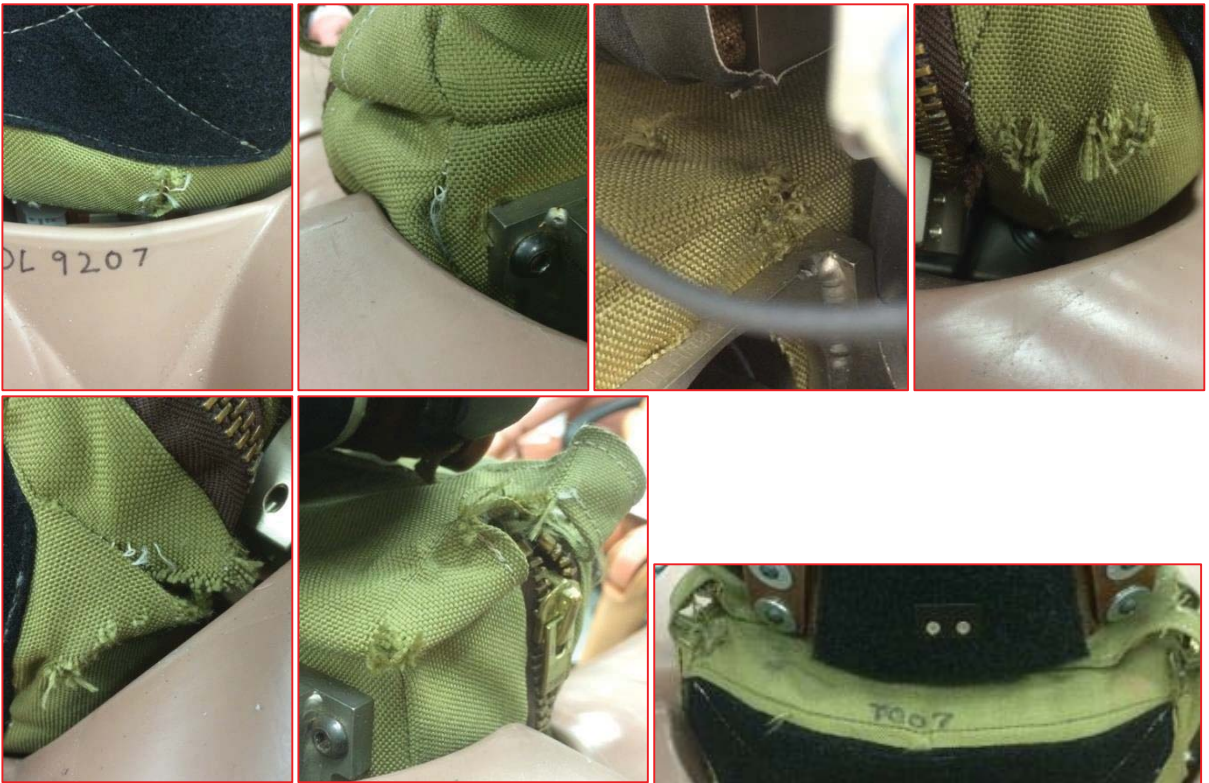
| ABDOMEN | |
|---|---|
| Y / N | No evidence of tearing, cuts, or broken stitches in lower abdomen bag and zipper<br><b>Multiple tears and broken stitches in lower abdomen bag. The upper and lower abdomen bags appear to be from THOR SN007</b> |

| <u>Physical evidence of damage:</u><br><b>Abdomen Bag tears, missing fabric over bags, left lower leg tear, left femur flesh tear.</b> | | |

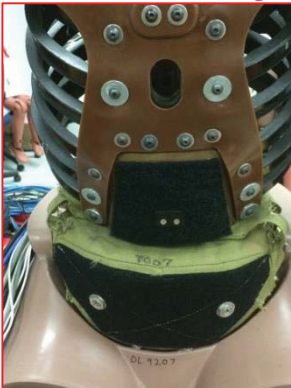
| ABDOMEN | |
|---|---|
| OTHER | <b>Velcro fabric is missing between the upper and lower abdomen bags.</b><br> |

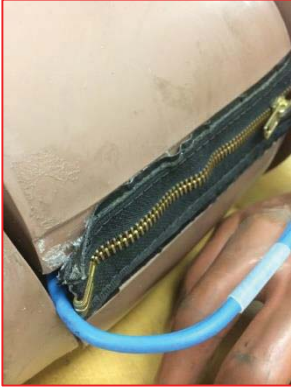
| FEMUR | |
|---|---|
| OTHER | <p><b>Left femur flesh is separating from zipper. We will place gaffer's tape across zipper to prevent further damage.</b></p> |

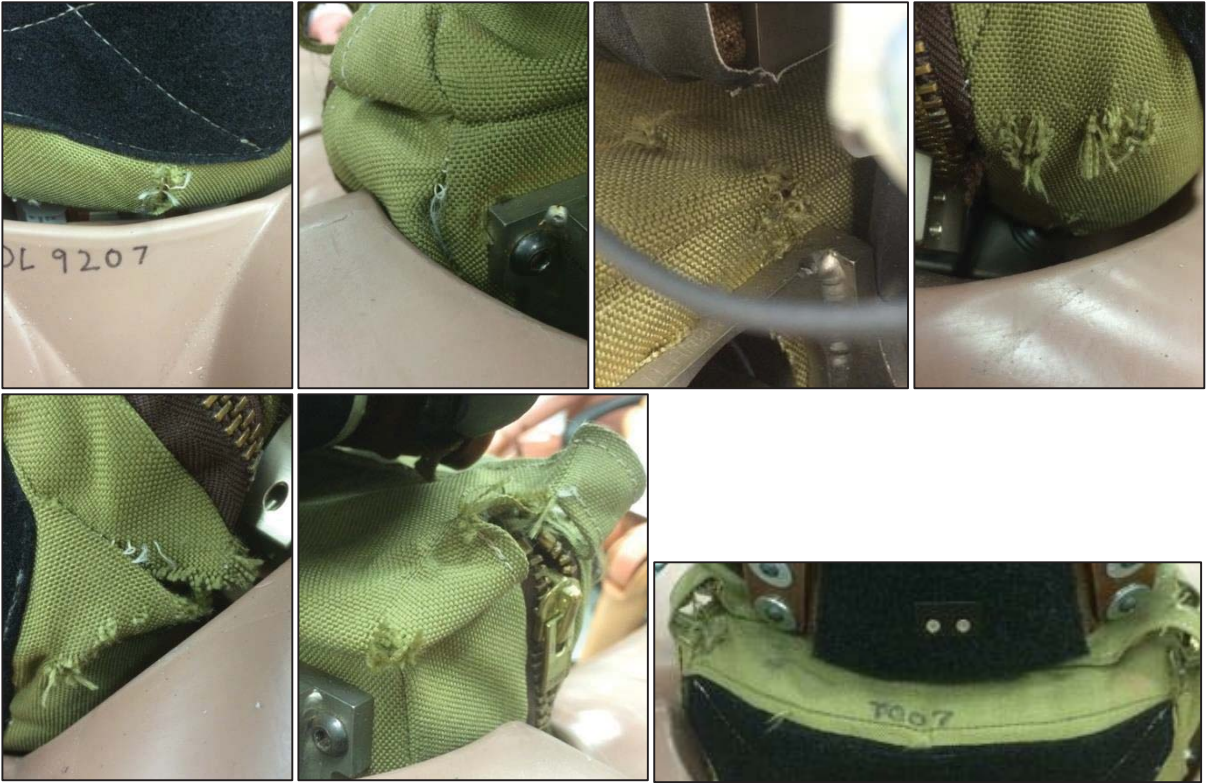
| ABDOMEN | |
|---|---|
| Y / N | No evidence of tearing, cuts, or broken stitches in lower abdomen bag and zipper<br><b>Multiple tears and broken stitches in lower abdomen bag. The upper and lower abdomen bags appear to be from THOR SN007</b> |

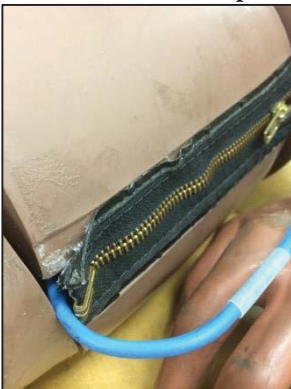
| ABDOMEN | |
|---|---|
| OTHER | <b>Left femur flesh is separating from zipper. We placed gaffer's tape across zipper to prevent further damage.</b><br> |

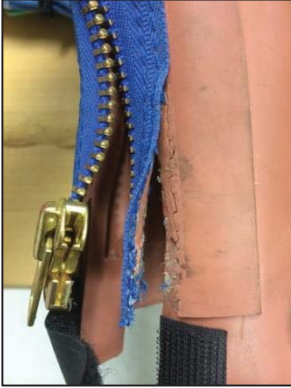
| LOWER EXTREMITY (LX) | |
|---|---|
| Y / N | No cuts, tears, or scuffing of leg flesh<br><b>Left lower leg flesh is torn near zipper. We placed gaffer's tape around the flesh to prevent further damage.</b> |
