**REPORT NUMBER: R&D-CAL-15-005**

**VEHICLE TO FRONTAL BARRIER CRASH TEST IN SUPPORT OF NHTSA'S  
FRONTAL RESEARCH PROGRAM**

**2015 Mazda 3**

**56.3 KPH RIGID BARRIER FRONTAL**

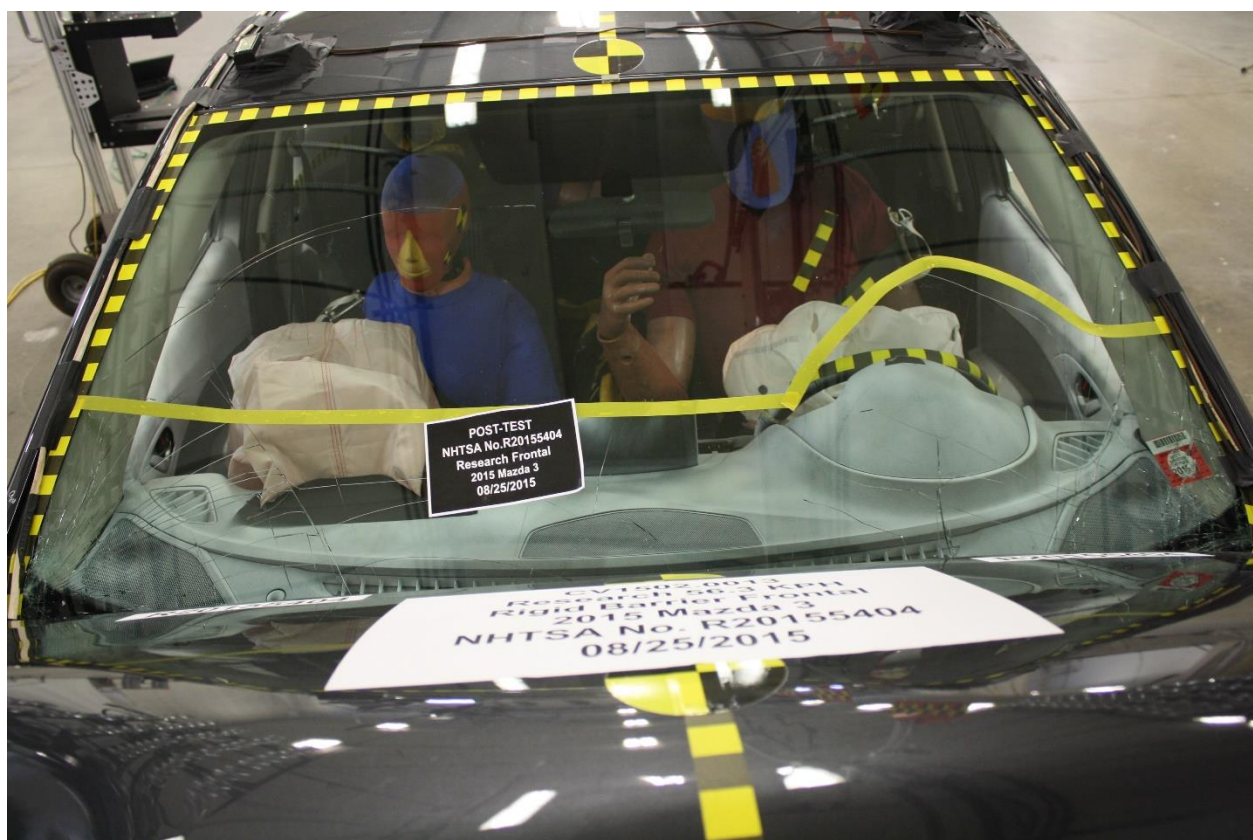
Figure A-18: Post-Test Windshield View

| Critical Areas of Performance | Observations and Conclusions |
|---|---|
| Windshield Damage | Cracks throughout with minor separation |

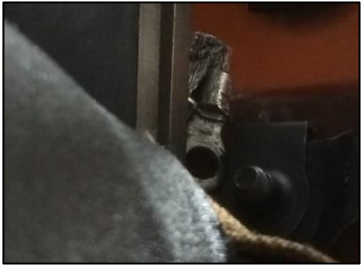
| HEAD | |
|---|---|
| OTHER | <p><b>Grounding strap disconnected from thorax damper to rib. We will reattach.</b></p> |

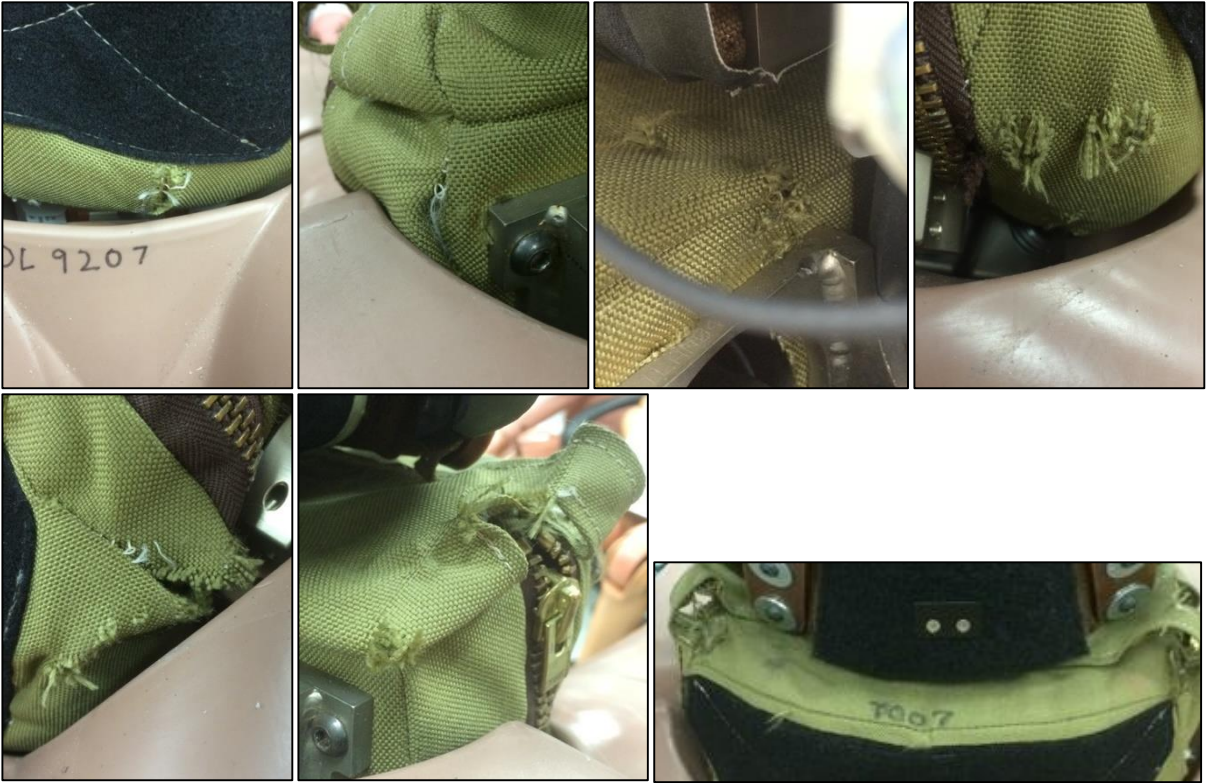
| ABDOMEN | |
|---|---|
| Y / N | No evidence of tearing, cuts, or broken stitches in lower abdomen bag and zipper<br><b>Multiple tears and broken stitches in lower abdomen bag. The upper and lower abdomen bags appear to be from THOR SN007</b> |

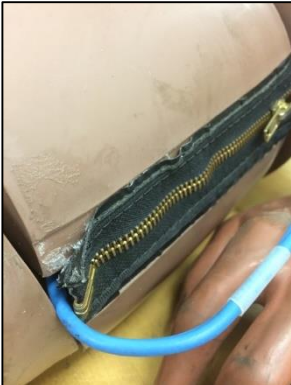
| ABDOMEN | |
|---|---|
| OTHER | <b>Left femur flesh is separating from zipper. We placed gaffer's tape across zipper to prevent further damage.</b><br> |

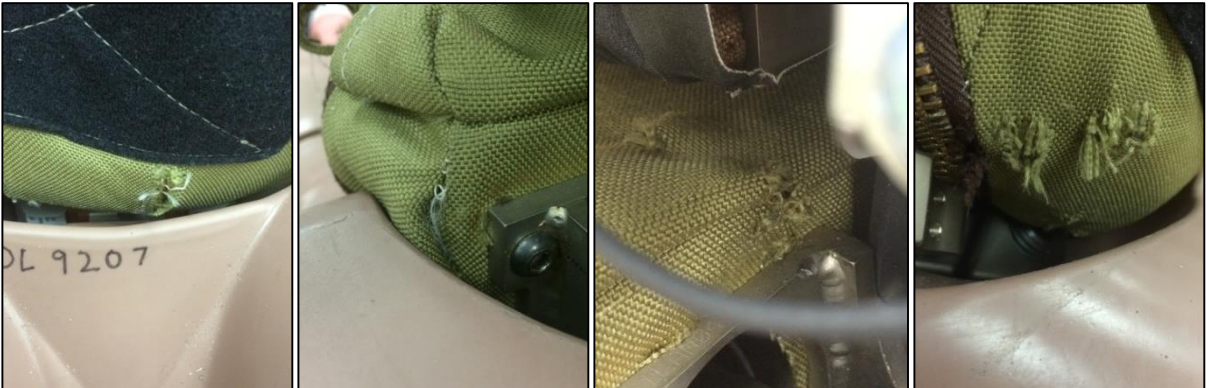
| HEAD | |
|---|---|
| Y / N | No evidence of tearing, cuts, or broken stitches in lower abdomen bag and zipper<br><b>Multiple tears and broken stitches in lower abdomen bag. The upper and lower abdomen bags appear to be from THOR SN007</b> |
