**REPORT NUMBER: R&D-CAL-15-006**

**VEHICLE TO FRONTAL BARRIER CRASH TEST IN SUPPORT OF NHTSA'S  
FRONTAL RESEARCH PROGRAM**

**2015 Honda Fit**

**56.3 KPH RIGID BARRIER FRONTAL**

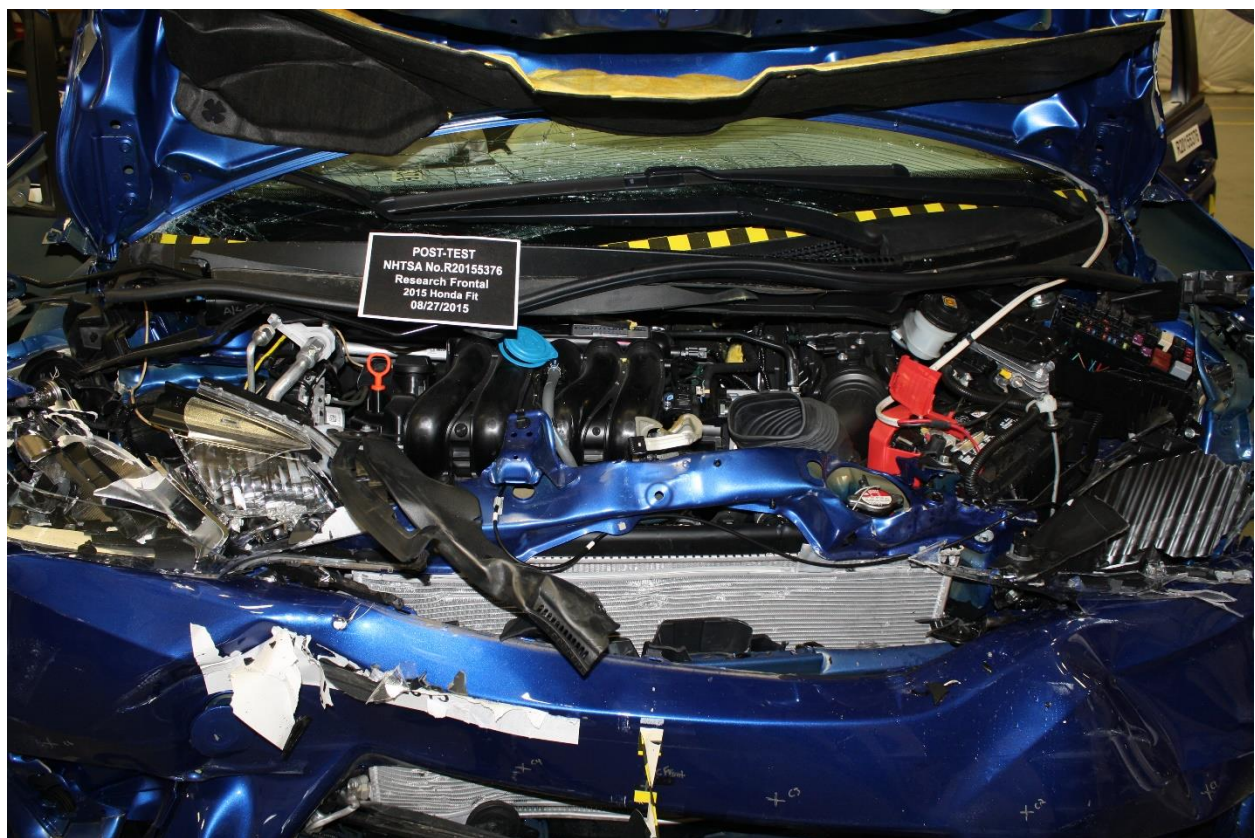
**Figure A-20: Post-Test Engine Compartment View**

- Hood bent inwards exposing part of the engine compartment
- Windshield has cracks throughout

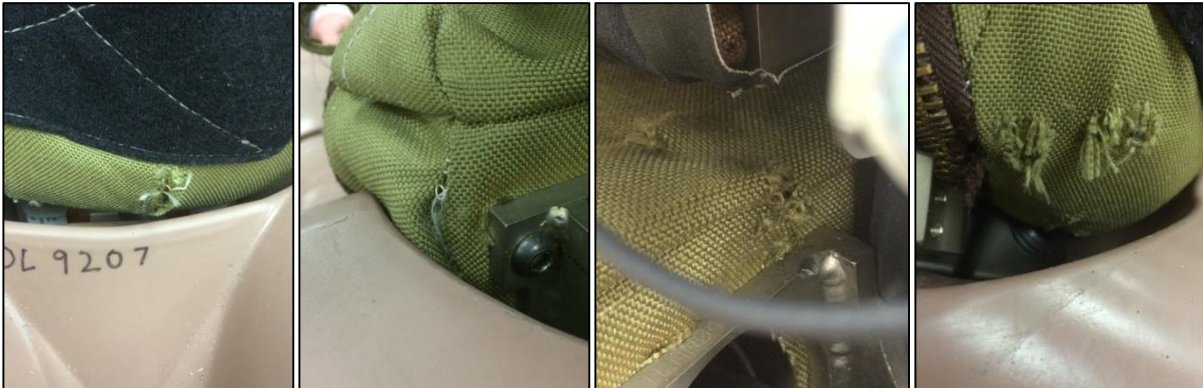
| HEAD | |
|---|---|
| Y / N | No evidence of tearing, cuts, or broken stitches in lower abdomen bag and zipper<br><b>Multiple tears and broken stitches in lower abdomen bag. The upper and lower abdomen bags appear to be from THOR SN007</b> |

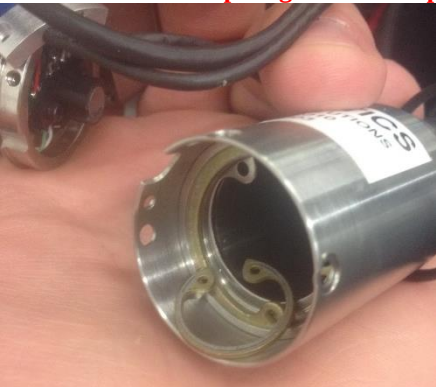
| OTHER | <p><b>Left ITRACC snap ring was loose upon disassembly of the telescoping section.</b></p> |

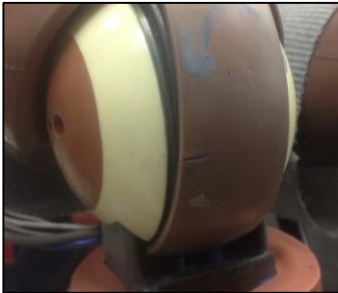
| Y / N | <p>No cuts, tears, or scuffing of knee flesh</p> <p><b>Right knee flesh torn</b></p> |

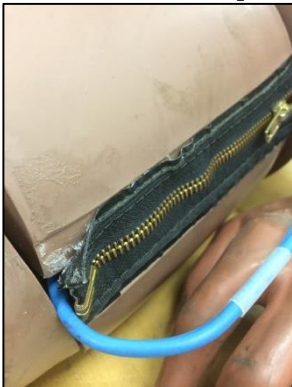
| OTHER | <p><b>Left femur flesh is separating from zipper. We placed gaffer's tape across zipper to prevent further damage.</b></p> |
