**REPORT NUMBER: NCAP-MGA-2016-020**

**NEW CAR ASSESSMENT PROGRAM (NCAP)  
Frontal Barrier Impact Test**

**Hyundai Motor Company  
2016 Hyundai Tucson SE AWD 5-Dr. SUV  
NHTSA No.: M20164203**

**FINAL REPORT**

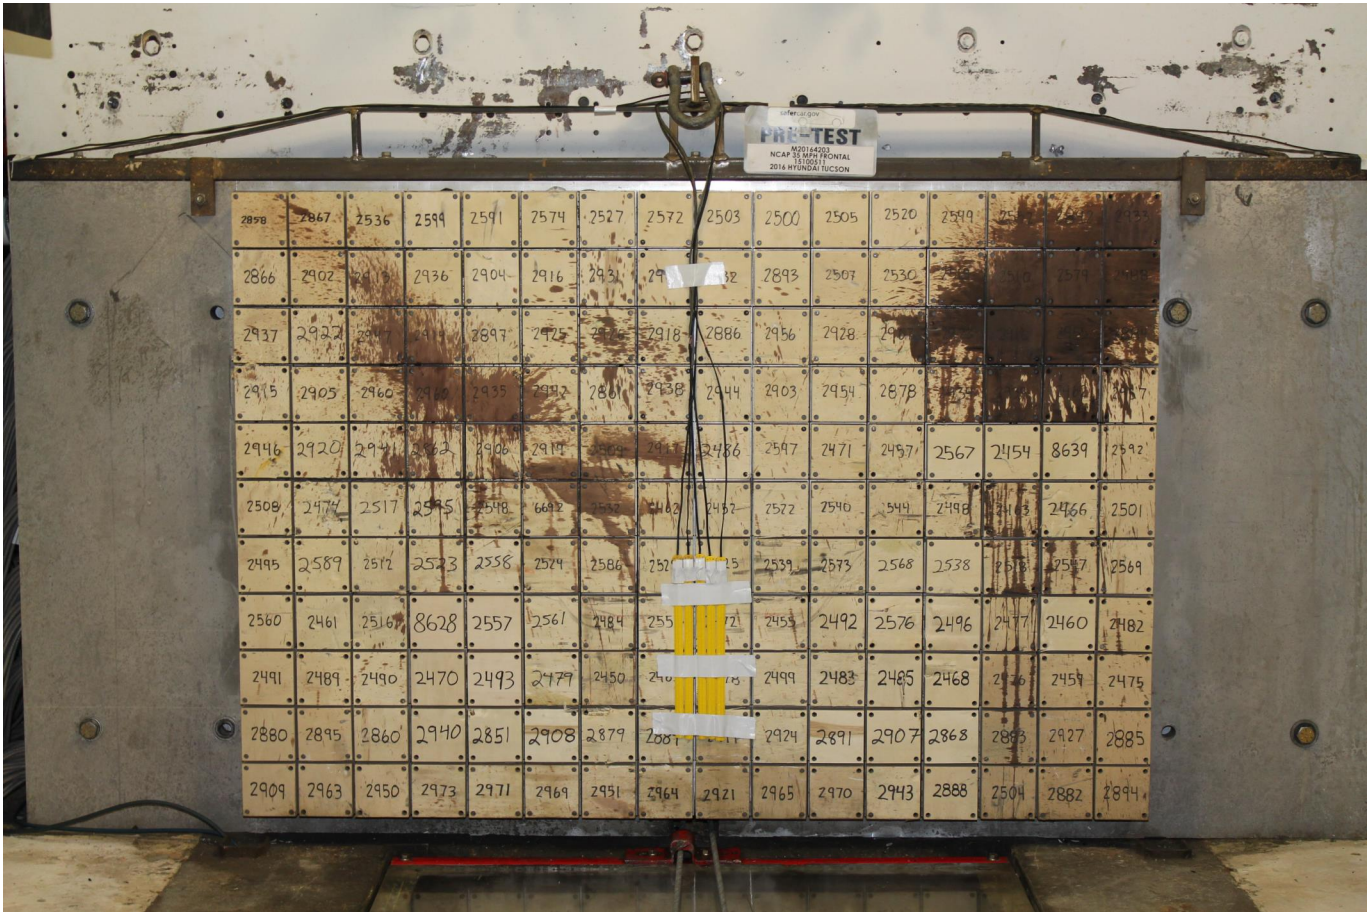
Photo No. 002 - Load Cell Wall

A load cell barrier consisting of 176 load cells was impacted by a 2016 Hyundai Tucson SE AWD 5-Dr. SUV at a velocity of 56.23 km/h. The test was performed at MGA Research Corporation on October 5, 2015. Pre-test and post-test photographs of the vehicle and dummies can be found in Appendix A.

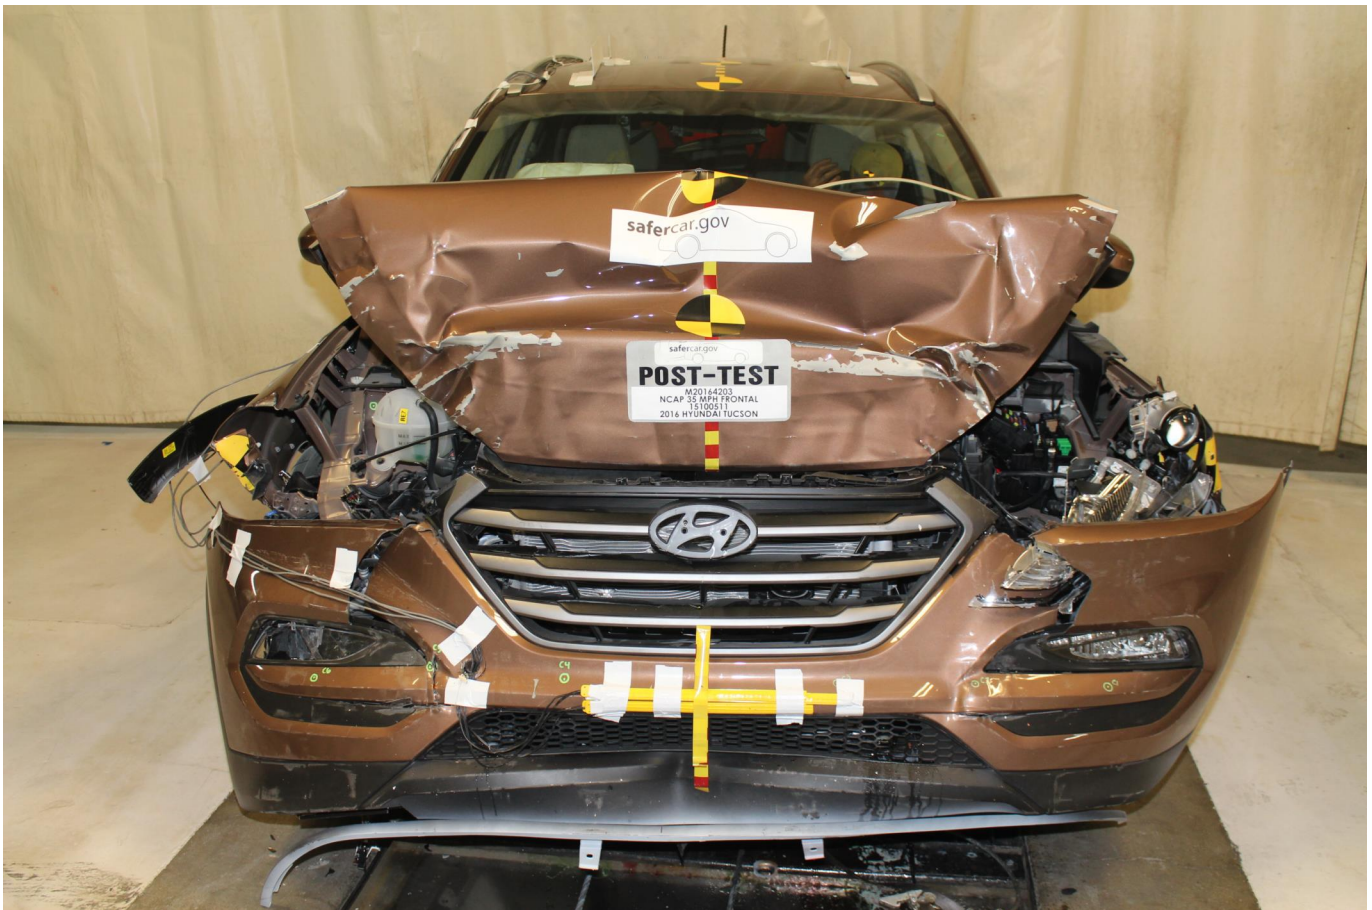
Photo No. 008 - Post-Test Front View of Test Vehicle

The maximum static crush of the vehicle was 450 mm and both the driver and passenger side doors remained closed during the impact event and were operable after the impact.

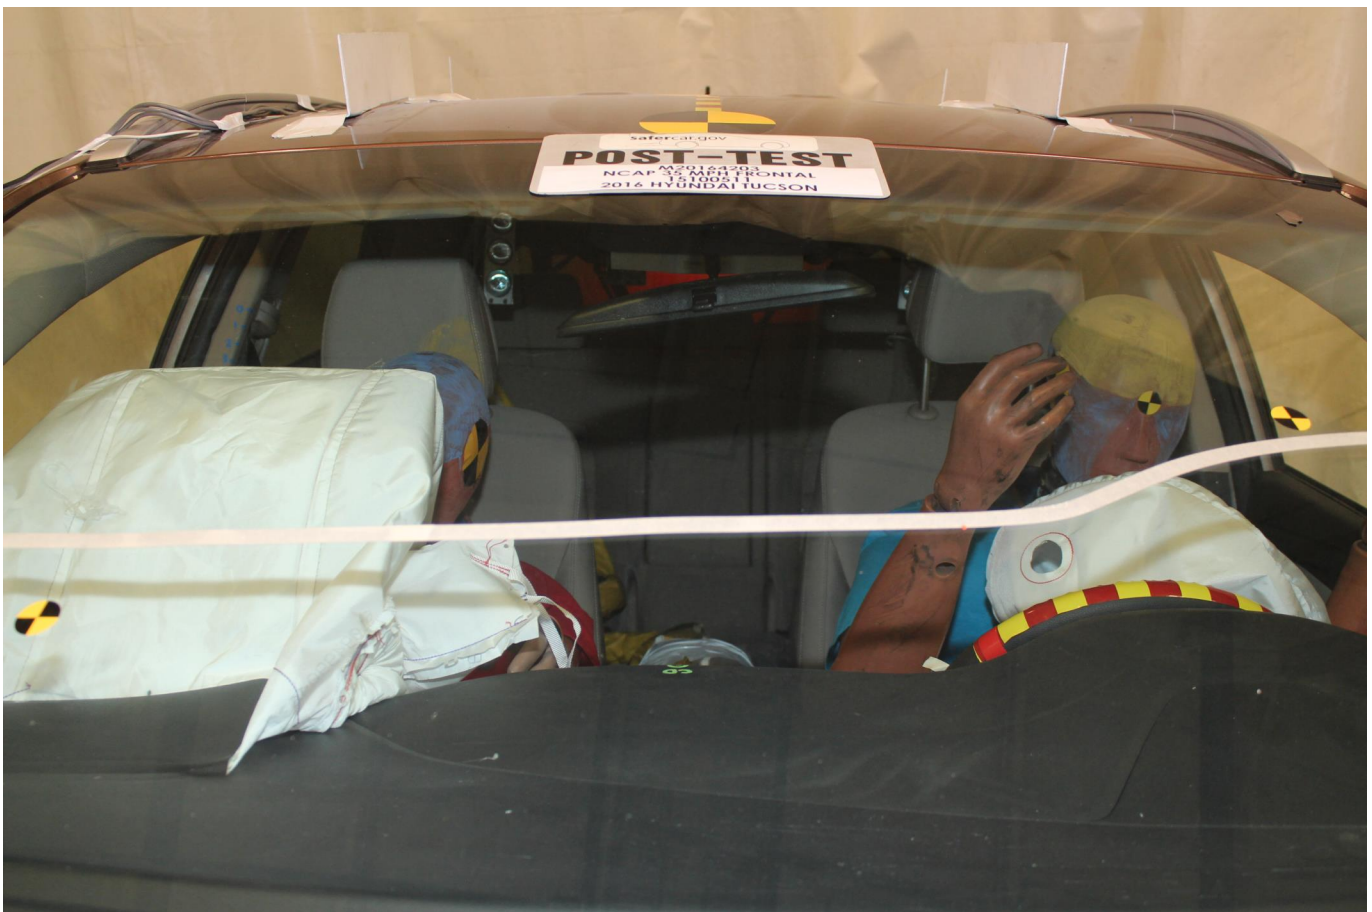
Photo No. 018 - Post-Test Windshield View

There was 100 percent windshield retention and no intrusion into the protected zone of the windshield during the event. There was no Stoddard Solvent leakage after the event or during any phase of the static rollover.

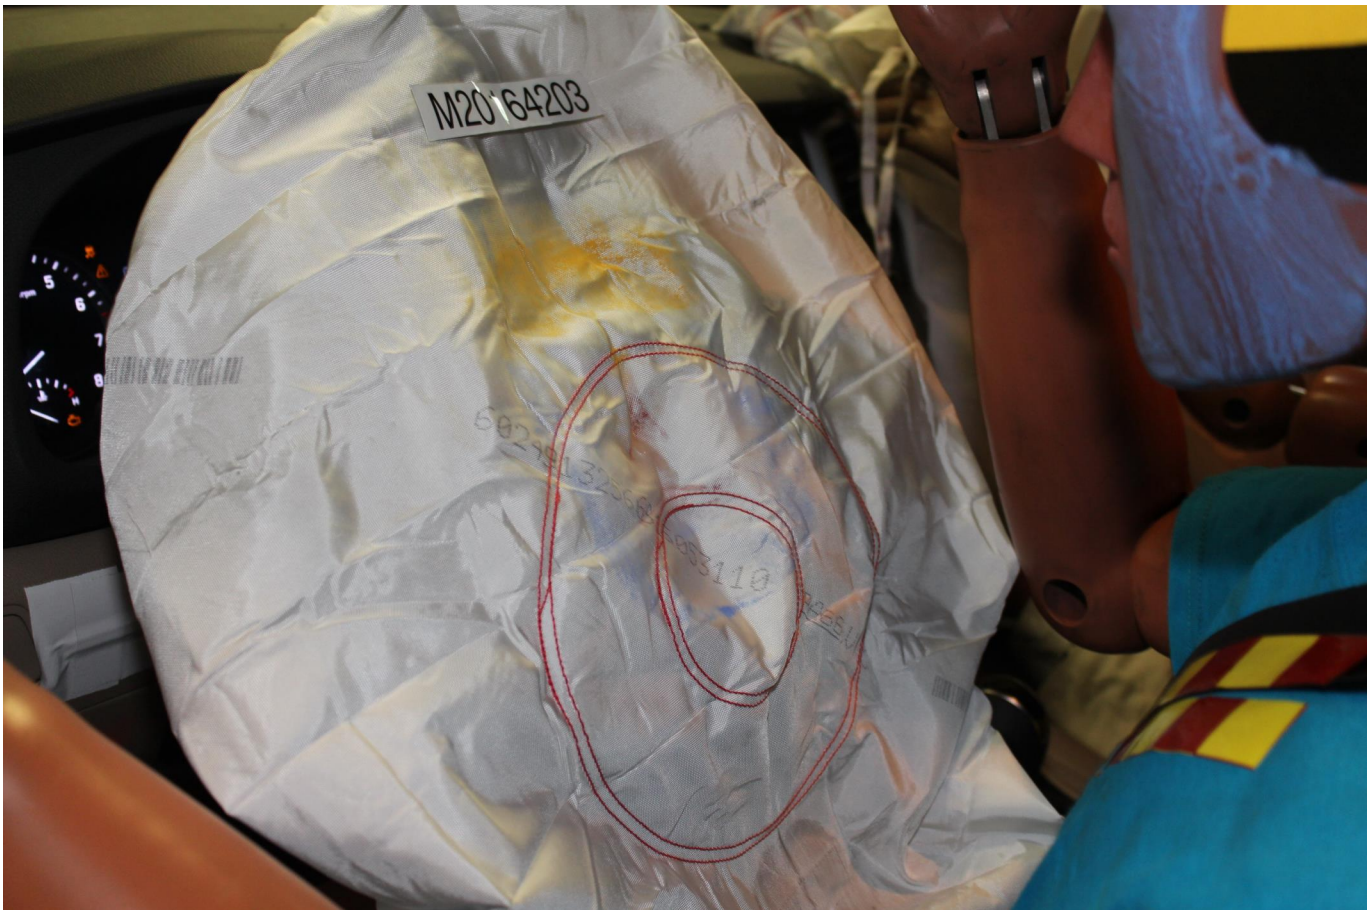
Photo No. 046 - Post-Test Driver Dummy Contact with Airbag

The driver's visible contact points were as follows: The driver's head contacted the airbag. The driver's head also contacted the headrest. The driver's knees contacted the knee bolster. The passenger's visible contact points were as follows: The passenger's head contacted the airbag. The passenger's head also contacted the headrest.

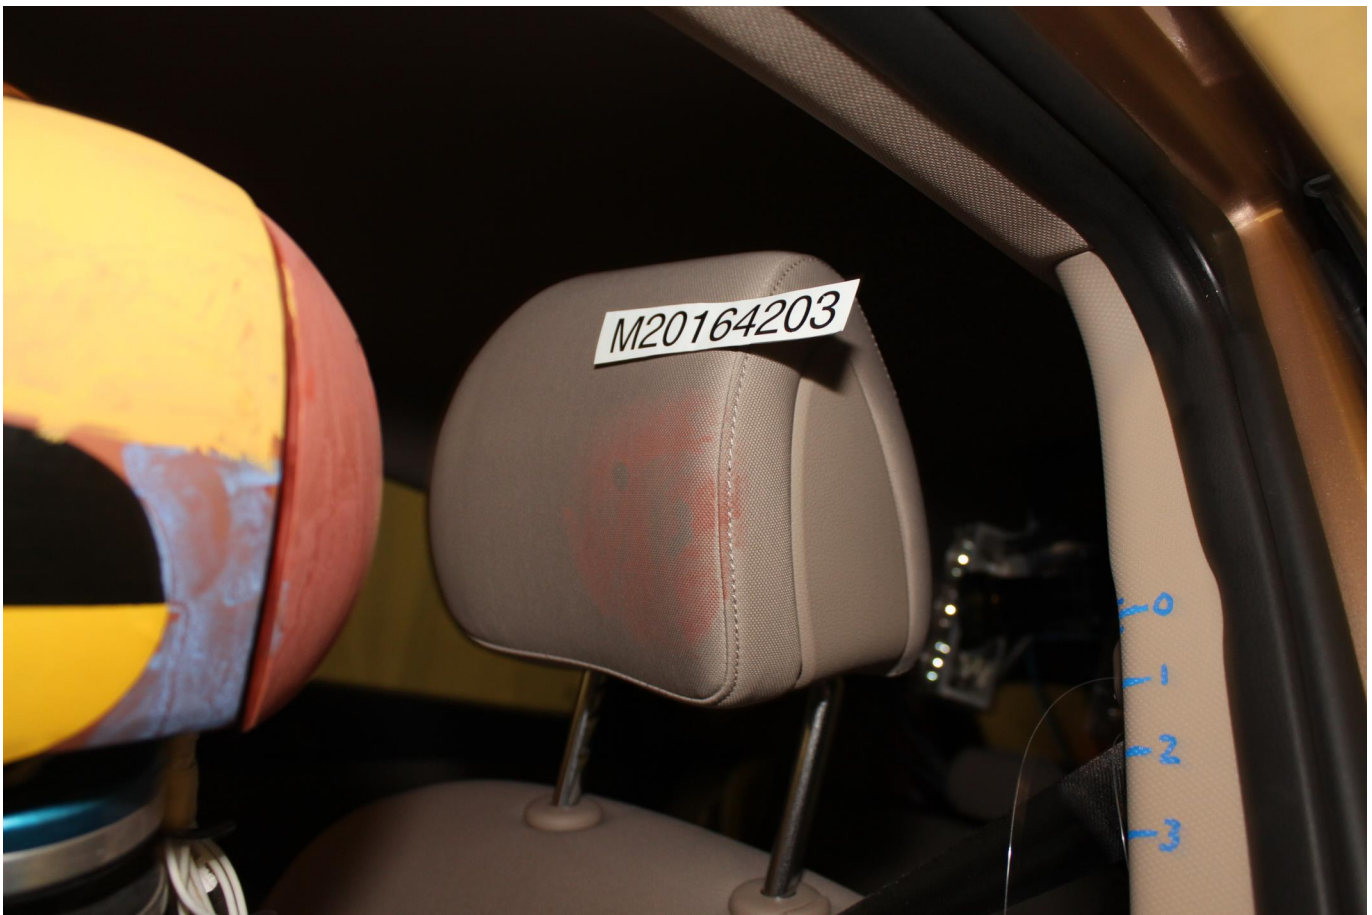
Photo No. 047 - Post-Test Driver Dummy Contact with Headrest

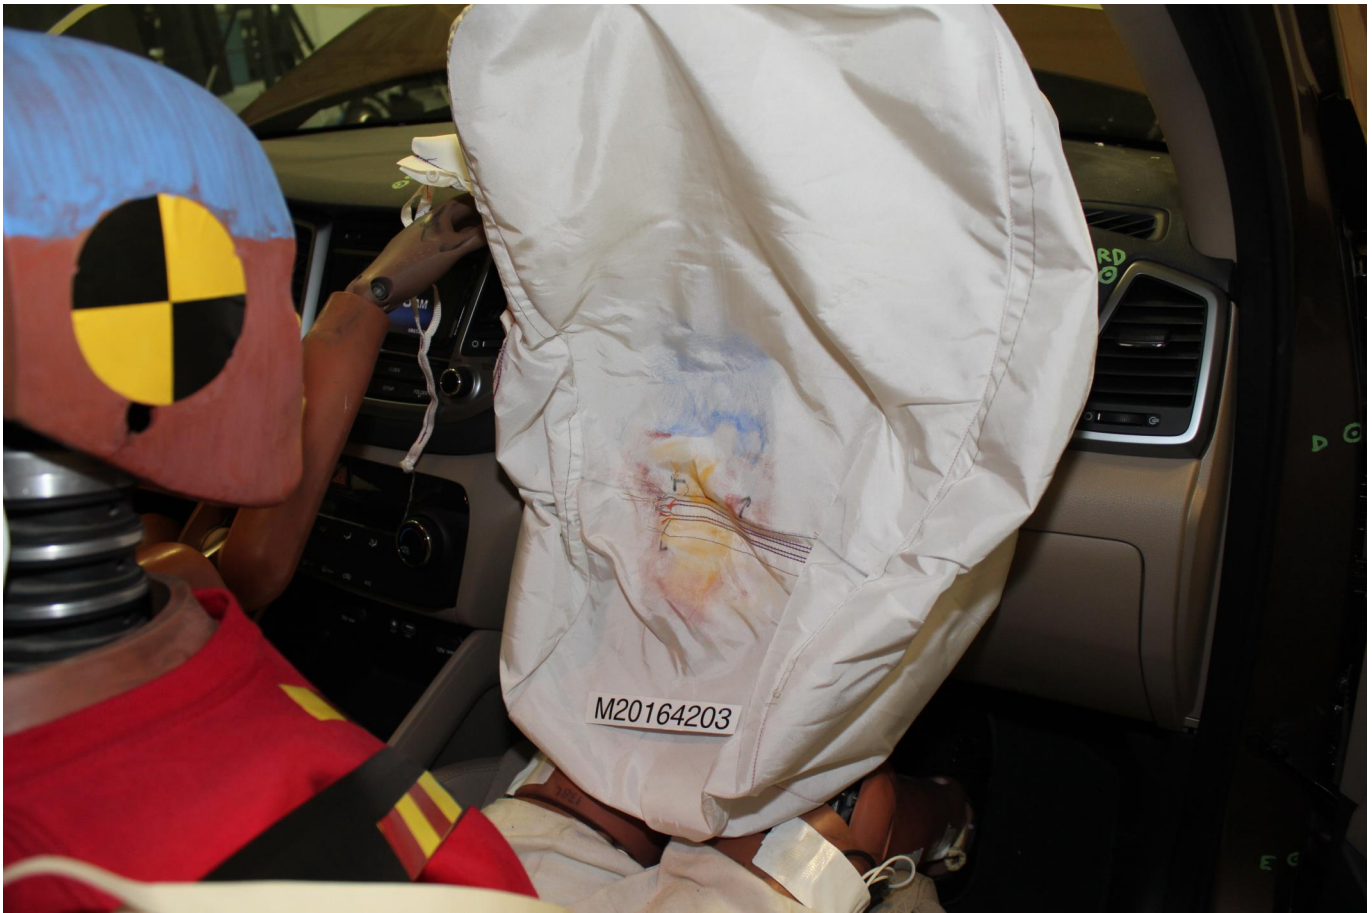
Photo No. 067 - Post-Test Passenger Dummy Contact with Airbag

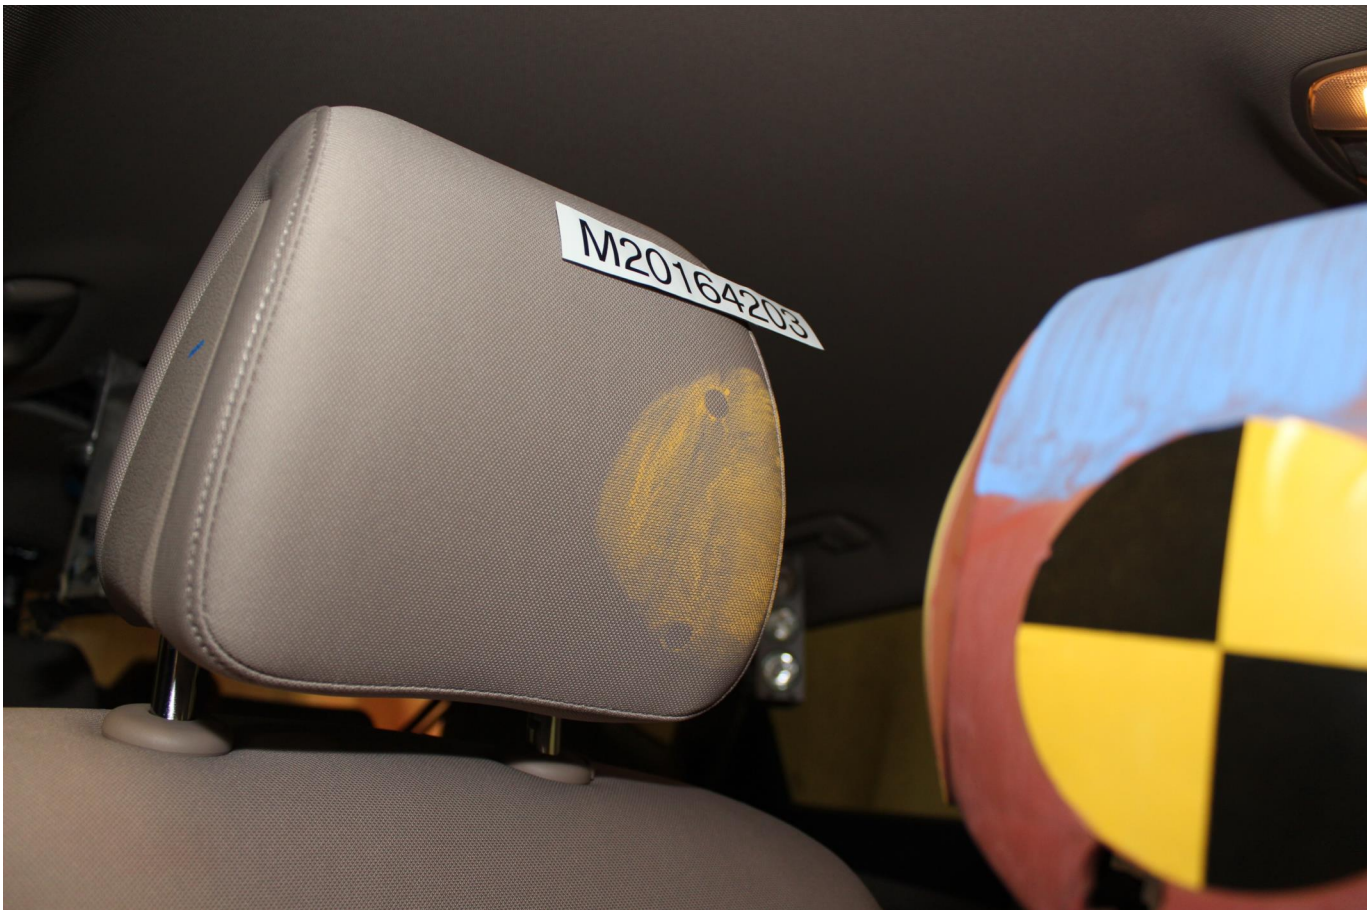
Photo No. 068 - Post-Test Passenger Dummy Contact with Headrest

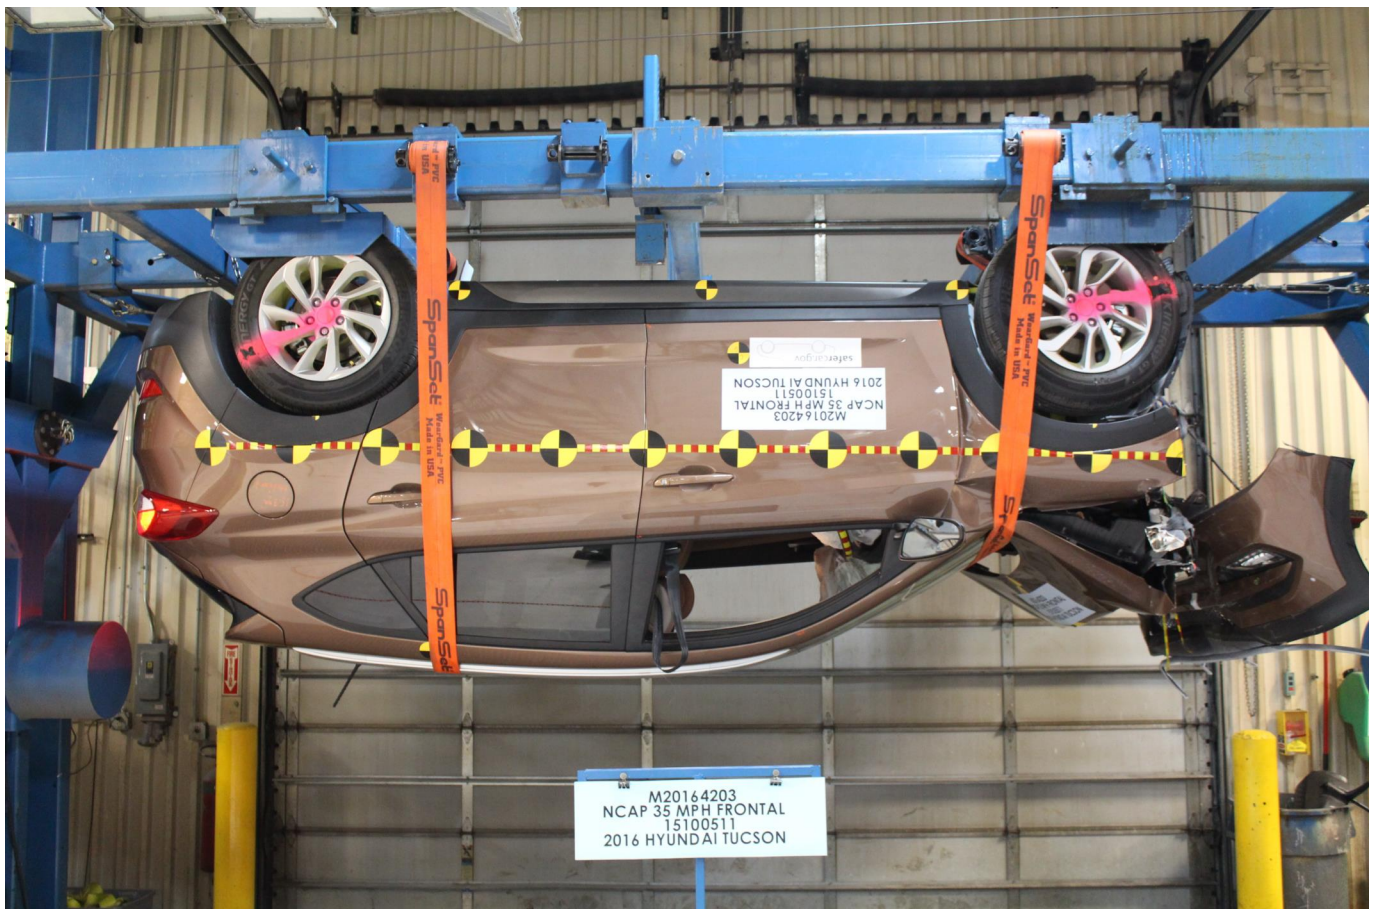
Photo No. 074 - Vehicle at 180 Degrees on Static Rollover Device

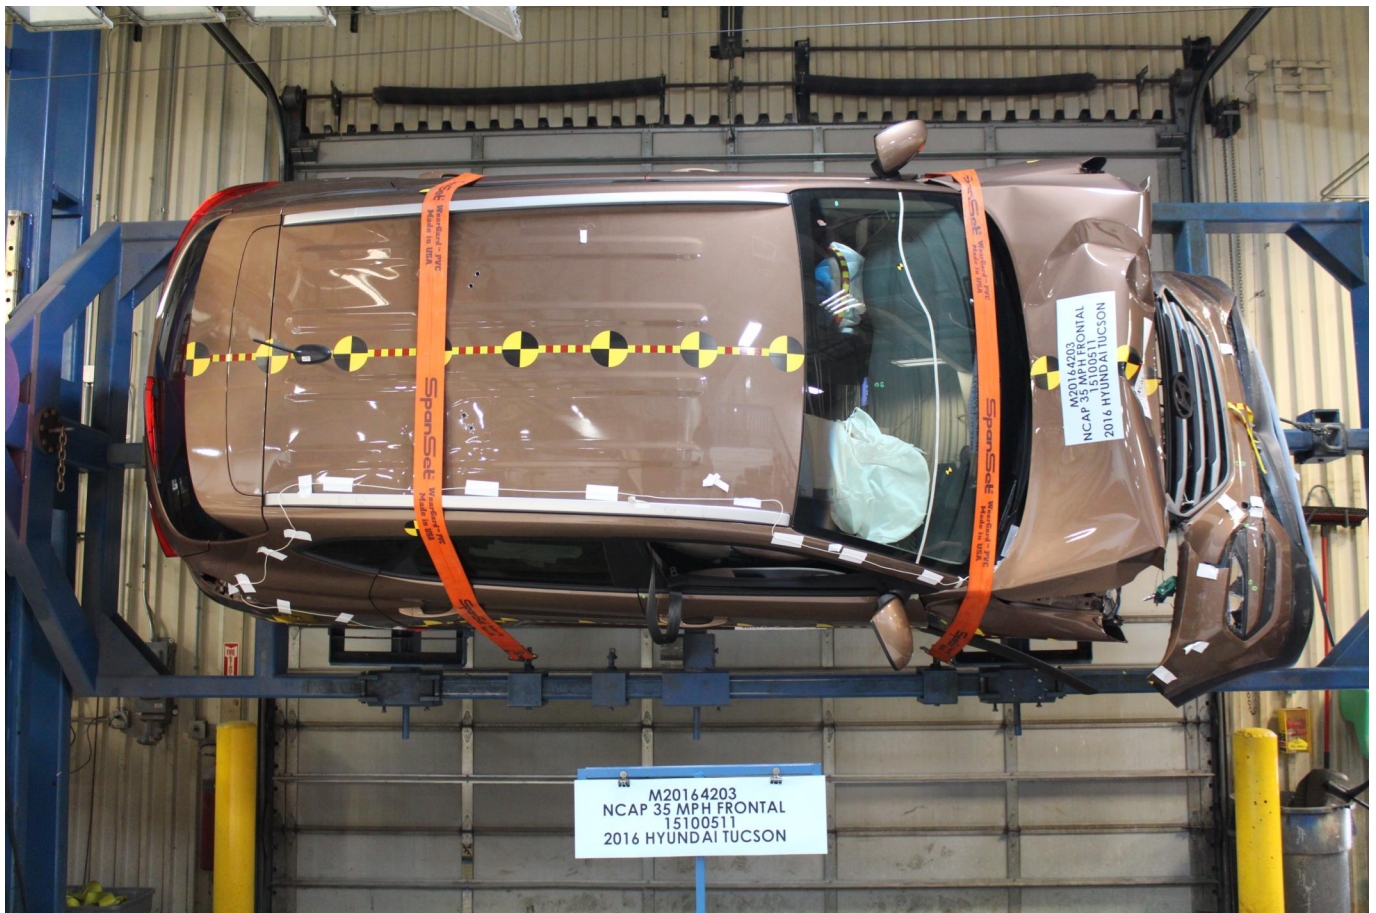
Photo No. 075 - Vehicle at 270 Degrees on Static Rollover Device

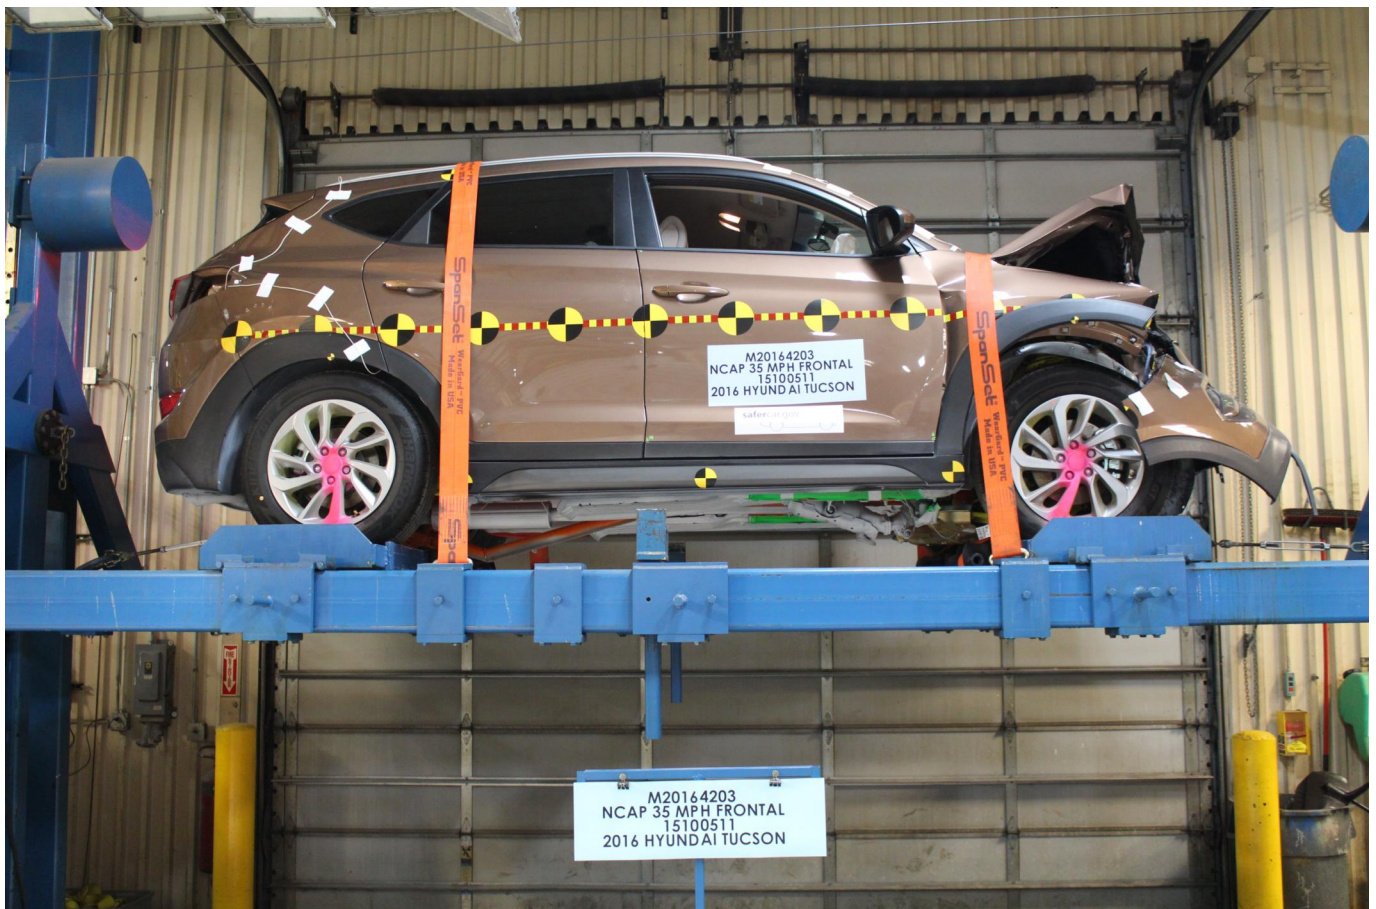
Photo No. 076 - Vehicle at 360 Degrees on Static Rollover Device
