FINAL REPORT NUMBER: SPNCAP-TRC-16-001

**NEW CAR ASSESSMENT PROGRAM (NCAP)
SIDE IMPACT POLE TEST**

**Ford Motor Company
2016 F-250 SuperCrew Pickup Truck
NHTSA NUMBER: M20160200**

**PREPARED BY:
Transportation Research Center Inc.
10820 State Route 347
P. O. Box B-67
East Liberty, OH 43319**

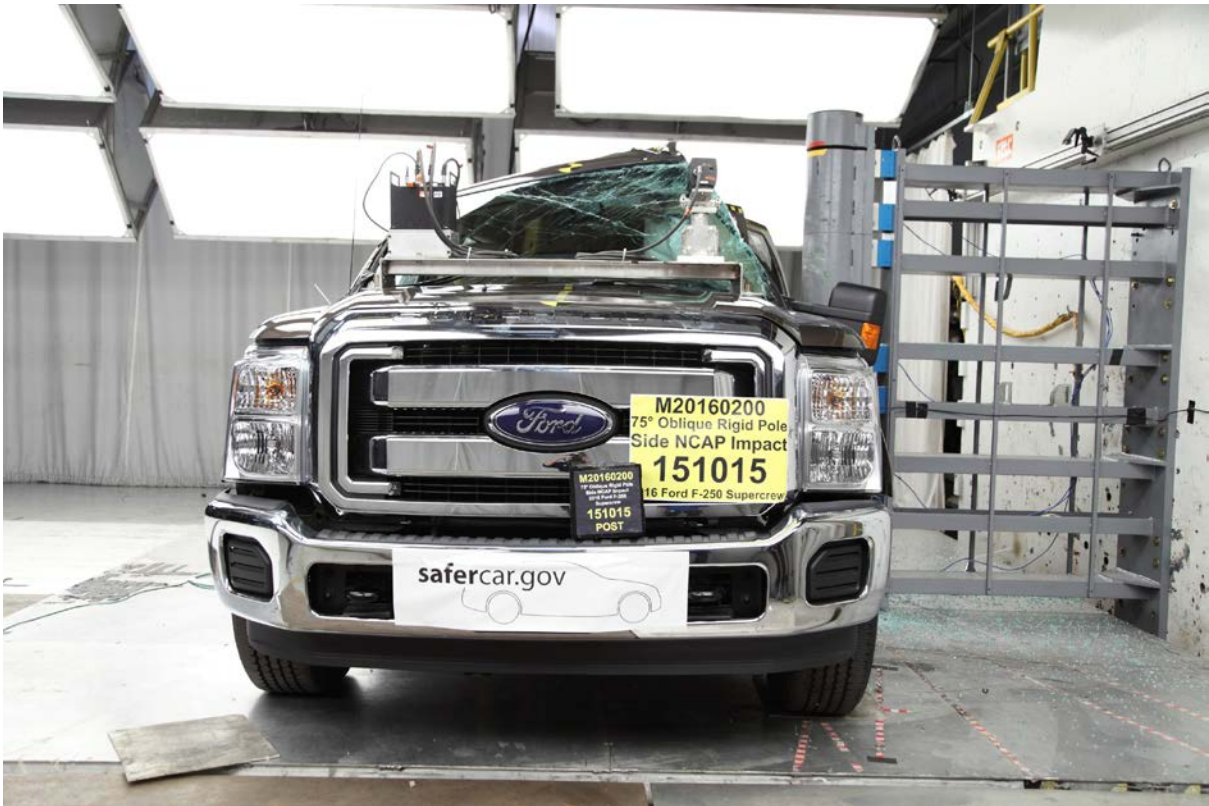
004 Post-Test Frontal View of Test Vehicle

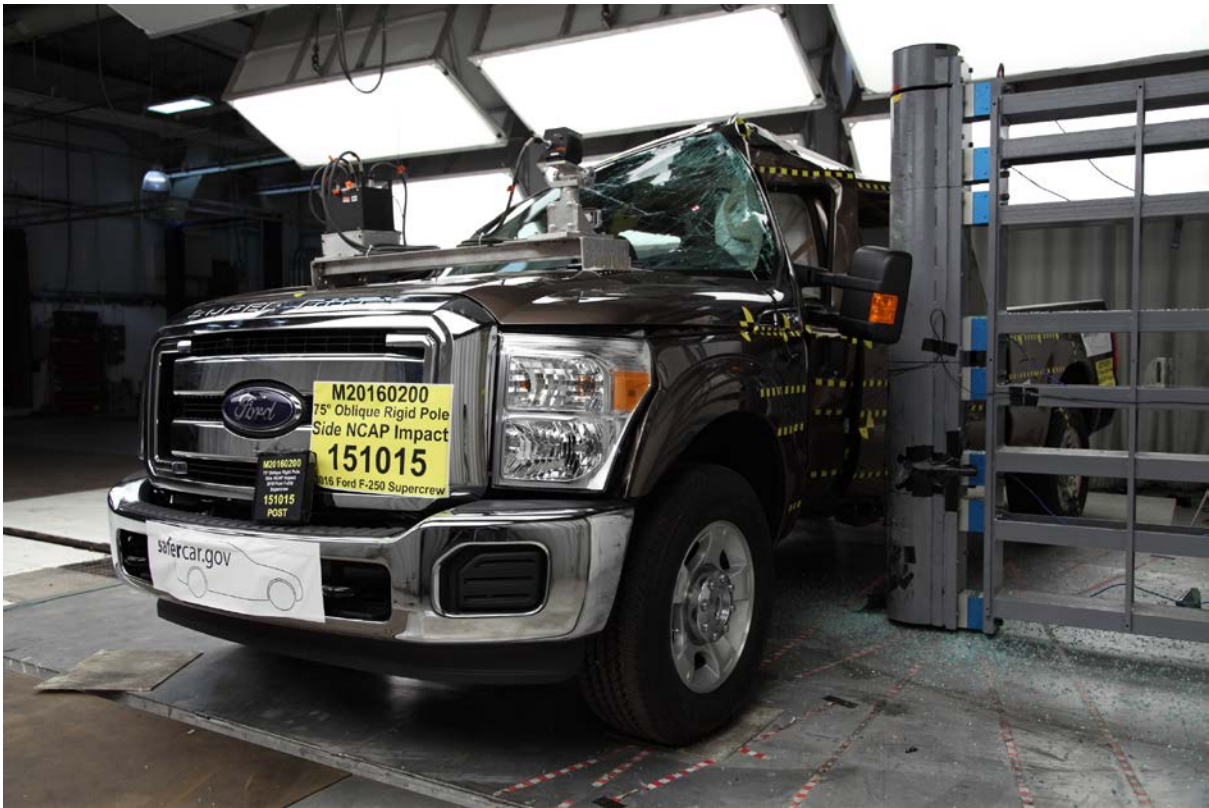
006 Post-Test Left Front 3-4 View of Test Vehicle

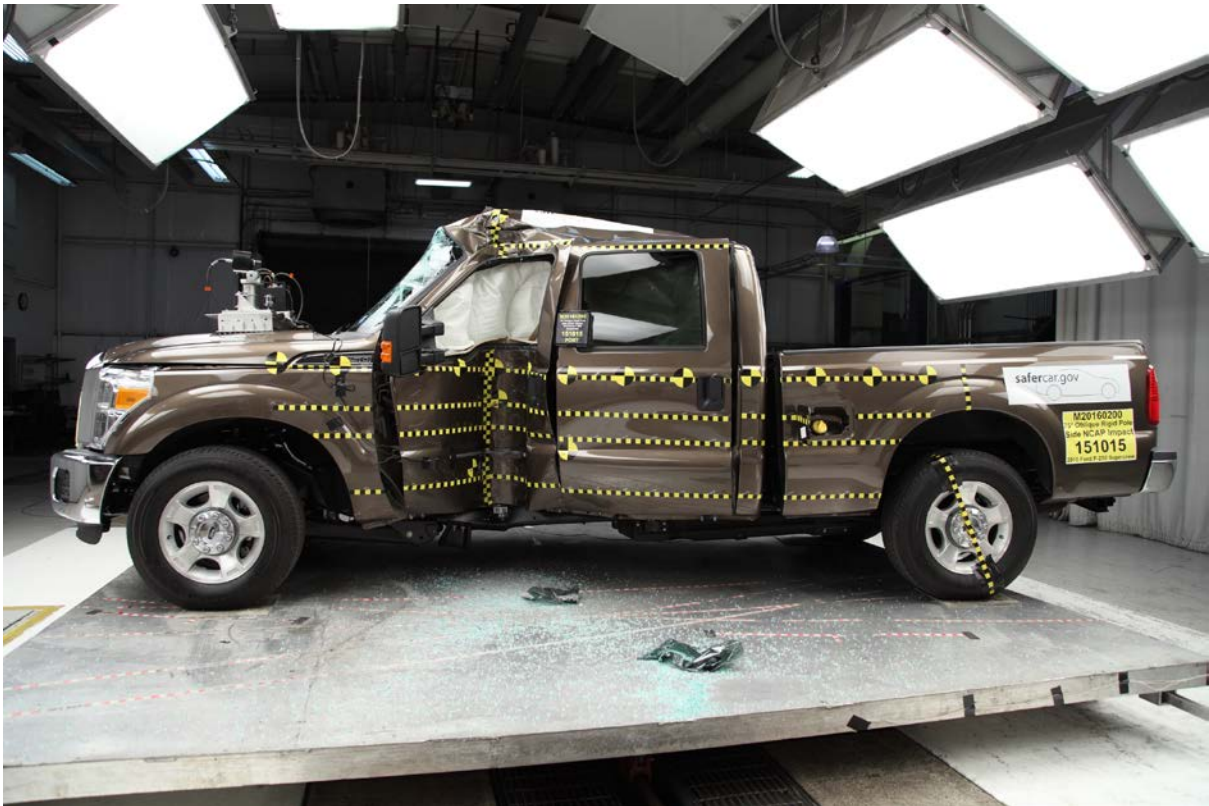
008 Post-Test Left Side View of Test Vehicle

Critical Areas of Performance	Observations and Conclusions
Pillar Performance	Severe Deformation
Sill Separation	None Visible
Windshield Damage	Broken
Side Window Damage	Shattered
Other Notable Effects	None

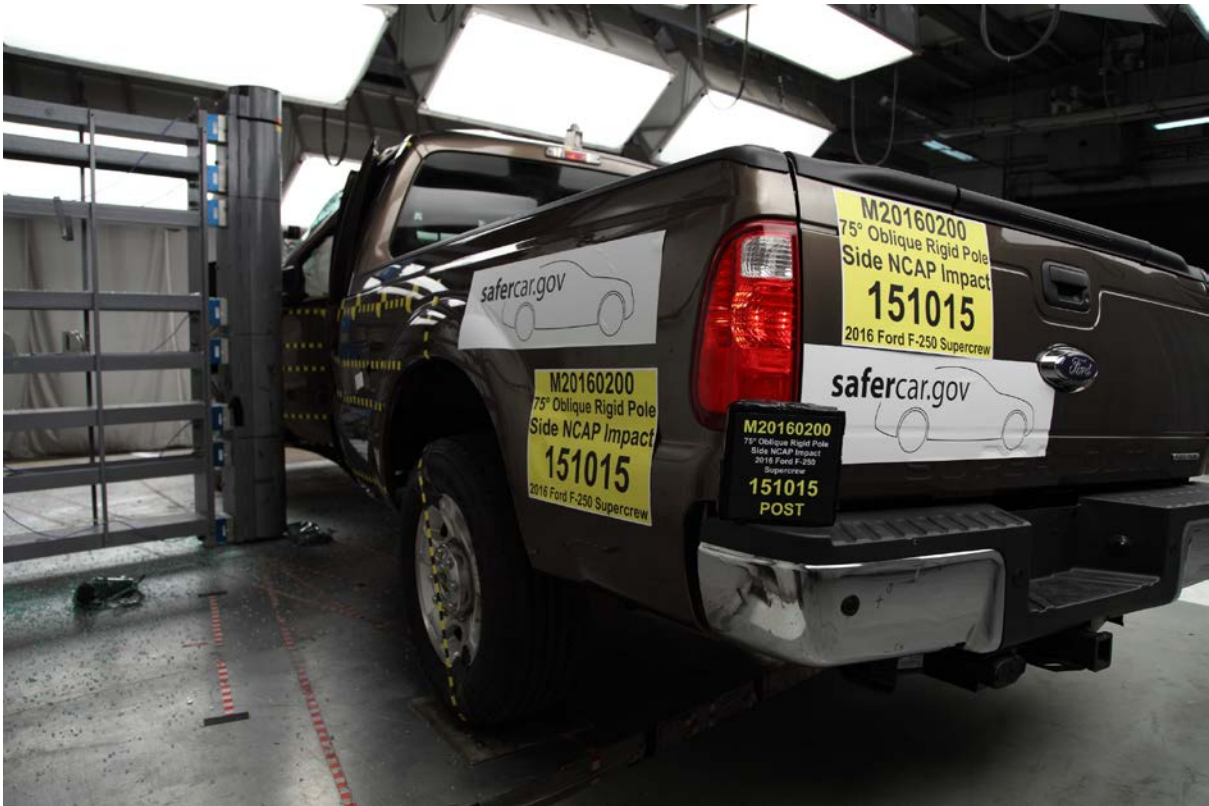
010 Post-Test Left Rear 3-4 View of Test Vehicle

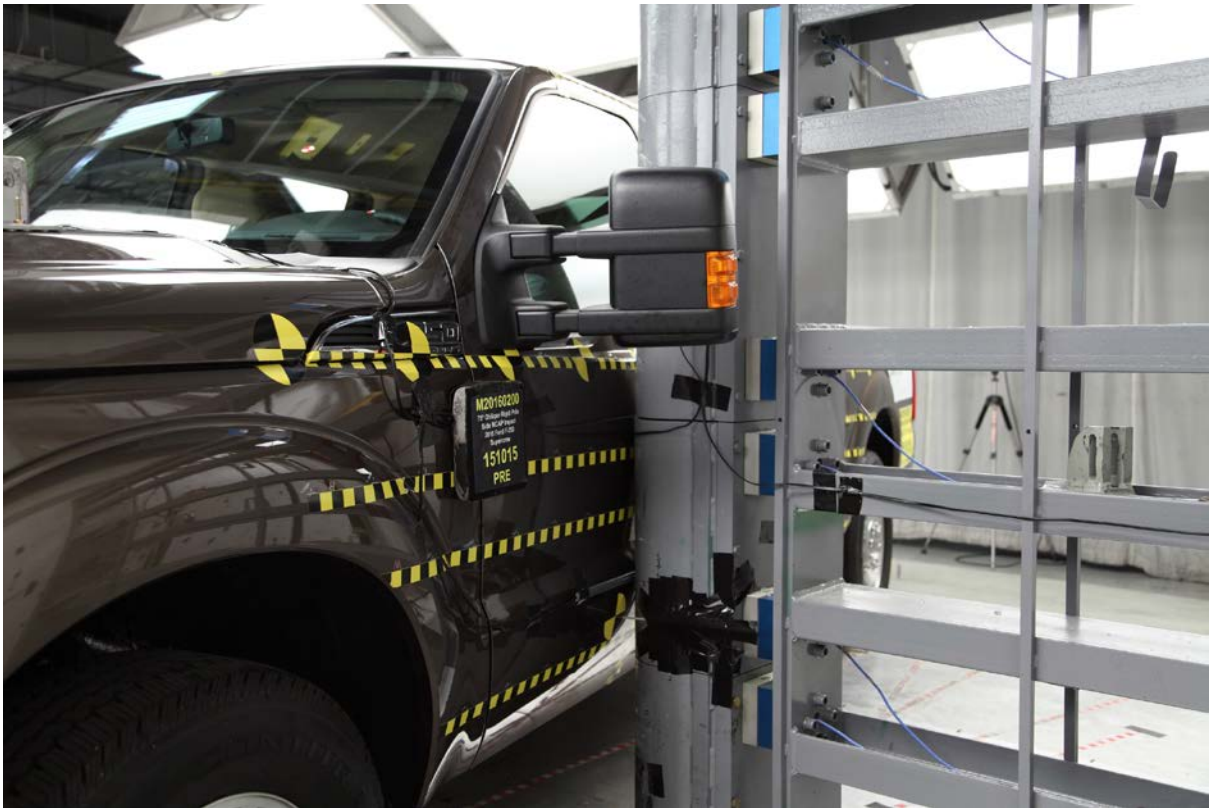
017 Pre-Test Left Side View of Pole Positioned Against Side of Vehicle

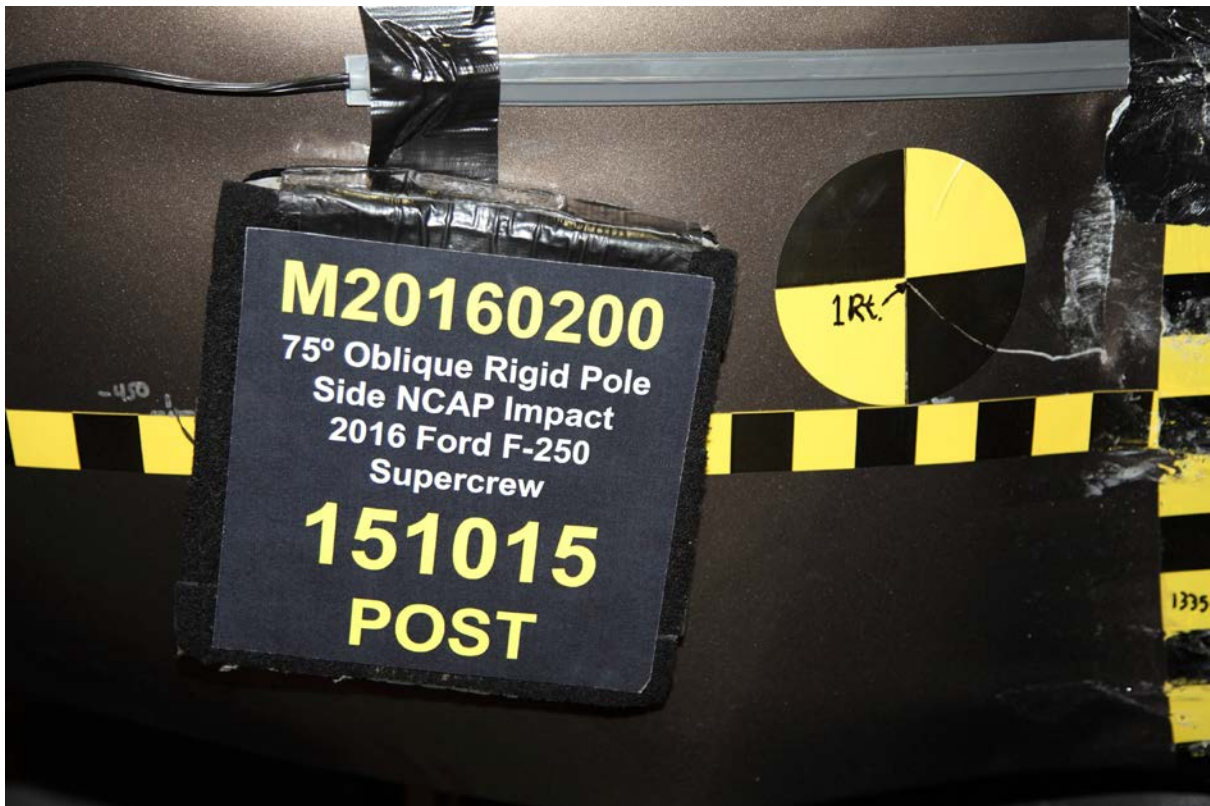
020 Post-Test Close-Up View of Impact Point Target Showing Impact Location

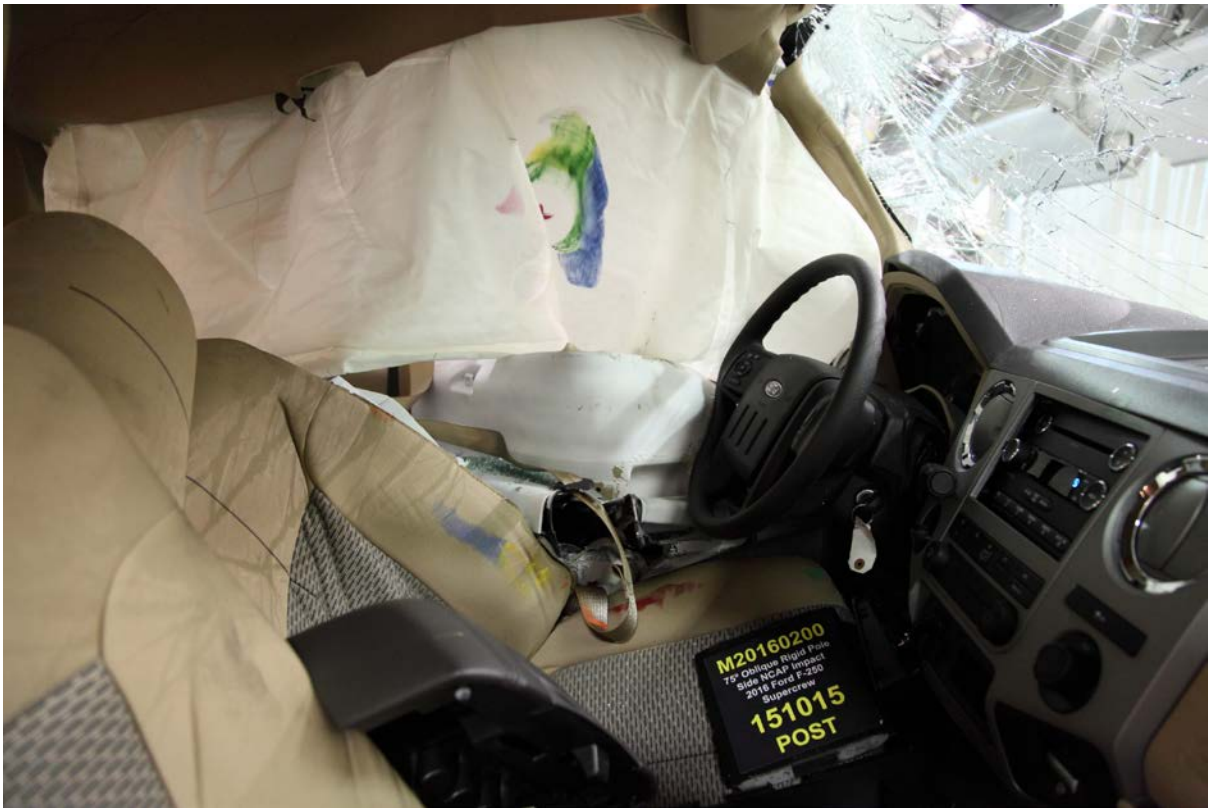
045 Post-Test Inner Driver Door Panel View Showing Dummy Contact Location

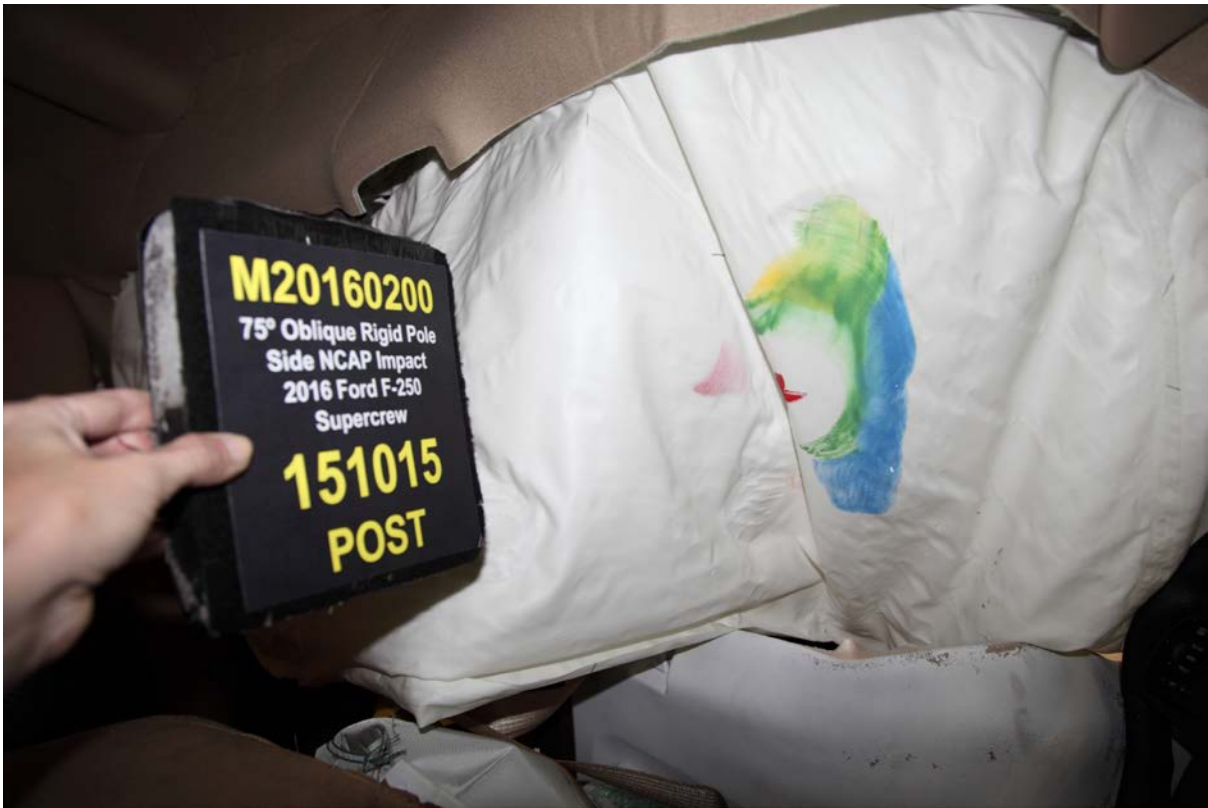
047 Post-Test Dummy Close-Up Head Contact with Side Airbag View

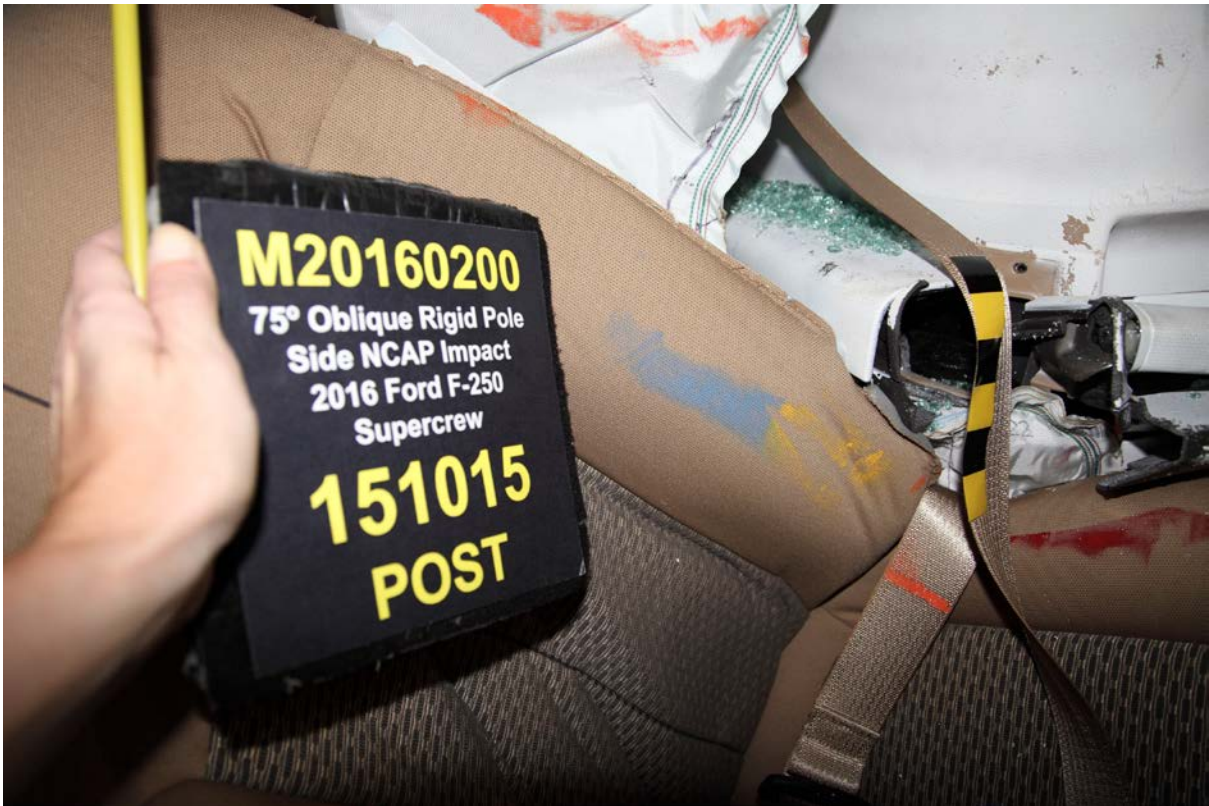
050 Post-Test Dummy Close-Up Pelvis Contact with Vehicle Interior View

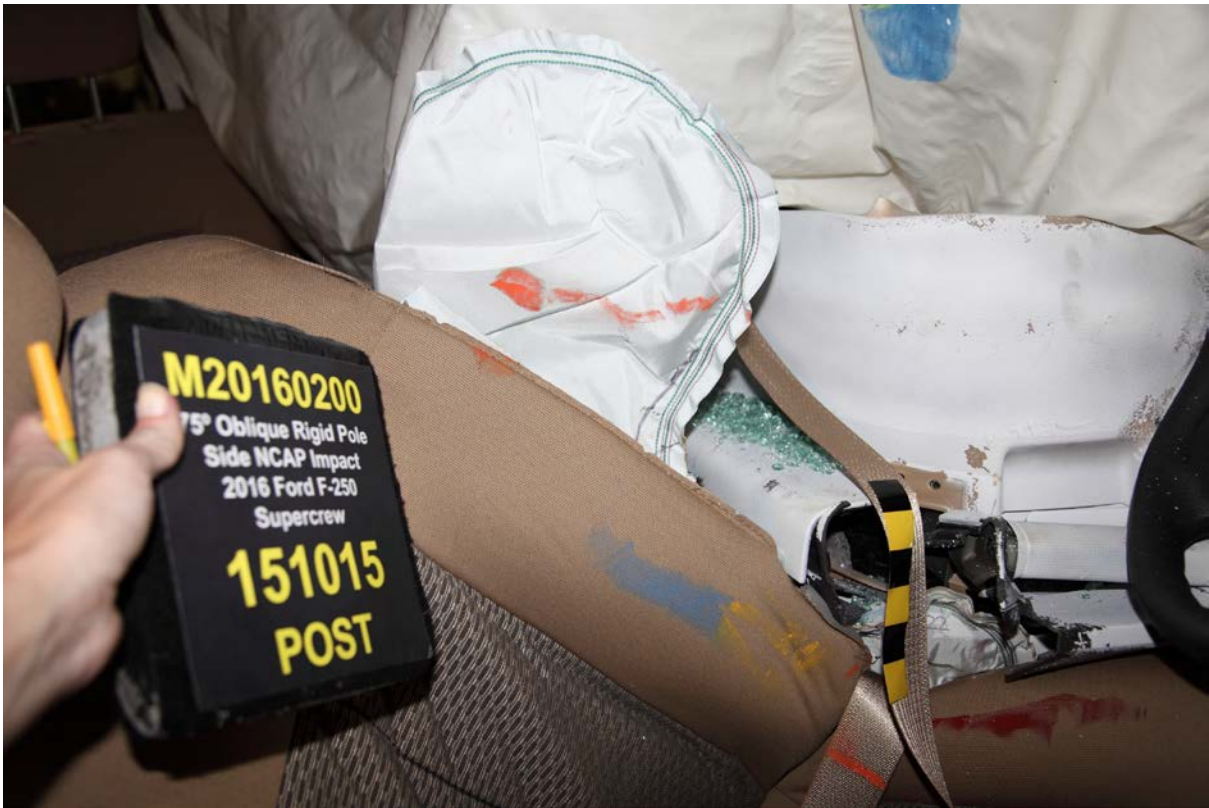
051 Post-Test Dummy Close-Up Pelvis Contact with Side Airbag View

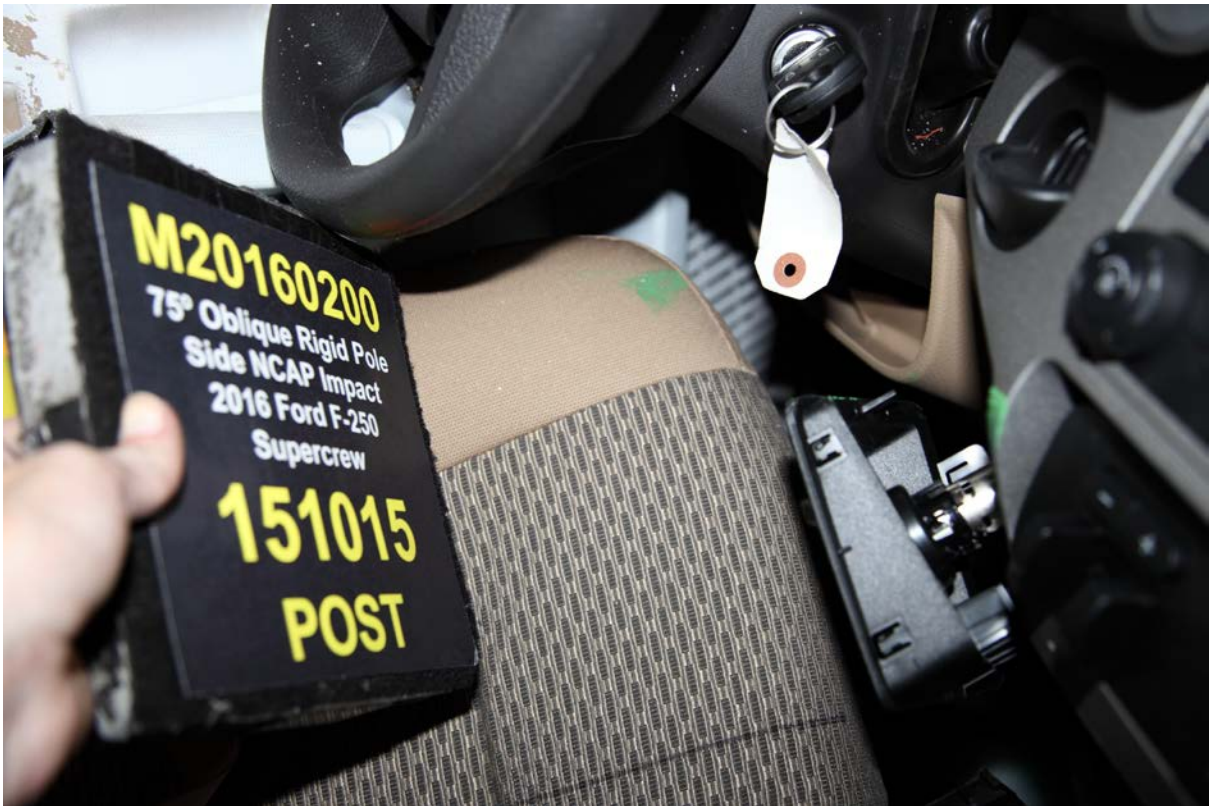
052 Post-Test Dummy Close-Up Knee Contact with Vehicle Interior View

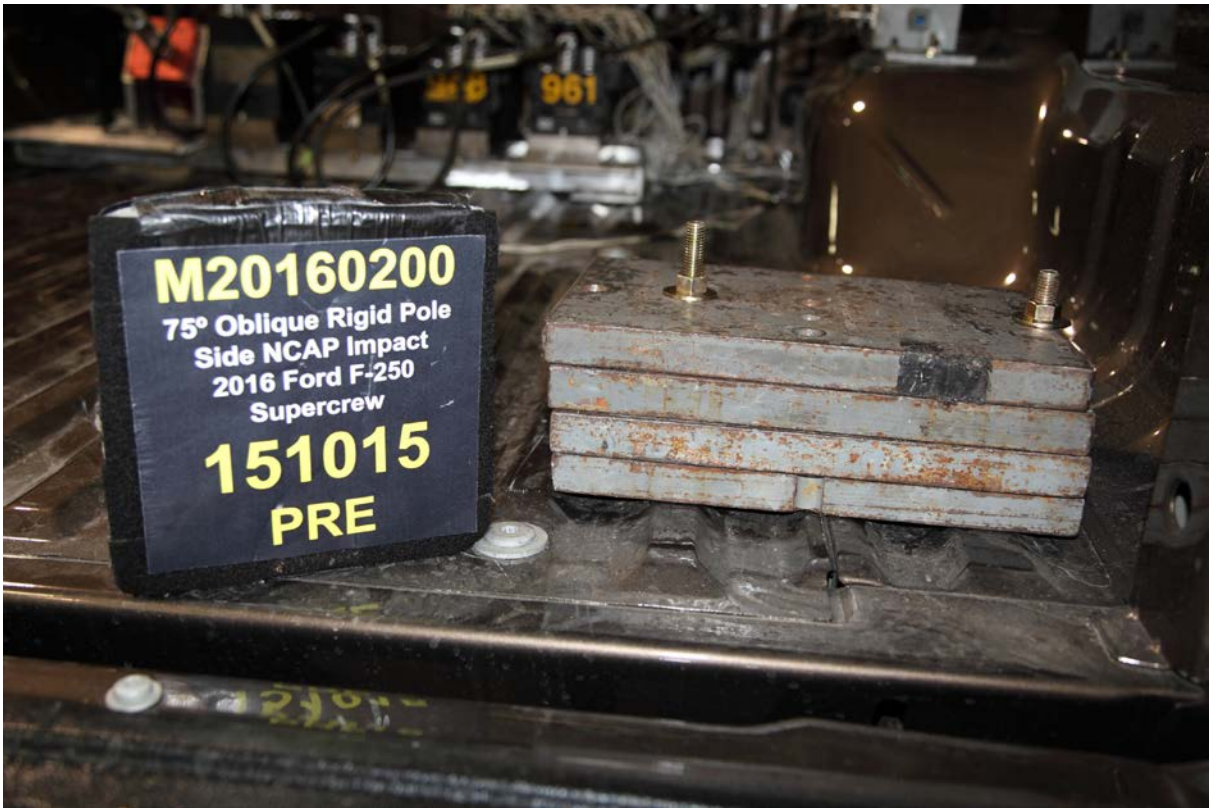
061 Pre-Test Ballast View 1

Component Description	Weight (kg)
Ballast: Steel plate mounted in cargo area	99.8
Components removed: None	0.0

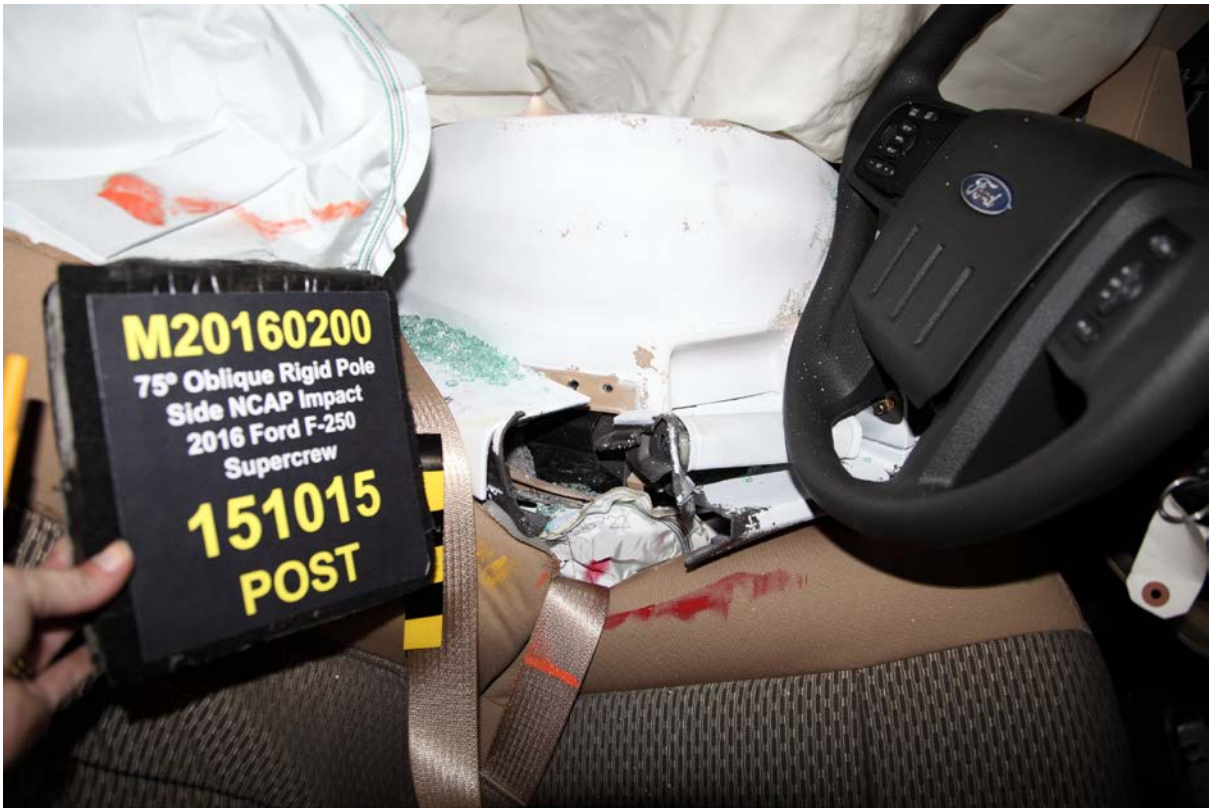
071 Post-Test View of Shattered Vehicle Inner Door Panel
