REPORT NUMBER: SINCAP-MGA-2016-024

**NEW CAR ASSESSMENT PROGRAM (NCAP)
Moving Deformable Barrier Side Impact Test**

**FCA US LLC
2016 Dodge Journey SE 5-Door SUV
NHTSA No.: M20160307**

**MGA RESEARCH CORPORATION
5000 Warren Road
Burlington, WI 53105**

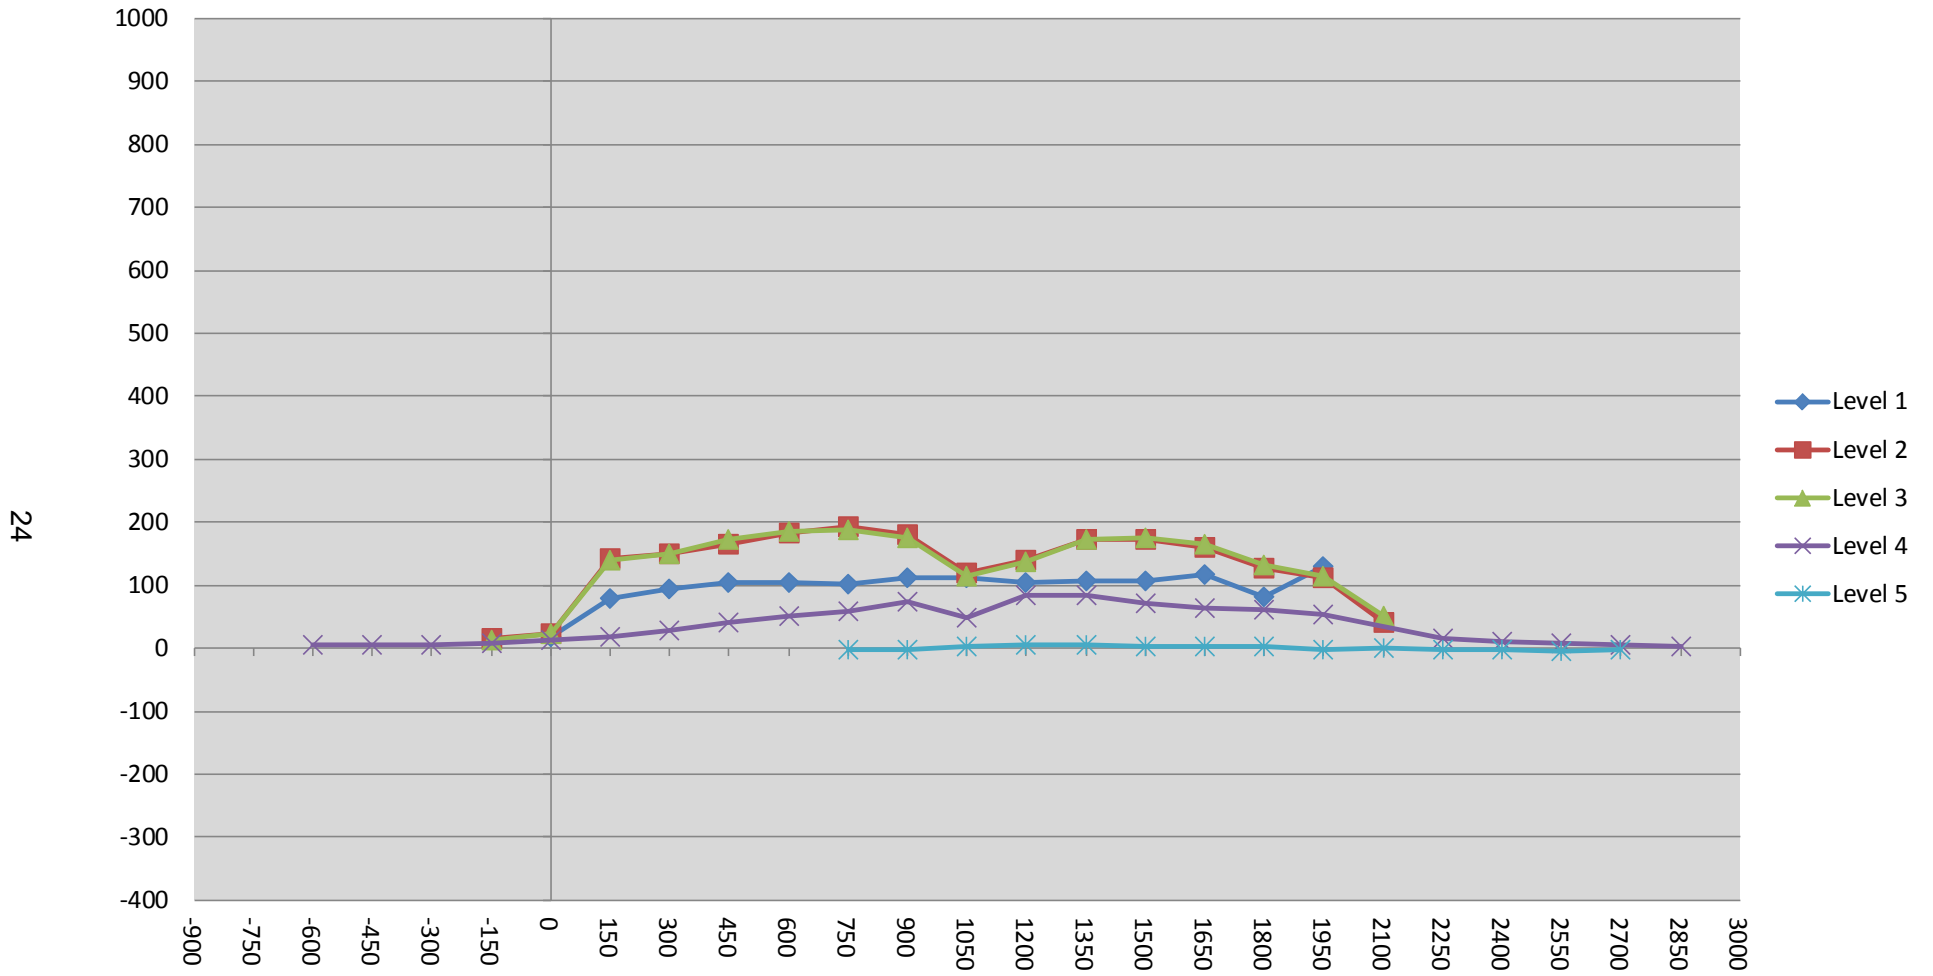
NOTE: Pre-test measurements are taken when the vehicle is in the "As Tested" weight condition. Vehicle measurements forward of the vertical impact reference line are negative. The crush profile grid is established prior to the test based on an estimated impact point.

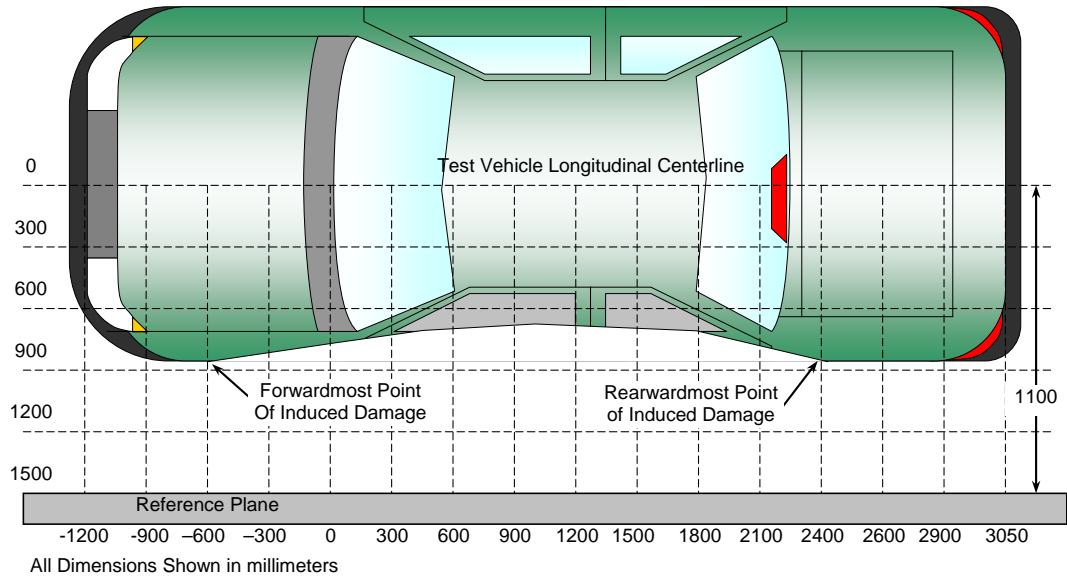
**DATA SHEET NO. 13
VEHICLE AND MDB DAMAGE PROFILE DISTANCES**

TOP VIEW

VEHICLE DAMAGE PROFILE DISTANCES

MDB DAMAGE PROFILE DISTANCES

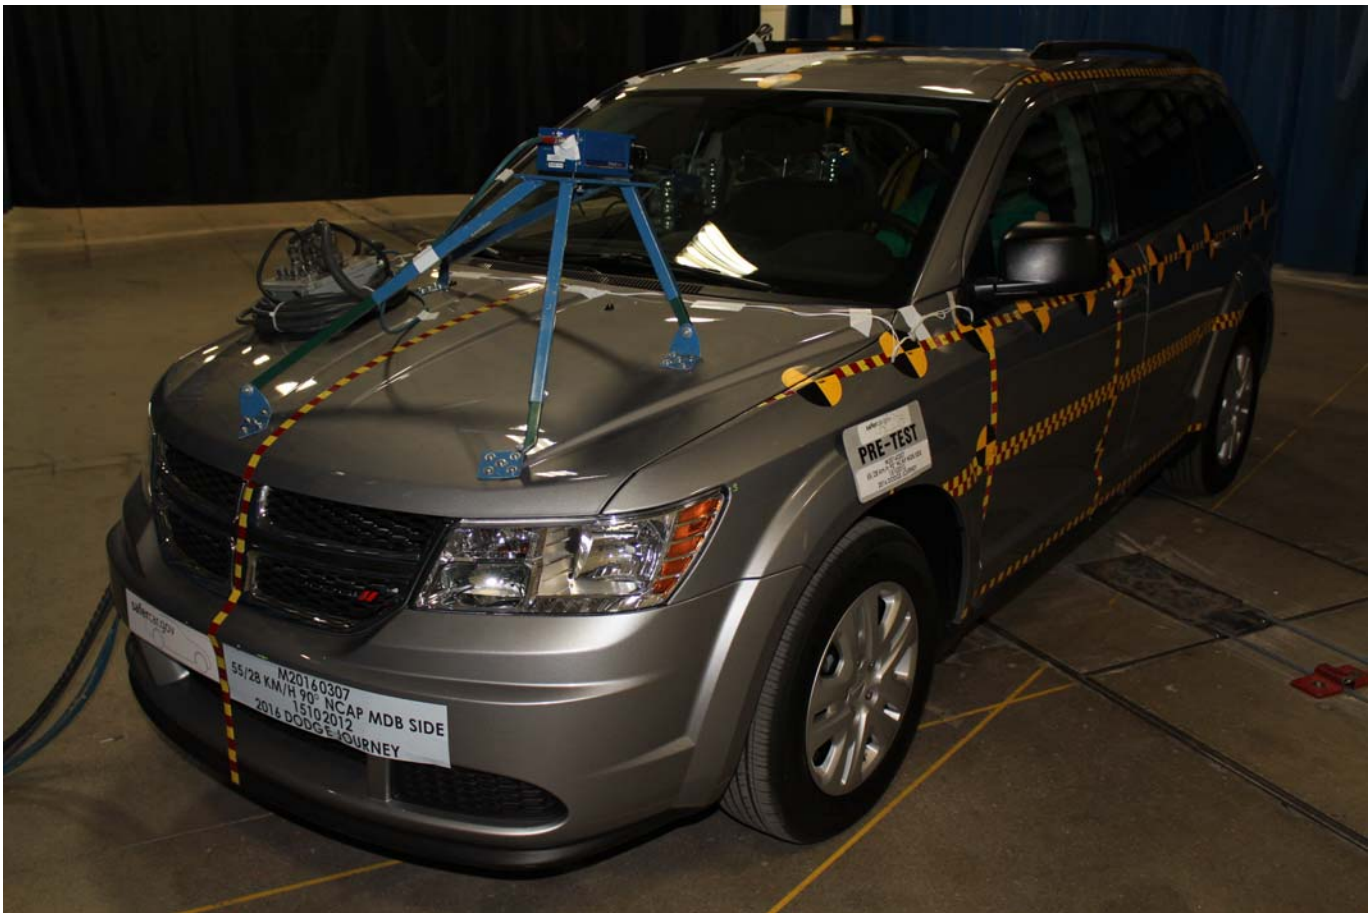
Photo No. 005 - Pre-Test Left Front Three-Quarter View of Test Vehicle

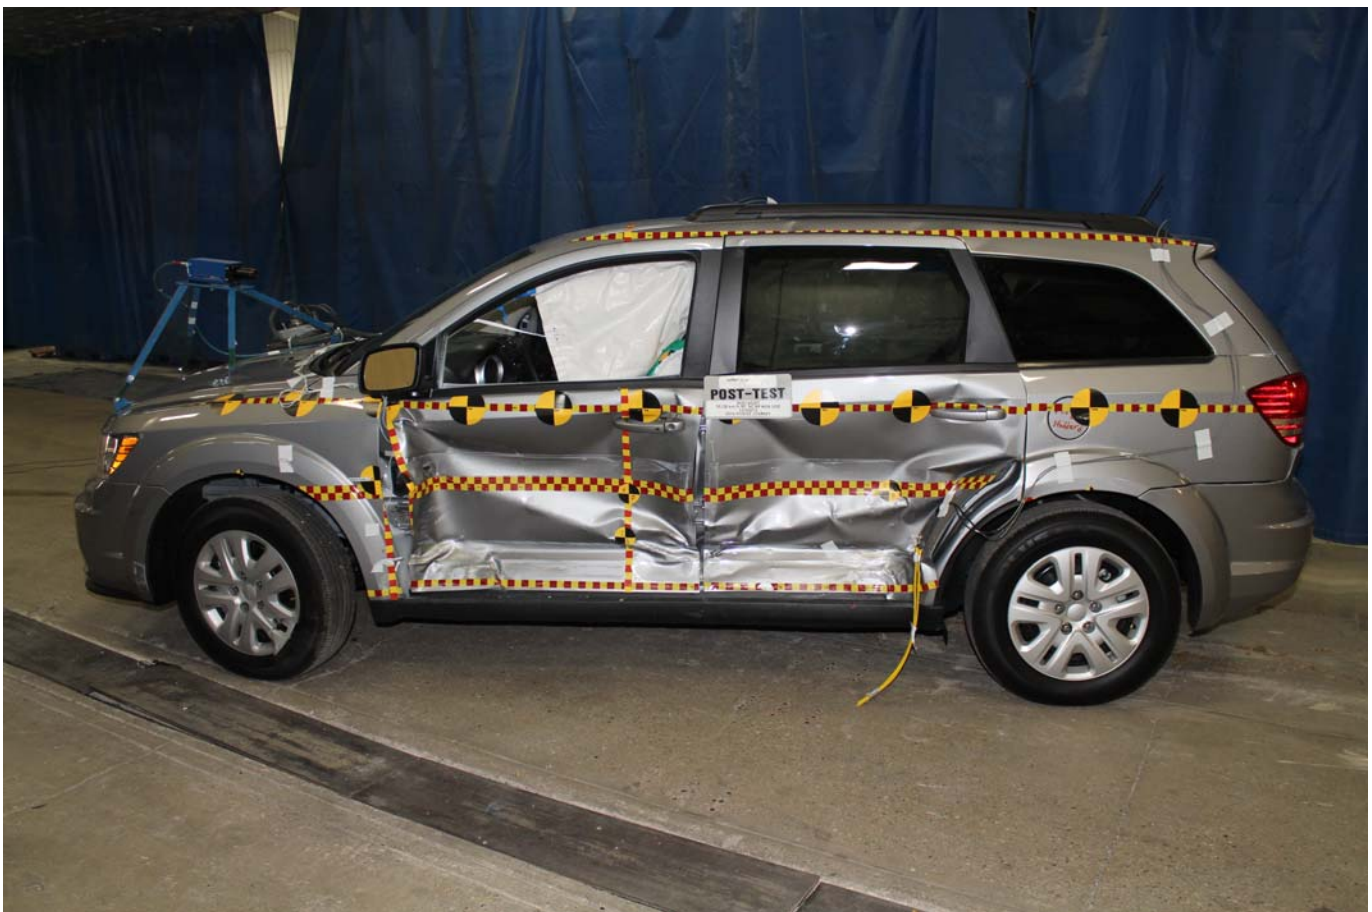
Photo No. 008 - Post-Test Left Side View of Test Vehicle

Critical Areas of Performance	Observations and Conclusions
Pillar Performance	No Separation
Sill Separation	None
Windshield Damage	None
Side Window Damage	LF Window Broken
Other Notable Effects	None

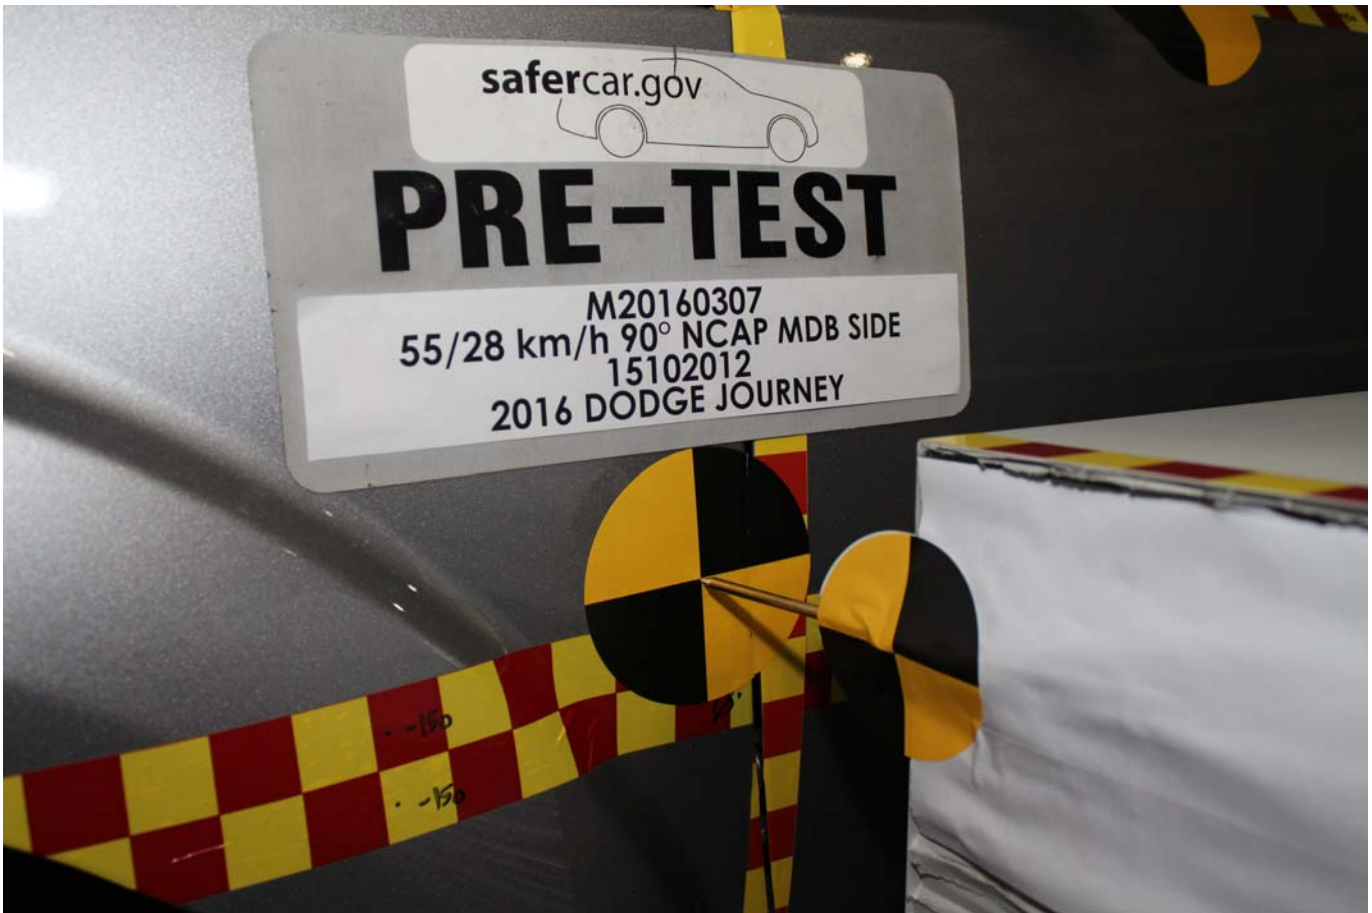
Photo No. 019 - Pre-Test Close-Up View of Impact Point Target

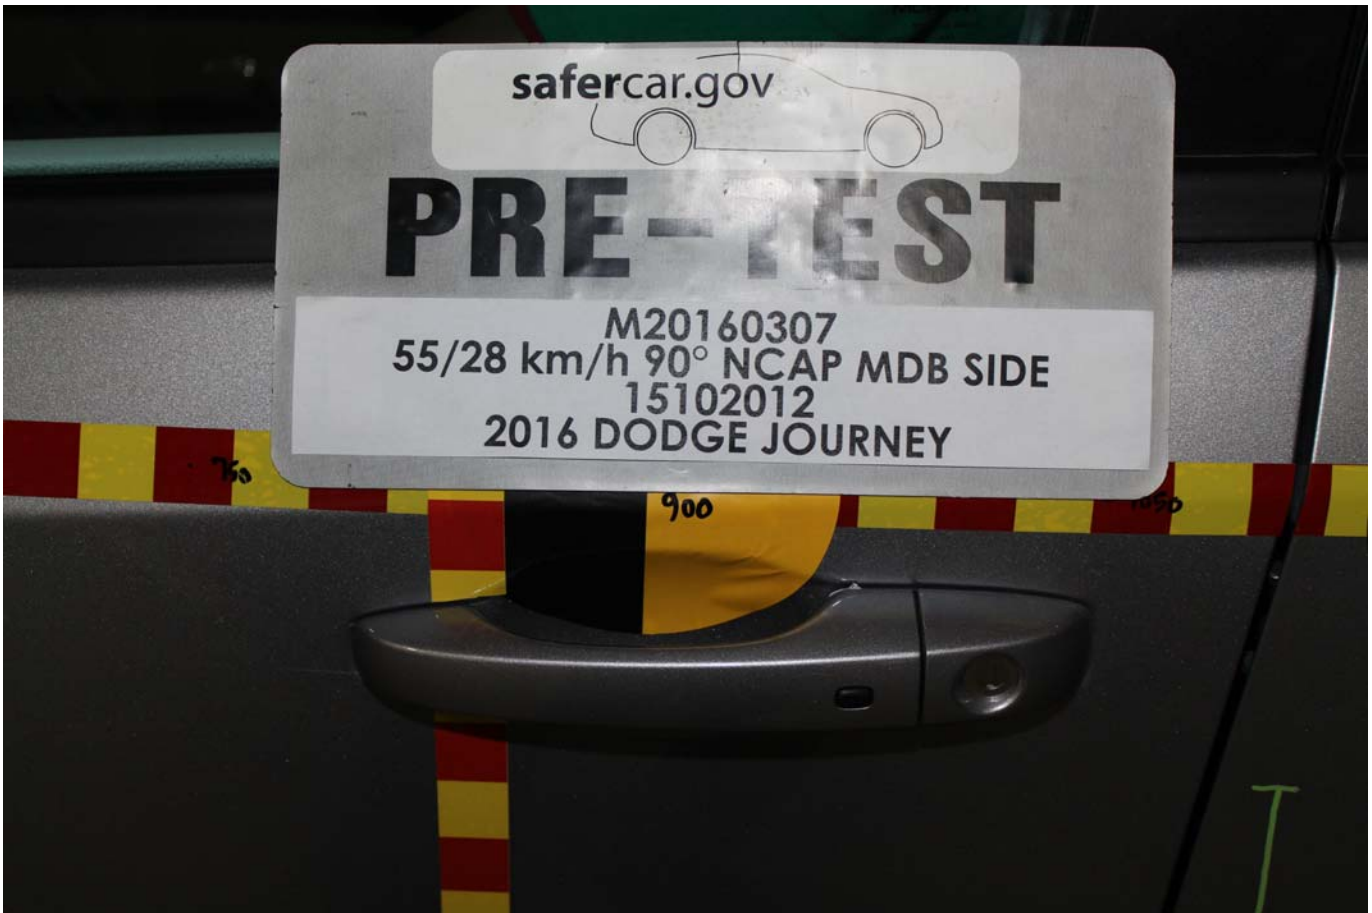
Photo No. 021 - Pre-Test Left Front Door Latch Close-Up

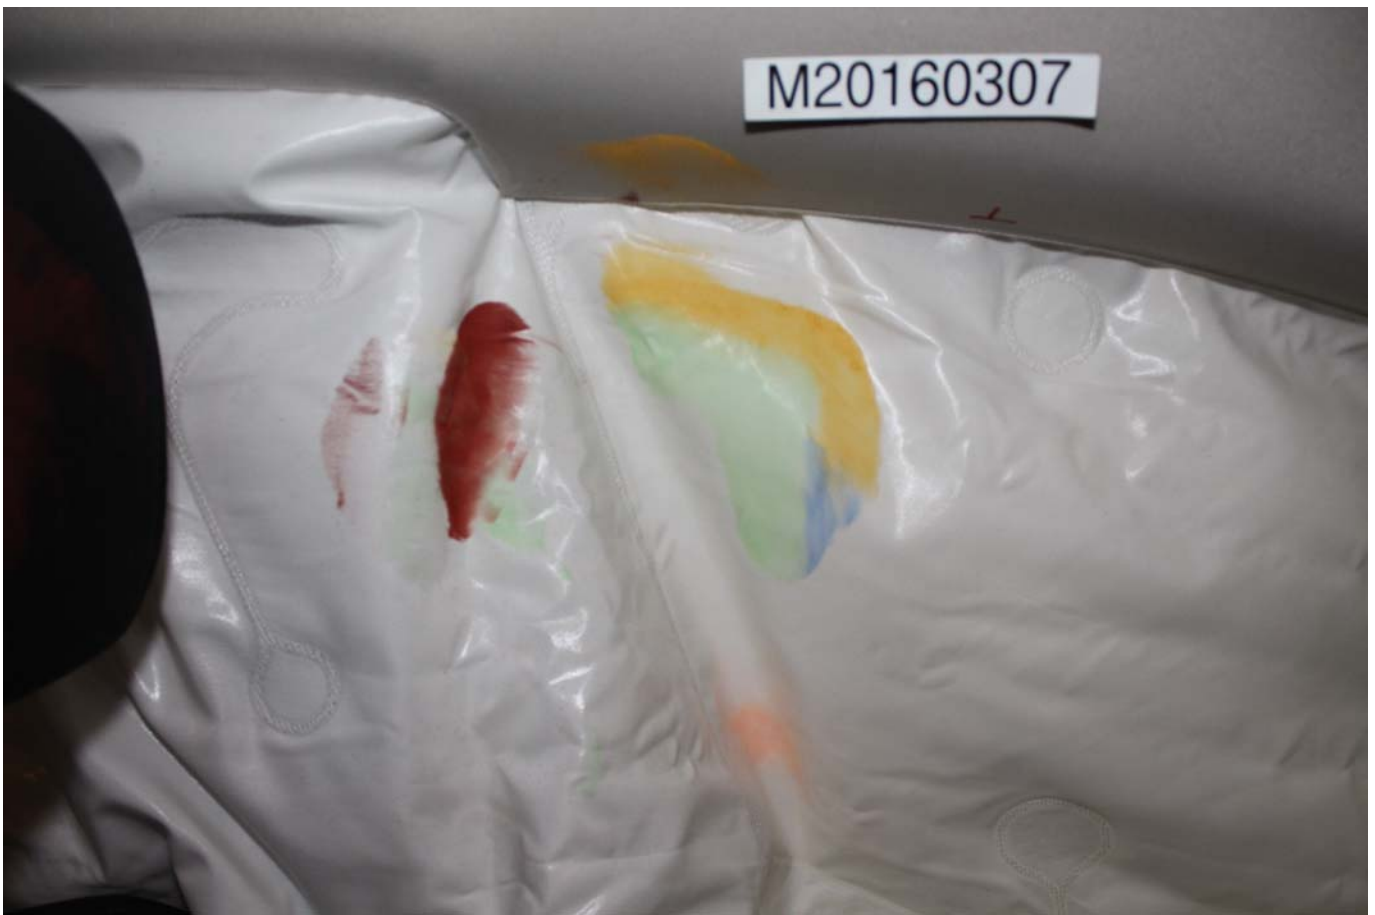
Photo No. 049 - Post-Test Driver Dummy Close-up Head Contact with Side Airbag View

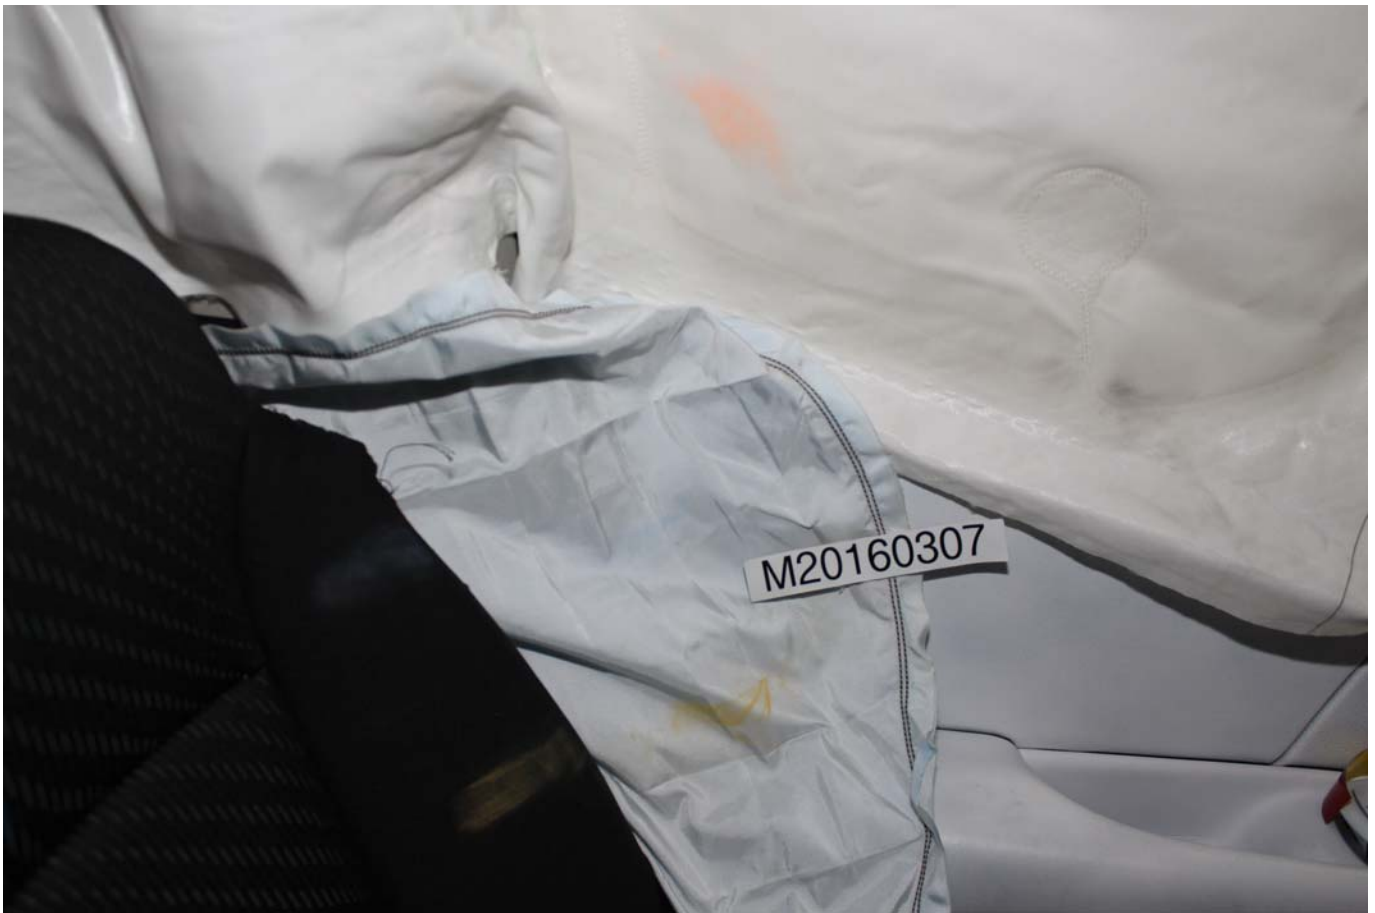
Photo No. 051 - Post-Test Driver Dummy Close-up Torso Contact with Side Airbag View

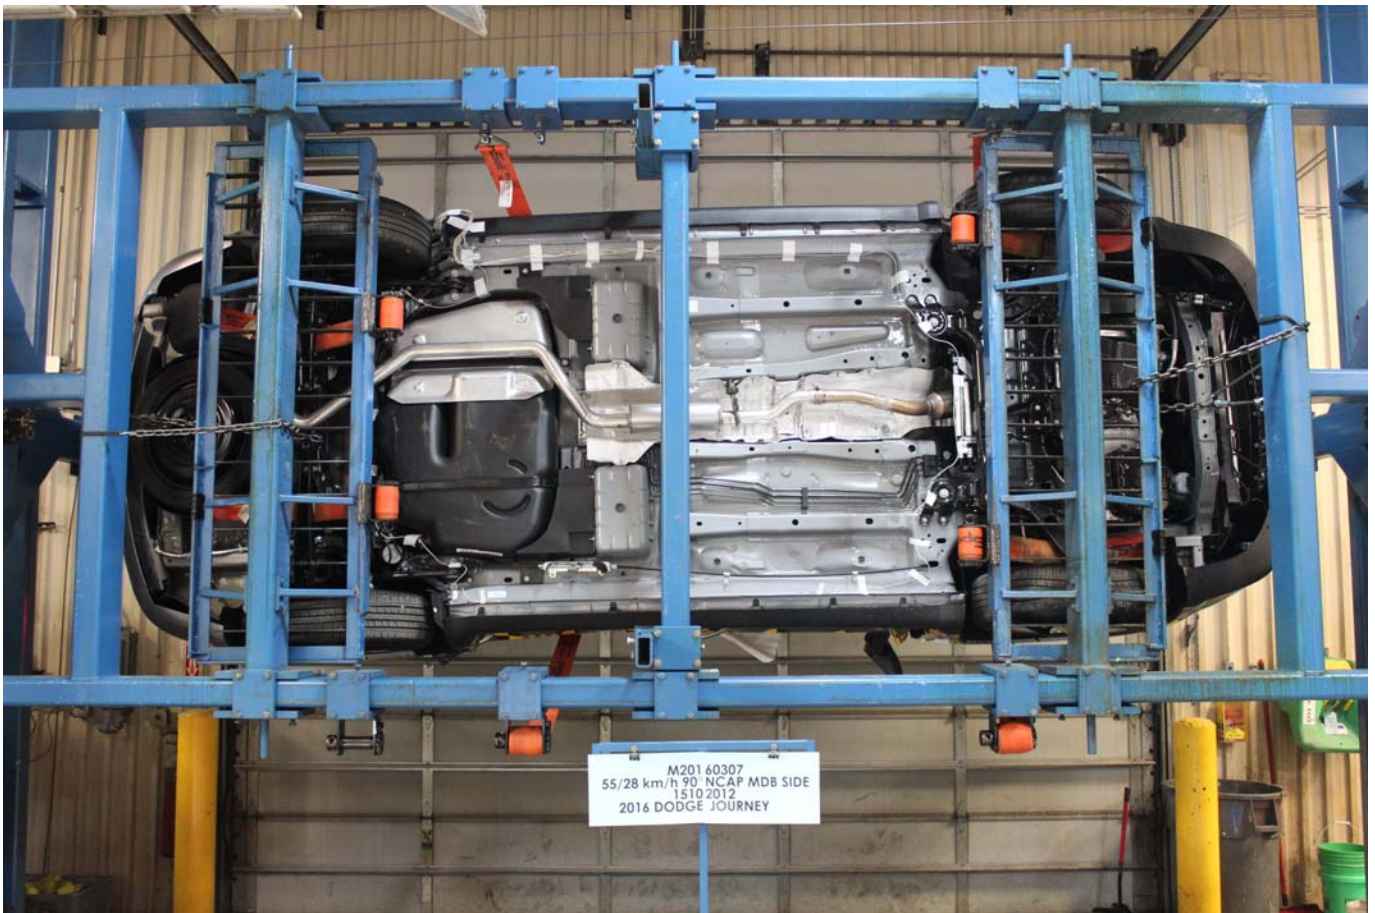
Photo No. 097 - FMVSS No. 301 Static Rollover 90 Degrees

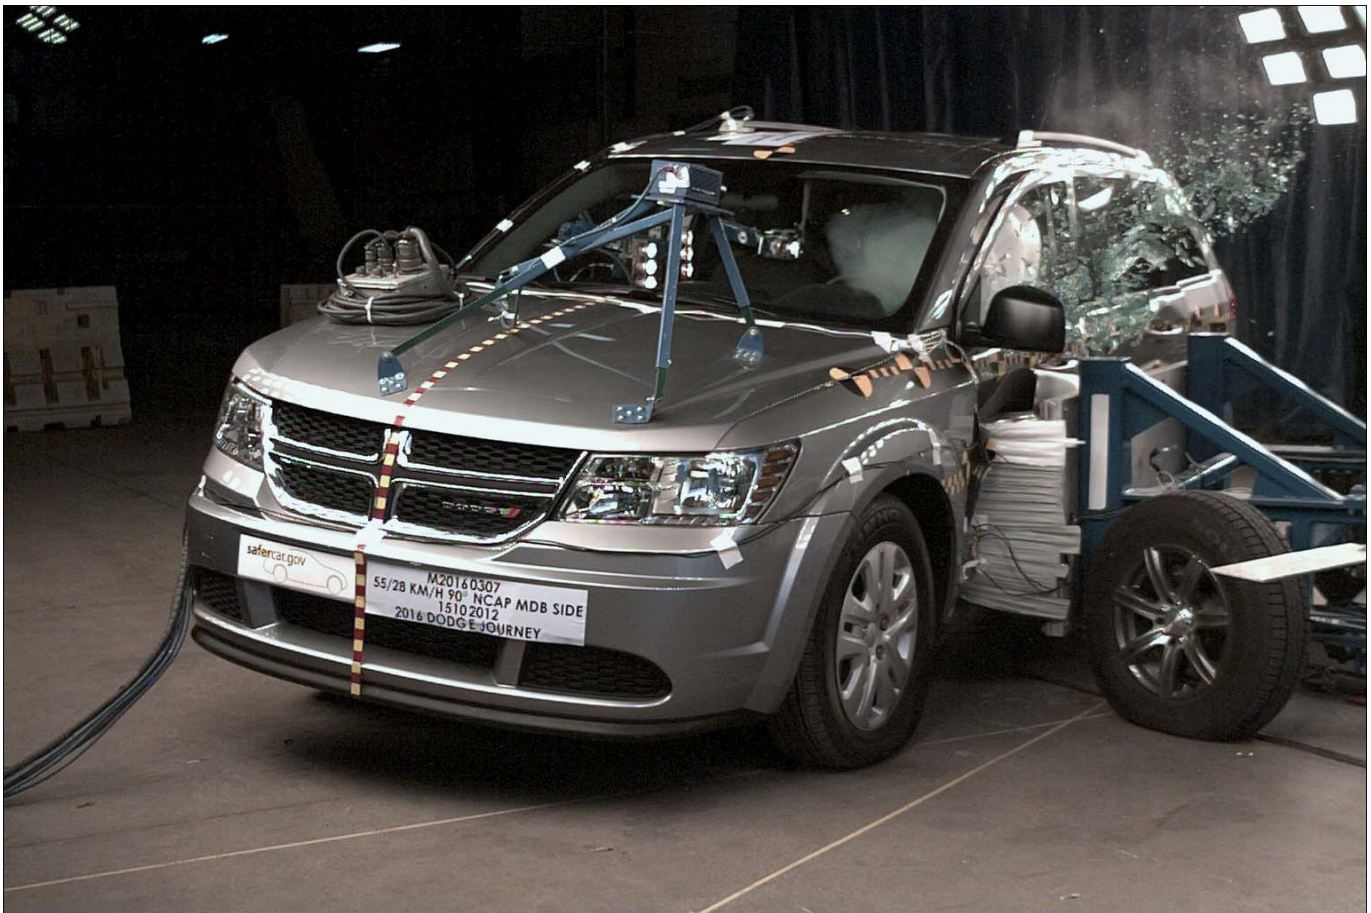
Photo No. 101 - Impact Event
