**DRAFT REPORT NUMBER: SPNCAP-TRC-16-002**

**NEW CAR ASSESSMENT PROGRAM (NCAP)  
SIDE IMPACT POLE TEST**

**Ford Motor Company  
2016 F250 SuperCab Pickup Truck  
NHTSA NUMBER: M20160203**

**PREPARED BY:  
Transportation Research Center Inc.  
10820 State Route 347  
P. O. Box B-67  
East Liberty, OH 43319**

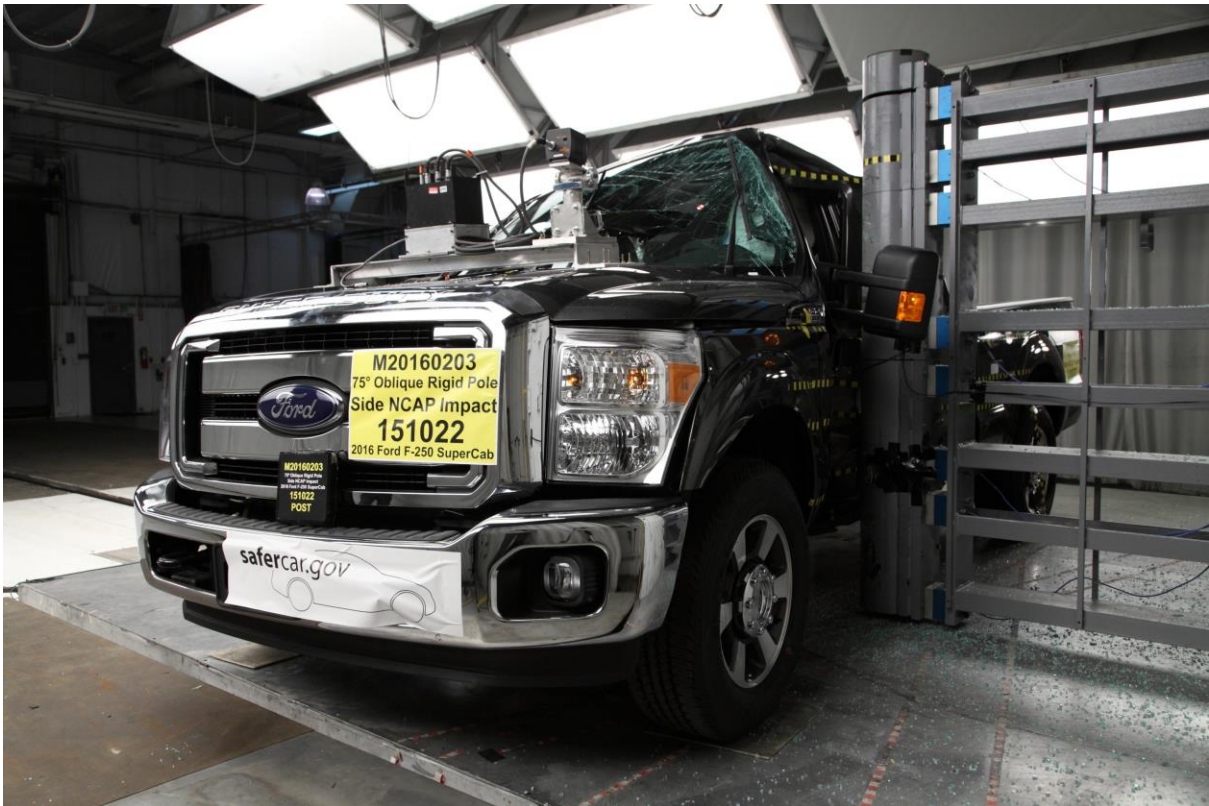
**006** Post-Test Left Front 3-4 View of Test Vehicle

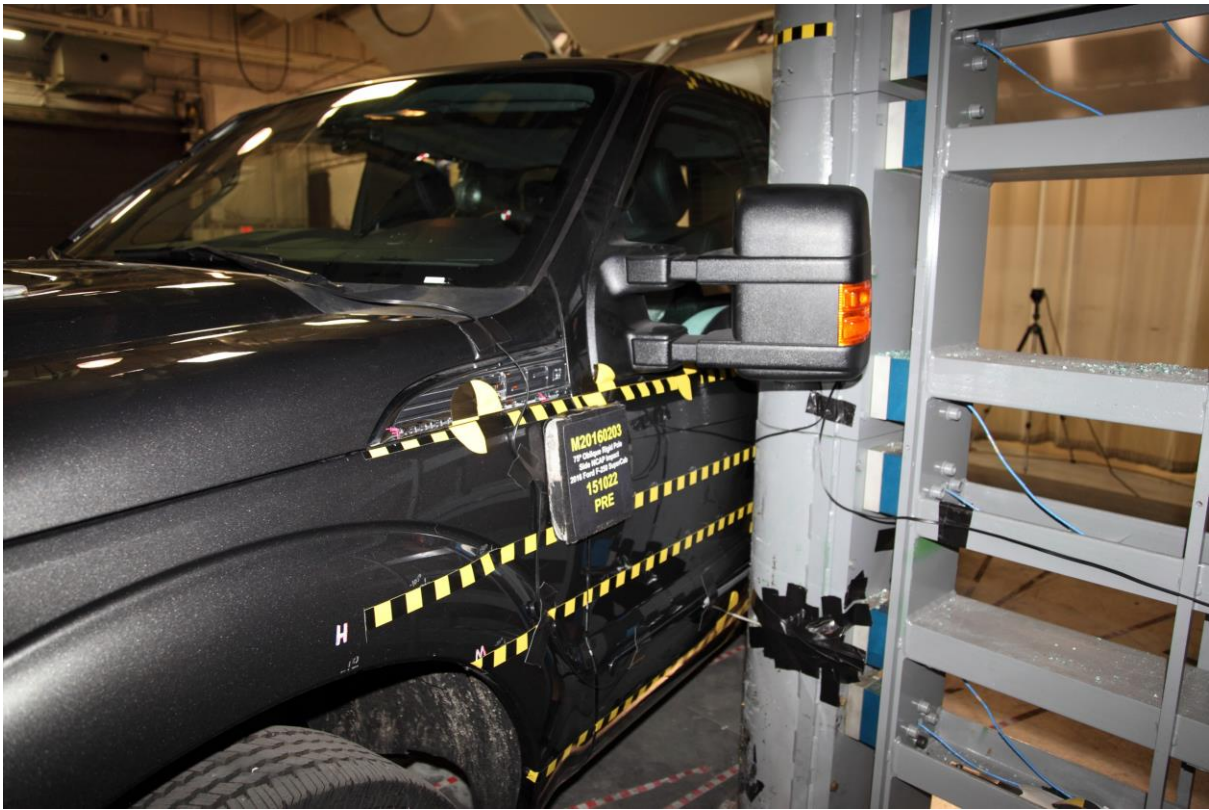
**017** Pre-Test Left Side View of Pole Positioned Against Side of Vehicle

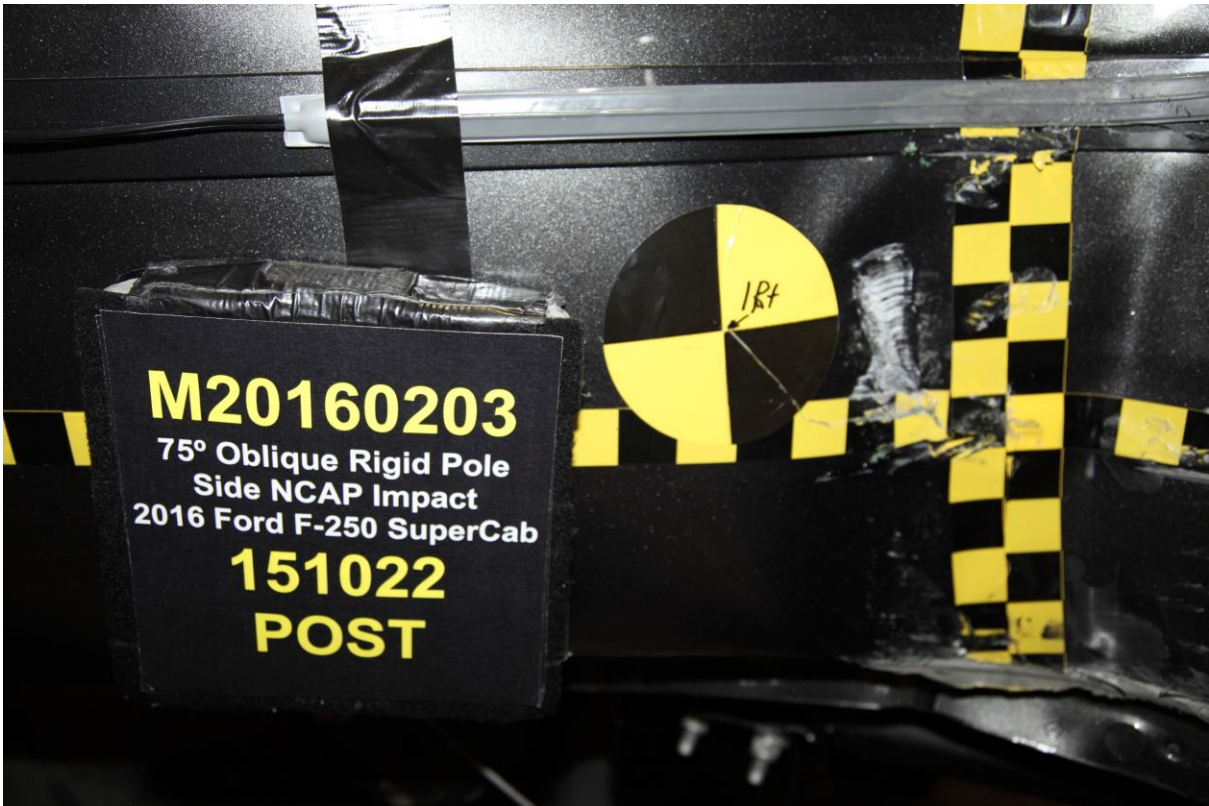
020 Post-Test Close-Up View of Impact Point Target Showing Impact Location

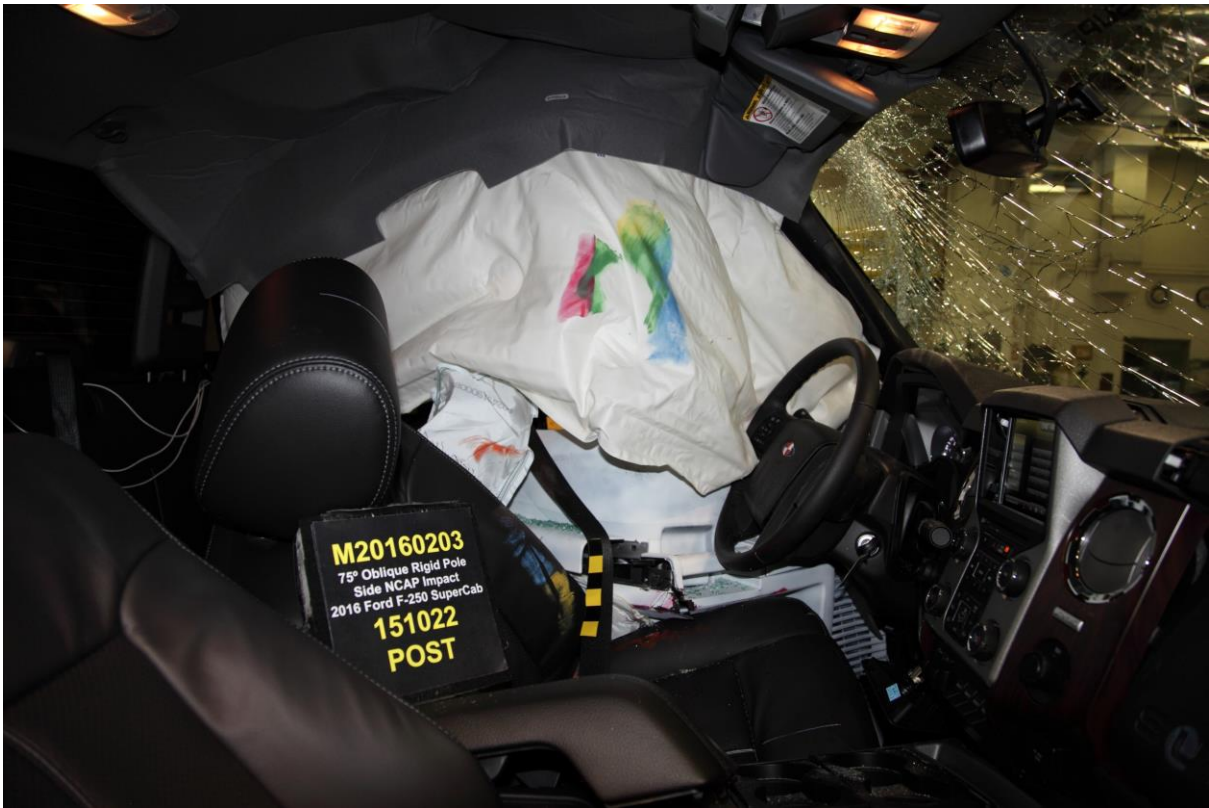
**045** Post-Test Inner Driver Door Panel View Showing Dummy Contact Location

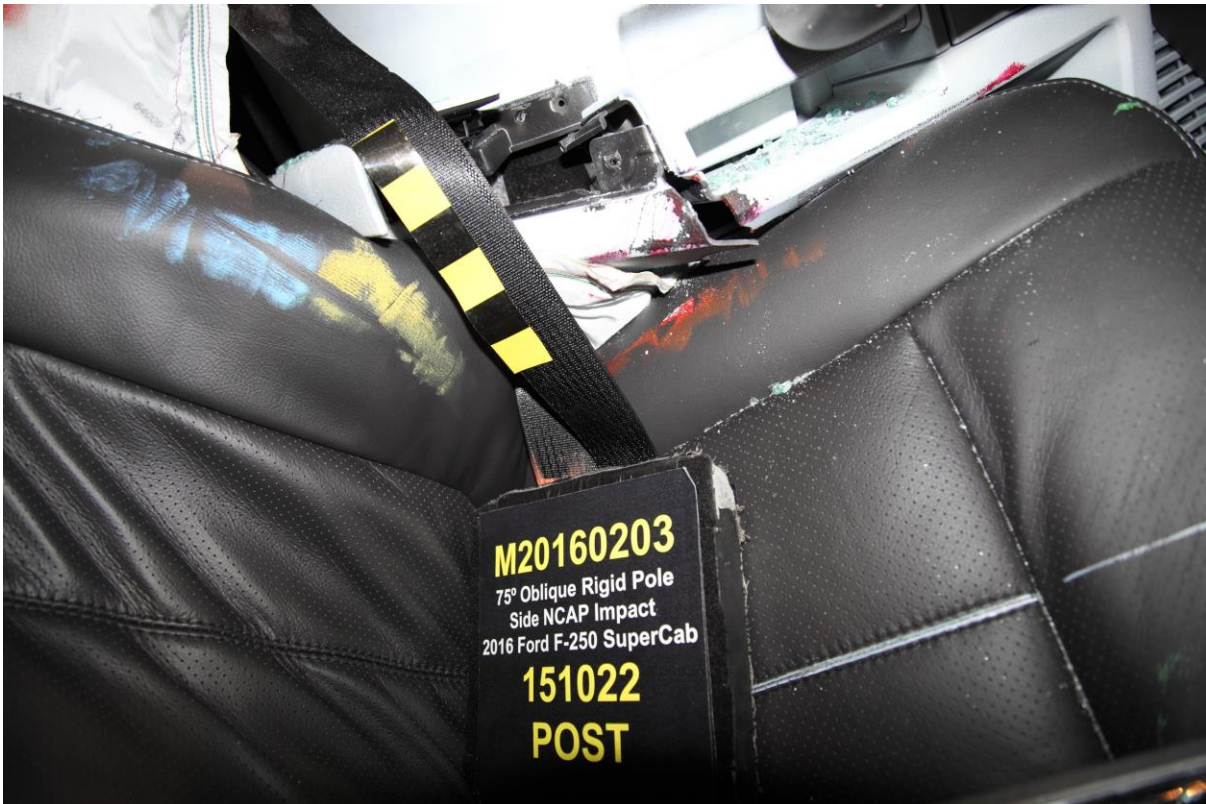
071 Post-Test View of Shattered Vehicle Inner Door Panel

Critical Areas of Performance	Observations and Conclusions
Pillar Performance	N/A no B-Pillar
Sill Separation	None Visible
Windshield Damage	Broken
Side Window Damage	Driver window shattered
Other Notable Effects	None
