REPORT NUMBER: SINCAP-CAL-16-001

**NEW CAR ASSESSMENT PROGRAM (NCAP)
MOVING DEFORMABLE BARRIER SIDE IMPACT TEST**

**Ford Motor Co.
2016 Ford Fiesta
Four Door Sedan**

NHTSA No: M20160205

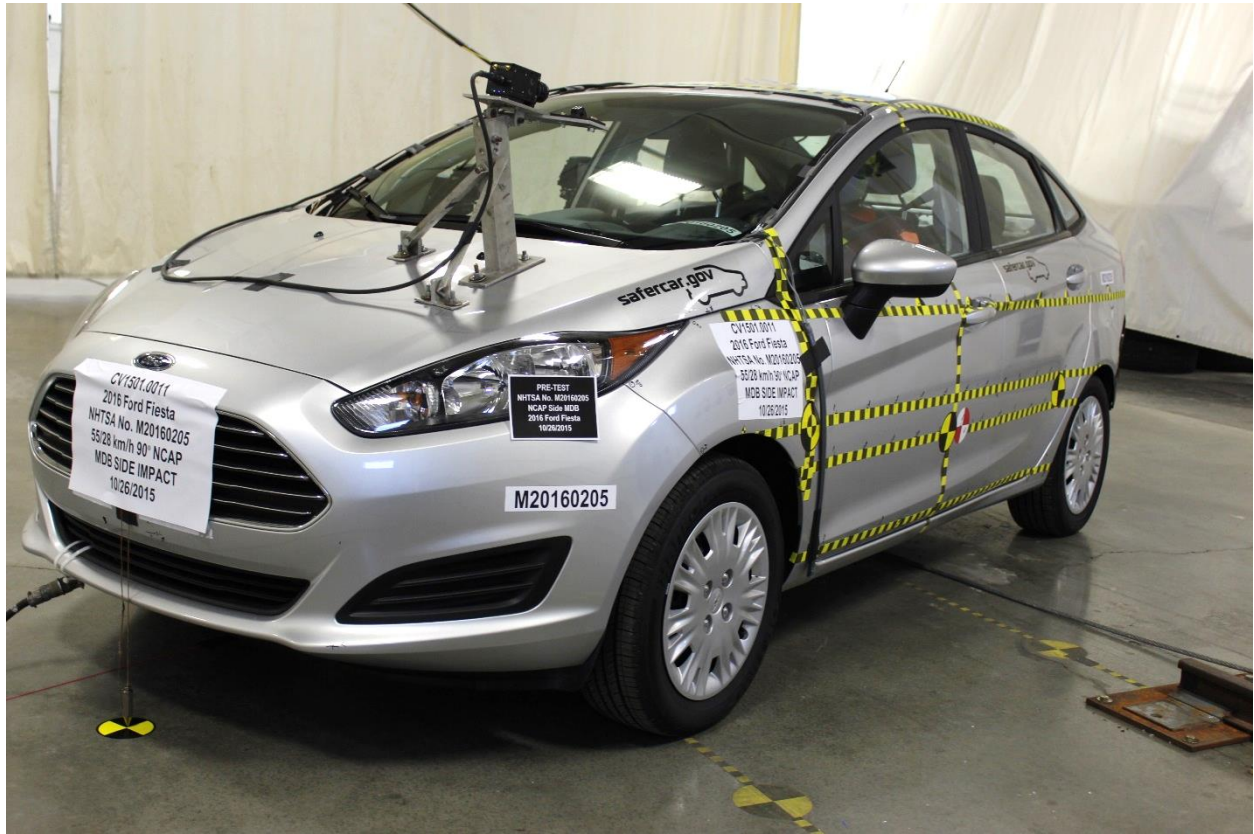
Figure A-5: Pre-Test Left Front 3/4 View of Test Vehicle

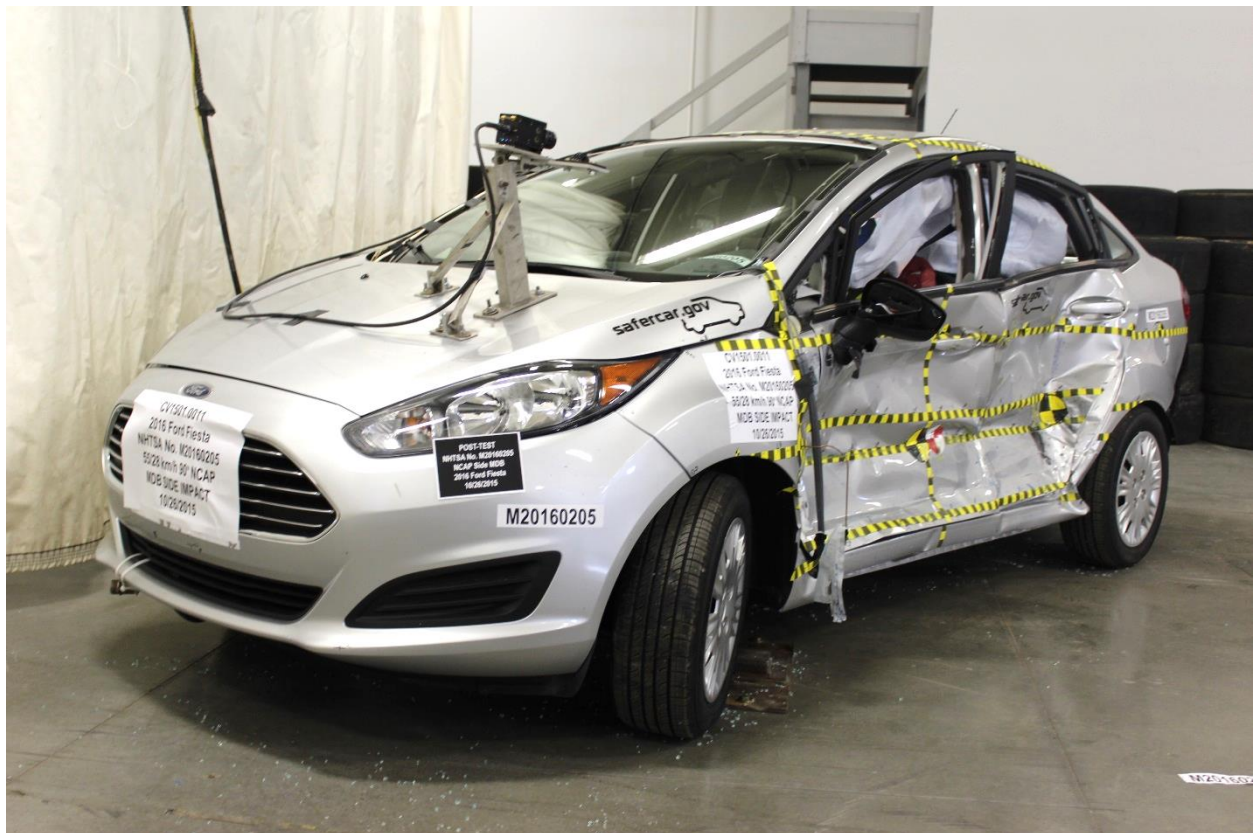
Figure A-6: Post-Test Left Front 3/4 View of Test Vehicle

Critical Areas of Performance	Observations and Conclusions
Pillar Performance	Remained in good condition
Sill Separation	None
Windshield Damage	None
Side Window Damage	Driver and Rear Passenger Windows Shattered on Impact
Other Notable Effects	None

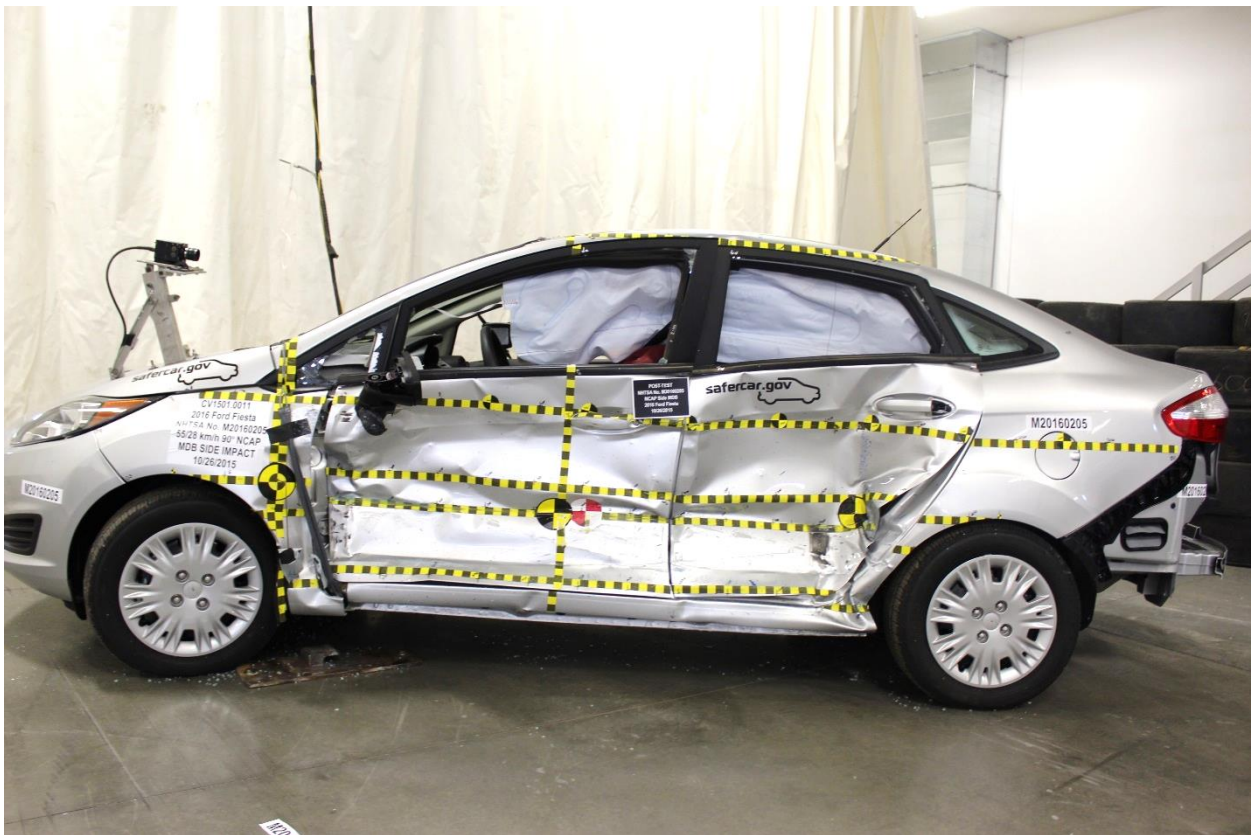
Figure A-8: Post-Test Left Side View of Test Vehicle

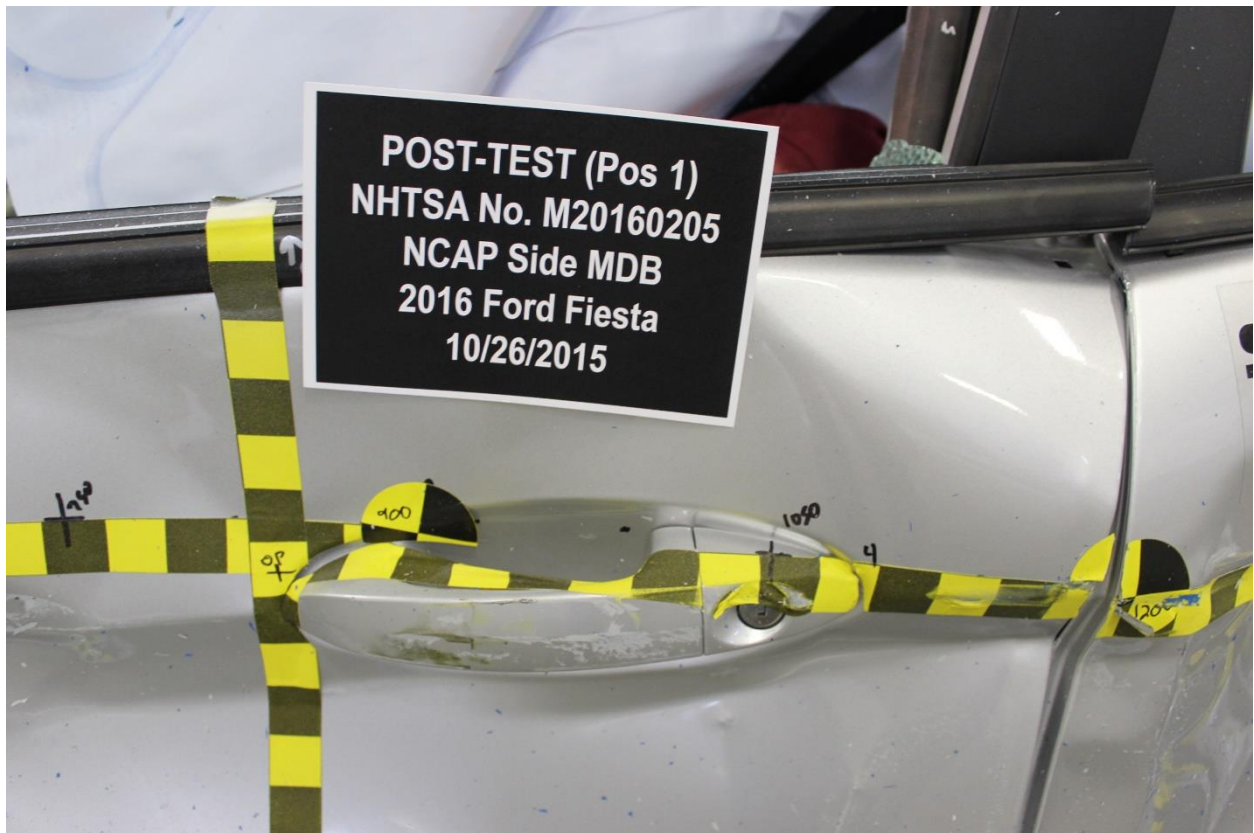
Figure A-22: Post-Test Left Front Door Latch Close-Up

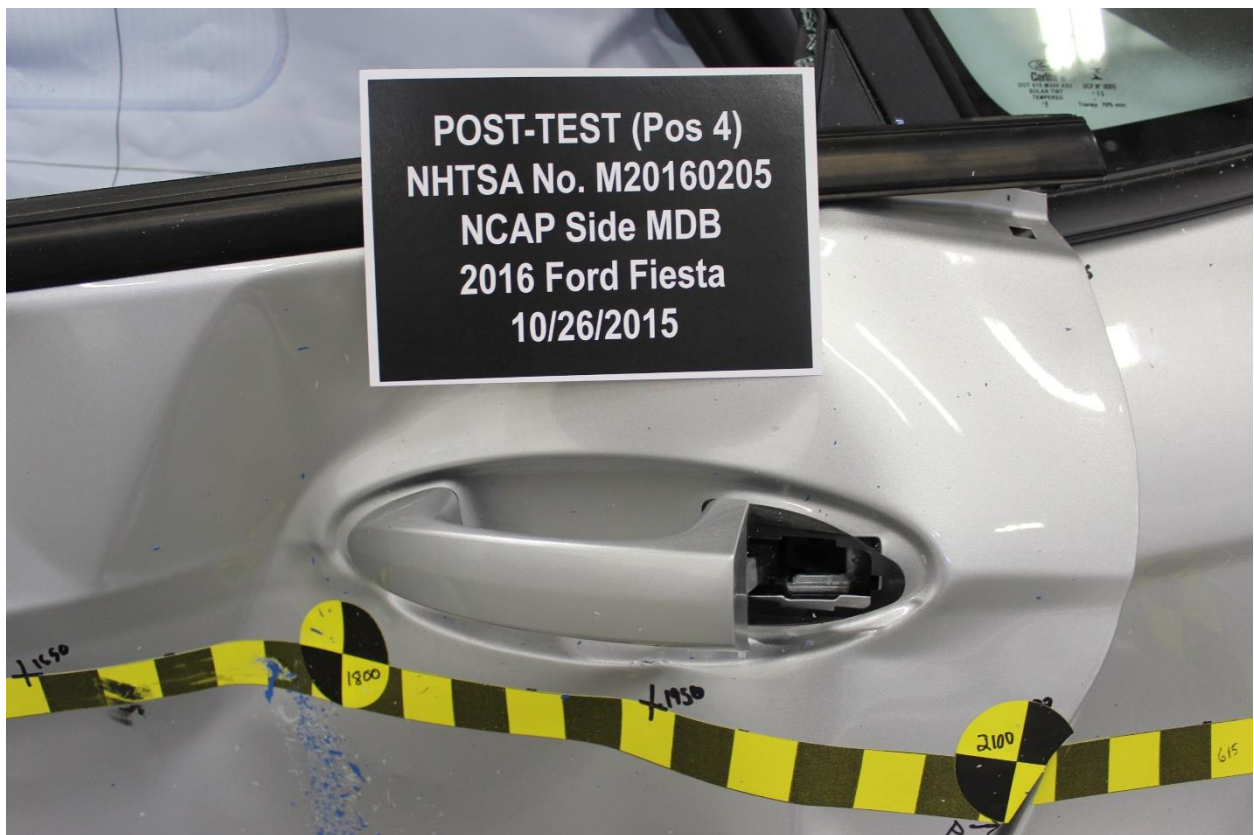
Figure A-24: Post-Test Left Rear Door Latch Close-Up

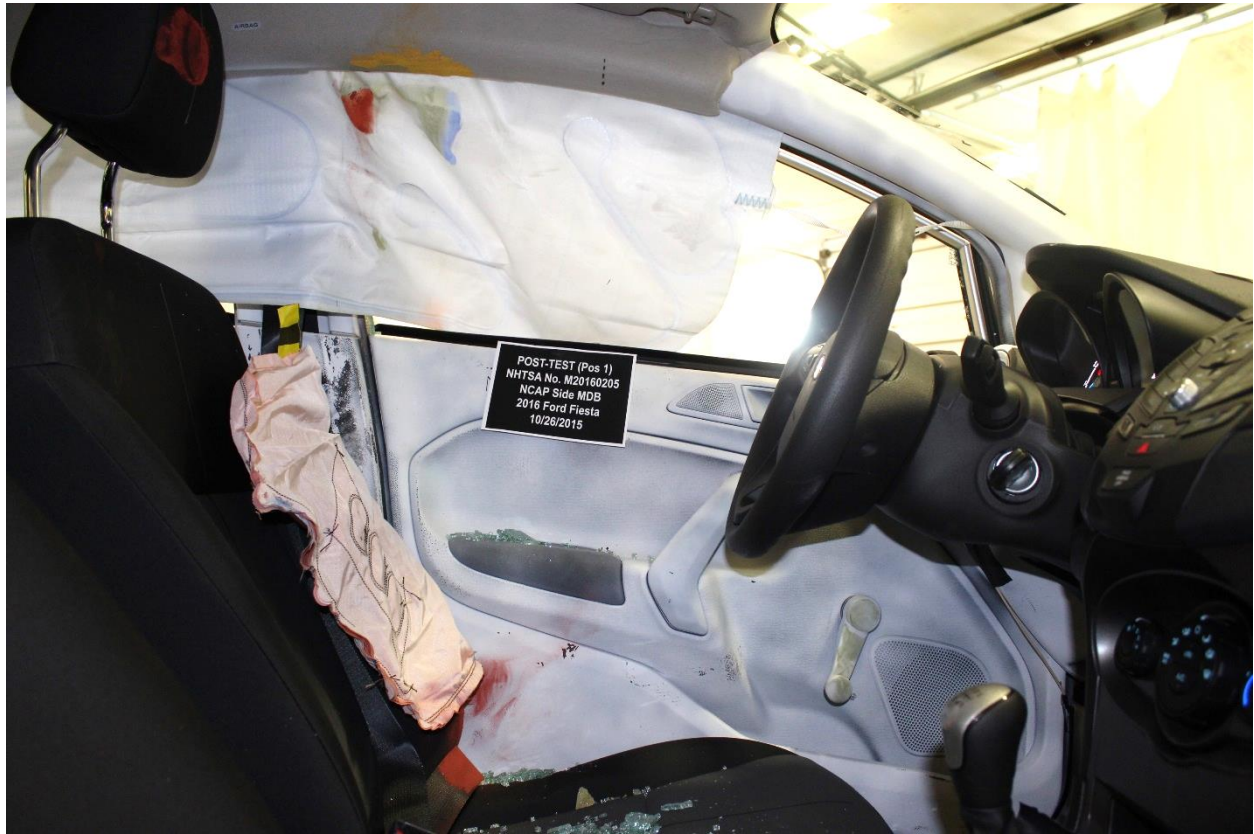
Figure A-47: Post-Test Driver Inner Door Panel View

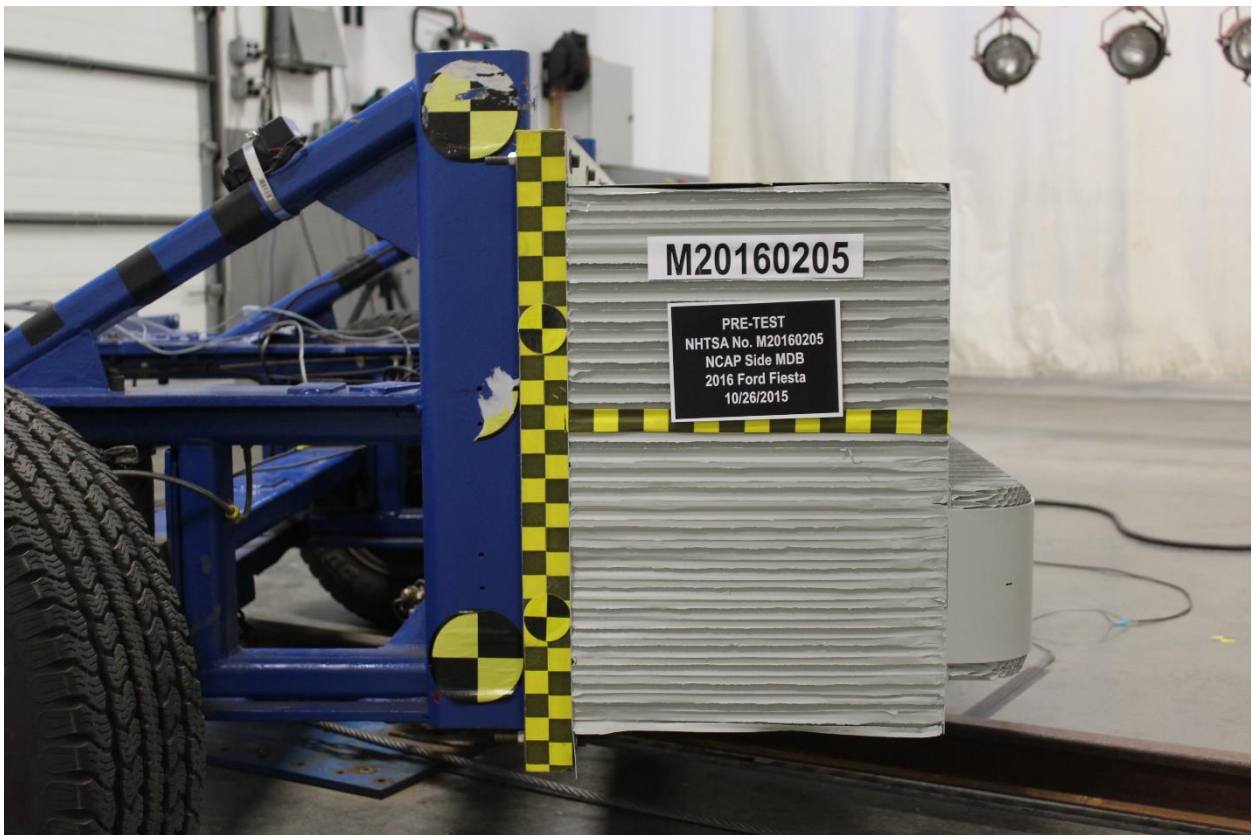
Figure A-90: Pre-Test Right Side View of MDB Impactor Face
