**REPORT NUMBER: R&D-CAL-15-002**

**MOVING BARRIER TO VEHICLE CRASH TEST IN SUPPORT OF NHTSA'S  
FRONTAL OBLIQUE OFFSET PROGRAM  
OBLIQUE MOVING DEFORMABLE BARRIER INTO RIGHT FRONT OF A**

**2015 Ford F-150**

**90.1KPH, 15 DEGREE ANGLE, 35% OVERLAP**

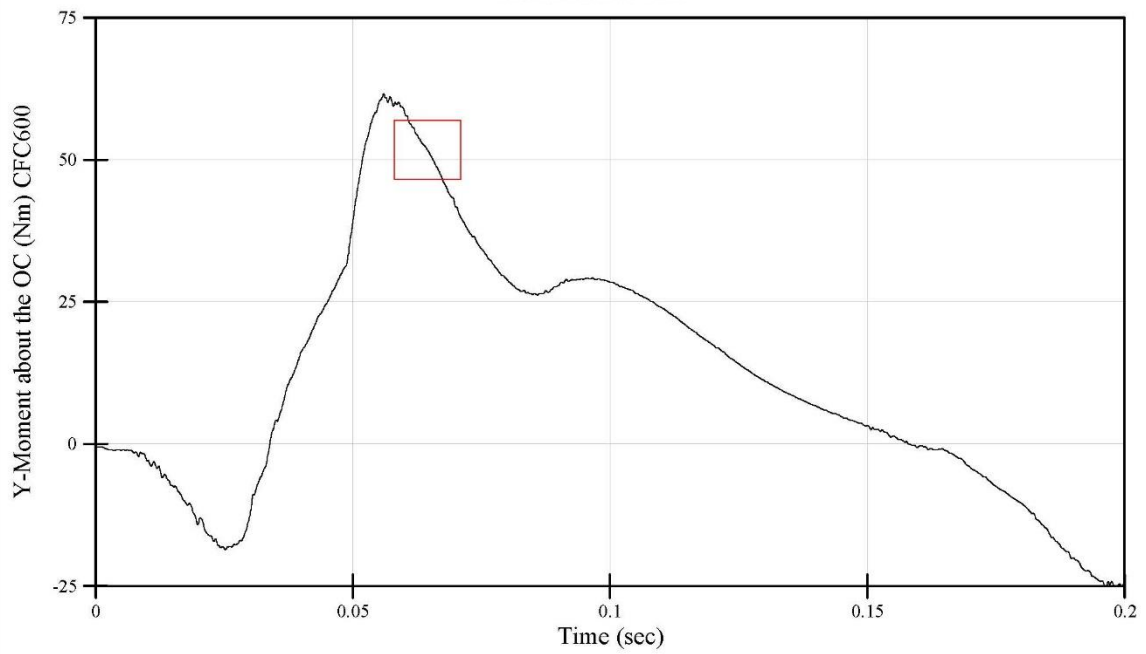
THOR Neck Flexion Certification  
Y-Moment  
Serial Number: T015

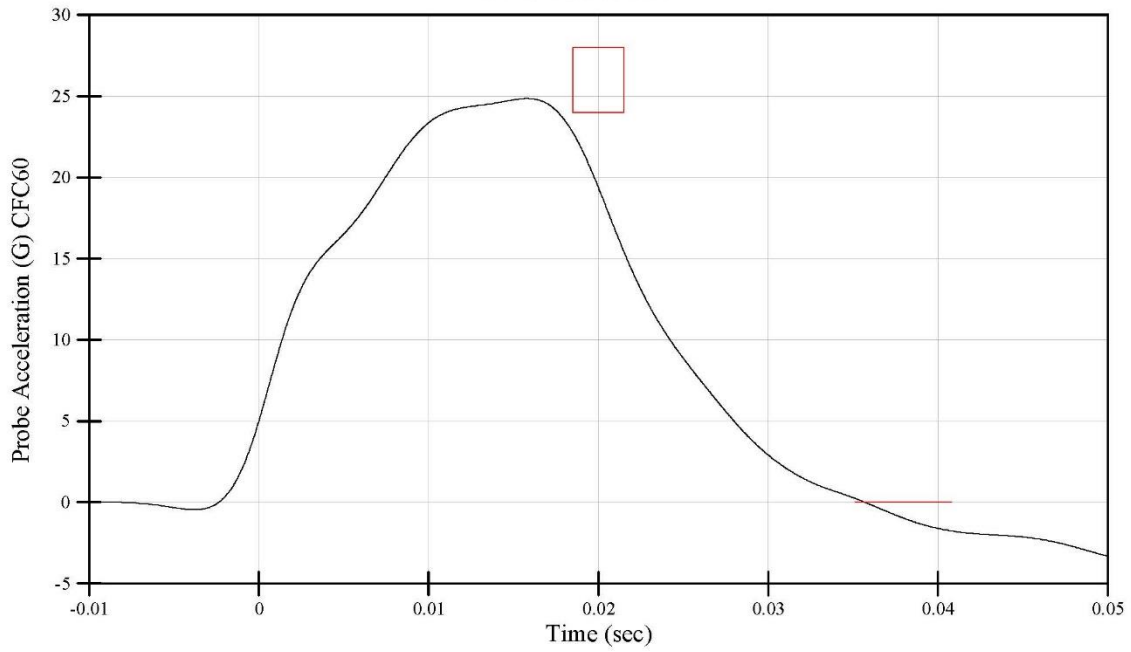
THOR Neck Flexion Certification  
Probe Acceleration  
Serial Number: T015

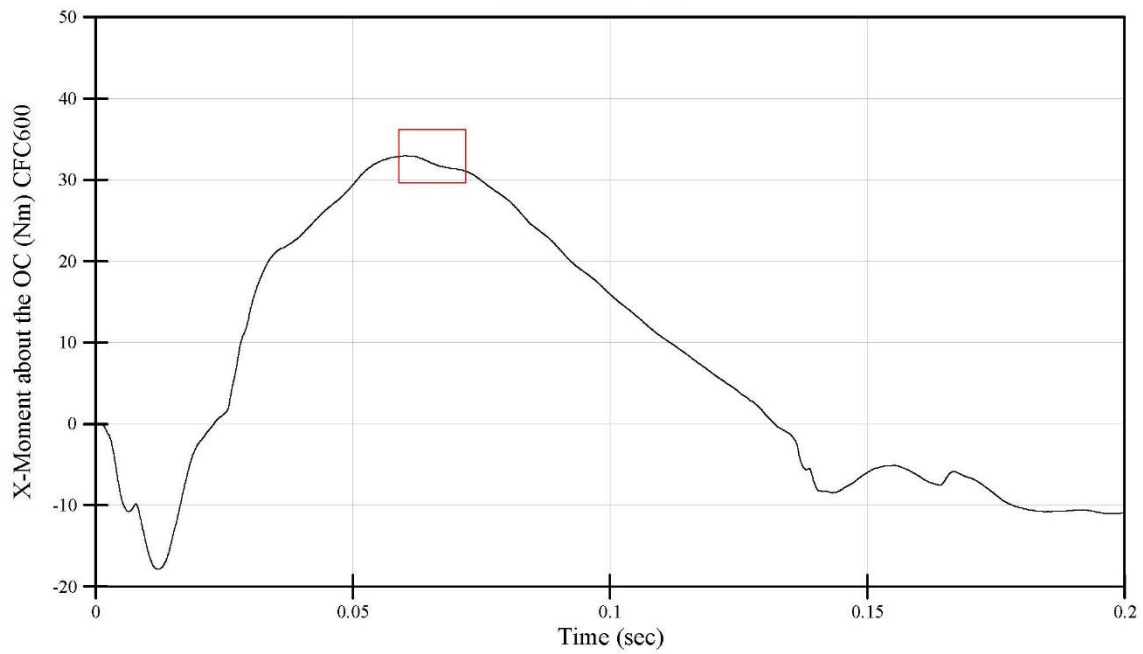
THOR Neck Left Lateral Flexion Certification  
X-Moment  
Serial Number: T015

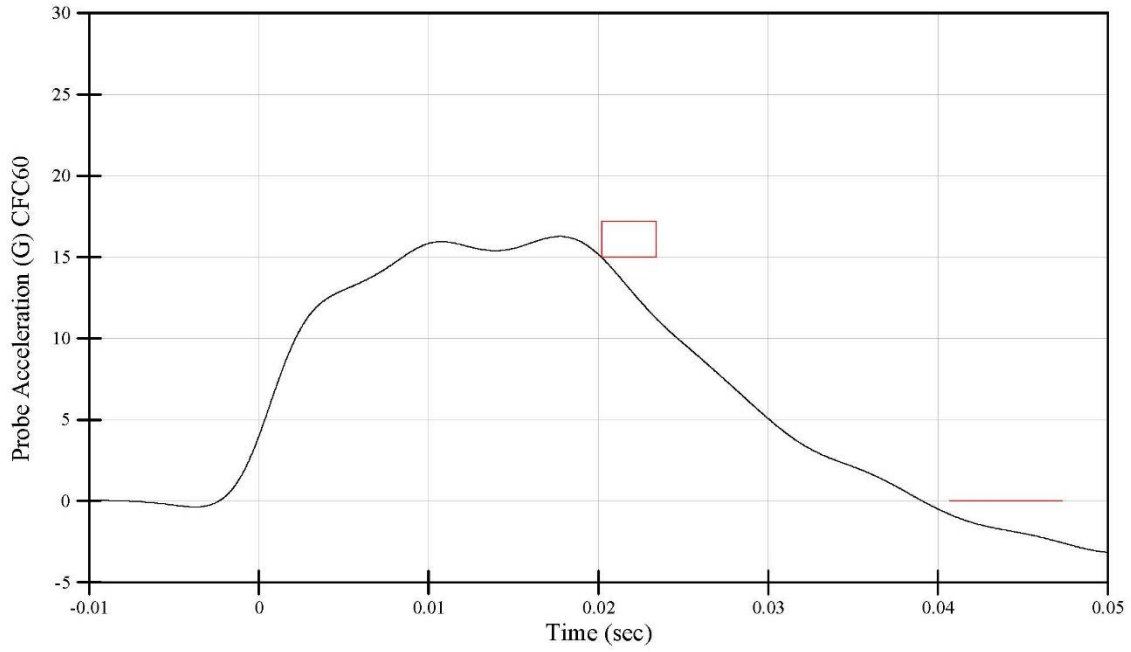
THOR Neck Left Lateral Flexion Certification  
Probe Acceleration  
Serial Number: T015

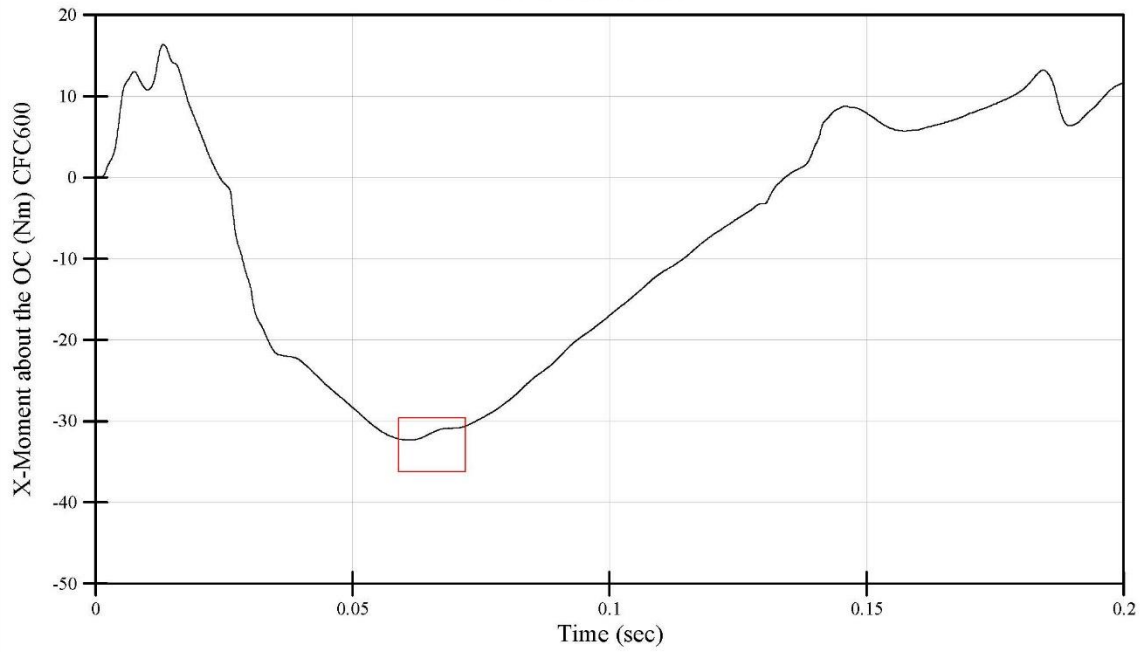
THOR Neck Right Lateral Flexion Certification  
X-Moment  
Serial Number: T015

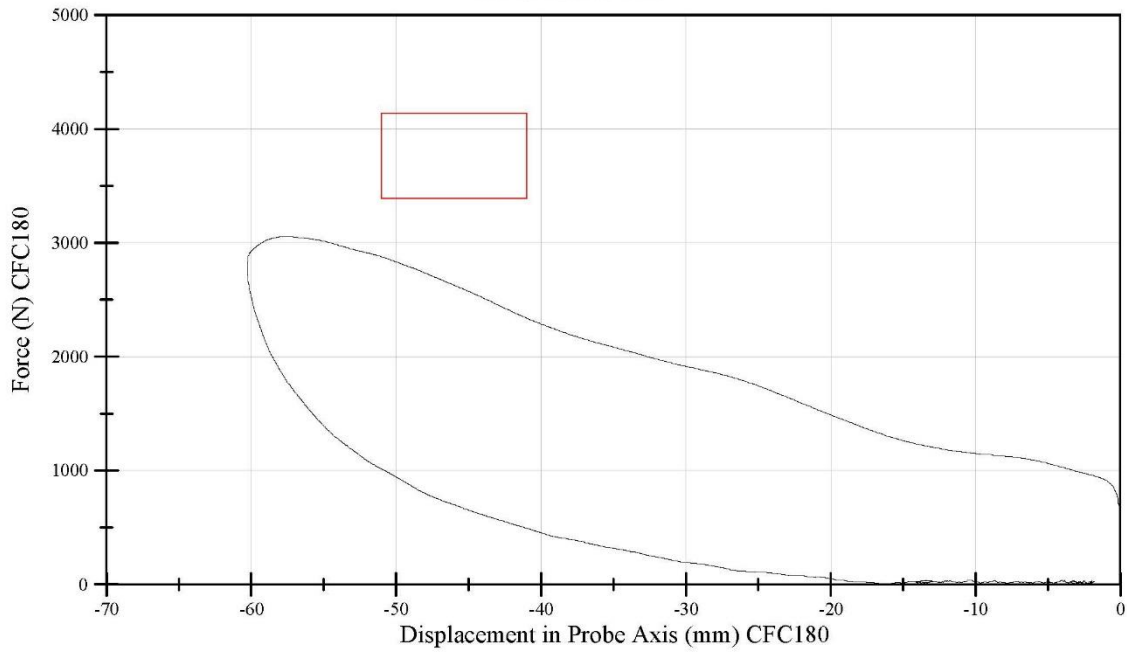
THOR Lower Left Oblique Thorax Certification  
Thorax Displacement vs. Probe Force  
Serial Number: T015

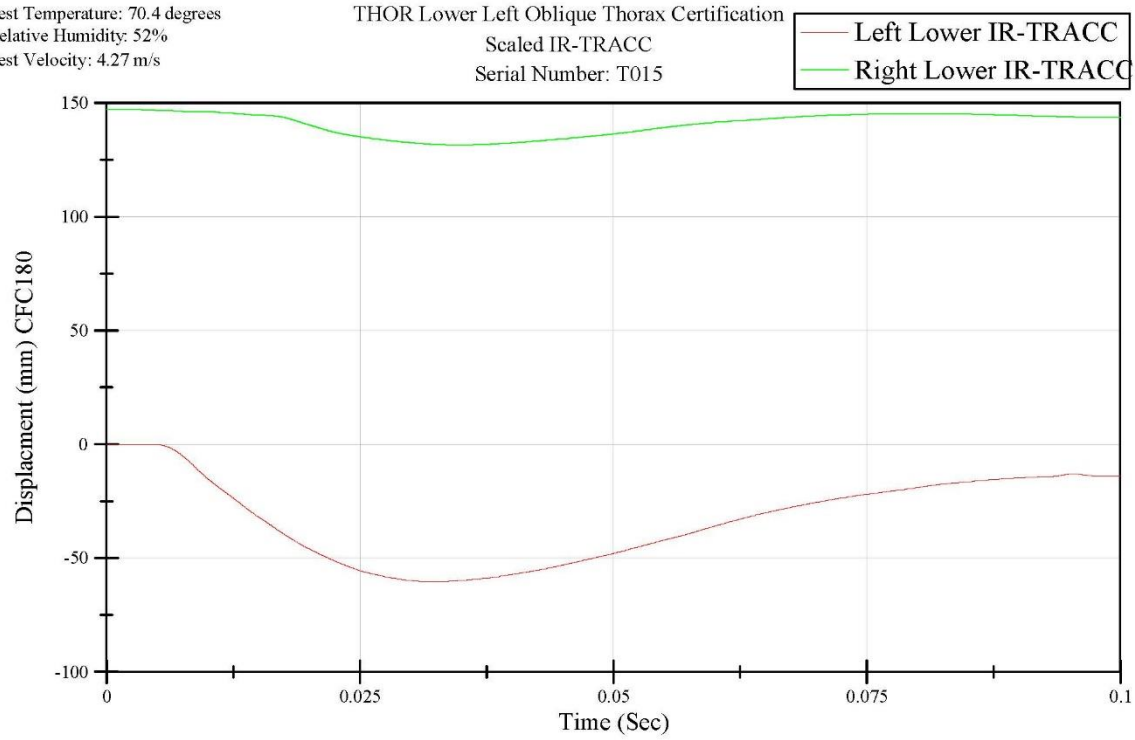
THOR Lower Left Oblique Thorax Certification  
Scaled IR-TRACC  
Serial Number: T015

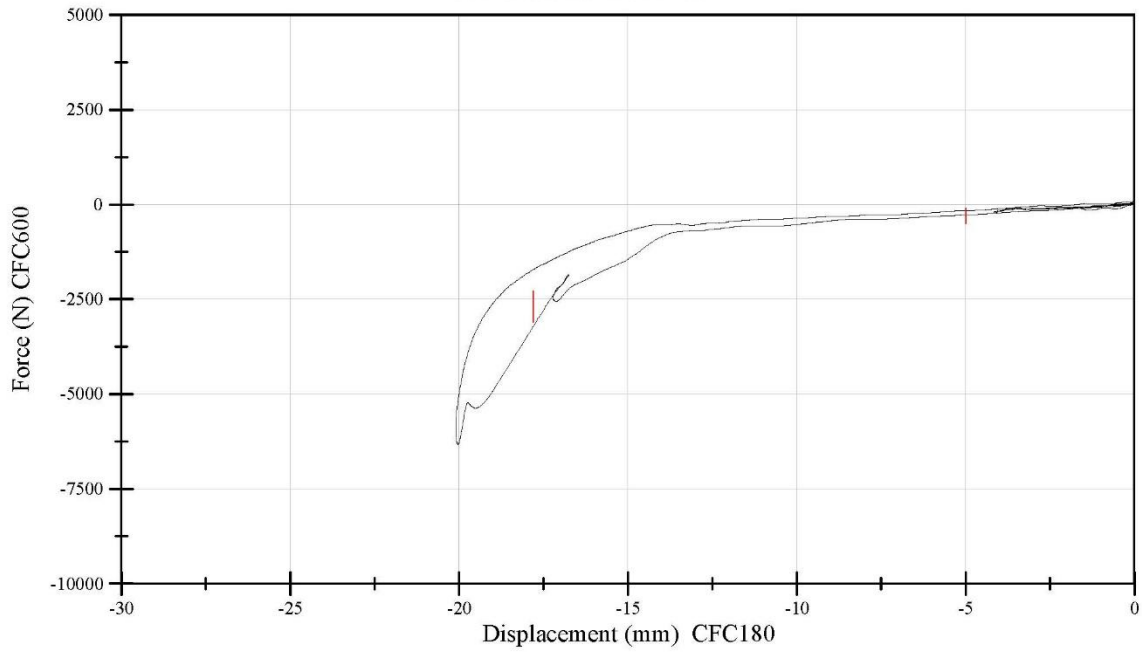
THOR Right Knee Certification  
Femur Force vs. Knee Displacement  
Serial Number: D2103657B

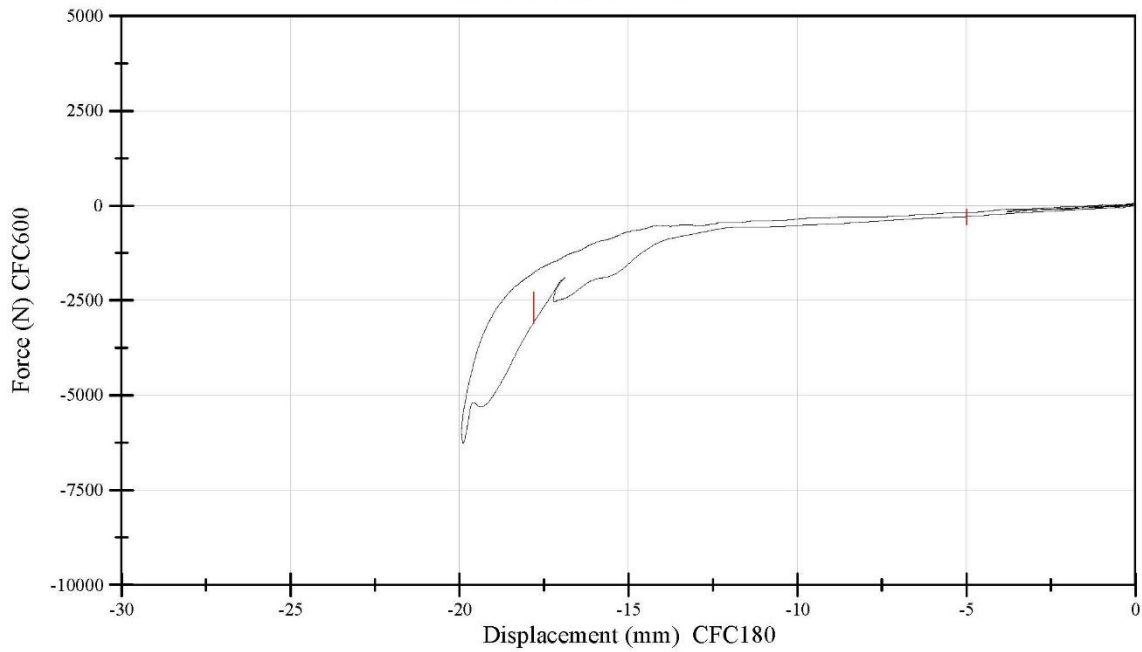
THOR Left Knee Certification  
Femur Force vs. Knee Displacement  
Serial Number: D2103665B

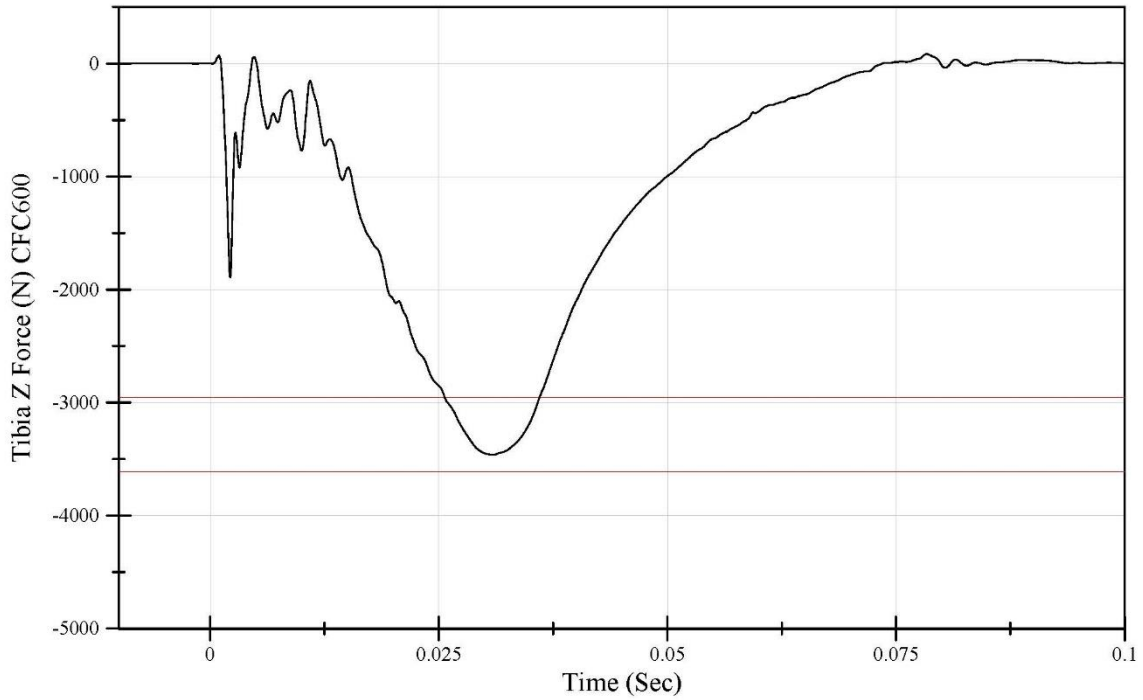
THOR Right Foot Dorsiflexion Certification  
Tibia Load  
Serial Number: LX0038

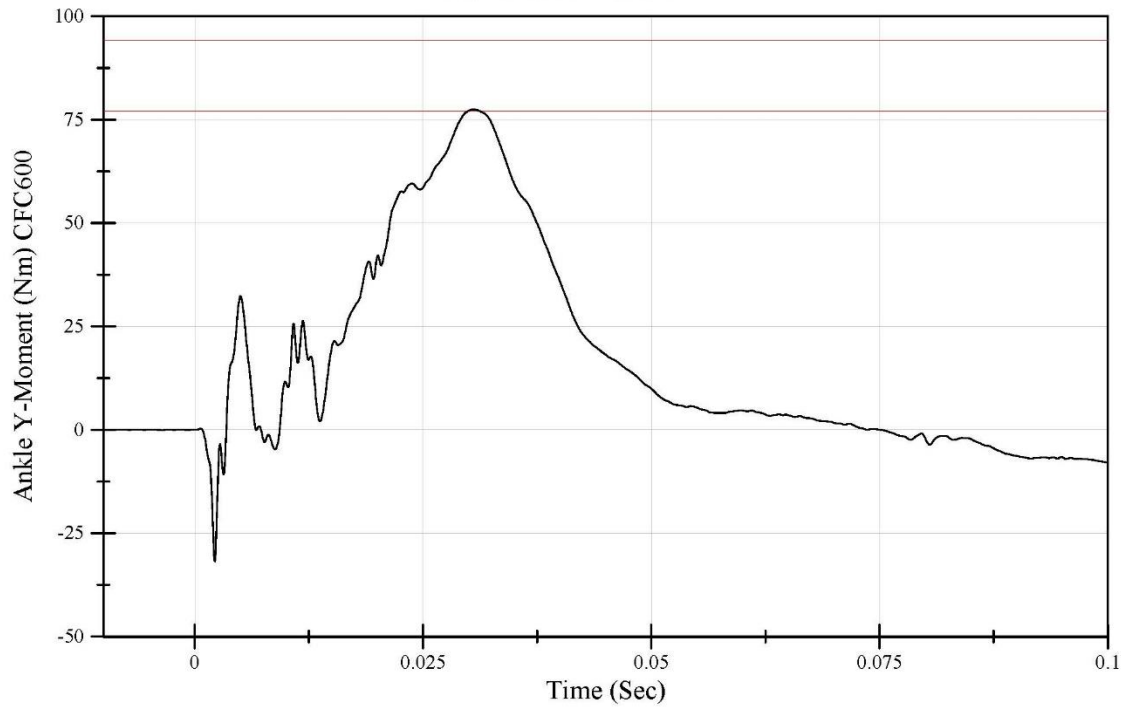
THOR Right Foot Dorsiflexion Certification  
Ankle Y-Moment  
Serial Number: LX0038

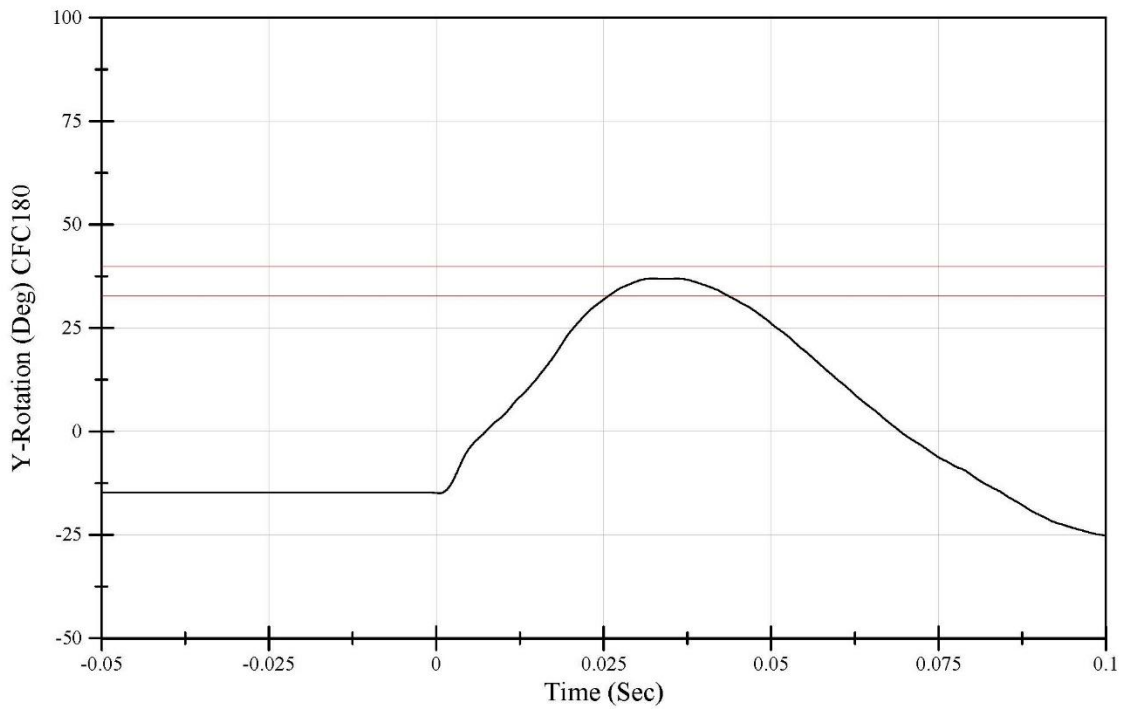
THOR Right Foot Dorsiflexion Certification  
Ankle Y-Rotation  
Serial Number: LX0038

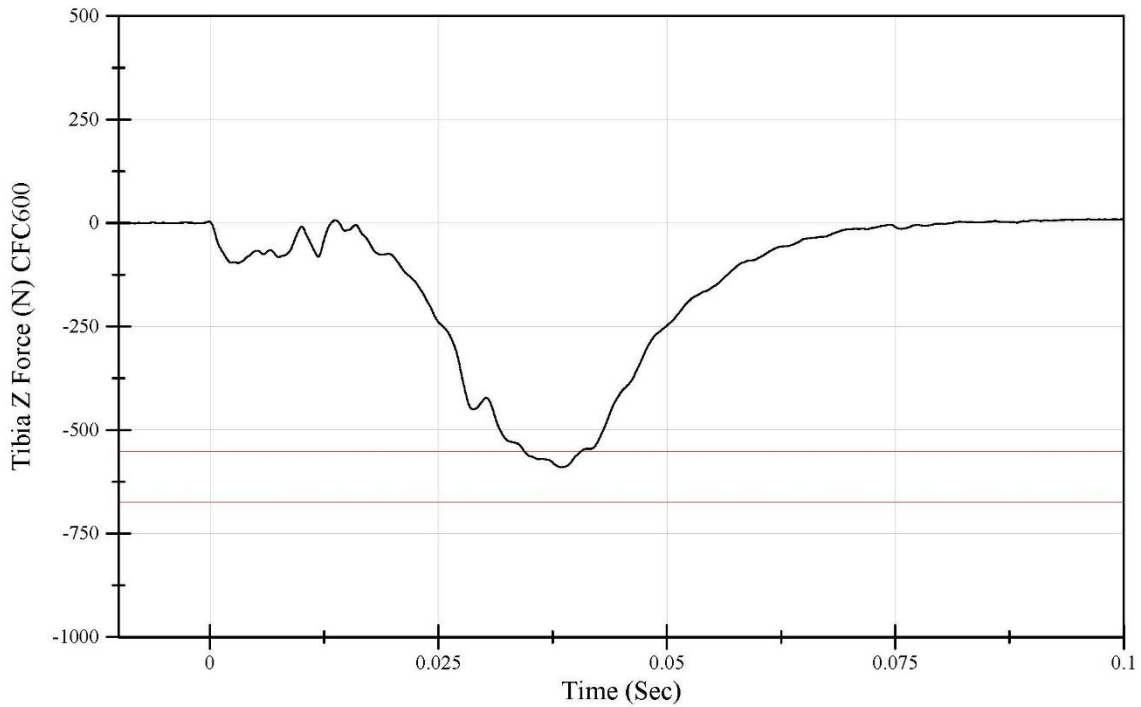
THOR Right Foot Eversion Certification  
Tibia Load  
Serial Number: LX0038

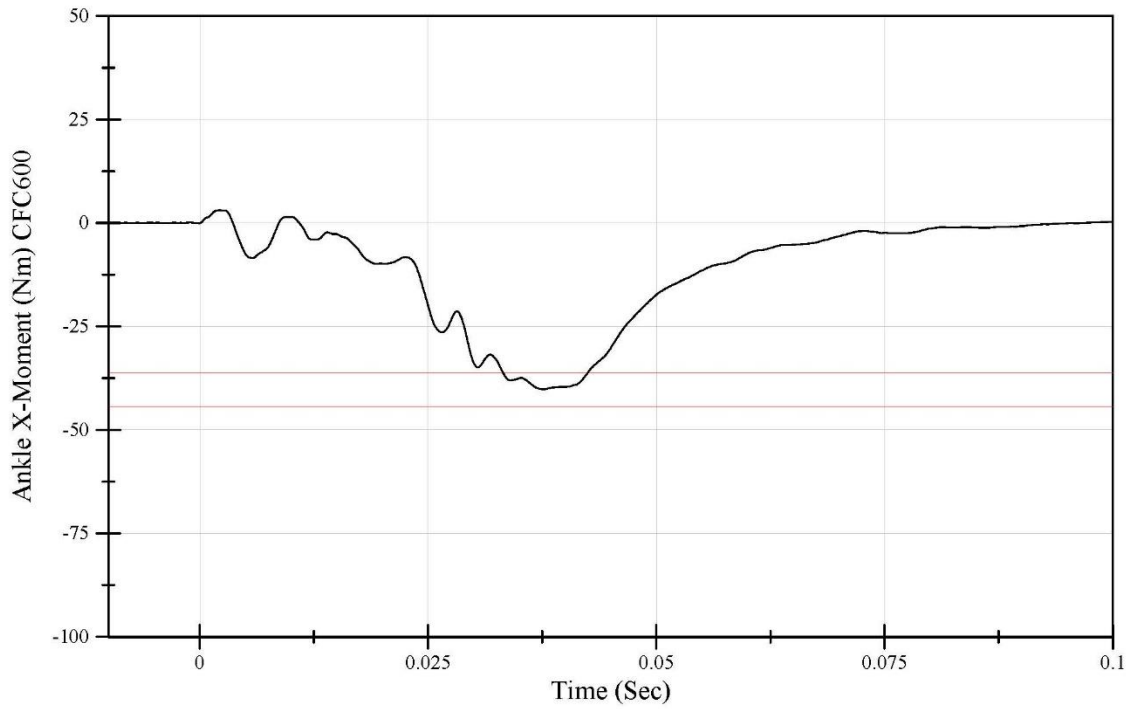
THOR Right Foot Eversion Certification  
Ankle Moment  
Serial Number: LX0038

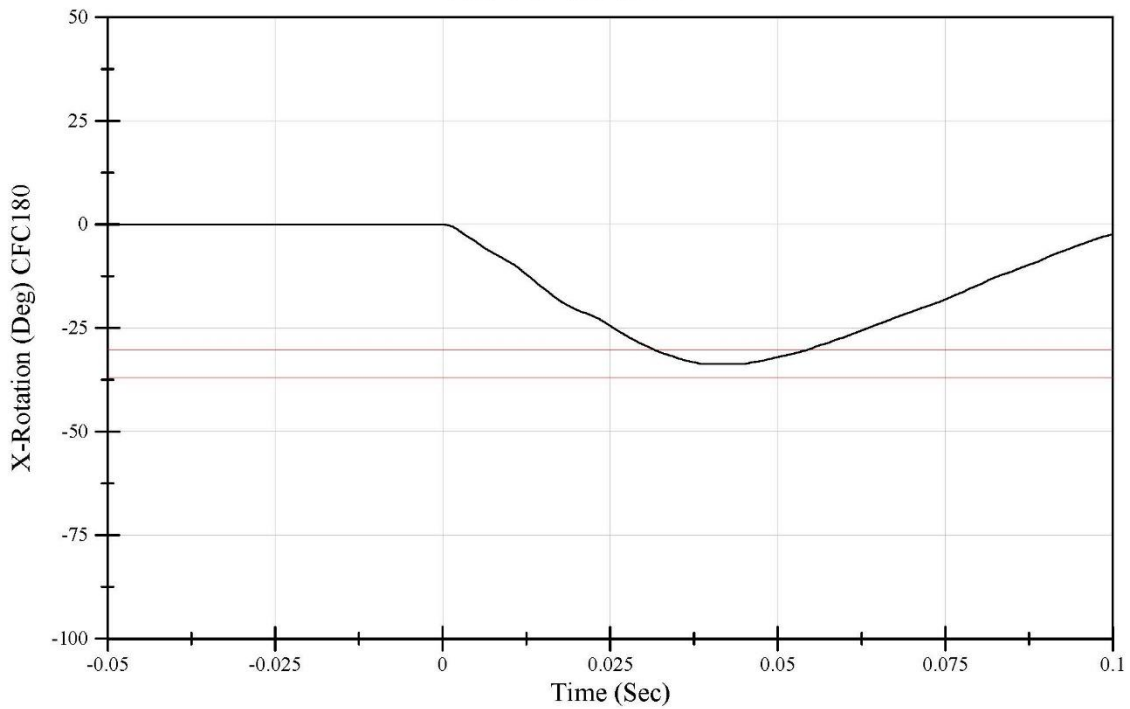
THOR Right Foot Eversion Certification  
Ankle X-Rotation  
Serial Number: LX0038

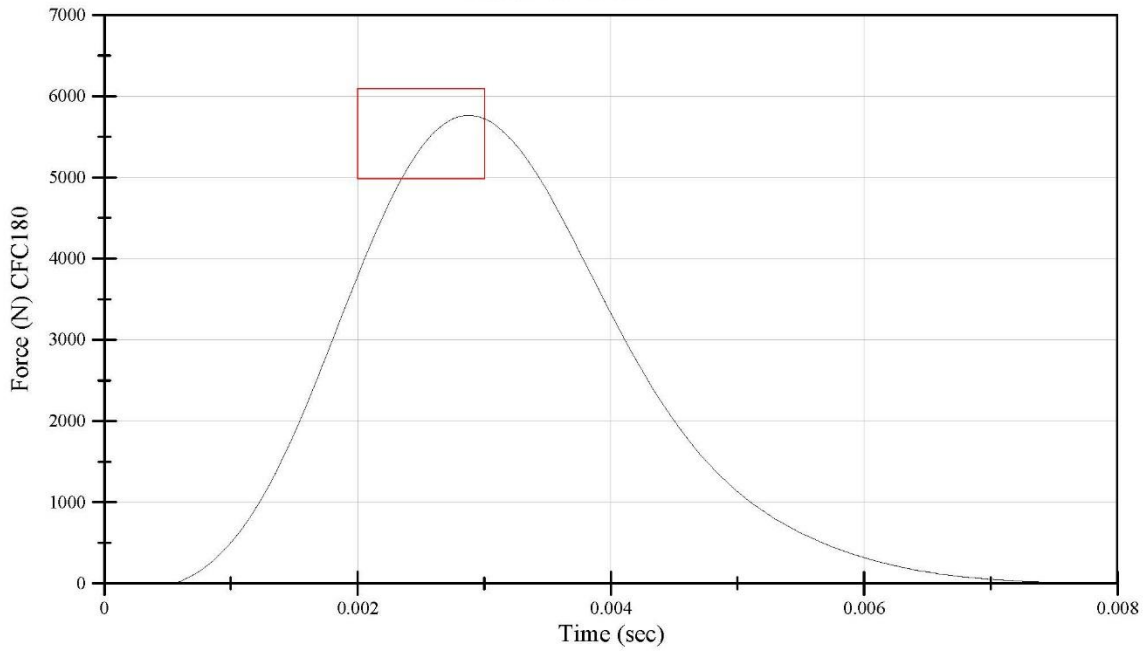
THOR Head Impact Certification  
Probe Force  
Serial Number: T0016

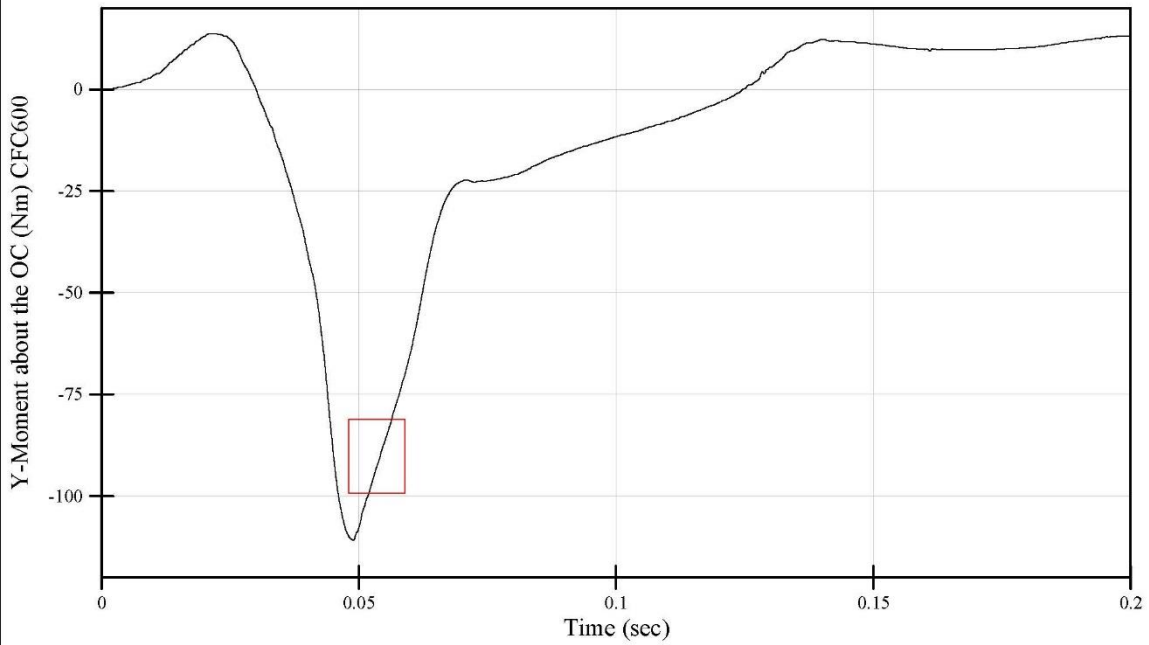
THOR Neck Extension Certification  
Y-Moment  
Serial Number: T0016

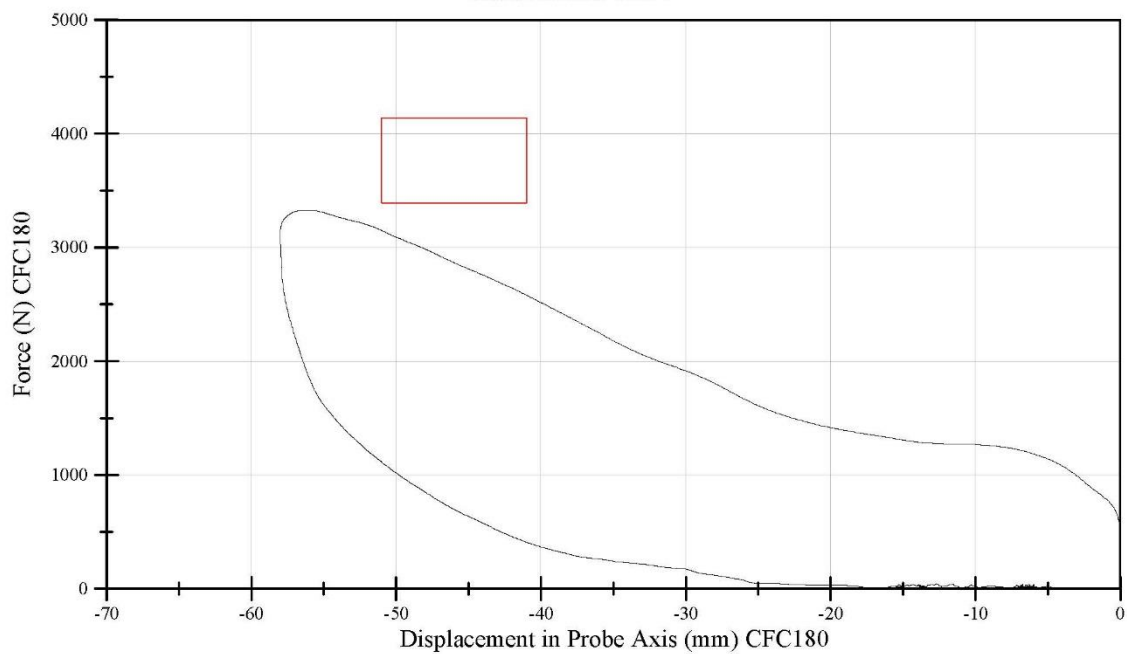
THOR Lower Left Oblique Thorax Certification  
Thorax Displacement vs. Probe Force  
Serial Number: T0016

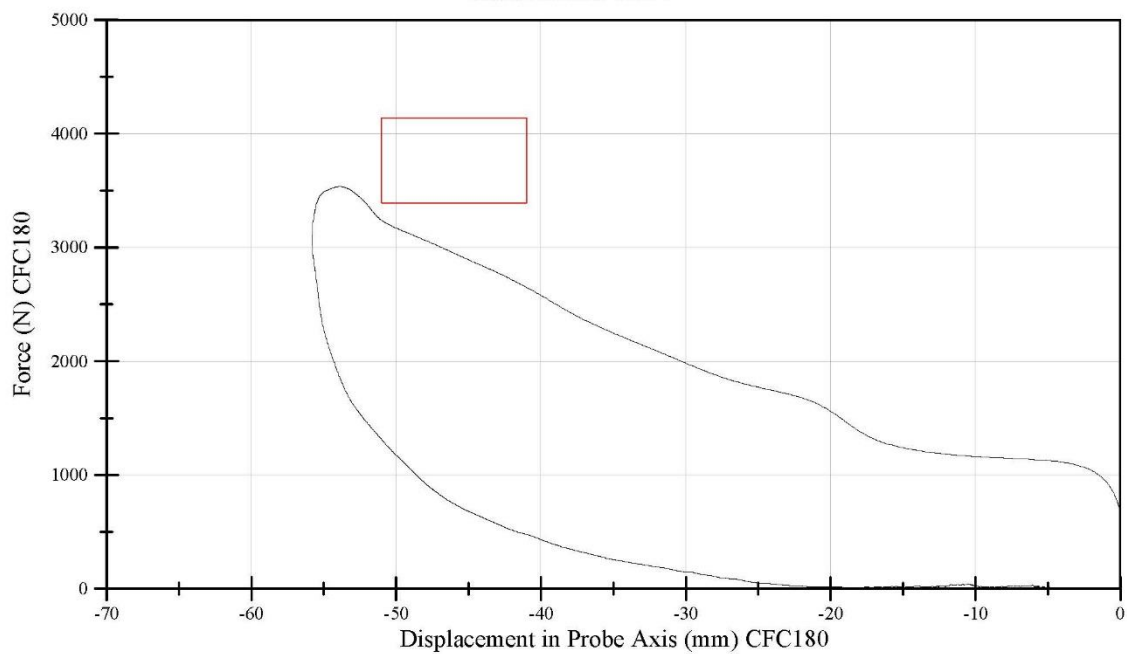
THOR Lower Left Oblique Thorax Certification  
Thorax Displacement vs. Probe Force  
Serial Number: T0116

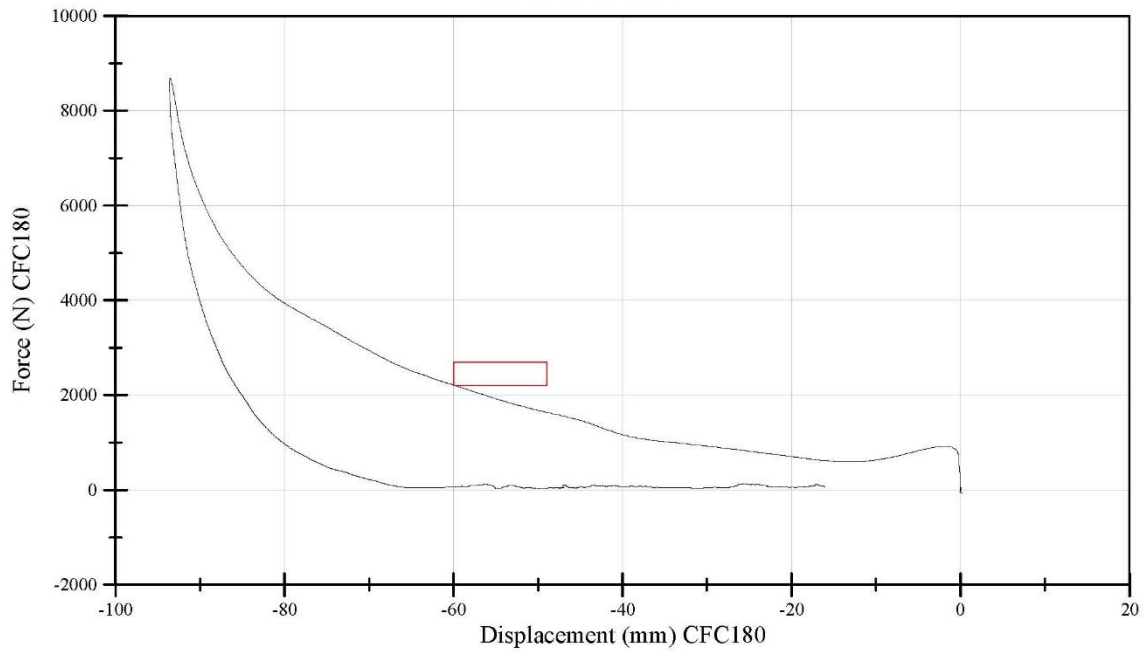
THOR Lower Abdomen Certification  
Abdomen Displacement vs. Probe Force  
Serial Number: T0016

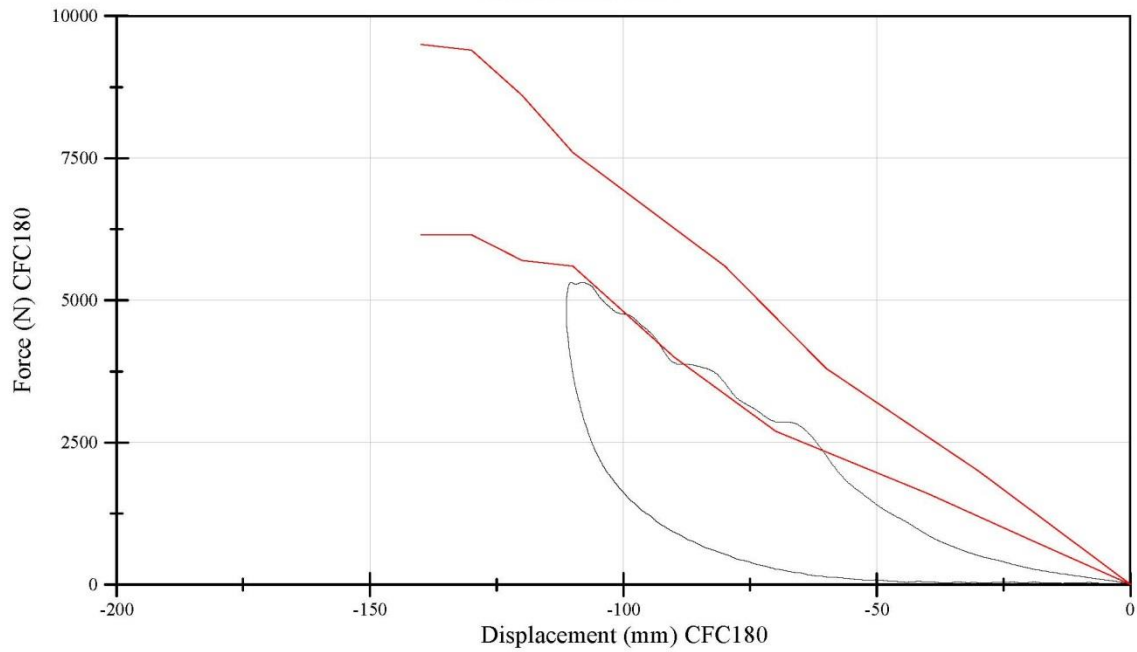
THOR Upper Abdomen Certification  
Abdomen Displacement vs. Probe Force  
Serial Number: T0016

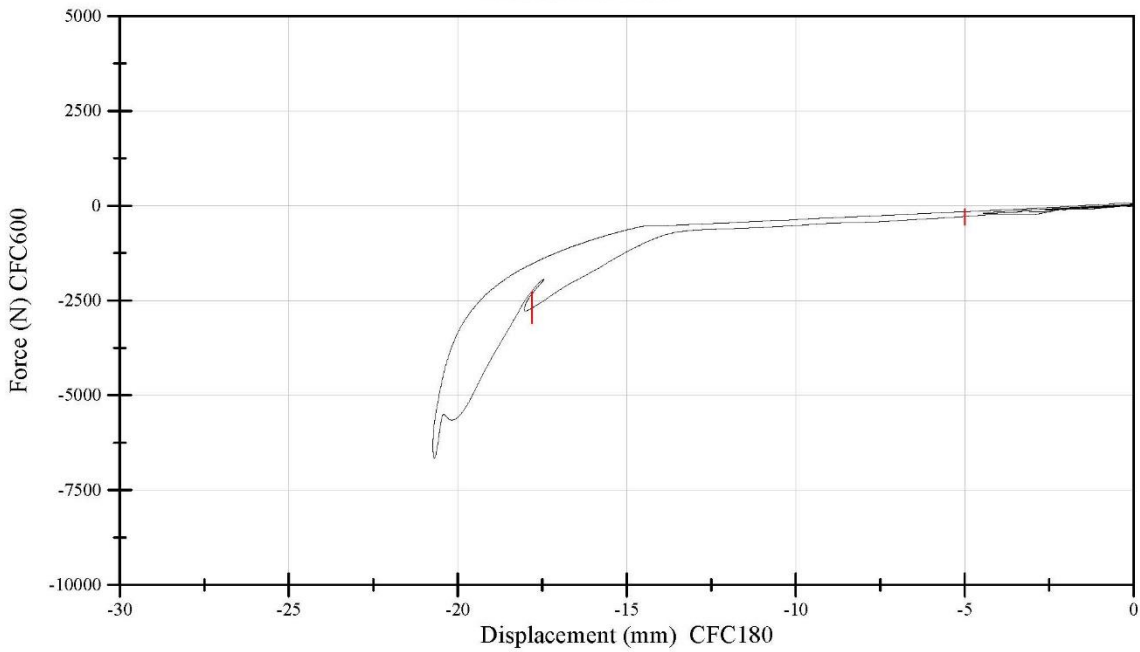
THOR Left Knee Certification  
Femur Force vs. Knee Displacement  
Serial Number: 017169

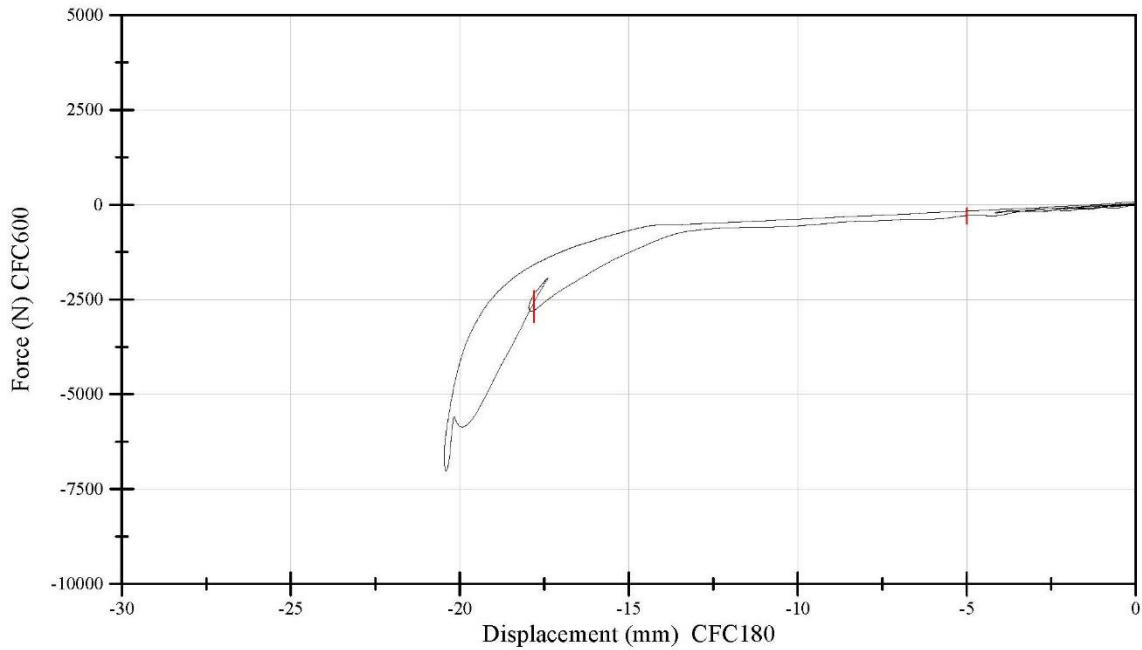
THOR Right Knee Certification  
Femur Force vs. Knee Displacement  
Serial Number: 12070382
