REPORT NUMBER: R&D-CAL-15-007

**MOVING BARRIER TO VEHICLE CRASH TEST IN SUPPORT OF NHTSA'S
FRONTAL OBLIQUE OFFSET PROGRAM
OBLIQUE MOVING DEFORMABLE BARRIER INTO LEFT FRONT OF A**

2015 Ford F-150

90.1KPH, 15 DEGREE ANGLE, 35% OVERLAP

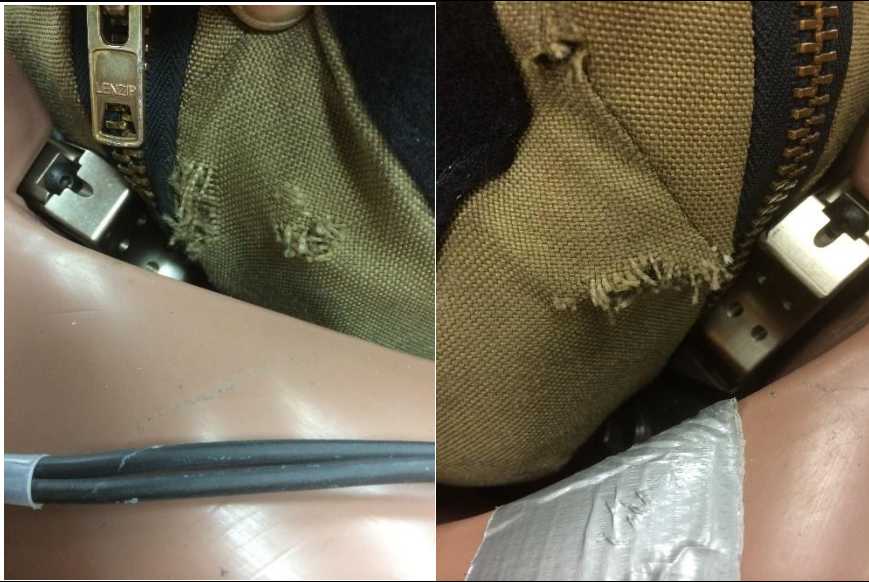
Y / N	Upper abdomen insert securely attached to spine
Y / N	Upper abdomen insert shows no evidence of permanent set
Y / N	No evidence of tearing, cuts, or broken stitches in lower abdomen bag and zipper Multiple tears and broken stitches in lower abdomen bag.

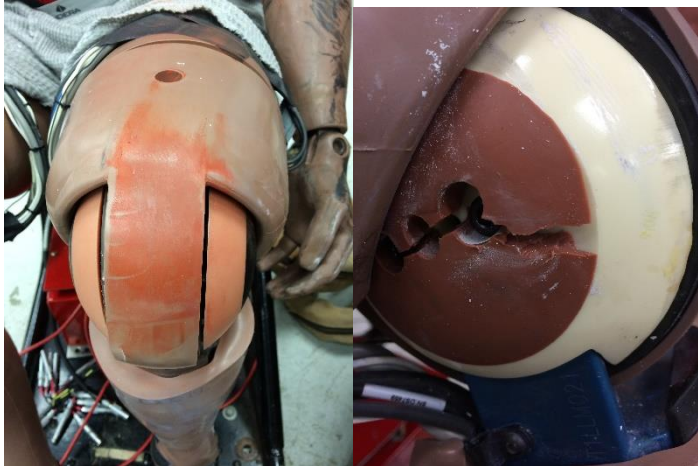
Y / N	Lower abdomen insert securely attached to spine	
Y / N	Lower abdomen insert shows no evidence of permanent set	
OTHER		
PELVIS		
Y / N	Pelvis flesh fits securely over pelvis bones	
Y / N	H-point tool fits securely into hole on both sides of pelvis	
OTHER		
FEMUR		
Y / N	Acetabular load cells firmly attached	
Y / N	Femur load cells firmly attached	
Y / N	No evidence of deformation of knee slider bump stop	
Y / N	No cuts, tears, or scuffing of knee flesh	
OTHER	Right knee- right cover flesh torn New heavy scuffing on left knee skin.

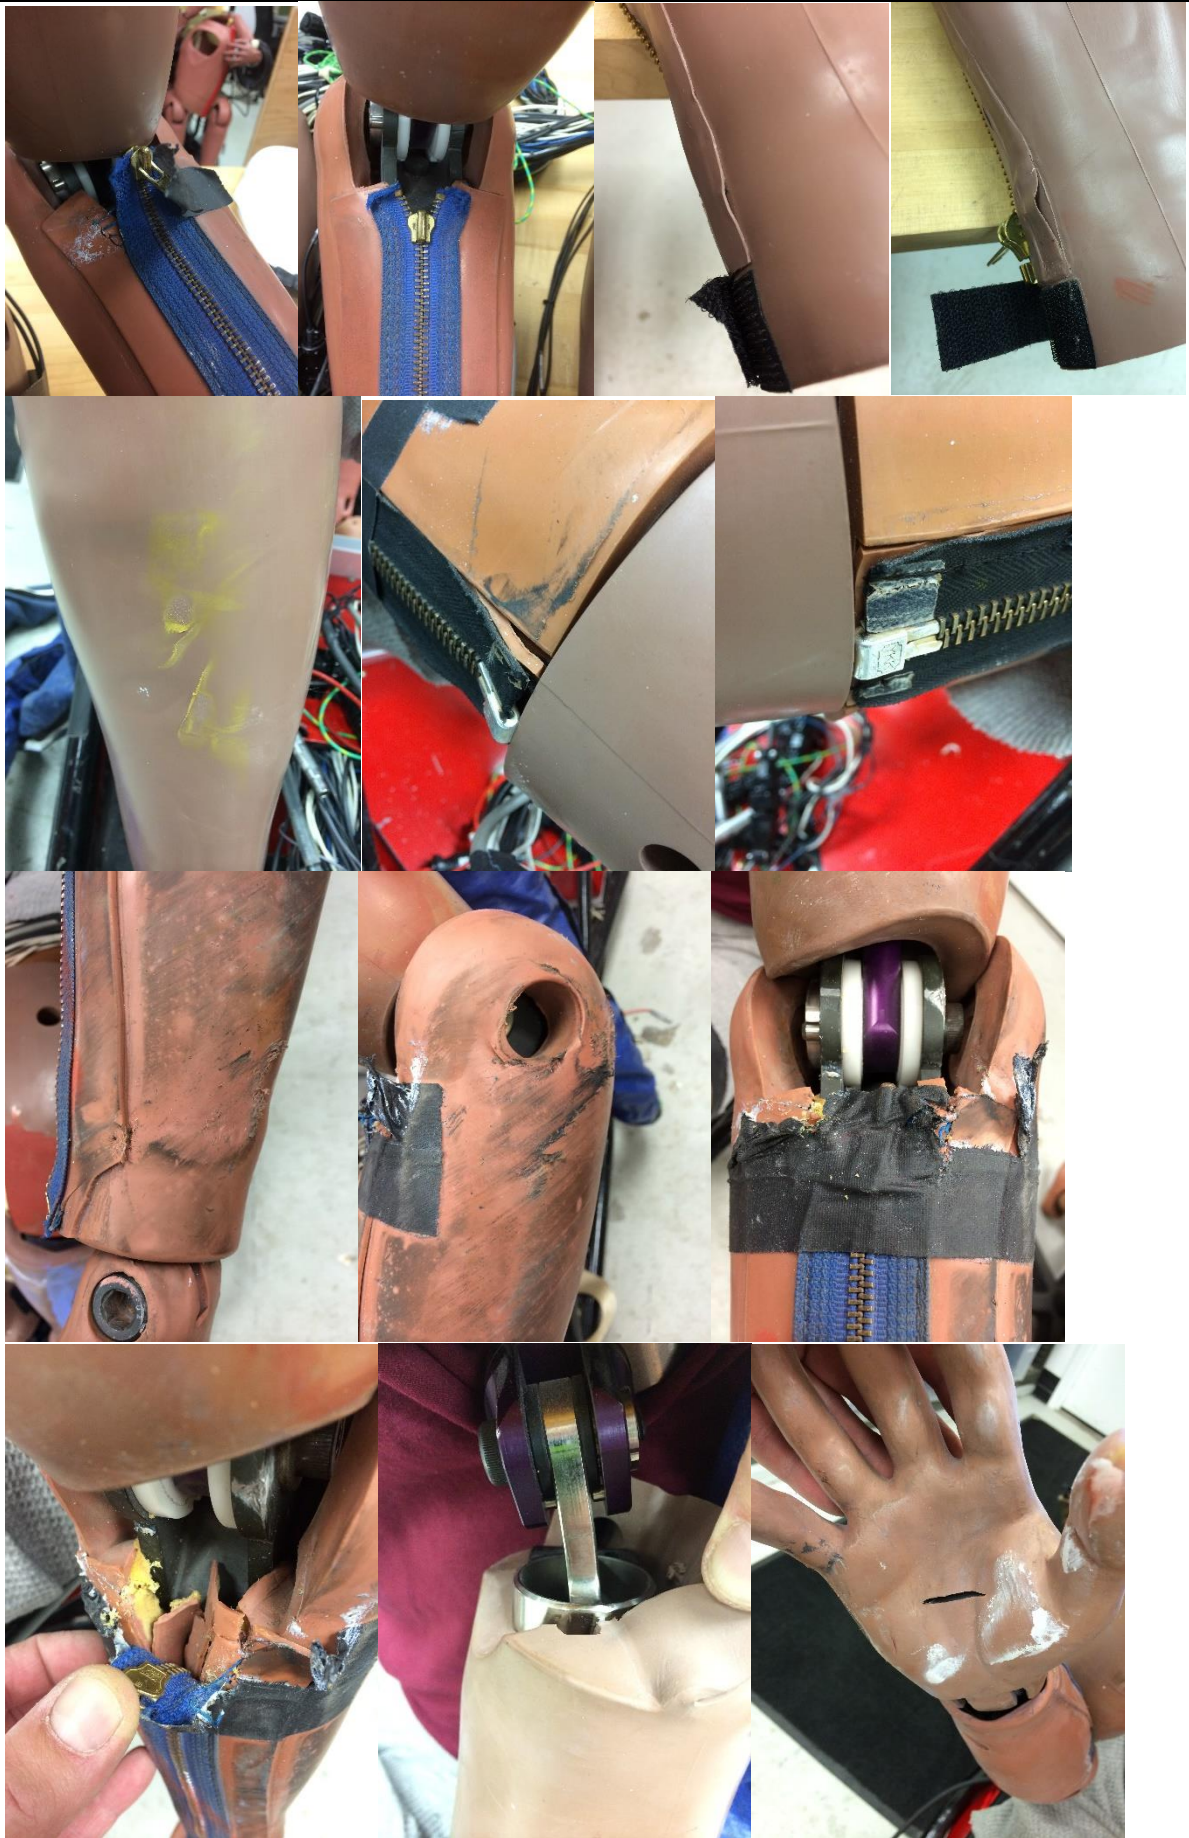
LOWER EXTREMITY (LX)		
Y / N	Rotational potentiometers in ankle securely attached	
Y / N	Achilles tendon provides resistance to dorsiflexion	
Y / N	No evidence of de-bonding, tearing, or permanent compression of ankle soft stops	
Y / N	No cuts, tears, or scuffing of leg flesh	
OTHER	Left forearm flesh damaged near elbow, heavy scuffing/abrasions all over left forearm, left humerus bent, puncture through palm of right hand. Heavy scuffing on front of right calf. Both thigh zippers detaching from flesh. Zippers detaching on left and right calves. Torn zippers/flesh on L & R forearms.

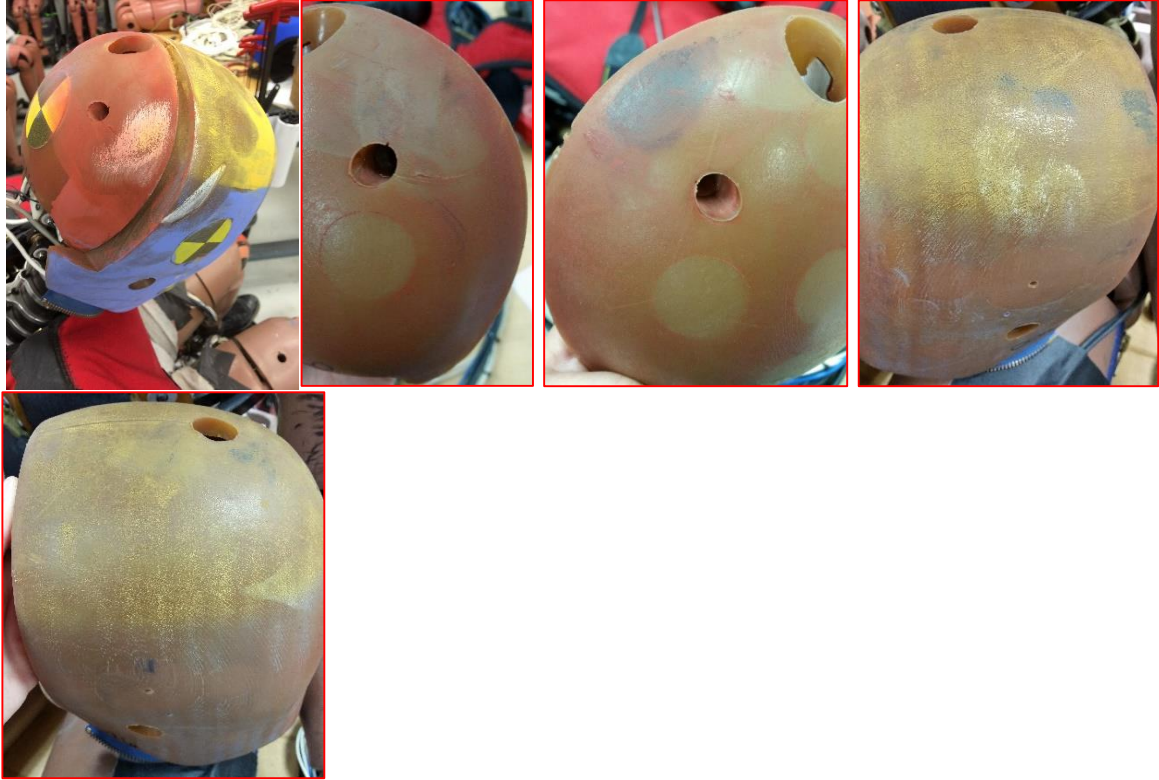
HEAD	
Y / N	Rear head cap mounts securely to head
Y / N	Head skin fits securely over skull
Y / N	Head skin shows no sign of tears or damage
Y / N	Interior components of skull cavity (ballast, accelerometer mount, accelerometers) securely attached
Y / N	Head securely mounted to OC joint
OTHER	<p>Right rear of head and right side of skull cap abrasions and scuffing. Rear head cap has a superficial cut and some scuffing. Head skin has scuffing.</p>

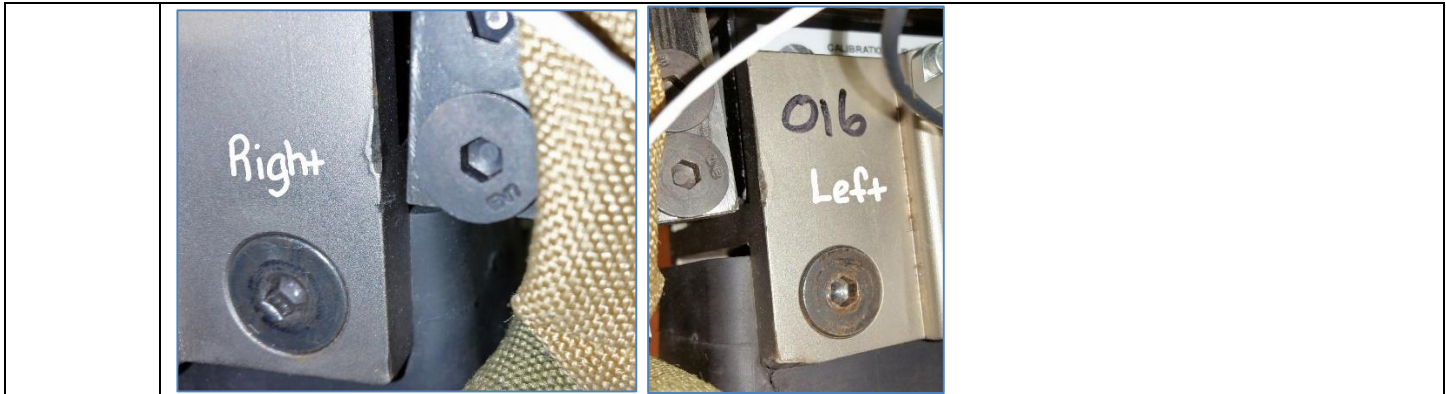
<p>Tears and rubbing damage to the front left Lumbar Spine. Tears also on rear sides – right side is pictured.</p>   <p>Damage is present on the surrounding metal structures of the Lumbar Spine</p>

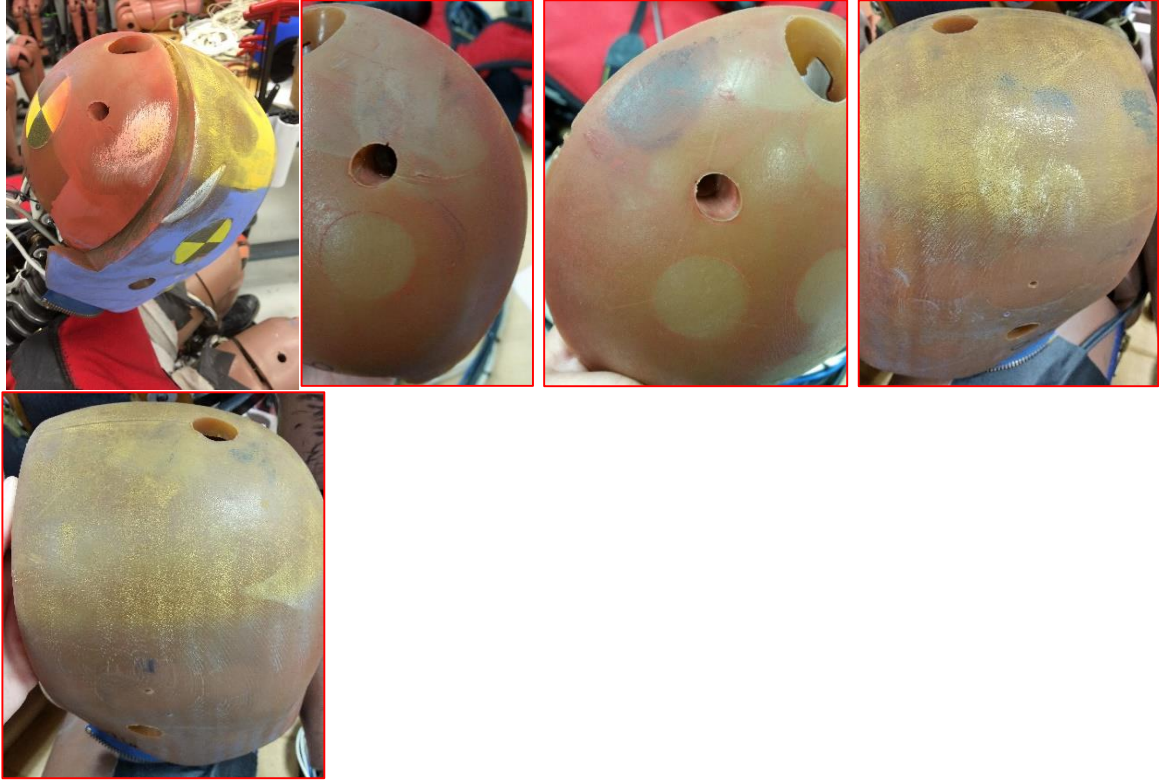
HEAD	
Y / N	Rear head cap mounts securely to head
Y / N	Head skin fits securely over skull
Y / N	Head skin shows no sign of tears or damage
Y / N	Interior components of skull cavity (ballast, accelerometer mount, accelerometers) securely attached
Y / N	Head securely mounted to OC joint
OTHER	<p>Right rear of head and right side of skull cap abrasions and scuffing. Rear head cap has a superficial cut and some scuffing. Head skin has scuffing.</p>

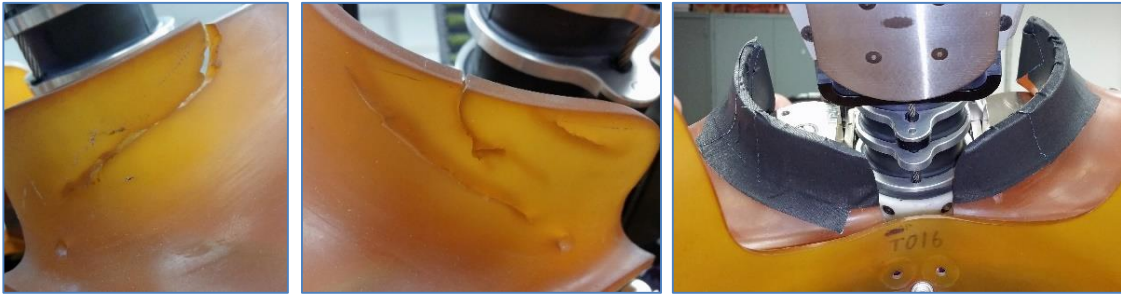
OTHER	<p>Urethane Pads are both torn, completely through, near the neck. We put Gaffer's tape over the tears to protect.</p>

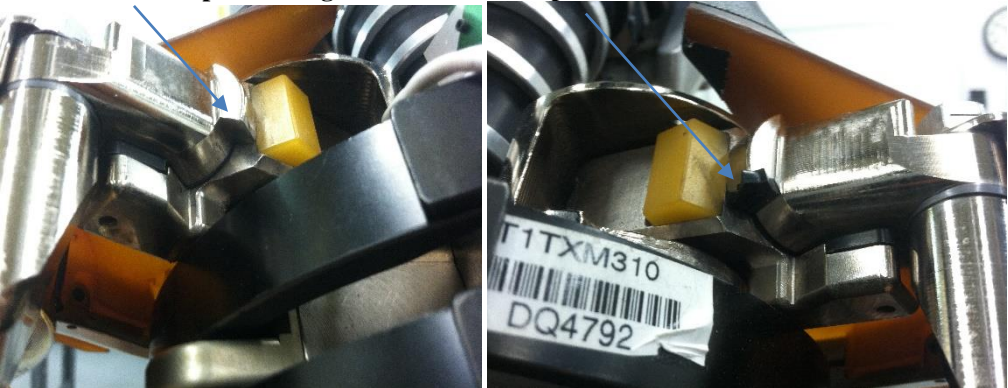
<p>LH shoulder bumper missing, RH shoulder bumper deformed</p>

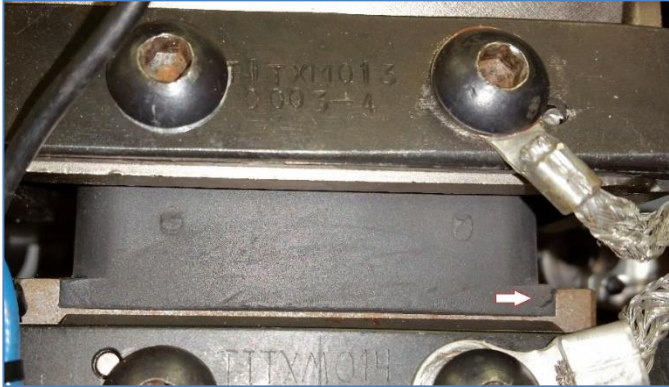
SPINE	
Y / N	No evidence of de-bonding between thoracic spine flex joint and metal plates
Y / N	No evidence of de-bonding between lumbar spine flex joint and metal plates
Y / N	Lumbar spine pitch change joint mechanism mating teeth are engaged
OTHER	<p>Small cut on the thoracic spine</p>

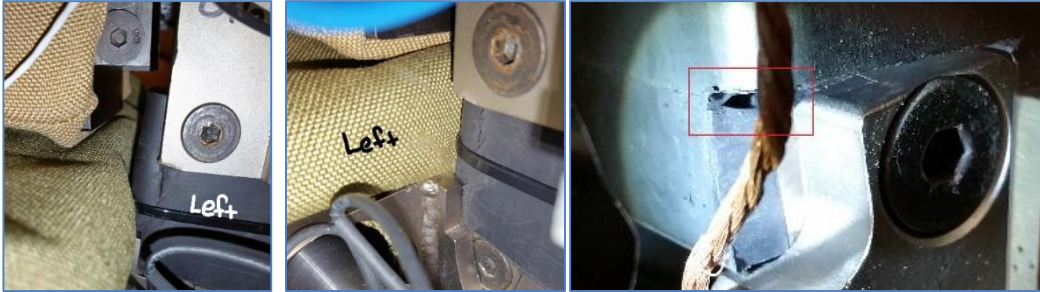
<p>Tears and rubbing damage to the front left Lumbar Spine. Tears also on rear sides – right side is pictured.</p>

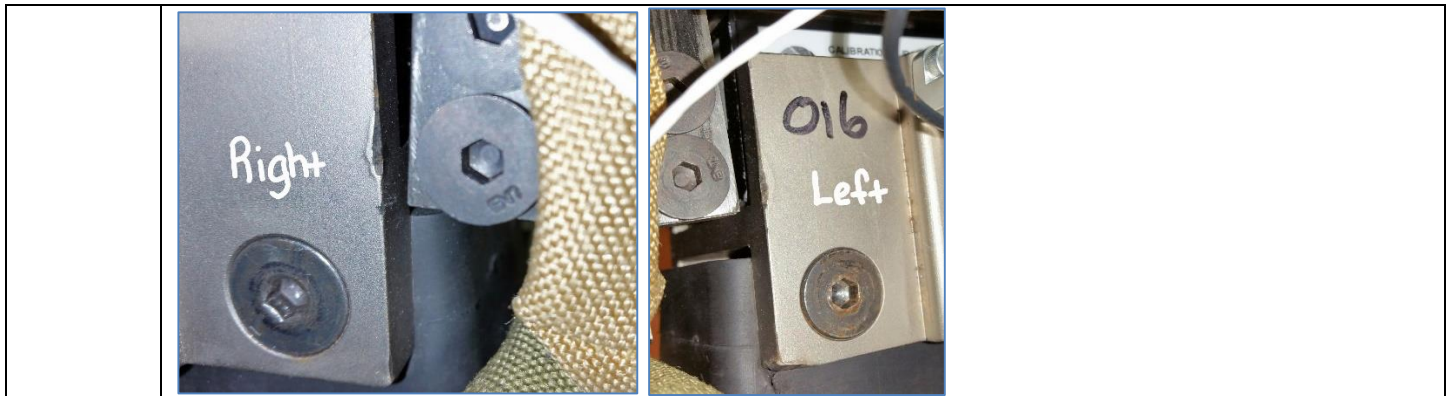
<p>Damage is present on the surrounding metal structures of the Lumbar Spine</p>

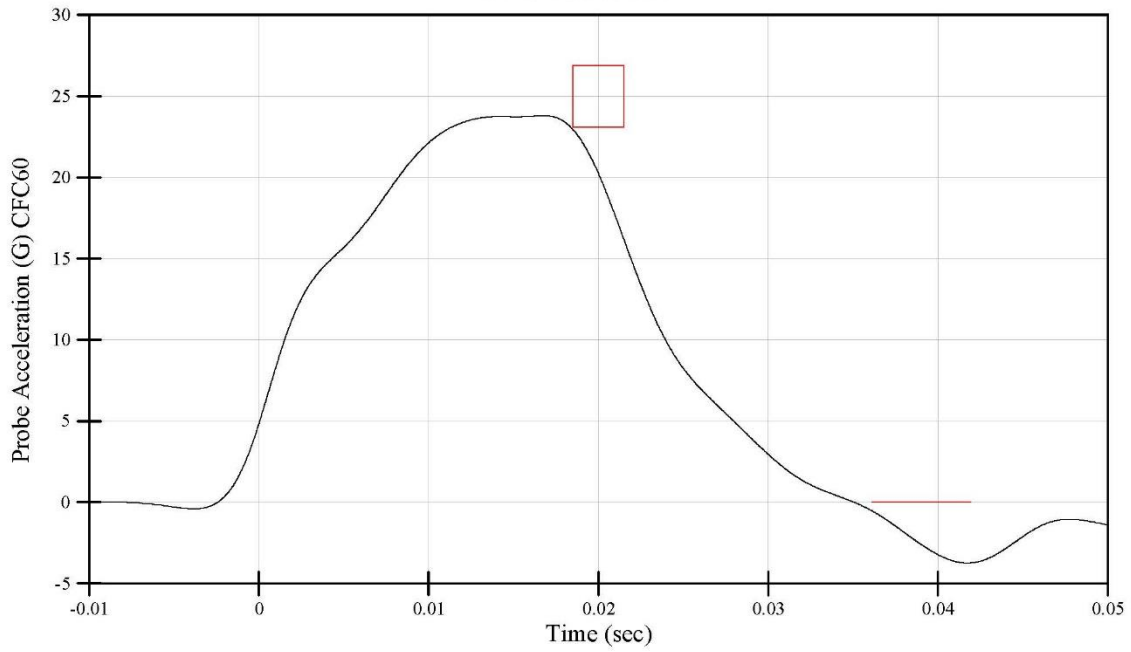
THOR Neck Extension Certification
Probe Acceleration
Serial Number: T015

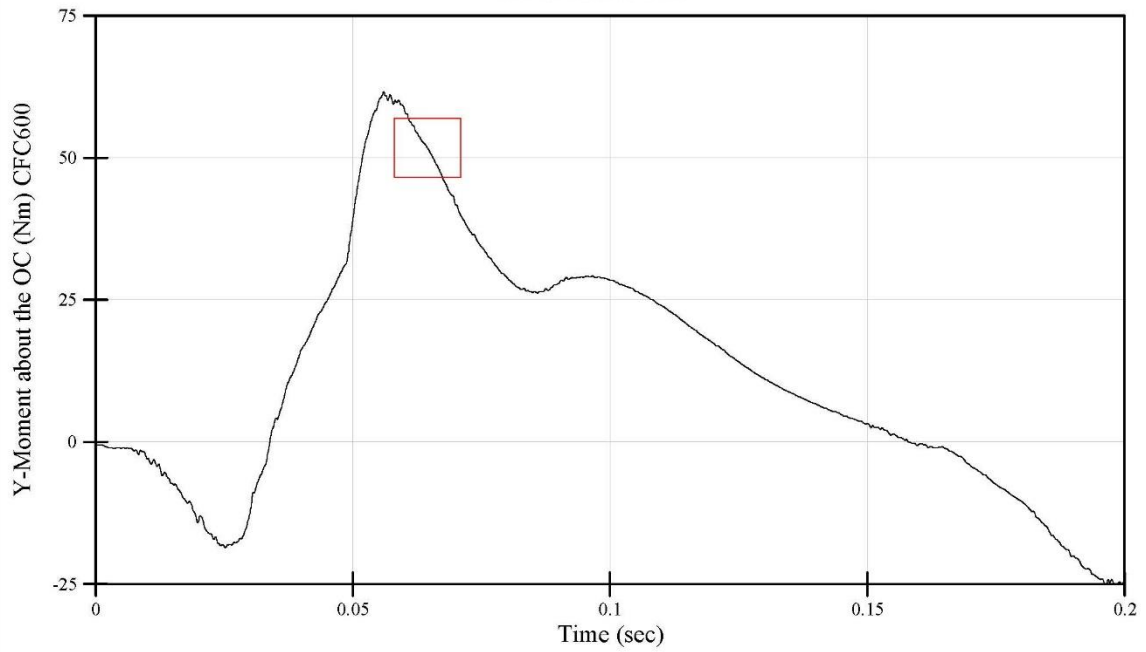
THOR Neck Flexion Certification
Y-Moment
Serial Number: T015

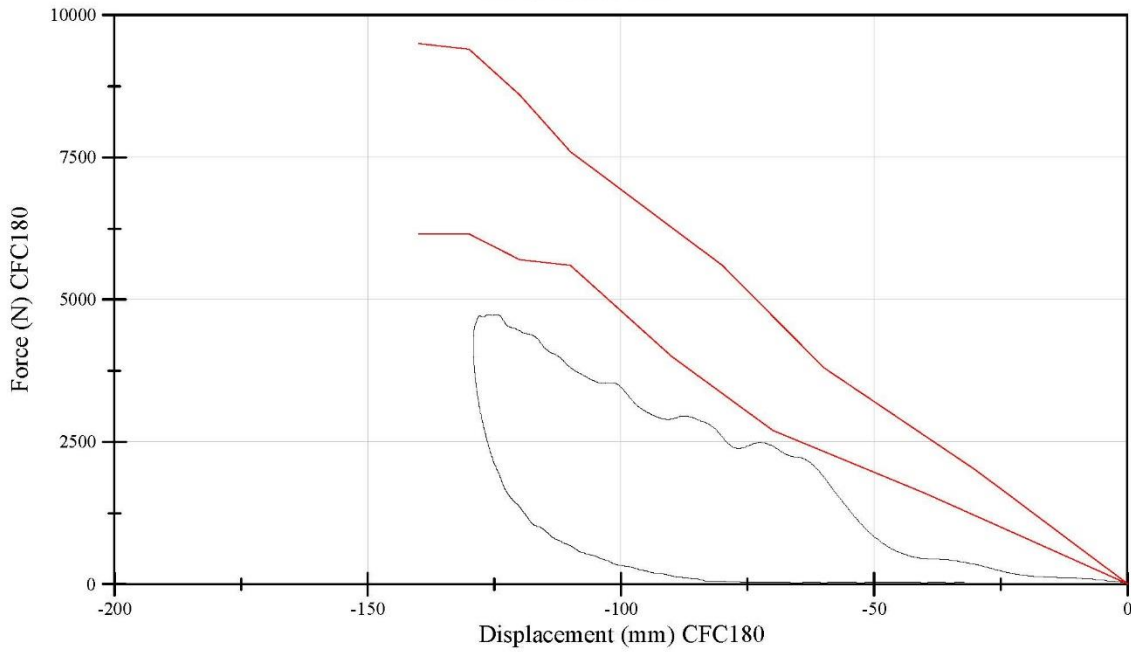
THOR Upper Abdomen Certification Abdomen Displacement vs. Probe Force Serial Number: T015

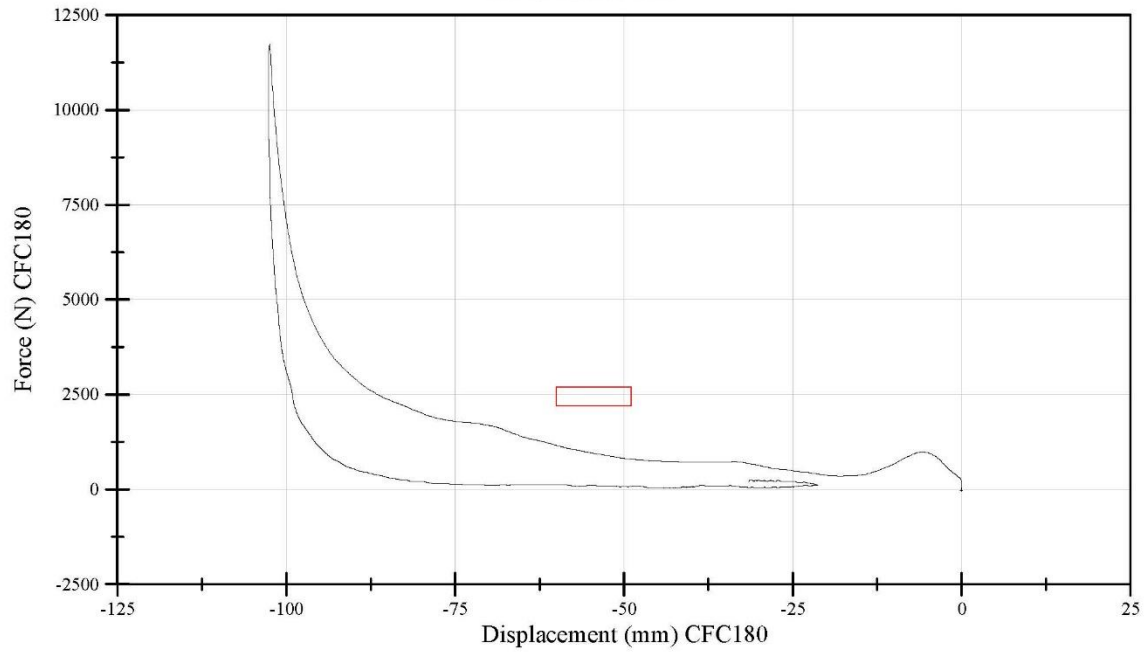
THOR Lower Abdomen Certification
Abdomen Displacement vs. Probe Force
Serial Number: T015

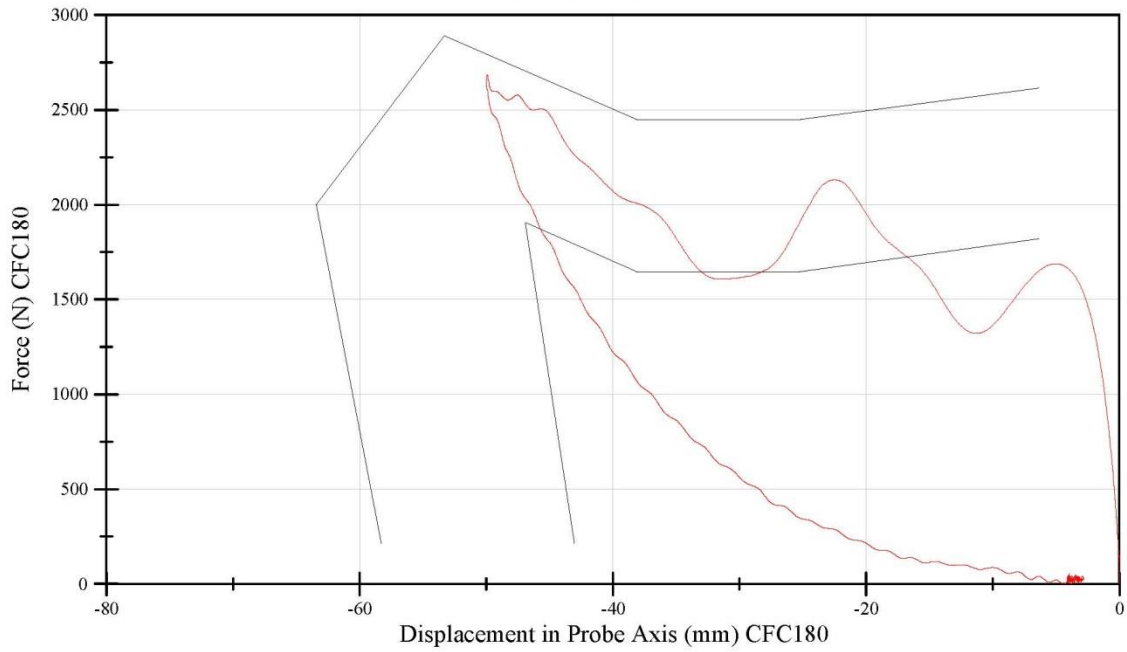
THOR Upper Thorax Certification
Thorax Response With Kroell Corridor
Serial Number: T015

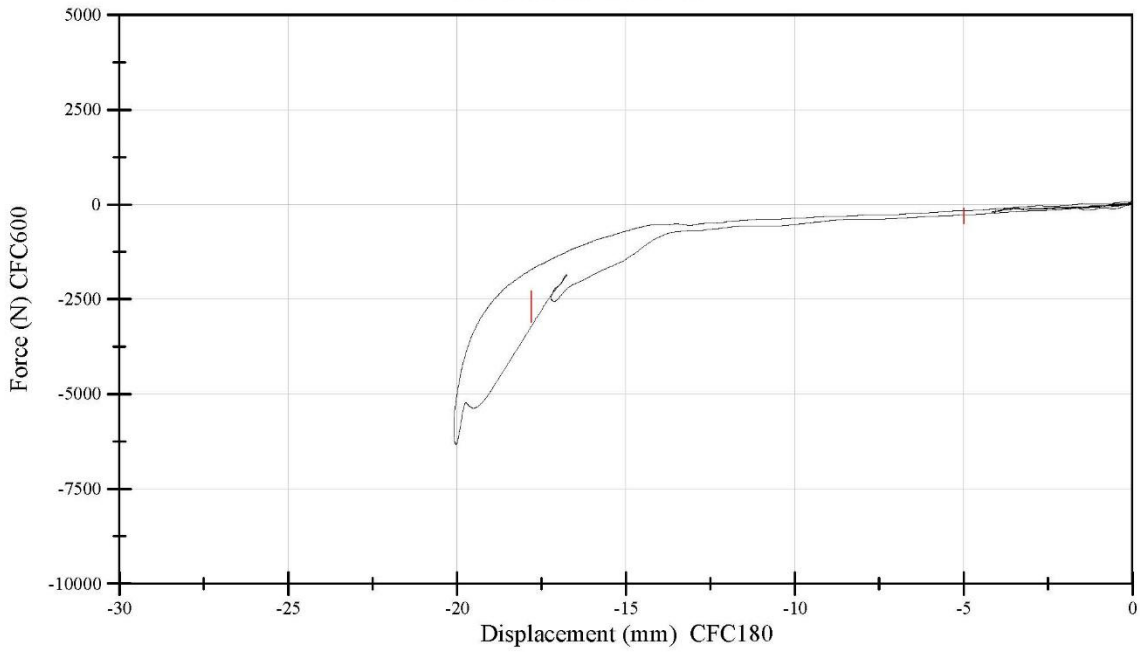
THOR Right Knee Certification
Femur Force vs. Knee Displacement
Serial Number: D2103657B

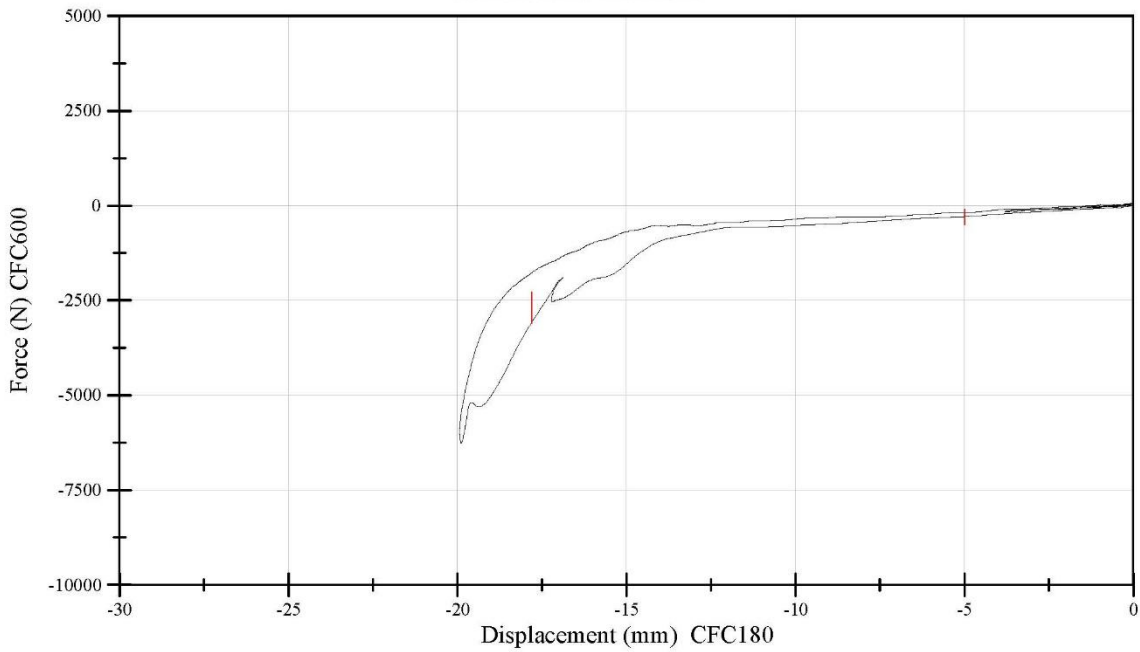
THOR Left Knee Certification
Femur Force vs. Knee Displacement
Serial Number: D2103665B
